Distribution Conductor Burndown Test Results

Small Bare and Large Covered Conductor

1017839

Technical Update, December 2009

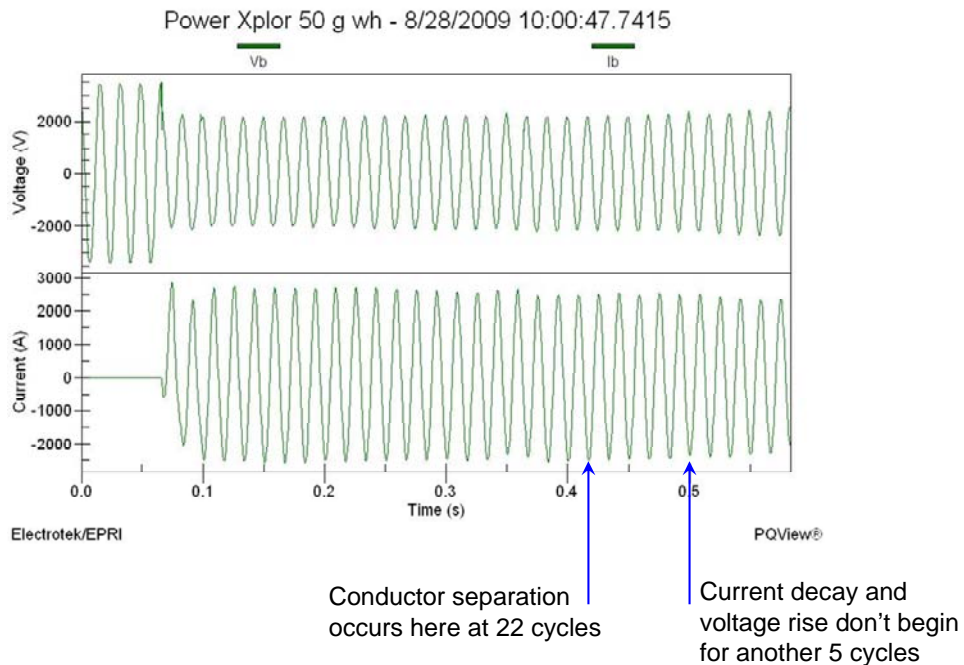
Figure 4-13
Instance Where Exact Timing of Conductor Failure Cannot Be Determined from Waveshapes

It also sounds as if the time of conductor failure was not clearly evident on all of the oscillograms. It can be extremely challenging to determine exactly when the conductor breaks from the waveshape alone. As the conductor separates, the arc continues to burn between the energized end of the conductor and the other electrode (an insulator pin in the Lasseter work). When the conductor breaks, the energized end swings away, drawing out the arc. The fault current will decay and the voltage will rebound as the arc length increases, but full arc current can still flow for several cycles as the conductor pulls away as illustrated in Figure 4-13. The burndown time for this event was accurately determined by reviewing the high-speed video recorded during the test. Figure 4-14 shows several frames from a 300-frame-per-second high-speed video of a burndown test, illustrating how the fault current continues to flow after conductor separation.

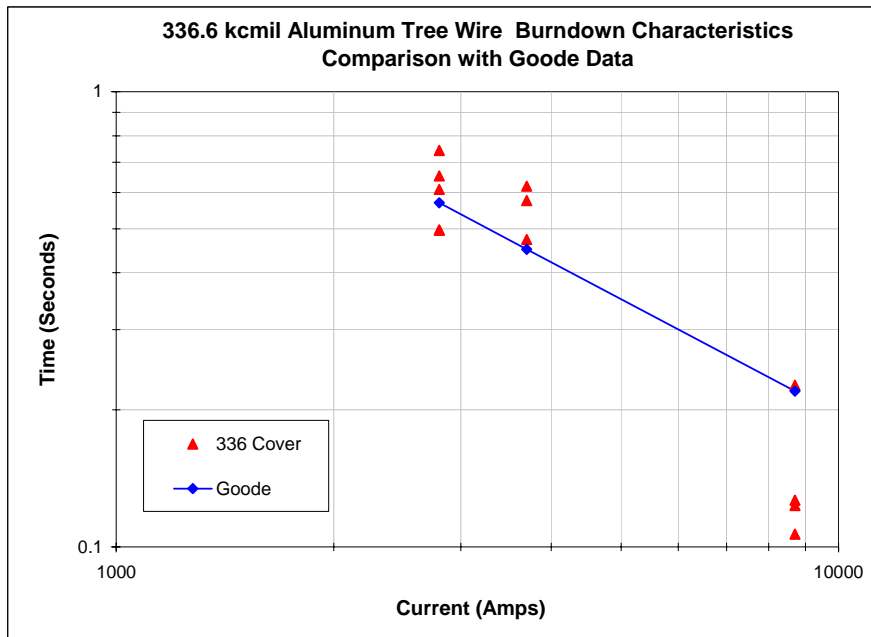
Figure 4-15
Comparison of Recorded Burndown Characteristics with Data Reported from Goode Work for 350-kcmil (177.3-mm^2) Aluminum Conductor (Goode and Gaertner 1965)

A comparison of the burndown characteristics recorded for the 336.4-kcmil (170.5-mm^2) aluminum conductor shows good coordination with the results reported by Goode, as shown in Figure 4-15. There is some discrepancy at the highest current value of 8,700 amps. The data recorded during this testing show two fast burndowns occurring in less than 10 cycles at 8,700 amps. The reason for this discrepancy is not known.

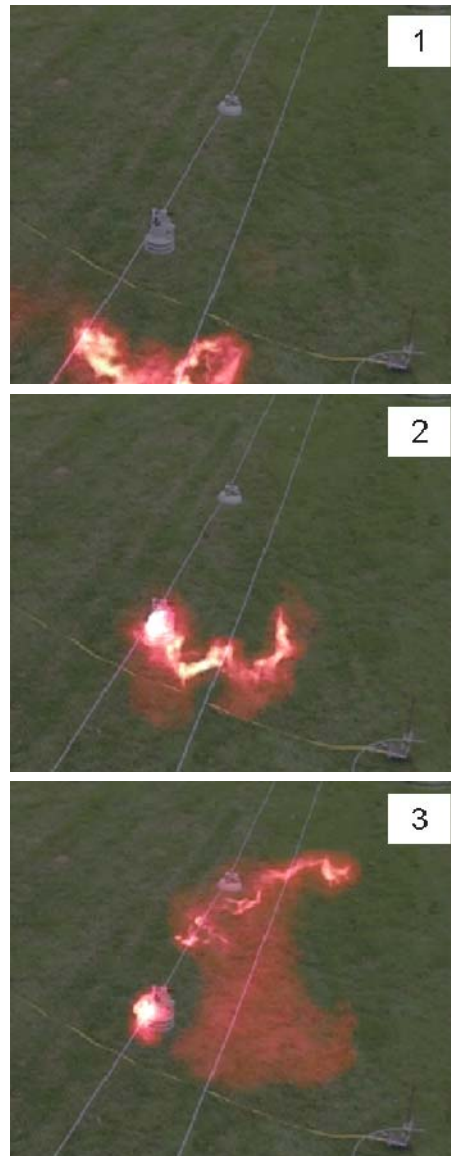
Figure 4-21
Arc Motoring Down the Test Line

Figure 4-21 shows an example of one arc attachment test. The images in Figure 4-21 are taken from a 3000 frame-per-second digital video recording of the test. An IR pass filter is used to isolate the arc channel, as discussed in Section 3, Test Setup and Methods, and then a static background image is overlaid on the video frames to produce these images.

- *Frame 1* – The arc is motoring toward the vice-top polymer insulator.
- *Frame 2* – The arc slows down and lingers at the vice-top, injecting more heat into the conductor at this location than at others where it moves swiftly past.
- *Frame 3* – The arc has motored past the vice-top insulator, but the damage is already done. The conductor begins to separate at the vice-top insulator, creating a second arc.

From the images in Figure 4-21, it appears that the arc is not attached to the conductor on the right side of the images. This is because the static background image is taken before the test begins. Once the arc is ignited, the fault current flowing in the conductors pushes them apart, making the arc to appear to be terminating in the air.

- *Polymer vice-top insulator* – The polymer vice-top insulator was attached to the bare #4 ACSR conductor, with the vice jaws clamped around the line per a typical installation. This test was repeated twice. During the first test, shown in Figure 4-21, the arc did not anchor at the insulator, but its motion down the line did slow considerably. Post-test inspection revealed that the conductor inside the jaws of the vice-top insulator had suffered significant damage (Figure 4-22). The test line was lightly tensioned during this test, and it is believed that the conductor would have fully separated had the line been under tension loading typical of field conditions. The other test conductor also incurred some “bird caging” damage as a result of the arc slowing down (Figure 4-23).

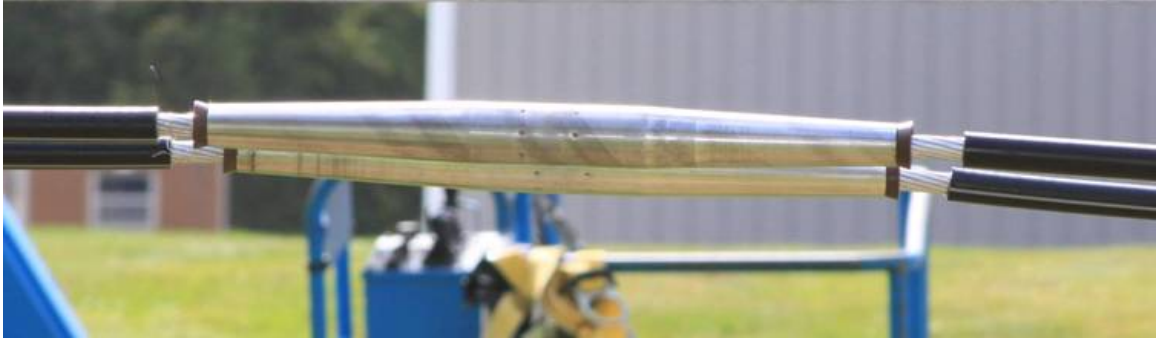
Figure 4-24
Automatic Splices Installed on 336.4 kcmil (170.5 mm²) Aluminum Tree Wire

The effectiveness of arc protective devices in preventing conductor damage or burndown was investigated using 336.4-kcmil (170.5-mm²) aluminum tree wire. The test conductors were configured with automatic splices at the midway point, as shown in Figure 4-24. The insulation was stripped back, such that there was an approximately 2-in. (5-cm) gap between the insulation and the splice. This was felt to be a reasonably accurate representation of a typical field installation. This configuration, with two test conductors approximately 24 in. (31 cm) apart, was used for all of the arc protective device tests. Arcs were ignited by shorting the two conductors together with a thin fuse wire prior to energizing the circuit. The fuse wire was placed on the exposed conductors on the source side of the splices.

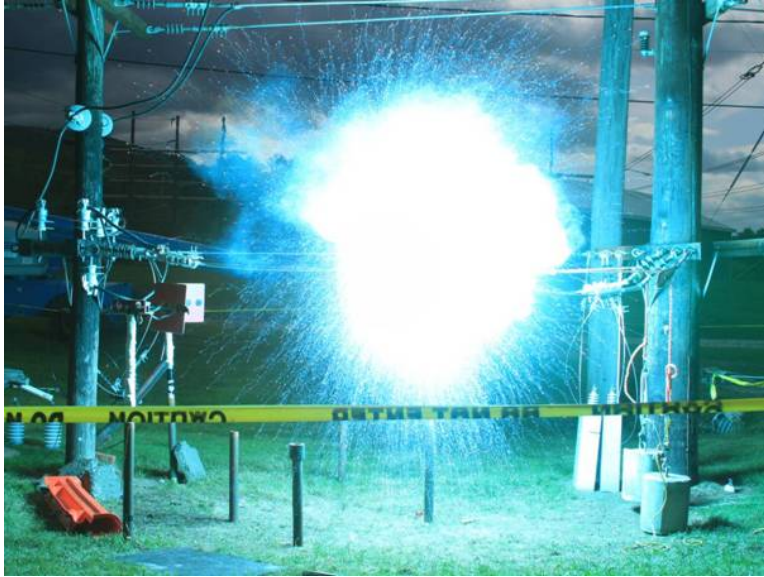
Figure 4-26
Conductor Burndown Test on 336.4-kcmil (170.5-mm²) Aluminum Tree Wire with Automatic Splices

The second test, shown in Figure 4-26, resulted in burndown of both conductors. The burndown locations are shown in Figure 4-27.

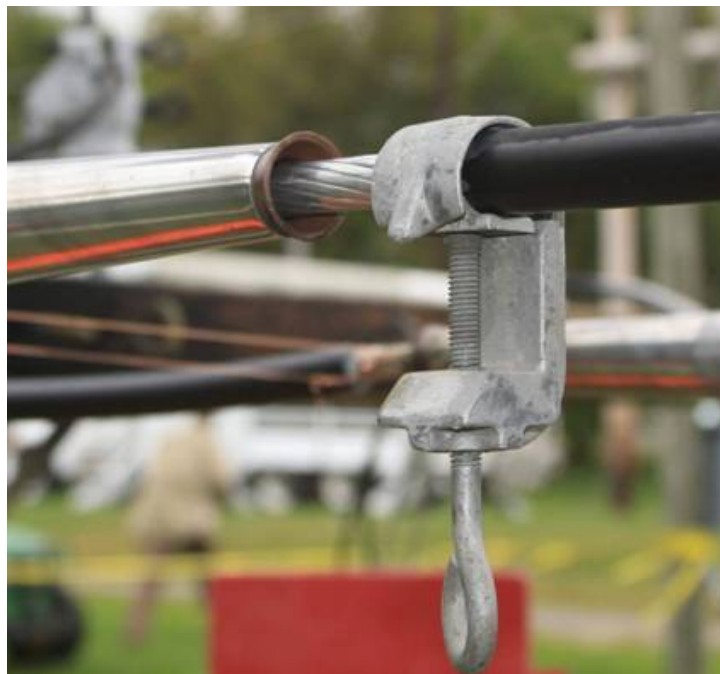
Figure 4-28
Properly Installed Arc Protective Device

The spliced conductor configuration was used again, but this time arc protective devices (APD) were added to the load side of each splice. The clamps were properly installed, with the clamp body bridging the interface between the bare conductor and insulation, as shown in Figure 4-28.

APDs are sometimes referred to as “do nothing clamps” by linemen who feel that the APDs do not protect the conductor from burndown during arcing events. However, this sentiment may be fueled by improper installation of the devices. The APD works by providing sacrificial metal and thermal mass at the arc attachment point. In order to work properly, they should be installed at the load-side junction, where the conductor transitions from stripped to covered. If there is a gap of bare conductor between the APD and the covering, the arc will motor past the clamp and attach to the conductor where the covering begins.
