Accelerated Corrosion Testing of BORAL®

1018911

Final Report, April 2009

Northeast Technology Corporation

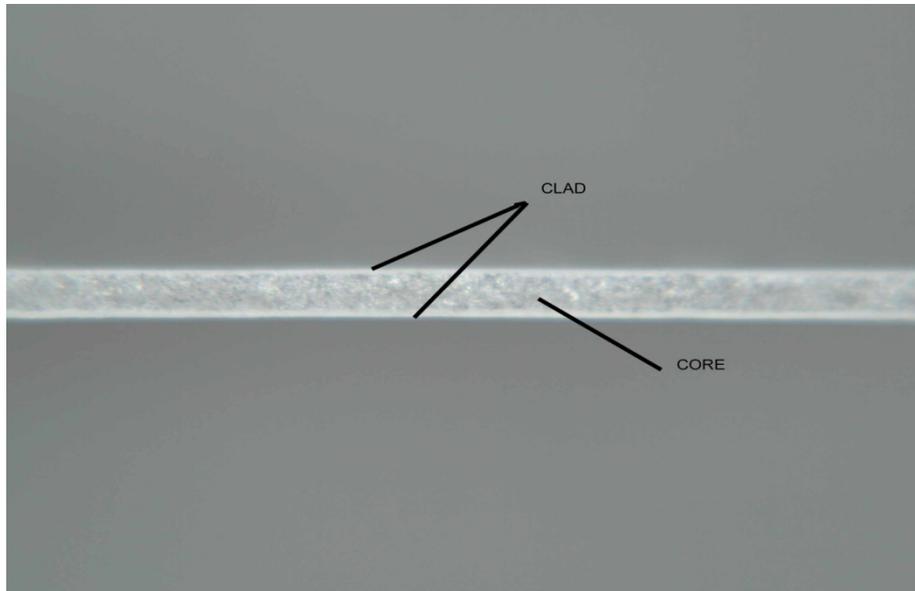
Figure 1-1
Microphotograph of the Trimmed Edge of BORAL

During the first two inspections, blisters and corrosion pits were noted in the cladding of the BORAL. Blister formation occurs when the cladding of BORAL separates from the Al/B₄C core region of the material. Figure 1-1 shows the trimmed edge of a BORAL coupon showing the Al-1100 cladding on both sides of the central core region.

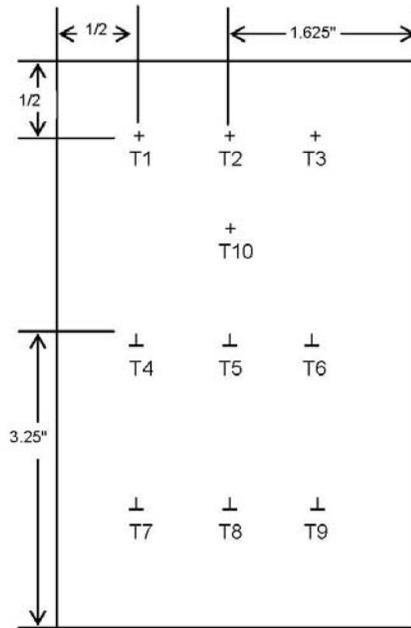
Figure 3-8
Locations for Coupon Thickness Measurements

The thickness of each coupon was measured before and after testing at ten locations as shown in Figure 3-8. Within the precision of the measurements, no significant change in thickness was observed.

Note: Location T10 is under the inspection port
