# Plant Engineering: Emergency Diesel Generator Excitation System End of Expected Life Guidance

2013 TECHNICAL REPORT

**3002000568**

Final Report, December 2013

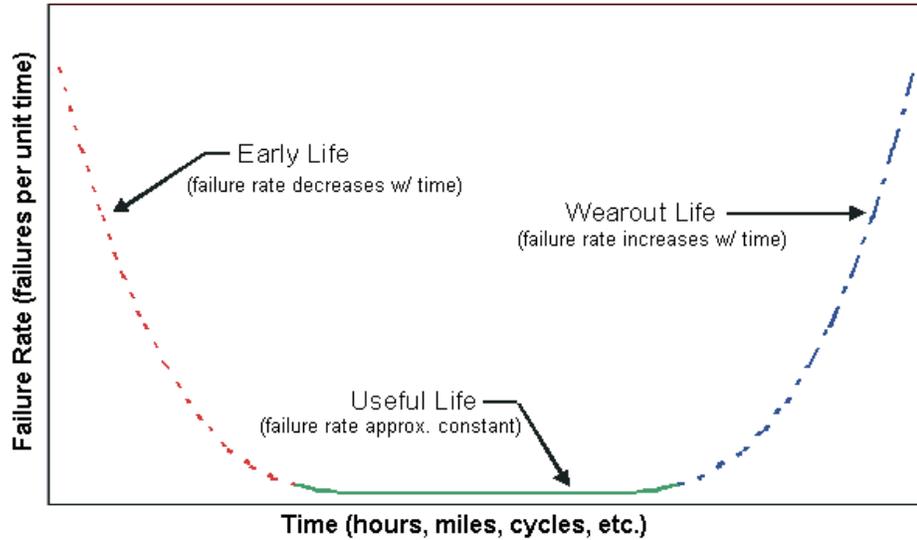
Figure 3-2  
Bathtub curve showing component reliability

- For a shape parameter  $< 1.0$ , the Weibull function takes the form of the gamma distribution with a decreasing failure rate (that is, infant mortality in the bathtub curve, Figure 3-2).
- For a shape parameter  $= 1.0$ , the failure rate is constant, so that the Weibull function takes the form of the simple exponential distribution (the flat part in the bathtub curve, Figure 3-2).
- A shape parameter  $> 1$  indicates a failure rate that is linearly increasing with time (that is, the wearout period in the bathtub curve, Figure 3-2).

Therefore, a calculated Weibull shape parameter of 1.43 indicates an increasing failure rate representing a wearout period. The root causes identified in the OE review show that this wearout is accelerated by external factors such as PM deficiencies, operational errors, and so on. Figure 3-3 shows how the cumulative probability of failure changes with years after installation.
