An EPRI White Paper

## CARNEGIE ROAD ENERGY STORAGE SYSTEM FAILURE RESPONSE, RECOVERY, AND REBUILD LESSONS LEARNED

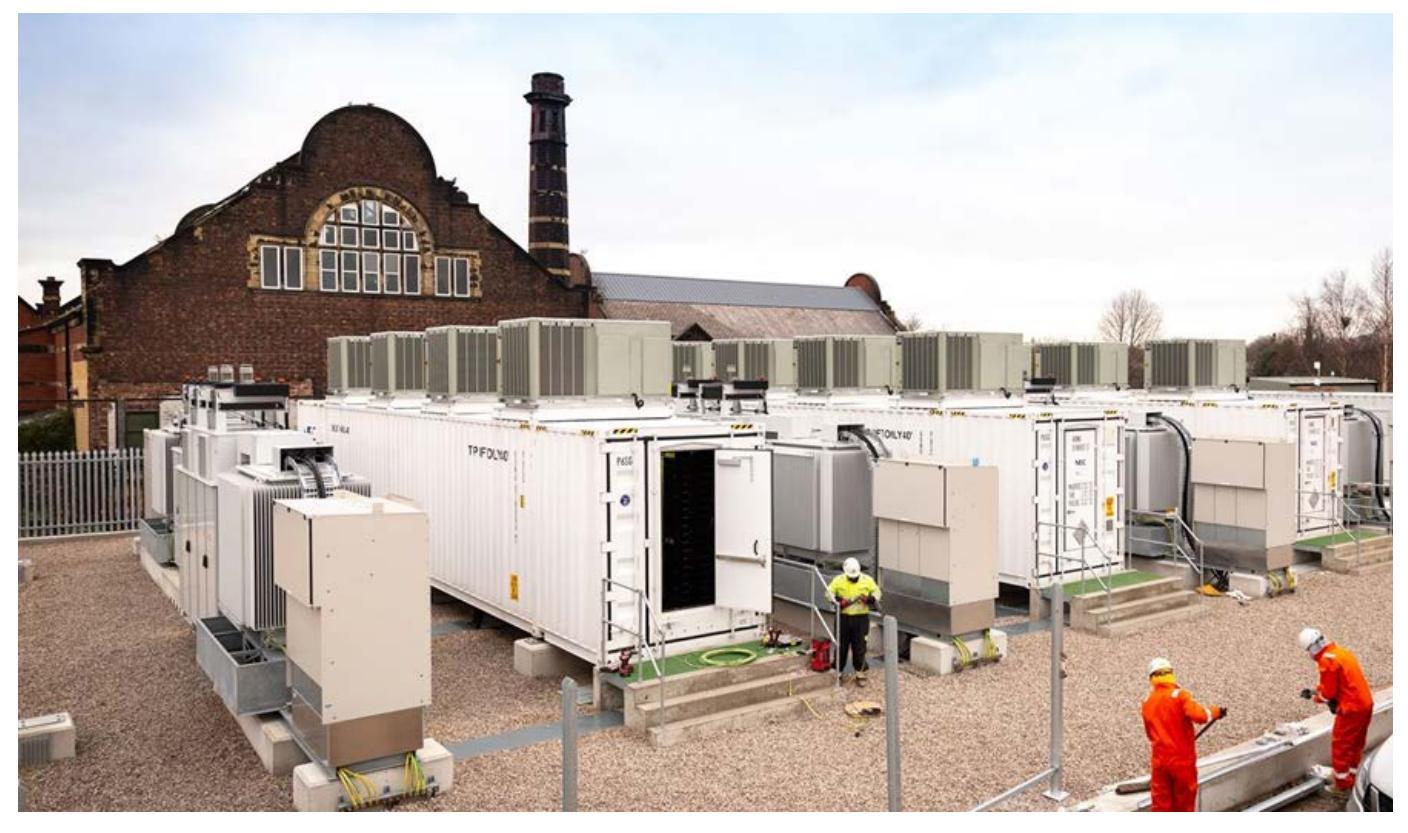
Figure 1

The Carnegie Road BESS was first energized in December 2018 and commissioned in May 2019. The BESS is located in Liverpool, UK and interconnected to the Scottish Power Energy Networks at 33 kV. It includes three containerized battery enclosures within the site footprint (see Figure 1).

Carnegie Road energy storage site image; source: <u>https://orsted.com/en/media/newsroom/news/2019/01/orsteds-first-standalone-battery-storage-project-now-complete</u>

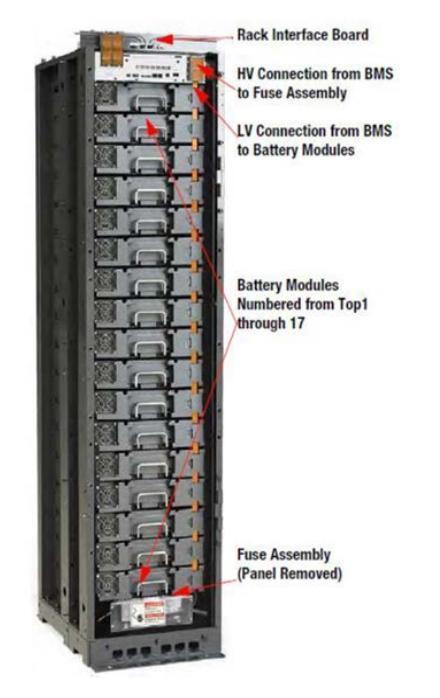
Each battery rack contains 17 modules, a fuse assembly panel, and a rack battery management system (BMS) (see Figure 2). Although the modules are supplied by LG Chem, NEC supplies and manages the BMS. Each rack is designed for 112.1 kWh (DC) of energy storage.

Figure 2 NEC battery rack and LG module configuration; source: Merseyside Fire & Rescue Service
