Swedish Utility Experience With ASEA- ATOM-Design Top Guides

Technical Report

NP-5947
Research Project 1930-4

Final Report, August 1988

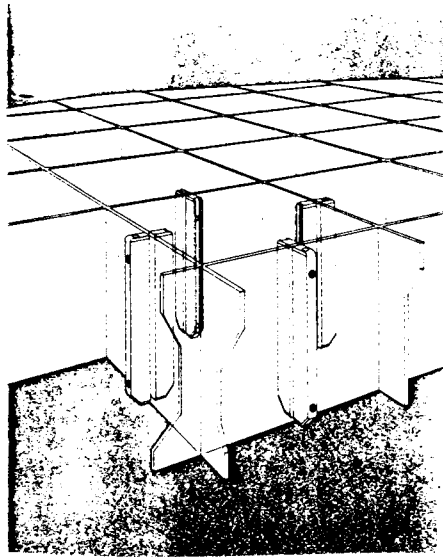
Figure 2-3
Attachment of Guide Bar Pairs to Core Grid Plates

The guide bars are fixed to the core grid plates with two bolts, as shown in Figures 2-3 and 2-4. All grids belonging to Generations 1 through 3 have the same guide bar arrangement. Dimensions and design details vary slightly however. Different materials have been used for the bolts, as discussed earlier.

During the refueling outage of Forsmark 2 in 1982 it was shown by ultrasonic inspection that a large number of bolts had cracked (more than 200 indications). At least two bolts had fractured completely. Later that same year the status of the bolts was investigated for Forsmark 1, TVO 1 and TVO 2. Fractured or cracked bolts were found in all three reactors. For all Generation 3 core grids the original bolts were manufactured from precipitation hardened A286 material.

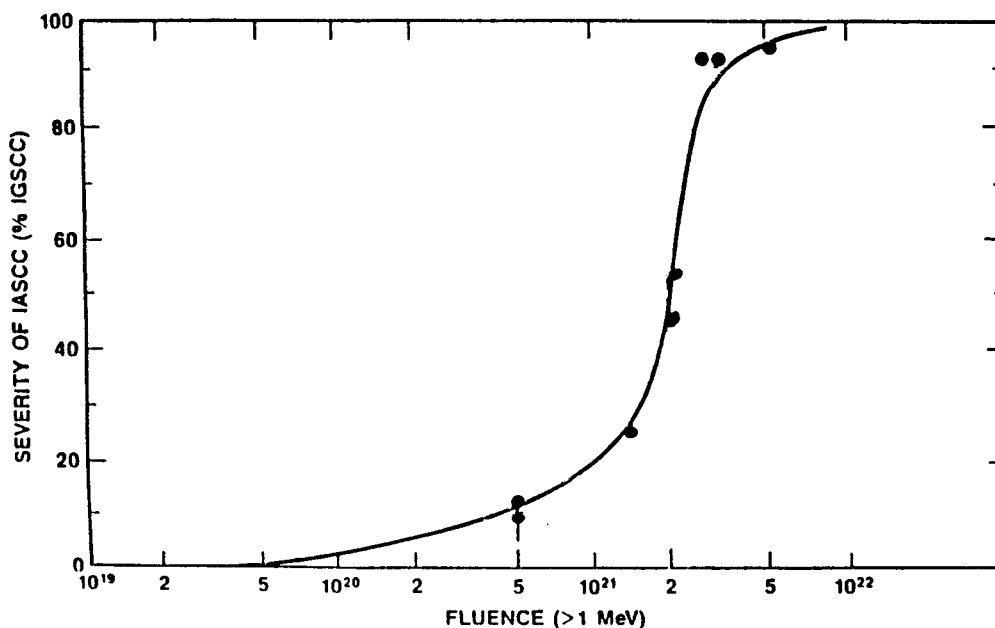
Figure 6-2
IASCC CERT Results on Irradiated Annealed
Type 304 SS (288°C, pure H₂O with 32 ppm O₂)

That IASCC may be a problem in austenitic stainless steels when the fast neutron fluence reaches values above approximately $5 \cdot 10^{20}$ n/cm² is now generally accepted (3). It is also accepted that certain impurities such as silicon and phosphorus play an important role for this form of stress corrosion. A summary of laboratory results is presented in Figure 6-2 (4). These results are not necessarily relevant for in-reactor condition. According to these data 50 % of the cracked area is intergranular when testing after irradiation to a fluence of approximately $2 \cdot 10^{21}$ n/cm².
