Advanced Gas Turbine Guidelines: Hot Gas Path Parts Condition and Remaining Life Assessment for GE 7FA in Baseload Operation

TR-106329
3125-02

Final Report, December 1996

The Guideline on Hot Gas Path Parts Condition and Remaining Life Assessment provides results of monitoring and inspection of four General Electric (“GE”) MS 7221 FA Advanced Gas Turbines, in baseload service at Florida Power & Light’s (“FP&L”) Martin Station, Indiantown, Florida.

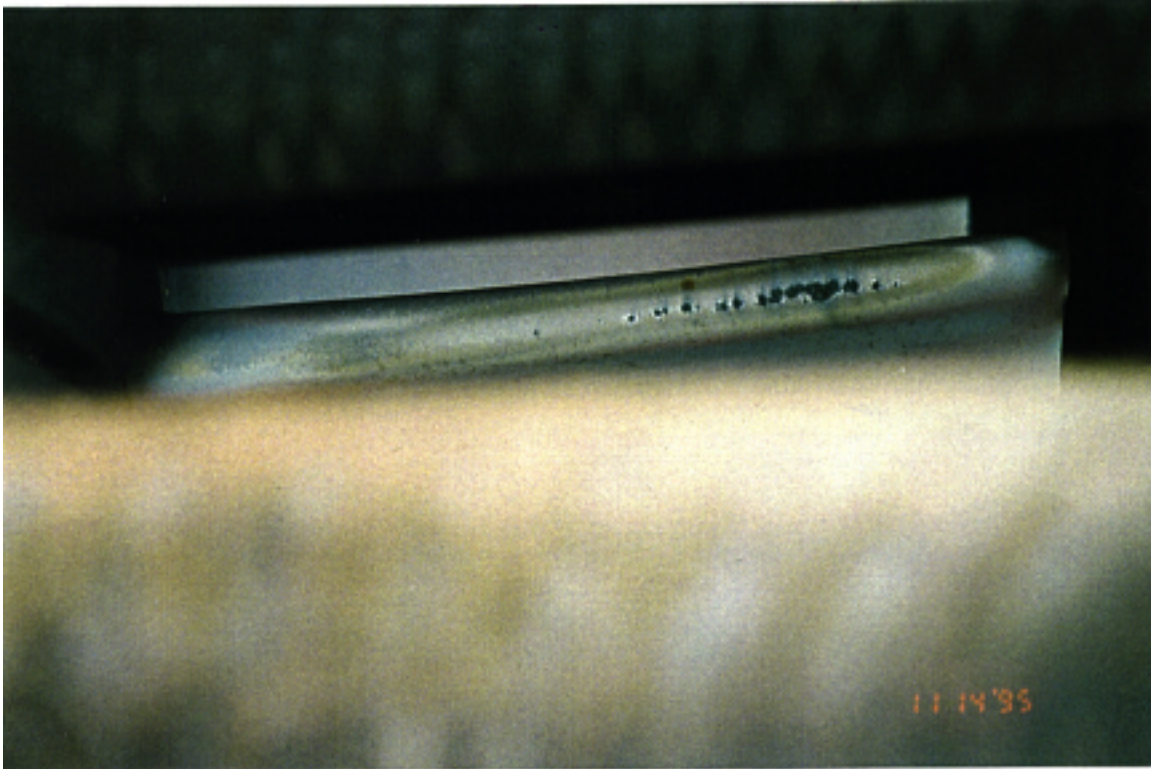
Figure 8 Unit 4B 11/95, 14,264 hrs. 1st Stage Buckets.

The coatings have been universally protective through all 8000 hours inspections, FOD excepted. The most recent inspection of Unit 4B did show localized leading edge attack (breach and 2-10 mils (0.05-0.25 mm) metal attack) at 14264 hours. (See Figure 8) The higher firing temperatures certainly contributed, to his oxidation. Additionally, traces of sand-like foreign material were ingested into this machine, but the deposit pattern was not necessarily associated with the oxidation. It would imply that the coating breach life for a 2350°F (1288°C) fired machine might be somewhere between 14000 and 24000 hours, but this can only be verified by future inspections.

1st stage bucket shows localized oxidation attack has breached the coating at the leading edge.

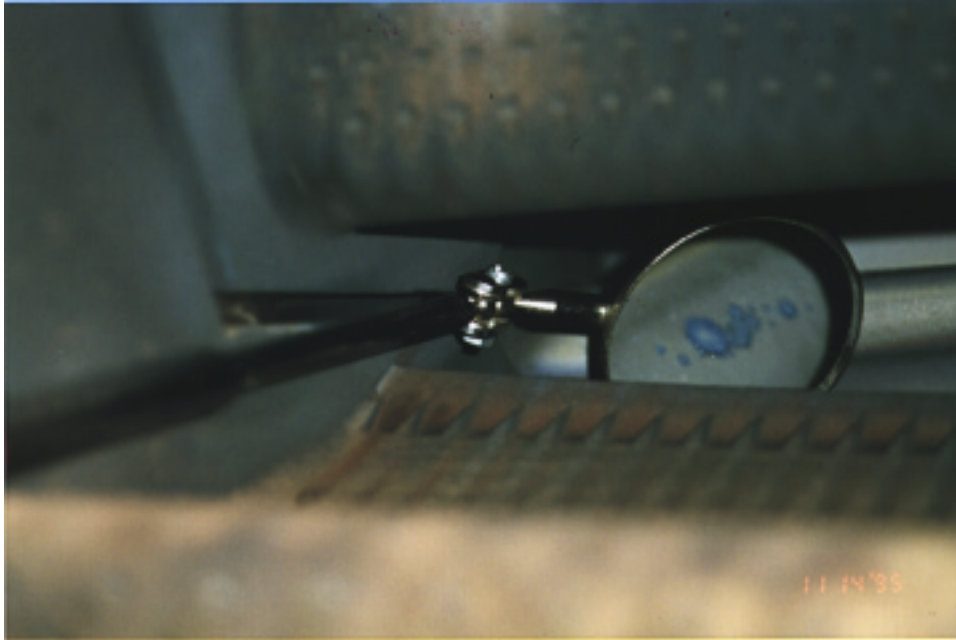
Figure 8.5 Unit 4B 11/95 14,264 hrs. 1st Stage Buckets.

1st stage bucket shows oxidation on the forward part of the concave vane. The mirror, which is part of this photograph, shows oxidation present elsewhere on the bucket.

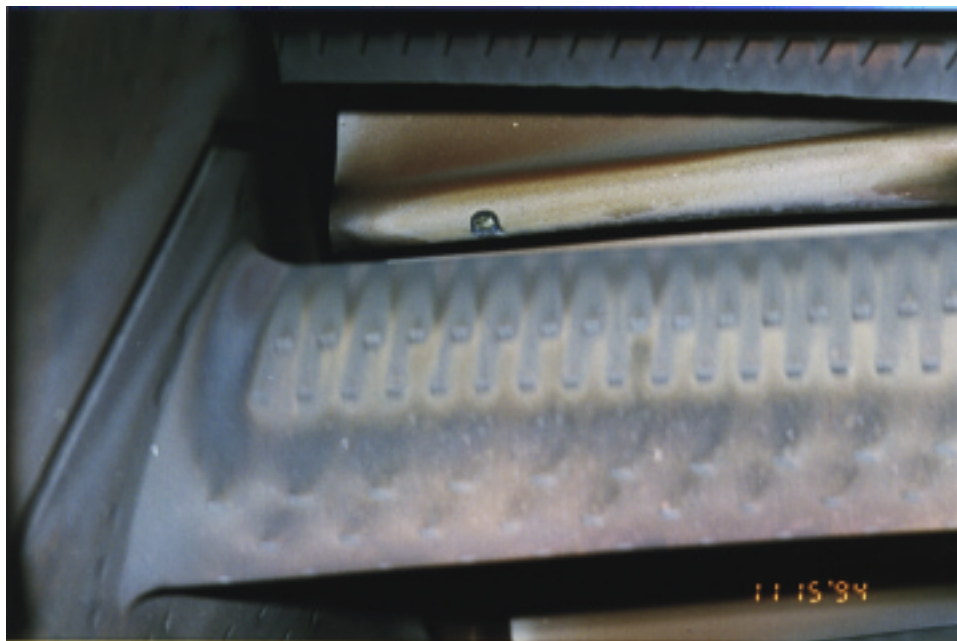
Figure 8.6 Unit 3A 11/94, 8,079 hrs. 1st Stage Buckets.

(11/94, 8079 hours) had a single, large leading edge impact (0.3" diam. x 20 mil deep) at 80% radial height which had disturbed both the coating and base metal (**Figure 8.6**), and was left in service.

This photograph shows a leading edge impact on one single bucket.

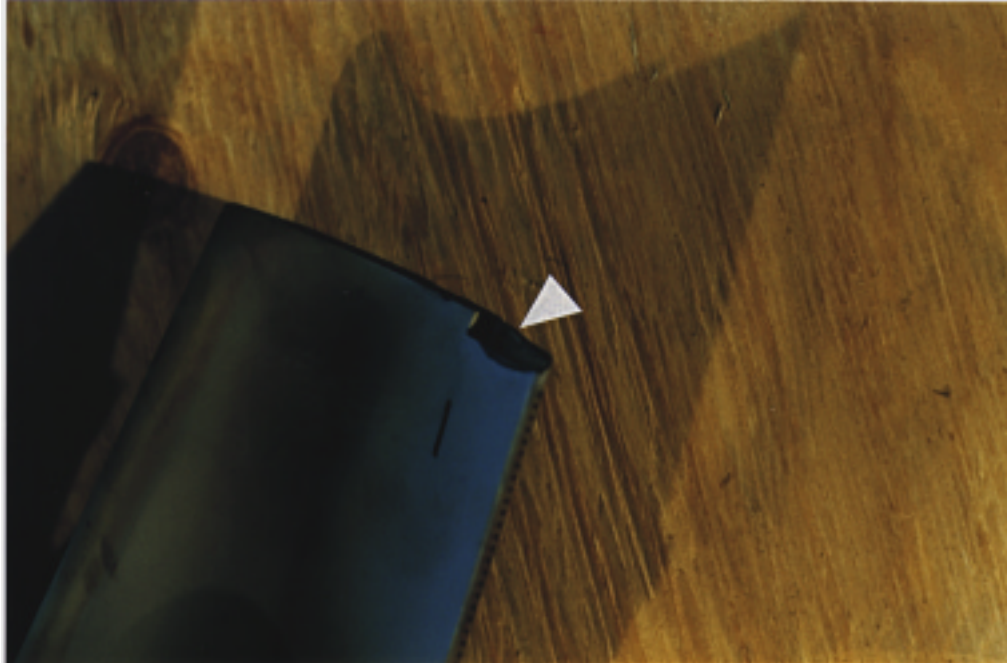
(5/94, 4082 hours) lost a fuel nozzle tip downstream, as is described in Section 4.3. Pictures are shown in **Figures 8.7, 8.11-8.13, 8.23-8.25, 8.28, 8.30, 8.32-8.35, and 8.39**. The downstream damage was surprisingly little. The 1st stage nozzle partitions and buckets were both removed for repair, while 2nd and 3rd stage nozzles and buckets were left in the machine. Leading edges on three 2nd stage buckets and two 3rd stage buckets were carefully blended in the machine.

1st stage bucket is showing oxidation at the tip of the trailing edge.
Figure 8.7 Unit 3B 5/94, 4,082 hrs. 1st Stage Buckets.

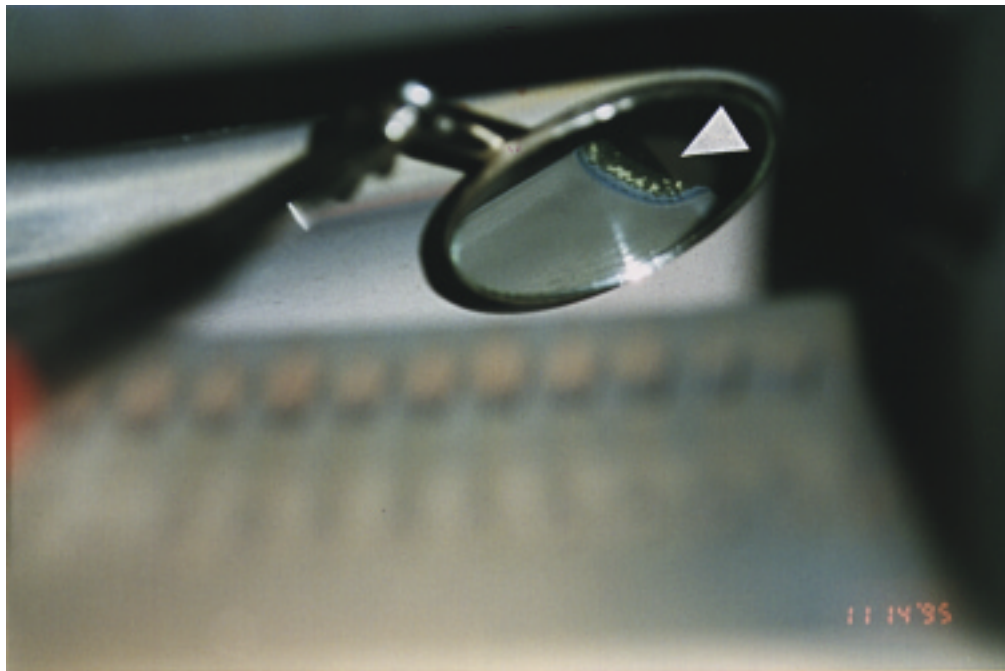
One 1st stage bucket shows oxidation at the tip of the trailing edge. (as viewed through a mirror).
Figure 8.8 Unit 4B 11/95, 14,264 hrs. 1st Stage Buckets.

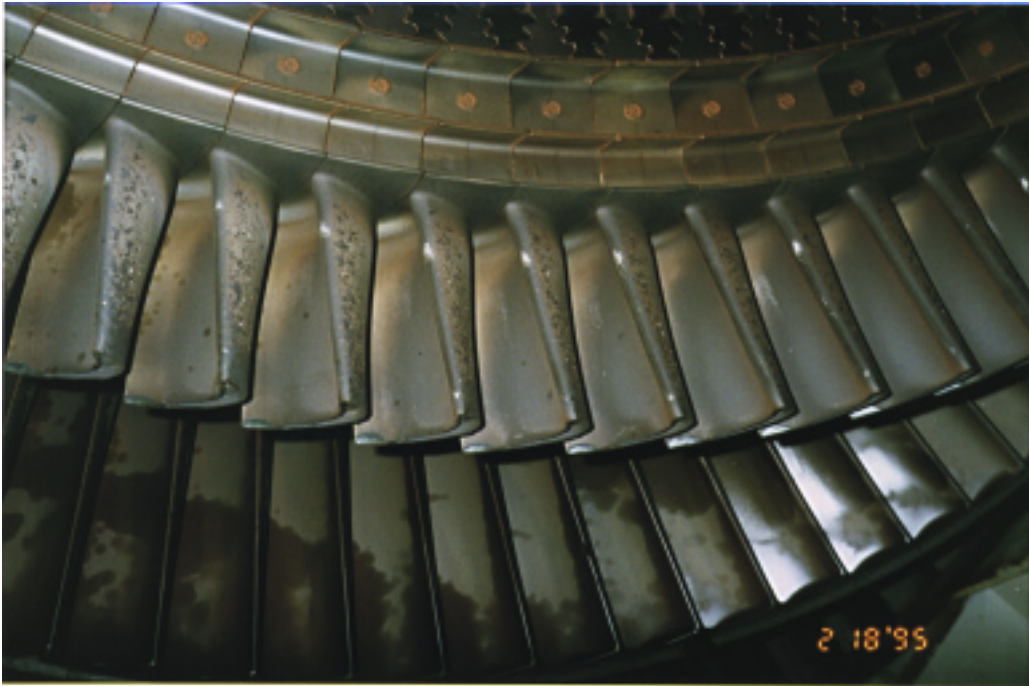
The compressor rotor developed significant vibration and was replaced with a compressor rotor section from another site. The rebuilt rotor then experienced a compressor blading failure in early February 1995. There had been a loss of output (8 MW) and the compressor discharge pressure dropped about 6% approximately sixteen (16) hours prior to the high vibration trip. Portions of three compressor blades went downstream (stator 4, rotor 4, stator 14), and most blades downstream of stage 3 were dented and bent. Combustion parts were essentially intact; 1st and 2nd stage nozzles and buckets and some 3rd stage buckets were removed for refurbishment, and the 3rd stage nozzle was quickly refurbished and reinstalled in the same machine. The rotor is under investigation by the OEM. Interestingly, station instrumentation indicated that the machine had been producing about 7 MW more power than the other three for at least part of its operation.

(2/95, 6120 hours) experienced a compressor blade failure as described in Section 4.3. Pictures are shown in **Figures 8.9, 8.10, 8.14, 8.26, 8.27, 8.29, 8.31**. Combustion parts were essentially intact; 1st and 2nd stage nozzles and buckets and some 3rd stage buckets were removed for refurbishment, while the 3rd stage nozzles were quickly refurbished and reinstalled in the same machine.

The 1st stage buckets are shown after the impactions from the compressor blades.
Figure 8.9 Unit 4A 2/95, 6,120 hrs. 1st Stage Buckets.

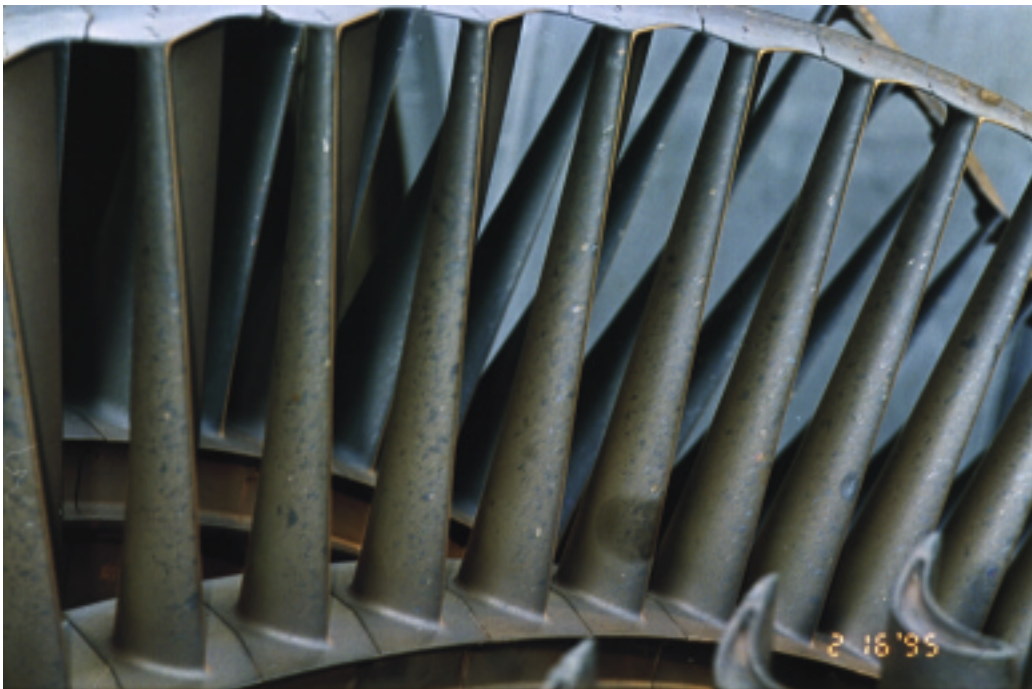
2nd stage buckets showing convex side scuffing from compressor blade impactions.
Figure 8.14 Unit 4A 2/95, 6,120 hrs. 2nd Stage Buckets.

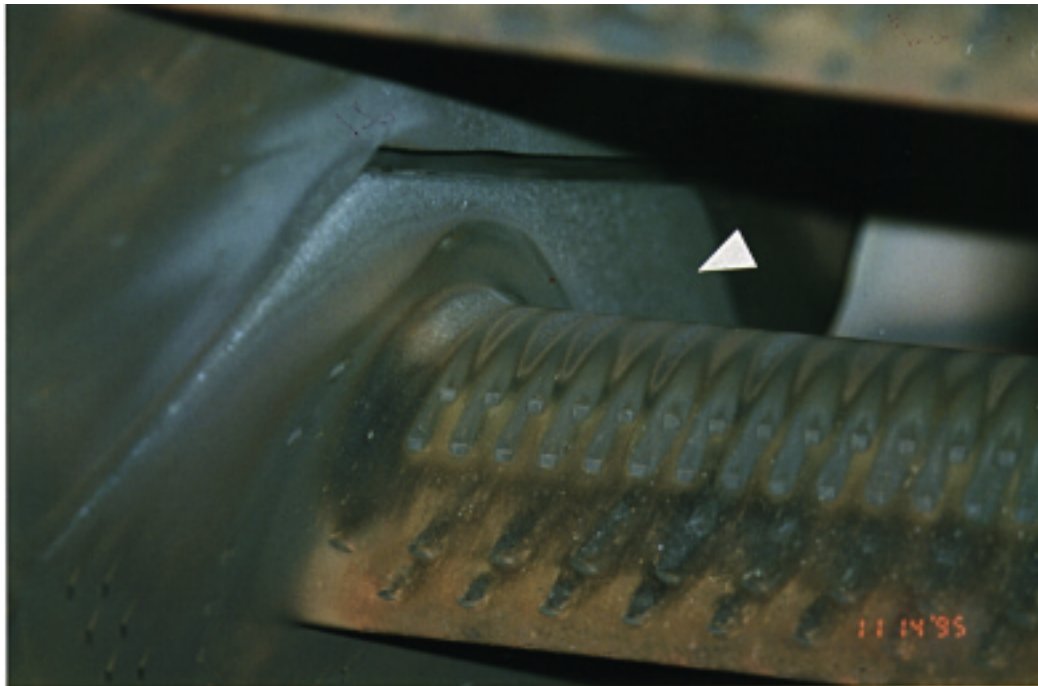
- Most 4x4 mm (0.158 x 0.158 in.) and 2x2 mm (0.079 x 0.079 in.) cooling holes, on the inner sidewall throat (10 mils or 0.254 mm oxidation), **Figure 8.20**
- Some sidewalls, at the Z-form joints between the segments (up to 60 mils or 1.524 mm oxidation), **Figure 8.21**
- Some convex side vane/inner sidewall fillets, near the leading edge (10 mils or 0.254 mm oxidation), **Figure 8.21**
- Two sidewalls in Unit 4B had oxidation troughs somewhat like the outer sidewall oxidation on the MS 6B/7E machines. These were the first seen on an MS 7FA machine. The oxidation cut was 80 mils (2.032 mm) on one segment, **Figure 8.22**.

1st stage nozzle showing significant sidewall oxidation.
(Seen on two segments only to date).
Figure 8.22 Unit 4B 11/95, 14,264 hrs. 1st Stage Nozzle.

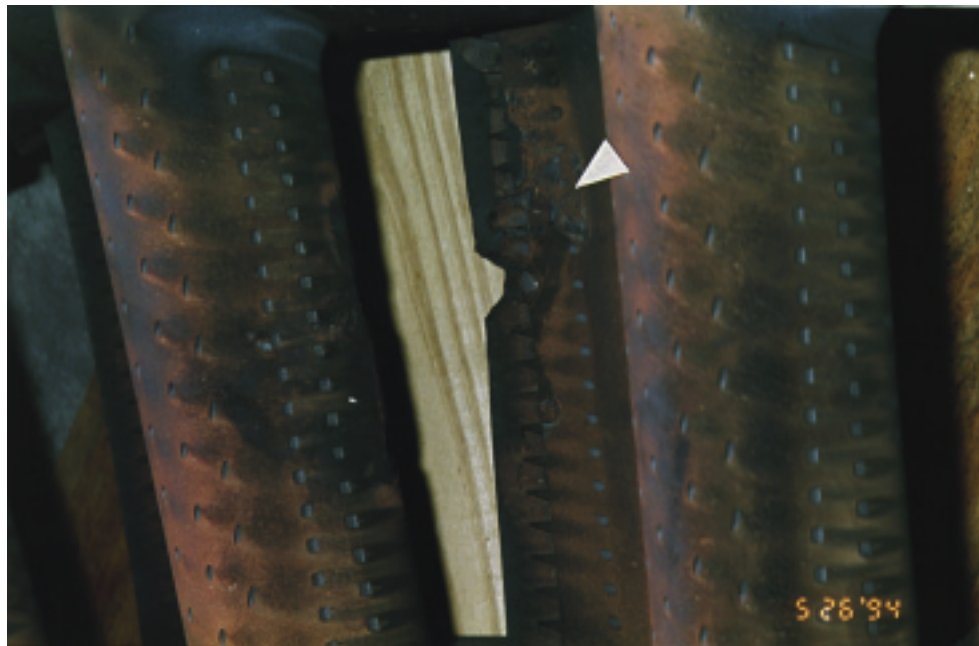
Figure 8.23 Unit 3B 5/94, 4,082 hrs. 1st Stage Nozzle.

Lost a fuel nozzle tip which was discovered at the scheduled inspection of 5/23/94 (there have been no subsequent tip losses). This is a 2"x2" (50.8 x 50.8 mm) cylinder of 60-120 mil (1.524-3.048 mm) wall thickness and 4 ounce (113.4 gms) weight. No defects were found in metallurgical examination and the observations were consistent with a fuel flashback. Exhaust temperature spreads were normal two months before, but were skewed within two weeks of the inspection (no interim data was available). It is believed that the tip loss triggered the exhaust temperature shift, and both occurred from combustion flashbacks. The downstream damage was surprisingly little. The 1st stage nozzle partitions and buckets were both removed for repair; while 2nd and 3rd stage nozzles and buckets were left in the machine. Leading edges on three 2nd stage buckets and two 3rd stage buckets were carefully blended in the machine.

1st stage nozzle showing heavy oxidation in the single throat where the fuel nozzle tip lodged temporarily. The other nozzle throats were unaffected.

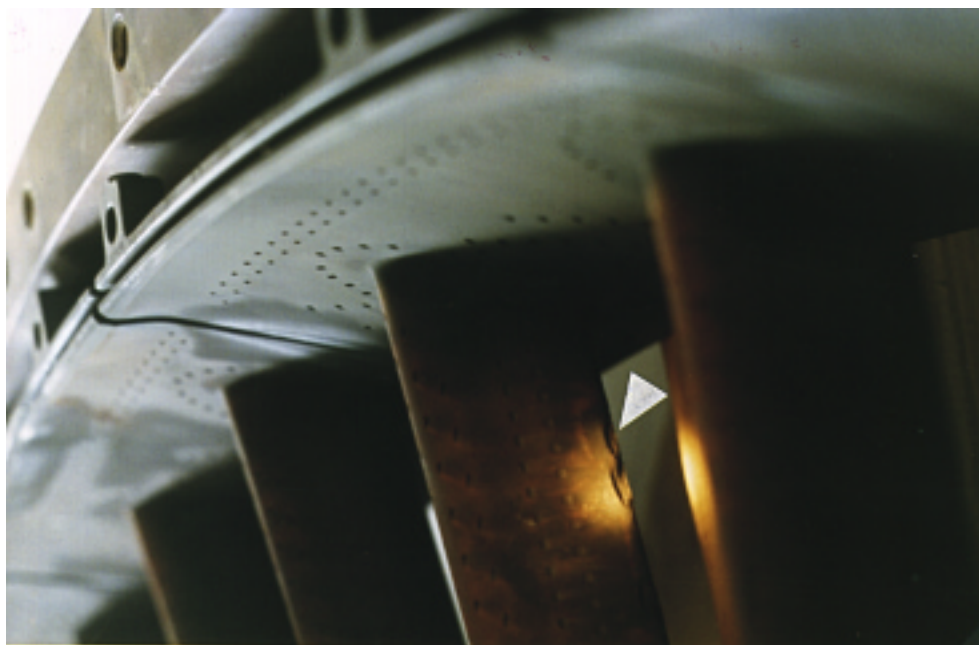
Figure 8.24 Unit 3B 5/94, 4,082 hrs. 1st Stage Nozzle.

Adjacent side of nozzle throat shown in Figure 8.23.

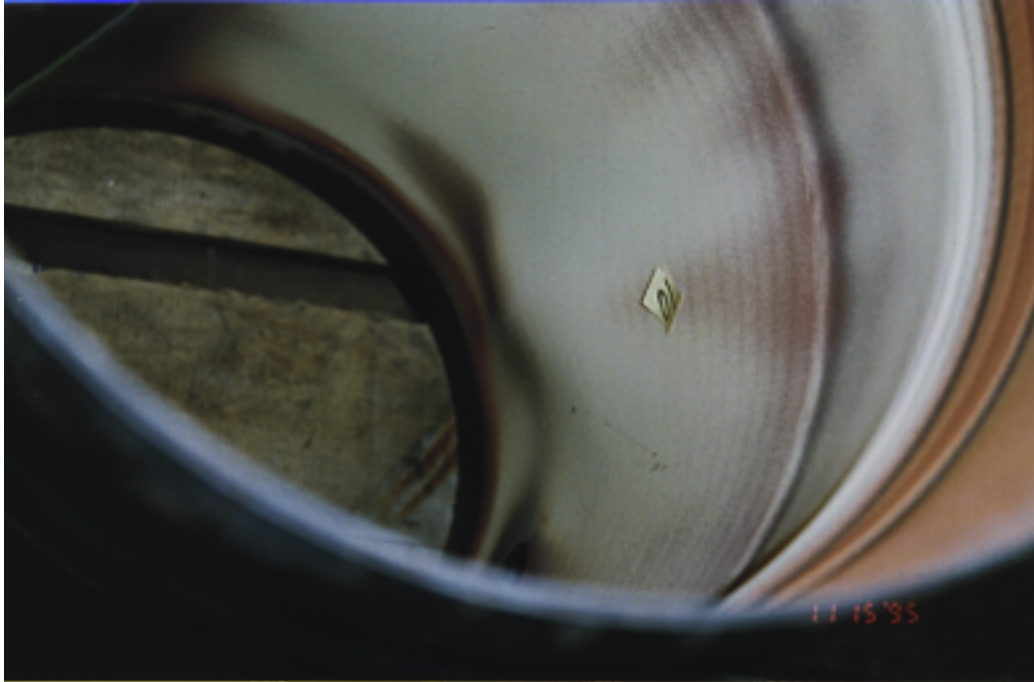
Interior view showing coating and area of distortion of the combustor liner.
Figure 8.47 Unit 4B 11/95, 14,264 hrs. Combustion Liner.
