Performance of NOREM Hardfacing in Plant Valves: In Situ Application and Leak Rate Testing of Feedwater Check Valves

In-Situ Application and Leak Rate Testing of Feedwater Check Valves

TR-107987

Final Report, September 1997

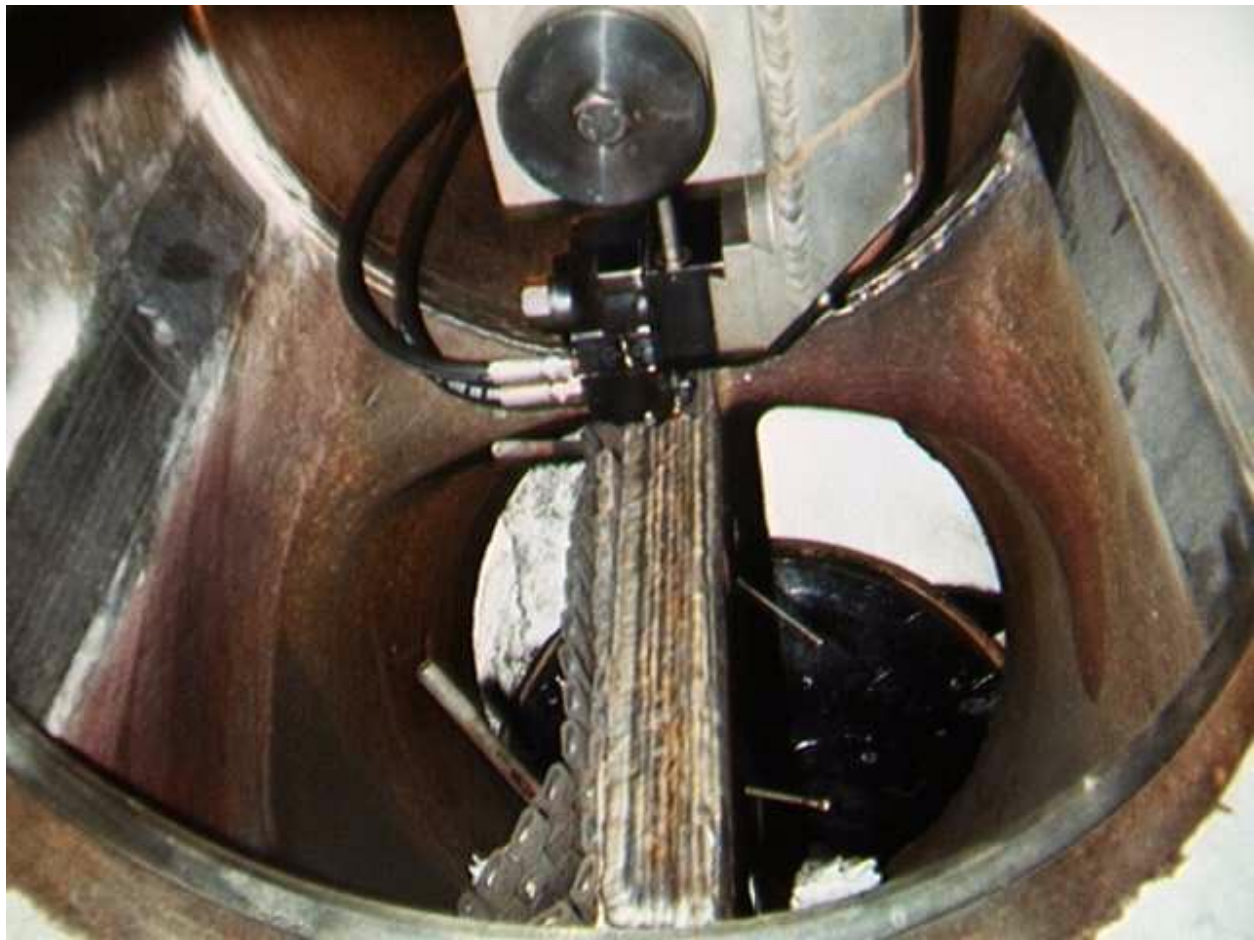
Figure 4-5 RFO8 Machining Mockup - Shaper Head

Climax staff attended the RFO7 mockup and supported and followed the project through its execution. Based on observations and lessons learned during RFO7, Climax developed an additional tooling head for their MSIV machine. This "shaper head" attachment, shown in Figure 4-5, was an outstanding performer in RFO8 mockups and RFO8 in-situ machining.

The "shaper head" attachment allows the Climax tool to operate in a user defined arc instead of rotating through 360° of travel. This allows one guide rib to be machined at a time while maintaining valve bore contour. Furthermore, significant increases in machining speeds were obtained. The "shaper head" allowed the Climax tool to take a 0.050 to 0.060 rough cut and greatly reduced tool insert wear. Travel was approximately 1½ inches per minute. The machining chips coming off the tool head had a nice "curl" indicating the tool was cutting and not scraping. During RFO8 mockup activities, the same insert was used to machine 3 guide ribs. This was accomplished with no discernible taper. The tool insert preference for NOREM machining with the "shaper head" was a Seco Carboloy TP40 with positive rake.

The Climax MSIV machine tool was used exclusively during RFO8. Since the RFO8 machining only required weld prep and final machining, the portable milling machine was not considered. However, given the outstanding performance of the "shaper head", the Climax Model 152 boring bar should be used for all machining setups.

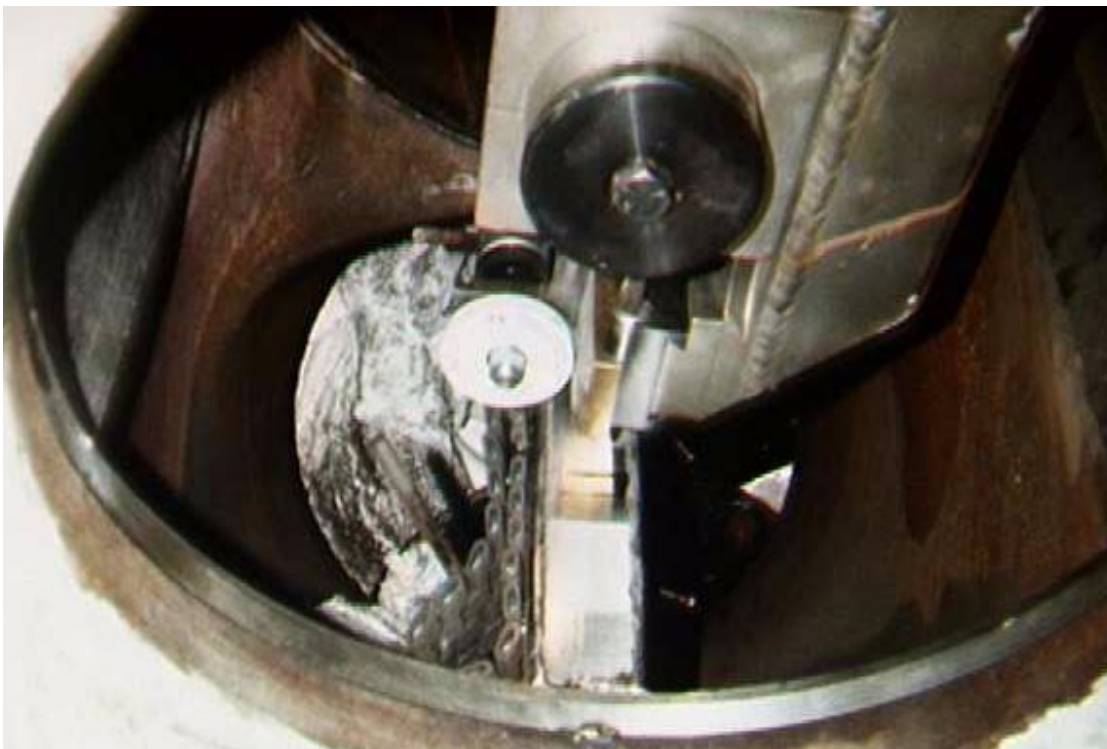
Figure 4-6 RFO8 Machining Mockup - Polishing Wheel

Another Climax attachment utilized in RFO8 is the polishing wheel shown in Figure 4-6. This photo is taken from the downstream side of the valve and shows the bottom

guide and a portion of the in-body seat. Figure 4-6 shows the polishing wheel being tested on the bottom guide. In actual practice, the polishing wheel was only used as the final seat machining step. Use of this wheel provides a 16 Ra finish and contributed to the outstanding "post-maintenance" LLRT results obtained in RFO8. All plug machining was performed utilizing lathes in the GGNS hot machine shop.

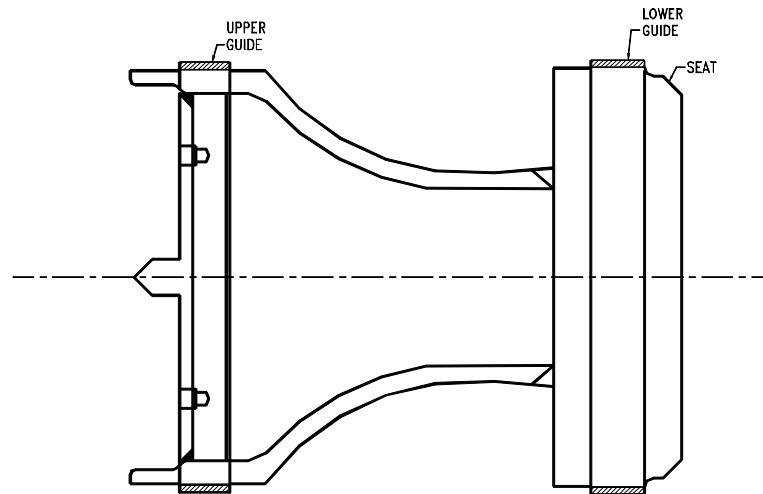
Figure 5-1 Plug Schematic

The F010 project scope required the valve plugs be returned to a hard seat only configuration. The dual seat plugs in service at the time had experienced wear on the plug guides (see Figure 5-1) and could not be easily retrofitted to a hard seat only configuration. Furthermore, outage schedule constraints would not allow extensive plug modifications to be performed during the outage.

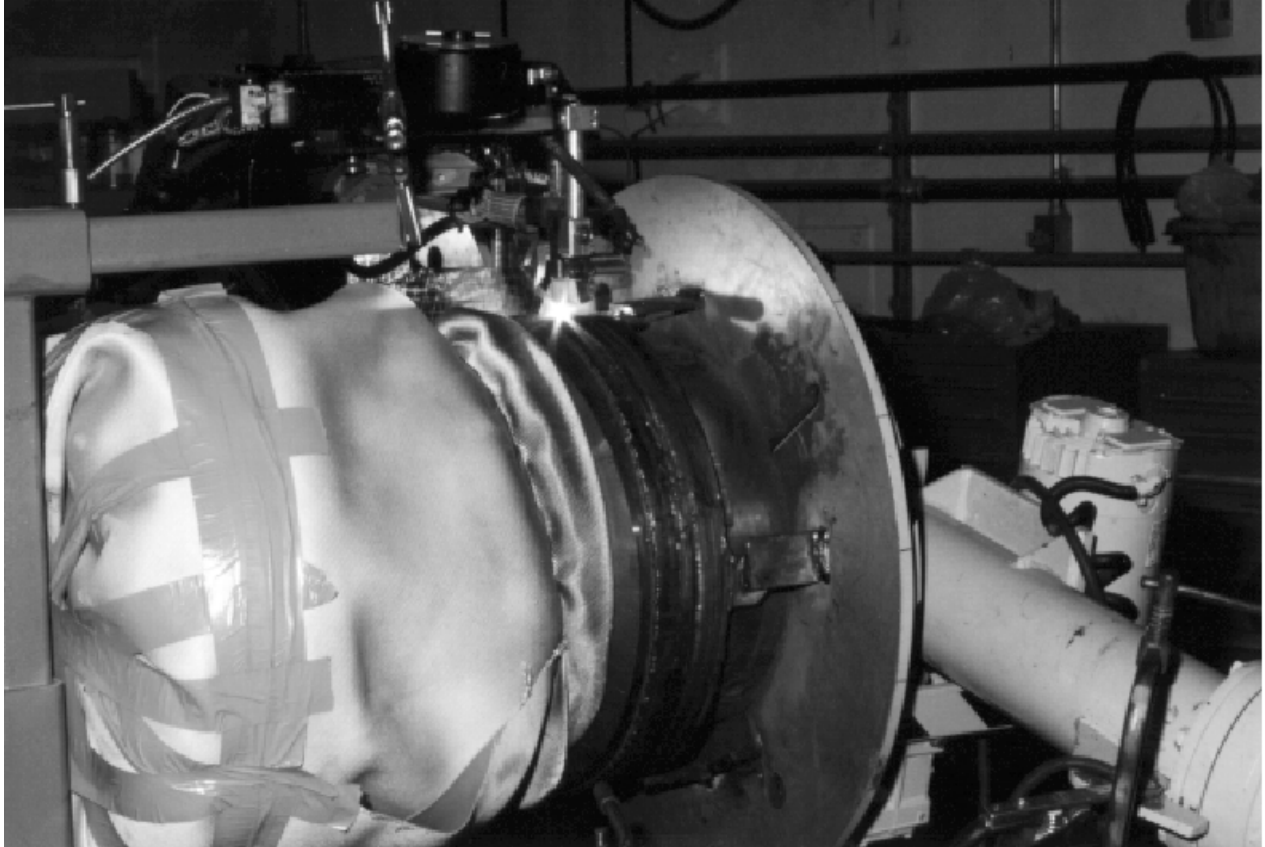
Figure 5-4 Welding Plug

The general welding setup used in the hot machine shop is shown in Figures 5-4 and 5-5. The plug was mounted on a turntable, which rotated the plug underneath the stationary weld head. To help maintain preheat, the plug was wrapped in insulation.

The upper guide area proved to be the most difficult area to weld. Cracking was experienced in the initial 309L welding. This cracking was attributed to welding technique. The 309L was removed and reapplied without incident. Cracking was also experienced in the initial NOREM welding. This problem was resolved by changing the method of preheat to induction heating and raising the preheat to 400°F. A torch was placed 180° from the weld head to maintain this preheat. The cracked NOREM was removed and NOREM was reapplied without incident.

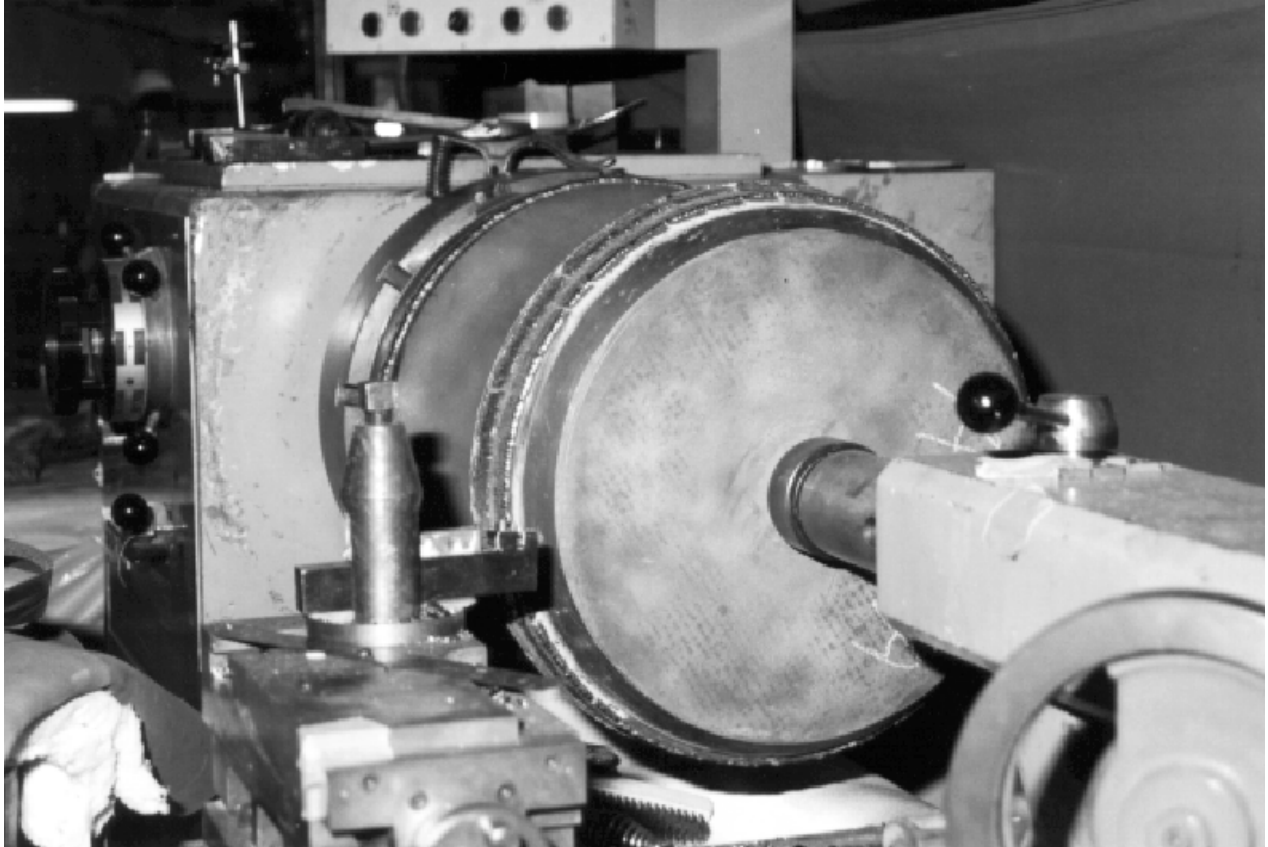
Figure 5-6 Machining Plug

Figure 5-6 shows a plug mounted in the lathe while machining the plug seat. The finished plug is shown in Figure 5-7. Close ups of the plug's bottom guide and seat are shown in 5-8 and 5-9.

Machining proceeded without incident until final machining on the last plug (F010A plug). The F010A plug seat and bottom guide were finished and the upper guide was nearing completion when a crack developed with the loud "ping" characteristic of hardfacing cracks.

This crack was removed by grinding and did not propagate into the 309L layer. After removing the flaw the plug was installed. An engineering evaluation determined the small transverse groove left after removing the indication would not hinder valve performance. However, a new plug was procured and installed during RFO8.

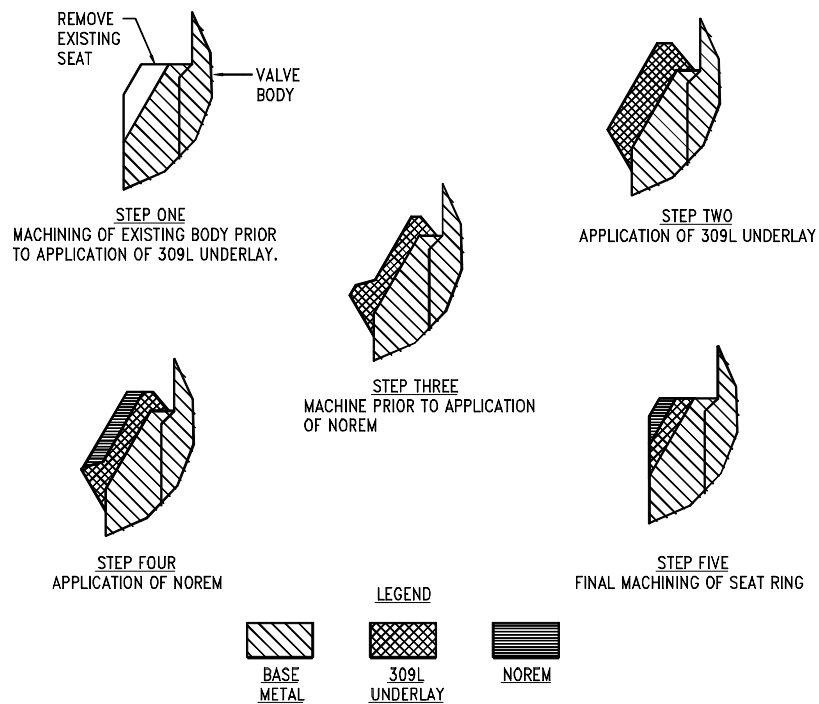
Figure 6-1 Valve Seat Weld Prep

Figure 6-1 shows the specific machining and welding activities required to hardface the valve seat in-situ. As shown in Step 3, the NOREM weld prep consisted of a special "cradle" to be machined into the 309L similar to that performed on the plug as discussed in chapter 5.

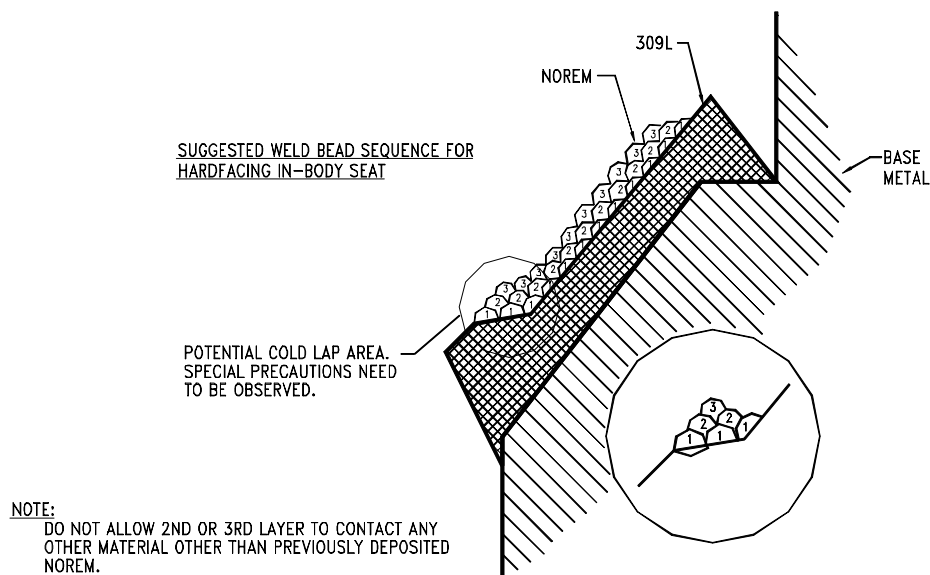
Figure 6-2 Suggested Weld Bead Sequence

The welding plan called for three layers of NOREM to be applied and then be machined to a final thickness of 1/16". As shown in Figure 6-2 special precautions need to be observed in weld bead sequencing to avoid cold lap. In general, the first layer of NOREM should be the only layer of NOREM that contacts the 309L. Each subsequent layer of NOREM should over-lap the previous layer but should not contact the 309L. This weld bead sequence is suggested for the in-body and plug guide hardfacing activities.

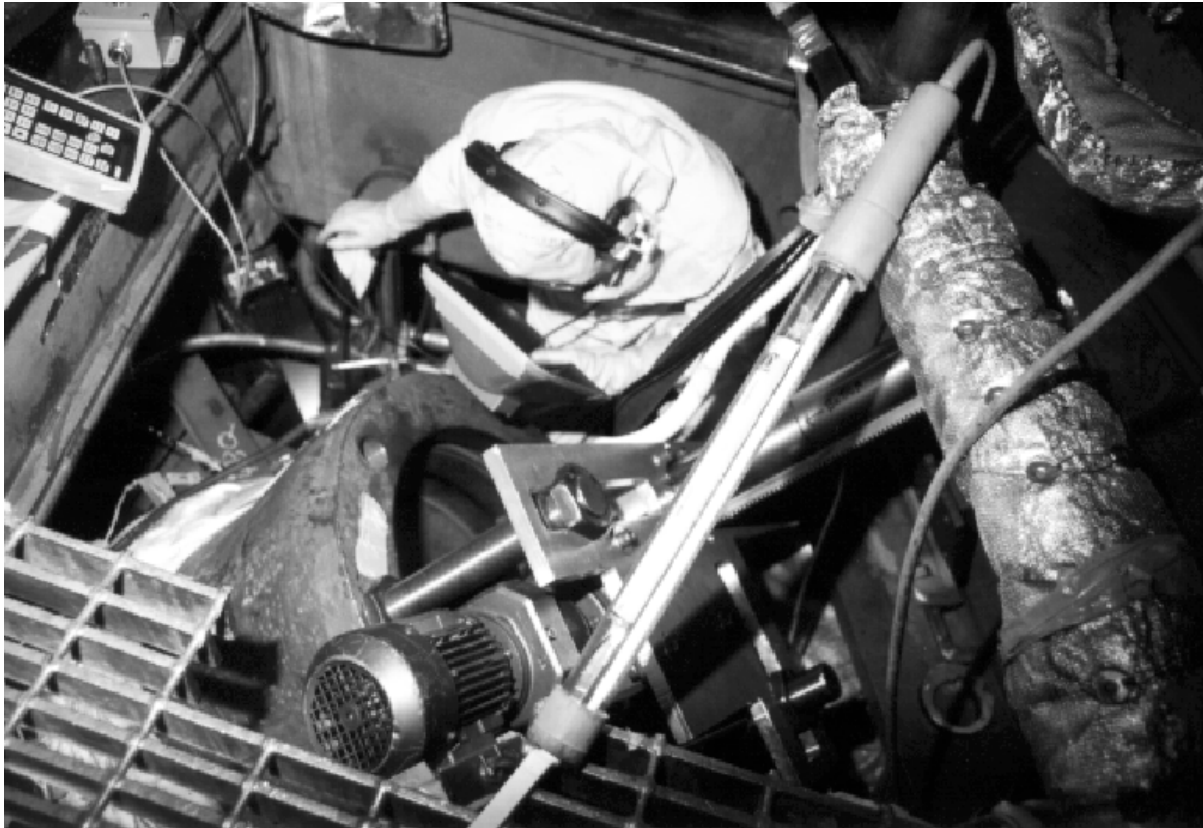
Figure 6-6 Welding At Valve

Figure 6-6 shows a welder stationed at the valve observing welding in progress during F010A welding. The welders communicated by head phone and rotated duties periodically. Each shift utilized two welding teams with two welders on each team for in-situ body welding activities. Figure 6-7 shows the weld head inside the valve body positioned to weld the bottom guide. This view is basically from the perspective of the welder shown in Figure 6-6.

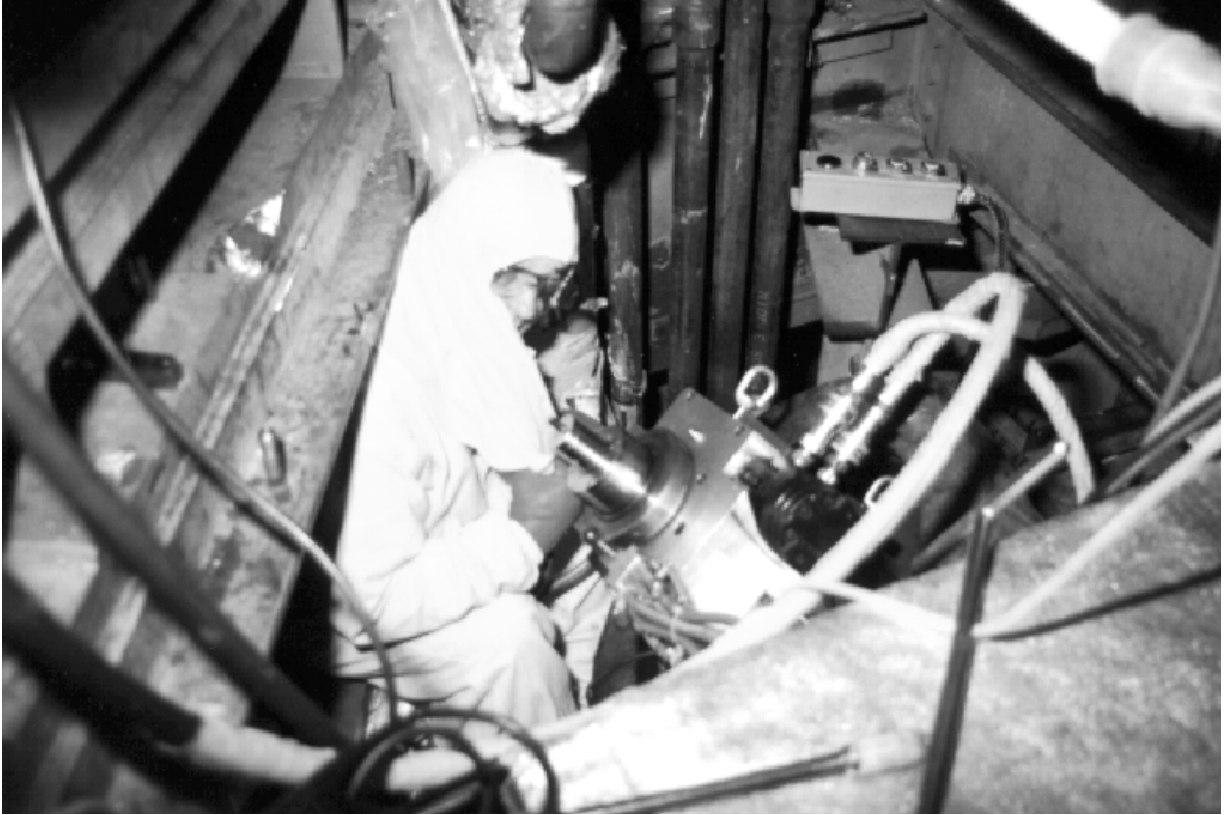
Figure 6-8 Valve Body Machining

Figure 6-8 is a photograph of the F010B valve body machining in progress with the Climax boring bar in place. This photograph clearly shows the cramped work space in the vicinity of the F010 valves. As previously stated, work in this area was performed in single PCs without respirator requirements. Figure 6-9 is a mockup photograph but is essentially the view the machinist in Figure 6-8 would have if the boring bar were removed.
