# **Socket Weld Resolution Guideline**

*Technical Update*

**1003542**

Technical Update, February 2003

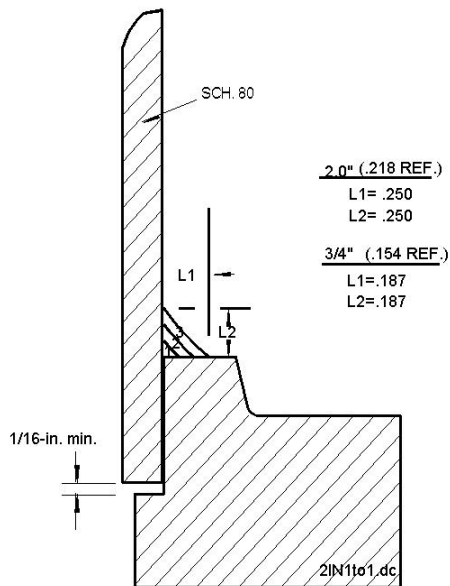
**Figure 2-1. Standard Code Fillet Weld Profile for Socket Welded Connections**

In the past, socket welded connections were typically welded with a standard 1x1 leg length fillet weld with a leg length meeting ASME Code minimum requirements. The ASME Code minimum leg length must equal or exceed 1.09 times the pipe nominal thickness (Figure 2-1). In most cases the weld leg length of the final weld is in excess of the minimal dimensions required. In addition the Code requires a minimum 1/16-in. axial gap. The gap is usually set by bottoming out the pipe or tube into the fitting and scribing a line around the pipe using the face of the fitting as a guide. The pipe is withdrawn from the fitting approximately 1/16-in. and tack welded. Inspection of the fit up (gap) is required prior to welding out the connection.

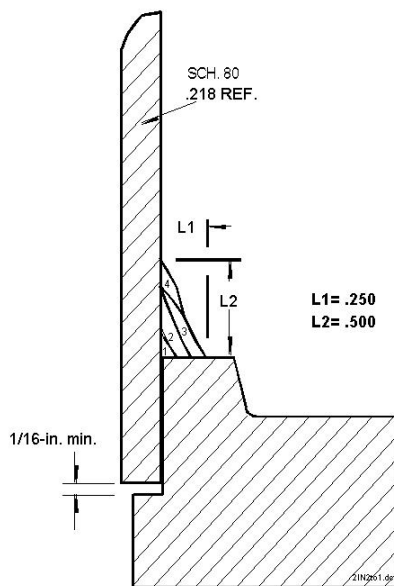
**Figure 2-2. 2x1 Weld Profile for Socket Welded Connections**

The use of even leg lengths on socket weld installation is commonly practiced at susceptible locations (high vibration) where past failures have been documented. EPRI Report TR-113890, showed evidence that the 2x1 weld configuration has an improved fatigue life when compared directly to the standard 1x1 Code weld profile. The improved resistance to vibrational fatigue is based on the increased weld cross sectional area and the reduced moment at the toe of the weld (pipe side). The extended weld leg practice meets all Code minimum requirements while extending the weld leg length on the pipe or tube side, by a factor of two (Figure 2-2).

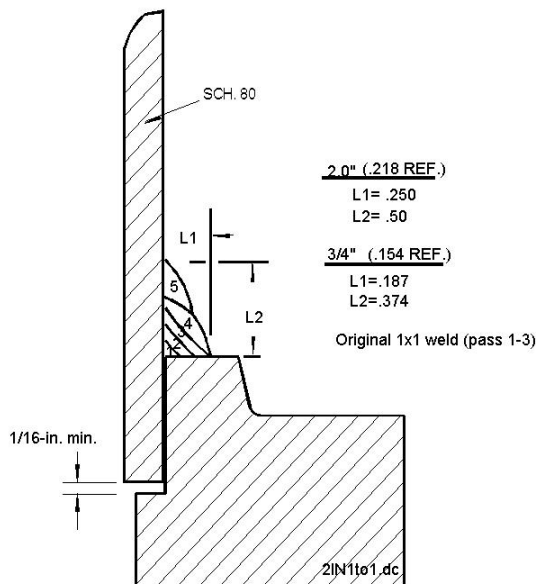
Figure 2-3. Code Minimum Socket Weld Profile enhanced to at 2x1 Weld Profile.

Preemptive weld build up of 1x1 weld profiles have been installed at locations deemed susceptible to high cycle vibration fatigue. The weld profile enhancement has a cross sectional area similar to the standard 2x1 weld profile. Weld bead sequence varies from the newly installed 2x1 configuration since the existing weld is not removed prior to extending the weld length on the pipe side (Figure 2-3). The weld alteration or enhancement maintains all Code minimum requirements.

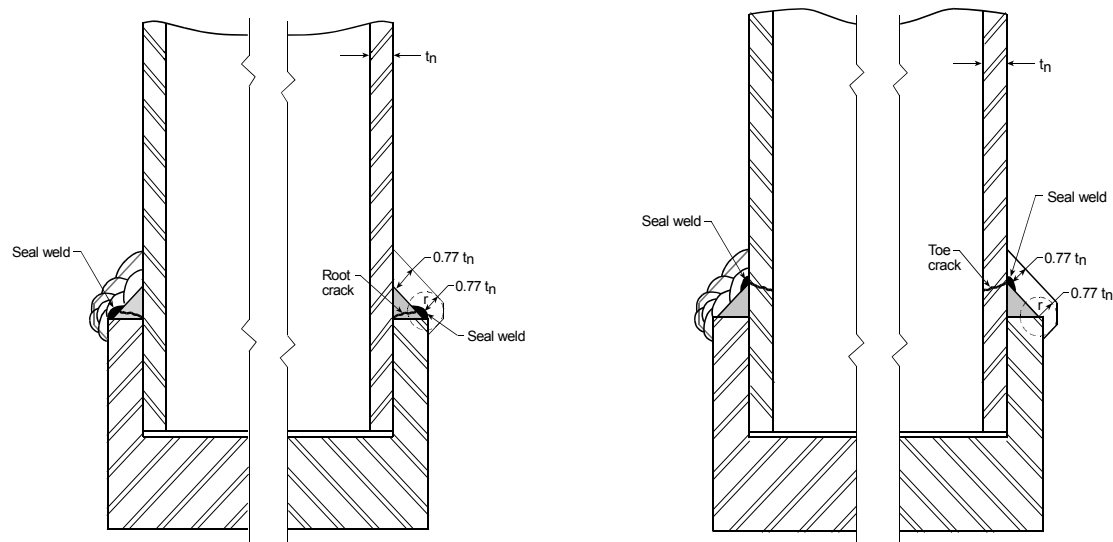
**Figure 2-4. Socket Weld Reinforcement Dimensions for root cracks and toe cracks.** Note: The right side of each figure shows the design dimensions while the left side shows the as-welded appearance.

The design of the overlay considers that the fatigue crack in the original socket weld could have originated from the root or toe or from both locations simultaneously. The overlay provides reinforcement at all locations equivalent to the original fillet weld throat. Fillet weld size is specified by leg length, therefore the throat of the reinforcement is 0.71 times the specified minimum fillet leg size. For welds made in accordance with ASME Section III, socket weld leg size for a fitting must be a minimum of 1.09 times the nominal wall thickness of the connecting pipe. Assuming an equal leg fillet weld, the throat dimension is 0.71 times the leg size or 0.77 times the nominal wall of the connecting pipe.. Therefore, the minimum reinforcement at all locations from the face of the socket weld, including both weld toes, is  $0.77 t_n$ . The minimum dimensions are shown in Figure 2-4.

A leaking socket weld must be seal welded before applying the reinforcement. The dimensions of the reinforcement must be measured from the surface of the seal weld rather than from the

face of the original socket weld. This ensures that the minimum throat dimension is measured from a crack-free surface.

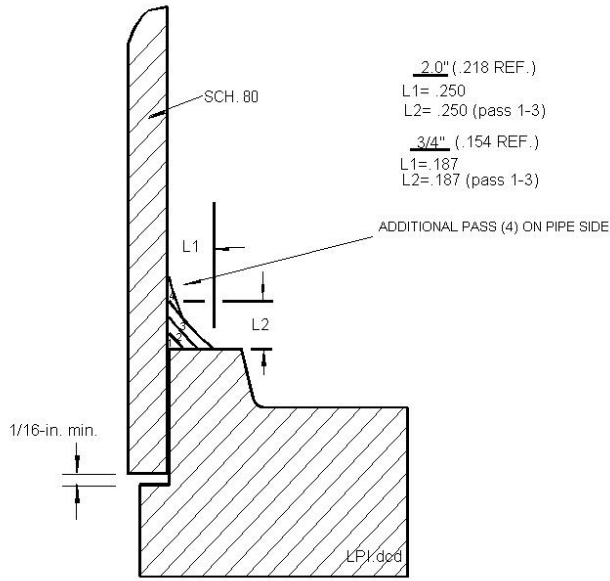
The LPI weld configuration utilizes a standard 1x1 code weld configuration with an additional pass placed at the toe of the weld on the pipe side. This additional weld typically increases the leg length on the pipe side but does not meet the requirements for a 2x1 recommended weld profile. The actual weld leg ratio is typically less than 1.5 x 1 (Figure 2-6). Unlike the test results of the 2x1 welds, the LPI did not consistently promote greater fatigue life. The LPI weld profile has not been utilized for socket weld repairs and is currently not recommended as an enhancement to the 1x1 weld profile.

**Figure 2-6. Last Pass Improved Weld Profile for Socket Welded Connections**
