# **Evaluation Tools for Electric Motor Testing**

Logic Diagrams

**1004003**

Final Report, December 2001

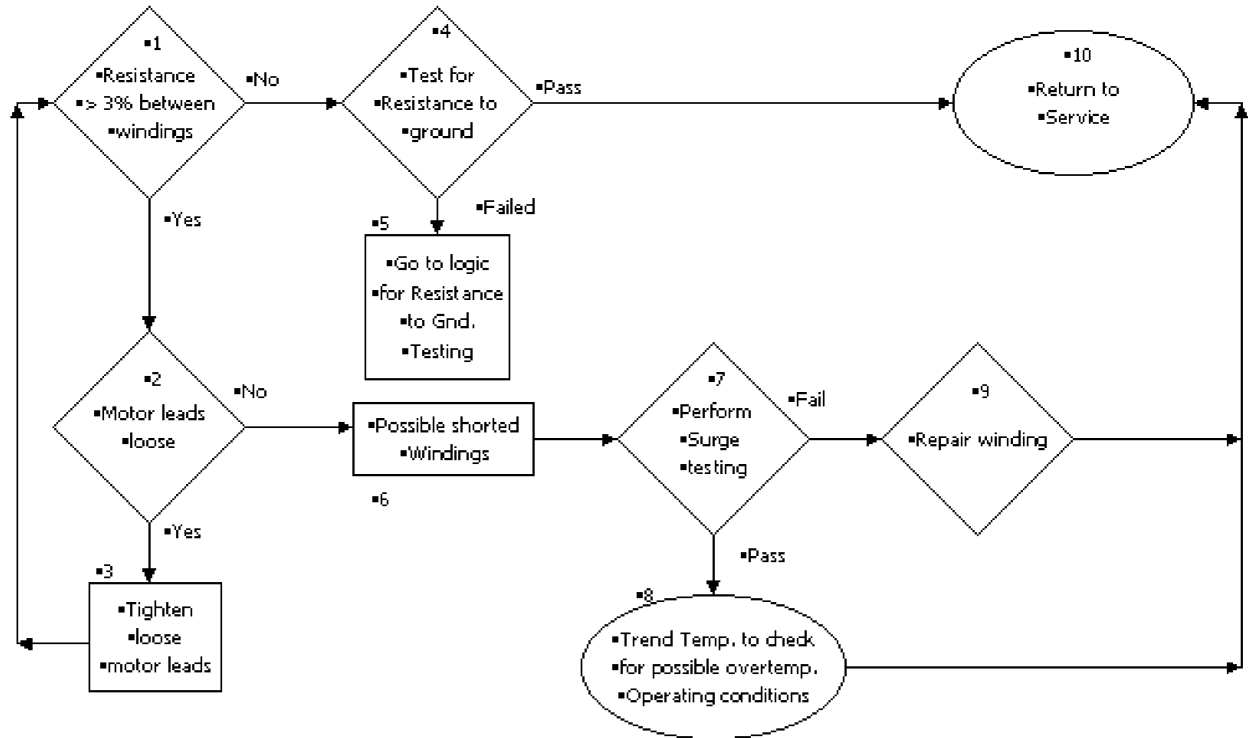
Box 9-This box indicates that the motor failed the surge test. The motor will require repair before it is returned safely to service. A complete rewind of the stator is the normal solution. However, it may be possible to cut out the failed turn or coil and continue operation. This process is described in “Temporary Operation of Motors With Cut-Out Coils” EPRI-4059 Project 2330-1 Final Report June 1985 and in “Synchronous Machine Operation with Cut-Out Coils” EPRI-4983 Project 2330-1 Final Report January 1987.

Box 10-This is the final step of returning the machine to service with additional monitoring after all the testing is completed or after the winding is repaired.

**Figure 1-1**  
**Winding Resistance to Ground**

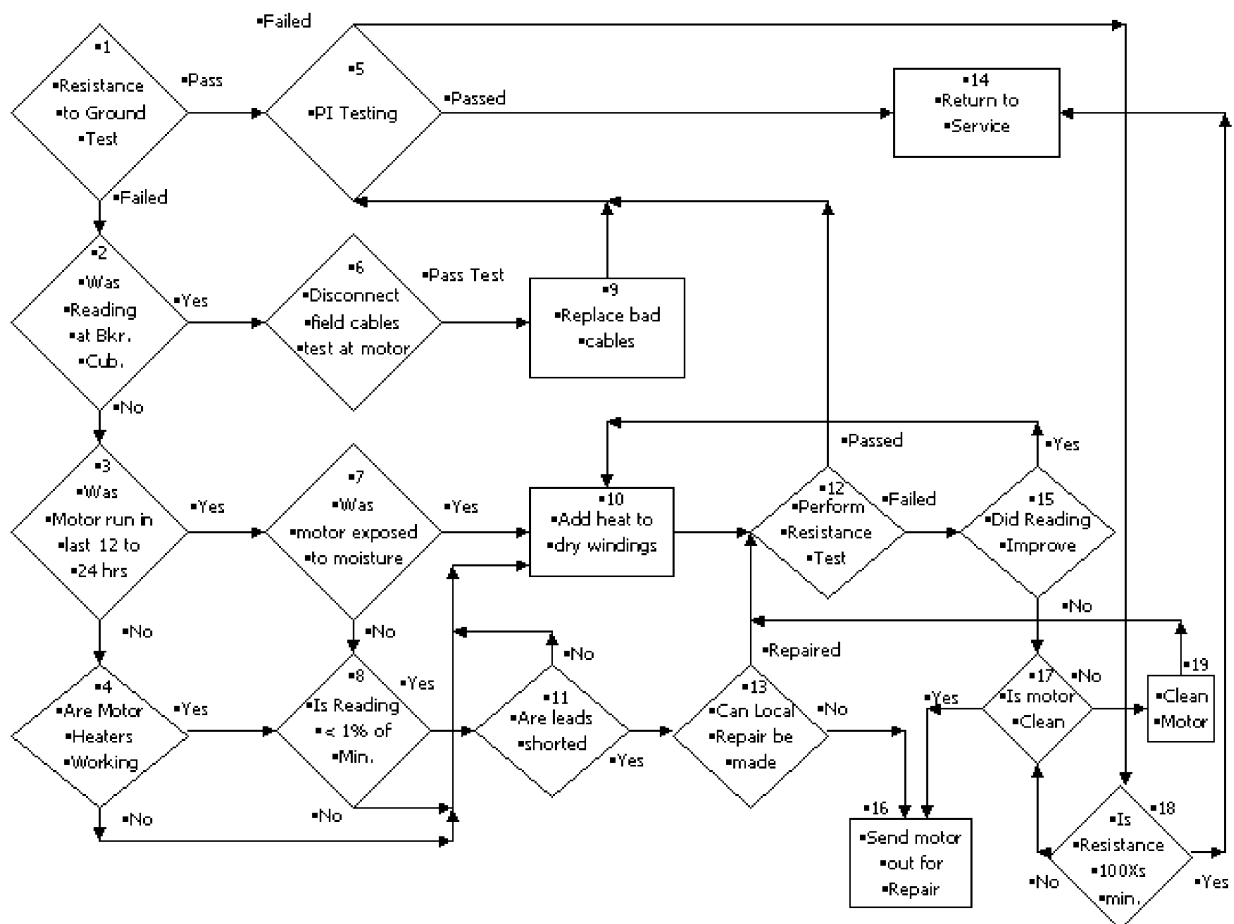
Box 5-If the motor successfully passes the one (1) minute IR testing, one should continue taking IR readings each minute for the next nine (9) minutes. If the ratio of the ten (10) minute reading divided by the one (1) minute reading is greater than two (2), the motor has successfully passed the IR and PI test indicating a high probability of good ground insulation condition.

A PI ratio of less than two (2) may not be an indication of bad insulation. If the insulation is of the modern epoxy and has a very high one (1) minute IR reading (greater than 5,000 megohms), the insulation can be considered to be in good condition. Older motors made with hydroscopic insulation systems, will provide good PI ratios when the windings are warm but will pick up moisture from the air very quickly once the motor is taken out of service resulting in low PI ratios. Additional cleaning and drying of the motor may be necessary before testing again.

Box 12-Once a corrective action has been taken by drying, cleaning, or repairing the motor; the motor should be subjected to a second IR test. If the motor passes the test the PI test can be started. In the event the motor fails the IR testing again, additional corrective action may be necessary.

**Figure 1-2**  
**Polarization Index Test**

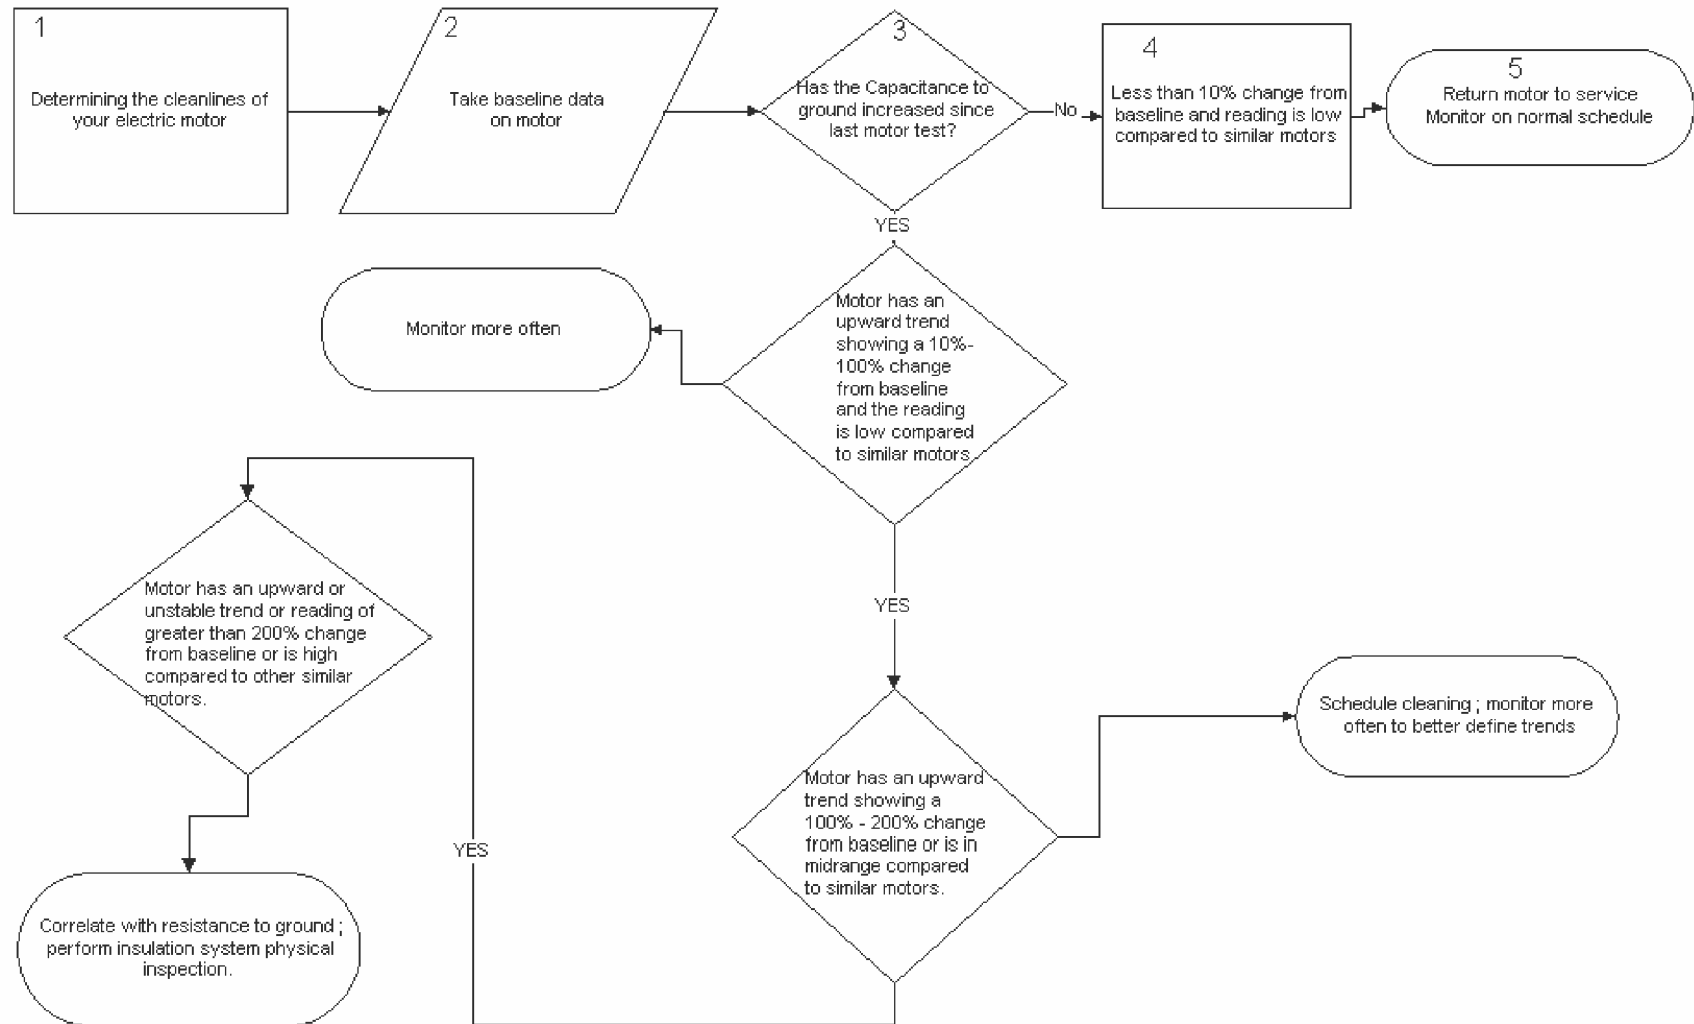
Box 10-NO-The motor has an upward or unstable trend or reading of greater than 200% change from baseline or is high compared to other similar motors.

Box 11-Result of the test is to correlate with the resistance to ground; perform insulation system physical inspection.

**Figure 1-3**  
**Capacitance to Ground Test**

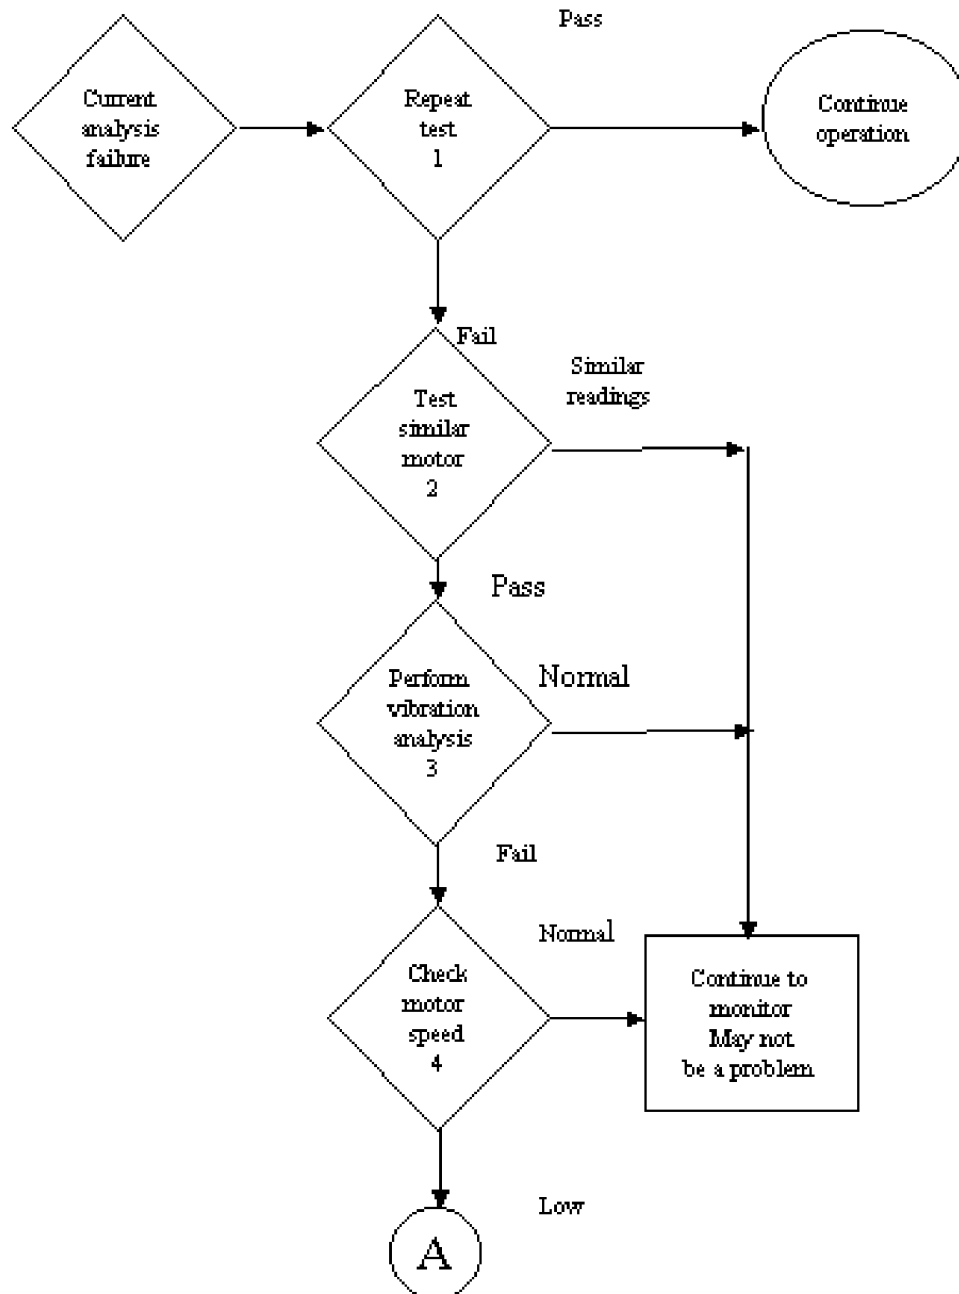
Current analysis utilizes current measurements to perform high frequency spectrum analysis to detect broken rotor bars and rotor eccentricity. Most test devices also have provisions to detect problems with power quality such as voltage or current imbalance. See phase current/voltage imbalance for more information.

Box 6-Disassemble motor, inspect for rotor bar cracking. Check bearings for wear.

Box 7-Perform Growler test or pass high current/low voltage through the rotor and check for cold rotor bars.

**Figure 1-4**  
**Motor Current Analysis for Rotor Bar Failure**

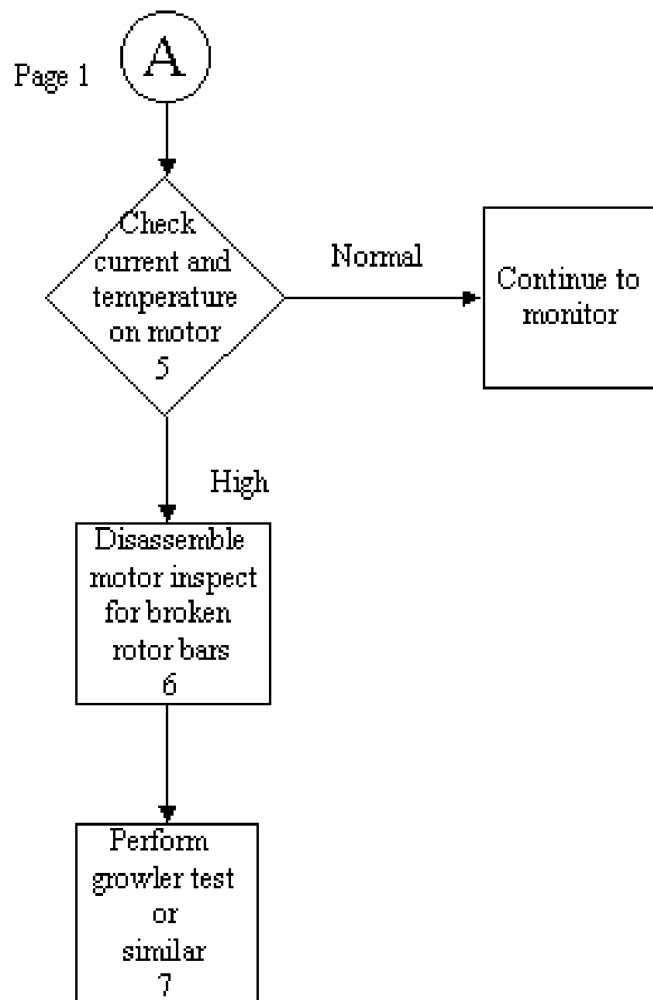
**Figure 1-5**  
**Motor Current Analysis for Rotor Bar Failure**

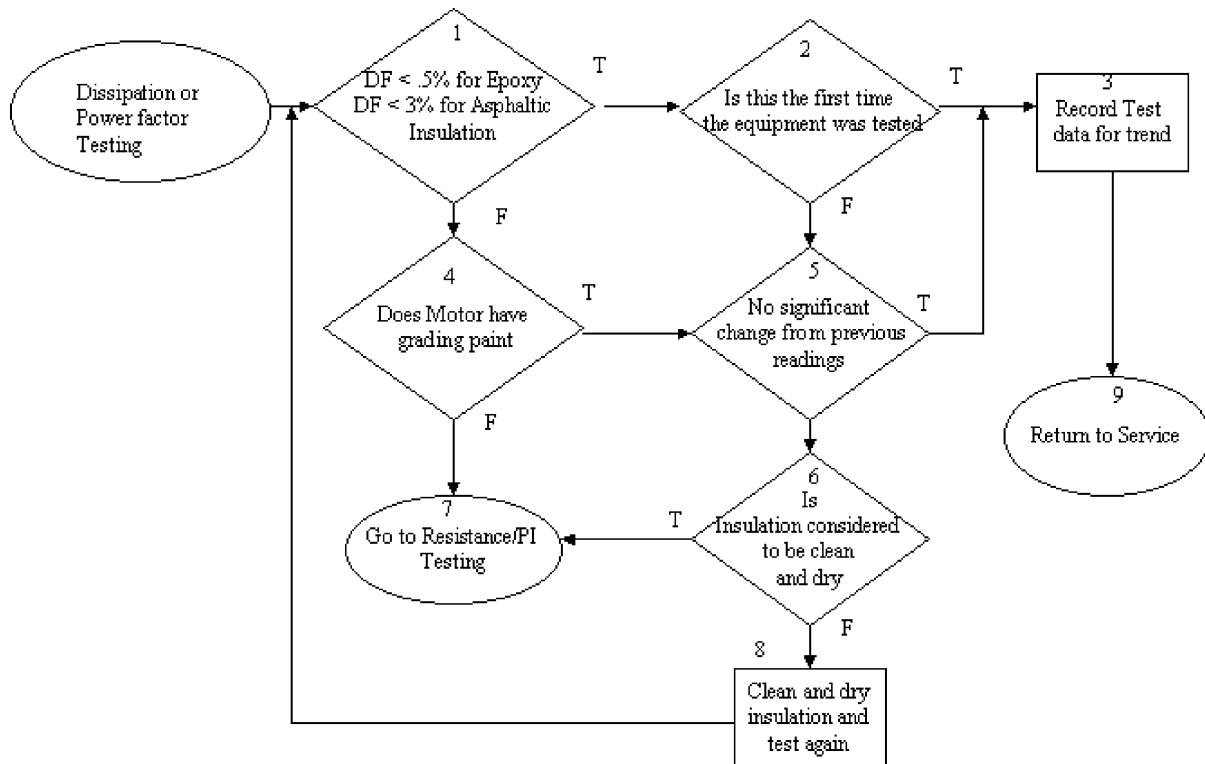
Box 8-Care should be used in cleaning insulation. Only clean with approved cleaning materials. Care should be taken not to overheat insulation anytime it is being dried. References included above cover procedures and practices for proper cleaning and drying insulation in rotating machines.

Box 9-If all indications are good and data is recorded the machine should be returned to service.

**Figure 1-6**  
**Dissipation/Power Factor Test**

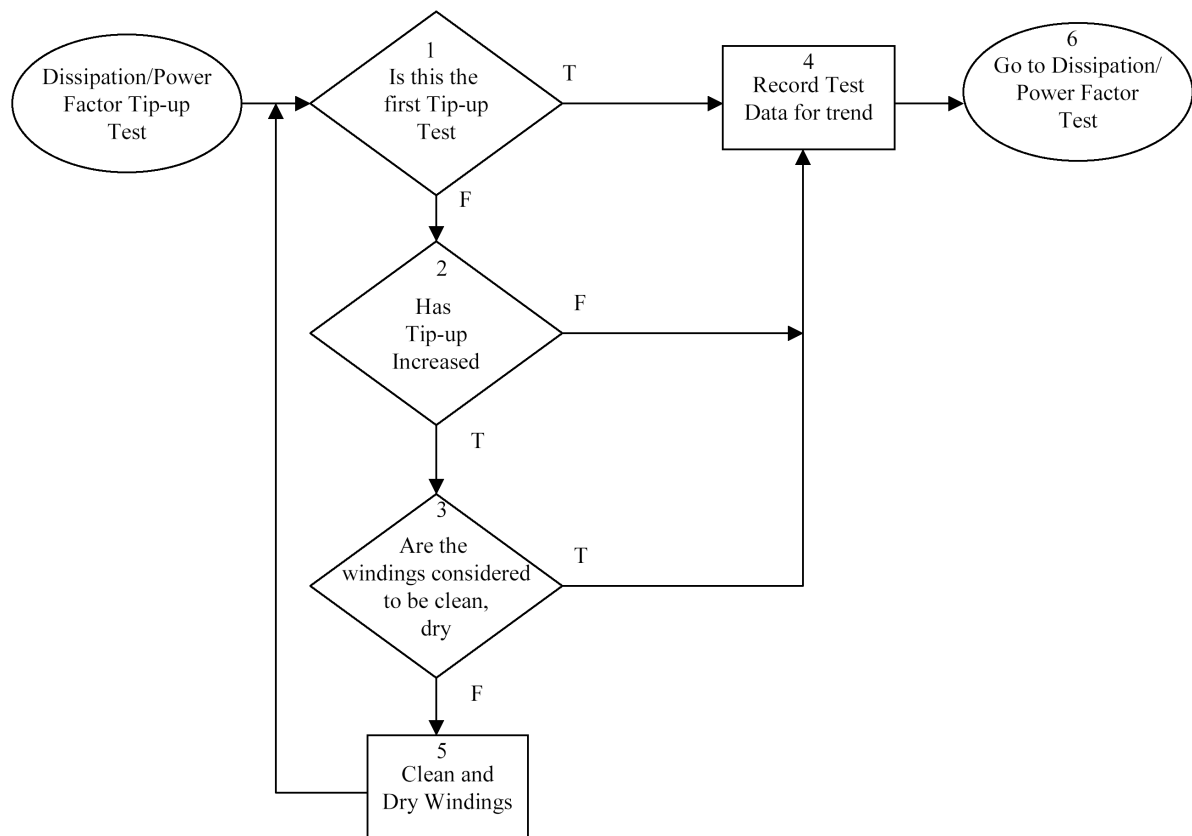
**Figure 1-7**  
**Dissipation Power Factor Tip-Up Testing**

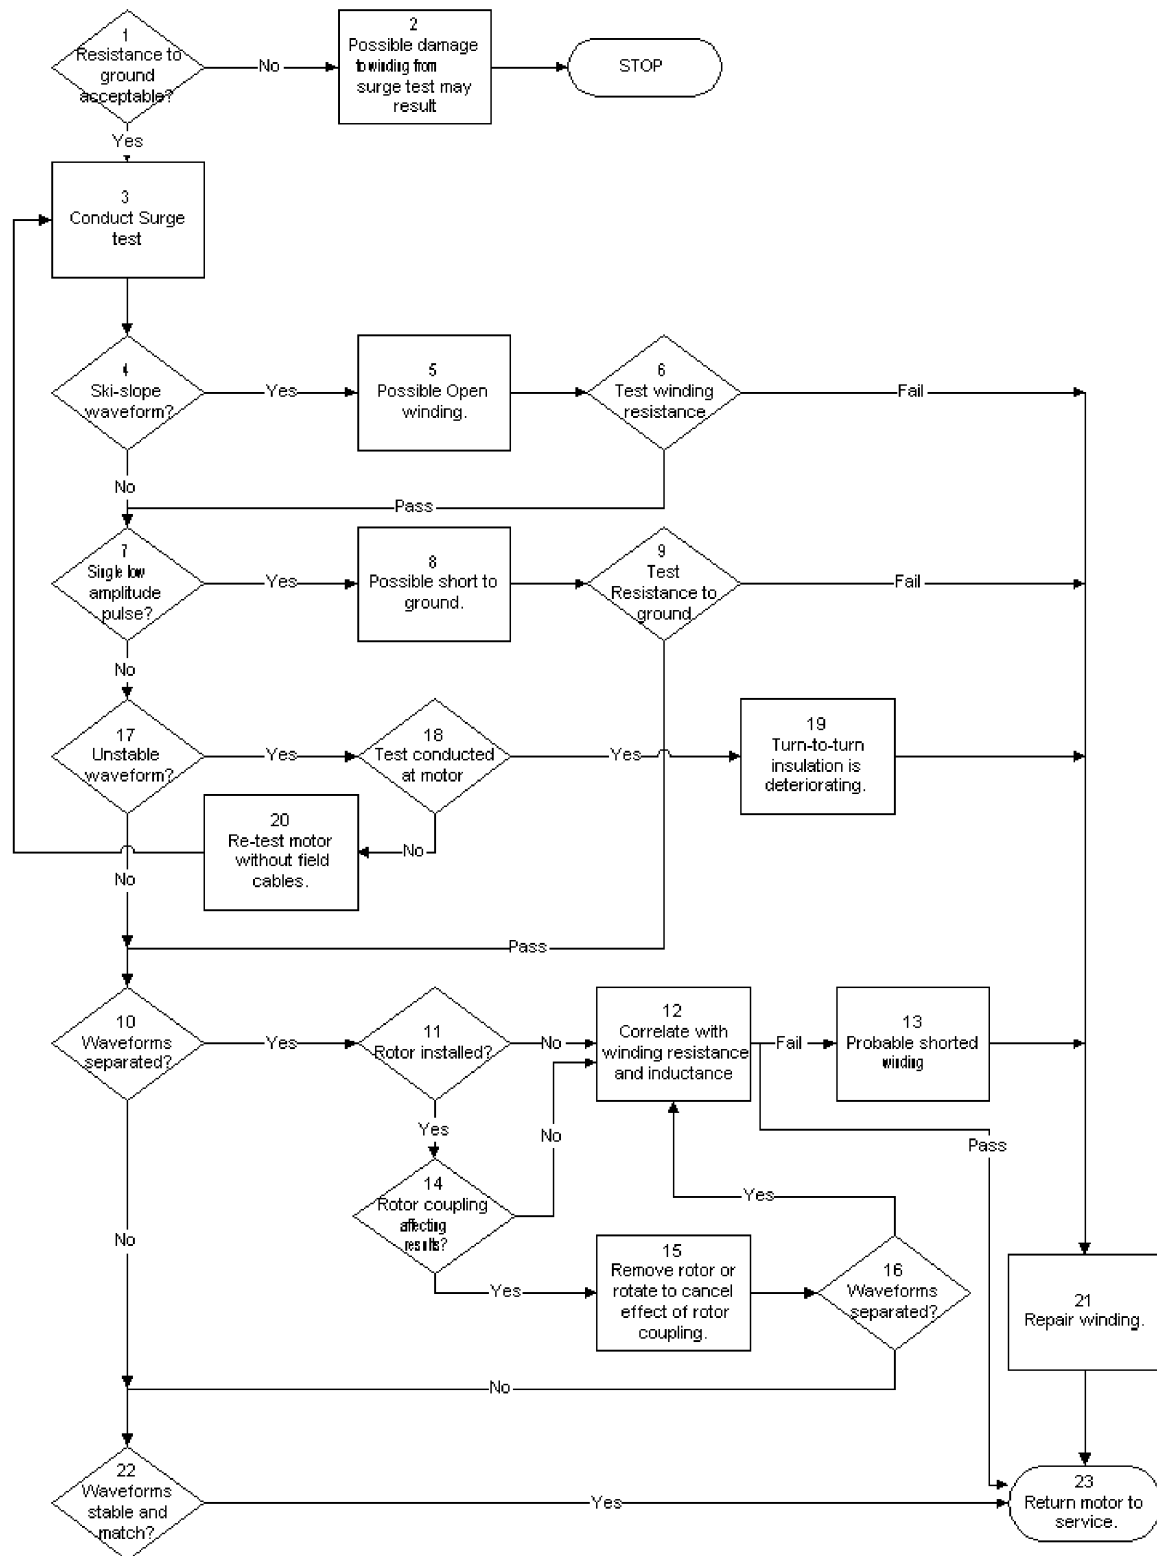
Box 21-If it is determined that the motor failed the surge test, the motor must be repaired before it is safely returned to service. Normally a motor would be completely rewound. However it may be possible to cut out the failed turn or coil and continue operation. Refer to “Temporary Operation of Motors with Cut-Out Coils” EPRI EL4095 Project 2330-1 Final Report June 1995 and “Synchronous Machine Operation with Cut-Out Coils” EPRI EL-4983 Project 2330-1.

Boxes 22 to 23-The motor turn insulation can be assumed to be in good condition if the waveforms are stable and overlap. The motor can be safely returned to service.

**Figure 1-8**  
**Surge Test**

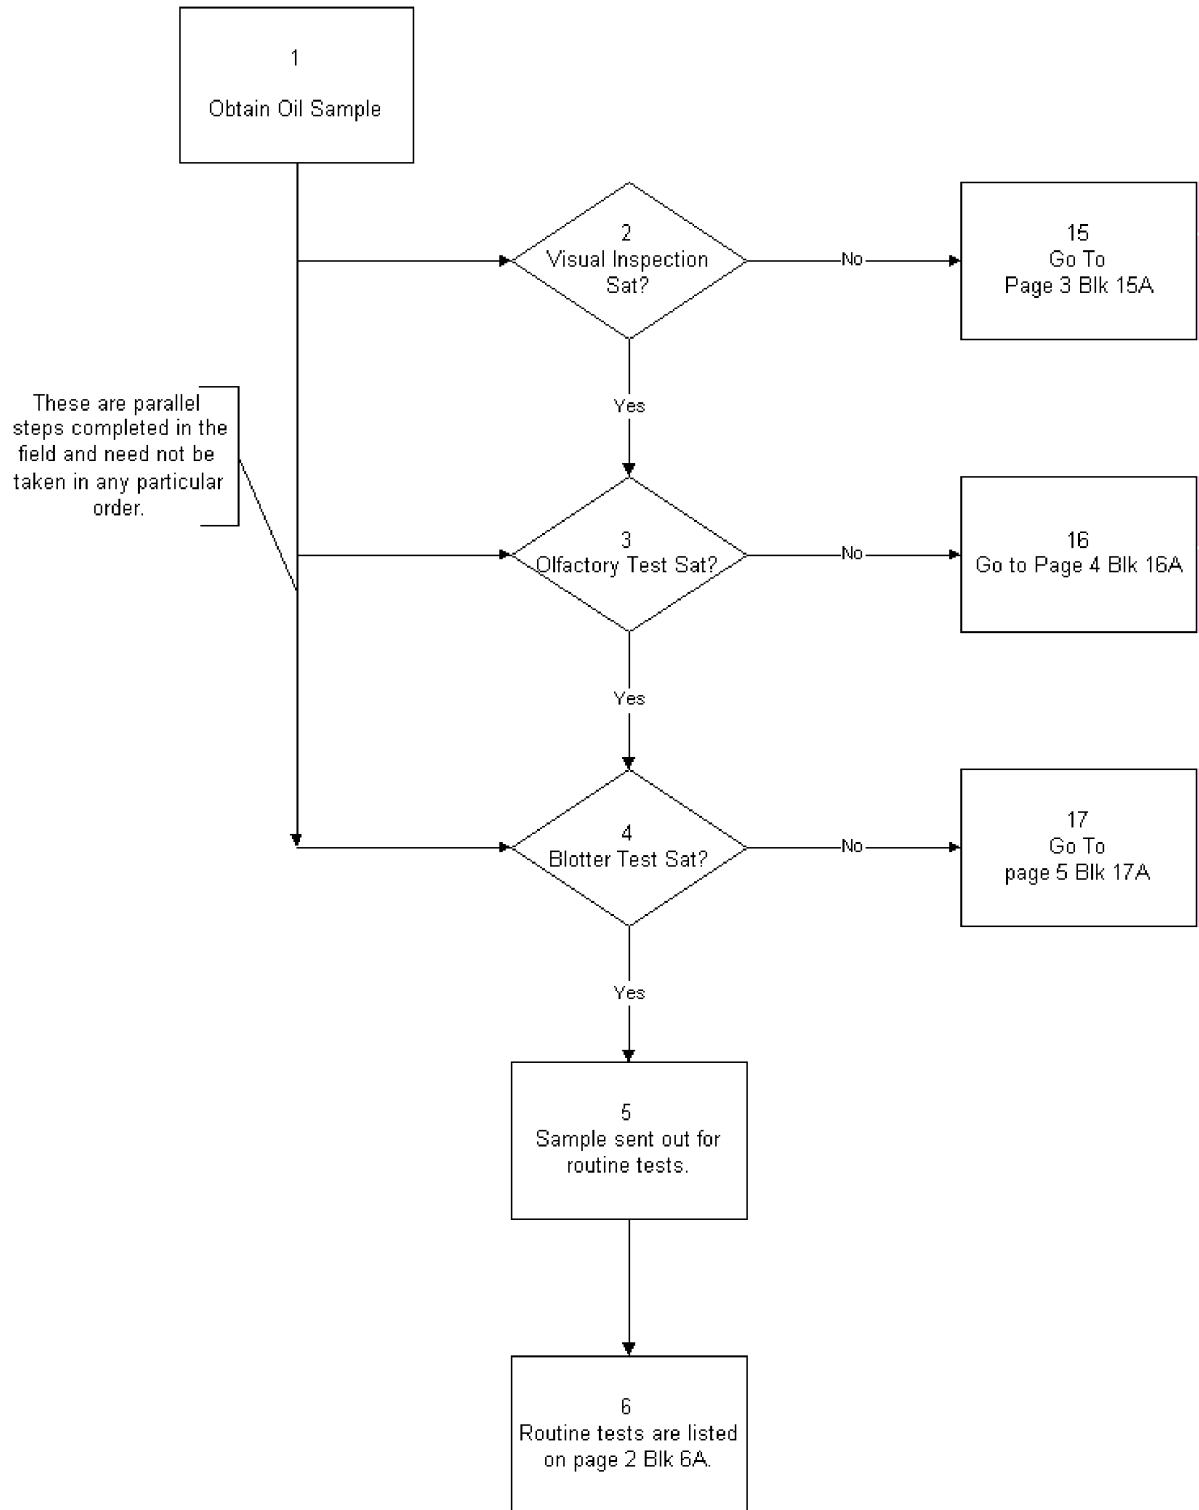
**Figure 1-9**  
**Oil Analysis**

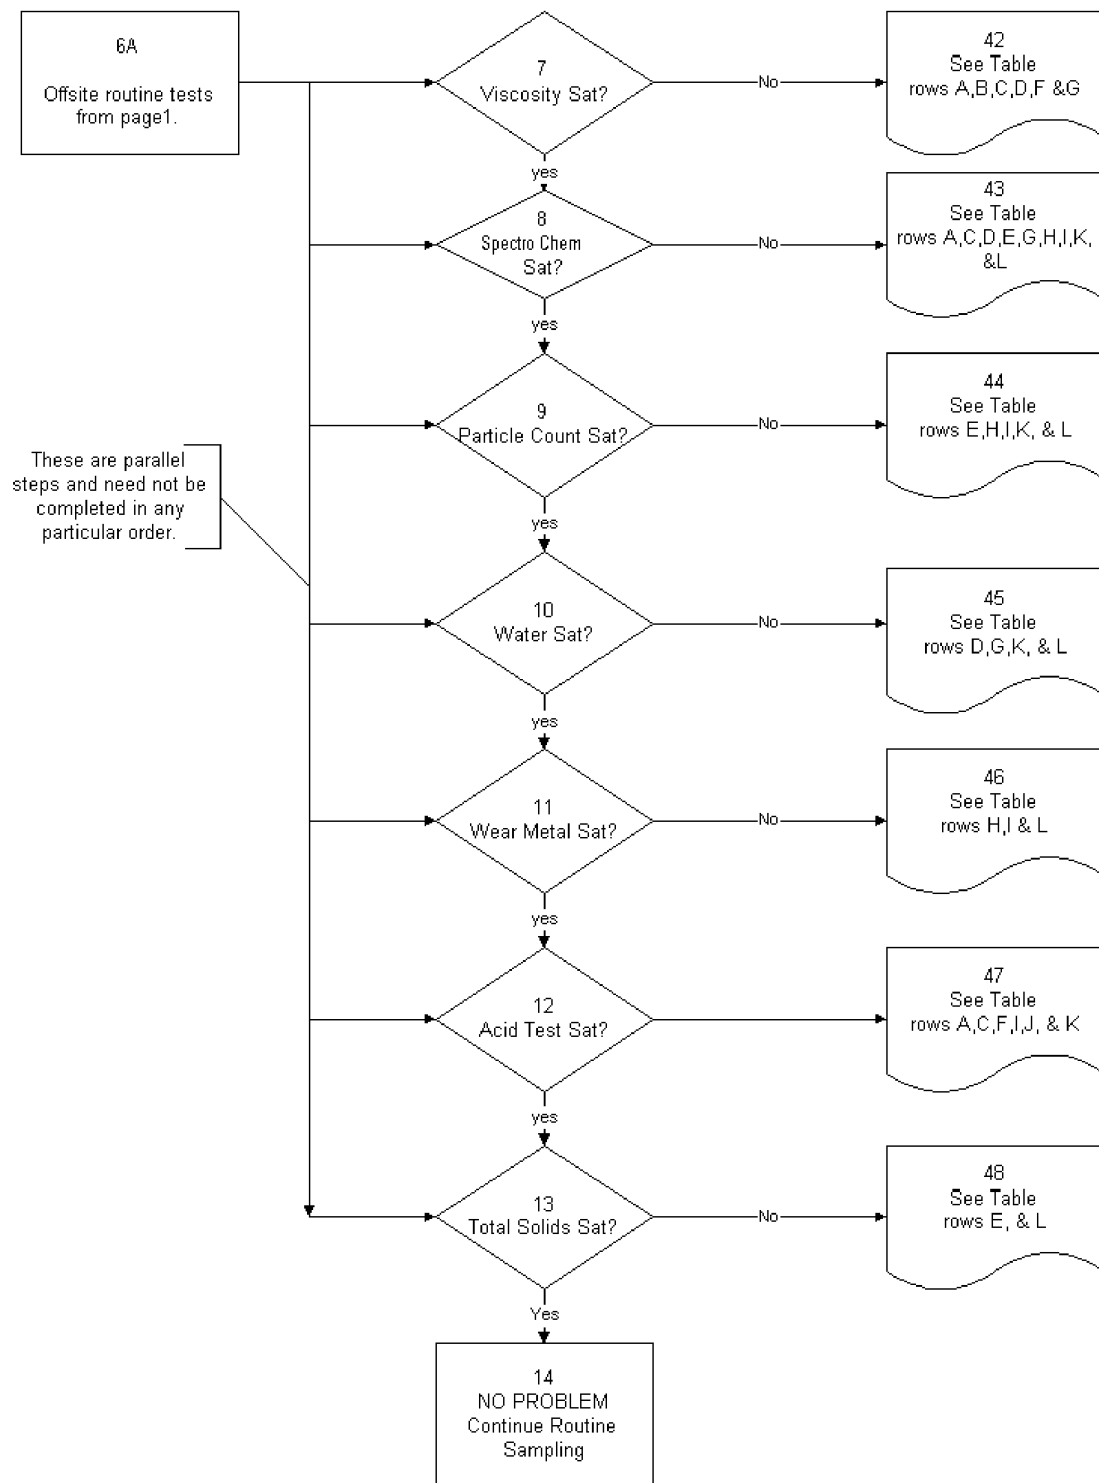
**Figure 1-10**  
**Oil Analysis**

### **Logic Tree (Figures 1-10 through 1-13)**

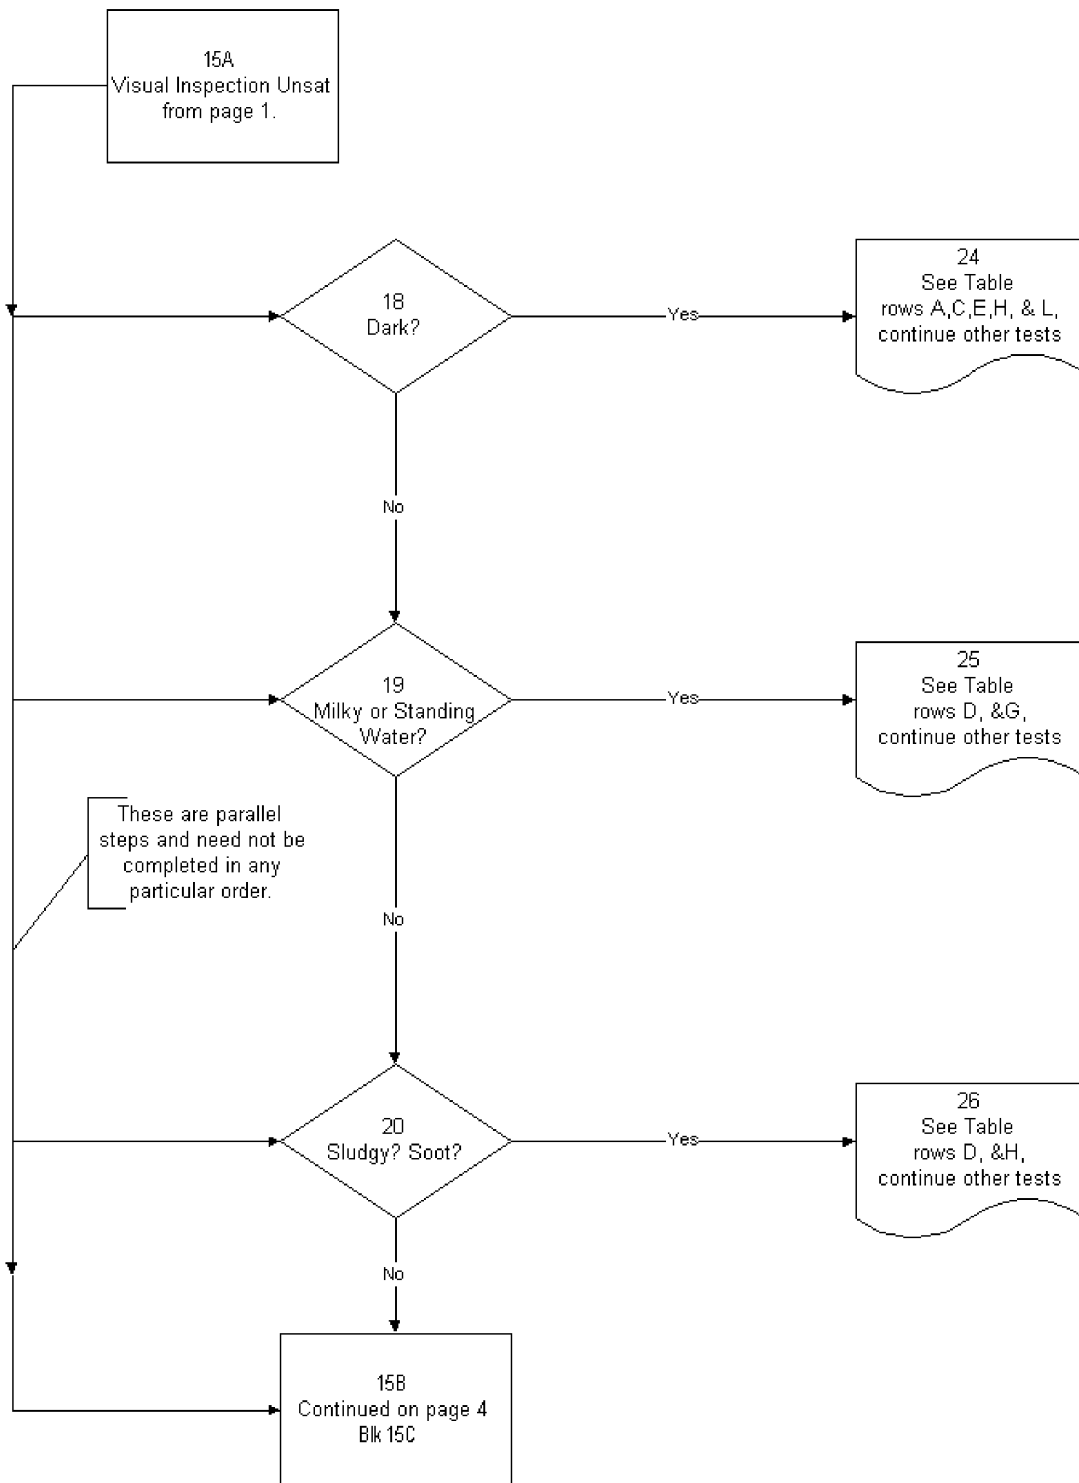
**Figure 1-11**  
**Oil Analysis**

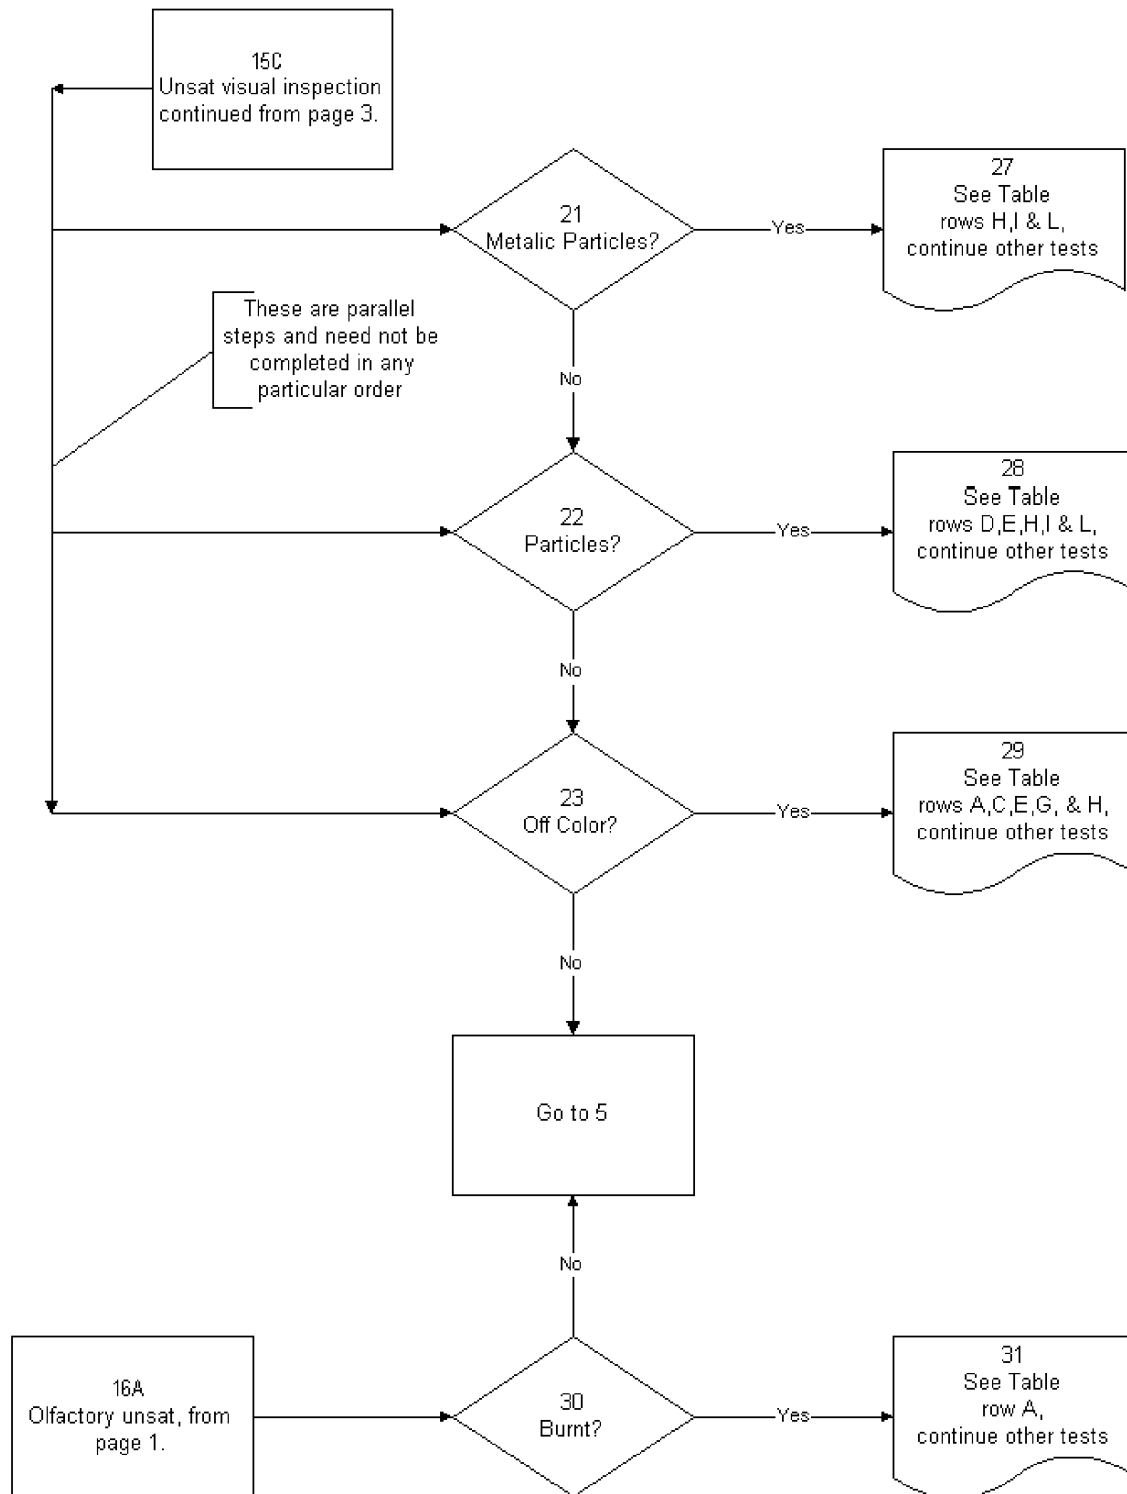
**Figure 1-12**  
**Oil Analysis**

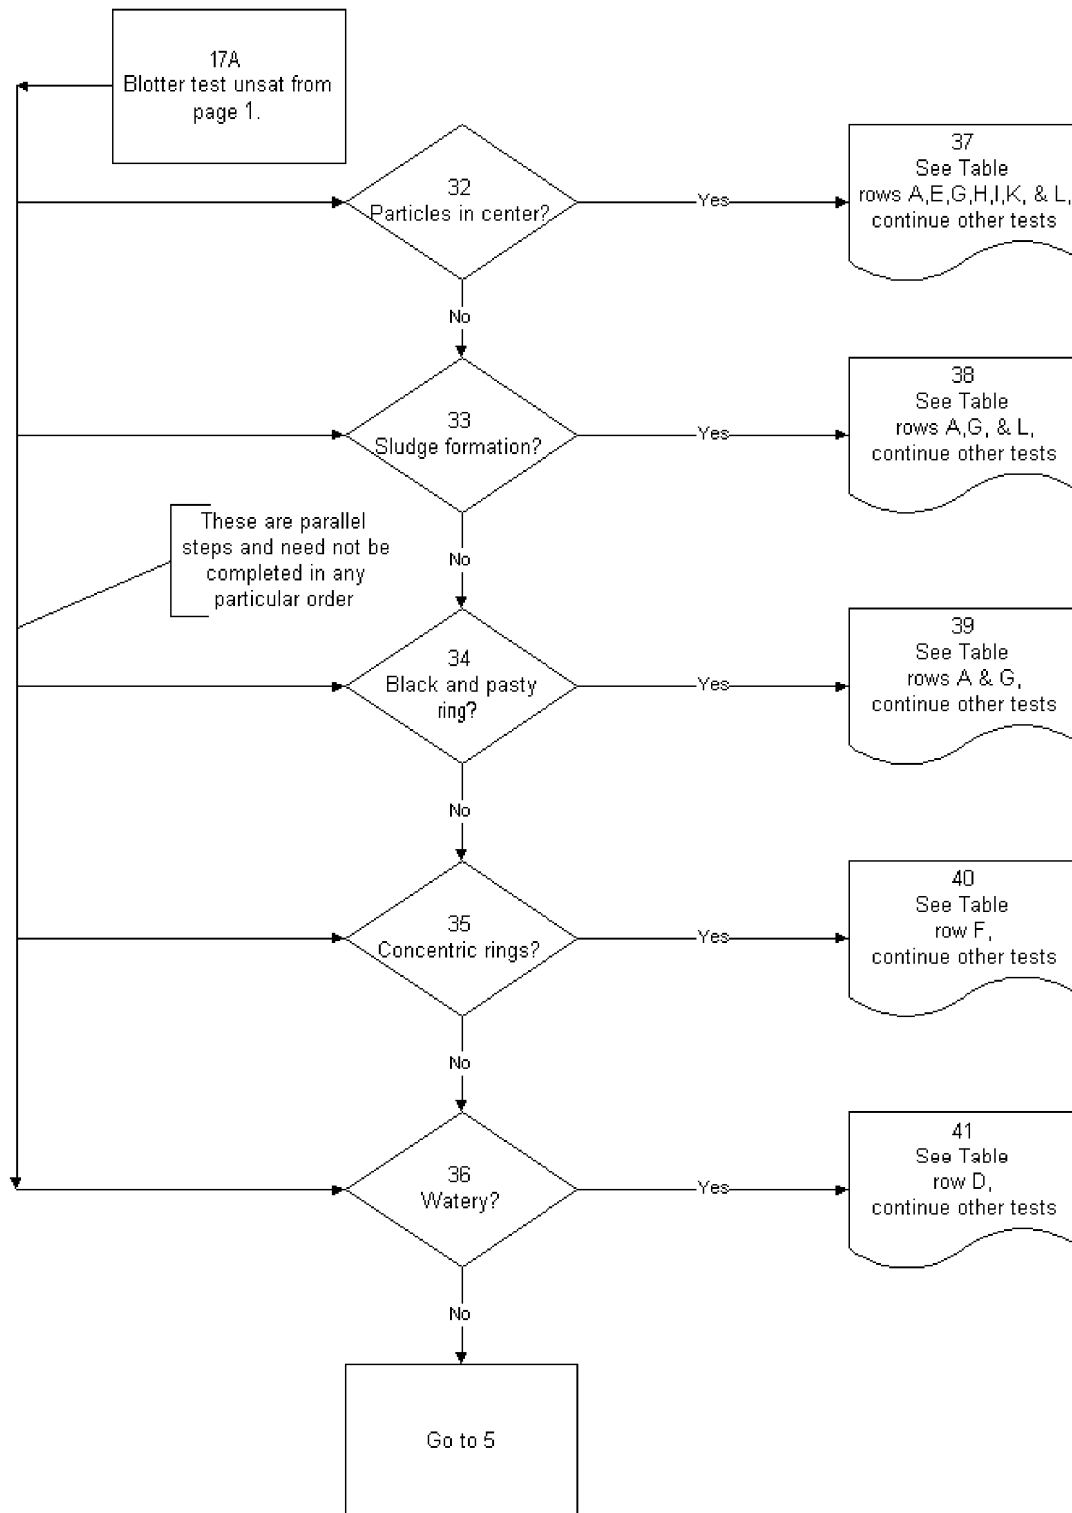
**Figure 1-13**  
**Oil Analysis**

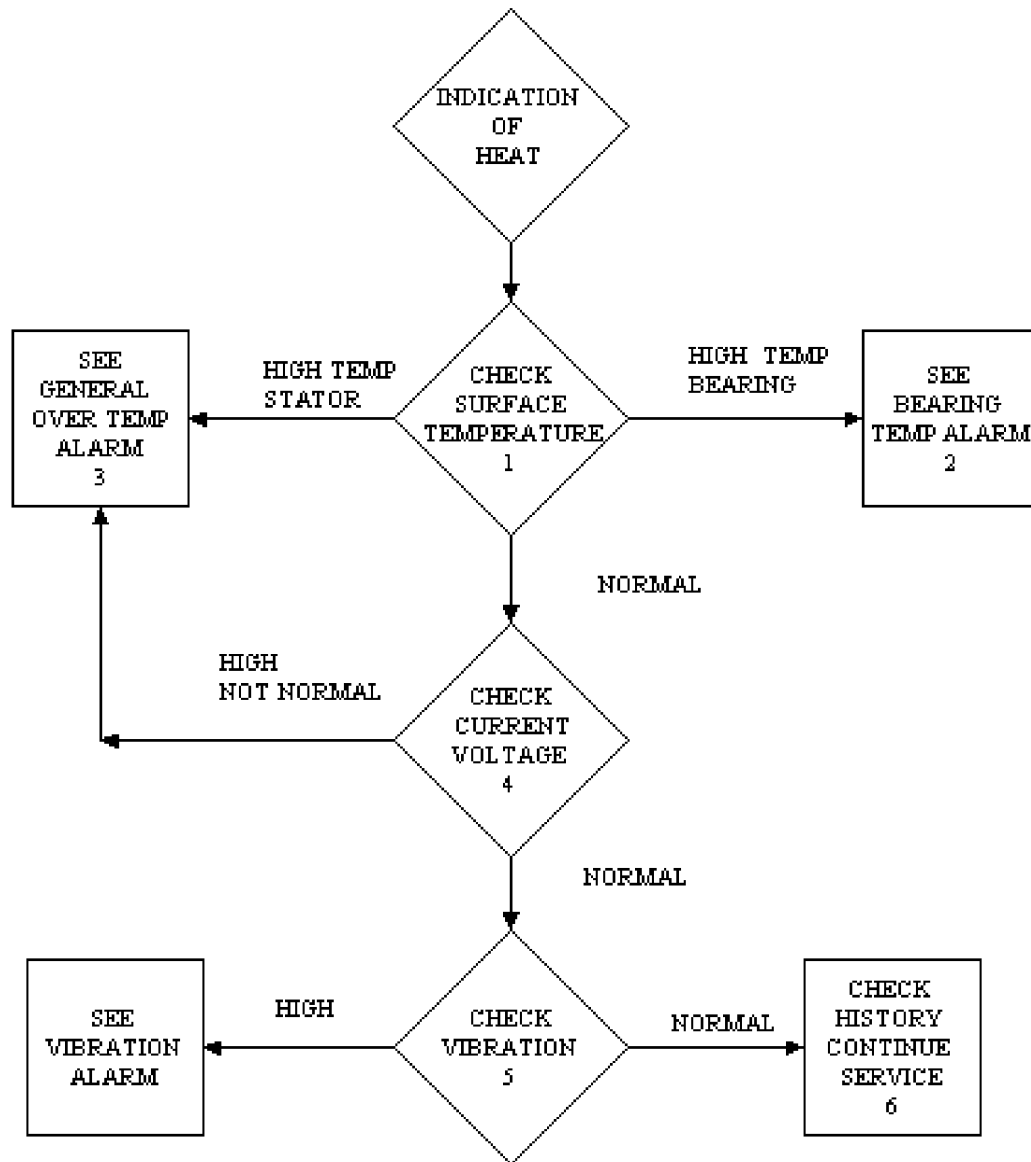
Box 5-Check vibrations as secondary check for other problems.

Box 6-If no problems are found continue running the motor and check the equipment history.

**Figure 1-14**  
**Discoloration of Housing or Indication of Heat**

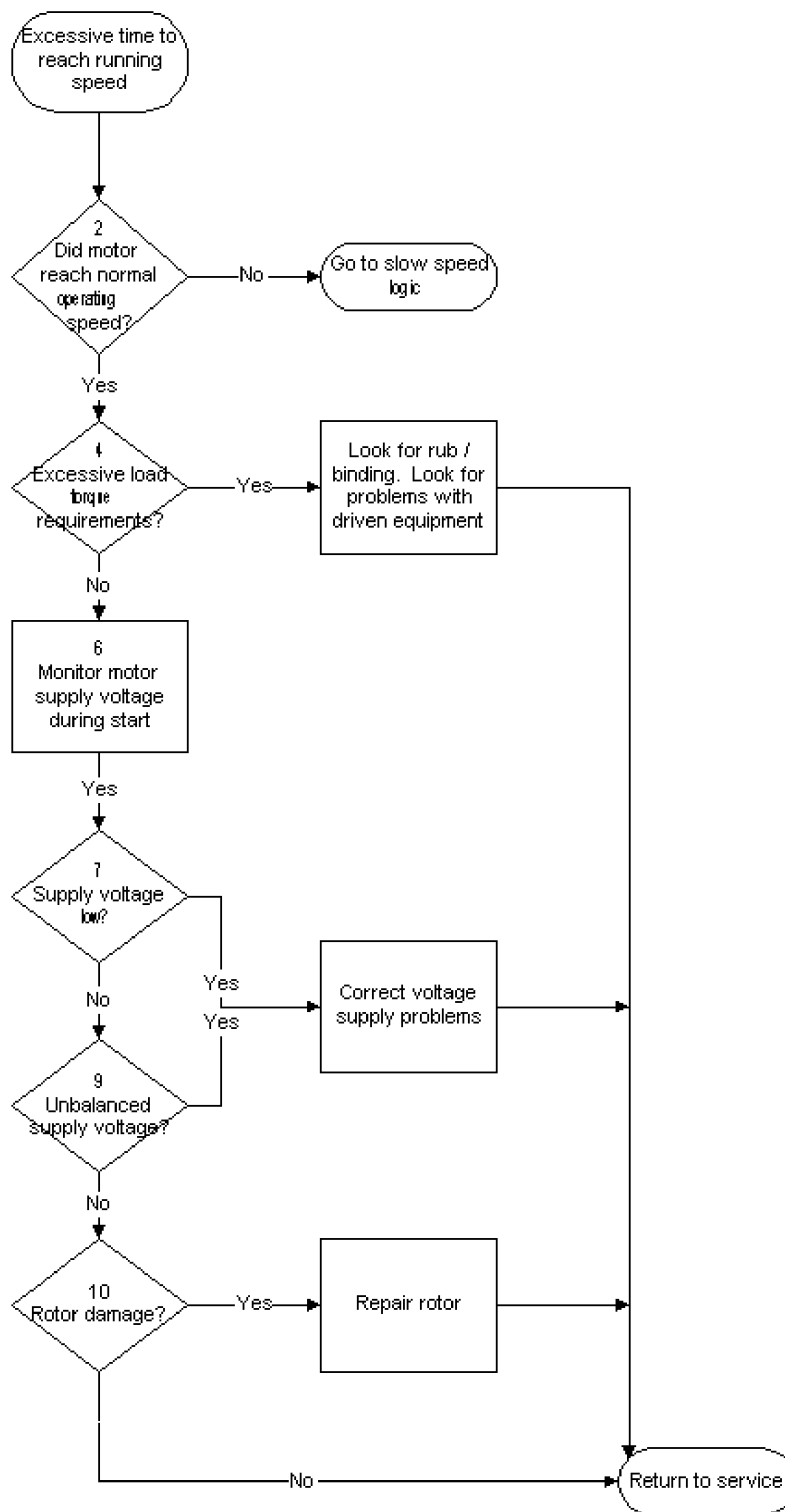
Box 10-Rotor cage defects can cause increased acceleration times. Listen for noise at start up due to broken rotor bars. Vibration analysis, current signature analysis, or power signature analysis can be used to test for broken rotor bars.

**Figure 1-15**  
**Slow Start (Excessive Acceleration Time)**

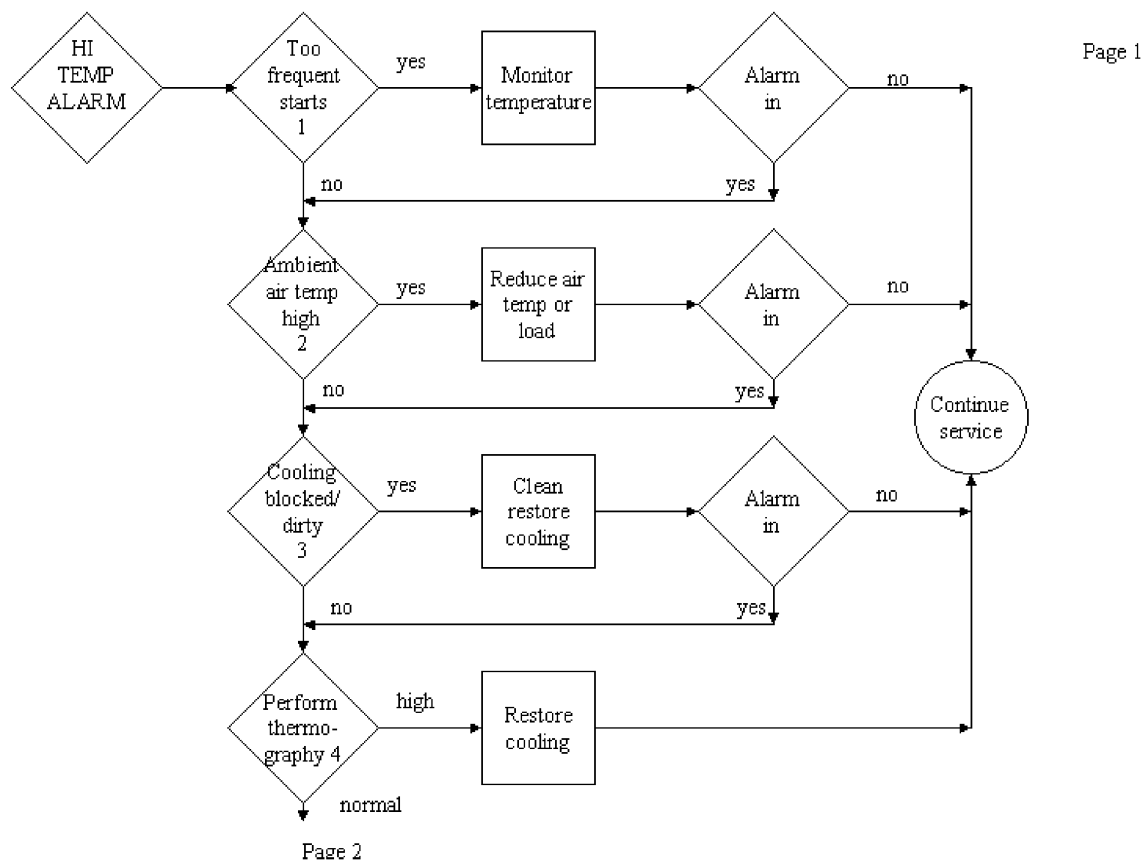
**Figure 1-16**  
**Over Temperature Alarm**
