# **Evaluation Tools for Electric Motor Testing**

Logic Diagrams

**1004003**

Final Report, December 2001

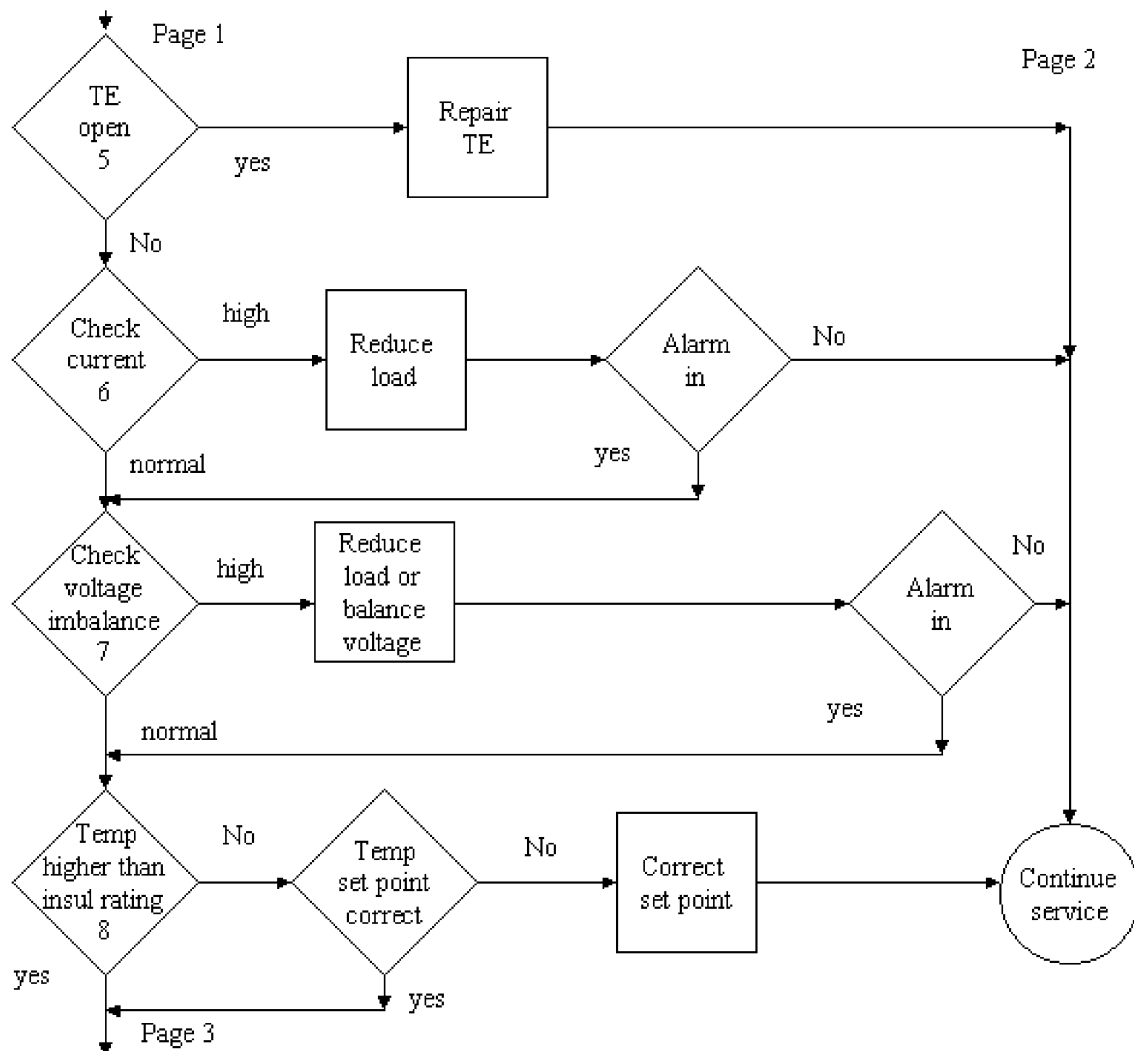
**Figure 1-17**  
**Over Temperature Alarm**

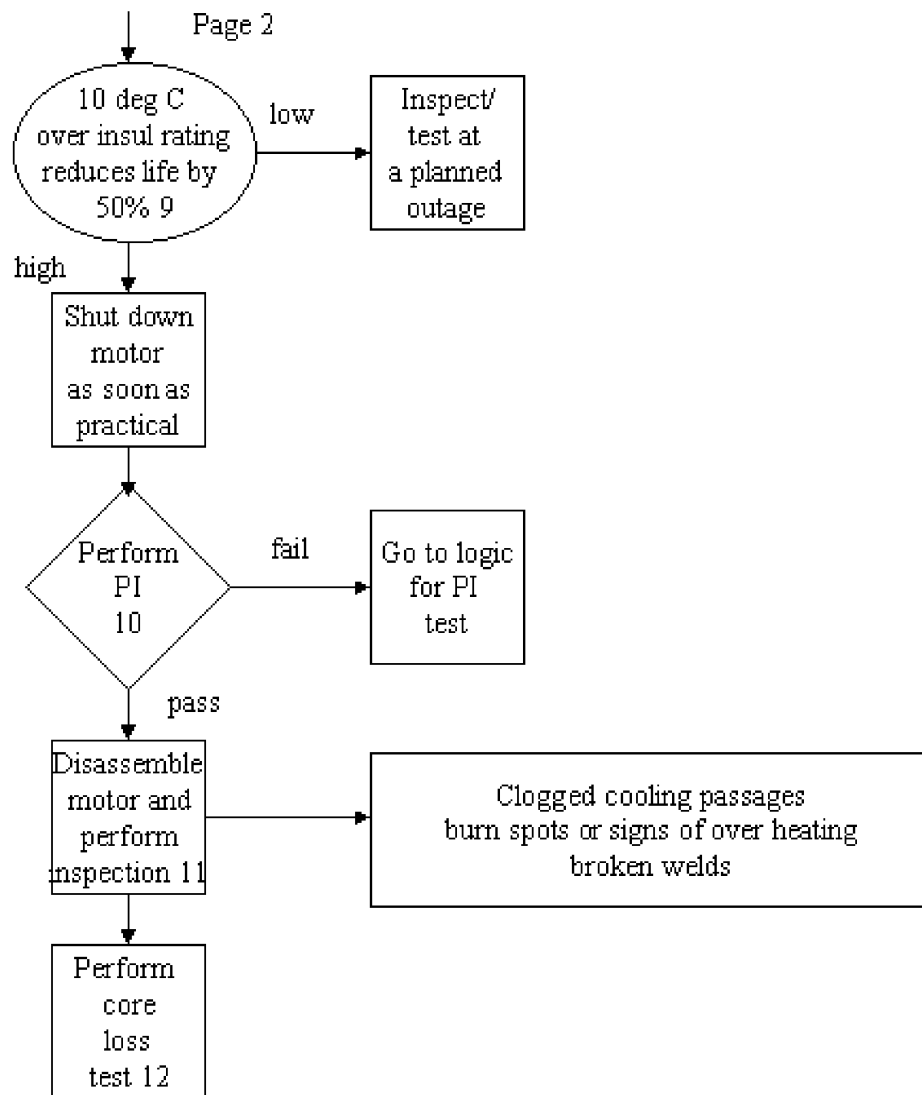
Box 11-Disassemble motor and inspect for clogged cooling passages or broken welds. Inspect core for discoloration, burn spots, broken teeth, fused metal or core insulation dusting. Check for tape separation and girth cracking just outside the slot. Check for wedge looseness and/or signs of axial movement outside of the slot.

Box 12-See logic for core loss testing.

**Figure 1-18**  
**Over Temperature Alarm**

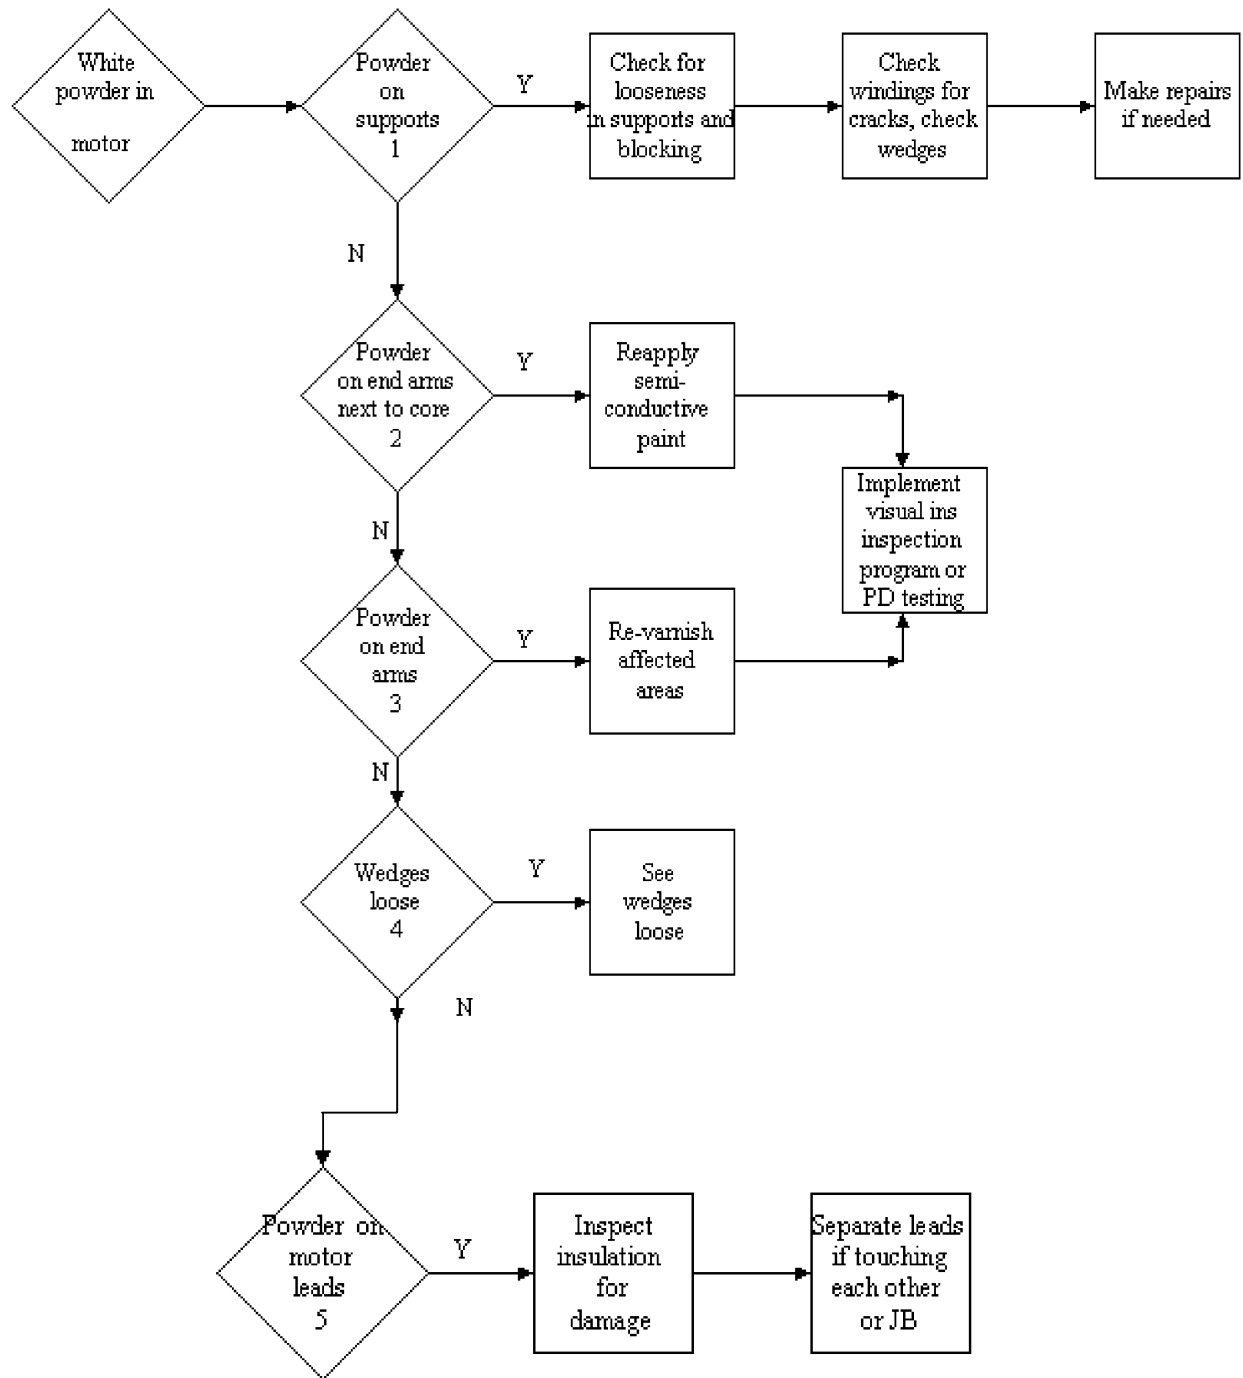
Box 4-Check wedges for signs of looseness. See stator core wedge loose for more information.

Box 5-If powder is in the motor leads, ensure the leads are not touching each other or the junction box. Separate the leads to ensure they have adequate air space. Inspect the leads to ensure the ozone created has not cracked the insulation.

**Figure 1-19**  
**White Powder Stator**
