Electric Distribution Hazard Tree Risk Reduction Strategies

Technical Report

Final Report, November 2004

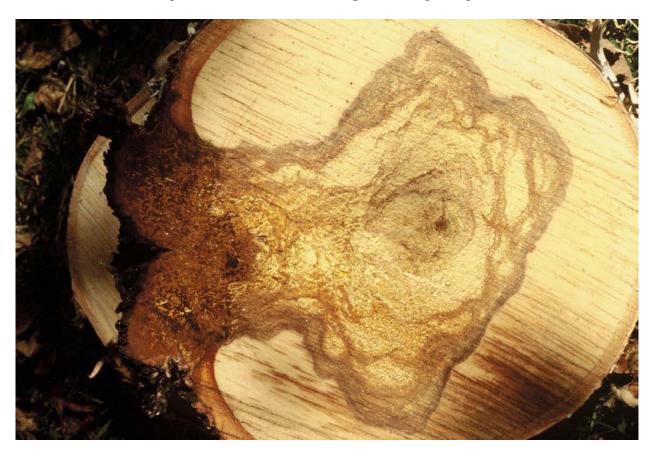
Figure 1-1
Decayed Tree Trunk, Reducing Tree Strength

Various formulae have been devised to establish numeric values of relative tree strength based on visual observation of the size and location of defects. Most measurement devices, however, are not yet practical for large-scale evaluations of tree hazards. Such evaluations generally rely on visual assessment, together with education and experience regarding tree failures.

At least one effort undertaken to compare the accuracy of visual evaluations in predicting actual decay patterns in laurel oaks (Quercus hemisphaerica) found that visual assessment can be a reliable means of predicting internal decay and voids that may be hazardous (Kennard, et al 1996). Another study of western hemlock (Tsuga heterophylla) found that external indicators are not sufficient to judge the internal conditions of hemlocks (Dunster, 1996).

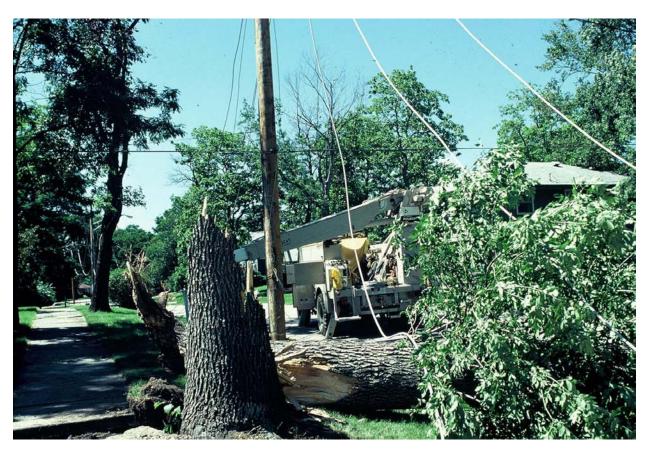
Figure 1-2 Hazard Tree Downed by Wind

Several field guides have been published for arborists to assist in evaluation of hazard trees (Clark and Matheny, 1993). Not only has significant work been conducted on how to best evaluate hazard trees, but new research has begun to challenge commonly held beliefs about how, when and under what circumstances trees fail through field experiments (Smiley and Coder, 2001). One research effort has demonstrated ranges in forces necessary to cause branches to fail under measured, static loads in an effort to simulate snow or ice loading (Lilly and Sydnor, 1995). Work has also been done to quantify certain wind thresholds that result in widespread branch failure. A recently reported 8-year study on the relationships between wind gusts and branch failure concluded that wind gusts of 50 mph or greater cause most branch failures when trees are in leaf. Gusts up to even 75 mph resulted in little branch damage during the dormant, leafless seasons (Luley, et al 2002).
