# Power Quality Implications of Transmission and Distribution Construction

## Tree Faults and Equipment Issues

**1008506**

Final Report, March 2005

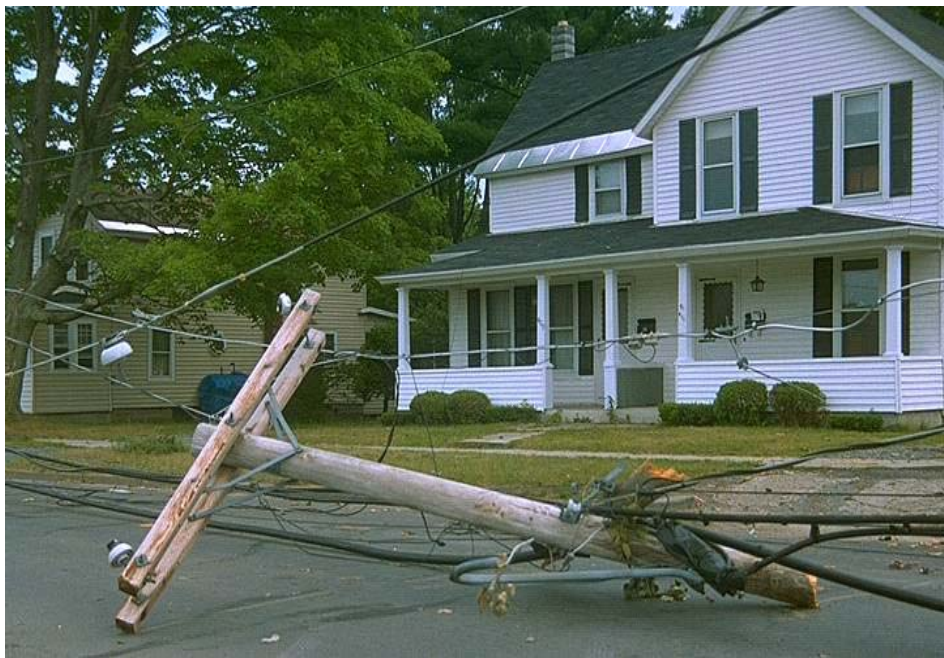
**Figure ES-1**  
**A Pole Broken in Half by a Tree Falling onto the Line Structure During a Windstorm**

- *Mechanical coordination*—Consider equipment component failures in structure designs, and try to coordinate the mechanical design such that when tree and large limb failures occur, equipment fails in a manner that is easier for crews to repair. When a tree falls on a line, crews will have an easier repair if it just breaks the conductors rather than breaking poles and other supports (see Figure ES-1). The fault still occurs, but crews are able to more quickly repair the damage and restore service.

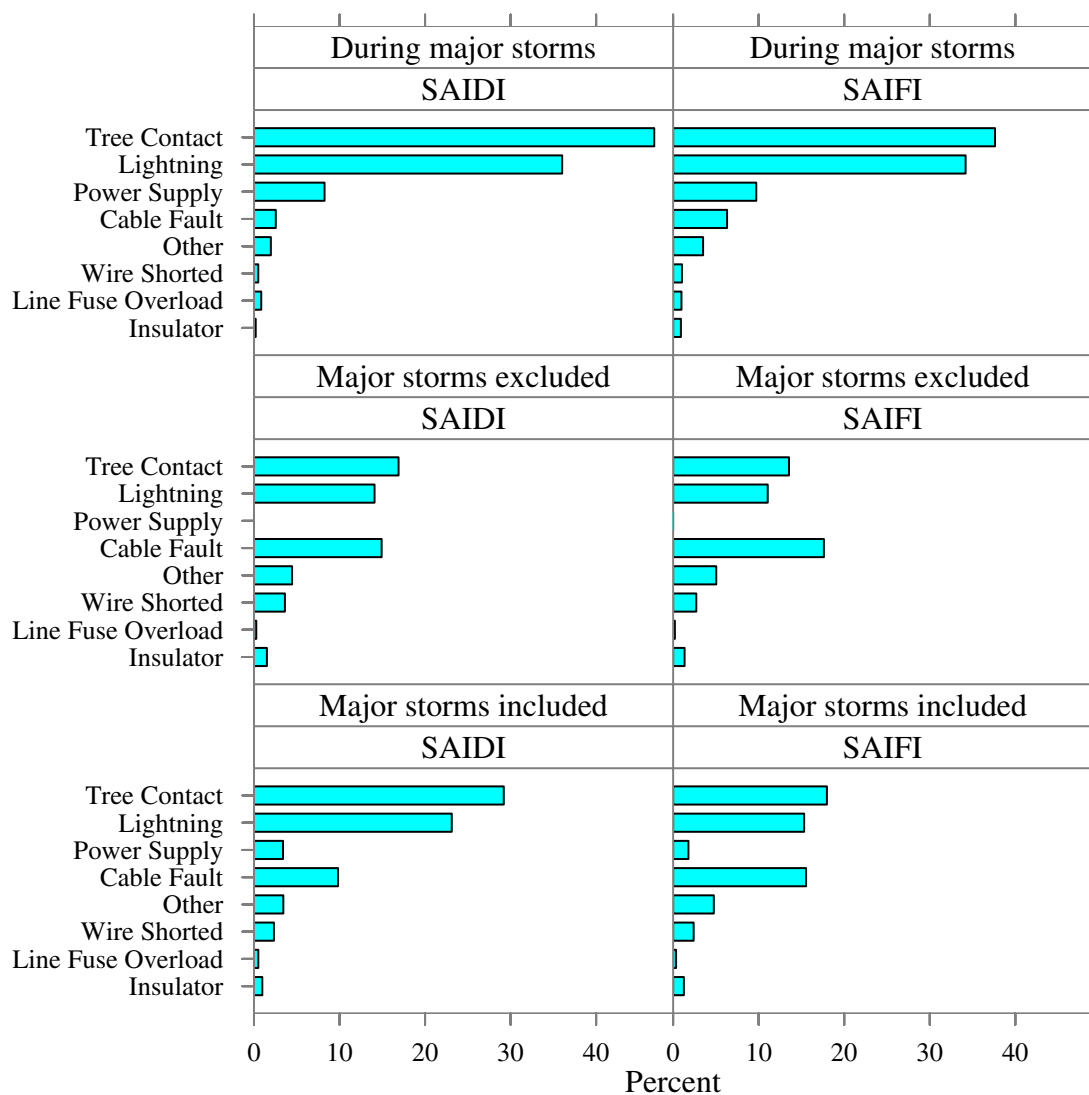
**Figure 2-6**  
**Interruption Indices by Cause During Major Storms and With and Without Major Storms**

For many utilities, tree-caused interruptions are the main cause of interruptions during “major storms” or “major events” (the IEEE terminology). Duke Power found that trees account for 81% of their outages during major event days [Taylor, 2004a]. The data for a northeastern US utility in Figure 2-6 also shows tree-contact as the main cause during major events (with lightning a close second). The effect of trees during major events depends on the dominant storm patterns and the utility’s definition of a major event.

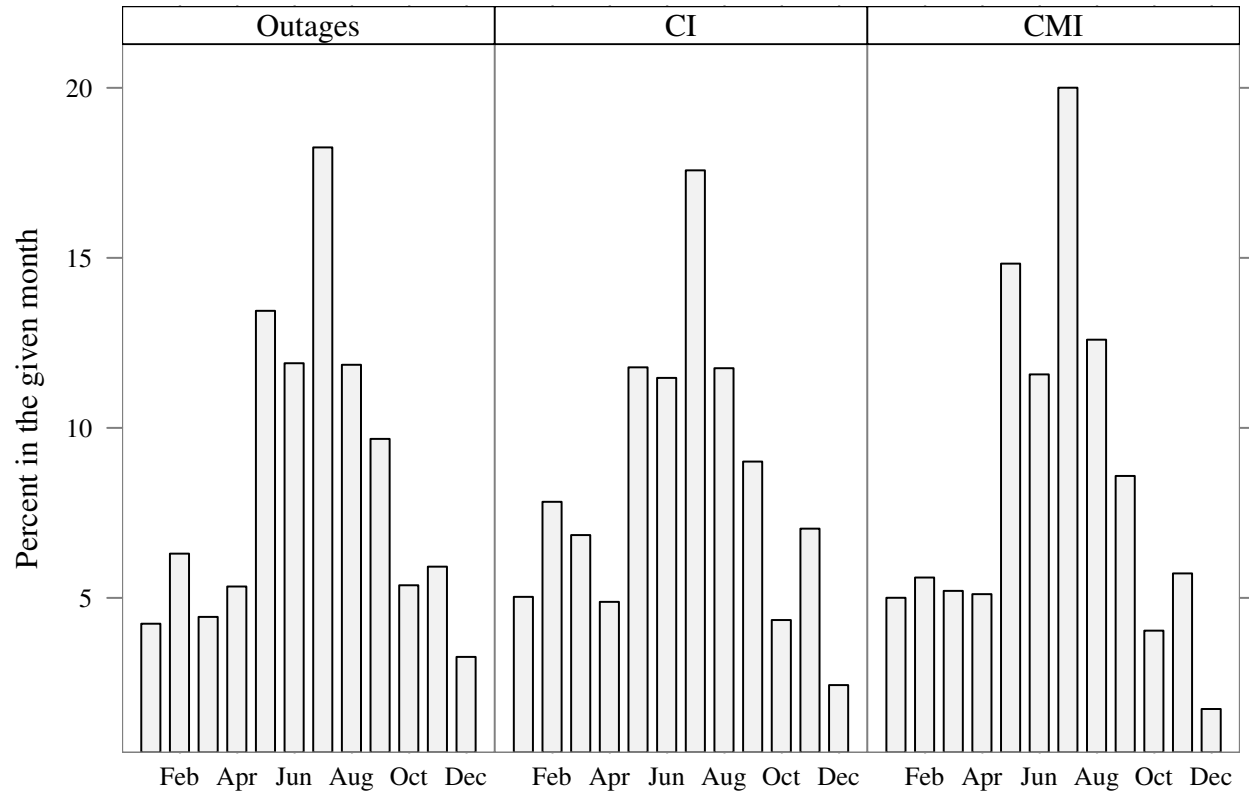
Source: Southeastern US utility, 2003 – 2004

Major Events Included

CMI = Customer minutes of interruptions

**Figure 2-7**  
**Tree-Caused Outage Impacts by Month**

Being highly correlated with weather, season has a large impact on tree-fault rates. Duke Power has the most tree-caused faults during the summer and the least during fall [Chow and Taylor, 1993; Xu et al., 2003]. Another southeastern US utility also has the most outages during the summer as shown in Figure 2-7 as does a northeastern US utility as shown in Figure 2-8.

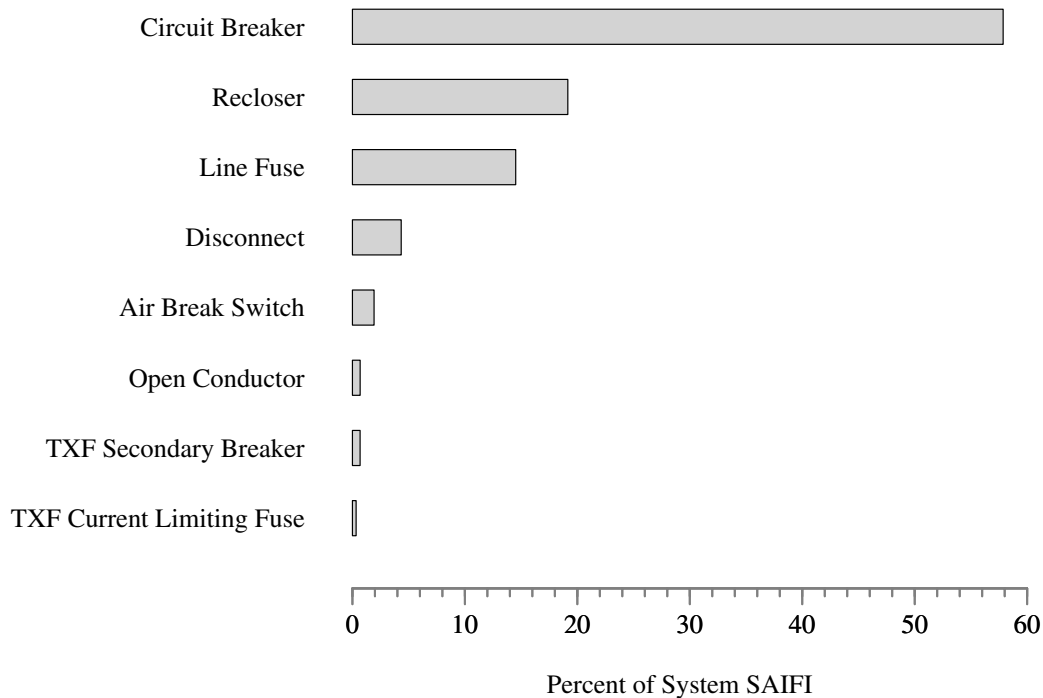
**Figure 2-9**  
**Tree-Caused Customer Interruptions by Interrupting Device for One Northeastern Utility**  
**(Major Events Included)**

Interruptions on the mainline affect the most customers. Figure 2-9 shows the breakdown of tree-caused SAIFI for one northeastern US utility. This utility had almost 60% of tree customer interruptions from breaker lockouts. Duke Power [Chow and Taylor, 1993; Xu et al., 2003] also found that of circuit breaker and recloser lockouts, trees caused 35 to 50% of the lockouts, which is over twice the rate of all tree outage events (trees cause 15 to 20% of all of Duke's outages).

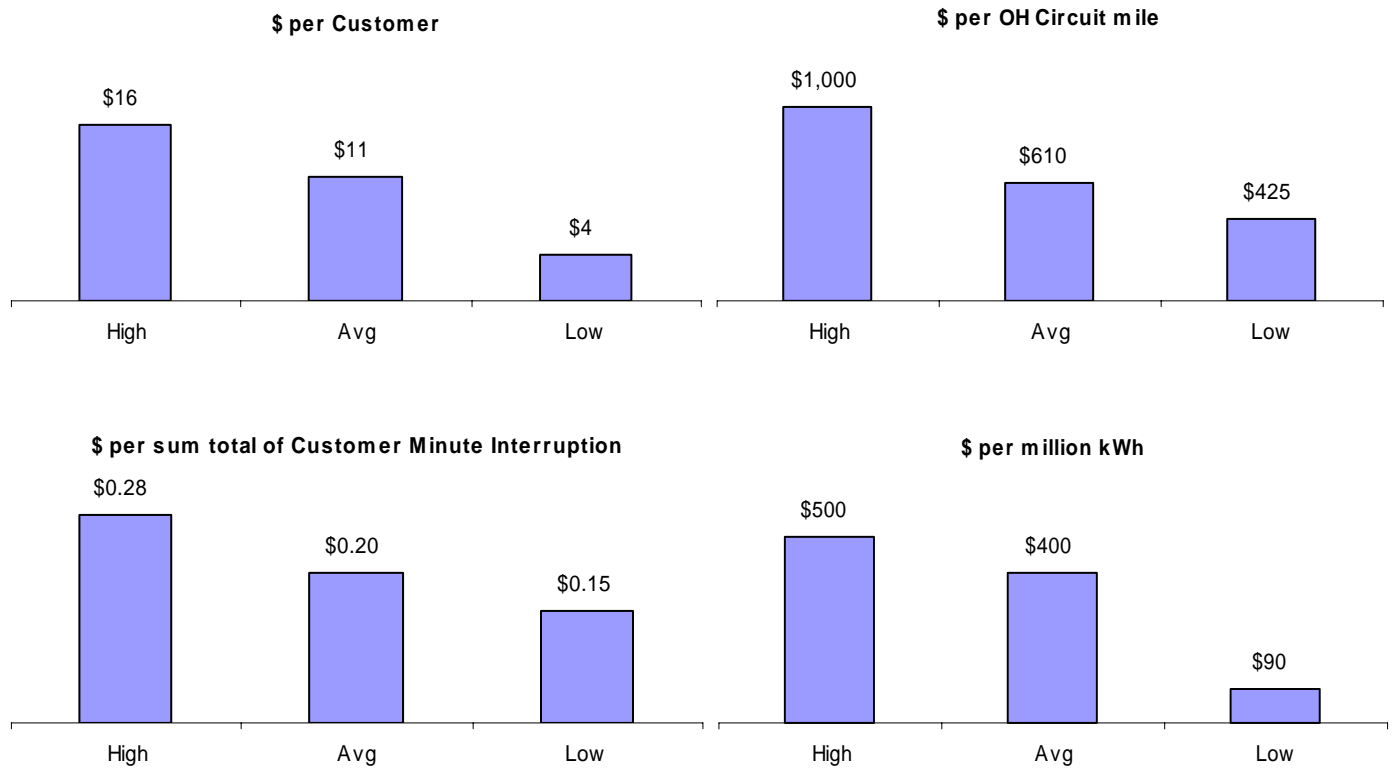
Data source: [EPRI TR-109178, 1998]

**Figure 2-14**  
**Utility Vegetation Management Costs of Five Utilities Surveyed**

Tree trimming is expensive—an EPRI survey found that utilities spend an average of about \$10 per customer each year on tree trimming ([EPRI TR-109178, 1998] and Figure 2-14). Trimming can also irritate communities. It is always a dilemma that people don't want their trees trimmed, but they also don't want interruptions and other power quality disturbances.

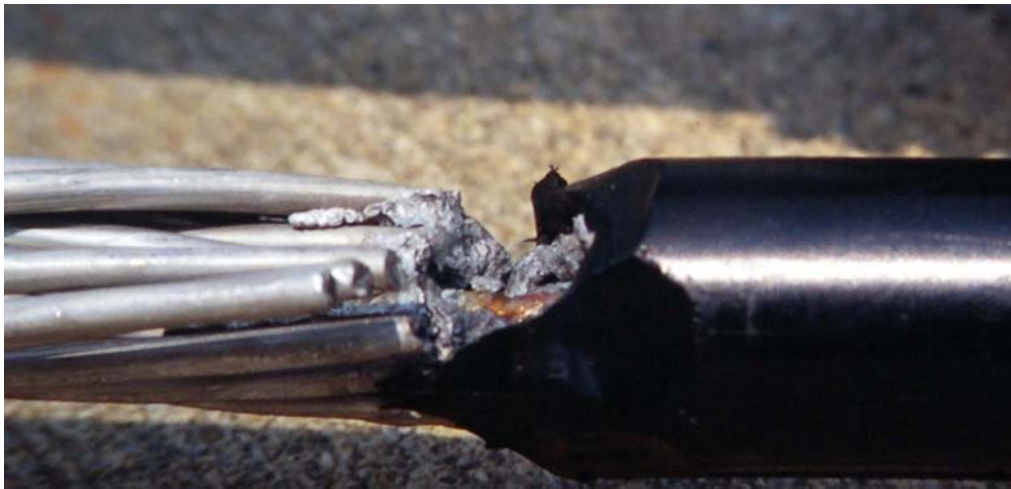
**Figure 3-3**  
**Conductor Damage From Arcing Where the Conductor Cover Begins**

Covered conductor is susceptible to burndowns because when a fault current arc develops, the covering prevents the arc from moving. The heat from the arc is what causes the damage. Although ionized air is a fairly good conductor, it is not as good as the conductor itself, so the arc gets very hot. On bare conductors, the arc is free to move, and the magnetic forces from the fault cause the arc to move (in the direction away from the substation—this is called *motoring*). The covering constricts the arc to one location, so the heating and melting is concentrated on one part of the conductor. If the covering is stripped at the insulators and a fault arcs across an insulator, the arc motors until it reaches the covering, stops, and burns the conductor apart at the junction (see Figure 3-3 for an example of such damage). A party balloon, lightning, a tree branch, a squirrel—any of these can initiate the arc that burns the conductor down.

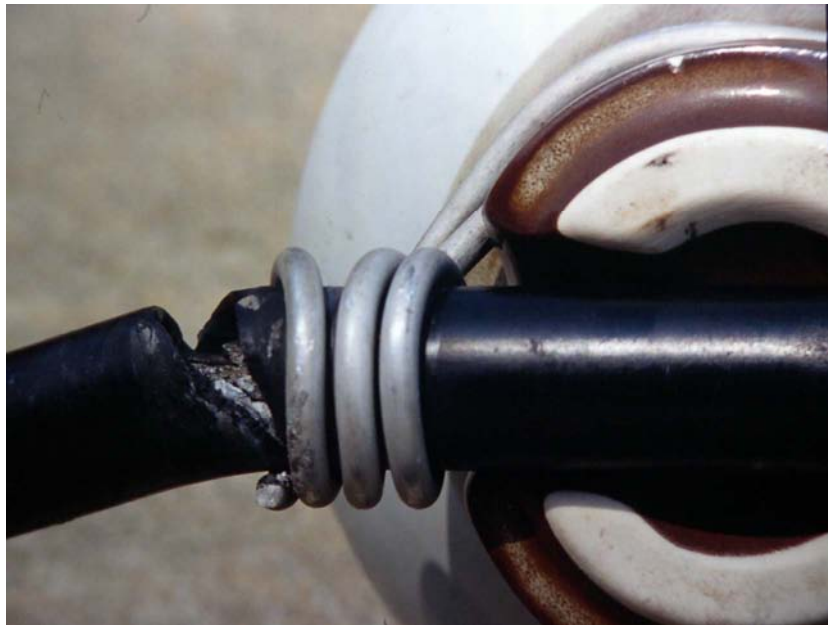
**Figure 3-4**  
**Conductor Damage From Arcing**

Burndowns are most associated with lightning-caused faults, but it's the fault current arc, not the lightning, that burns most of the conductor. Lightning triggers the arc; see Figure 3-4 for an example where a conductor was damaged by a puncture as the conductor flashed to the insulator tie. Lee et al. [1980] reported on a survey of 390 fallen covered conductor cases by the

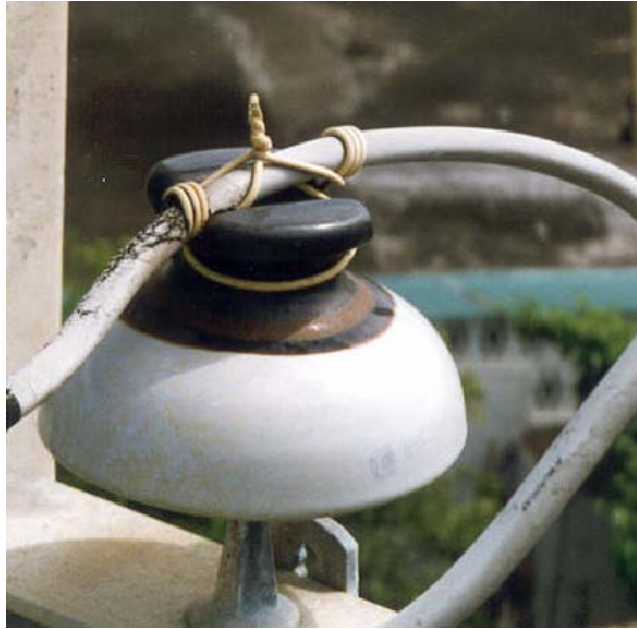
**Figure 3-8**  
**Example of a Covered Wire Tie on a Covered Conductor**

- Bare conductor tie on a covered line conductor that's not stripped at the insulator
- Insulated conductor tie on a bare or covered line conductor (see Figure 3-8)

A conducting insulator tie in close proximity to the phase conductors creates a prime arcing scenario. A voltage can develop between the conducting insulator tie and the line conductor. The capacitance between the two is on the order of 30 to 50 pF, which is enough to charge the conducting tie relative to the line conductor [Vincent and Munsch, 2002]. The line covering may hold this voltage, but the covering may deteriorate or lightning may puncture it. Once the insulation has been bridged, repetitive arcing can occur across the air gap as the tie wire charges and then discharges into the line conductor. Arcing will further deteriorate the conductor insulation, possibly causing more arcing. Vincent and Munsch [2002] also document a second cause of RFI from incompatible insulator ties: if the insulation deteriorates enough so that the conducting insulating tie touches the line conductor, then an insulating oxide layer can build between the two, leading to microsparking noise from breakdowns across this small gap.

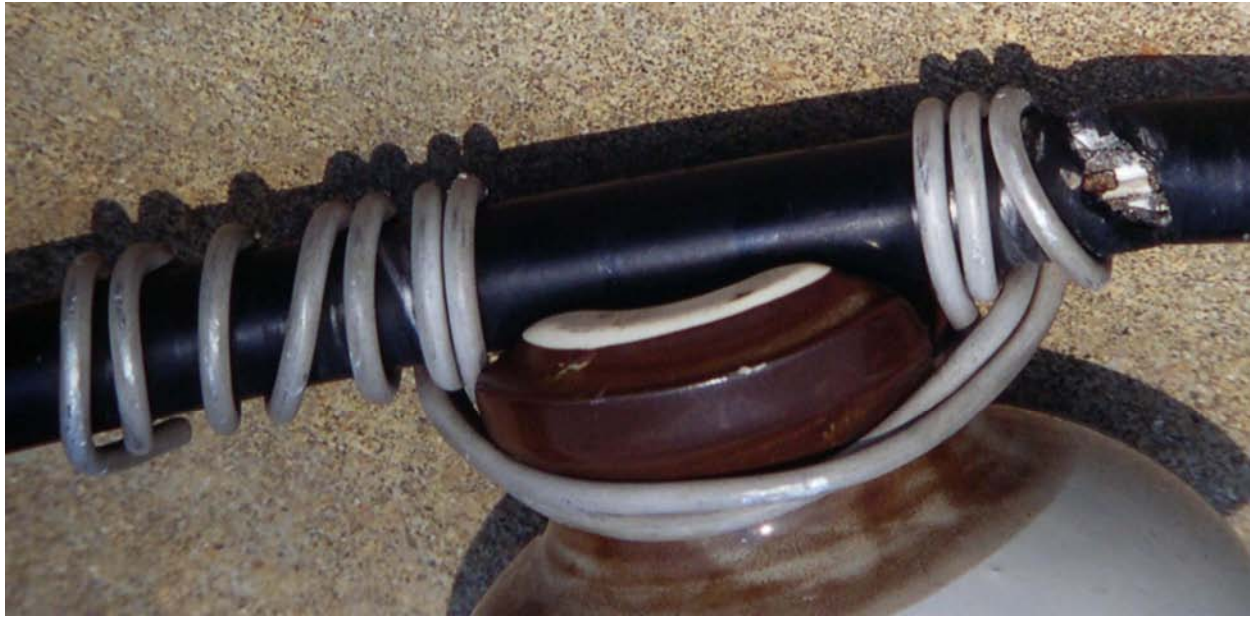
**Figure 3-9**  
**Example of Damage on a Covered Conductor From Flashover at the Insulator Tie**

point is where the insulation is weakest: at the insulator where the tie comes in contact with the covering (Figure 3-9). The covering will not add significant insulation to a structure with an insulator and a foot or more of wood or fiberglass.

Some utilities argue that lines have better lightning protection if the covering is left on the conductor. While the improvement is marginal, there is some difference between different covering and insulator tie combinations. Tests at Clarkson University [Baker, 1984] of 15-kV class pin insulators in the 1980's found that keeping the cover on raises the critical flashover voltage from about 115 kV with bare wire to about 145 kV with the cover on using a preformed plastic tie (with a semiconductive tie or a polyethylene covered aluminum tie, the values were slightly less than this). For a direct strike, these differences should not matter, but for a weakly insulated line (with little wood or fiberglass), the extra insulation could help reduce induced-voltage flashovers, but for most North American designs, the difference in overall insulation is small. Direct strikes will still cause flashovers and possible damage; the most likely flashover

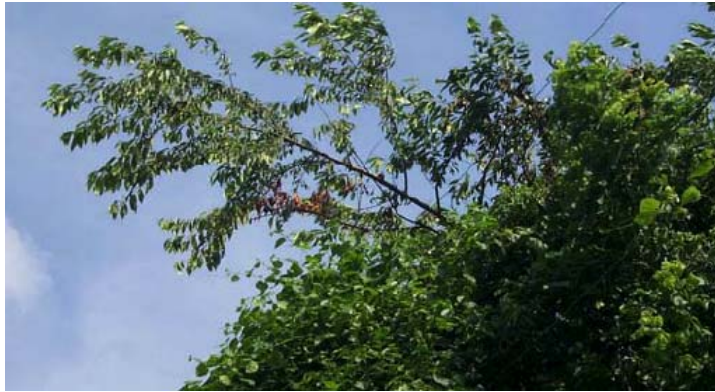
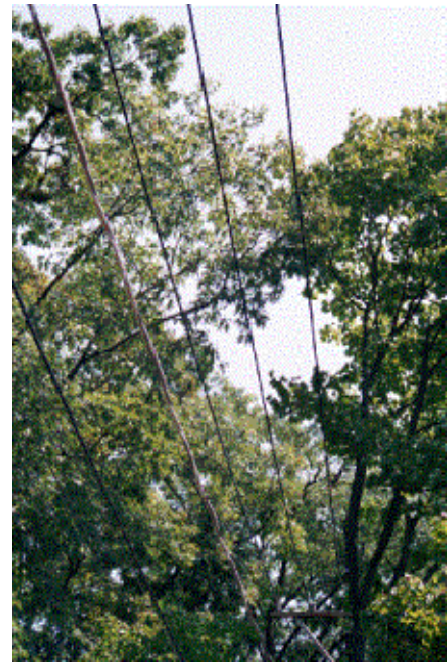
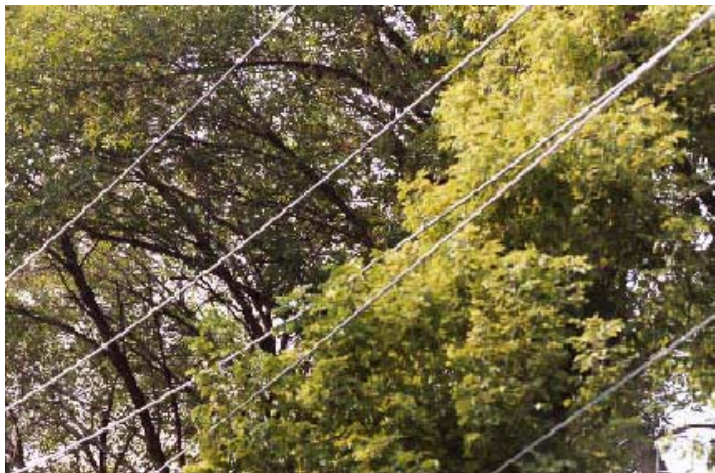
**Figure 4-1**  
**Circuits With Significant Tree Overhang**

Consider the type of tree exposure affecting a line. Compare the circuits in Figure 4-1 that have significant tree overhangs to the circuits in Figure 4-2 that have exposure to growth. Which are worse? As shown by the data from several utilities, branch failure and tree failure are much more of a problem than tree growth. So, tree maintenance strategies should concentrate on removing overhangs and removing trees in danger of falling on circuits.

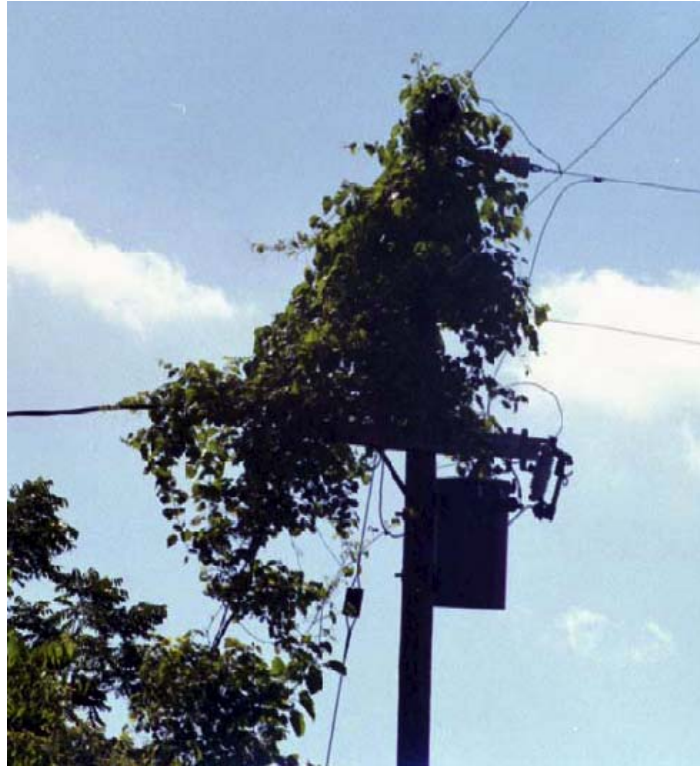
**Figure 4-3**  
**Circuits With Vines**

Vines are a special situation that requires special attention (Figure 4-3). Vines can grow very quickly, and they cause some of the most repeatable faults. Because of the repeatability, when responding to a vine-caused interruption, crews should exterminate the offending vines as best as possible (or flag the pole for later attention by vegetation crews). Repeatability is also a reason to have a separate outage cause code for vines—this makes it easier to follow vine-caused faults for vegetation crews. Especially on circuit mainlines, vines should be targeted for removal because they are so fast growing and will cause repeated outages if not kept under control.

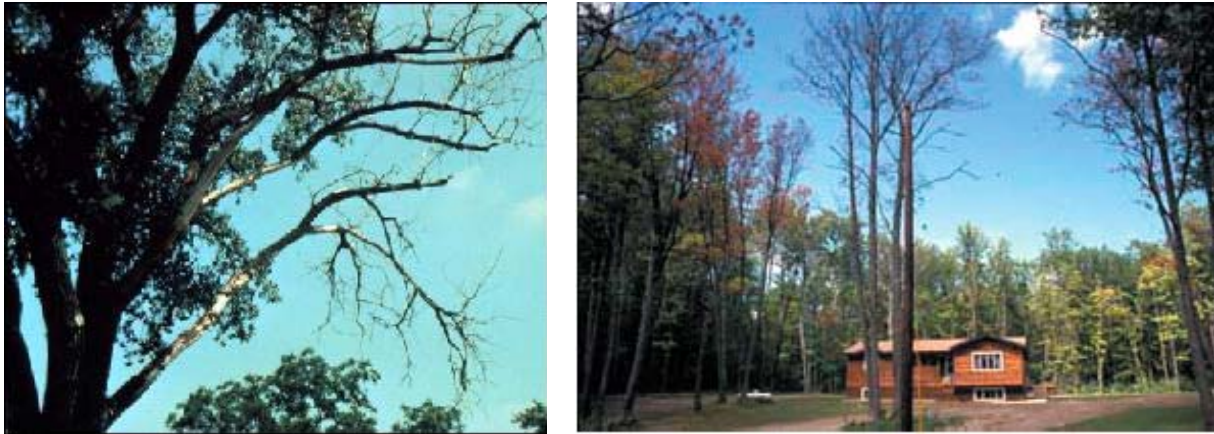
**Figure 4-5**  
**Example of Deadwood**

- *Deadwood* – as the name implies, this is wood that has died. Deadwood is dry and brittle and cannot bend under load (wind, ice, etc.) and is therefore prone to breakage. This defect can range from individual branches to whole trees. Deadwood is often indicated by limbs or

trees that do not have green, new growth leaves during the summer season such as that shown in Figure 4-5. Dangling dead branches are particularly dangerous.

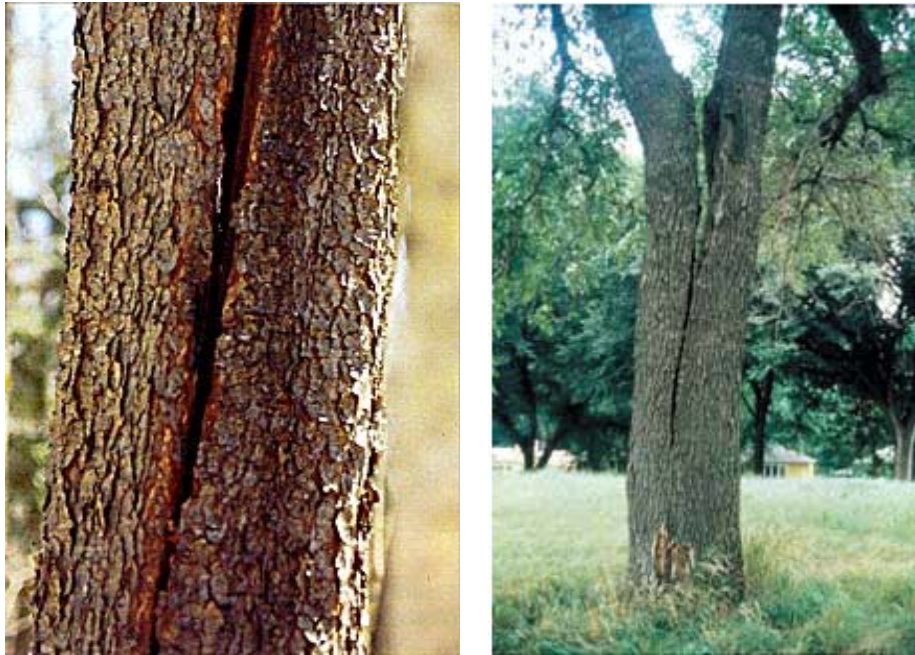
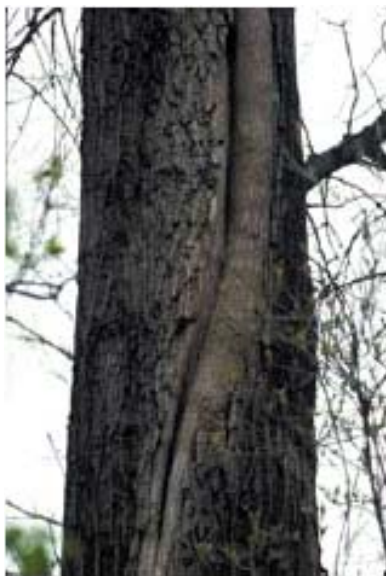
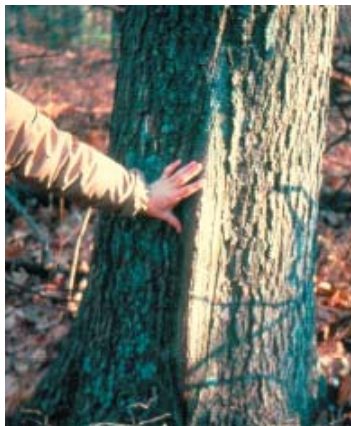
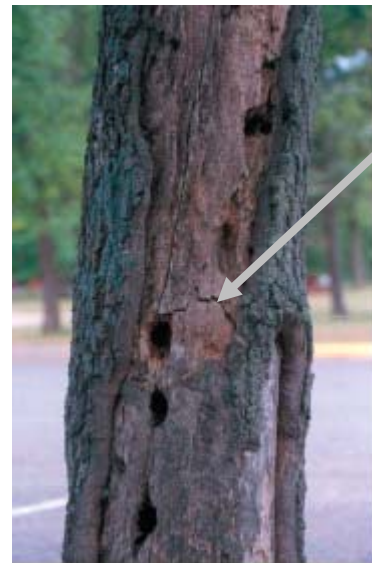
**Figure 4-6**  
**Examples of Cracks**

- *Cracks* – A crack is a deep split that extends through the bark and into the wood. Cracks are a sign that the tree has already started to fail. There are four types of cracks (Figure 4-6):
  - Shear Crack - A shear crack, as shown in Figure 4-6, separates the stem into two halves and carries a high risk of failure.
  - Inrolled Crack – The edges of this vertical crack are inrolled encompassing the bark and wood. Trees with inrolled cracks almost always suffer serious decay at the crack site.
  - Ribbed Crack – A ribbed crack is a fissure in a raised rib of wood along the length of the stem.
  - Horizontal Crack – These cracks run across the wood grain and are rare to find since they develop just before the tree fails.

Shear cracks

Inrolled crack

Ribbed crack

Horizontal crack

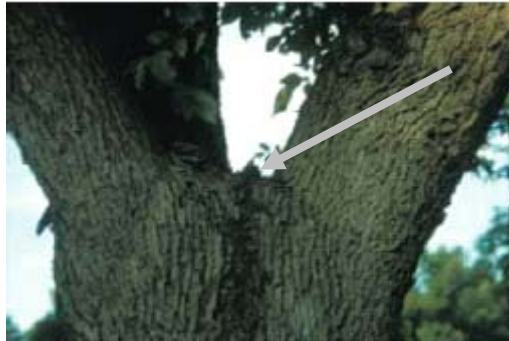
**Figure 4-7**  
**Example of a Strong Branch Union**

- *Weak Branch Unions* – A weak branch union is a defect or weakness at the point at which two branches separate. A strong branch union is characterized by a small bark ridge line in the center of the union as shown in Figure 4-7. This indicates that the annual rings of the branch and stem are growing together creating a strong union. Weak unions lack this ridge

Notice the small ridge of bark in the center of the union

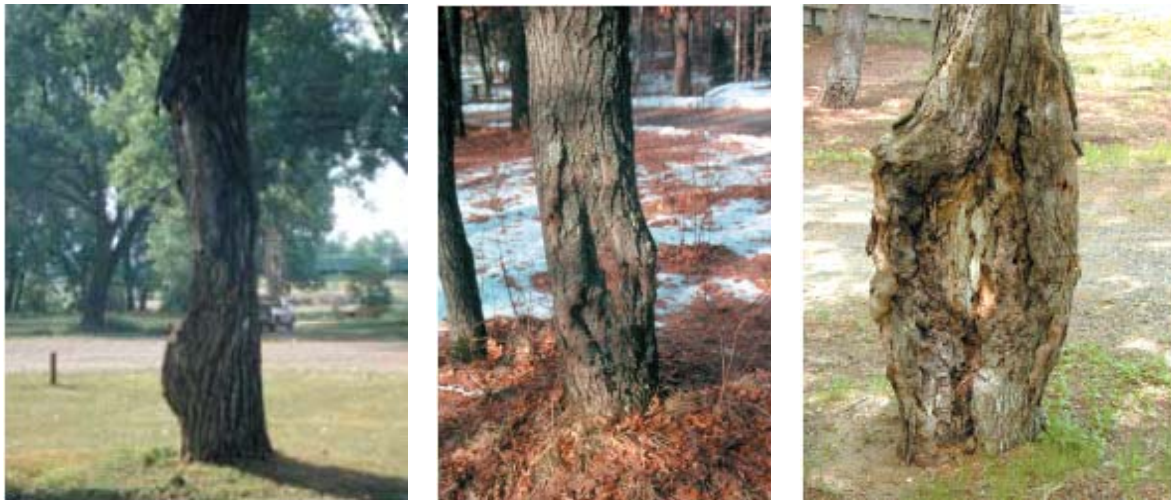
**Figure 4-10**  
**Examples of Cankers**

- *Cankers* – A canker is a dead area of bark and/or cambium which stops a new annual ring from being added each year at that location. Since cankers do not allow tree growth they reduce the trees strength by limiting the amount of wood at that location. Several examples of cankers are shown in Figure 4-10.

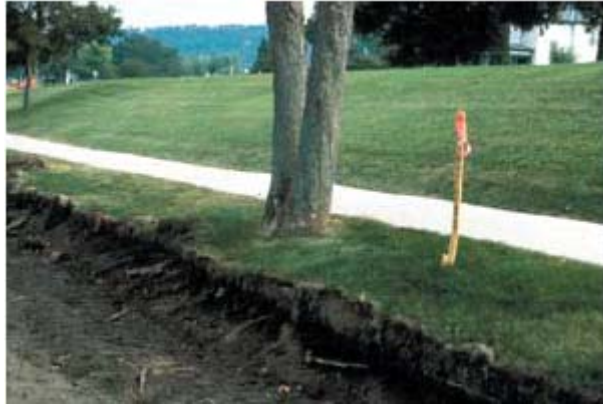
**Figure 4-11**  
**Example of Root Damage due to Excavation**

- *Root Problems* – Root damage or inadequate root anchoring results in the tree tipping over because it cannot anchor itself into the ground. Root problems can be caused by tree growth in a confined earth area (such as a city sidewalk), excavation or paving near the tree, fungal infection, drought, or flood. Some indications of root problems include leaning trees, reduced tree crown, exposed roots, and recent construction work near the tree(s) as shown in Figure 4-11, Figure 4-12, and Figure 4-13.

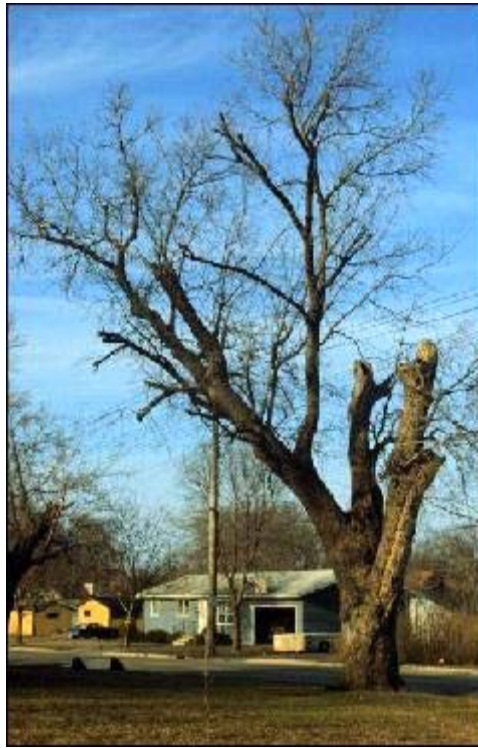
**Figure 4-14**  
**Example of Poor Tree Architecture**

- *Poor Tree Architecture* – Poor architecture is a growth pattern, such as that shown in Figure 4-14, that indicates structural imbalance or weakness in the tree. Poor tree

architecture develops over many years due to damage and poor environmental conditions. Trees that are leaning or have large branches that are out of proportion to the rest of the crown are particularly prone to failure.

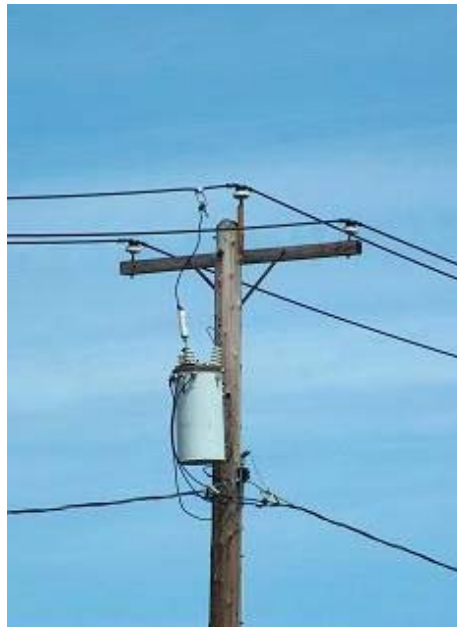
**Figure 6-1**  
**Wooden Cross Arm Construction**

Historically, distribution line construction utilized ceramic insulators mounted on metal pins and wooden cross arms to support the phase conductors as shown in Figure 6-1. Although wooden cross arms have performed very well, being both strong and durable, they are also heavy and labor intensive to assemble. As an alternative, the insulator industry began producing polymer based replacements for the wooden cross arms in the form of fiberglass reinforced polymer (FRP) standoff brackets. A typical polymer cross arm installation is shown in Figure 6-2. The main advantage of the fiberglass standoff over traditional wooden cross arms lies in the speed and ease of installation resulting in lower labor costs. Therefore, even with a slightly higher materials cost, the fiberglass standoff can still show an economic advantage.

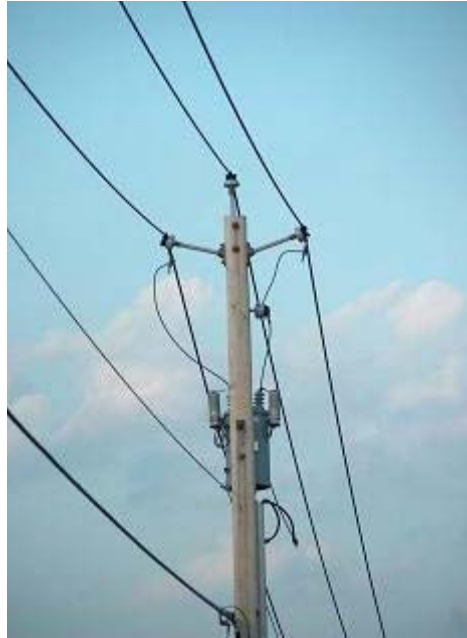
**Figure 6-2**  
**Fiberglass Standoff Construction**

A polymer standoff consists of a fiberglass reinforced polymer (FRP) core with metal end-fittings bonded or clamped to each end. One end-fitting provides a flat base where the standoff can be mounted to the utility pole while the other end-fitting provides a threaded connection point for a pin-type insulator (Figure 6-3). FRP is used for the core because it is relatively inexpensive, easy to fabricate, and mechanically strong. Under dry conditions FRP is non-conductive. The FRP core is coated with a UV resistant paint to give the standoff a weather resistant finish.

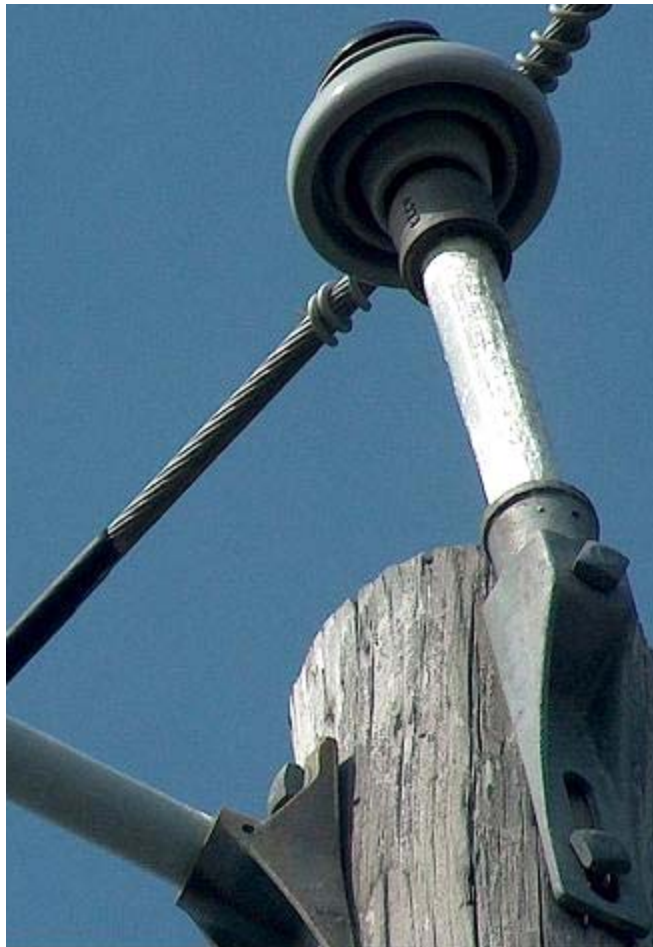
**Figure 6-6**  
**Vertically Mounted Fiberglass Standoff Bracket Showing Surface Degradation**

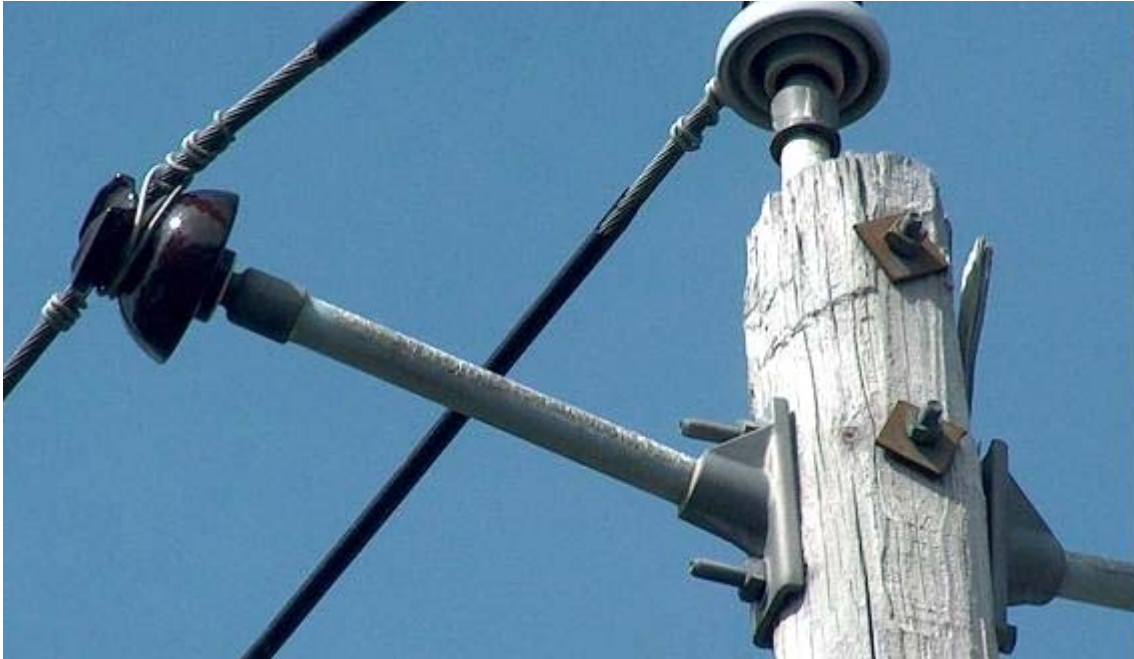
Note that the pole top is split, and the opposite standoff is pulling away from the pole

**Figure 6-7**  
**Horizontally Mounted Fiberglass Standoff Bracket Showing Surface Degradation**

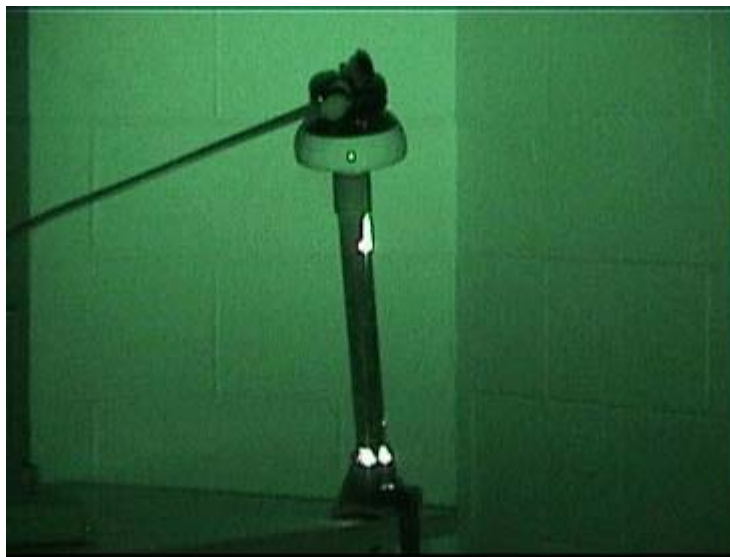
**Figure 6-10**  
**Discharges Over the Surface of an Energized Fiberglass Standoff**

A laboratory experiment was set up to investigate the discharge behavior of a fiberglass standoff upon energization after the passage of a storm. In this test an I6, complete with a tied conductor, was placed on top of a standoff. The standoff used had previously been in service for sufficient time for most of the painted surface to have been lost due to weathering, revealing much of the underlying resin and reinforcing glass fibers. A small amount of distilled water was sprayed over the entire assembly to simulate wetting due to passage of the storm. The output of a voltage source was connected to the conductor on top of the I6, while the bottom of the standoff was grounded. The applied voltage was chosen to be at a high frequency to correspond to the oscillations present in a typical energizing switching operation. Numerous discharges were found to appear along the length of the standoff, occasionally accompanied by discharges on the I6 and conductor assembly. Figure 6-10 shows an example of the discharge behavior.

The voltage applied in this test was 35 kV, at a frequency of 1 kHz. In Figure 6-10 it can be seen that there are several coincident arcs along the length of the fiberglass rod, indicating that most of the applied voltage lies across its surface rather than on the insulator that it is supporting.
