Power Quality Implications of Transmission and Distribution Construction

Tree Faults and Equipment Issues

Technical Report

Final Report, March 2005

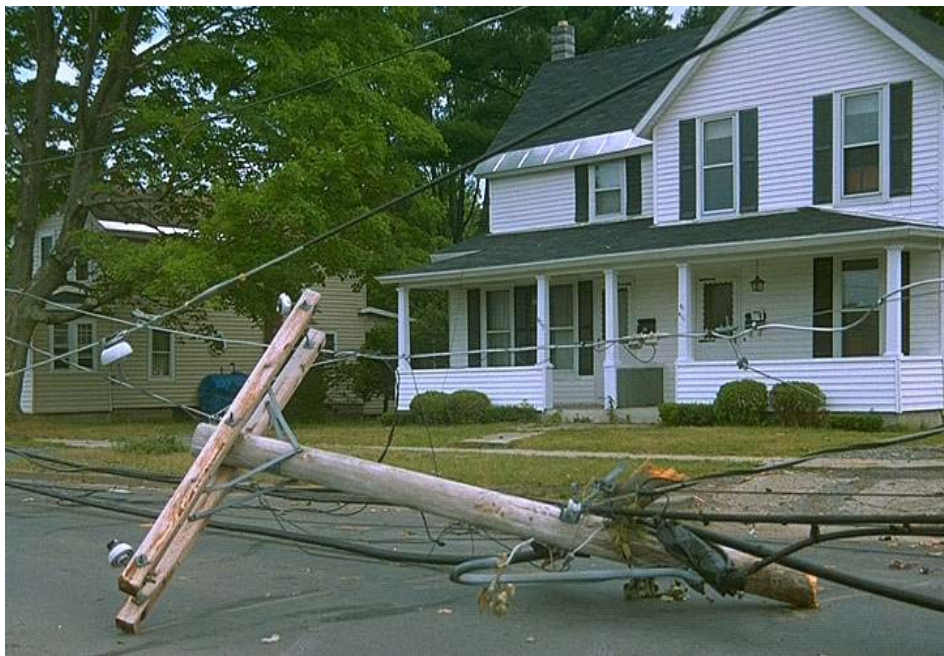
Figure ES-1
A Pole Broken in Half by a Tree Falling onto the Line Structure During a Windstorm

- *Mechanical coordination*—Consider equipment component failures in structure designs, and try to coordinate the mechanical design such that when tree and large limb failures occur, equipment fails in a manner that is easier for crews to repair. When a tree falls on a line, crews will have an easier repair if it just breaks the conductors rather than breaking poles and other supports (see Figure ES-1). The fault still occurs, but crews are able to more quickly repair the damage and restore service.

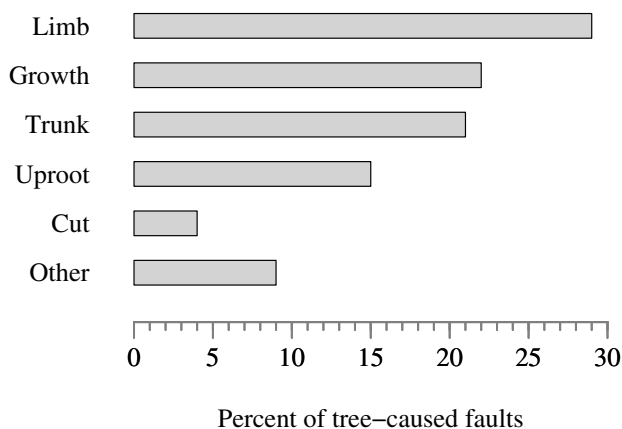
Figure 2-2
ECI Survey of Tree Outage Causes

Finch [2003a] reported on results of a 1995 Environmental Consultants Inc. (ECI) survey of over 20 utilities and a total of 2328 tree outages. The ECI survey found that tree failures and limbs caused the most tree outages (see Figure 2-2).

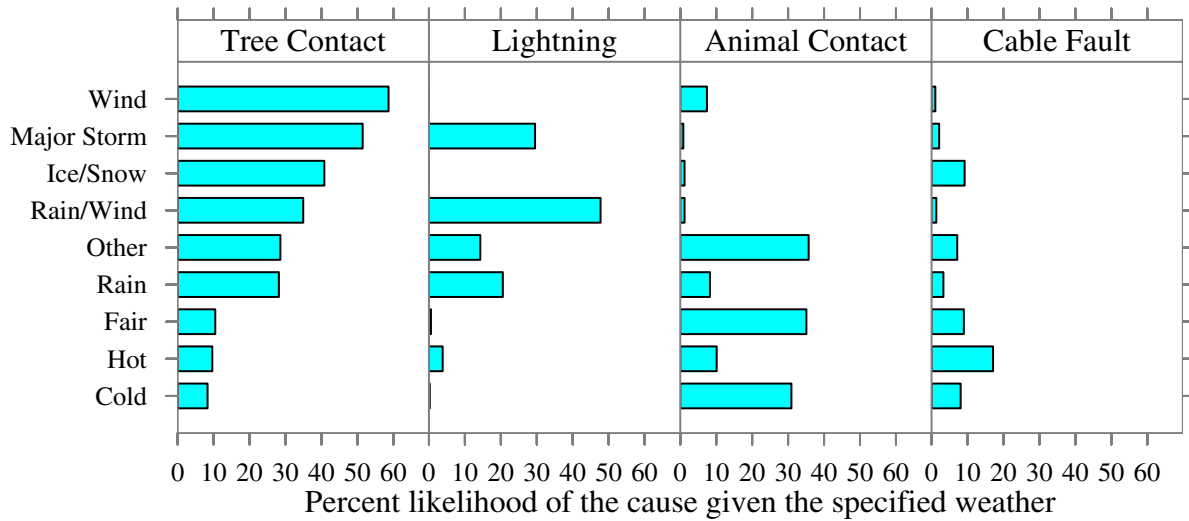
Figure 2-5
Likelihood of the Given Cause for the Specified Weather for a Northeastern Utility

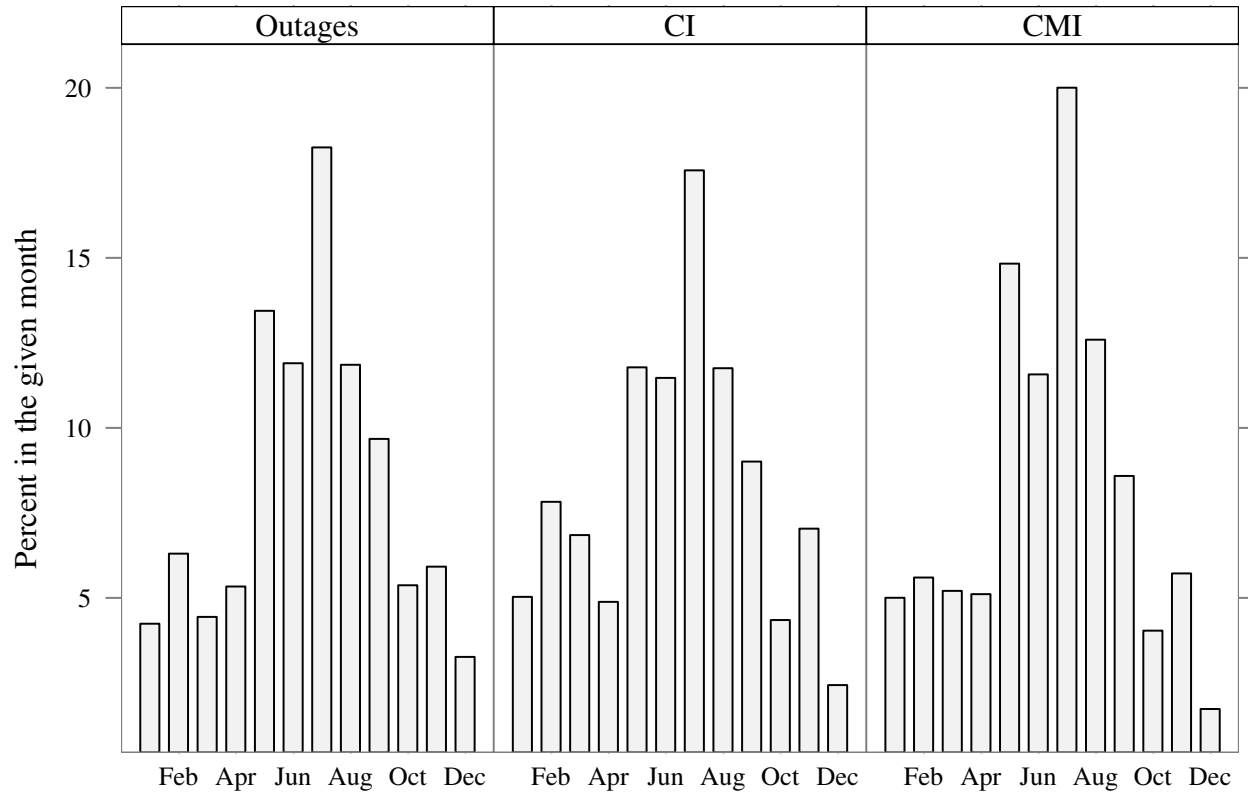
Source: Southeastern US utility, 2003 – 2004

Figure 2-7
Tree-Caused Outage Impacts by Month

Being highly correlated with weather, season has a large impact on tree-fault rates. Duke Power has the most tree-caused faults during the summer and the least during fall [Chow and Taylor, 1993; Xu et al., 2003]. Another southeastern US utility also has the most outages during the summer as shown in Figure 2-7 as does a northeastern US utility as shown in Figure 2-8.

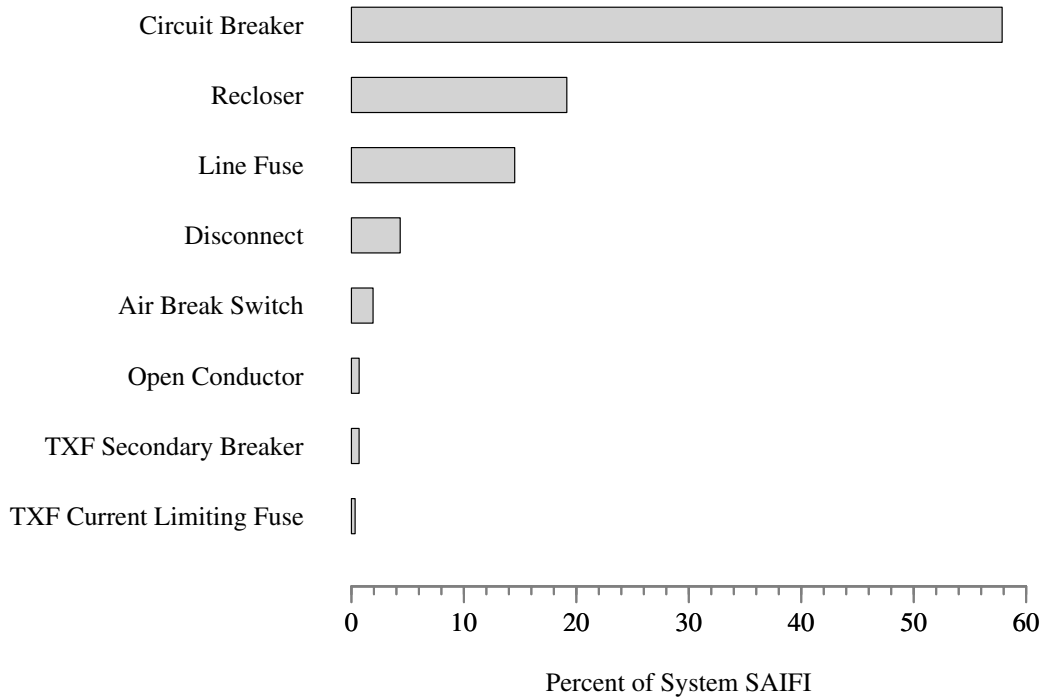
Figure 2-9
Tree-Caused Customer Interruptions by Interrupting Device for One Northeastern Utility (Major Events Included)

Interruptions on the mainline affect the most customers. Figure 2-9 shows the breakdown of tree-caused SAIFI for one northeastern US utility. This utility had almost 60% of tree customer interruptions from breaker lockouts. Duke Power [Chow and Taylor, 1993; Xu et al., 2003] also found that of circuit breaker and recloser lockouts, trees caused 35 to 50% of the lockouts, which is over twice the rate of all tree outage events (trees cause 15 to 20% of all of Duke’s outages).

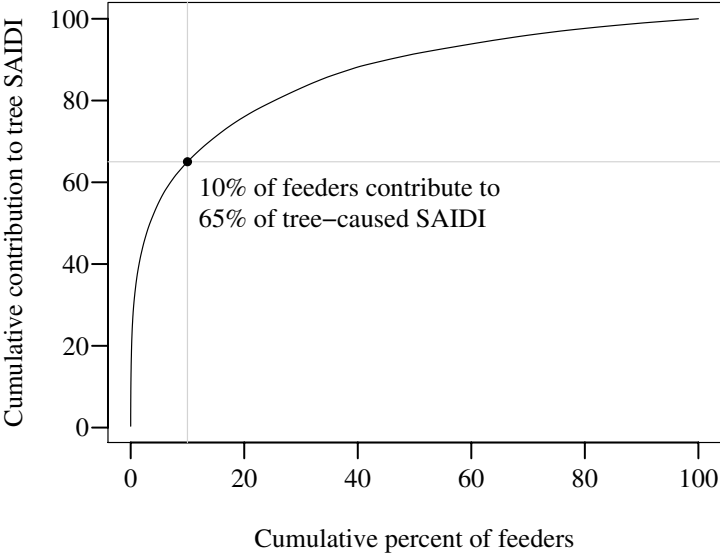
Figure 2-10
Allocation of Tree-Caused System SAIDI by Feeder for One Northeastern US Utility

Of tree-caused faults, a small number cause the greatest contribution to SAIFI and SAIDI. These are mainline faults. Restoration time is longest during major events and tree failures normally have the longest (and most expensive) cleanup and repair. Finch [2003a] reported that on Niagara Mohawk’s system with over 2000 feeders in a given year, more than half of tree faults, half of customer outages, and half of customer hours of outage occurred on just 100 circuits (5% of feeders). Another utility in the northeast shows similar trends in Figure 2-10; half of the customer outage hours were from outages on just 4% of feeders. This data included major events, which tends to exaggerate the “clustering” effect.

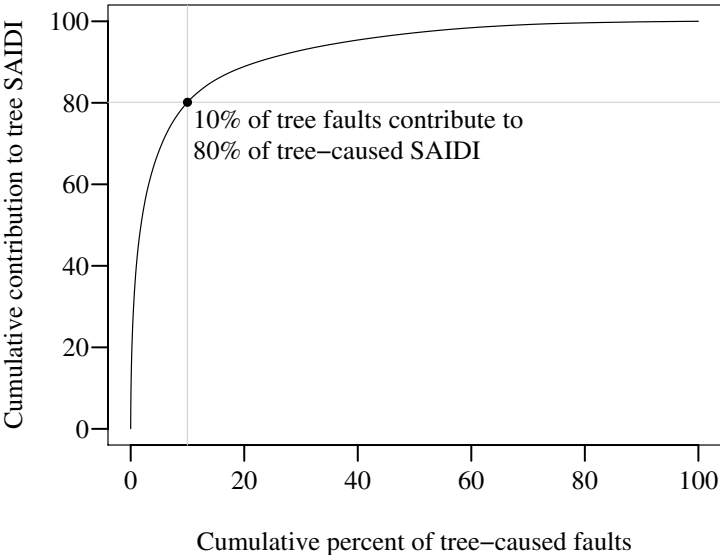
Figure 2-11
Allocation of Tree-Caused System SAIDI by Tree Outage for One Northeastern US Utility

Finch [2003a] also reported that Niagara Mohawk found 3% of all tree-caused faults contributed to 52% of the total tree-caused SAIFI. Another northeastern US utility has similar results as shown in Figure 2-11.

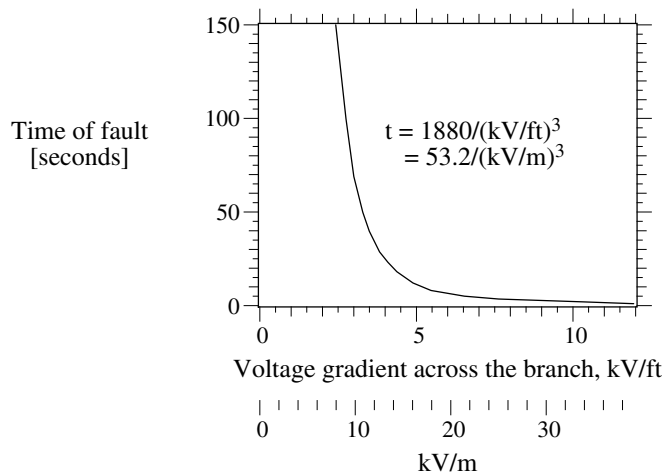
Data source: [Goodfellow, 2000] with the curvefit added

Figure 2-13
Time to Fault Based on the Voltage Gradient Across the Tree Branch

- The time it takes for a fault to occur also depends on the voltage gradient (see Figure 2-13).
- Lower voltage circuits are much more immune to flashovers from branches across conductors. A 4.8-kV circuit on a 10-foot crossarm has about a phase-to-phase voltage gradient of 1 kV/foot, very unlikely to fault from tree contact. A 12.47-kV circuit has a 2.7 kV/foot gradient, which is more likely to fault.

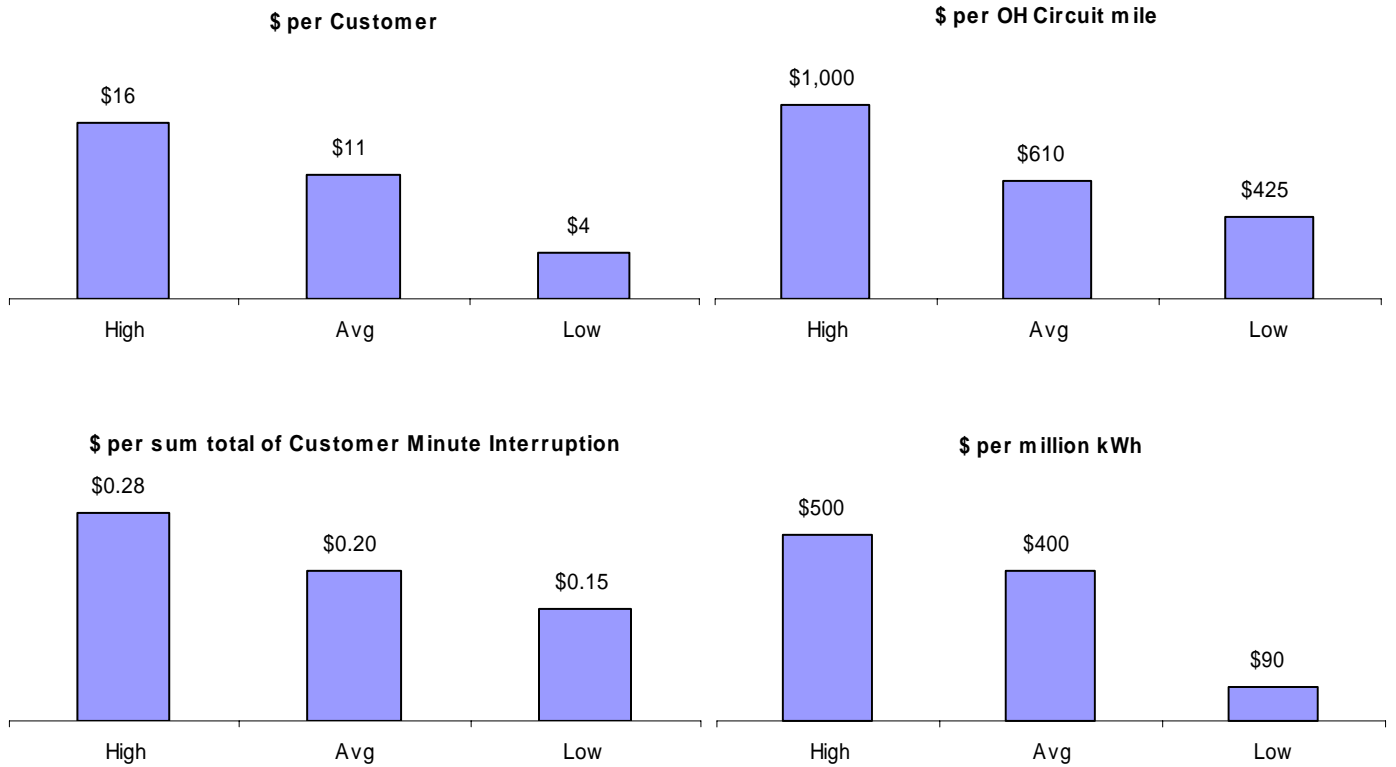
Figure 2-14
Utility Vegetation Management Costs of Five Utilities Surveyed

Tree trimming is expensive—an EPRI survey found that utilities spend an average of about \$10 per customer each year on tree trimming ([EPRI TR-109178, 1998] and Figure 2-14). Trimming can also irritate communities. It is always a dilemma that people don't want their trees trimmed, but they also don't want interruptions and other power quality disturbances.

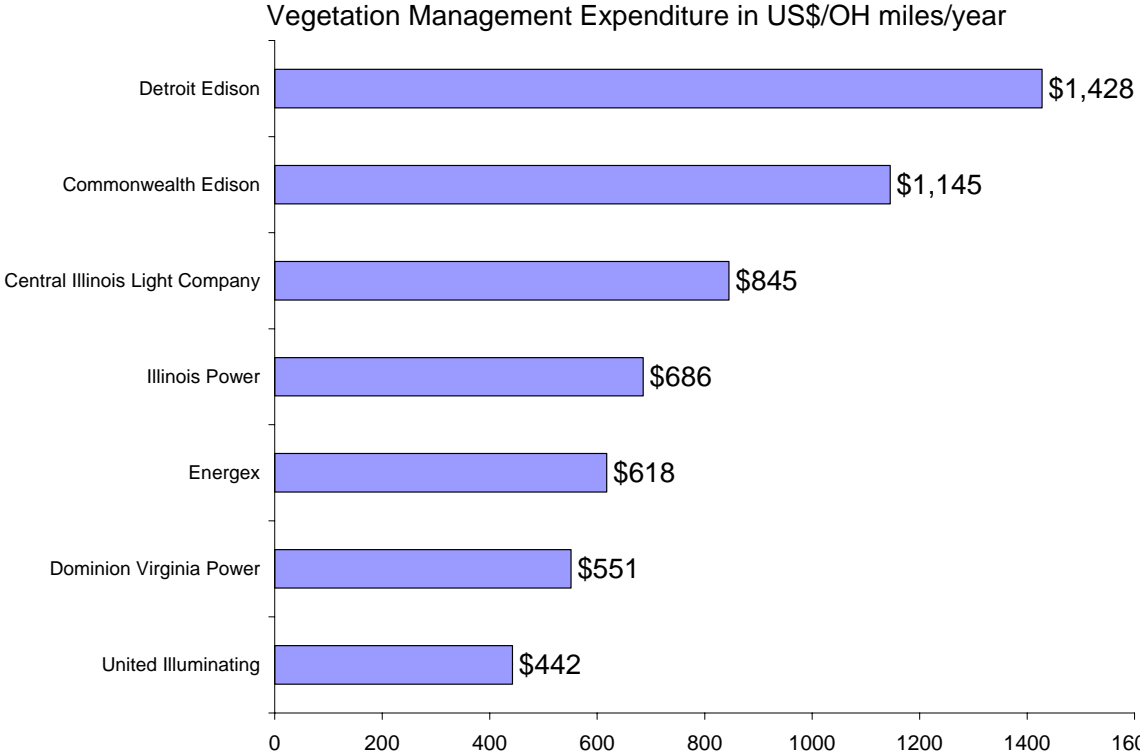
Figure 2-15
Costs of Vegetation Management From Several Utilities

Figure 2-15 shows costs for other utilities from publicly available data (mainly regulatory filings). Costs vary significantly from utility to utility and reflect differences in tree coverage, load density (urban and suburban trimming is more difficult than rural tree maintenance), vegetation management cycle, and tree growth rates.

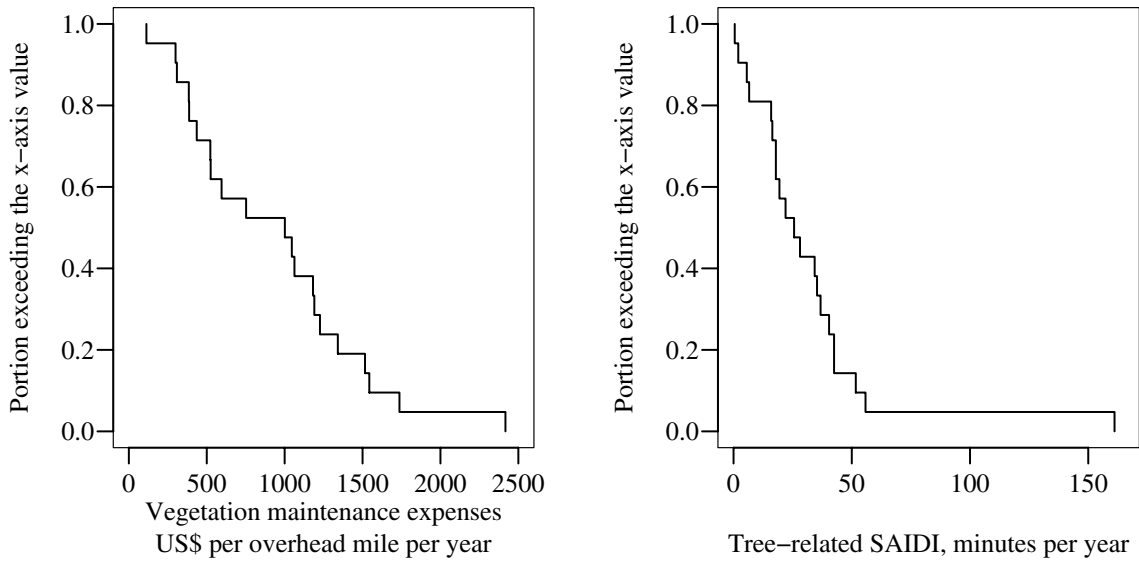
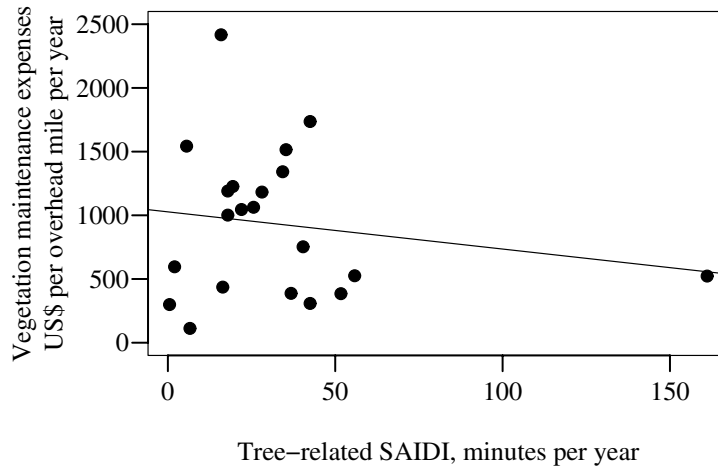
Figure 2-16
Vegetation Management Costs Versus Performance

Figure 2-16 shows additional data on the costs of vegetation management programs and also ties that to performance using the SAIDI index. There is little direct correlation between spending and SAIDI between utilities. This is not surprising given wide variances in tree coverage, load and customer densities, and weather between utilities.

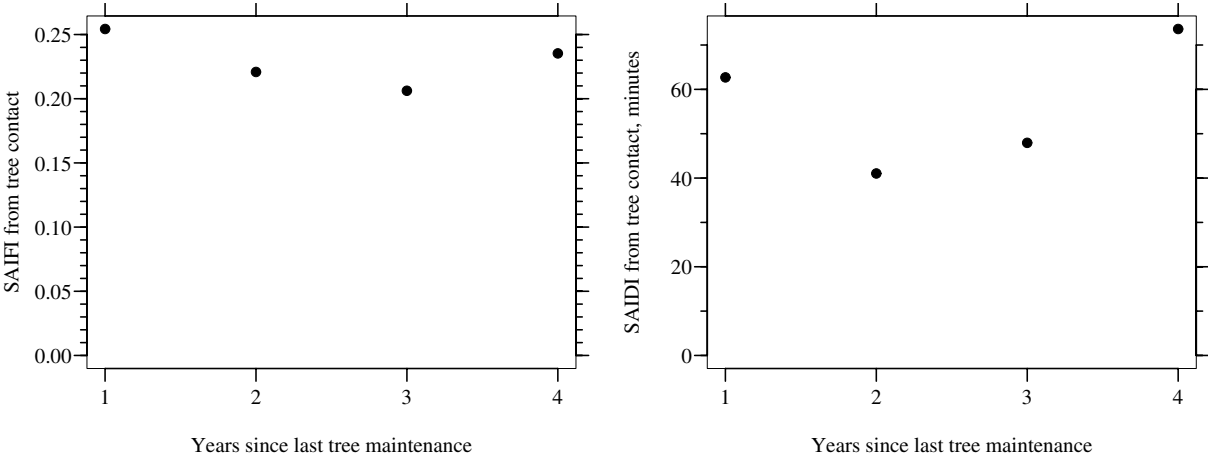
Figure 2-17
Tree Maintenance Effect on SAIFI and SAIDI for a Northeastern Utility

The following graphs characterizes one utility’s tree-caused outages from 1999 to 2003, including major storms. Each graph shows the effect of the time since the last tree trimming. So,

the first datapoint in each graph is the given reliability index of all circuits that had tree maintenance during the previous year. One would expect that tree-caused outages would decrease immediately following tree maintenance, but the data does not show this. There is no strong trend for any of the benchmarks shown in the graphs.

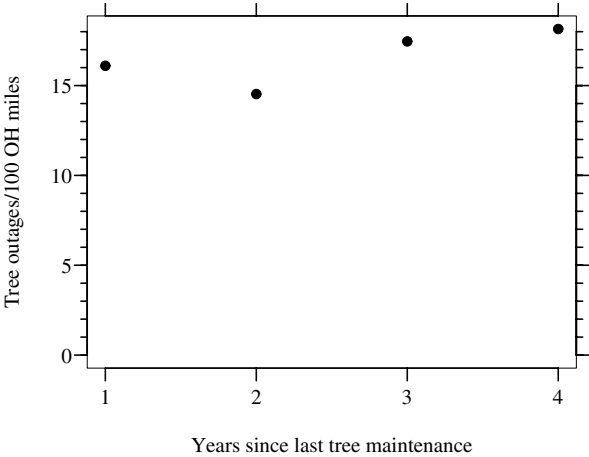
Figure 2-18
Tree Maintenance Effect on Tree Outage Rate Per Mile

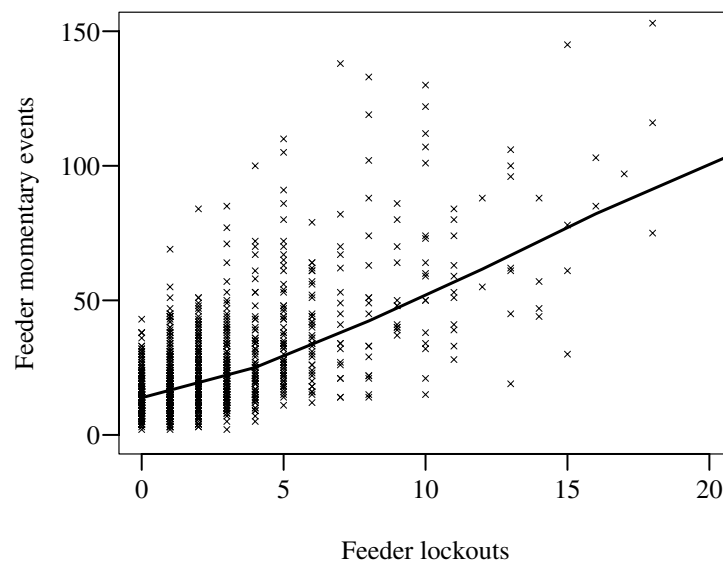
Figure 2-20
Feeder Lockouts Versus Momentary Events

To explore this further, outage data from a southeastern utility was used to estimate the relationship between feeder lockouts and momentary interruptions. This utility tracks momentary interruptions. Figure 2-20 plots the number of feeder lockouts in a day against the number of feeder momentary events per day on the utility's system. We're using feeder lockouts as a proxy for tree-caused faults (which were not available in this dataset) under the assumption that days with high numbers of feeder lockouts are during stormy weather, and most lockouts are due to tree faults. Figure 2-20 shows that momentary interruptions generally increase with increasing number of feeder lockouts. But there were days with 5 to 15 lockouts where there were not a lot of momentaries.

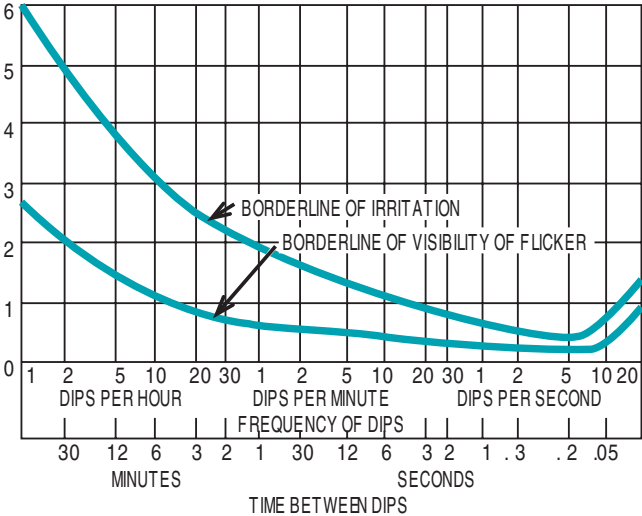
Figure 2-22
GE Voltage Flicker Curve

Small limbs can arc and burn off before the phase-to-phase or phase-to-ground path is fully bridged. This can happen repeatedly. The current drawn is mainly a function of the resistance of the tree branch bridging the gap. Whether this causes flicker or not depends on the stiffness of the utility system at this point. The widely cited GE flicker curve shown in Figure 2-22 can serve as a baseline for judging how severe voltage deviations need to be before utility customers notice light flicker. Because of the arcing nature of the progressing breakdown across a tree limb, we should assume the worst-case frequency on the flicker curve where voltage changes of 0.3% can be troublesome.

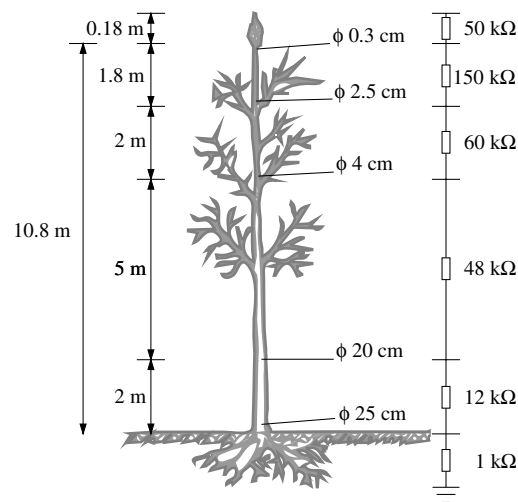
Figure 2-23
Resistance Measurements on a Live Poplar Tree

- *Germany*—Hoffmann et al. [1984] tested a tree in contact to a 20-kV line, which drew 80 mA initially then rose to 600 mA. They also measured a poplar tree and found the distribution of impedances shown in Figure 2-23 with impedances of 1.8 kΩ/foot (6 kΩ/m) near the base of the tree rising to 25 kΩ/foot (80 kΩ/m) near the top of the tree. The total impedance of this tree is 320 kΩ, which would draw from 0.2 to 0.7 A from a 12.47-kV line. Hoffman also found resistances from the base of the tree to ground of about 300 Ω for soil resistivities near 600 Ω-m.

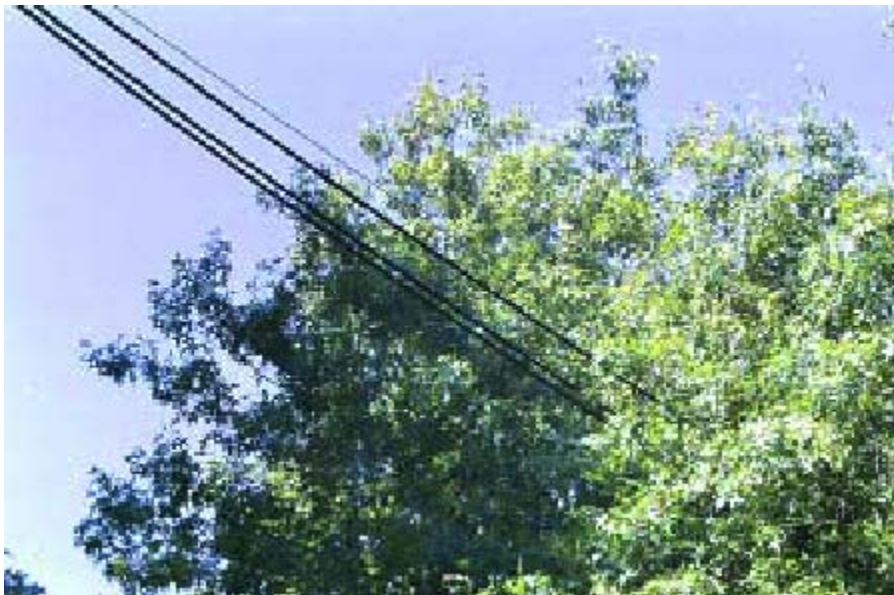
Figure 3-2
Example of a Spacer Cable Run Through Trees

Spacer cable and aerial cables are also alternatives that perform well in treed areas (Figure 3-2). Spacer cables are a bundled configuration using a messenger wire holding up three phase wires that use covered wire. Aerial cables have fully-rated insulation just like underground cables.

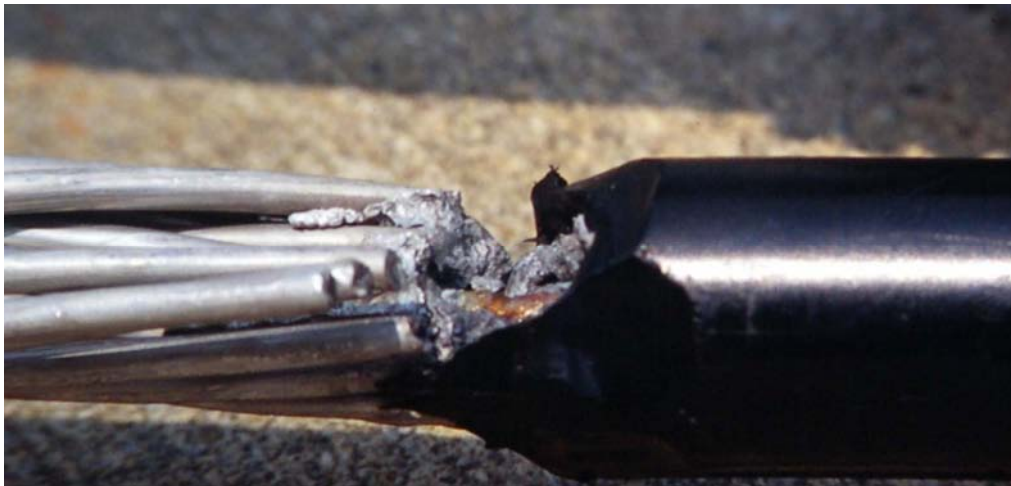
Figure 3-3
Conductor Damage From Arcing Where the Conductor Cover Begins

Covered conductor is susceptible to burndowns because when a fault current arc develops, the covering prevents the arc from moving. The heat from the arc is what causes the damage. Although ionized air is a fairly good conductor, it is not as good as the conductor itself, so the arc gets very hot. On bare conductors, the arc is free to move, and the magnetic forces from the fault cause the arc to move (in the direction away from the substation—this is called *motoring*). The covering constricts the arc to one location, so the heating and melting is concentrated on one part of the conductor. If the covering is stripped at the insulators and a fault arcs across an insulator, the arc motors until it reaches the covering, stops, and burns the conductor apart at the junction (see Figure 3-3 for an example of such damage). A party balloon, lightning, a tree branch, a squirrel—any of these can initiate the arc that burns the conductor down.

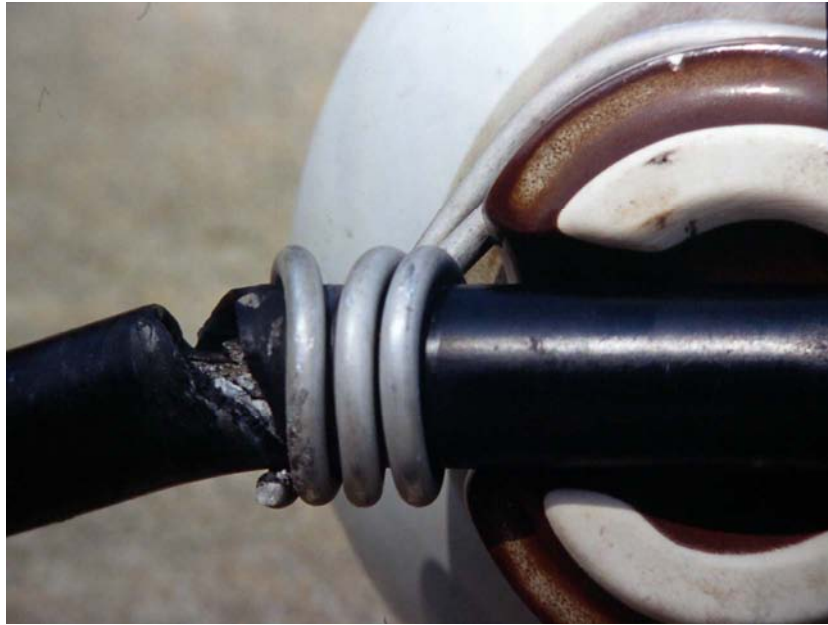
Figure 3-4
Conductor Damage From Arcing

Burndowns are most associated with lightning-caused faults, but it's the fault current arc, not the lightning, that burns most of the conductor. Lightning triggers the arc; see Figure 3-4 for an example where a conductor was damaged by a puncture as the conductor flashed to the insulator tie. Lee et al. [1980] reported on a survey of 390 fallen covered conductor cases by the

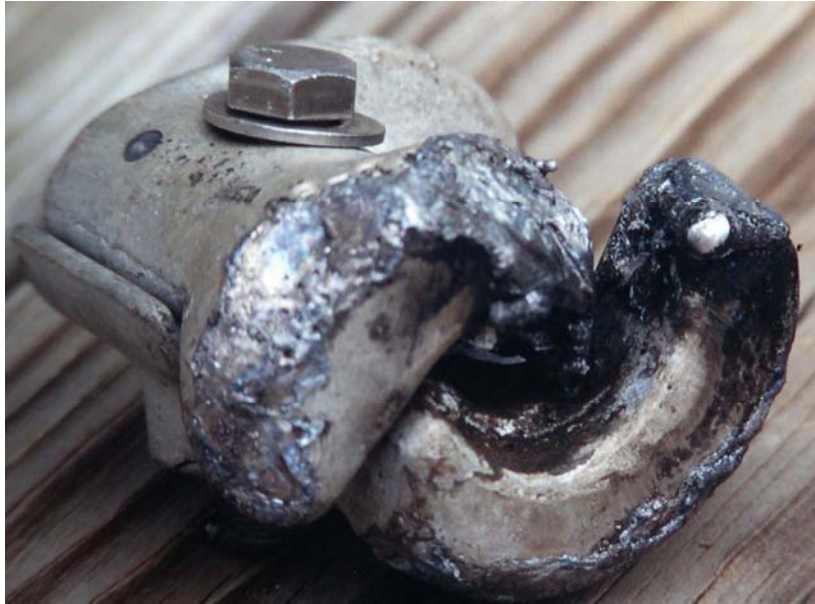
Figure 3-7
An Arc Protective Device That Has “Operated”

Arc protective devices (APD's) are sacrificial masses of metal attached to the ends of where the covering is stripped (see Figure 3-6 for an example). The arc end attaches to the mass of metal, which has a large enough volume to withstand much more arcing than the conductor itself. Figure 3-7 shows an example of an APD that has absorbed the energy from a fault-current arc; based on the loss of mass, this device could absorb several more such fault arcs before the conductor was endangered. Lee et al. [1980] reported work by PP&L to study burndowns and test arc protective devices as a solution. Based on this work, their standard practice is to strip the covering at each insulator and install APD's [Lee et al., 1981].

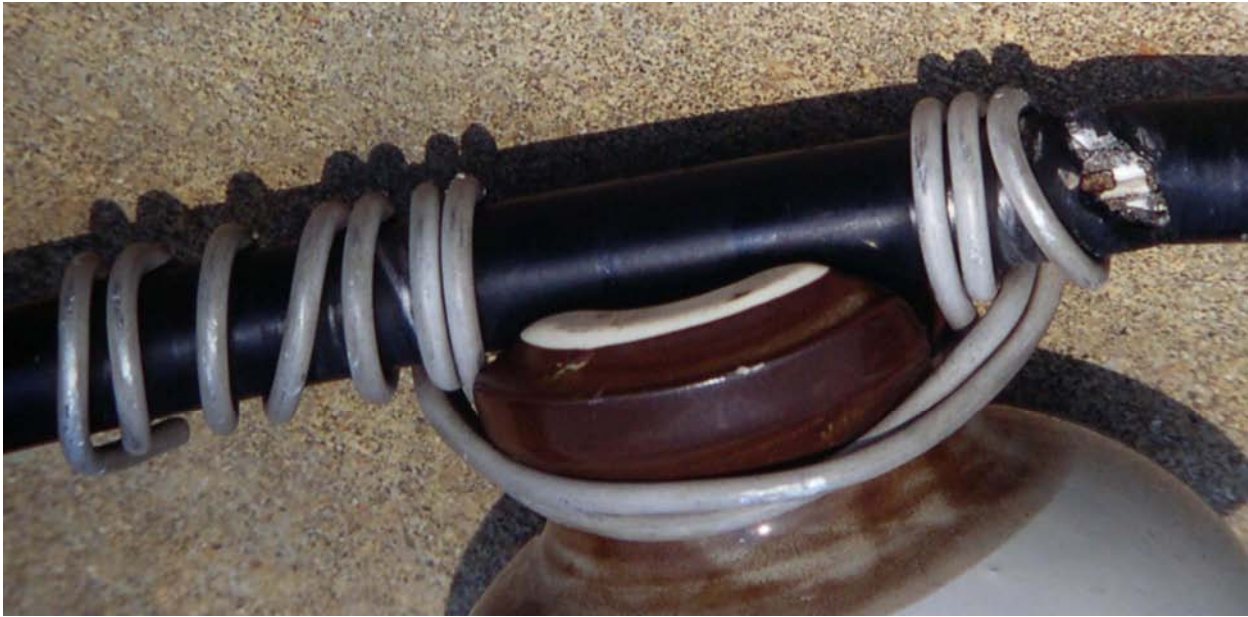
Figure 3-9
Example of Damage on a Covered Conductor From Flashover at the Insulator Tie

point is where the insulation is weakest: at the insulator where the tie comes in contact with the covering (Figure 3-9). The covering will not add significant insulation to a structure with an insulator and a foot or more of wood or fiberglass.

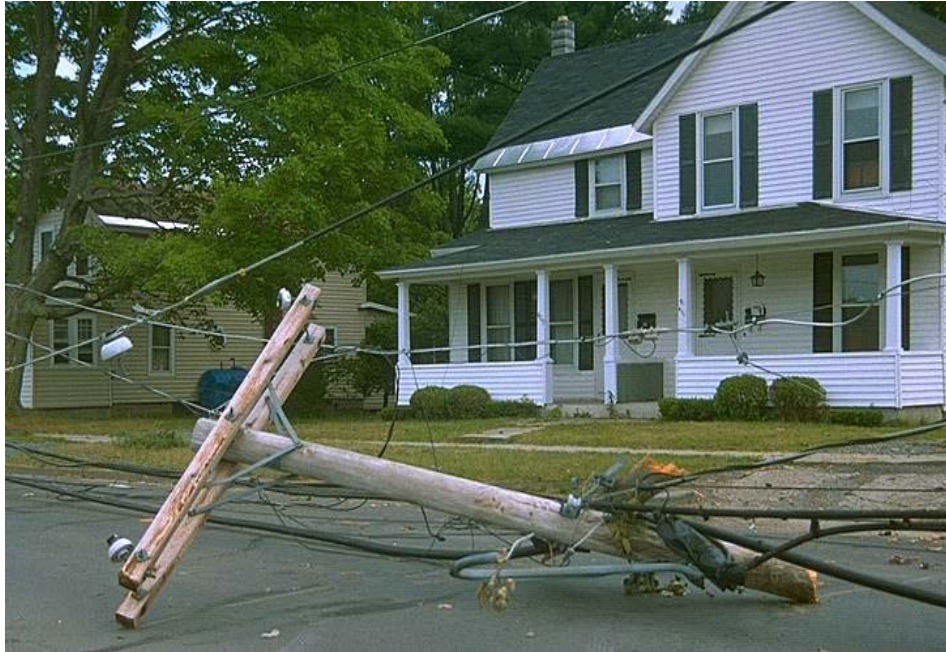
Figure 3-10
A Pole Broken in Half by a Tree Falling Onto the Line Structure During a Windstorm

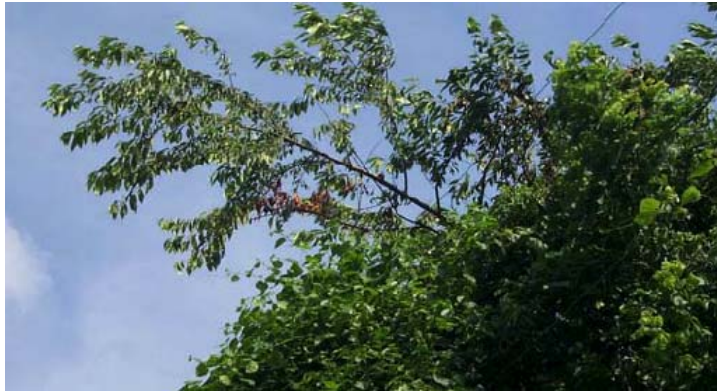
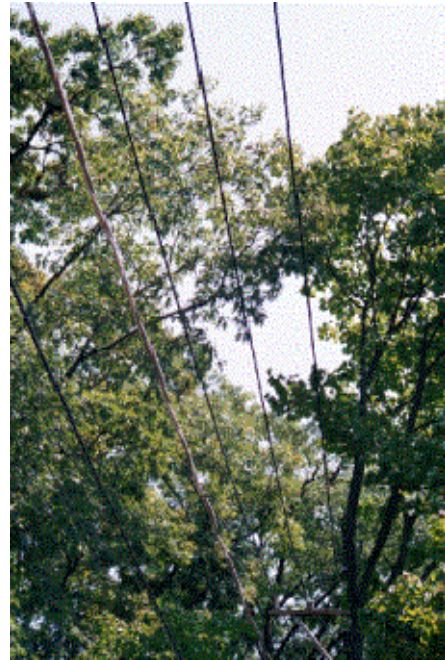
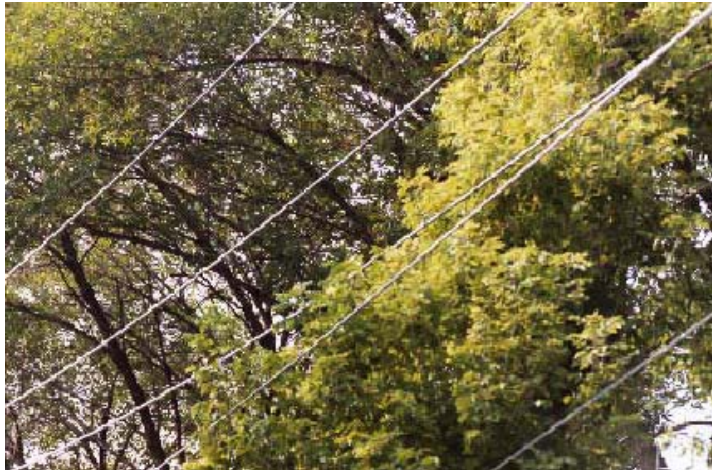
Figure 4-1
Circuits With Significant Tree Overhang

Consider the type of tree exposure affecting a line. Compare the circuits in Figure 4-1 that have significant tree overhangs to the circuits in Figure 4-2 that have exposure to growth. Which are worse? As shown by the data from several utilities, branch failure and tree failure are much more of a problem than tree growth. So, tree maintenance strategies should concentrate on removing overhangs and removing trees in danger of falling on circuits.

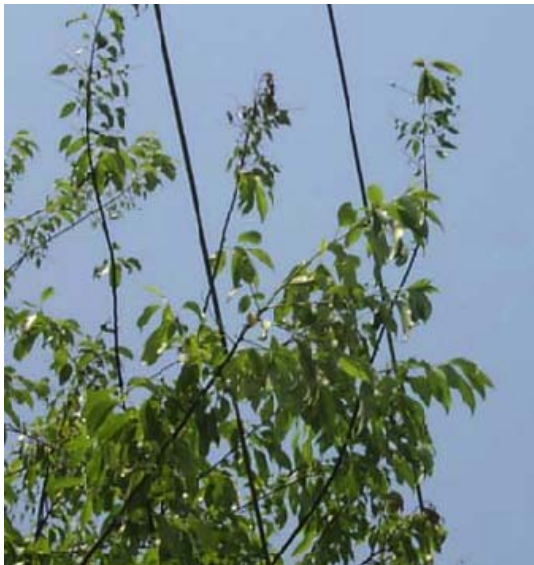
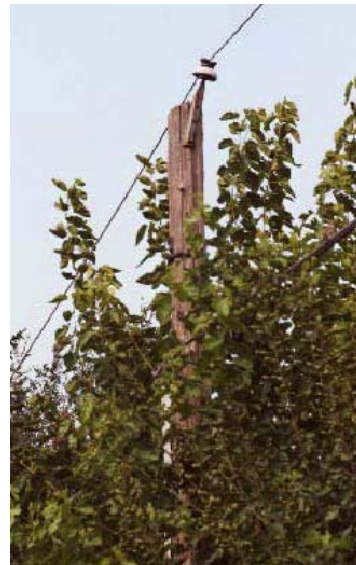
Figure 4-2
Circuits With Impending Tree Growth Contact

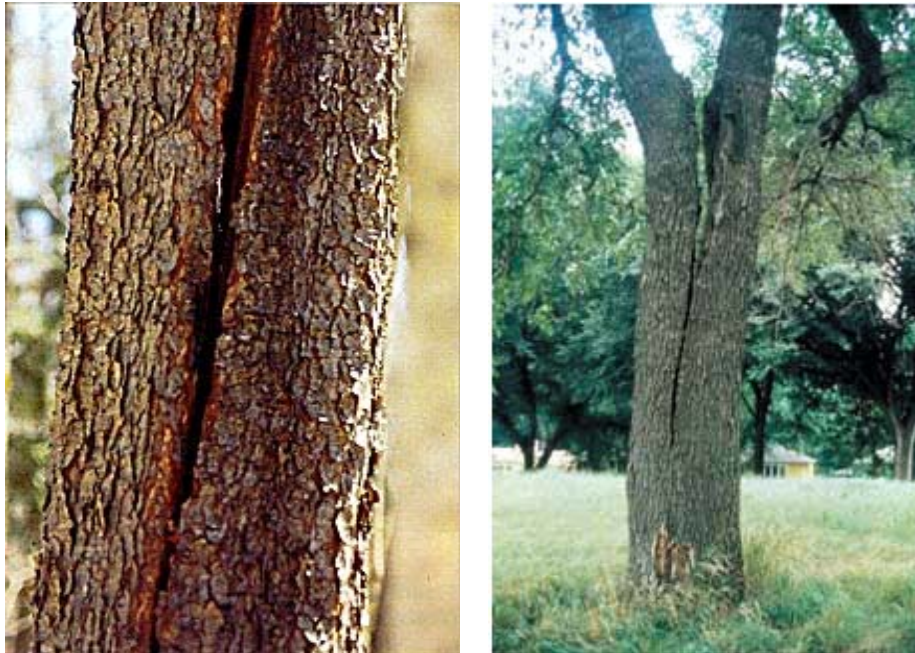
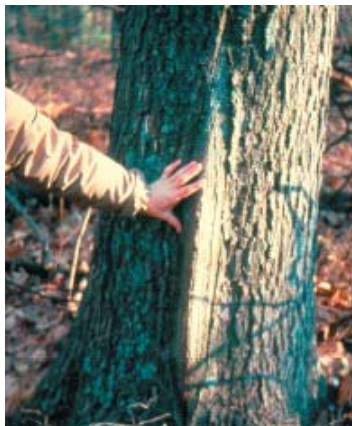
Shear cracks

Inrolled crack

Ribbed crack

Horizontal crack

Figure 4-6
Examples of Cracks

- *Cracks* – A crack is a deep split that extends through the bark and into the wood. Cracks are a sign that the tree has already started to fail. There are four types of cracks (Figure 4-6):
 - Shear Crack - A shear crack, as shown in Figure 4-6, separates the stem into two halves and carries a high risk of failure.
 - Inrolled Crack – The edges of this vertical crack are inrolled encompassing the bark and wood. Trees with inrolled cracks almost always suffer serious decay at the crack site.
 - Ribbed Crack – A ribbed crack is a fissure in a raised rib of wood along the length of the stem.
 - Horizontal Crack – These cracks run across the wood grain and are rare to find since they develop just before the tree fails.

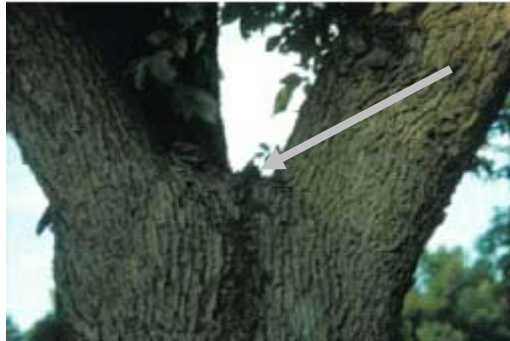
Notice the small ridge of bark in the center of the union

Figure 4-7
Example of a Strong Branch Union

- *Weak Branch Unions* – A weak branch union is a defect or weakness at the point at which two branches separate. A strong branch union is characterized by a small bark ridge line in the center of the union as shown in Figure 4-7. This indicates that the annual rings of the branch and stem are growing together creating a strong union. Weak unions lack this ridge

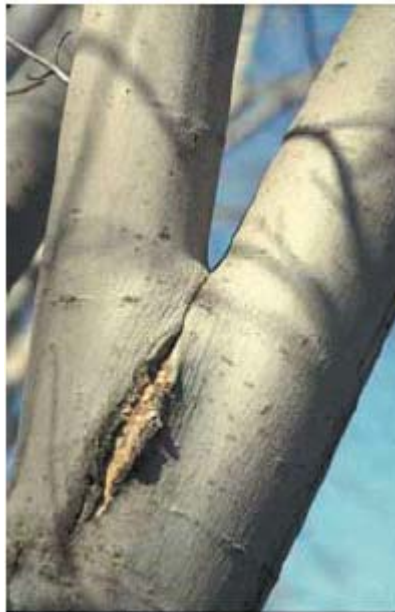
Notice the absence of a bark ridge line in the center of the union and the ingrown bark

Figure 4-8
Example of a Weak Branch Union

line indicating that bark may be growing into the union (Figure 4-8) or that the union is an offshoot from a previously damaged spot.

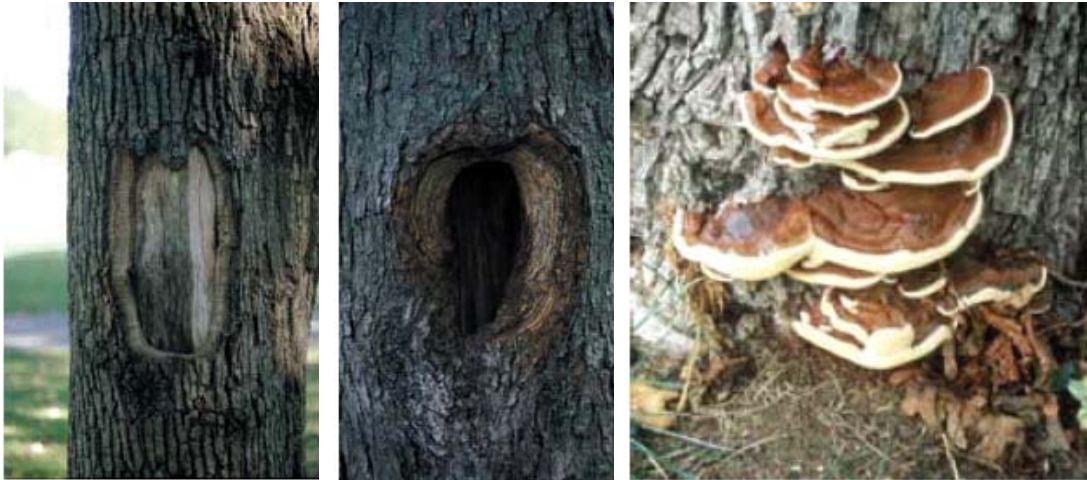
Figure 4-9
Examples of Outward Signs of Tree Decay – Discoloration, Holes, and Fungal Activity

- *Decay* – Decayed wood is the result of long-term exposure to decay-causing fungi. Decay is primarily an internal process that offers few outward indications and it can occur in the roots, stem, or branches. Decayed wood is always weaker than healthy wood and is therefore prone to failure. When present, outward signs of decay include discoloration, holes, and fungal fruiting bodies as shown in Figure 4-9.

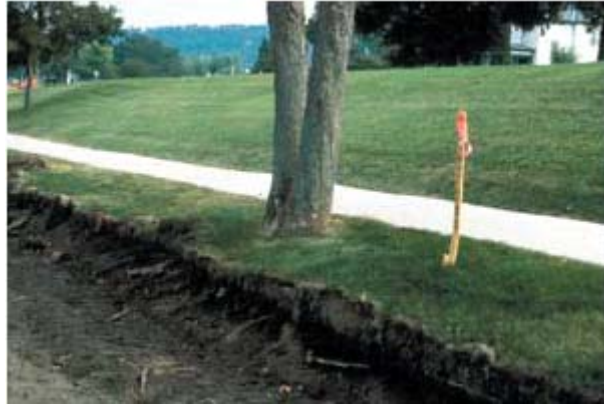
Figure 4-11
Example of Root Damage due to Excavation

- *Root Problems* – Root damage or inadequate root anchoring results in the tree tipping over because it cannot anchor itself into the ground. Root problems can be caused by tree growth in a confined earth area (such as a city sidewalk), excavation or paving near the tree, fungal infection, drought, or flood. Some indications of root problems include leaning trees, reduced tree crown, exposed roots, and recent construction work near the tree(s) as shown in Figure 4-11, Figure 4-12, and Figure 4-13.

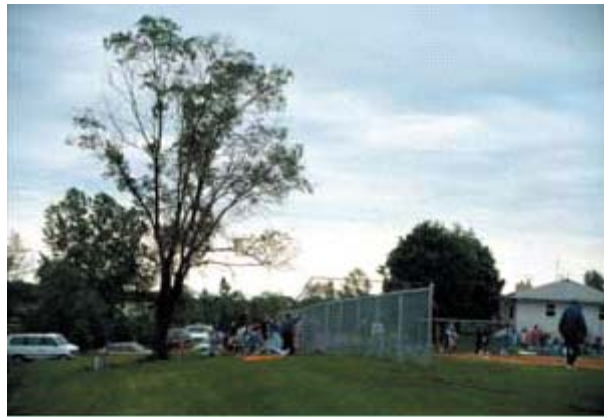
Figure 4-12
Example of Crown Decline due to Root Damage

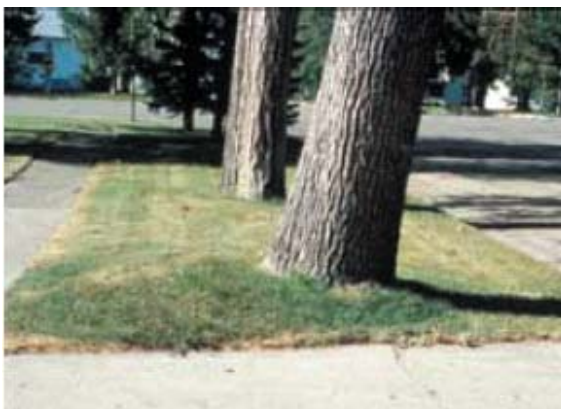
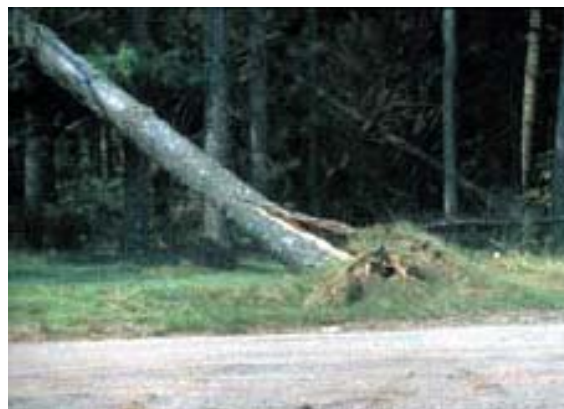
Figure 4-13
Examples of Leaning Trees due to Root Damage

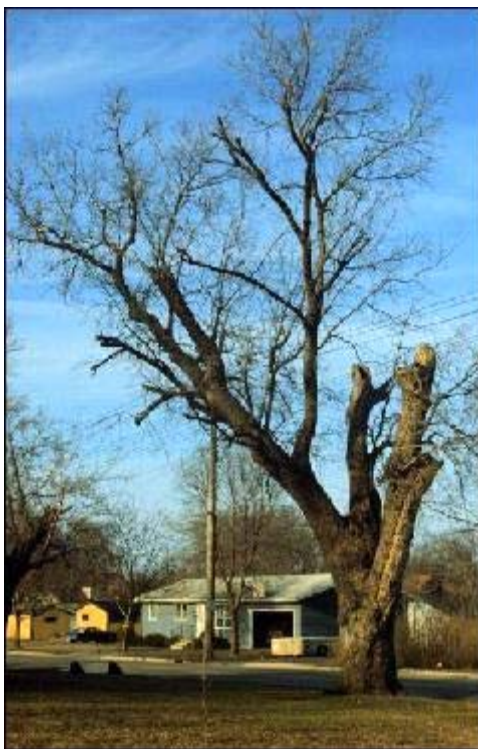
Figure 4-14
Example of Poor Tree Architecture

- *Poor Tree Architecture* – Poor architecture is a growth pattern, such as that shown in Figure 4-14, that indicates structural imbalance or weakness in the tree. Poor tree

architecture develops over many years due to damage and poor environmental conditions. Trees that are leaning or have large branches that are out of proportion to the rest of the crown are particularly prone to failure.

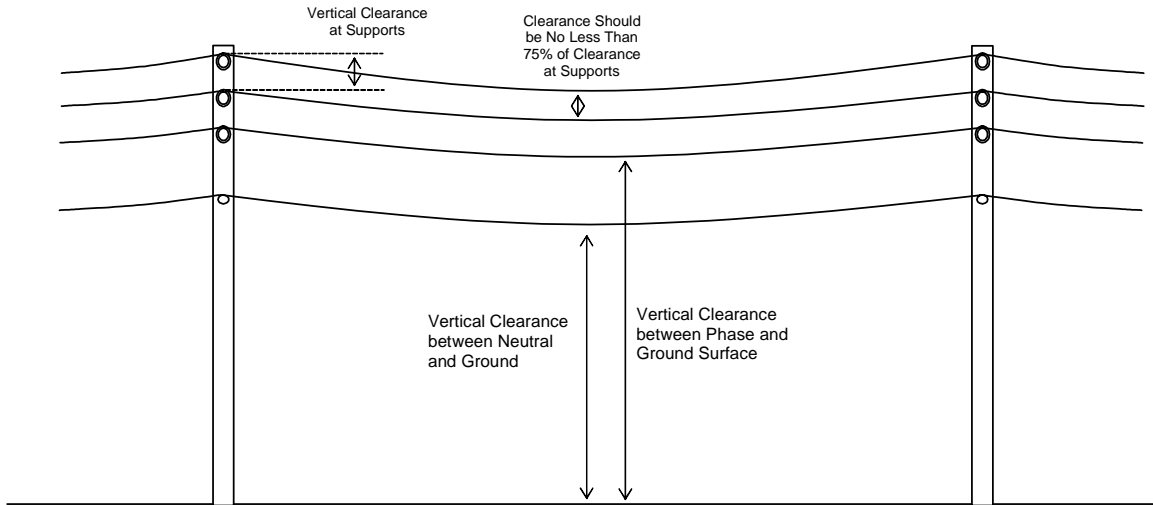
Figure 5-2
Vertical Clearances Between Conductors

The application of the clearances in Table 5-1 through Table 5-4 is illustrated graphically in the following diagrams. Figure 5-1 shows the application of horizontal clearances at the supporting crossarm as well as the vertical clearance above a roadway. The vertical clearances are measured at the point of minimum clearance under the worst-case sag conditions discussed earlier. Figure 5-2 shows the application of vertical clearances between open conductors of the same circuit.

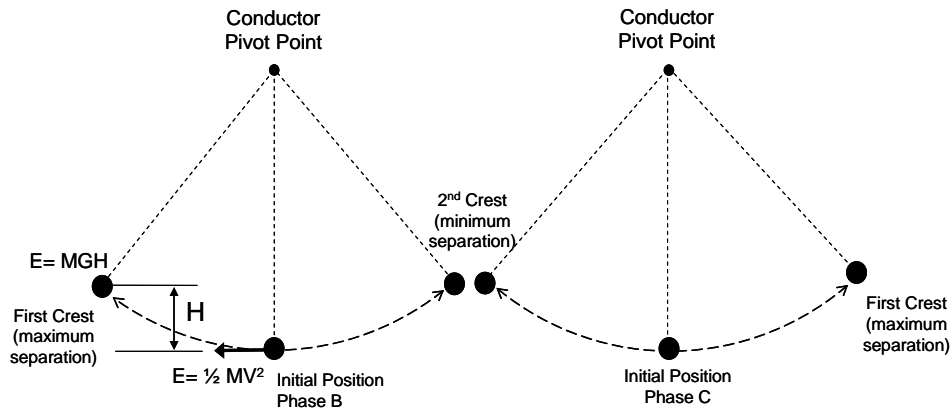
Figure 5-8
Shows the Method of Conservation of Energy to Calculate the Height H of the Initial Swing

From the force input, we can now calculate the acceleration of the conductor using $F=MA$ (we know the mass of the conductor and the force applied). From $F=MA$, acceleration and speed are determined, and we can now calculate the kinetic energy of the conductor at the bottom of the swing angle, which is equal to $1/2 MV^2$. Due to conservation of energy, the conductor's kinetic energy must be transformed completely into potential energy (MGH) at the first crest of the swing. If we set $MGH = 1/2 MV^2$, we can find the height of the initial swing (H) as shown in Figure 5-8. Once we know the height (H), we can assume the conductor, acting a pendulum, will

swing the same amount to the other side based on conservation of energy. (In fact, it won't swing quite as far due to losses but these can be ignored.) From this point, it is a simple matter of trigonometry to calculate the X and Y axis displacements and clearance between the conductors during the second crest.
