Power Quality Implications of Transmission and Distribution Construction

Tree Faults and Equipment Issues

Technical Report

Final Report, March 2005

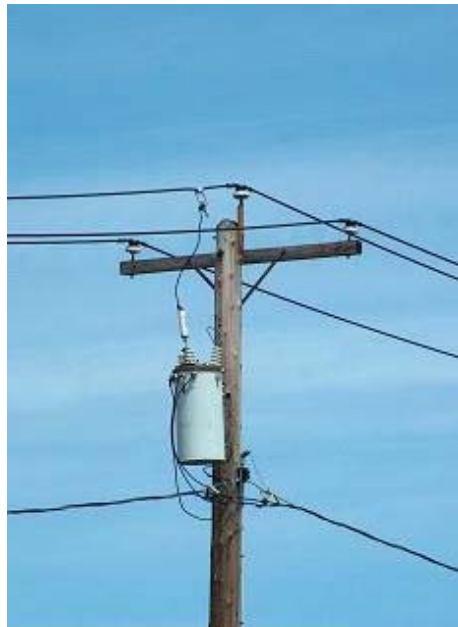
Figure 6-1
Wooden Cross Arm Construction

Historically, distribution line construction utilized ceramic insulators mounted on metal pins and wooden cross arms to support the phase conductors as shown in Figure 6-1. Although wooden cross arms have performed very well, being both strong and durable, they are also heavy and labor intensive to assemble. As an alternative, the insulator industry began producing polymer based replacements for the wooden cross arms in the form of fiberglass reinforced polymer (FRP) standoff brackets. A typical polymer cross arm installation is shown in Figure 6-2. The main advantage of the fiberglass standoff over traditional wooden cross arms lies in the speed and ease of installation resulting in lower labor costs. Therefore, even with a slightly higher materials cost, the fiberglass standoff can still show an economic advantage.

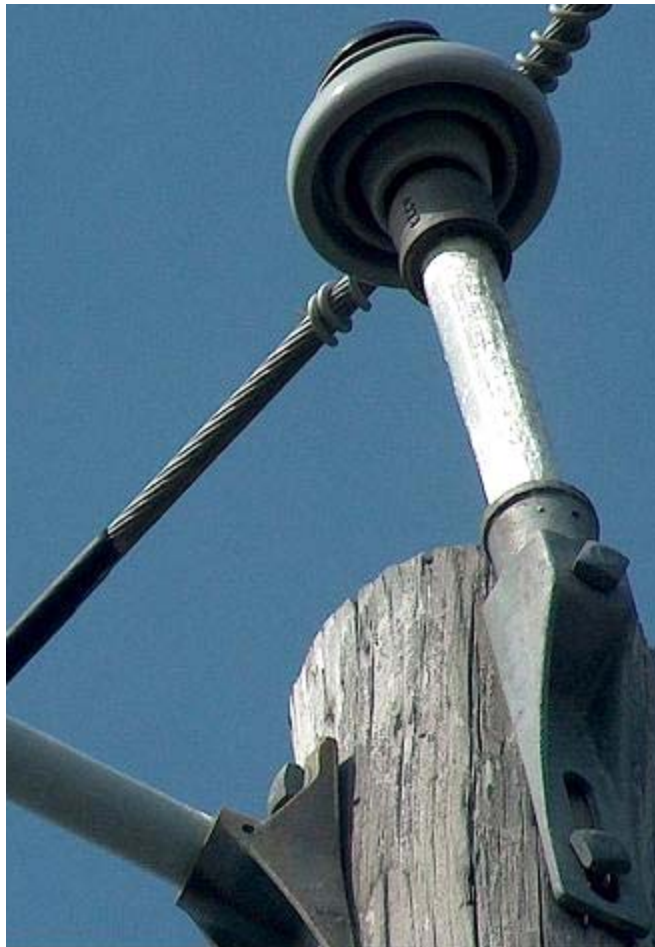
Figure 6-6
Vertically Mounted Fiberglass Standoff Bracket Showing Surface Degradation

The failure of the fiberglass standoff is the result of a combination of factors, each of which by itself would probably not lead to a flashover. The first cause to be considered is the poor weathering characteristics of the epoxy coating on the standoff. The epoxy coating is seen to degrade rapidly when exposed to the UV present in natural sunlight. Figure 6-6 through Figure 6-8 show weathered standoff brackets. These pictures were taken as part of an informal field survey. The location was selected at random and did not have any remarkable features that would accelerate ageing (such as chemical or food processing plants or other unique contaminant sources).

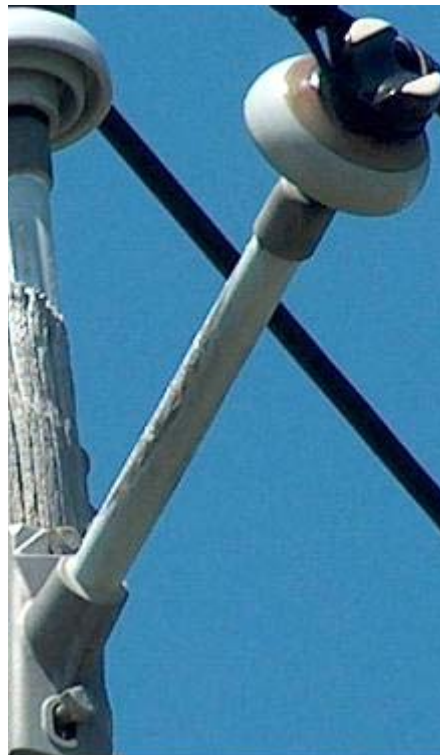
Figure 6-8
Fiberglass Standoff Bracket Showing Surface Degradation

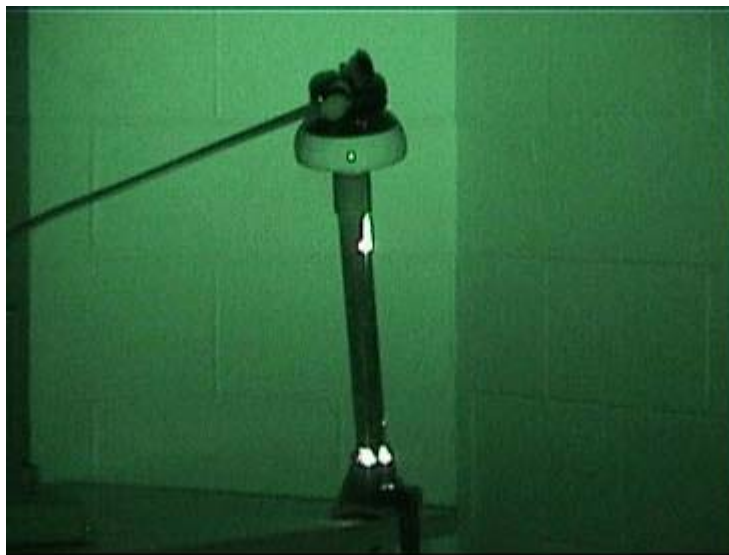
Figure 6-10
Discharges Over the Surface of an Energized Fiberglass Standoff

A laboratory experiment was set up to investigate the discharge behavior of a fiberglass standoff upon energization after the passage of a storm. In this test an I6, complete with a tied conductor, was placed on top of a standoff. The standoff used had previously been in service for sufficient time for most of the painted surface to have been lost due to weathering, revealing much of the underlying resin and reinforcing glass fibers. A small amount of distilled water was sprayed over the entire assembly to simulate wetting due to passage of the storm. The output of a voltage source was connected to the conductor on top of the I6, while the bottom of the standoff was grounded. The applied voltage was chosen to be at a high frequency to correspond to the oscillations present in a typical energizing switching operation. Numerous discharges were found to appear along the length of the standoff, occasionally accompanied by discharges on the I6 and conductor assembly. Figure 6-10 shows an example of the discharge behavior.

The voltage applied in this test was 35 kV, at a frequency of 1 kHz. In Figure 6-10 it can be seen that there are several coincident arcs along the length of the fiberglass rod, indicating that most of the applied voltage lies across its surface rather than on the insulator that it is supporting.
