# Materials Reliability Program

## Fatigue Issues Assessment (MRP-138)

# **Materials Reliability Program Fatigue Issues Assessment (MRP-138)**

Final Report, February 2005

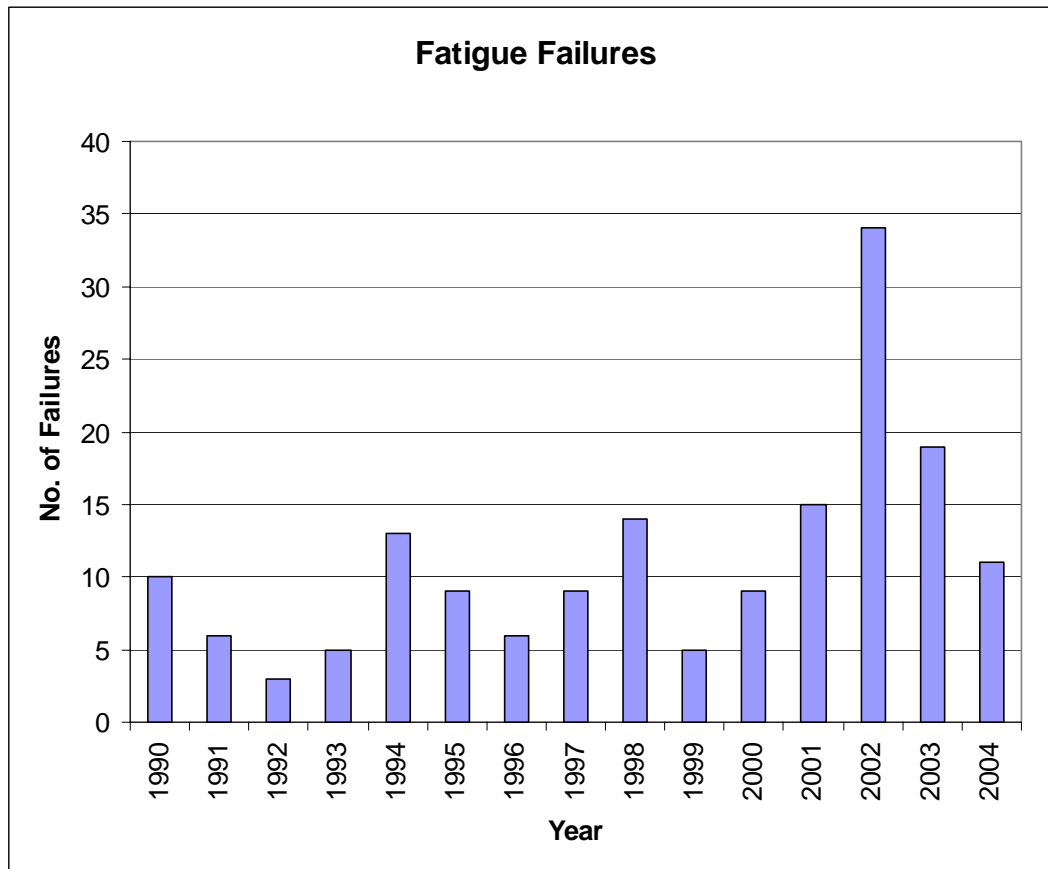
**Figure 3-1**  
**Fatigue Failures Sorted by Year**

It should be noted that the number of reported fatigue failures for the year 2004 only include the first six months of the year, so the expectation is that the number of failures in 2004 will be greater than those that occurred in 2003. The trend of the fatigue failures appears to be increasing slightly, with a sudden increase in failures in 2002. The fatigue failures were relatively low until the year 2002 where the number of failures more than doubled from previous years. The increase in 2002 is due to small bore pipe fatigue failures which accounted for 13 of the 34 failures. The fatigue failures have been separated into BWR and PWR fatigue failures per year and are shown in Figures 3-2 and 3-3, respectively.

Figure 3-1 shows a plot of the failures versus time for all the nuclear plants and Figures 3-2 and 3-3 shows the number of fatigue failures by type of plant, BWRs and PWRs, respectively.

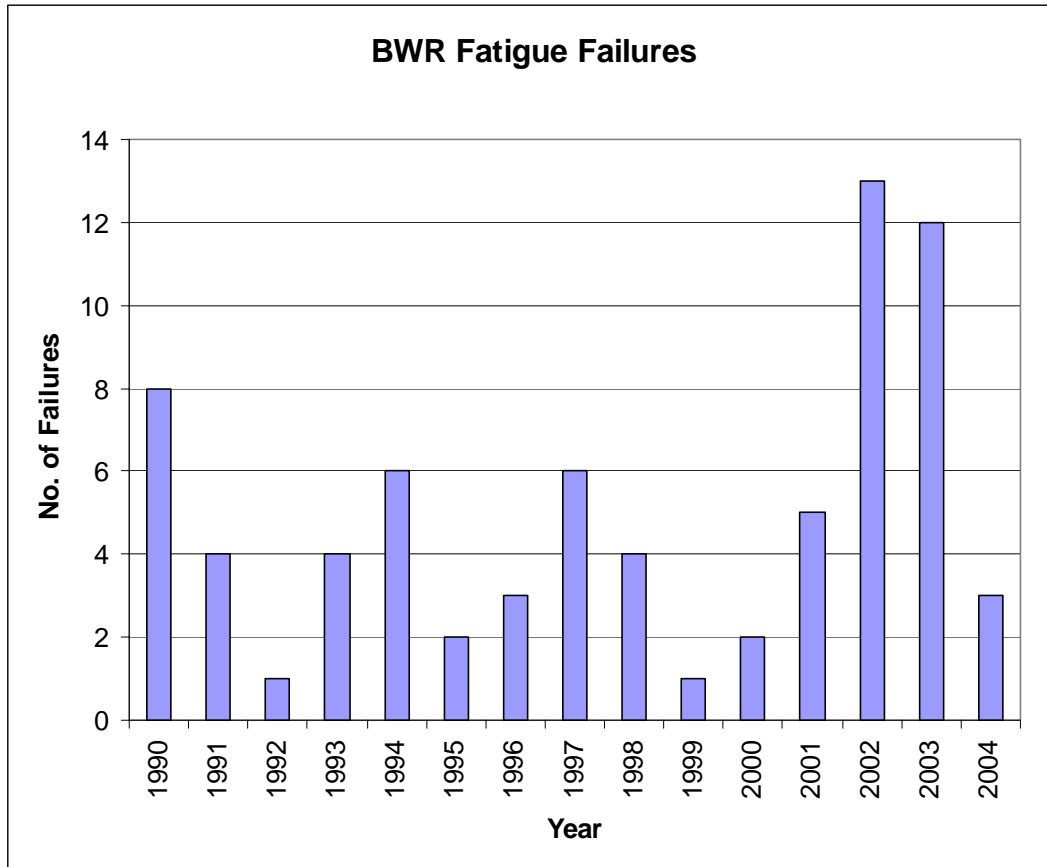
**Figure 3-2**  
**BWR Fatigue Failures Sorted by Year**

A comparison of Figure 3-2 to Figure 3-3 shows that the trend in fatigue failures is similar between BWRs and PWRs. For BWRs, almost half of the fatigue failures in 2002 are due to small-bore pipe failures and the main cause of the failure was attributed to system/plant operation. The main forcing function that caused the failures in 2002 was flow induced vibration (FIV) loads. A portion of the more recent failures is related to EPU.

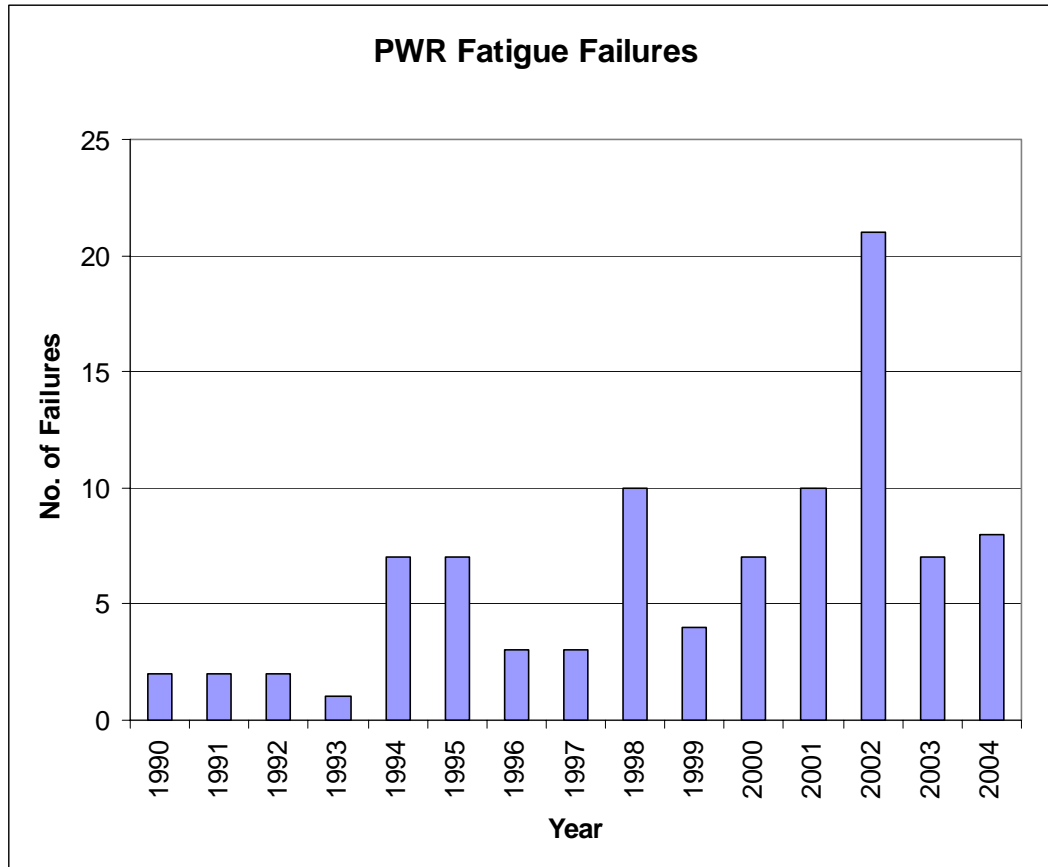
**Figure 3-3**  
**PWR Fatigue Failures Sorted by Year**

In PWRs, small bore pipe fatigue failures average one to two a year with the exception of 2002 where eight fatigue failures occurred in small bore pipe. The main causes for the failures in 2002 were attributed to design configuration and aging.

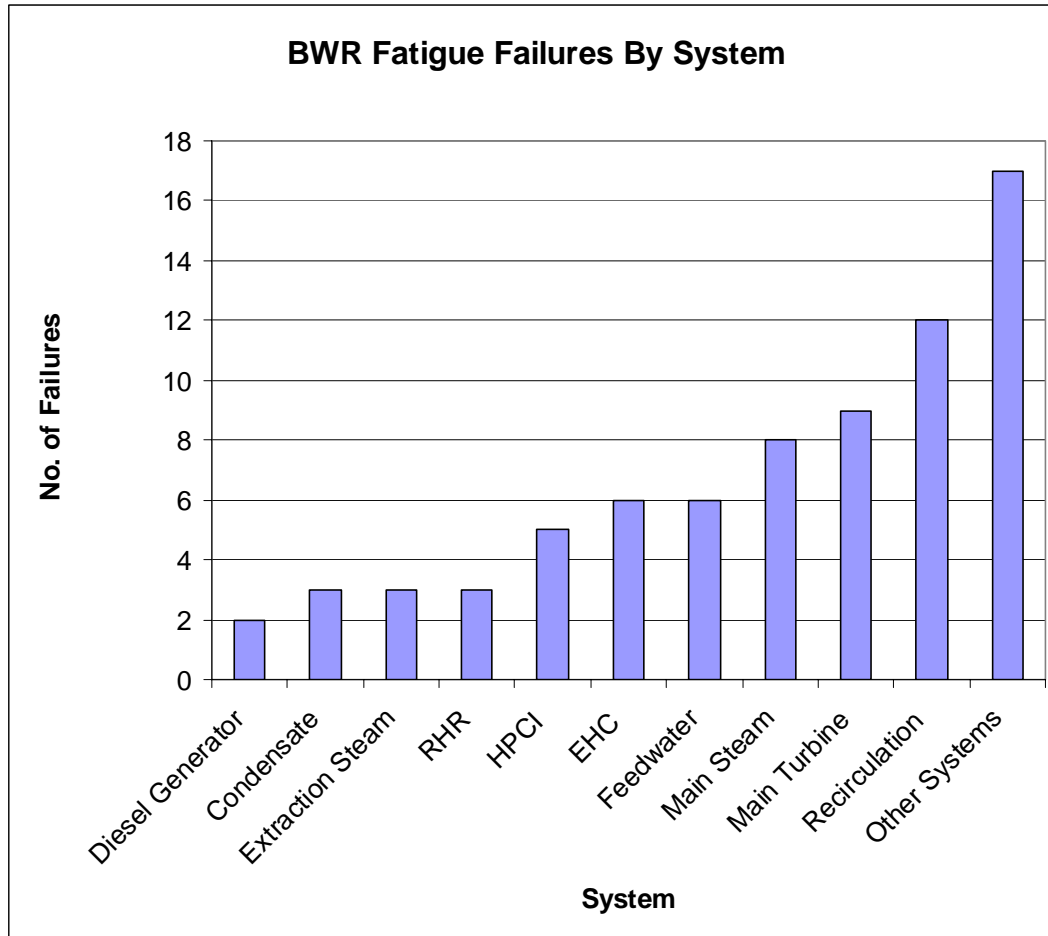
**Figure 3-4**  
**BWR Fatigue Failures Sorted by System**

Figure 3-4 shows a breakdown by system of the total number of failures occurring in BWRs between 1990 and 2004. In the previous survey [1], the recirculation system had the most failures and remains a high contributor for the current survey period. The “Other Systems” include closed cooling water, HVAC, instrument air, main condenser, main generator, service water, and reactor internal systems.

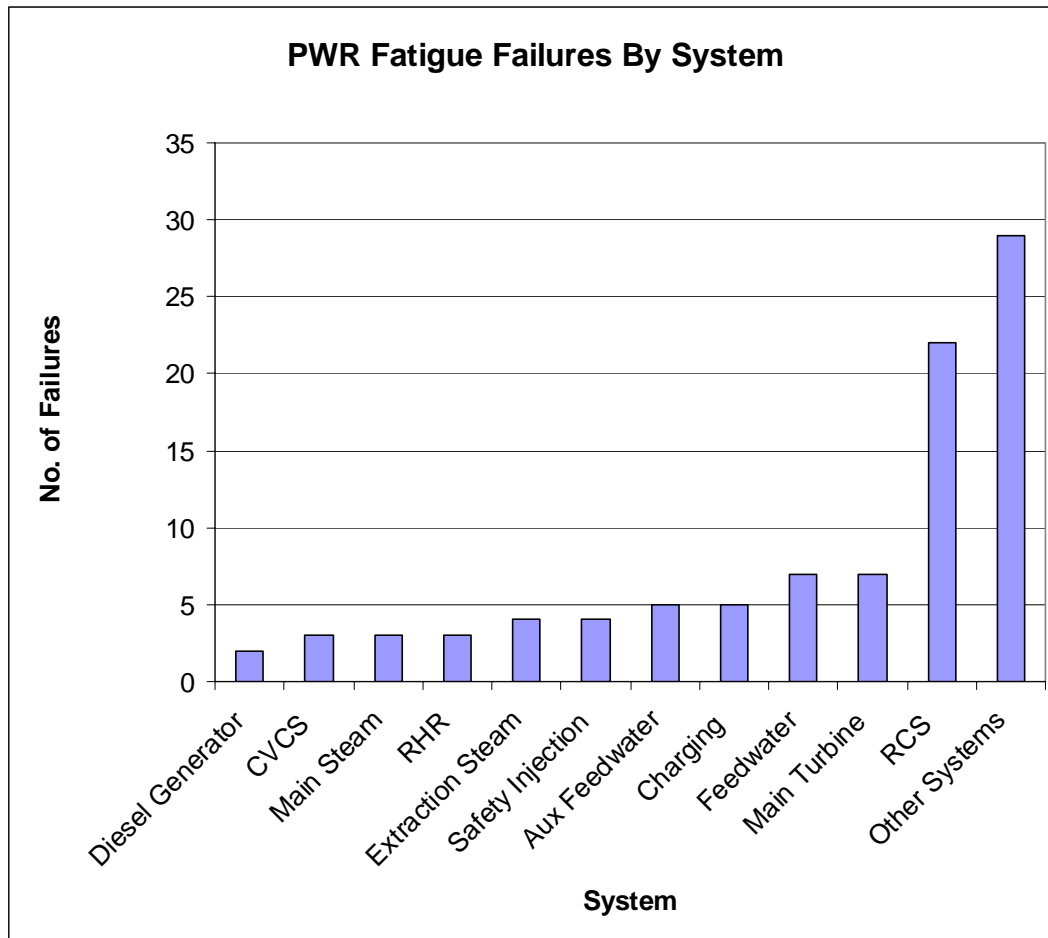
**Figure 3-5**  
**PWR Fatigue Failures Sorted by System**

Figure 3-5 shows a breakdown by system of the total number of failures occurring in PWRs between 1990 and 2004. In the previous survey [1], the chemical and volume control system (CVCS), consisting of the letdown and charging (or make-up) systems, had the most failures by a large margin. This is not the case anymore; the reactor coolant system (RCS) has had the most fatigue related failures for the current survey period. The previous survey also reported that the next system with the most The “Other Systems” include closed cooling water, HVAC, instrument air, main condenser, main generator, service water, and the steam generator systems.

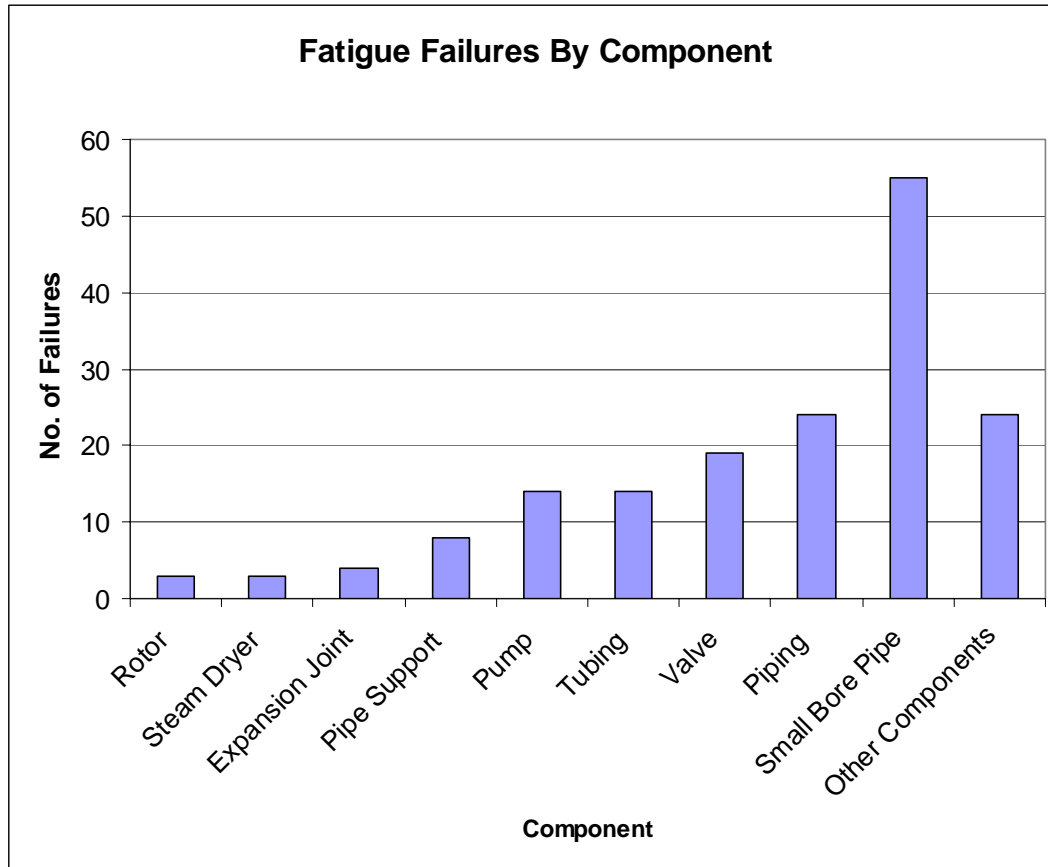
**Figure 3-6**  
**Fatigue Failures Sorted by Component**

Figure 3-6 shows failures reported in the current survey sorted by component. Similar to the earlier survey, small bore pipe fatigue failures continue to affect plant availability. Some of the valve and piping fatigue failures are welds at valve to pipe connections. Most of the fatigue failures on valves, piping, and small-bore pipe occurred at welds. The “Other Components” include accumulators, bellows, fans, heat exchangers, condenser, and a diesel generator gear. With the exception of the steam dryer which is unique to BWRs, all other component failures occurred in both BWRs and PWRs.

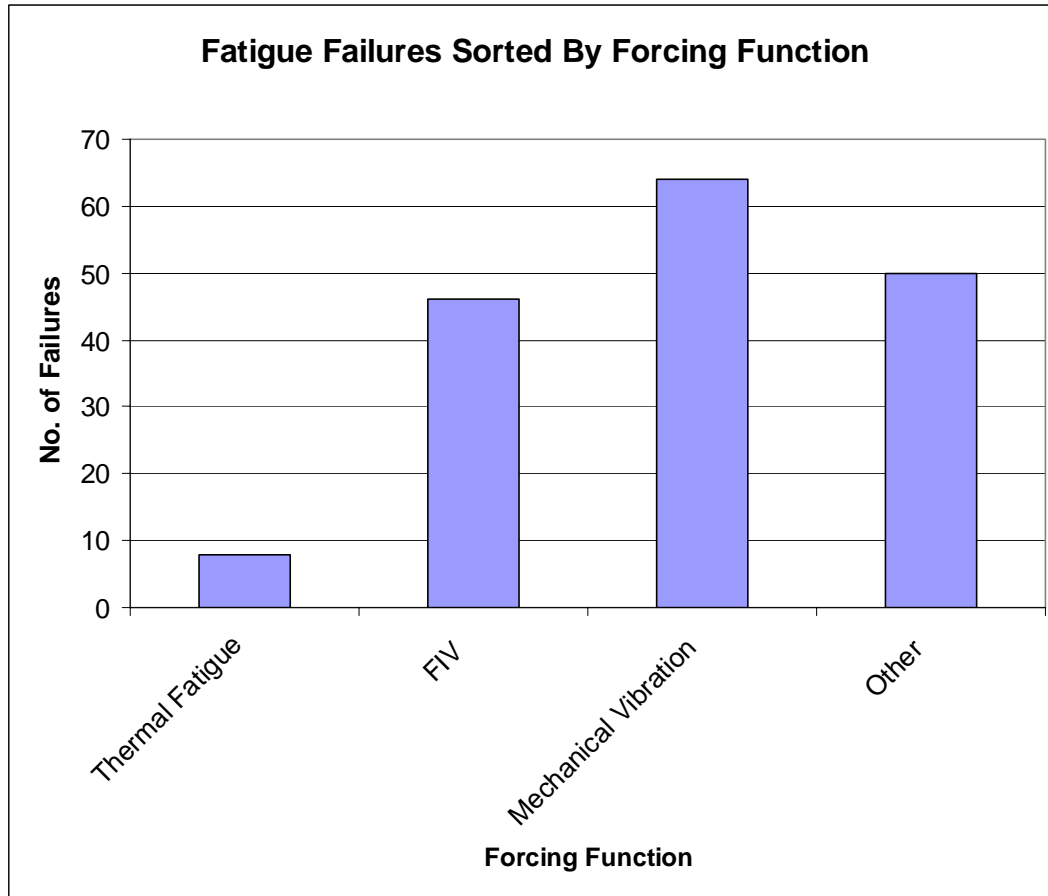
**Figure 3-7**  
**Fatigue Failures Sorted by Forcing Function**

Figure 3-7 shows the failures sorted by forcing function. The main forcing functions of vibration fatigue failures are mechanical vibration and flow induced vibration loads. The “Other” forcing functions include torsional vibration, water hammer loads, cavitation loads, and forcing functions that otherwise could not be identified. A review of the mechanical vibration events shows that there has been a gradual increase over the years but twelve failures attributed to mechanical vibration occurred in 2002 while only three fatigue failures occurred in 2003. The fatigue failures due to FIV have remained fairly constant over the survey period at around two to three per year.

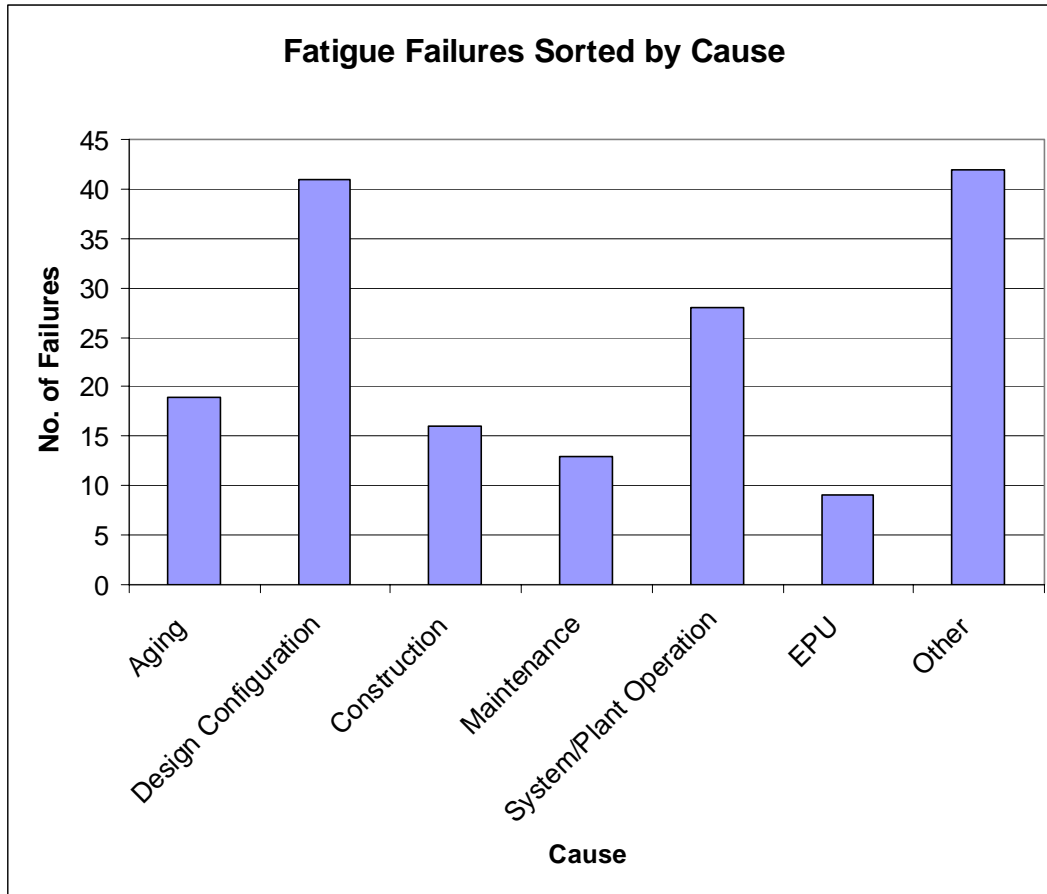
**Figure 3-8**  
**Causes of Fatigue Failures**

The fatigue failures have been sorted by the cause of the failure in Figure 3-8. The main fatigue failure cause is due to the design configuration. This includes the original design of the system or component that did not properly account for steady state vibration loads. Design modifications to a system or component that result in a fatigue failure are also included in this category. While the number of failures due to design configuration has remained relatively constant over the survey period, design modifications have contributed to the fatigue failures in the recent years. Some of the design modifications are due in part to replacement of components that appear to be the same but have slight differences that change the natural frequency of the component or system. EPU, which is specific to BWRs, is shown as a separate category even though it is a subset of system/plant operation. The “Other” category includes equipment design, manufacturing defects, and unknown causes.
