## **Manhole Event Mitigation Strategies**

*Explosion Testing of Manhole Covers with Pressure Relief Mechanisms*

Technical Update, December 2006

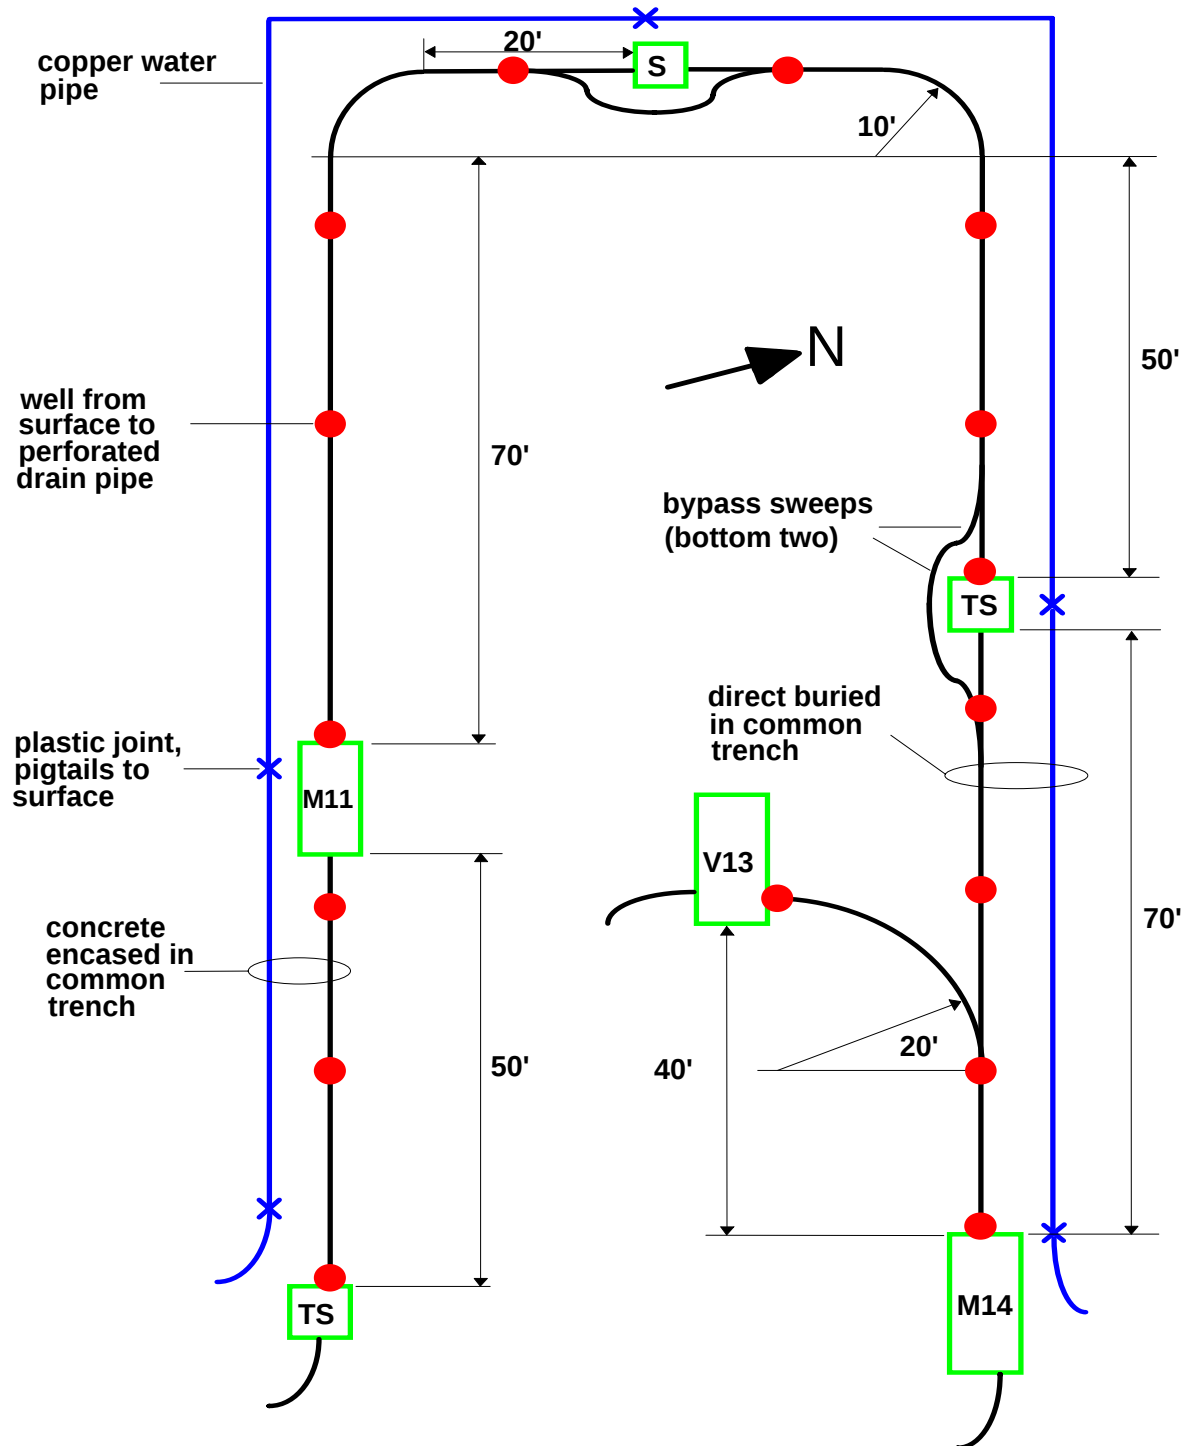
Figure 1-1  
General map of the EPRI-Lenox Manhole Test Facility

Figure 1-1 shows the general map of the facility. Tests were conducted in the M11 manhole. For safety reasons, the test site (the M11 manhole) is surrounded by protective netting consisting of Dacron mesh, see Figure 1-2.

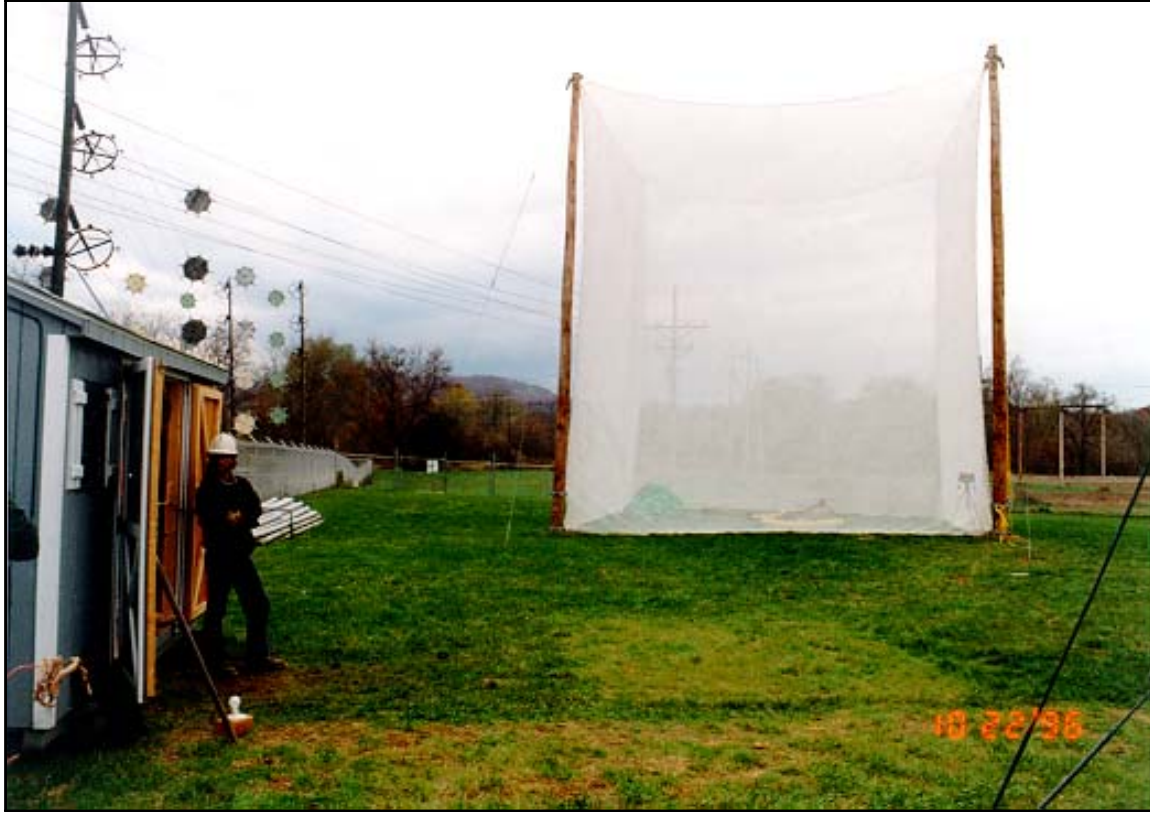
**Figure 1-2**  
**Protective tent around the M11 test site**

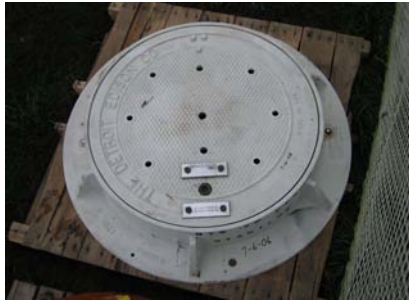
**Figure 2-1**  
**Cover #1 – solid, white with**  
**Stabiloc locking mechanism**

- Cover with the Stabiloc locking mechanism installed, see Figure 2-1, designated in this report as Cover #1,
- Cover identical to Cover #1 but with the Stabiloc mechanism removed, see Figure 2-2, designated as Cover #2,
- Hinged cover provided by Saint Gobain with Stabiloc locking mechanism, see Figure 2-3, designated as Cover #3.

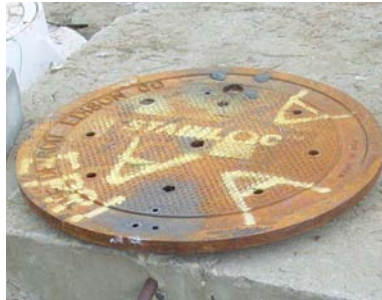
**Figure 2-2**  
**Cover #2 – solid, brown,**  
**without Stabiloc locking**  
**mechanism**

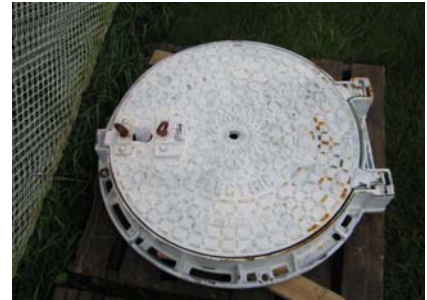
**Figure 2-3**  
**Cover #3 – Hinged Saint Gobain**  
**solid, white with Stabiloc**  
**locking mechanism**

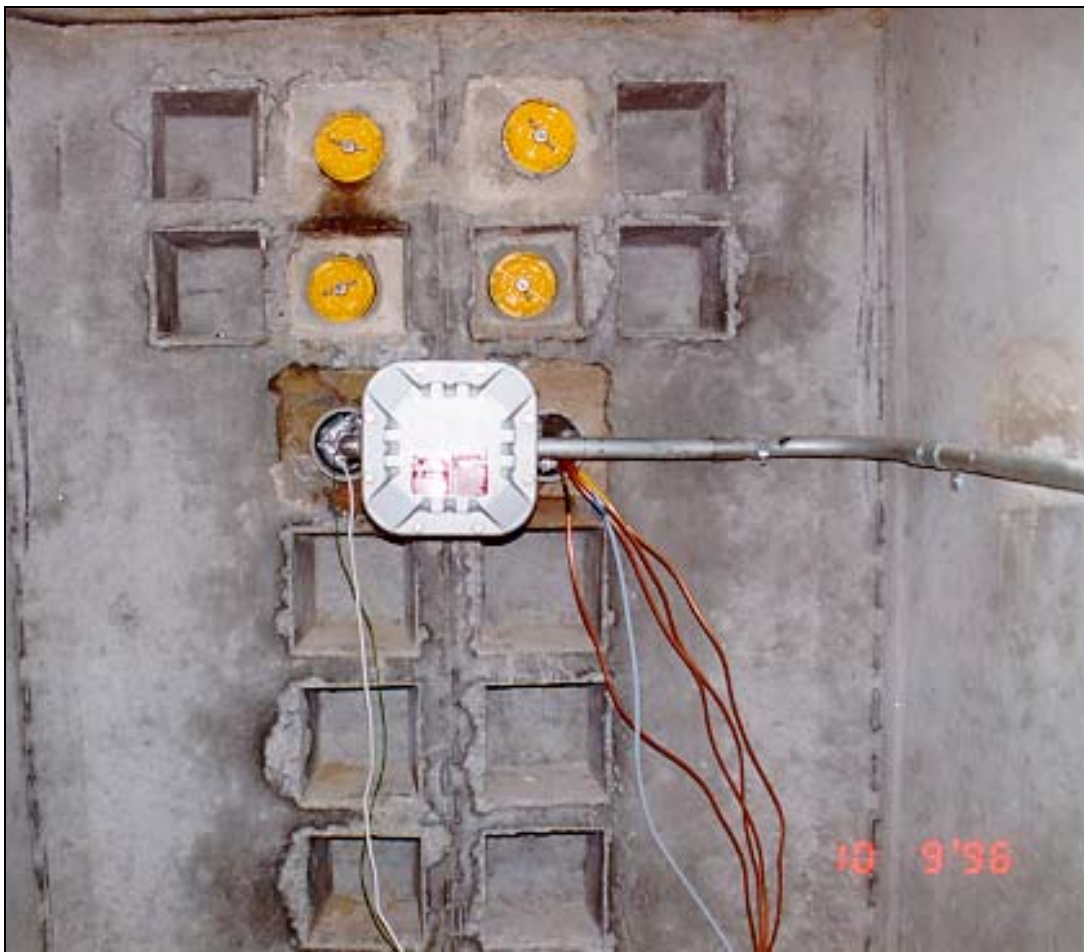
**Figure 3-1**  
**Photograph of the East Wall of the M11 Manhole Showing the Feed Tubes Entering the Manhole**

Pressure and temperature sensors were placed in explosion-proof boxes mounted on each internal wall of the M11 manhole. Gas injection tubing and all instrumentation cables are brought into the M11 manhole through underground ducts at the East wall of the manhole. The ignition source is located on the floor approximately in the center of the M11 manhole, and a mixing fan is located at the South-East corner. Figure 3-1 shows the East wall with the sensor box, gas injections tubing, and instrumentation cables.

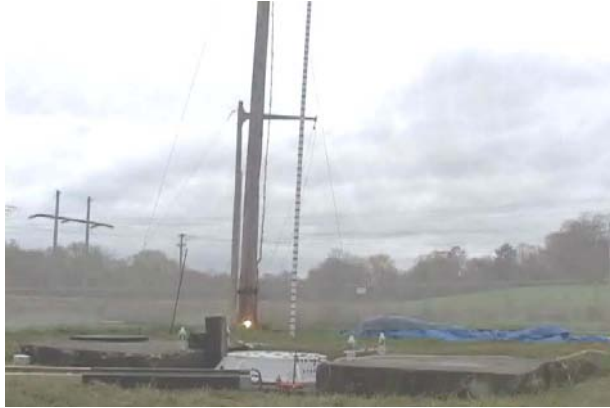
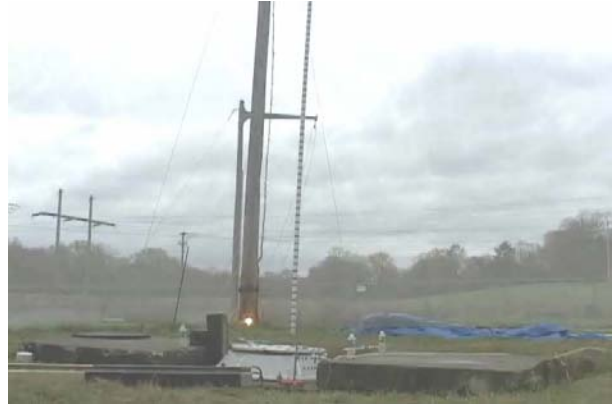
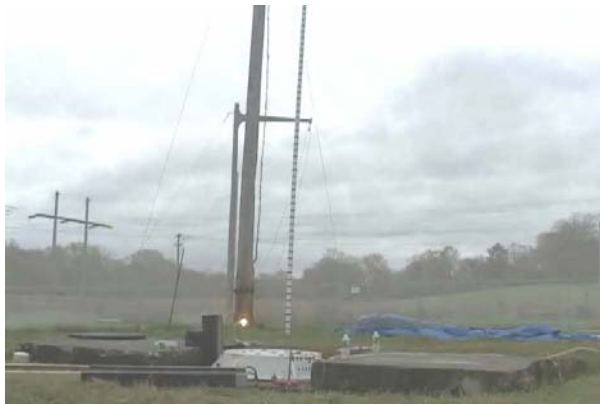
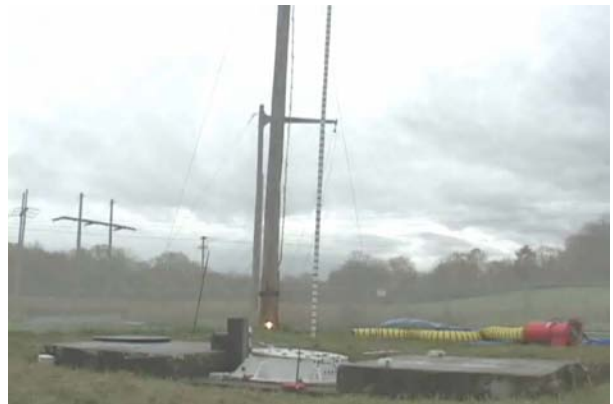
(a) Initiation of explosion. Cover still in its frame.

(b) Cover rose about 2 inches for the first time.

(c) Cover fell back into its frame.

(d) Cover rose again.

**Figure 4-1**  
Cover relieves internal pressure by “bobbing” up-and-down about 6 times. Test with 6% hydrogen by volume (Event 4).

In those cases, the cover rose about 2 inches as allowed by the locking/restraining mechanism, fell back into the frame thus allowing internal pressure to increase again. Then the cover rose and fell back, repeating this behavior several times until the internal pressure decreased below that value needed to lift the cover (overcome gravity). This is shown in Figure 4-1 in a sequence of frames copied from the video.

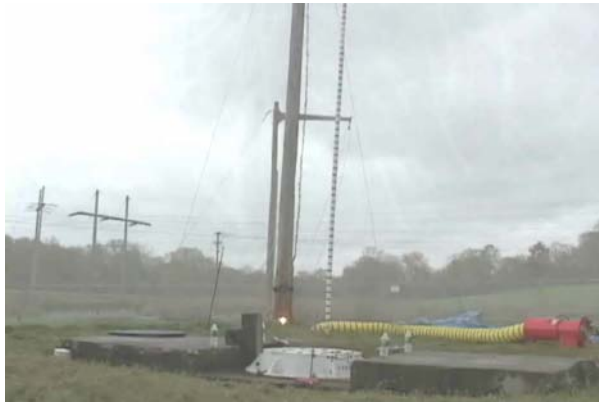
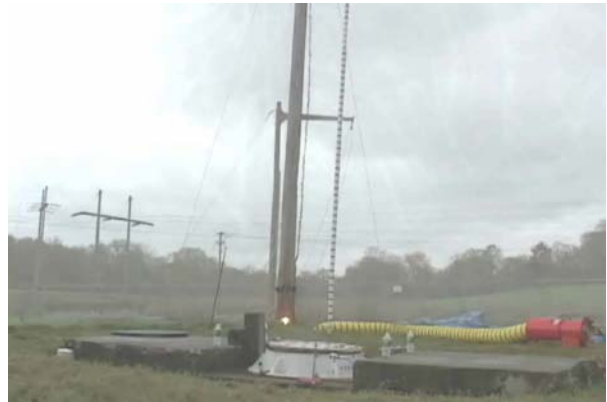
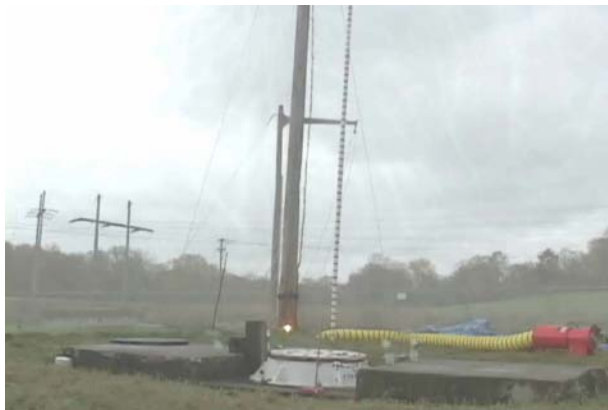
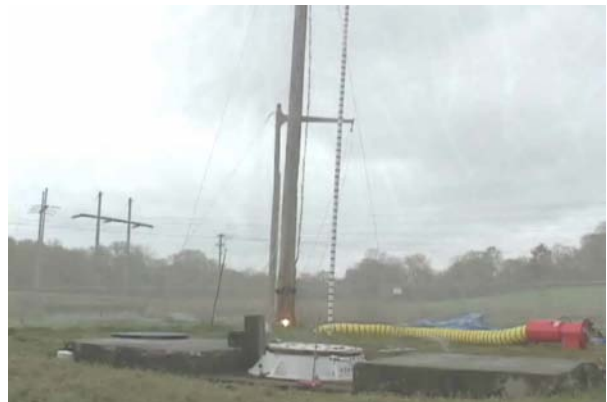
#### Figure 4-2

(a) Initiation of explosion. Cover still in its frame.

(b) Cover rose about 2 inches for the first time.

(c) Cover remains aloft. Note that the bottles are being "sucked" towards the frame.

(d) Cover remains aloft. Bottles are blown away from the cover.

**Cover relieves internal pressure by rising and remaining aloft for a significant length of time. Bottles are initially "sucked" towards the frame, then blown away. Test with 8% hydrogen by volume (Event 5).**

Also, very useful information on pressure waves was obtained by observing empty plastic bottles placed near the frame. In many tests, the bottles appeared to be initially “sucked” toward the frame opening, and then blown away. This indicated very dynamic and rapid pressure changes near the frame which include pressure reversals. In particular, it indicates the presence of a strong lateral pressure wave near the frame than could present significant hazards to the public near the frame. This behavior of pressure changes was confirmed by data collected by the external pressure sensors.

The sequence of frames in Figure 4-2 indicates the presence of a lateral pressure wave in the vicinity of the annulus between the rising cover and its frame.

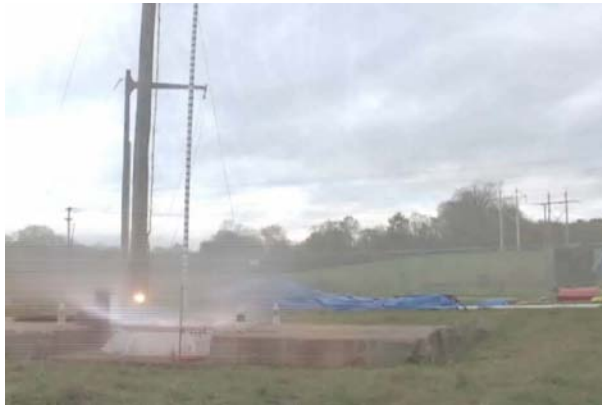
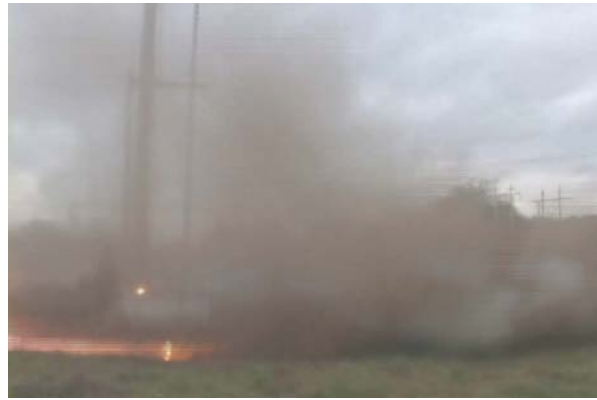
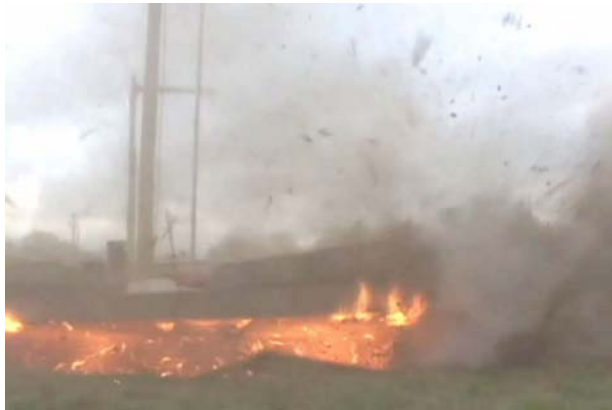
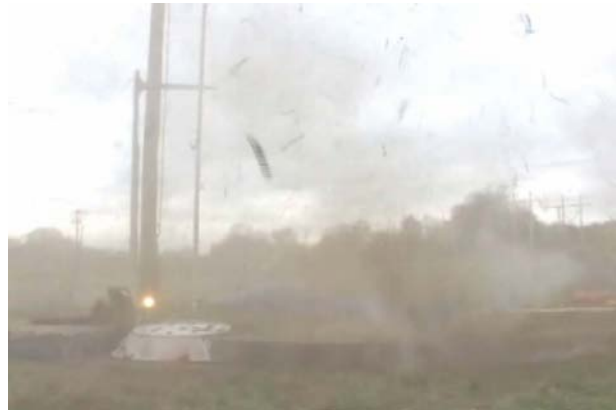
#### Figure 4-3

(a) Explosion. Cover rises and partially relieves pressure. Lateral pressure wave is visible.

(b) The roof slab begins to rise.

(c) Roof slab rises to about 1.5 ft. Cover remains restrained by the locking mechanism.

(d) Roof slab falls back down. Cover remains restrained by the locking mechanism.

In major explosions, the entire roof slab of the M11 manhole, weighing 13,200 lbs (which approximately represents a roadbed) lifted because the pressure relieving action of the restrained cover was not adequate if the shear pin did not break. This is shown in Figure 4-2.

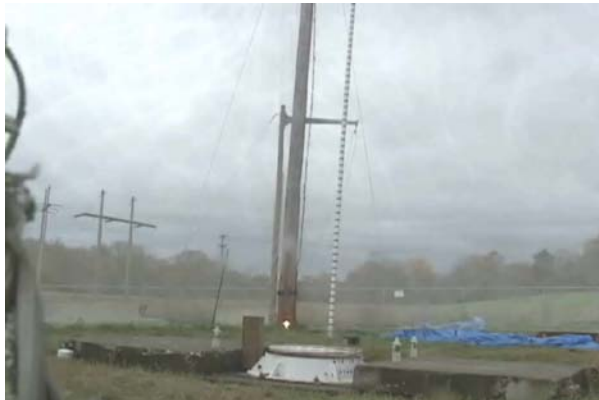
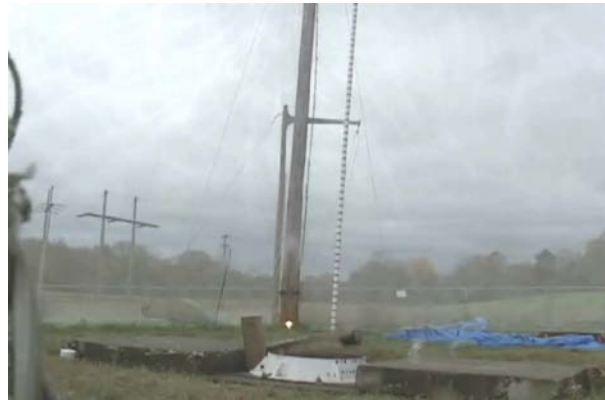
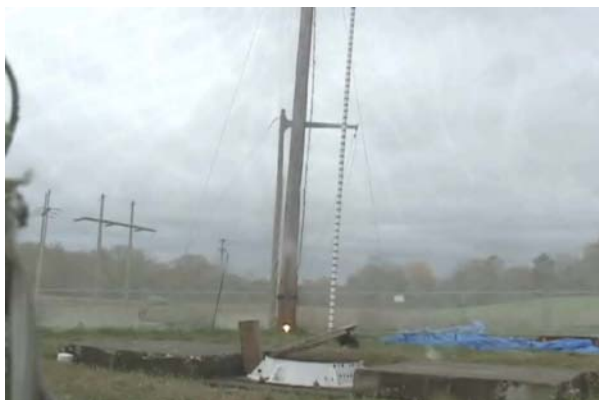
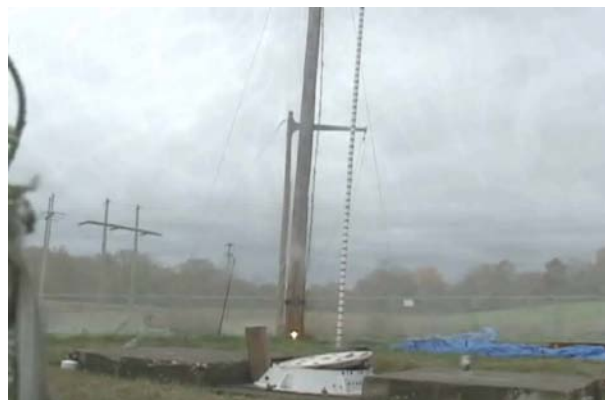
#### Figure 4-4

(a) Cover begins to rise.

(b) Cover rises unevenly since the restraining mechanism is disengaged on one side.

(c) Maximum height reached. Cover remains partially restrained on one side by the passive lip.

(d) Cover falls back into its frame.

Tests were also performed on Cover #1 with the locking mechanism disengaged under test conditions similar to those in Event 5 in Figure 4-2. In this case, the cover rose to a height of about 8 inches, remained aloft for a period of time and fell back into its frame, see Figure 4-4.

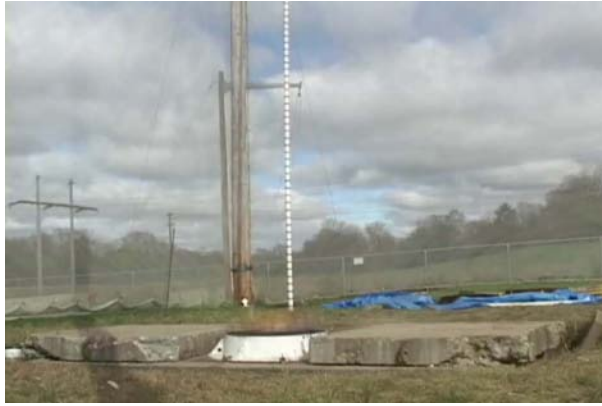
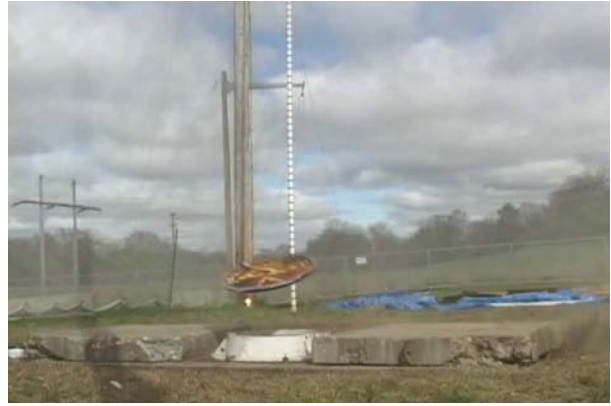
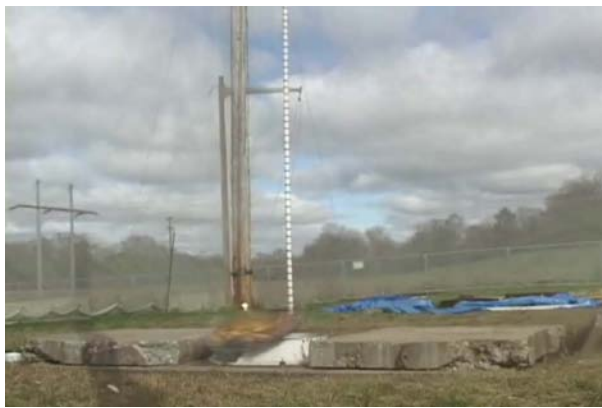
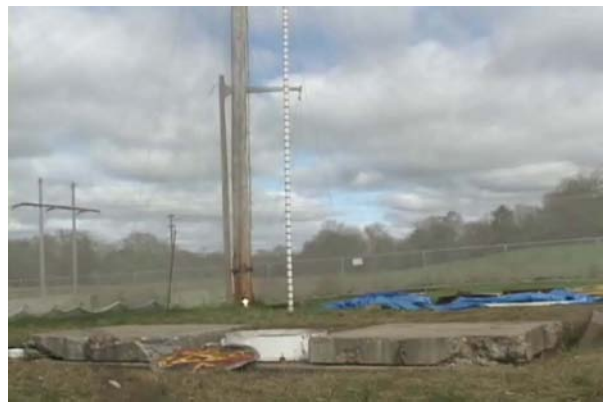
#### Figure 4-5

(a) Cover begins to rise.

(b) Cover at maximum height.

(c) Cover falls.

(d) Cover lands on the ground near the M11 manhole.

Cover #2 did not have a locking mechanism during tests. Figure 4-5 shows that in this case the cover is dislodged and hurled away. Significant collateral damage is possible.

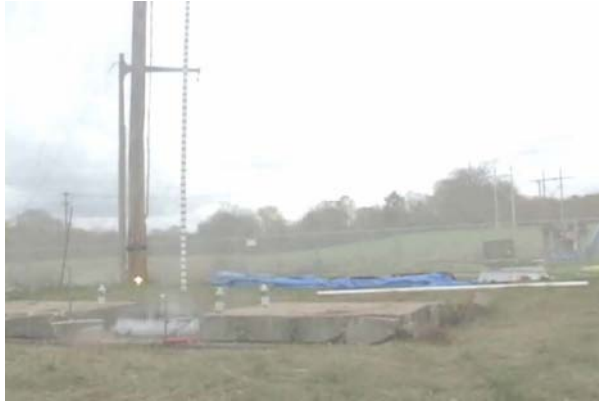
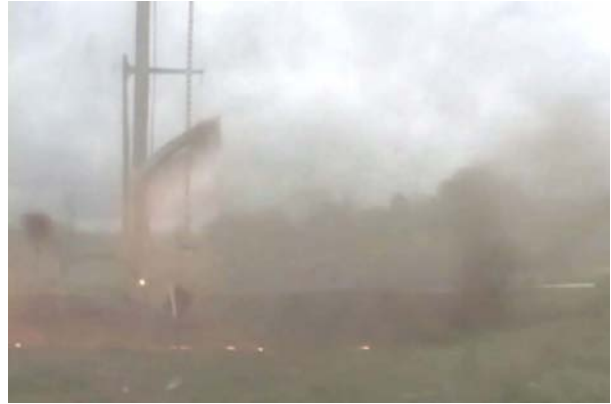
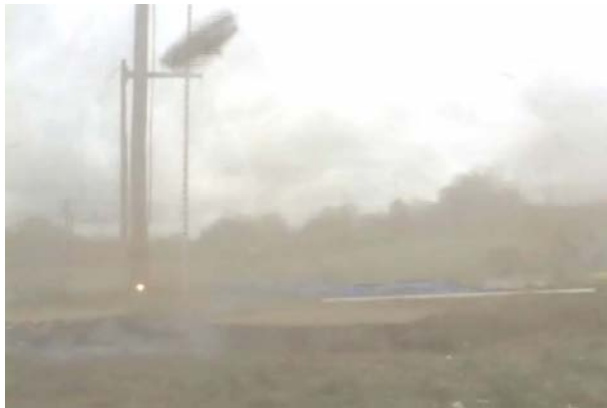
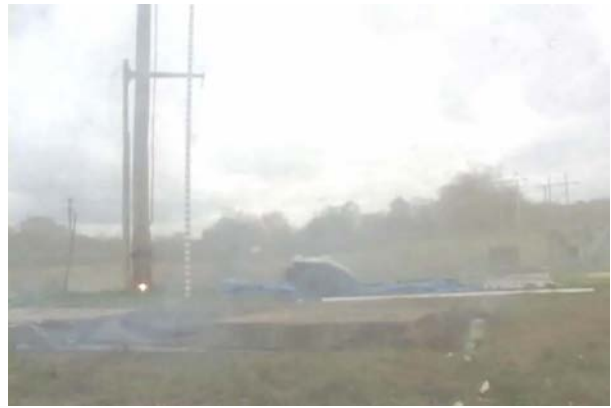
(a) Cover begins to open to relieve pressure.

(b) Cover and its frame are ripped off the M11 manhole roof slab and hurled upwards.

(c) Cover and frame at maximum height.

(d) Cover and frame land on the ground away from the M11 manhole.

**Figure 4-6**  
The hinged cover did not provide sufficient pressure relief. Test with 6% UL mixture by volume (Event 11).

| <b>Event #</b> | <b>Cover type</b> | <b>% UL</b> | <b>Max. press. (psi)</b> | <b>Cover height (ft-in)</b> | <b>Comments</b> |
|---|---|---|---|---|---|
| 11 | #3, with Stabiloc locking mechanism | 6 | About 7.8 | 2" (as allowed by the lock) | Very significant explosion. Cover lifted about 2" out of the frame. Pin held. However, the frame and cover were ripped off the roof slab and hurled together about 14', and landed on the grass about 8' from the M11 manhole. Roof slab lifted about 8". |

Cover #3 is a hinged cover. It was equipped with the Stabiloc restraining mechanism for these tests. The cover did not provide sufficient pressure relief. It and its frame were ripped off the M11 manhole and hurled to a height of about 14 ft in a test with 6% UL mixture, see Figure 4-6.

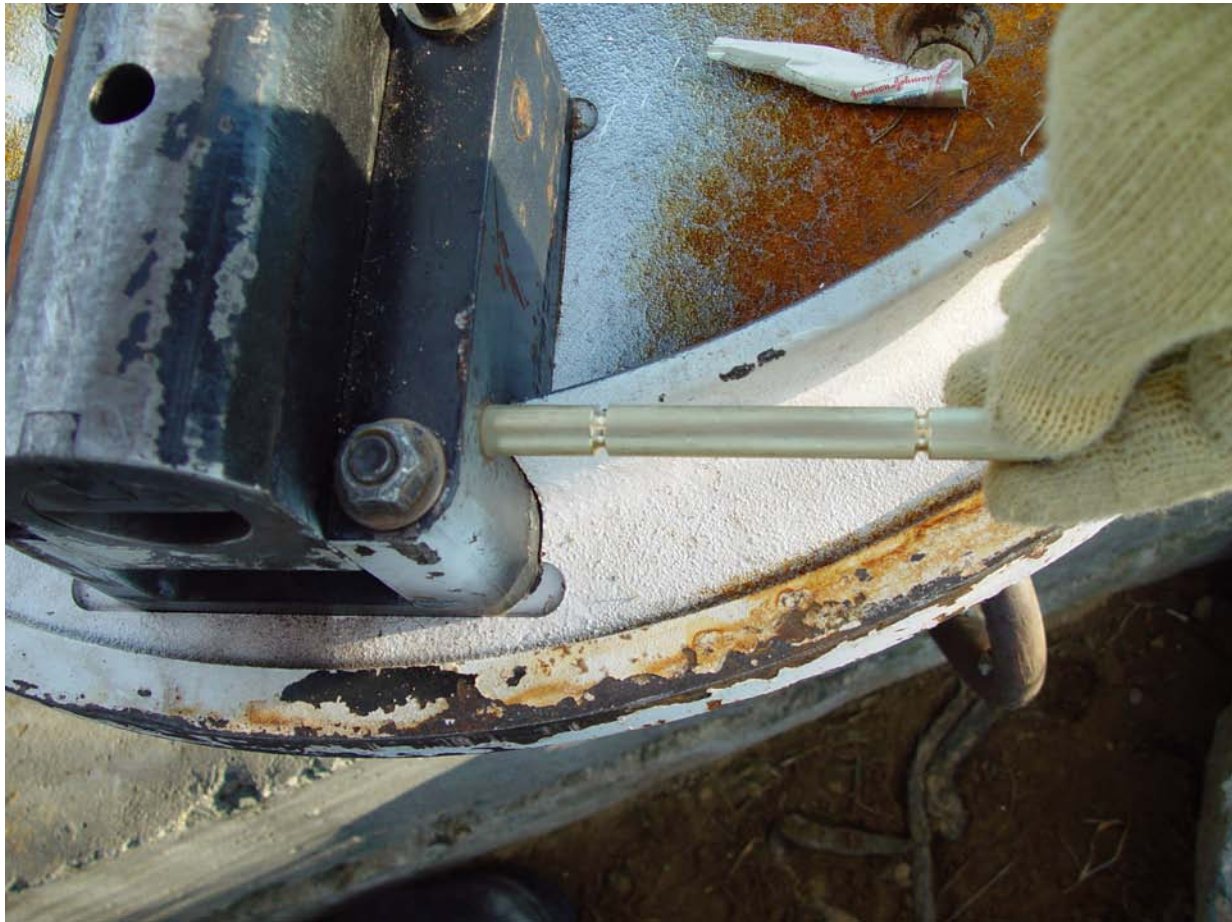
**Figure 4-7**  
**Shear pin with notches.**

The shear strength of the pin was adjusted by beveling two notches as shown in Figure 4-7. This introduces controlled weak points in the pin. The amount of remaining material in the notch area determines the shear strength of the pin.

Tests discussed previously used a pin 0.5 inch in diameter without notches. Additional brass pins were manufactured with remaining material diameters ranging from 0.350 to 0.250 inches, in decrements of 0.025 inch.

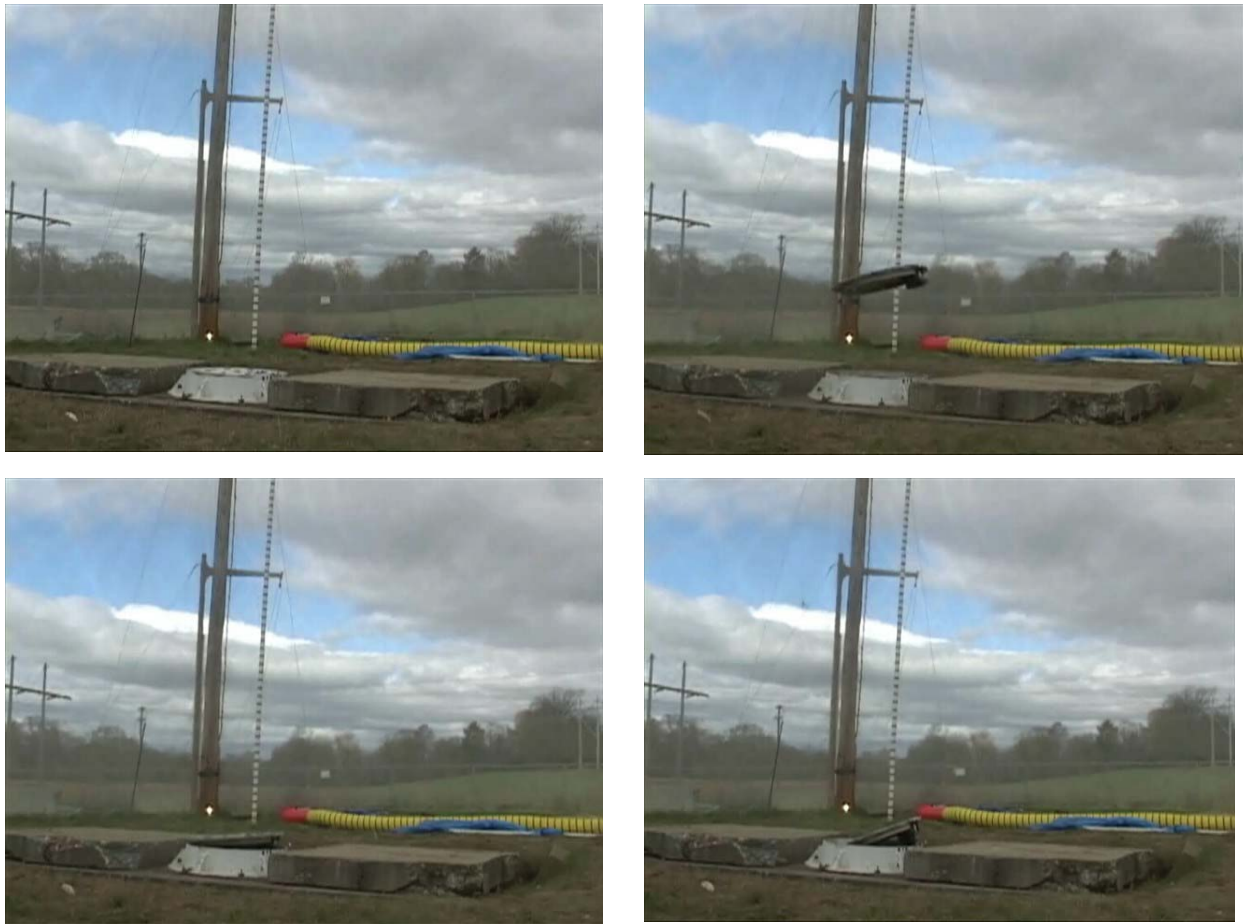
**Figure A-1**  
**Event 17. Pin size 0.275". Hydrogen concentration 13%.**

| Event # | Cover type | % H <sub>2</sub> | Max. press. (psi) | Cover height (ft-in) | Comments |
|---|---|---|---|---|---|
| 17 | #1, lock engaged, 0.275" dia shear pin | 13 | About 5.8 | About 5' | Cover lifted about 5', tilted, fell down, bounced and fell inside frame tilted. Pin failed |

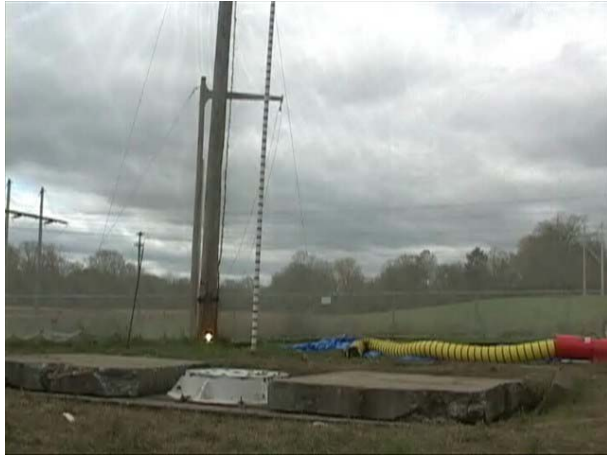
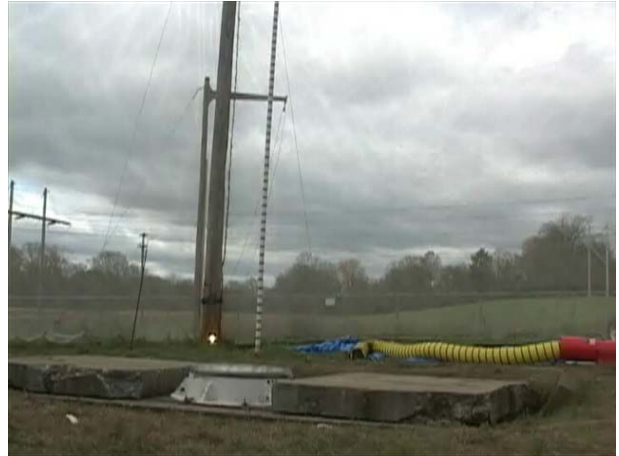
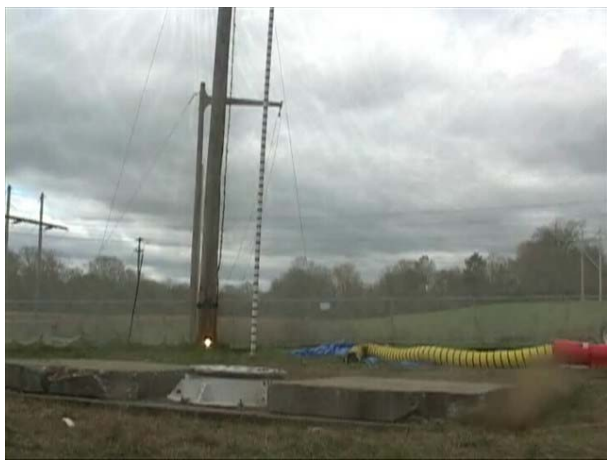
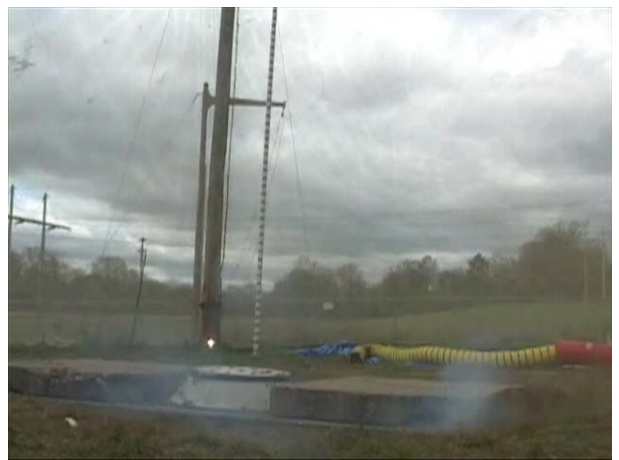
**Figure A-2**  
**Event 20. Pin size 0.350". Hydrogen concentration 13%.**

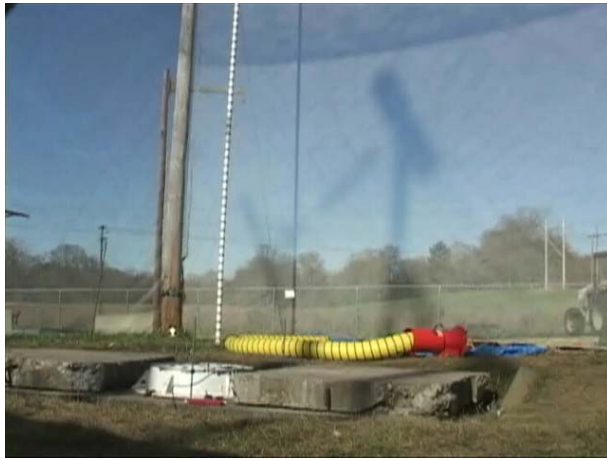
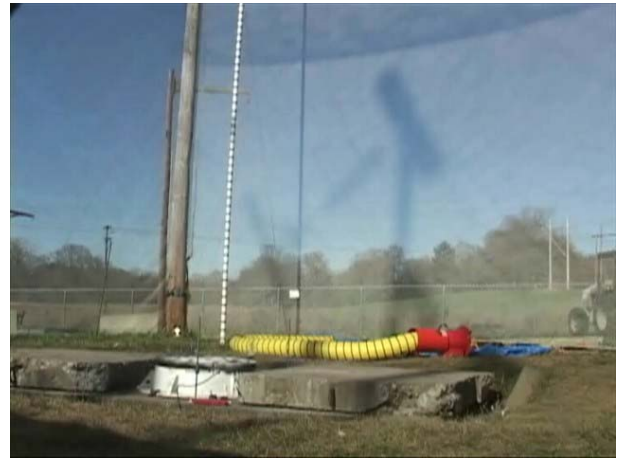
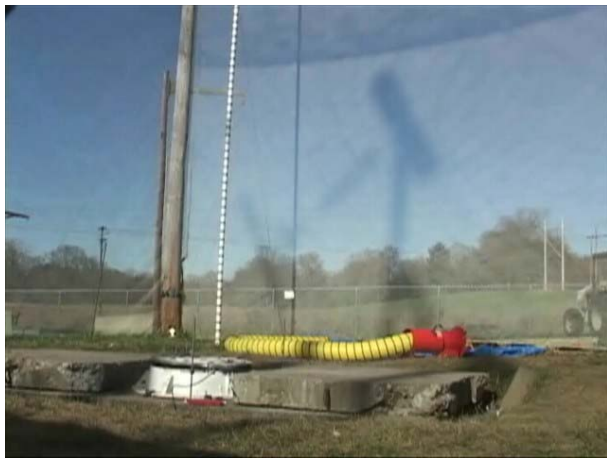
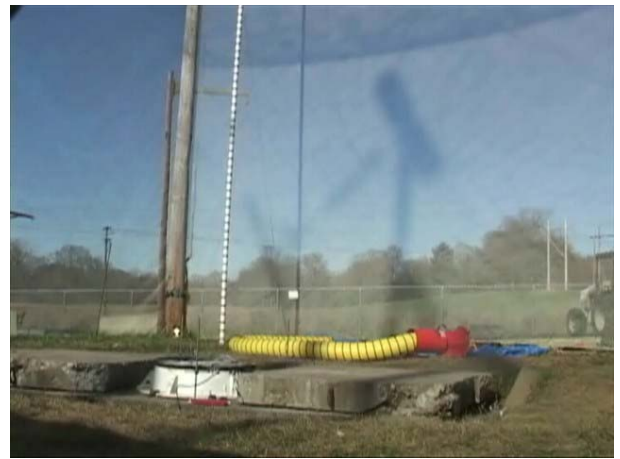
**Figure A-3**  
**Event 28. Pin size 0.250". Hydrogen concentration 10%.**
