Heat Recovery Steam Generator Repair Welding Technologies to Address FAC in Tube Bends

1012762

Technical Update, March 2007

EPRI Project Manager

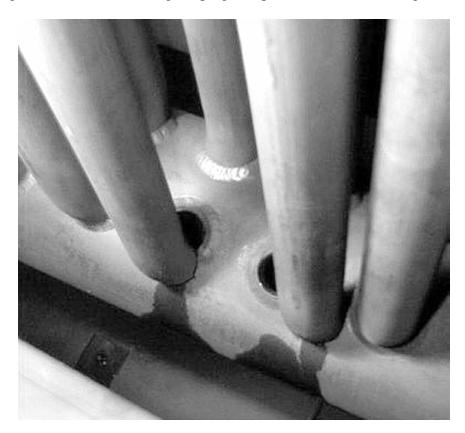
Figure 3-1
Failed HRSG Tube at the Header Location

One form of repair identified during the preparation of the EPRI report, *HRSG Material Selection and Repair Guidelines* (1004875), was tube-to-header attachment repair (see tube failure at header location in Figure 3-1). Due to limited access, this form of repair is often more difficult to perform than conventional tube repairs. A photograph of several tube-to-header attachments, shown in Figure 3-2, reveals the complexity and limited access of such repairs, particularly those that may be buried deep within the bundle. As a result of access limitations, tube failures are often left in place and simply plugged. Figure 3-3 provides an example of a plug-weld configuration. Plugging requires 1) removing a window within the header 180 deg away from the stub tube attachment location, 2) machining and inserting a plug into the damaged tube bore, 3) welding the plug into place, and 4) reinstalling the window.

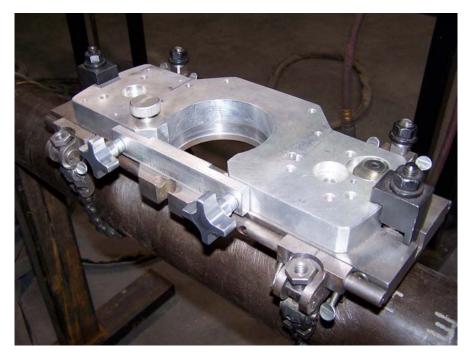
Figure 3-5
A Saddle is Attached to the HRSG Header to Accommodate Various Tooling Used in the HRSG Elbow Repair Process

A saddle attached is attached to the header at a location 180 degrees away from the damaged weld location to accommodate various tooling used in many of the following steps. The saddle shown in Figure 3-5 has been reconfigured somewhat from that identified in the earlier EPRI Report (1010441) that describes the repair approach utilized for straight tube to header connections. The purpose of this reconfiguration is to accommodate new EDM and modified header ID welding equipment (described later). Saddle attachment can be accomplished using either a chain-type approach or a belt-type arrangement.

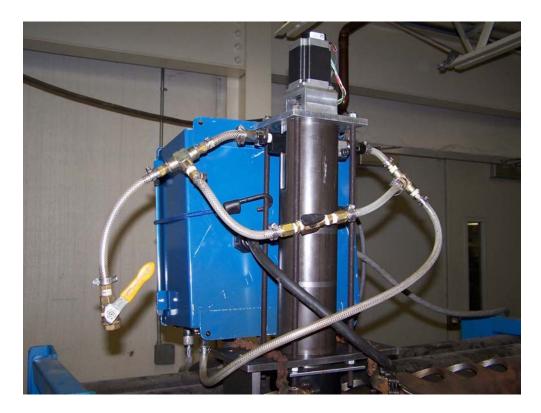
Figure 3-6
A Contoured EDM Profile Device is Used to Remove the Damaged Header-to-Existing Weld

In the previous approach used for removal of the damaged header to weld attachment region, a machining device was employed (Report 1010441). The machining approach generated a considerable amount of machining chips and concerns about leaving chips inside the header or in the tube were expressed. To eliminate this concern, the EDM head developed for Step 1 is utilized to also remove the header-to-existing weld attachment and is positioned 180 degrees from the access hole. This is accomplished using a smaller profile device than was used for the "access hole" in Step 1. The device is shown in Figure 3-6.

The device creates a penetration in the header that is slightly oversized (0.125 inches) over the original tube size. This facilitates insertion of a slightly oversized stub tube later in Step 12 and removal of the elbow through the header ID in Step 7.

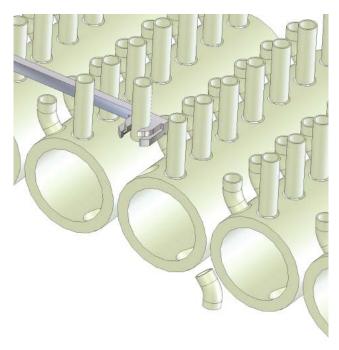
Figure 3-13
The replacement elbow is inserted through the header access window

Step 9 of the process involves insertion of a new replacement elbow. This is accomplished once again from the inside of the header. The tube can be inserted through the access hole and then through the "over-bored" hole wherein the stub tube will be inserted later in Step 12. Insertion of the new replacement elbow is shown in Figures 3-13 through 3-15.

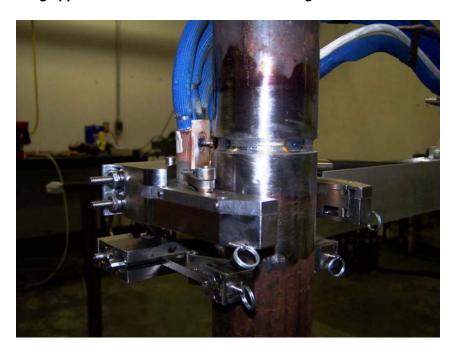
Figure 3-19 Another view of the C-Frame welding approach used for CANDU reactor tubing.

The current equipment as shown in Figure 3-18 through 3-20 is being modified to address somewhat more confined spaces and smaller diameter tubing than was encountered for the CANDU tubing applications.

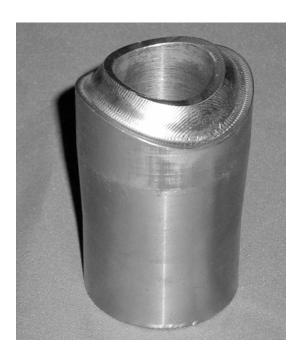
Figure 3-22 Upper Profile of Tube Fabricated to Match Contour of Header ID

Step 12 involves insertion of the new, slightly larger, stub tube through the header (at the attachment location) until it is contacts and is slid over the new elbow section. The stub tube is designed with a recess (or female) receptor on the tube end which acts similar to a backing strip during welding that occurs in Step 13 (Figure 3-21 and 3-22). The stub tube is identical to that described in Report 1010441 for straight tube. Figure 3-23 shows the insertion of the stub tube, while Figure 3-24 shows the tube being inserted over the elbow.

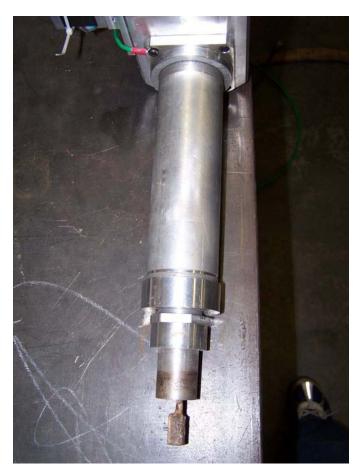
Figure 3-27 ID Tube Welding Head

Two photographs of the actual ID welding device are shown in Figures 3-27 and 3-28. Figure 3-29 provides a cut-away view of a tube welded with the ID welding device. To date, >25 welds have been made with the ID welding device demonstrating its consistency.

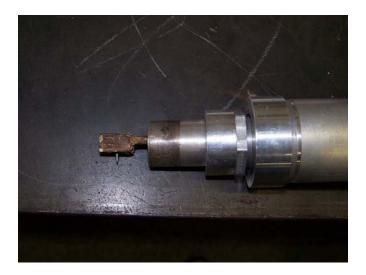
Figure 3-28 A closer view of ID Tube Welding Head shown in Figure 3-27

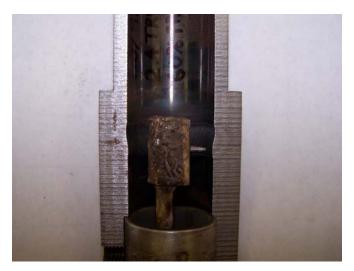
Figure 3-29
The ID Tube Weld Head Is Shown Inserted Into a Cut-away of a Tube (top) to Stub Tube (bottom) Mockup. Tube Diameter is 1-1/4 inches.

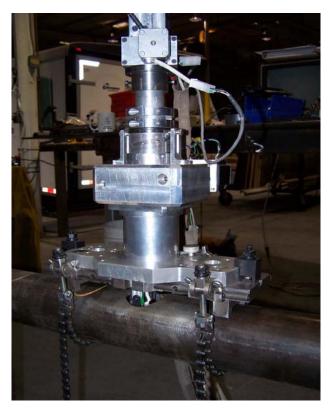
Figure 3-32 Header-to-stub tube welding device inserted into a header.

The third welding step in the process utilizes the device shown schematically in Figure 3-31. The actual welding device is shown mounted onto a 4-inch diameter tube in the shop (Figure 3-32). The welding device is approximately 21 inches tall and mounts directly into the saddle fixture described earlier. The device employs a cam follower (Figure 3-33) to improve welding consistency and quality. It also minimizes welder error.

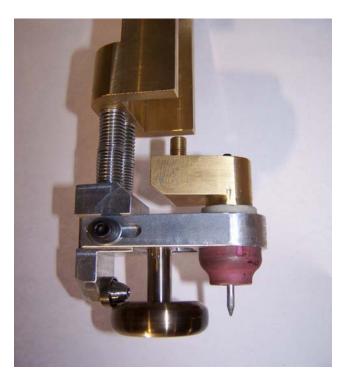
Figure 3-33 A cam follower is an integral part of the ID header welding device.
