Nuclear Maintenance Applications Center: Switchgear and Bus Maintenance Guide

Technical Report

1013457

Final Report, December 2006

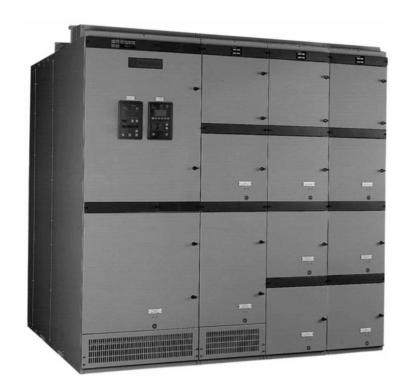
Figure 2-1
Eaton/Cutler-Hammer DSII Low-Voltage Switchgear

LV switchgear completely enclosed on all sides and top with sheet metal. Metal-enclosed construction is used up to 1000 V. The main buses consist of copper bus bars or, in some cases, tin-plated aluminum bars, which are enclosed in a metal compartment.

The bus compartment is located in the rear of the LV switchgear unit. Horizontal and vertical buses connect all equipment in the unit. LV bus is normally uninsulated, and metal barriers between the bus and rear field cable terminations are optional. The LV circuit breakers are contained in individually grounded metal compartments and controlled either remotely or from the front of the unit. Refer to Figures 2-1 and 2-2 for examples.

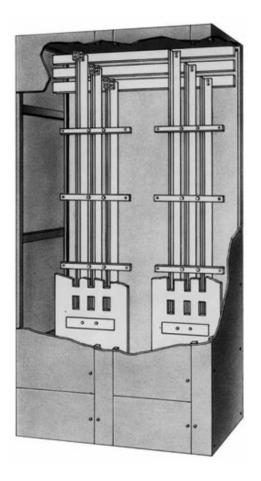
Figure 2-3 MCC Buswork Sketch (buckets cut away)

MCCs are completely enclosed on all sides and the top with sheet metal. Vertical sections or stacks are bolted together to make an MCC unit. The front of each vertical stack contains removable compartments or buckets with hinged doors, and each bucket contains the feeder disconnecting device (breaker or disconnect switch) along with control and protection components (control transformer, contactor, thermal overload relays, and so on). A small adjacent compartment in each vertical stack provides space for associated control and power cables.

The MCC bus work is at the rear and is almost always inaccessible unless the buckets are removed. Typically MCCs are located against a wall, although large MCCs (that is, those that contain many buckets) might be free-standing with sections mounted back-to-back. When buckets are inserted, stabs on the rear of the bucket plug into the vertical bus. The main horizontal bus is usually at the top of the MCC; standard horizontal bus ratings are usually 600 and 800A, with optional ratings as high as 3200A. Each vertical bus has ratings of 300 and 600A typical, with optional ratings as high as 1200A. Bus bars are usually tin-plated copper. Refer to Figure 2-3 for an example of the typical bus arrangement.

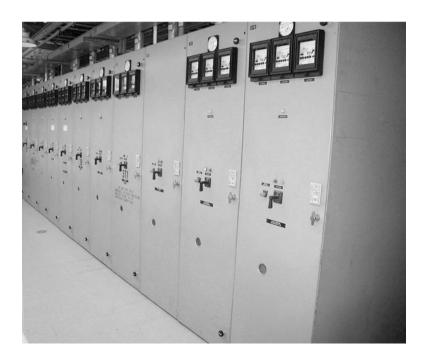
Figure 2-4 Medium-Voltage Switchgear

The MV switchgear structure is generally an assembly of steel housing units that are normally mounted side by side and connected both mechanically and electrically to form a metal-clad switchgear structure. For older switchgear, each air circuit breaker occupies a single vertical unit. The front of the switchgear enclosure has hinged doors and contains the circuit breaker and PT compartments, as shown in Figure 2-4.

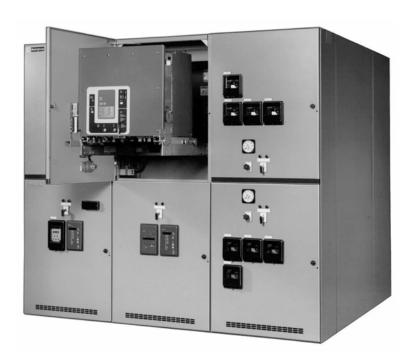
Figure 2-5
Eaton/Cutler-Hammer Medium-Voltage Vacuum Switchgear

In the newer vacuum switchgear, two breakers normally occupy a single vertical unit, a two-high configuration, as shown in Figure 2-5.

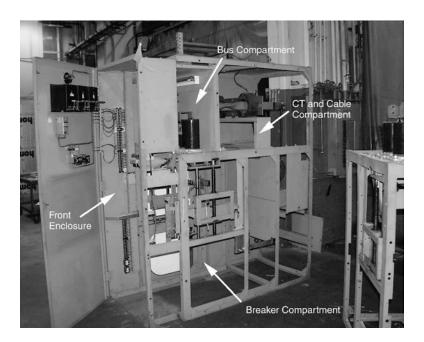
Figure 2-6
15-kV Switchgear Cubicle (metal barriers removed)

The rear of the switchgear enclosure normally has bolted-on panels and contains the buswork, CTs, and power cable connections. Each compartment is separated from the others by metal barriers. The main buses are copper bus bars or, in some cases, tin-plated aluminum bars. Electrical connections between bus bar segments (and sometimes CTs) are bolted for overlapping segments and/or with similar bolted metal plates if a gapped butt connection is necessary for thermal expansion. The bus bars are connected to the primary disconnect studs at the back of the circuit breaker compartment. Some bus construction is welded and does not include bolted joint connections. This is illustrated in Figures 2-6 and 2-7.

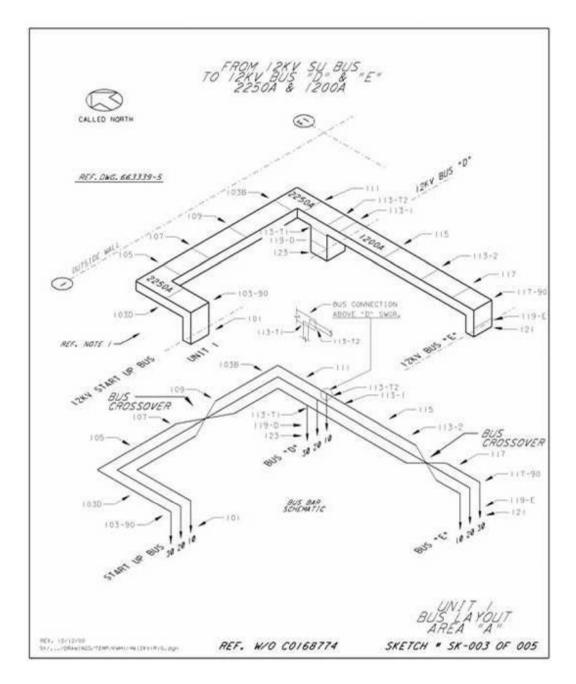
Figure 2-8
Bus Duct Drawing

Principles from this report can apply to other LV and MV equipment, such as bus ducts with similar design features and attributes. Refer to Figure 2-8 for an example.

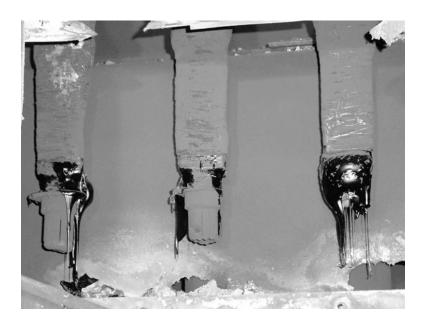
Figure 3-1 Palo Verde Damage

In 1988, a phase B to ground fault occurred on a 13.8-kV non-Class 1E bus. The fault ionized the air surrounding the bus and caused all three phases to short to ground. Failure of the bus, initiated by the phase B to ground fault, was attributed to cracked and brittle Noryl insulation and dirt that had accumulated in the cubicles. These conditions led to arc tracking, which caused the single phase-to-ground fault. This fault propagated into a three-phase-to-ground fault and the subsequent rupture and ignition of the unit auxiliary transformer (UAT). Figure 3-1 shows the bus damage.

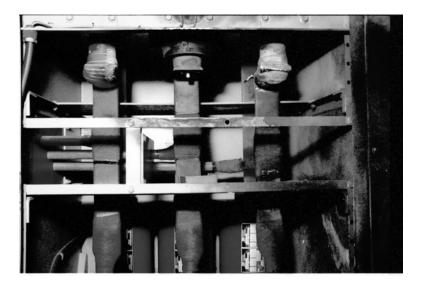
Figure 3-2 Bruce Corona Damage – Bus Area

The Bruce station experienced corona on their 13.8-kV switchgear. Partial discharge (PD) testing both on-line and off-line confirmed insulation degradation, as explained in Section 5.5. Holes were identified in the solid copper bus with silver plating. The remediation project involved upgrading the switchgear insulation with epoxy coatings on conductors and silicone on thruinsulators to minimize PD. The duration of the project was approximately three weeks. Figures 3-2 and 3-3 illustrate corona damage in the area of the switchgear bus.

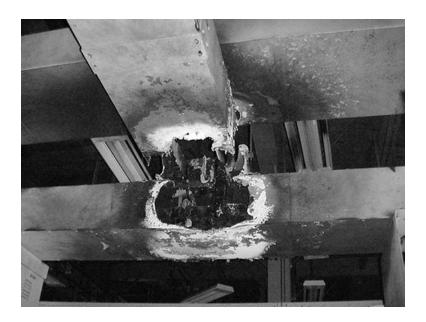
Figure 3-4
Diablo Canyon Bus Duct Damage

The bus work in the room was a combination of aluminum and copper bus bars connected with aluminum splice plates secured by four 1/2-in. bolts. The bus bars and splice plates were silverplated at the connection points to ensure conductivity. The bus bars had a nominal 3/16-in. gap between them at the splice plate to allow for thermal expansion. The 12-kV bus bars had a 6-in. air gap between phases, which is slightly below the required air gap for uninsulated conductors; therefore, the bus bars and connections were insulated with a combination of sleeves and wraps. The 4-kV bus bars were similarly insulated. Figures 3-4 and 3-5 show the extent of the damage.

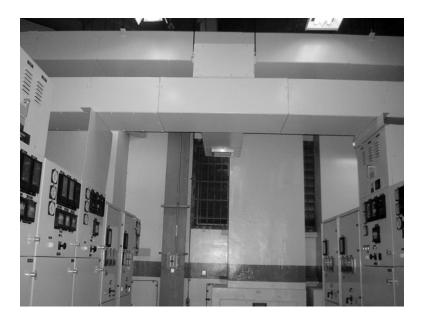
Figure 3-6
Diablo Canyon Bus Duct Repair (external view)

Figure 3-6 shows the subsequent bus duct repair.

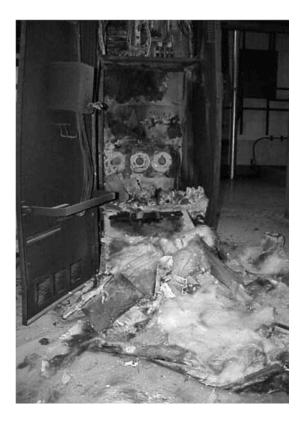
Figure 3-7
Prairie Island Switchgear Damage

In August 2001, while transferring buses to the Unit 1 Main Transformer as part of normal startup, a catastrophic failure occurred on one of the primary disconnect assemblies (PDA) on a breaker. Damage from the subsequent fault and fire resulted in a unit shutdown to effect repairs for approximately six weeks.

The root cause investigation determined that a connector PDA between the breaker and the bus had failed, causing the air to ionize, leading to a phase-to-phase fault. The specific failure mode that brought about the PDA failure was difficult to determine due to the general condition of the equipment following the event, as shown in Figure 3-7. However, one of the root cause investigation primary actions was to inspect PDAs prior to racking circuit breakers to the connected position.

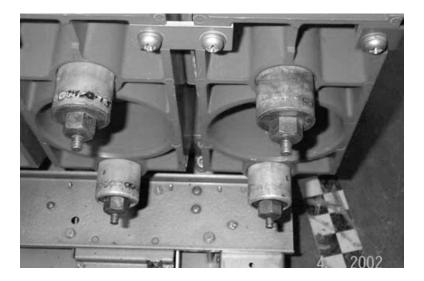
Figure 3-8
Prairie Island PDA Overheating Damage

Subsequent to the August 2001 event, PDAs on other circuit breakers were found to be in poor condition. All six PDAs on one breaker were glued in place due to the high temperatures experienced, and this caused the NO-OX to run and then lacquer, as shown in Figure 3-8. One of the breaker terminals showed signs of significant overheating as well.

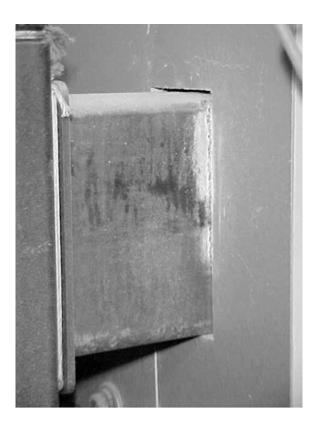
Figure 4-1 Fossil Plant Corona Damage

Air gaps or voids between bus bar and insulation and insulation support barriers can lead to corona at the air gaps. Figure 4-1 is an example of corona damage from switchgear at a fossil-fired generating station.

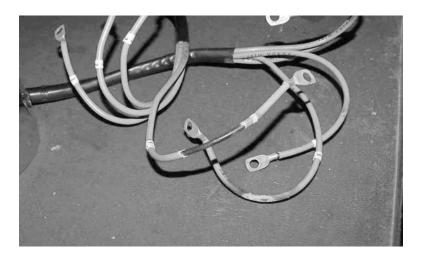
Figure 4-2
Bruce Corona Damage of Wire Insulation

Insulation deterioration, particularly associated with older MV switchgear designs, can result from air gaps in the insulation. The insulation deterioration can lead to failures (for example, phase-to-phase or phase-to-ground MV faults, or PT or CT secondary wiring faults, as noted in Figure 4-2) if the deterioration is not detected by visual inspection or some other inspection and/or monitoring means (refer to Section 5). Some areas might not be easily inspected without a switchgear outage and partial disassembly.

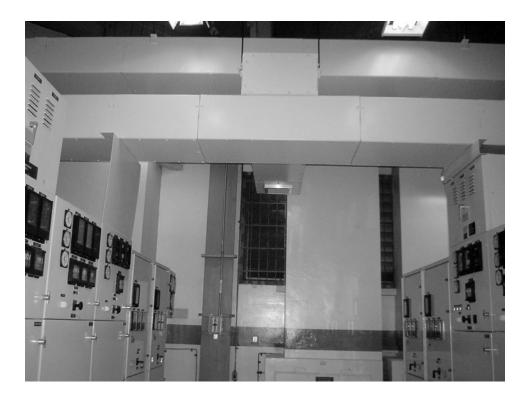
Figure 6-1
Diablo Canyon Bus Duct Repair

- Change bolt material to carbon steel.
- Apply epoxy coating on switchgear bus.
- Use stainless steel Belleville washers torque.
- Add silicone bronze and lock washers.
- Replace splice plates and copper bus with larger size ones to achieve higher ampacity. Silver plating on joints should be dipped to at least 1 mil thickness.
- Add fiber-optic temperature monitoring to heavily loaded bus duct joints.
- Replace all PVC boots at joints.
- Produce isometric drawing of splice joints having unique ID numbers.
- Eliminate air gaps on older switchgear designs.
