# Nuclear Maintenance Applications Center: Switchgear and Bus Maintenance Guide

*Technical Report*

**1013457**

Final Report, December 2006

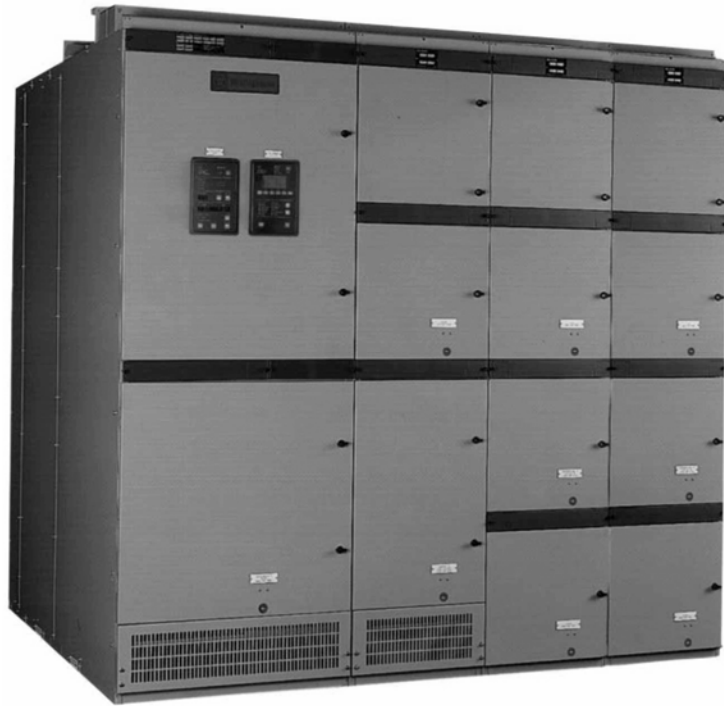
LV switchgear completely enclosed on all sides and top with sheet metal. Metal-enclosed construction is used up to 1000 V. The main buses consist of copper bus bars or, in some cases, tin-plated aluminum bars, which are enclosed in a metal compartment.

The bus compartment is located in the rear of the LV switchgear unit. Horizontal and vertical buses connect all equipment in the unit. LV bus is normally uninsulated, and metal barriers between the bus and rear field cable terminations are optional. The LV circuit breakers are contained in individually grounded metal compartments and controlled either remotely or from the front of the unit. Refer to Figures 2-1 and 2-2 for examples.

**Figure 2-1**  
**Eaton/Cutler-Hammer DSII Low-Voltage Switchgear**

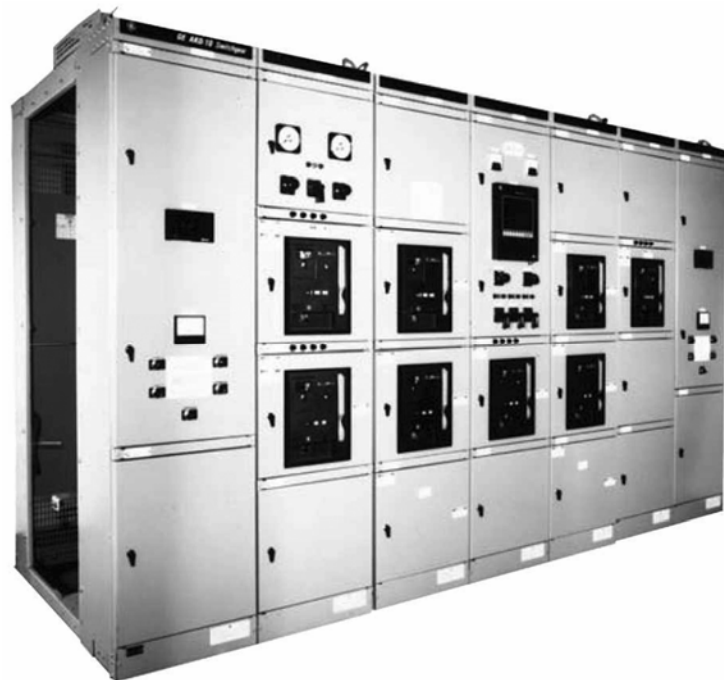
**Figure 2-2**  
**General Electric AKD-10 Low-Voltage Switchgear**

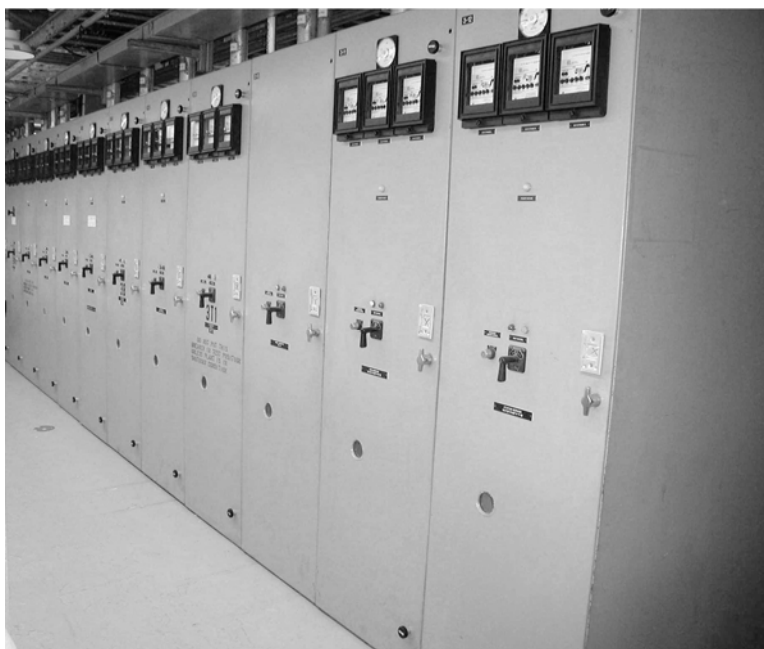
The MV switchgear structure is generally an assembly of steel housing units that are normally mounted side by side and connected both mechanically and electrically to form a metal-clad switchgear structure. For older switchgear, each air circuit breaker occupies a single vertical unit. The front of the switchgear enclosure has hinged doors and contains the circuit breaker and PT compartments, as shown in Figure 2-4.

**Figure 2-4**  
**Medium-Voltage Switchgear**

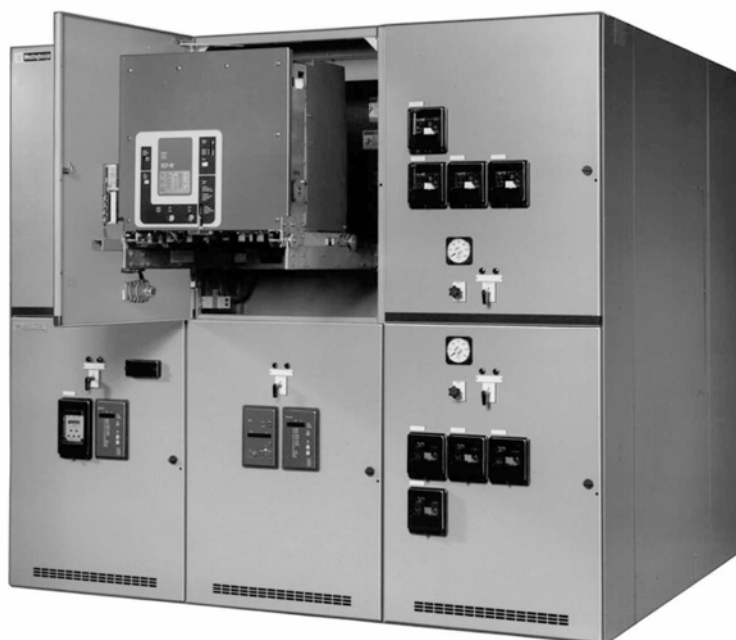
In the newer vacuum switchgear, two breakers normally occupy a single vertical unit, a two-high configuration, as shown in Figure 2-5.

**Figure 2-5**  
**Eaton/Cutler-Hammer Medium-Voltage Vacuum Switchgear**

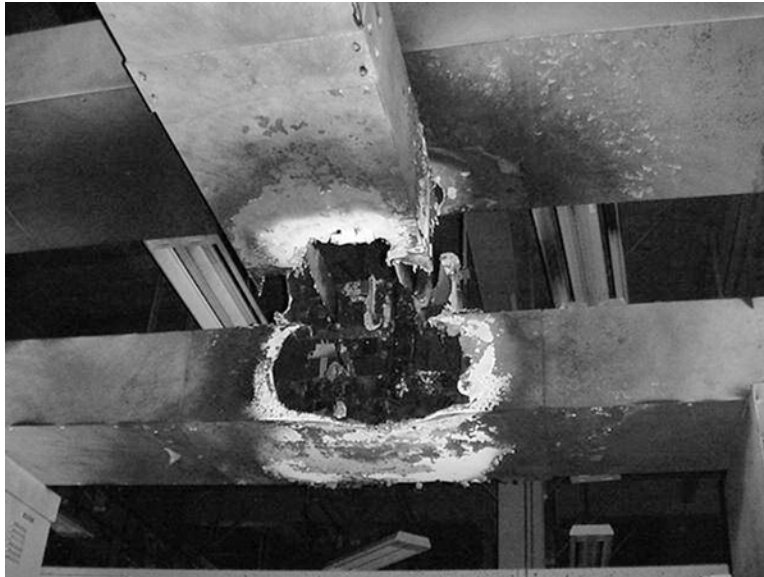
The bus work in the room was a combination of aluminum and copper bus bars connected with aluminum splice plates secured by four 1/2-in. bolts. The bus bars and splice plates were silver-plated at the connection points to ensure conductivity. The bus bars had a nominal 3/16-in. gap between them at the splice plate to allow for thermal expansion. The 12-kV bus bars had a 6-in. air gap between phases, which is slightly below the required air gap for uninsulated conductors; therefore, the bus bars and connections were insulated with a combination of sleeves and wraps. The 4-kV bus bars were similarly insulated. Figures 3-4 and 3-5 show the extent of the damage.

**Figure 3-4**  
**Diablo Canyon Bus Duct Damage**

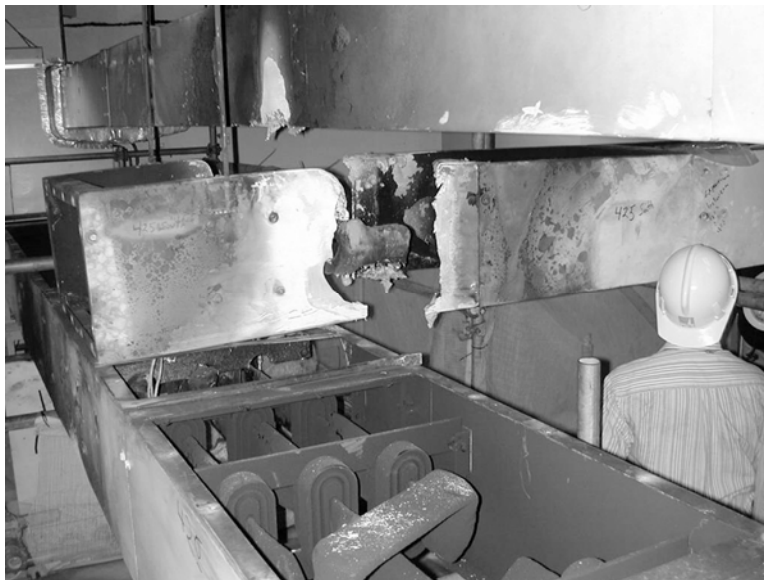
**Figure 3-5**  
**Diablo Canyon Bus Duct Damage**

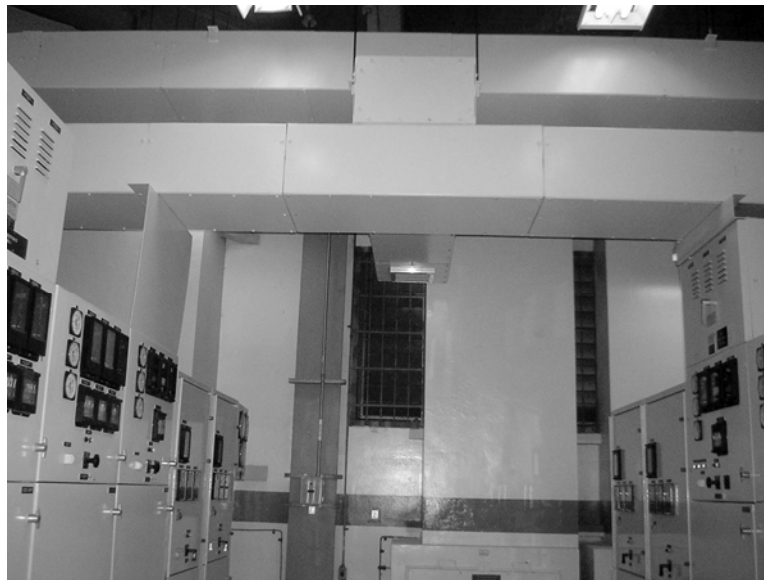
Figure 3-6 shows the subsequent bus duct repair.

**Figure 3-6**  
**Diablo Canyon Bus Duct Repair (external view)**

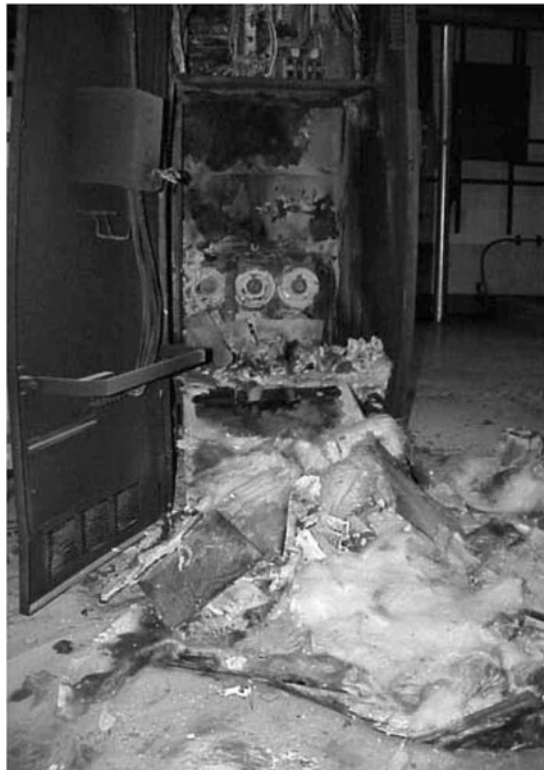
The root cause investigation determined that a connector PDA between the breaker and the bus had failed, causing the air to ionize, leading to a phase-to-phase fault. The specific failure mode that brought about the PDA failure was difficult to determine due to the general condition of the equipment following the event, as shown in Figure 3-7. However, one of the root cause investigation primary actions was to inspect PDAs prior to racking circuit breakers to the connected position.

**Figure 3-7**  
**Prairie Island Switchgear Damage**

In August 2001, while transferring buses to the Unit 1 Main Transformer as part of normal startup, a catastrophic failure occurred on one of the primary disconnect assemblies (PDA) on a breaker. Damage from the subsequent fault and fire resulted in a unit shutdown to effect repairs for approximately six weeks.

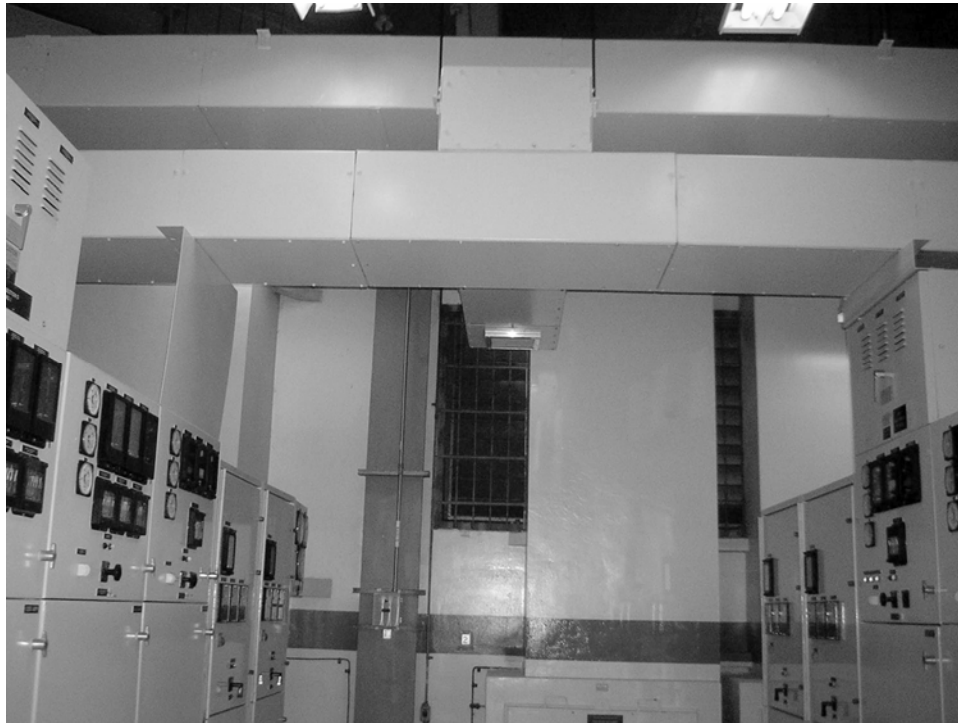
Figure 6-1 depicts repairs and upgrades to a 12-kV switchgear bus.

**Figure 6-1**  
**Diablo Canyon Bus Duct Repair**

- Change bolt material to carbon steel.
- Apply epoxy coating on switchgear bus.
- Use stainless steel Belleville washers torque.
- Add silicone bronze and lock washers.
- Replace splice plates and copper bus with larger size ones to achieve higher ampacity. Silver plating on joints should be dipped to at least 1 mil thickness.
- Add fiber-optic temperature monitoring to heavily loaded bus duct joints.
- Replace all PVC boots at joints.
- Produce isometric drawing of splice joints having unique ID numbers.
- Eliminate air gaps on older switchgear designs.
