# Main Generator Rotor Maintenance

## Lessons Learned

**1013458**

Final Report, November 2006

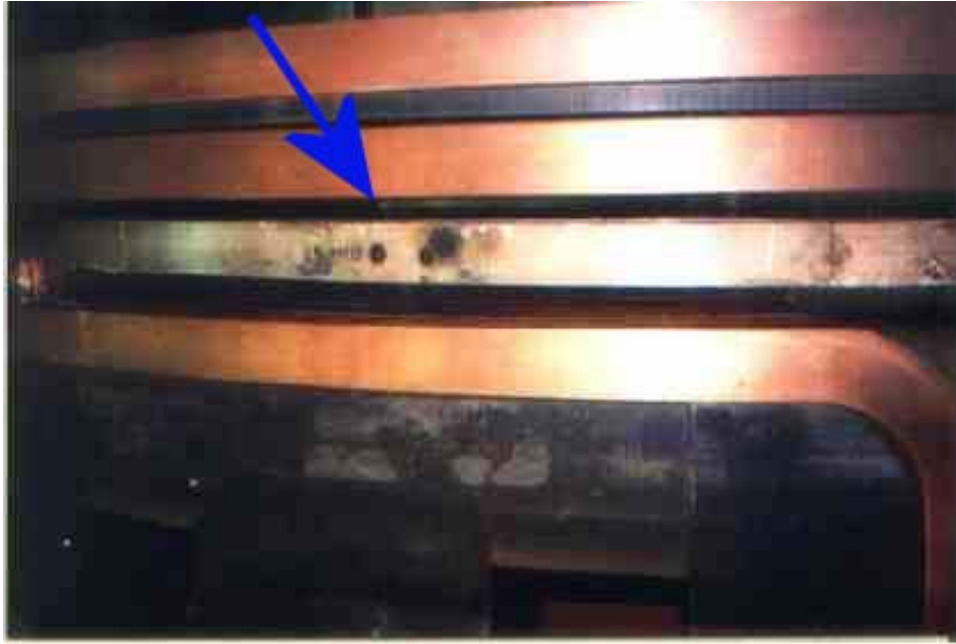
**Figure 2-3**  
**End Turn Arcing Damage**

Fretting damage to the insulation liner of the retaining ring can occur if the top end winding is pressed by centrifugal force against the retaining ring. Evidentially, fretting wear will perforate the insulation creating a field ground. Possible arcing and resistive heating from a ground can damage both the end winding and the retaining ring.

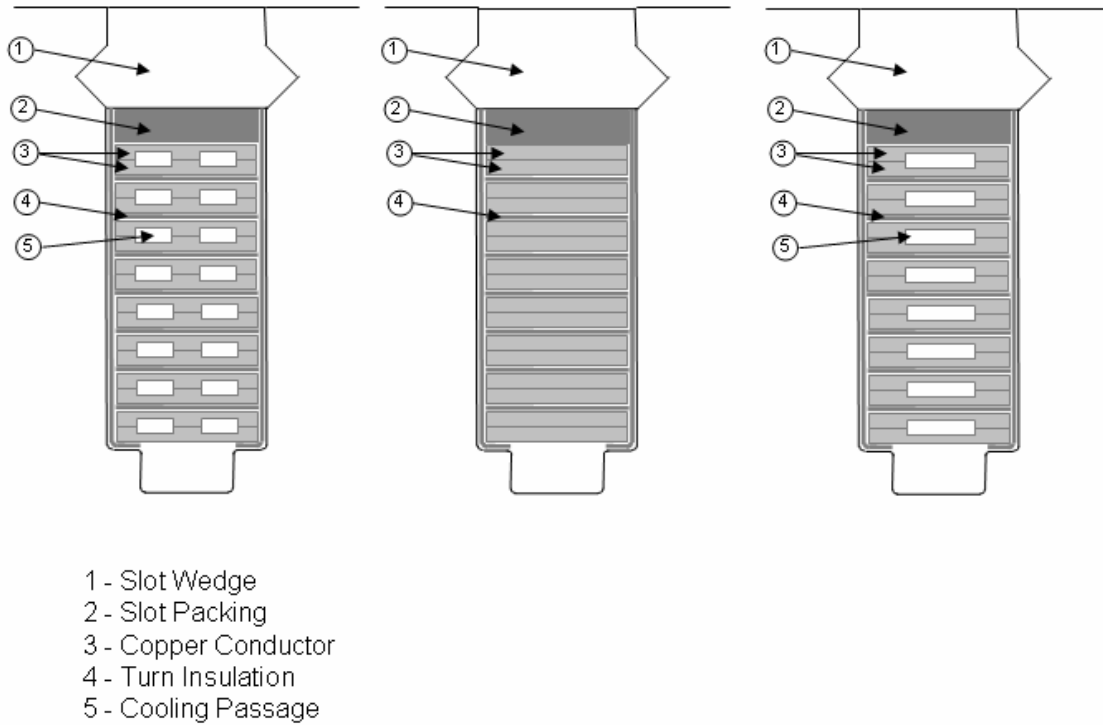
**Figure 2-4**  
**Two Part Conductor Cross Sections**

Certain field winding designs incorporate two part conductors. These two part conductors are copper bars with C-shaped or E-shaped cross sectional areas, that when install face to face form one or two cooling passages through them. One other two part conductor design is comprised of two flat pieces of copper that does not form cooling passages. Regardless of shape of the two parts making up a conductor, relative movement between the copper parts can cause them to rub and abrade each other. This abrasion wears off some of the copper forming a copper dust. Relative movement of the copper conductor parts may be due to thermal expansion and slight rotor flexing experienced during start-up, operation, and cool down of the generator. Being on turning gear for a period of time may cause significant copper dusting.

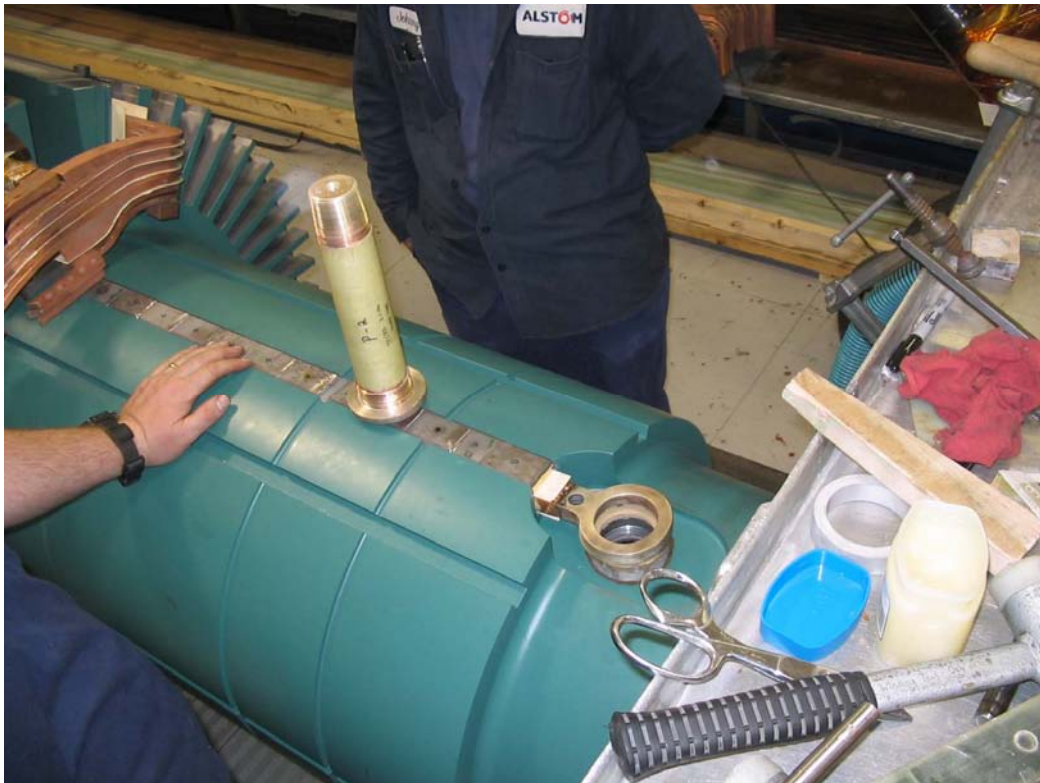
**Figure 2-7**  
**Radial Stud Removed from Shaft**

Hydrogen cooled generators will have seals on the radial studs at either one or both ends of the bore copper. The radial studs connect the field winding leads to the bore copper at one end, and the collector to the bore copper at the other end. Generators with brushless exciters may have radial studs at the field end, using butterfly connectors at the shaft's end for connection to the brushless exciter. The hydrogen seals, as the name implies, prevent hydrogen leakage through the shaft. Cyclic stresses and flexing of the bore copper can also put strain on the radial studs and the hydrogen seals; potentially initiate seal failure and hydrogen leakage.

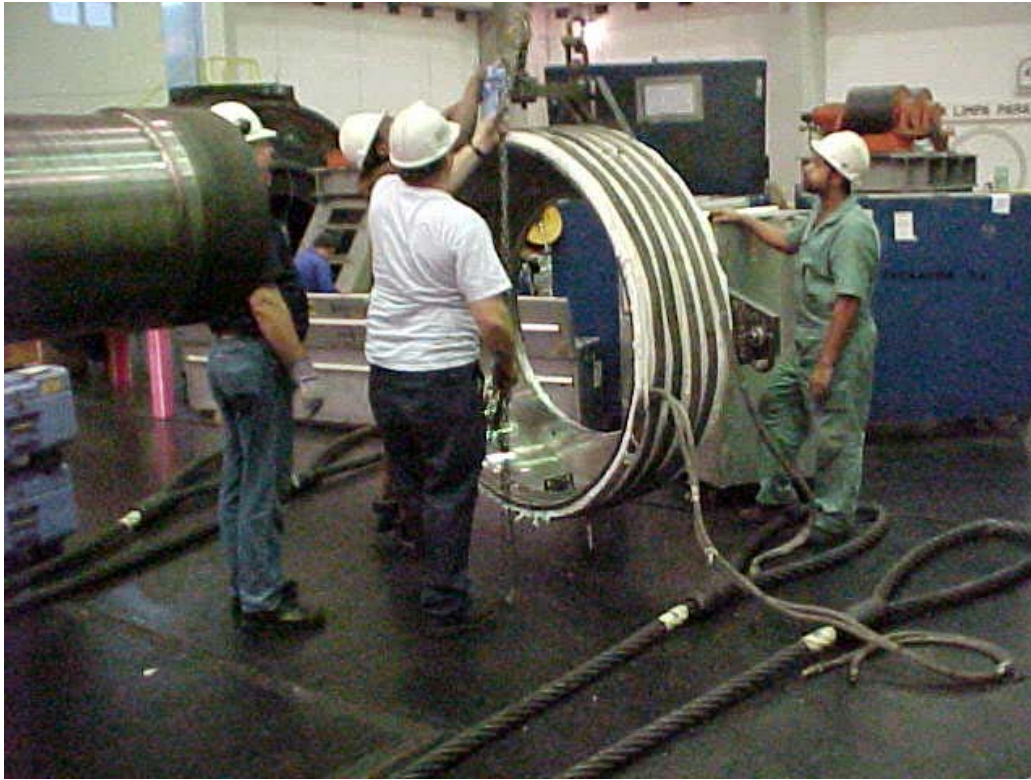
**Figure 2-9**  
**Retaining Ring Removal, Note Heating Coil**

complete and thorough inspection. Ring material may need to be removed to eliminate some corrosion and defects, but only a limited amount of material can be removed without weakening the ring. Care has to be exercised when planning and performing ring material removal, so as not to create new stress risers.

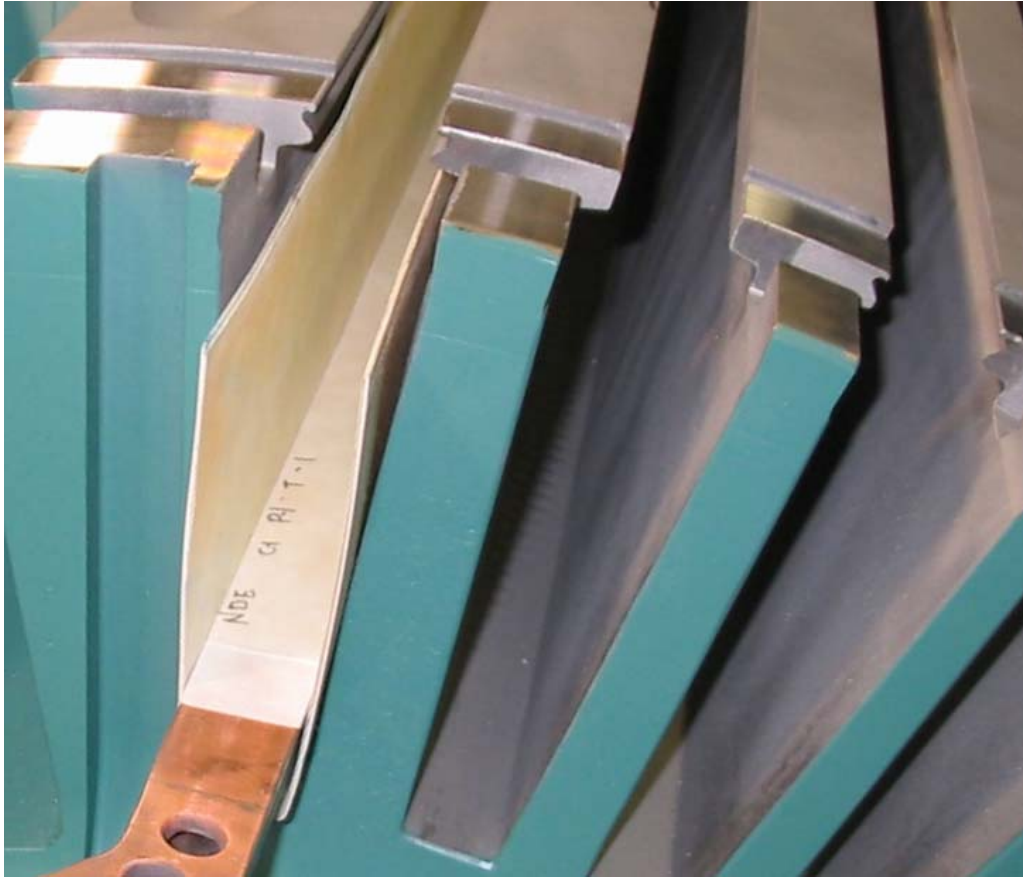
**Figure 2-11**  
**Turn Insulation and Ground Wall Insulation with One Turn Installed**

The generator field winding insulation is subject to a variety of stresses from mechanical, thermal and electrical actions. Fretting wear can occur from relative movement of the conductor against another object such as the slot wall or another conductor. High voltages and harmonic content can overstress the insulation and lead to its eventual failure. Over heating of the field, which may be due to high current, poor cooling or other factors cause accelerated aging of the insulation. Obviously, insulation failure causes field grounds and possibly shorts in the winding.

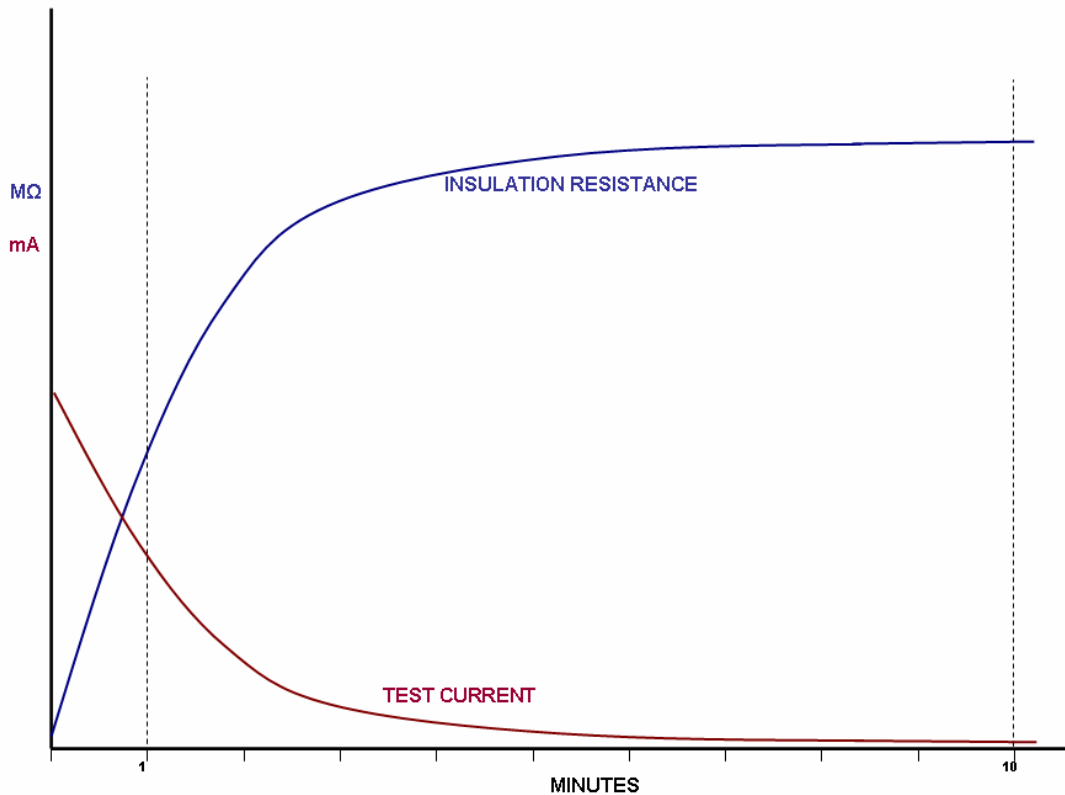
**Figure 4-1**  
**Insulation Resistance Over Time**

The polarization index or PI test is often performed in conjunction with the insulation resistance test. A PI test performed by applying the insulation resistance test voltage for 10 minutes and taking insulation resistance measurements at 1 minute and 10 minutes. The PI is equal to the ratio of the 10 minute reading over the 1 minute reading. Unless the leakage current is abnormally large, the PI should be greater than 1. For most windings the value should be greater than 2. However, in cases where the insulation resistance is very high, more than 5,000 megohms, the PI reading is considered unimportant and a low PI reading with high insulation resistance is acceptable. IEEE 43 also provides guidance on performing and analyzing PI test result.

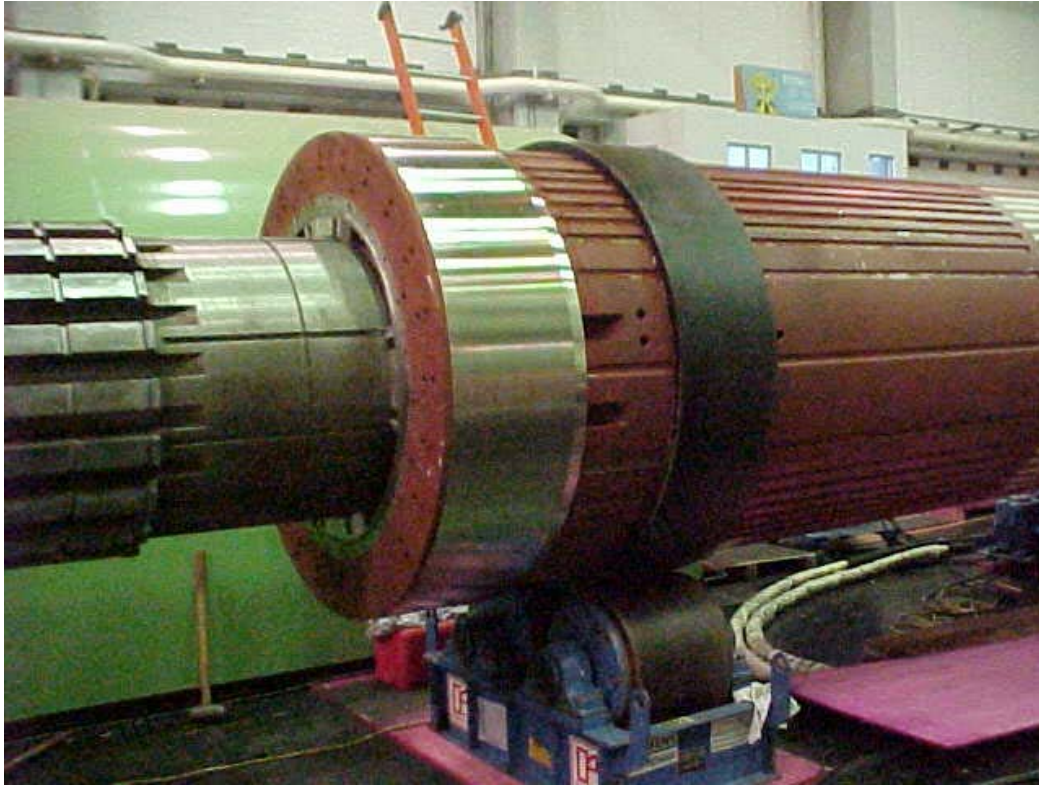
**Figure 4-4**  
**Rotor with Retaining Ring and Centering Ring**

The retaining ring is shrunk onto the centering ring, putting a large amount of stress on the centering ring. Centrifugal force during operation relieves some of this stress. Cyclic generator operation can produce varying stresses, leading to low cycle fatigue of the centering ring.

Whenever the retaining rings are removed, the centering rings should be thoroughly inspected, to include NDE inspections. As with other components, the lock key groove and other possible stress risers should receive added attention during inspections.

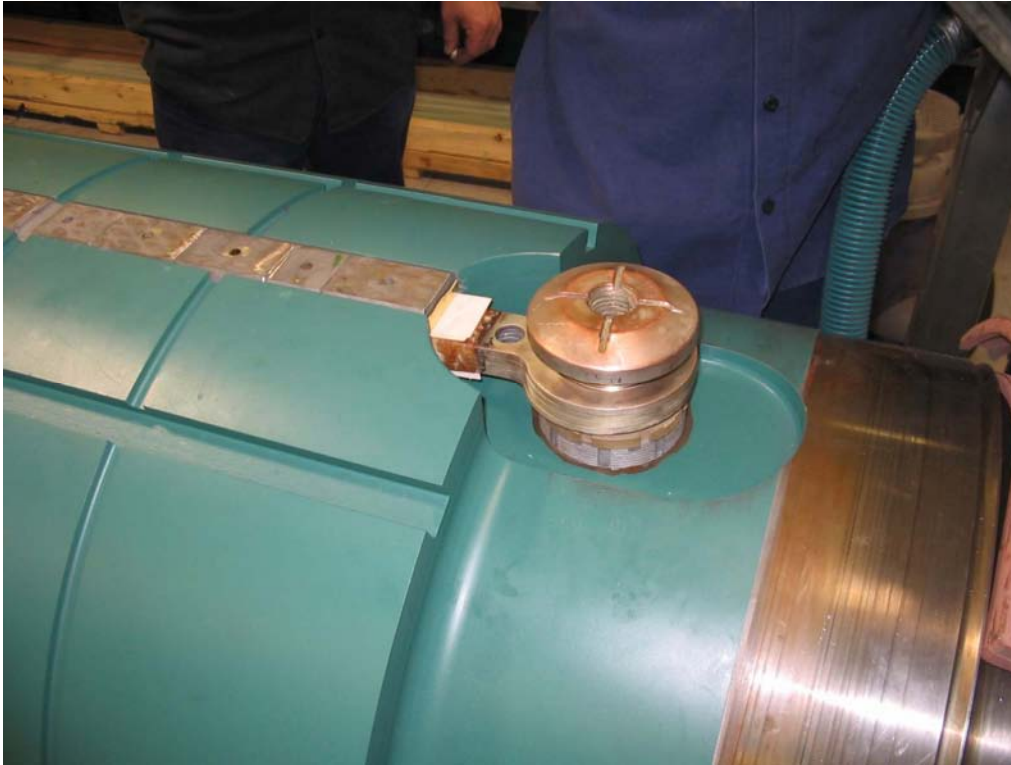
**Figure 4-6**  
**Radial Stud with Field Lead**

The field current is carried to the field winding through the turbine generator shaft by two copper conductors, or the bore copper. Radial studs conduct the current into the bore at the collector or diode end, and out of the bore to the field winding. Not all generators will have radial studs on the outboard end of the rotor shaft. Brushless exciter generators may employ a butterfly connection at the exciter end of the shaft.

The radial studs are often difficult to inspect without some rotor disassembly. Bore copper inspection is almost impossible without removal, even with rotor disassembly. The insulation resistance test is the best method to evaluate the condition of the bore copper insulation and radial stud insulation; these are tested simultaneously with the field winding when performing an insulation resistance test.

With some disassembly of the field circuit, the radial studs can usually be removed, typically to inspect the hydrogen seals. When removed, the condition of the studs can be inspected. Also, a borescope might be able to be used in the stud holes to partially inspect the bore copper ends on some generators.

The radial studs at one or both ends of the bore copper typically have a hydrogen seal to prevent leakage of hydrogen back through the shaft bore. Obviously on air cooled generators, there will not be hydrogen seals. On hydrogen cooled generators, the seals cannot usually be inspected without removal of the radial studs. Often when seal integrity needs to be verified, a pressure test is performed. A test device is fitted over the seal, and pressurized to a test value above operating pressure. If the seal holds the pressure it is deemed to be good, otherwise it will need to be replaced.
