Plant Support Engineering: Large Vertical Pump End-of-Expected-Life Report

1019154

Final Report, December 2009

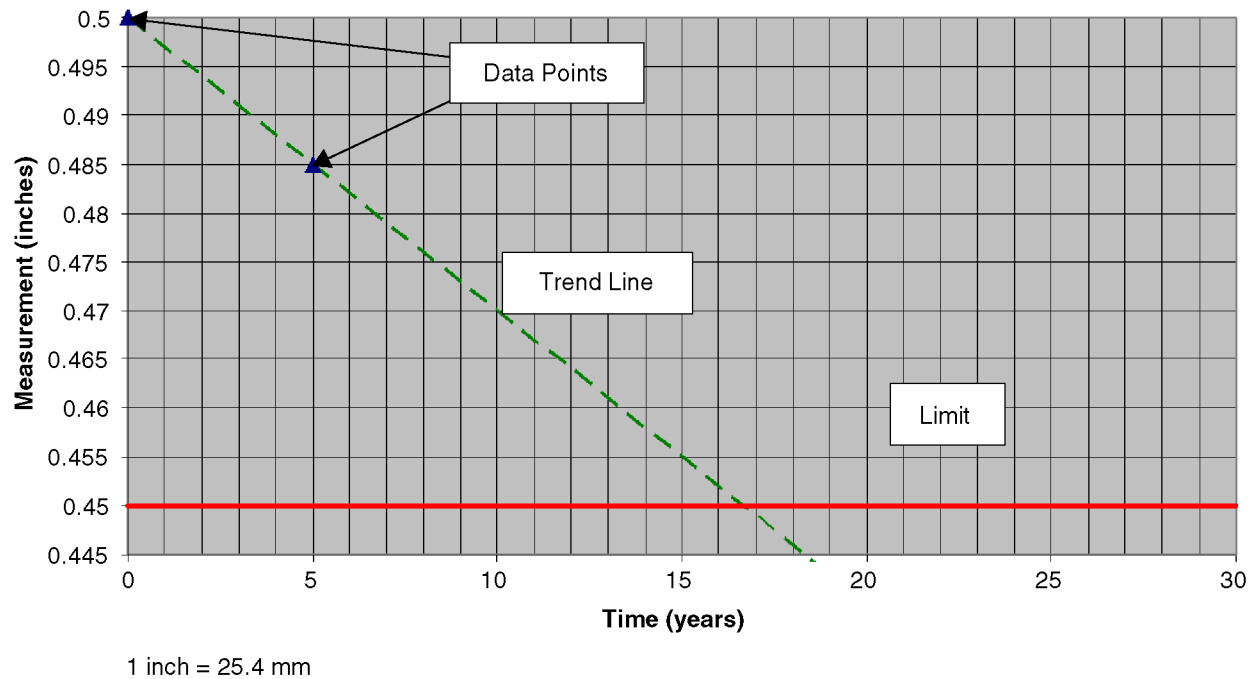
Figure 2-2
Casing Thickness

This data can be plotted and a trend developed to evaluate when the parameter would reach its limit for an estimation of the life of the pump. Figures 2-2 and 2-3 show the plots from the data in Table 2-4. The data points (shown as triangles and diamonds) represent the measurement, the dashed line represents the trend, and the thick solid line represents the limits. The figures show that the casing thickness reaches its limit at 16.5 years, whereas the flow limit is reached at 12.5 years. Based on these results, another detailed inspection should be done at between 10 and 12 years to evaluate the status of the trend and to provide a new estimate (from the latest trend) on the life expectancy of the pump.

In addition to the trends viewed in the data, additional relationships should also be reviewed. For instance, the casing thickness in this example reduced by 0.015 inch (0.381 mm) or 3%, while flow reduced by 60 gpm (227 l/min) or 1.2%. If the casing wear could be related directly to flow, then another method exists to determine when the casing reaches its limit of a 10% reduction (0.050 inch [1.27 mm] wear). This casing reduction would not be directly measured until the next scheduled inspection; however, a 4% flow reduction could indicate a 10% casing thickness reduction. Care must be taken when analyzing relationships to ensure that they are valid. It is recognized that as normal wear progresses, the rate of wear slows, so that the straight-line approach may be conservative.
