Assessment of Electromagnetic Interference Events in Nuclear Power Plants

Reported to INPO 1975 to 2011

2011 TECHNICAL REPORT

Final Report, December 2011

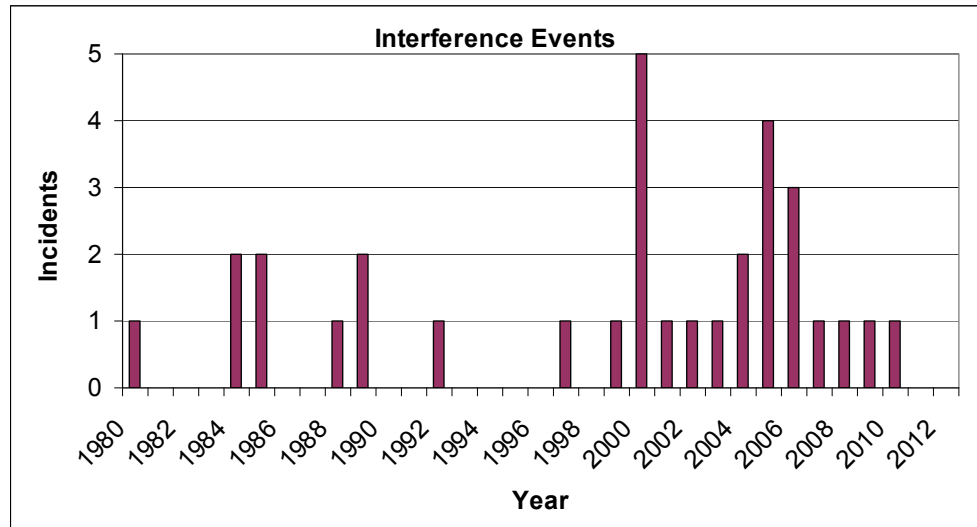
Figure 2-1

The number of EMI-related events shows an increase in frequency (i.e., how often they occur) over time as illustrated in Figure 2-1. Since 2000, there has been a steady rate of one to five events per year reported into the INPO system.

Base (Rev. 0) Analysis: Total EMI Related Events

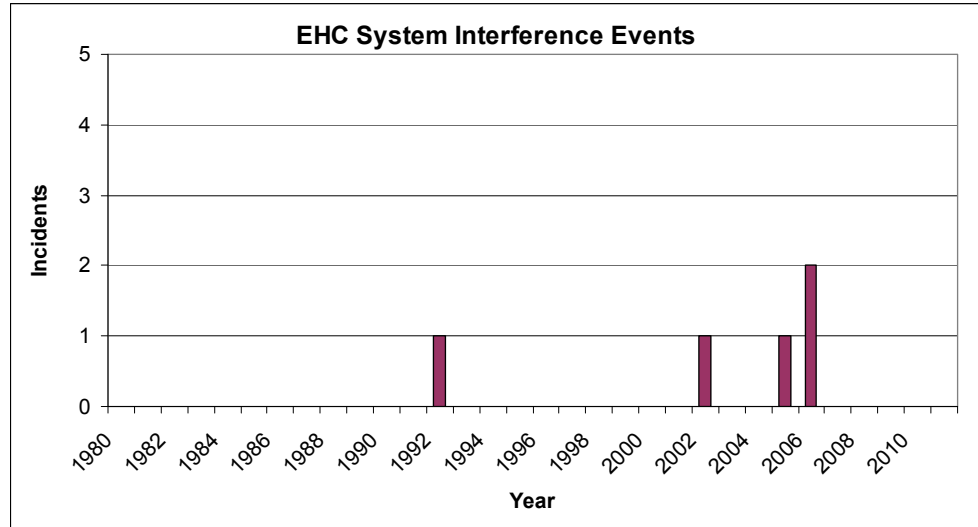
Because there have been multiple cases of interference to Electro Hydraulic Control (EHC) systems these were tracked separately, as shown in Figure 2-3, they are shown in addition to the I&C system interference events in Figure 2-2.

Figure 2-3
EHC System Interference Events

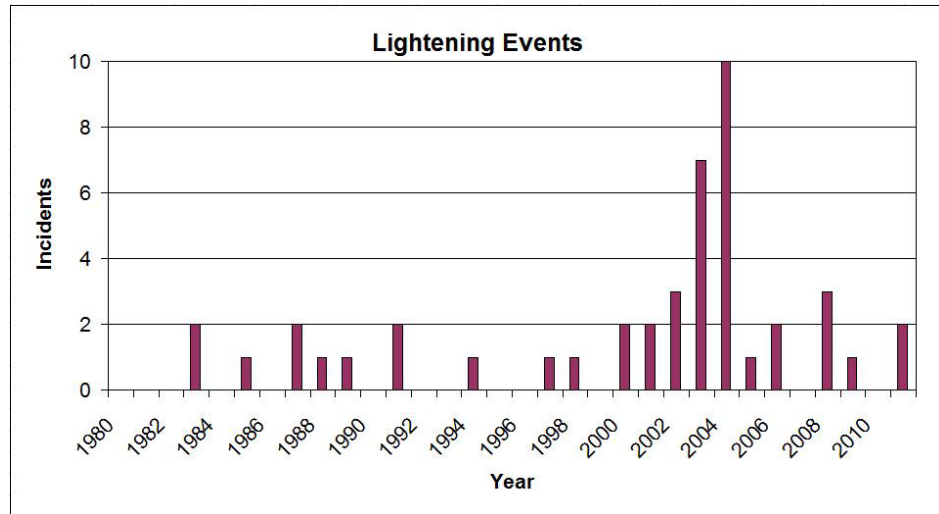
Because of these characteristics, when lightning strikes close to a plant it tends to stress all the equipment in the plant over a wide range of frequencies. In some ways, lightning may be considered to be a broad spectrum plant-wide test. The vulnerabilities exposed by lightning could equally be excited by lower power, but more localized and frequency-specific sources. Hence, the lightning incidents are of interest both in their own right but also because they give insight to vulnerabilities that may not have been exposed by other sources of electromagnetic energy. Figure 2-6 illustrates the distribution of these 45 events from 1980 to present.

Figure 2-6
Base (Rev. 0) Analysis: Lightning Events by Year

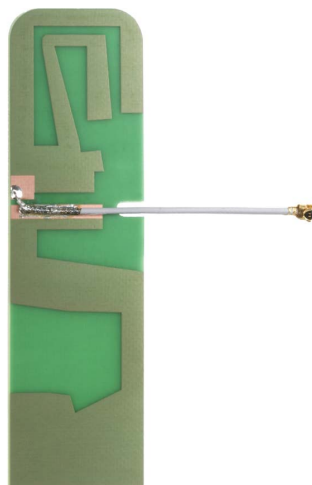
Band	Frequency Range (MHz)
GSM 850	824-894
GSM 900	880-960
DCS	1710-1880
PCS	1850-1990

*Figure 5-1
This quad-band antenna supports 4 different frequency bands listed in Table 5-1*

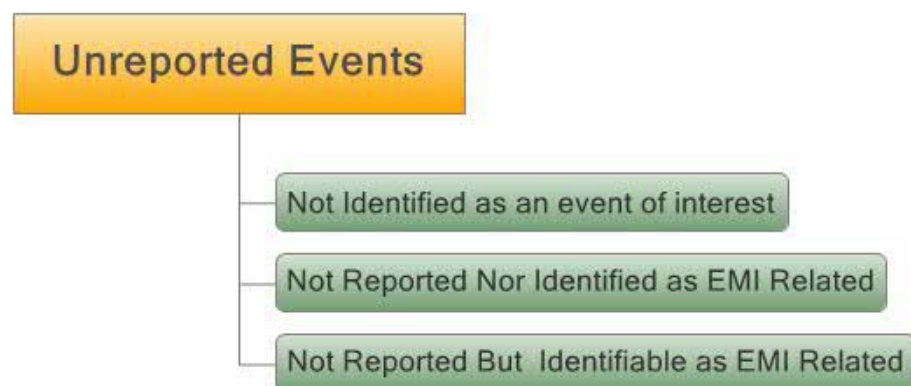
There are at least three reasons an event would not be reported at all. As these events are not reported, they are not available for analysis. The three categories of unreported events are:

- Incidents which are not identified as warranting a report.
- Incidents which are difficult to determine an EMI causal relationship.
- Incidents which while not reports could be identified as EMI related.

Figure 6-3
Categories of Unreported EMI-Related Events

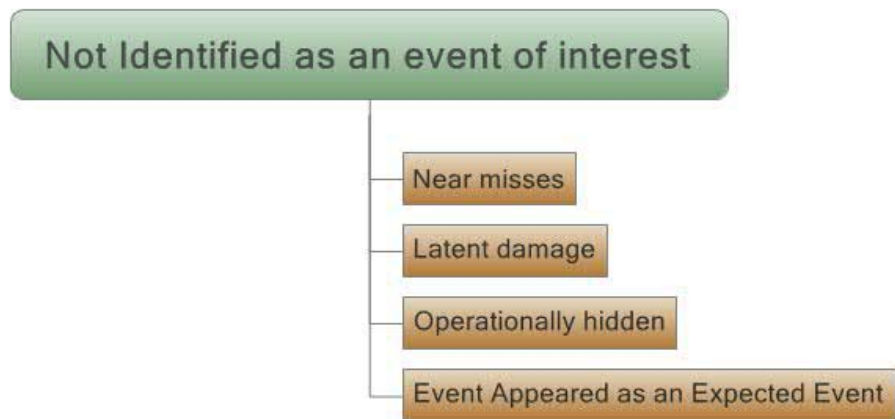
First, an incident may be incorrectly judged to be not of interest and so not reportable. This is particularly likely if the consequences of an incident were not significant and the personnel involved did not recognize it as a 'near-miss' of a more significant event. The personnel who observed the event simply didn't think it required reporting.

Figure 6-4
Reasons an EMI-Related Event May be Judged to Not be of Interest

Events which cause latent damage are a second group which will not be reported, illustrated in Figure 6-4. In such cases, a component may be damaged or degraded, but continue to operate normally. Only later will it completely fail. In some cases, the EMI damaged the component and a subsequent stress, EMI related or perhaps entirely different, causes the final and complete component failure. These kinds of events are difficult or even impossible to identify.
