Nondestructive Evaluation: Operating Experience with Heat Exchanger Tubing Damage

2014 TECHNICAL REPORT

3002003028

Final Report, December 2014

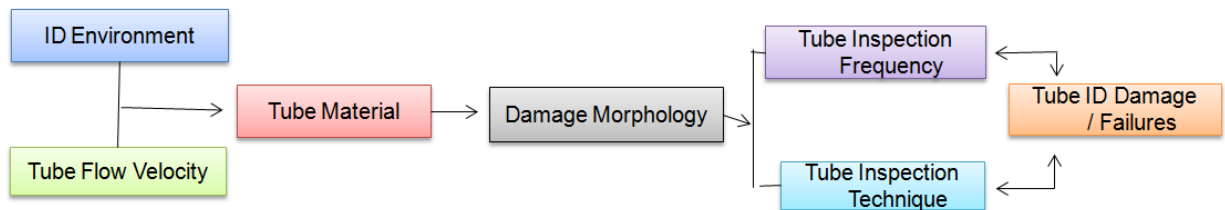
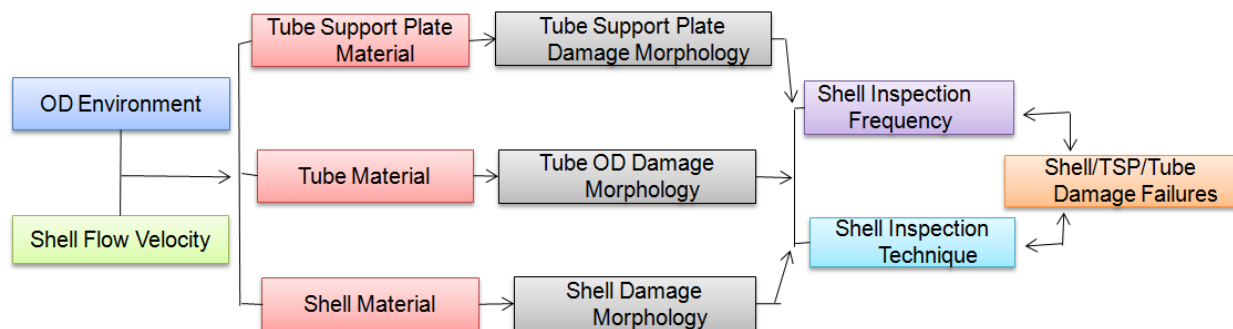
Figure 3-1
Database Flow Diagram

It is envisioned, then, that on one end information is provided on the HX service environment and flow velocity. This information determines the material selection and the corrosion damage morphology.

At the other end, information is provided on the tube failure history. The tube failure history and corrosion damage morphology then determine the inspection technique and implementation frequency.

This flow of information is shown graphically in Figure 3-1. As seen in the figure, distinction is made between damage that originates in the tube's internal diameter (ID), the tube's outside diameter (OD), and the shell side of the HX.

Tube ID

Shell Side / Tube OD

Using Figure 3-1 as a basis, the following database categories were identified:
