# Losses of Offsite Power at U.S. Nuclear Power Plants

## Summary of Experience Through 2013

2014 TECHNICAL REPORT

**3002003115**

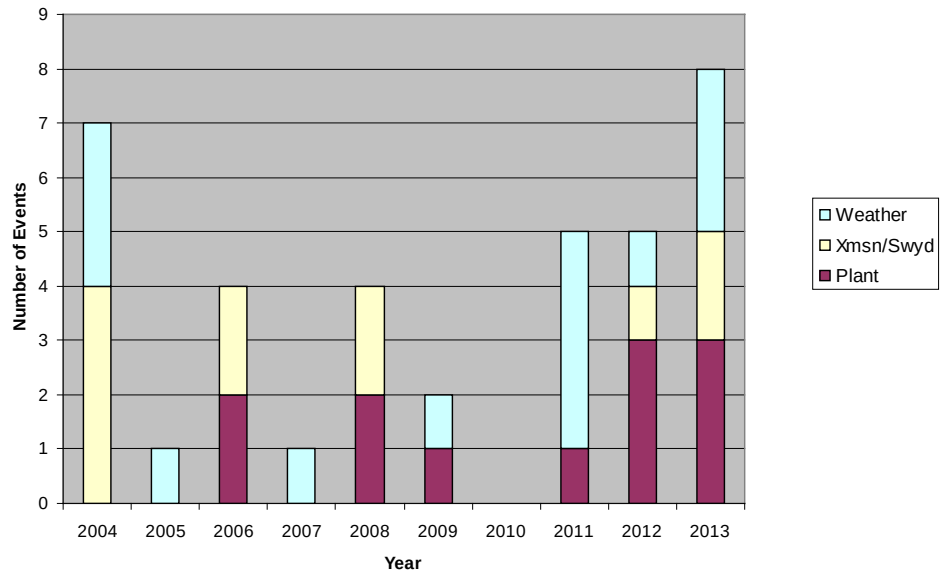
*Figure 3-1*  
*Category I Events by Initiating Situation*

It is instructive to examine the distribution of events involving the total loss of offsite power and their duration (Category Ia and Ib) during the 10-year period 2004 through 2013. This is shown below in Table 3-4 and Figure 3-1, “Category I Events by Initiating Situation”. In Table 3-4, the letters following the durations (W= weather related; S=seismic related) indicate the types of events. The chart presents this type of information graphically, by initiating situation, e.g., weather, plant problems, or switchyard/transmission system problems.

The median duration of all 39 events involving a total loss of offsite power during the past 10 years was 7.32 hr. This is somewhat larger than the median duration of approximately 4 hr for the ten-year period from 1996 through 2005. The median duration of the 16 weather-related events during the most recent ten-year period was about 12.7 hours, while the median duration of the 23 non-weather-related losses of all offsite power was 5.4 hours. Equipment failure events in either the plant, the switchyard, or the transmission system caused losses with median durations of 6.4 hours.

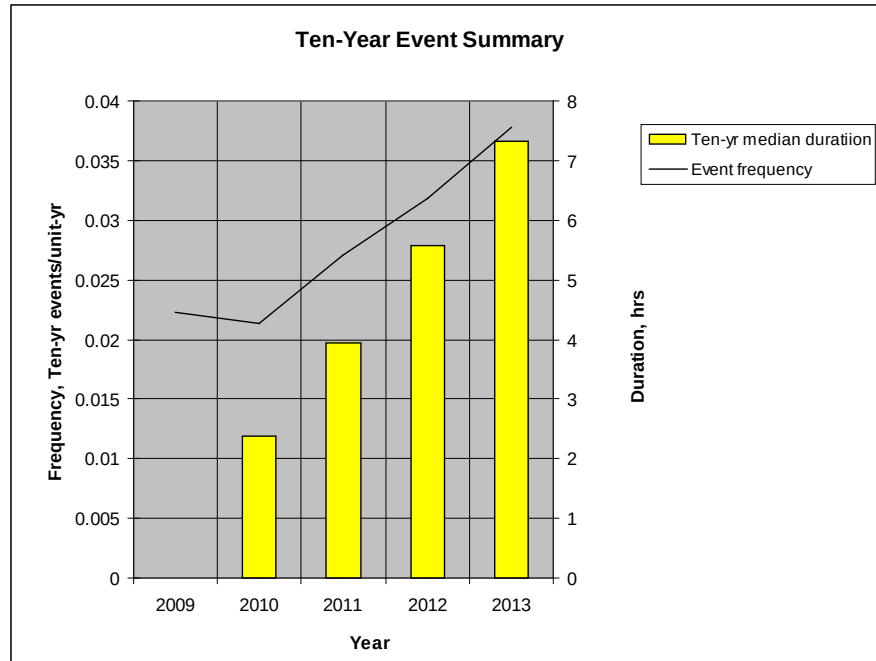
Figure 3-2  
Ten-Year Category I Frequency and Duration Summary

Figure 3-2 presents the median LOOP duration (in hours) and the event category I median LOOP duration (hours) and the event frequency for the ten-year periods ending in 2009 through 2013 for category I events. Note that since 2010, there has been an increasing trend both in the duration of category I LOOP events and in their frequency. While weather was a predominant cause of these events in several of the years, it is not the only significant factor. In the EPRI summary of LOOP experience through 2012<sup>1</sup>, the statement was made that “many of the events might have been terminated without progressing to a total LOOP had it not been for complications occurring after the initiating event.” In 2013, for all categories, seven instances (design, workmanship, installation, unrecognized degradation, etc.) were significant in the initiation of events resulting in a LOOP or a partial LOOP. Following the triggering event, there were at least three events that could have been avoided or for which severity could have been limited were it not for secondary complications.
