## Endesa Develops Technical Basis for Extending Rotor Life of High-Cycle Gas Turbines

Endesa, the largest electric utility in Spain, organized and led a team, including EPRI and Spanish companies, to develop an independent, condition-based life management approach for the continued safe operation of Endesa's fleet of gas turbines beyond the original equipment manufacturer (OEM) nominal limit for turbine rotors of 5,000 starts.

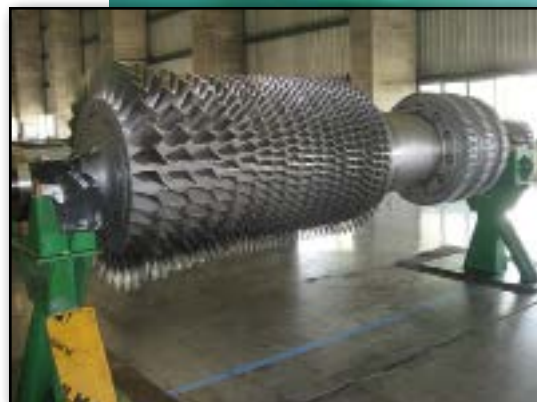
*Endesa and EPRI jointly developed a condition-based rotor life management approach.*
