# Field Guide: Flow-Accelerated Corrosion and Erosion

3002008124

Final Report, December 2016

EPRI Project Manager  
R. Wolfe

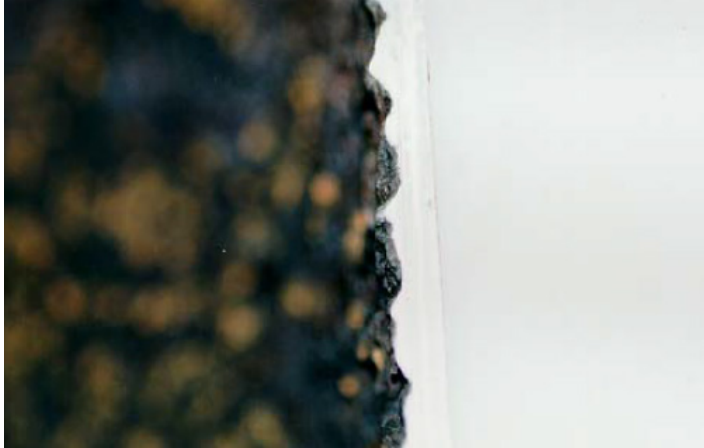
**Figure 2-3 Profile of Pipe Surface Damage from Cavitation Erosion [11]**

- The center of the image shows the pock-marked appearance with jagged edges, while the left half of the image is out of focus due to pipe curvature.
- Surface is very rough
- Can appear porous

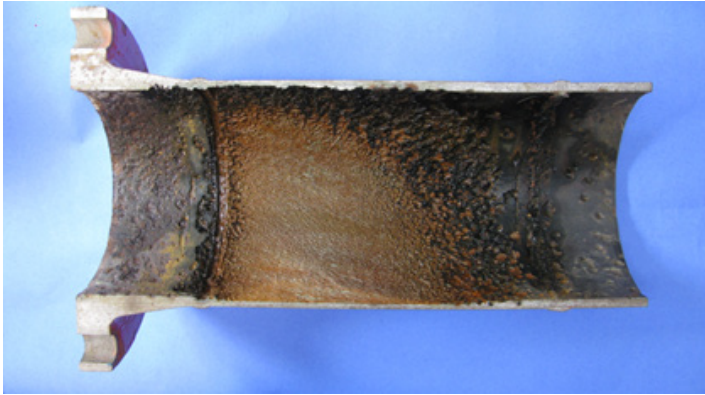
**Figure 2-4 Fire Protection Downstream of Orifice - Cavitation Erosion [14]**

- Piping downstream of orifice
- Surface is rough and cratered
- Installed in a line used for periodic testing
- Low temperature line
- Oxygen concentration is high
- Erosion locations in FAC systems: locations of extreme flashing flow, downstream of orifices, location of pressure drop
- Erosion locations in non-FAC systems: fire protection test lines, safety relief valve (SRV) tail pipes, throttling gate valves, stainless steel tank liners, chrome-moly components

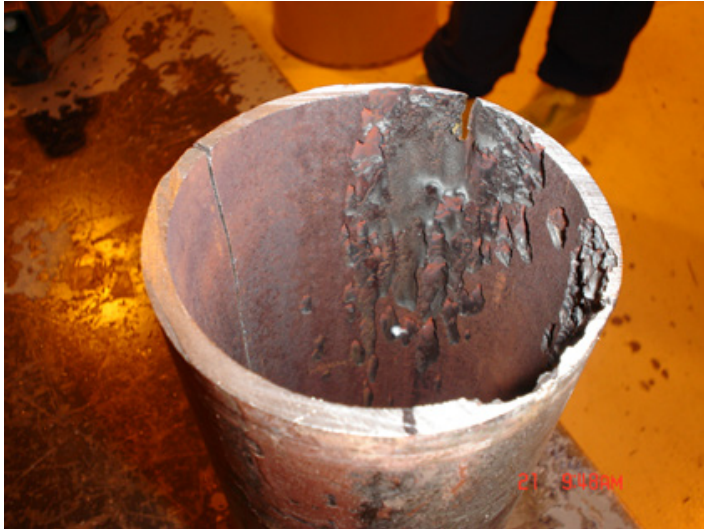
**Figure 2-5 Pipe Downstream of Control Valve - Cavitation Erosion [14]**

- Pipe downstream of control valve
- Surface is rough, cratered, and irregular
- Significant pipe wall loss

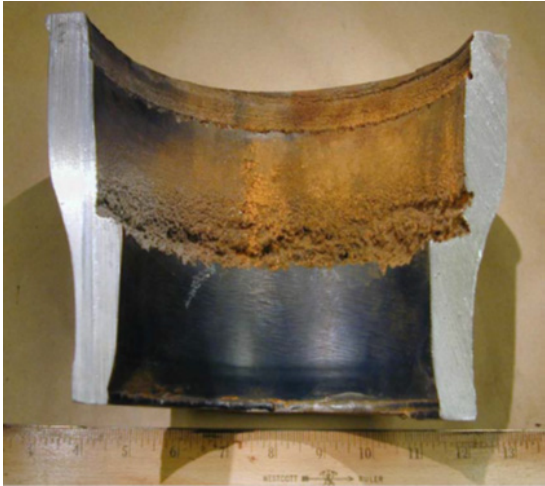
**Figure 2-6 Reducer Constructed of P22 Material on 8" (20.3 cm) Feedwater Recirculation Line - Cavitation Erosion [3, 18]**

- Reducer downstream of an orifice
- Surface is rough and cratered
- Constructed of FAC-resistant ASTM A234 WP22 material
- Large pressure drop across orifice
- Future modification eliminated the reducer
- See next photograph for close-up of surface damage

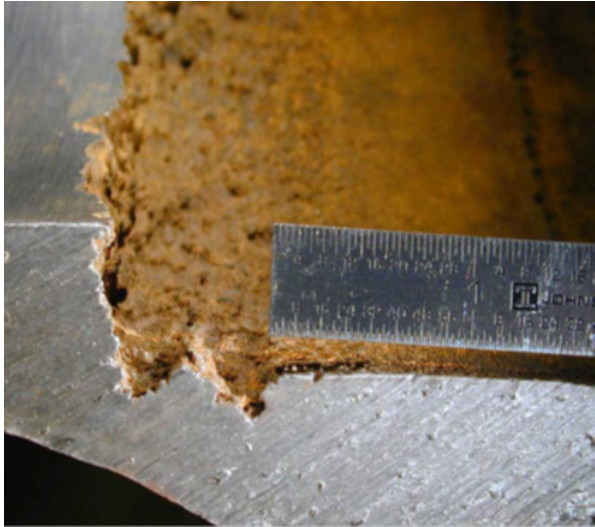
**Figure 2-7 Close-Up View of Degraded Surface of P22 Fitting  
- Cavitation Erosion [3, 18]**

- Surface is degraded with craters into the fitting wall
- Very rough and irregular surface

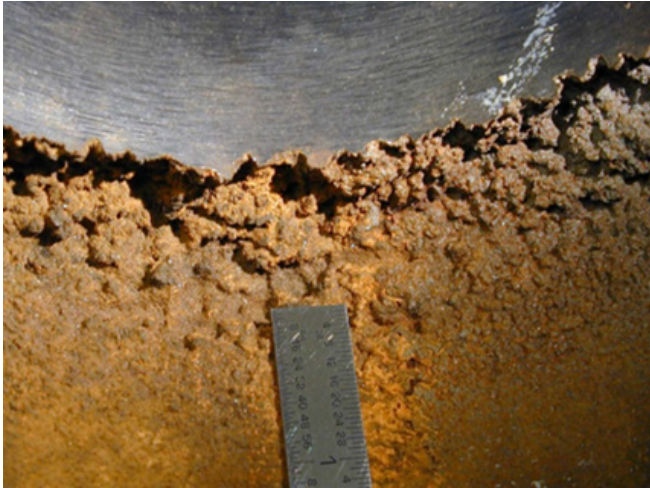
**Figure 2-8 Close-Up View of Degraded Surface of WP22 Fitting - Cavitation Erosion [3, 18]**

- Closer view of degraded surface
- Surface has craters, extremely rough and porous looking

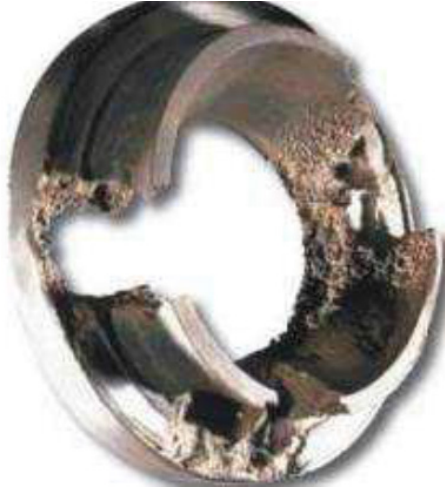
- Valves are susceptible to erosion mechanisms
- Surface appears rough and pock-marked
- Significant loss of control valve trim metal
- Non-linear damage rate

**Figure 2-9 Control Valve Trim - Cavitation Erosion [8, 19]**

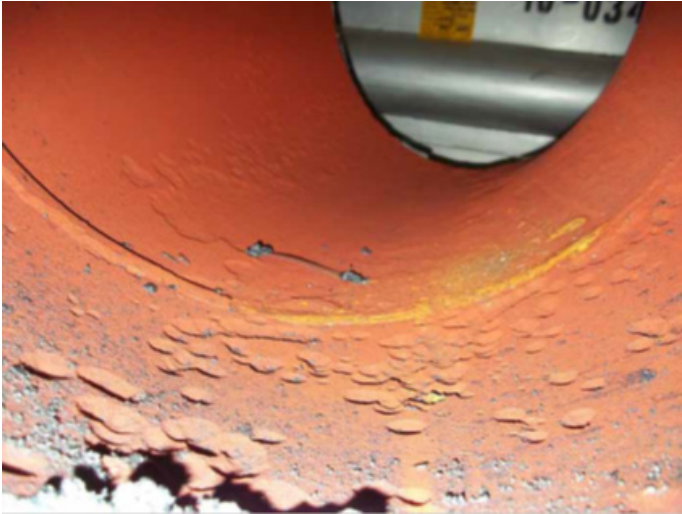
Figure 2-10 Heater Drains - Cavitation Erosion [20]

- Wear mechanism in feedwater heater cascading drain
- Operating temperature  $\sim 174^{\circ}\text{F}$  ( $\sim 79^{\circ}\text{C}$ )
- 18" (45.7 cm) nominal pipe size (NPS) carbon steel elbow
- 0.375" (9.53 mm) nominal thickness
- Surface degradation has craters and pits

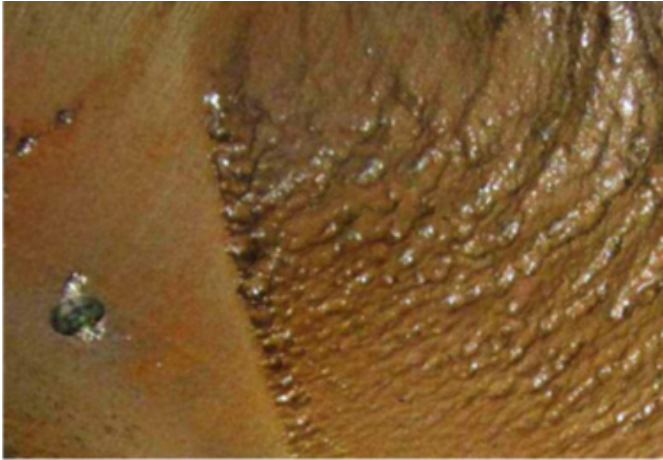
**Figure 2-12 High Pressure Core Spray – Close-Up of Degraded Surface - Cavitation and Flow Curvature Erosion [3, 20]**

- Rough, pitted surface degradation
- Findings indicated cavitation and flow curvature erosion

<b>Plant System</b>	<b>Wear Mechanism Identified</b>	<b>Figure No.</b>
High Pressure Coolant Injection Drain System	Liquid Droplet Impingement	Figure 4-7
High Pressure Core Spray System	Cavitation/Flow Curvature	Figure 2-11
High Pressure Core Spray System	Cavitation/Flow Curvature	Figure 2-12
High Pressure Extraction Steam System	Two Phase FAC	Figure 8-11
High Pressure Extraction Steam System	Two Phase FAC	Figure 8-18
High Pressure Extraction Steam System	Two Phase FAC	Figure 8-20
High Pressure Core Injection Flush Line to Torus	Cavitation	Figure 2-1
High Pressure Core Injection Flush Line to Torus	Cavitation	Figure 2-2
Low Pressure Extraction Steam Line to Condenser	Liquid Droplet Impingement	Figure 4-21
Low Pressure Extraction Steam System	Liquid Droplet Impingement	Figure 4-19
Low Pressure Extraction Steam System	Two Phase FAC	Figure 8-10
Low Pressure Feedwater Heater	Two Phase FAC	Figure 8-8

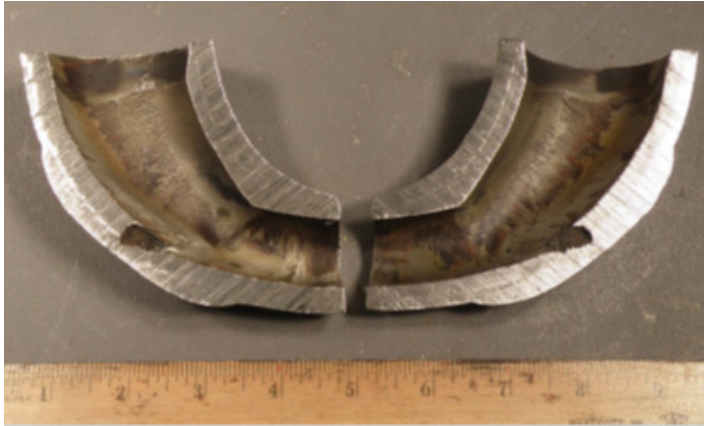
**Figure 2-13 Steam Generator Blowdown - Cavitation/Liquid Droplet Impingement Erosion [21]**

- Low Capacity Steam Generator Blowdown System used for Start-Up
- FAC-resistant stainless steel SA403 WP304 1" x 2" (2.54 cm x 5.08 cm) expanding elbow downstream of manual angle valve
- Photograph shows previous weld overlay on the extrados of the expanding elbow
- Elbow replaced every five years
- Cavitation/Liquid Droplet Impingement surface degradation very rough and porous in the previously repaired area
- See Figure 2-14 for close-up view of surface damage

<b>Plant System</b>	<b>Wear Mechanism Identified</b>	<b>Figure No.</b>
Steam Generator Blowdown System - P11 Clad Lined	Solid Particle	Figure 5-7
Steam Generator Blowdown System - Stainless Steel Elbow	Cavitation and LDI	Figure 2-13
Steam Generator Blowdown System - Stainless Steel Elbow	Cavitation and LDI	Figure 2-14
Steam Line	Two Phase FAC	Figure 8-21
Steam Line	Two Phase FAC	Figure 8-22
Steam Seal System	Two Phase FAC	Figure 8-16
Steam Supply System to Gland Steam	Combination FAC and LDI	Figure 8-7
System Unknown	Cavitation	Figure 2-3
System Unknown	Cavitation	Figure 2-5
System Unknown	Entrance Effect/Leading Edge Effect	Figure 9-8

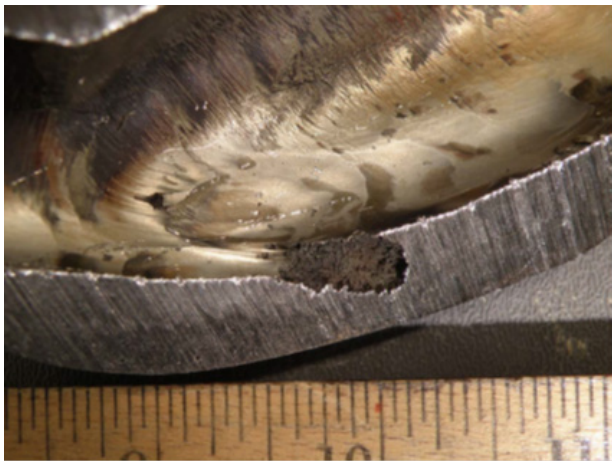
**Figure 2-14 Steam Generator Blowdown – Close-Up of Degraded Surface - Cavitation/Liquid Droplet Impingement Erosion [21]**

- Cavitation/Liquid Droplet Impingement surface degradation very rough and porous in the previously repaired area
- The smooth grooves surrounding the area of significant attack are indicative of solid particle erosion
- Large amounts of copper were detected in the area of heavy wall loss, which also suggests some contribution from solid particle erosion by particles in the blowdown stream

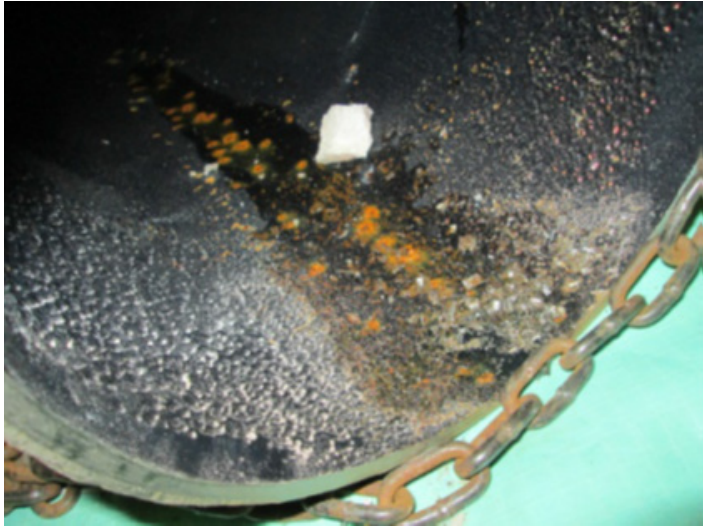
**Figure 2-15 Heater Drains Downstream of Check Valve – Cavitation Erosion and Flow Accelerated Corrosion [22]**

- 8" (20.3 cm) NPS pipe section
- Upstream check valve disc nut was very loose/worn, allowing it to float in the flow stream
- Significant wall loss from Flow Accelerated Corrosion and Cavitation between the 4 o'clock and 6 o'clock positions
- Surface degradation shows single-phase scallop wear pattern (left side of pipe) and rough surfaces pits (right side)
- Internal surface of the check valve also indicated wear.

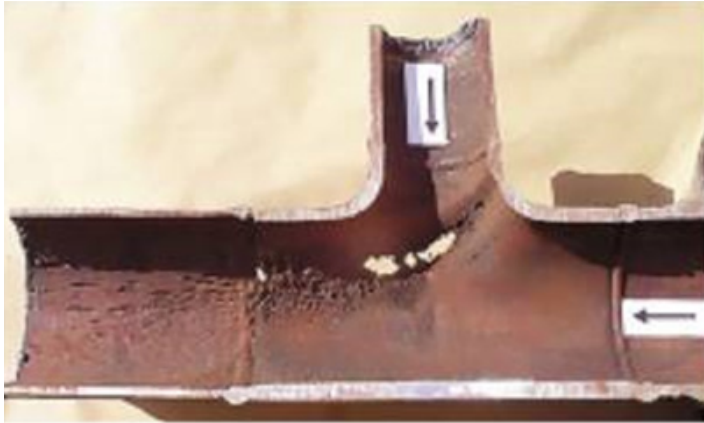
**Figure 2-18 Tee and Downstream Pipe – Cavitation Erosion [3, 8]**

- Flow directions shown by arrows on photograph
- Tee exhibiting “Flow Curvature” or Re-circulation Cavitation with elongated sweeping hole in sidewall of tee

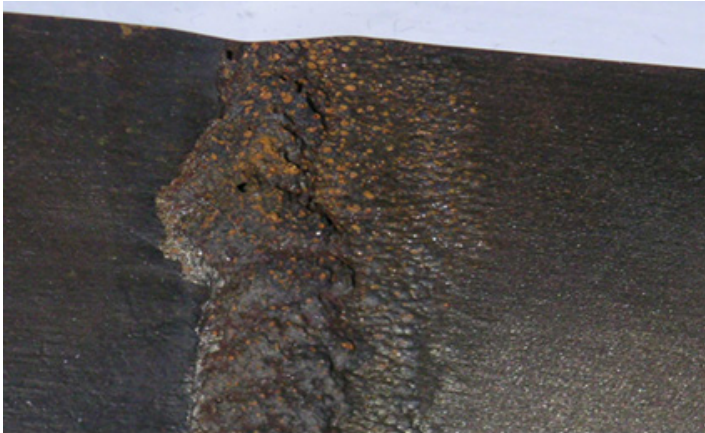
**Figure 2-19 Feedwater Recirculation Line to Condenser – Cavitation Erosion [3, 8]**

- Damage ~1 foot (30.48 cm) downstream from vendor supplied, stainless steel orifice
- Surface degradation is rough and irregular with pits
- Line operated only when the feedwater pump was in recirculation mode (less than 1% of plant operating time)

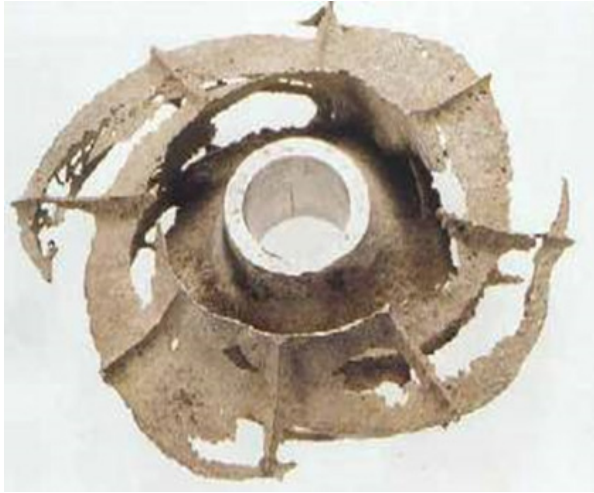
**Figure 2-21 Pump Impellor – Cavitation Erosion [2, 8]**

- Localized damage on pump impellers
- Low pressure side of impeller vane tops and close tip clearance regions more likely to be damaged by cavitation.
- Items that can increase pump cavitation: piping modifications, increase operating temperature, fouled inlet strainers, increasing pump speed

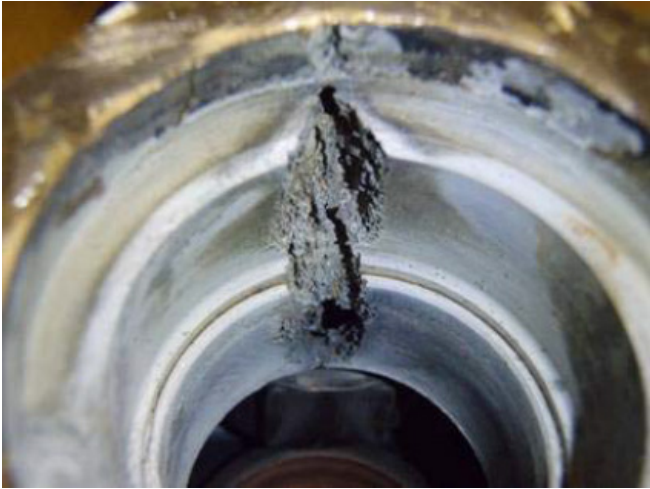
**Figure 2-22 Steam Generator Blowdown – Downstream of Throttled Gate Valve – Cavitation Erosion [5]**

- Throttling of gate valve
- Cavitation erosion to valve body
- Rough, pitted, and irregular surface degradation
- Downstream pipe damage is shown in the next photograph

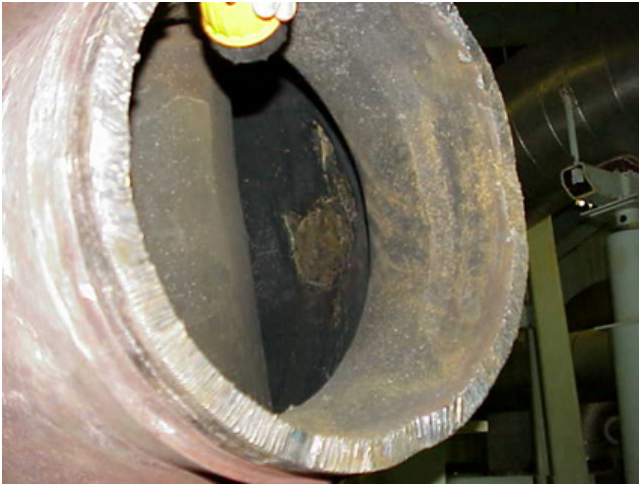
**Figure 2-24 Feedwater Regulating Valve Body – Cavitation Erosion [3]**

- Cavitation erosion to valve body
- Surface degradation is rough and pitted
- Wall loss of 0.500 inches (12.7 mm)

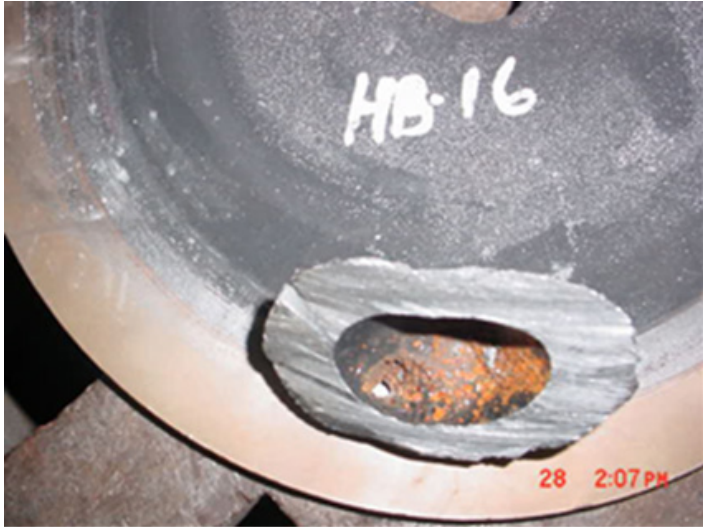
**Figure 2-25 Condensate Pump Equalizer Line Downstream of Orifice – Cavitation Erosion [3]**

- Cavitation damage
- Surface degradation is rough and pitted
- Damage downstream of flow orifice
- Operating temperature is 100°F (38°C)
- Damage after four years of service

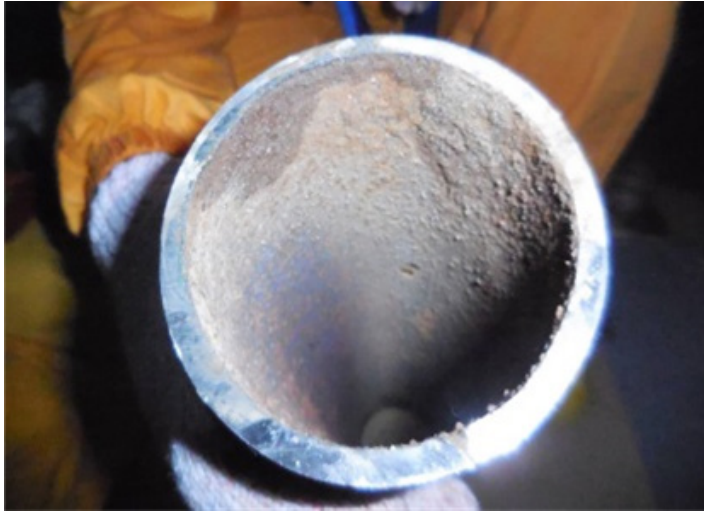
**Figure 2-27 Core Spray System Component – Cavitation Erosion (Photo Courtesy of Taiwan Power)**

- Orifice is located upstream of the component
- Component shows wall loss between the 10 o'clock to 12 o'clock position
- Surface is very rough and irregular with several craters
- System tested every 92 days for pump reliability and flow test for a duration lasting < 2 hours
- System test temperature is between 90°F (32°C) to 110°F (43°C)
- Component was replaced with stainless steel material
- Sister unit had similar issues

<b>Plant System</b>	<b>Wear Mechanism Identified</b>	<b>Figure No.</b>
Condensate Polisher and Demineralizer System	Low Temperature FAC	Figure 10-6
Condensate Polisher and Demineralizer System	Low Temperature FAC	Figure 10-7
Condensate Polishing System	Low Temperature FAC	Figure 10-1
Condensate Polishing System	Low Temperature FAC	Figure 10-8
Condensate Polishing System	Low Temperature FAC	Figure 10-9
Condensate Polishing System	Low Temperature FAC	Figure 10-10
Condensate System	Cavitation	Figure 2-25
Condensate System	Single Phase FAC	Figure 7-6
Control Rod Drive System	Low Temperature FAC	Figure 10-11
Condenser Tubing, Copper Alloy	Liquid Droplet Impingement	Figure 4-9
Condenser Tubing, Copper Alloy	Liquid Droplet Impingement	Figure 4-10
Core Spray System	Cavitation	Figure 2-27

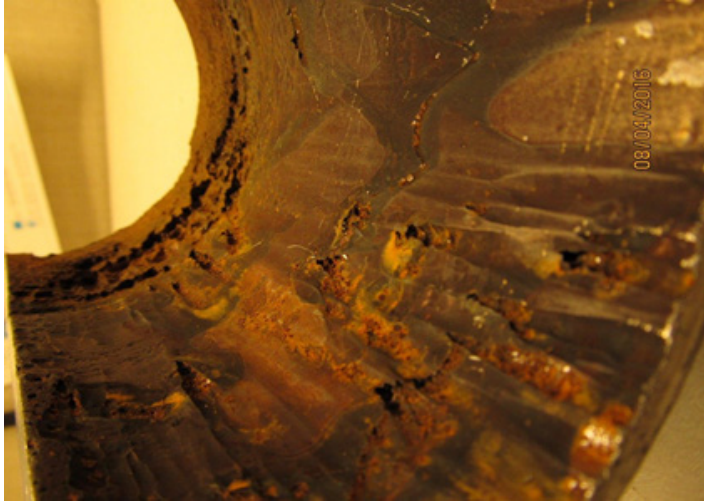
**Figure 2-29 Condensate Cooling Water – Cavitation Erosion  
(Photo Courtesy of PG&E)**

- Lower section of pipe
- Flow into picture
- Condensate cooling water from SGBD Coolers
- Orifice is located upstream of the component
- Operating pressure is 150 psig (10.3 bar)
- Operating temperature is 135°F (57°C)
- Flow rate ~450 gpm (1,703 l/m)
- Surface is very rough and irregular with craters
- Carbon steel component was replaced with carbon steel material
- See related Figures 2-28, 2-30, and 2-31

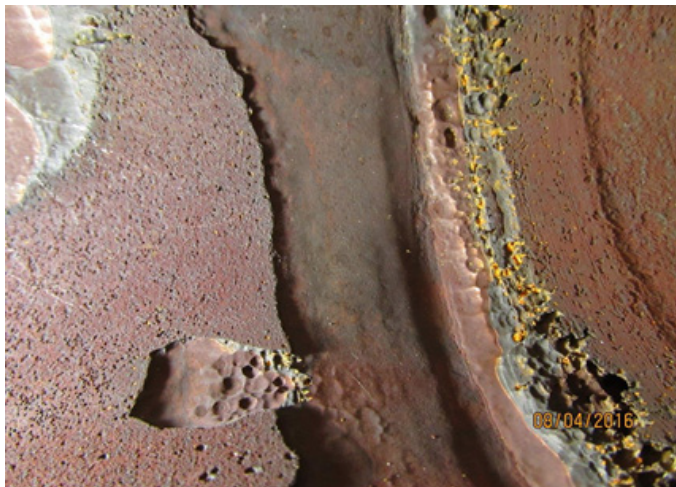
**Figure 2-30 Condensate Cooling Water – Cavitation Erosion**  
(Photo Courtesy of PG&E)

- Top section of pipe
- Flow is from the left
- Condensate cooling water from SGBD Coolers
- Orifice is located upstream of the component
- Operating pressure is 150 psig (10.3 bar)
- Operating temperature is 135°F (57°C)
- Flow rate ~450 gpm (1,703 l/m)
- Surface is very rough and irregular with craters
- Carbon steel component was replaced with carbon steel material
- See related Figures 2-28, 2-29, and 2-31

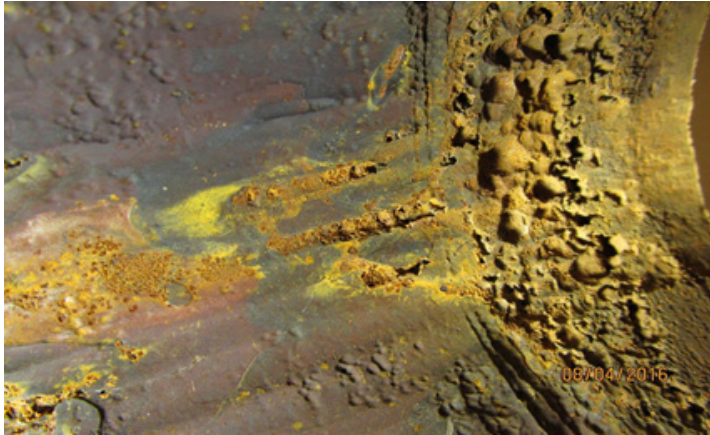
**Figure 2-31 Condensate Cooling Water – Cavitation Erosion**  
(Photo Courtesy of PG&E)

- Condensate cooling water from SGBD Coolers
- Orifice is located upstream of the component
- Operating pressure is 150 psig (10.3 bar)
- Operating temperature is 135°F (57°C)
- Flow rate ~450 gpm (1,703 l/m)
- Surface is very rough and irregular with craters
- Carbon steel component was replaced with carbon steel material
- See related Figures 2-28 through 2-30

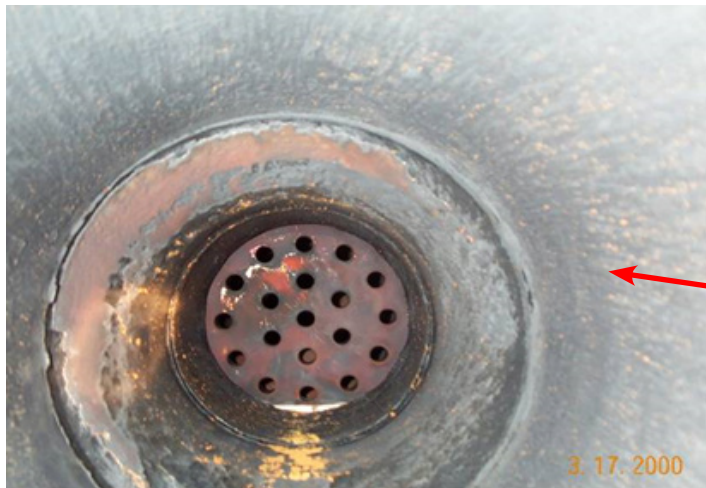
### Items of Note

- Liquid filled line upstream of orifice
- Large pressure drop across orifice with ~1,100 psi (75.84 bar) differential
- Surface appears smooth or polished
- Issues are still possible with multi-hole orifice plates

Smooth or Polished  
Surface Downstream  
of Orifice

Figure 3-1 Reactor Feedwater Pump Minimum Flow Line to Condenser – Flashing Flow Erosion [2, 3, 11]

<b>Plant System</b>	<b>Wear Mechanism Identified</b>	<b>Figure No.</b>
Reactor Feedwater Pump Minimum Flow System	Flashing Flow	Figure 3-1
Reactor Water Cleanup System	Single Phase FAC	Figure 7-4
Reactor Water Cleanup System	Single Phase FAC	Figure 7-5
Reactor Water Cleanup System	Single Phase FAC	Figure 7-10
Reactor Water Clean-Up System	Liquid Droplet Impingement	Figure 4-8
Reheat Steam and Moisture Separator System	Two Phase FAC	Figure 8-12
Reheat Steam and Moisture Separator System	Two Phase FAC	Figure 8-13
Reheat Steam and Moisture Separator System	Two Phase FAC	Figure 8-14
Reheat Steam and Moisture Separator System	Two Phase FAC	Figure 8-15

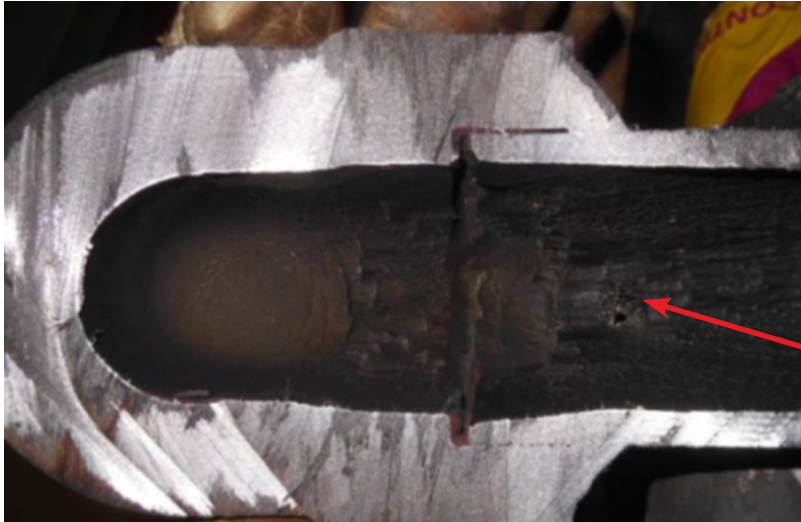
**Figure 3-2 Feedwater Minimum Flow Recirculation Line –  
Flashing Flow Erosion [2, 9, 11]**

#### Items of Note

- During an earlier outage, line replaced with FAC-resistant chrome-moly material
- Socket welded pipe now has hole
- Socket welded elbow has erosion wear and was replaced
- Lower section of socket welded joint shows wall loss

<b>Plant System</b>	<b>Wear Mechanism Identified</b>	<b>Figure No.</b>
Feedwater Heater Vent System - P22 elbow	Liquid Droplet Impingement	Figure 4-18
Feedwater Minimum Flow Recirculation System	Flashing Flow	Figure 3-2
Feedwater Recirculation System	Liquid Droplet Impingement	Figure 4-1
Feedwater Recirculation System	Liquid Droplet Impingement	Figure 4-2
Feedwater Recirculation System - P22 Fitting	Cavitation	Figure 2-6
Feedwater Recirculation System - P22 Fitting	Cavitation	Figure 2-7
Feedwater Recirculation System - P22 Fitting	Cavitation	Figure 2-8
Feedwater Recirculation System to Condenser	Cavitation	Figure 2-19
Feedwater System	Cavitation	Figure 2-24
Feedwater System	Single Phase FAC	Figure 7-7
Feedwater System	Single Phase FAC	Figure 7-8
Feedwater System	Single Phase FAC	Figure 7-11

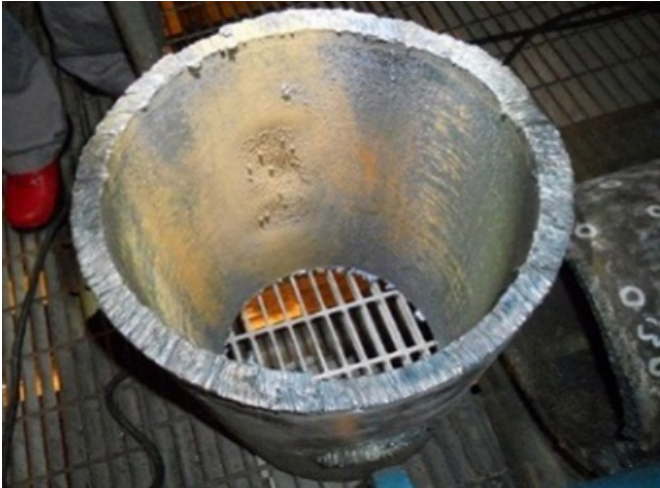
**Figure 3-3 Reactor Feed Pump Turbine (RFPT) Main Steam Supply Drain Line – Flashing Flow Erosion [18]**

Plant System	Wear Mechanism Identified	Figure No.
Reheater Drain System	Cavitation	Figure 2-26
Reactor Feed Pump Turbine Main Steam Supply Drain System	Flashing Flow	Figure 3-3
Solid Particle Erosion Carbon Steel Pipe and Stainless Steel Pipe	Solid Particle	Figure 5-1
Solid Particle Erosion in Heater Shell	Solid Particle	Figure 5-2
SPE Damage to Turbine Blades	Solid Particle	Figure 5-6
Steam Erosion on Feedwater Heater Shell	Steam Cutting	Figure 6-1
Steam Erosion on Feedwater Heater Shell	Steam Cutting	Figure 6-2
Steam Generator Blowdown System	Cavitation	Figure 2-22
Steam Generator Blowdown System	Cavitation	Figure 2-23
Steam Generator Blowdown System	Solid Particle	Figure 5-5

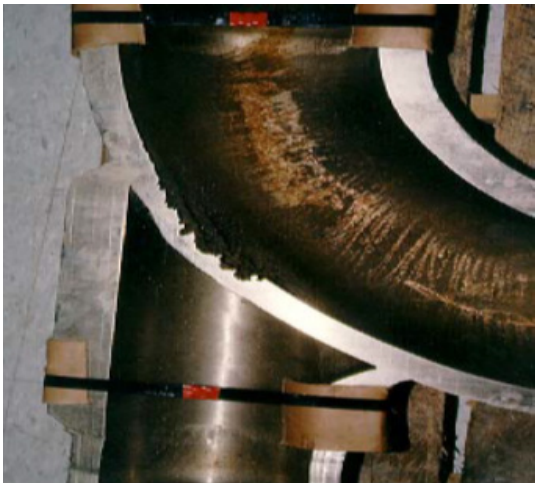
Figure 4-1 Feedwater Recirculation Line to Condenser Downstream of Control Valve [11]

- Liquid Droplet impingement (LDI) on extrados of elbow
- Surface degradation typical of LDI wear mechanism
- Large pressure drop across the control valve
- Previously installed temporary enclosure to allow re-start operation until permanent modification is implemented

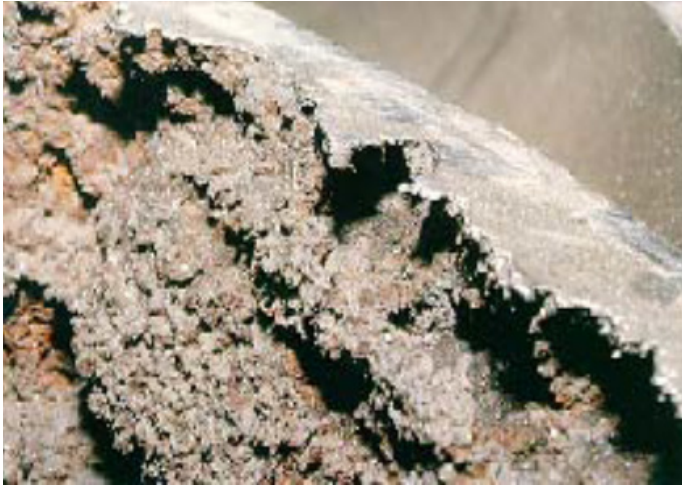
**Figure 4-2 Magnified View of Surface Degradation from Liquid Droplet Impingement [11]**

- Liquid Droplet Impingement wear mechanism surface degradation
- Surface very rough, irregular, and crater-like features

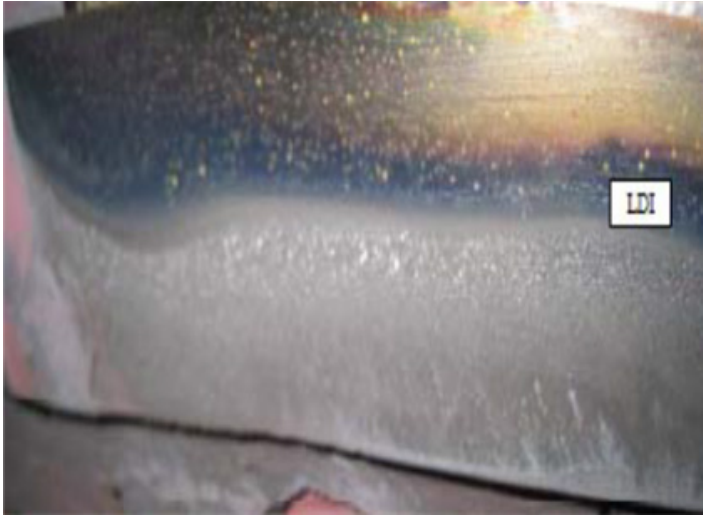
**Figure 4-3 Heater Shell Surface Damage from Liquid Droplet Impingement [15]**

- Plant equipment is susceptible to Liquid Droplet Impingement
- Surface degradation on Feedwater Heater Shell
- Rough surface
- Dominant mechanism for heater shells is flow-accelerated corrosion

Plant System	Wear Mechanism Identified	Figure No.
Feedwater System	Entrance Effect/Leading Edge Effect	Figure 9-1
Feedwater System	Entrance Effect/Leading Edge Effect	Figure 9-2
Feedwater System	Entrance Effect/Leading Edge Effect	Figure 9-3
Feedwater System	Entrance Effect/Leading Edge Effect	Figure 9-6
Fire Protection System	Cavitation	Figure 2-4
Heater Drain System	Cavitation	Figure 2-10
Heater Drain System	Cavitation and FAC	Figure 2-15
Heater Drain System	Flashing Flow	Figure 3-4
Heater Drain System	Entrance Effect/Leading Edge Effect	Figure 9-4
Heater Drain System	Entrance Effect/Leading Edge Effect	Figure 9-5
Heater Shell	Liquid Droplet Impingement	Figure 4-3

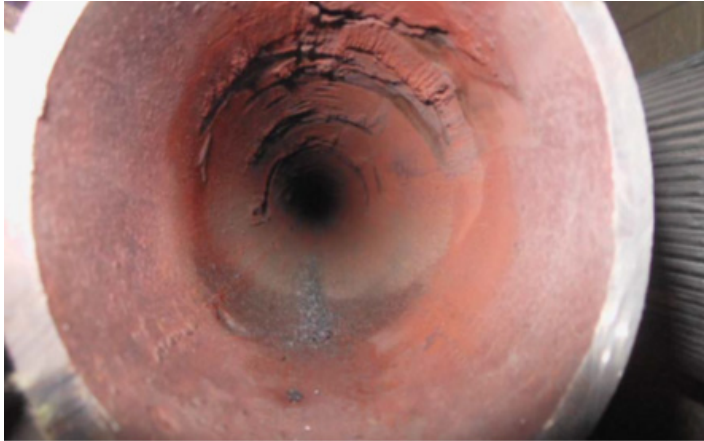
**Figure 4-5 Feedwater Heater Operating Vent Line [18]**

- Feedwater Heater Vent line downstream of orifice
- Red color indicates hematite
- Wall loss between 11 o'clock to the 12 o'clock position
- Liquid Droplet Impingement degradation along the pipe wall surface along the 12 o'clock position

Plant System	Wear Mechanism Identified	Figure No.
Crossover System	Two Phase FAC	Figure 8-19
Drain System	Single Phase FAC	Figure 7-9
Extraction Steam System	LDI and FAC	Figure 4-16
Extraction Steam System	Two Phase FAC	Figure 8-6
Extraction Steam System	Two Phase FAC	Figure 8-9
Extraction Steam	Two Phase FAC	Figure 8-2
Extraction Steam	Two Phase FAC	Figure 8-3
Extraction Steam System - Chrome-Moly	Liquid Droplet Impingement	Figure 4-14
Feedwater Heater Shell Wear	Two Phase FAC	Figure 8-4
Feedwater Heater Shell Wear	Two Phase FAC	Figure 8-5
Feedwater Heater Vent System	Liquid Droplet Impingement	Figure 4-5

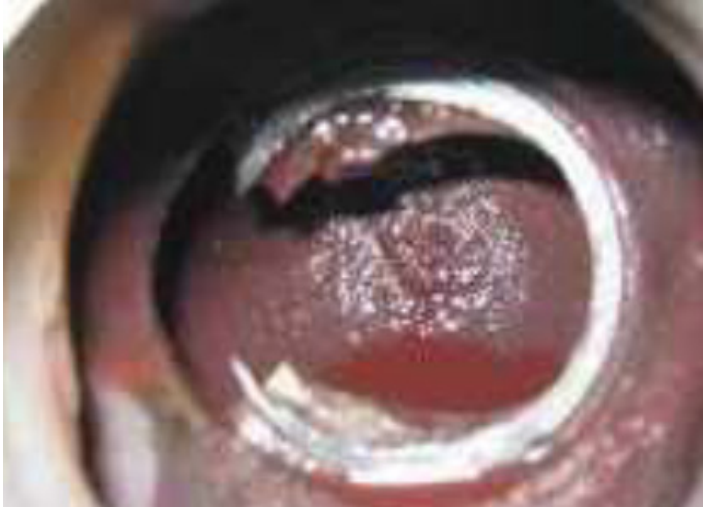
**Figure 4-7 Liquid Droplet Impingement on High Pressure Coolant Injection Steam Line Drain Pot Valve Body and Internals [19]**

- ASME Section III Class 2 line
- Two leaks in body of valve
- Liquid Droplet Impingement damage to valve body and internals
- Valve seat is missing as a result of the wear mechanism

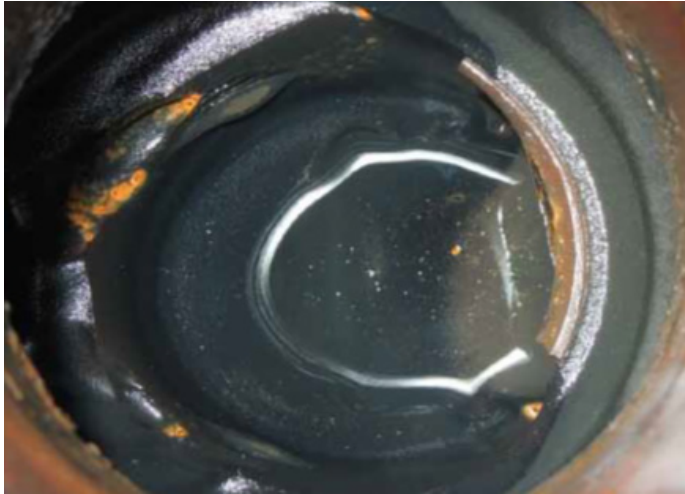
**Figure 4-8 Reactor Water Clean-Up (RWCU) Valve Body Leak and Internals LDI [20]**

- ASME Section III Class 3 Valve
- Carbon steel body
- Leak in valve body just downstream of seat
- Liquid Droplet Impingement surface degradation (craters and rough surface) on bottom of valve body
- Valve disassembled
- Significant plug and seat damage identified
- Missing seat and base metal material not recovered

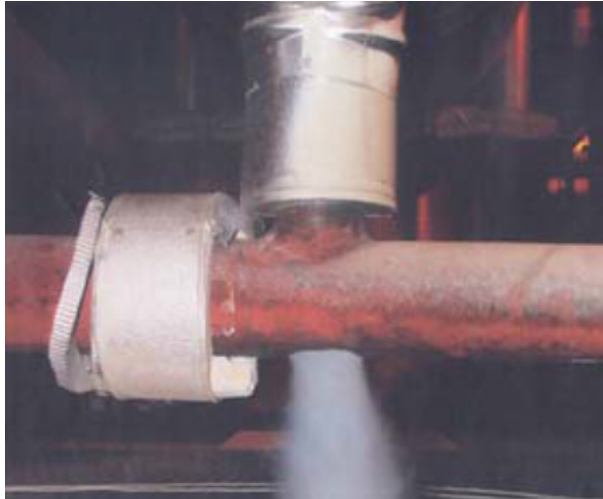
**Figure 4-11 Turbine Stop Valves and 'B' Moisture Separator Re-heater (MSR) cross-under piping drains to the Condenser [23]**

- Drain line normally used during outage startup activities
- Liquid Droplet Impingement attributed to seat leakage from upstream isolation valves
- Fitting is a 2" x 4" (50.8 mm x 101.6 mm) tee
- Branch piping is constructed of chrome-moly material
- Main run pipe is constructed of carbon steel material
- Hole in tee directly opposite of the drain line connection is ~2" (50 mm) in diameter

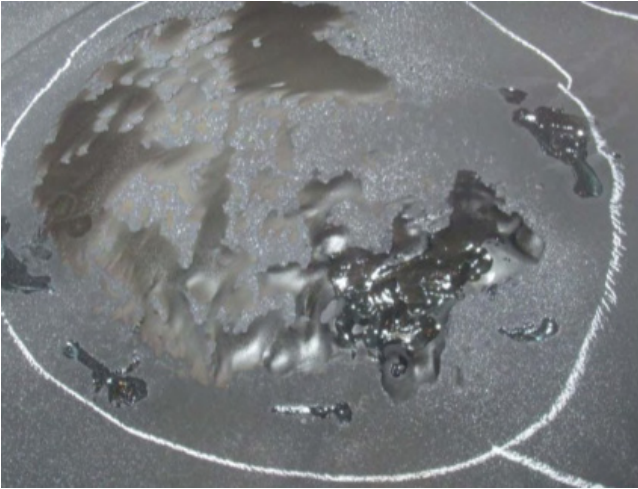
**Figure 4-12 Main Steam End Cap Liquid Droplet Impingement [25]**

- End cap installed on long 30" (76.2 cm) NPS Main Steam Header
- A234 WPB carbon steel material
- Liquid Droplet Impingement
- Deep craters on degraded surface are approximately 0.500" (12.7 mm) to 0.650" (16.5 mm) deep
- End cap to be replaced at a later date using super duplex stainless steel

<b>Plant System</b>	<b>Wear Mechanism Identified</b>	<b>Figure No.</b>
Main Steam System	Liquid Droplet Impingement	Figure 4-12
Miscellaneous Equipment Drain Header	Liquid Droplet Impingement	Figure 4-20
Moisture Separator Drain System	Liquid Droplet Impingement	Figure 4-17
Moisture Separator Emergency Drain	Steam Cutting	Figure 6-5
Moisture Separator Reheater Drain System	Single Phase FAC	Figure 7-15
Moisture Separator Reheater Drain System - P22 Elbow	Cavitation	Figure 2-20
Moisture Separator Reheater System	Two Phase FAC	Figure 8-17
Moisture Separator Reheater System Vents	Liquid Droplet Impingement	Figure 4-15
Moisture Separator Reheater Vent System	Entrance Effect/Leading Edge Effect	Figure 9-7
Reactor Building Closed Loop Cooling System	Low Temperature FAC	Figure 10-2

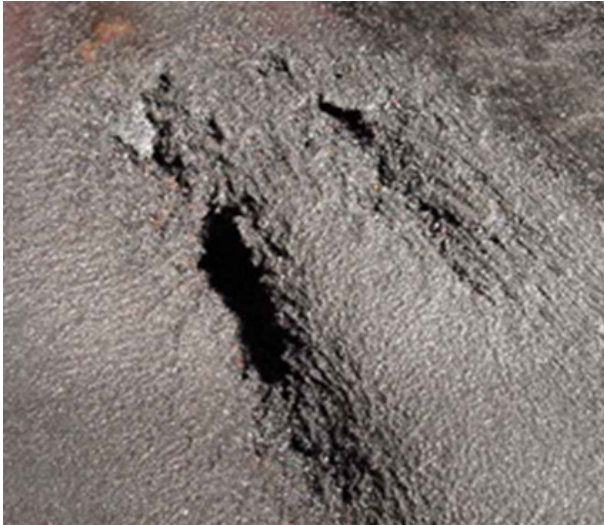
**Figure 4-13 Piping Downstream of a Normally Closed Bleed Line Valve which was Leaking By [3, 8]**

- Leak in Low Pressure Bleed Line from Liquid Droplet Impingement
- Line is normally closed
- Surface around hole is jagged, rough, and crater-like

Plant System	Wear Mechanism Identified	Figure No.
Bleed Steam System	Liquid Droplet Impingement	Figure 4-4
Bleed Steam System	Liquid Droplet Impingement	Figure 4-13
Boiler Blowdown System	Solid Particle	Figure 5-3
Boiler Blowdown System	Solid Particle	Figure 5-4
Condensate Cooling Water	Cavitation	Figure 2-28
Condensate Cooling Water	Cavitation	Figure 2-29
Condensate Cooling Water	Cavitation	Figure 2-30
Condensate Cooling Water	Cavitation	Figure 2-31
Condensate Polisher and Demineralizer System	Low Temperature FAC	Figure 10-3
Condensate Polisher and Demineralizer System	Low Temperature FAC	Figure 10-4
Condensate Polisher and Demineralizer System	Low Temperature FAC	Figure 10-5

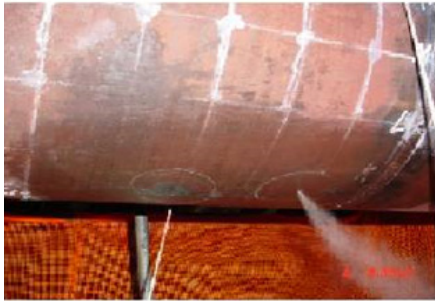
- FAC resistant chrome-moly material
- Two leaks directly opposite the drain line connections
- Liquid Droplet Impingement from water droplets impacting header pipe wall

**Figure 4-14 Through Wall Leak in Chrome-Moly Extraction Steam Header Diagonally Opposite to MSR Drain Lines [3, 8]**

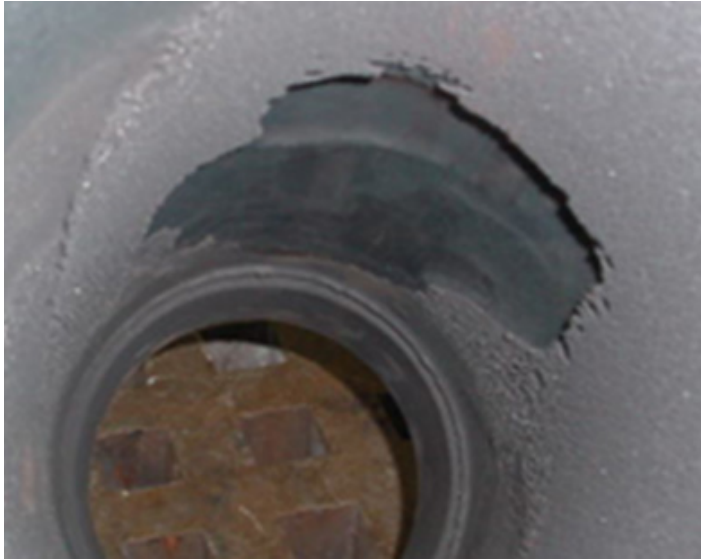
**Figure 4-15 MSR Vent Line Liquid Droplet Impingement [3]**

- Liquid Droplet Impingement damage located downstream of orifice
- Moisture Separator Reheater Vent Line
- 6" (15.2 cm) NPS, carbon steel material
- Rough and small craters located in degraded areas

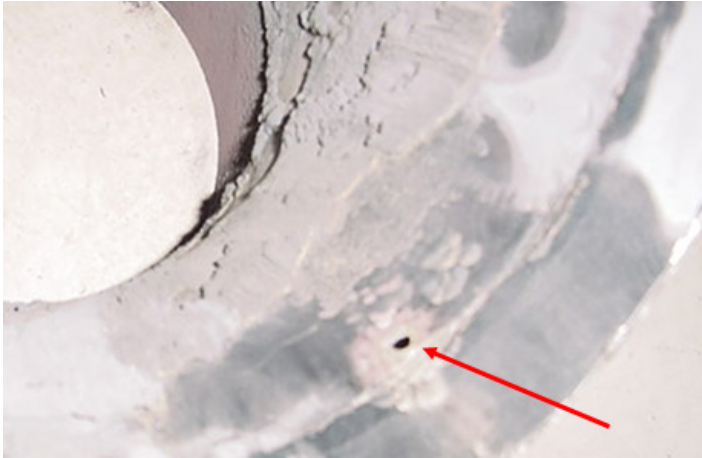
**Figure 4-16 Extraction Steam Line Combinations of LDI and FAC [3]**

- Combination of (rough) liquid droplet impingement and two-phase flow accelerated corrosion

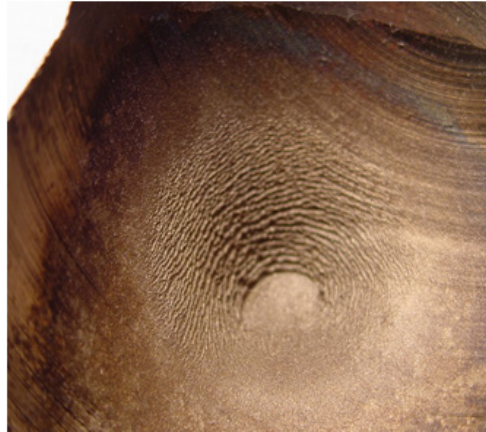
- Through-wall leak in the extrados of the elbow
- Liquid Droplet Impingement wear mechanism
- Socket welded elbow constructed of FAC-resistant material
- Elbow installed downstream of restriction orifice

**Figure 4-18 Feedwater Heater Vent Line P22 Socket Welded Elbow Downstream of an Orifice [3]**

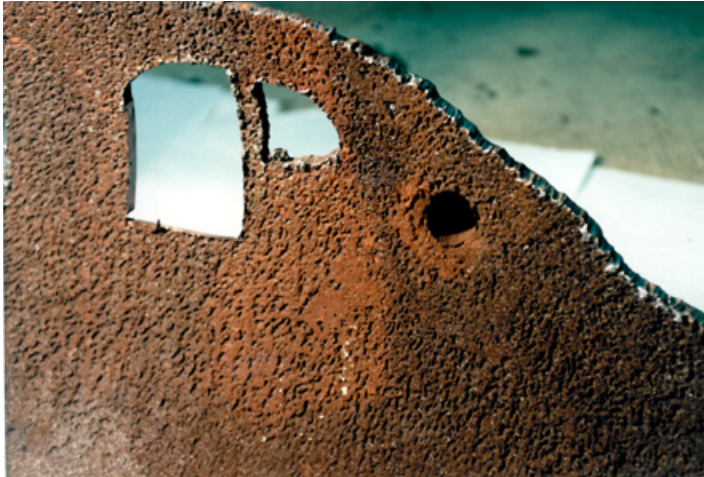
**Figure 4-19 Low Pressure Extraction Steam Line Degradation from Liquid Droplet Impingement [26]**

- Cutout section of 24" (61.0 cm) NPS Tee in Low Pressure Extraction Steam line
- Surface degradation is rough with crater-like excavations
- Liquid Droplet Impingement wear mechanism

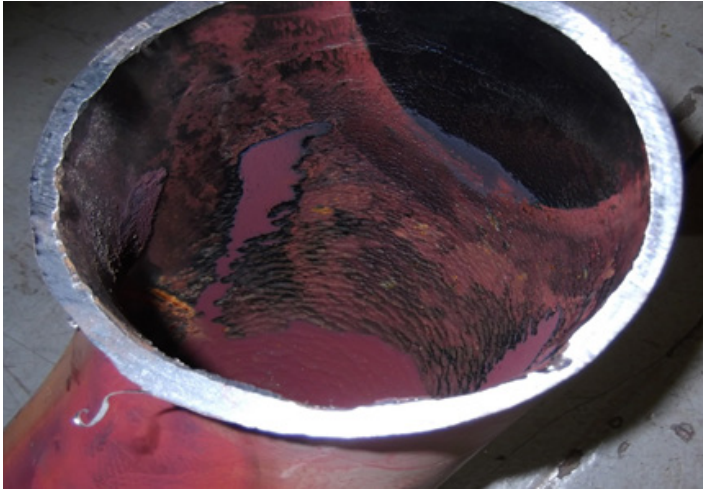
- Surface degradation at the left side (9 o'clock position) and lower right quadrant of cut elbow is cratered and irregular
- Internal surface is very rough, cratered, and irregular

**Figure 4-20 Miscellaneous Equipment Drain Header Elbow Degradation from Liquid Droplet Impingement (Photo Courtesy of TVA)**

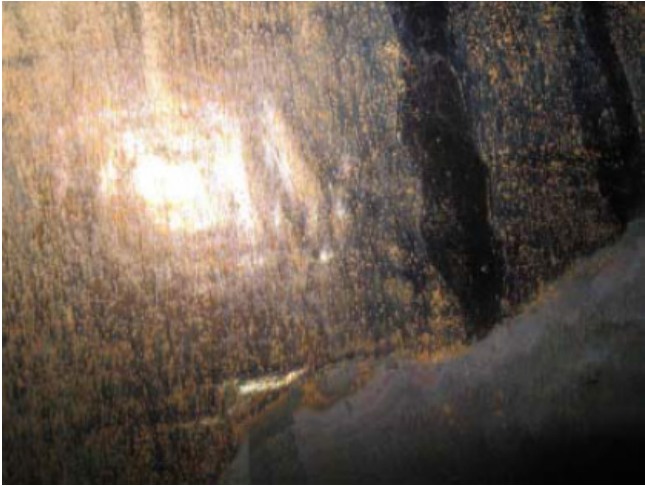
**Figure 5-2 Feedwater Heater Shell – Solid Particle Erosion**  
[15]

- Inside surface of Feedwater Heater Shell
- Small channels on the surface
- Surface is also rough

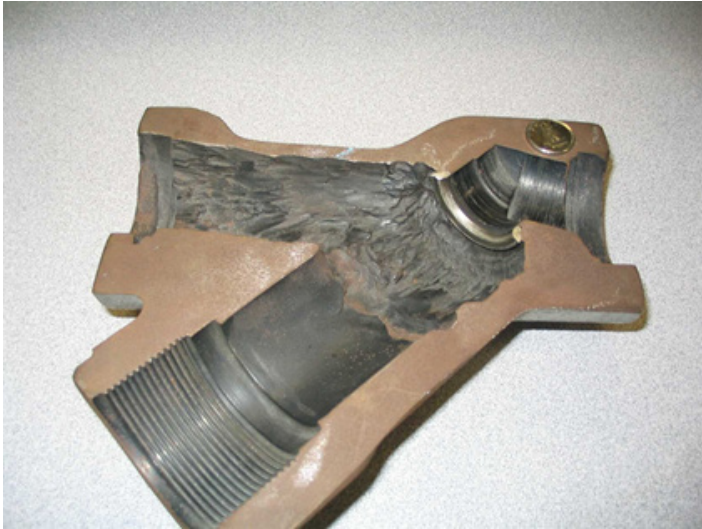
**Figure 5-3 Boiler Blowdown Valve Body – Solid Particle Erosion [3, 19]**

- Solid Particle Erosion damage to valve body
- Grooves on surface
- Side view provides an indication as to the approximate depth of the grooves into the valve body

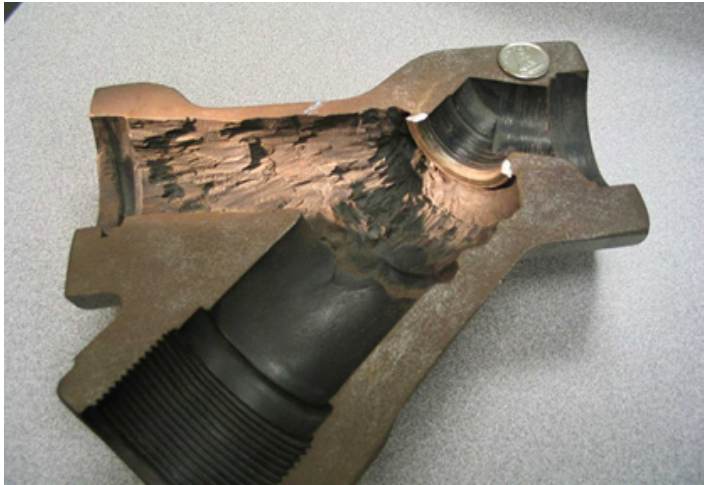
**Figure 5-4 Boiler Blowdown Valve Body – Solid Particle Erosion [3, 20]**

- Solid Particle Erosion damage to valve body
- Grooves on surface
- Side view provides an indication as to the approximate depth of the grooves into the valve body

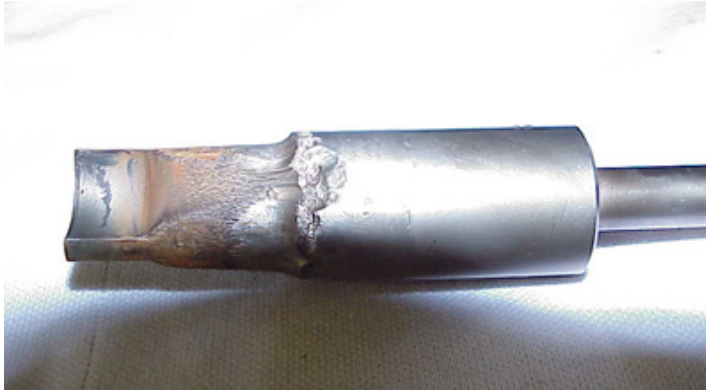
**Figure 5-5 Steam Generator Blowdown Valve Internal – Solid Particle Erosion [2, 3, 8]**

- Solid Particle Erosion damage to valve internal stem
- Grooves on the surface of the stem
- Large pieces of the stem material have been removed

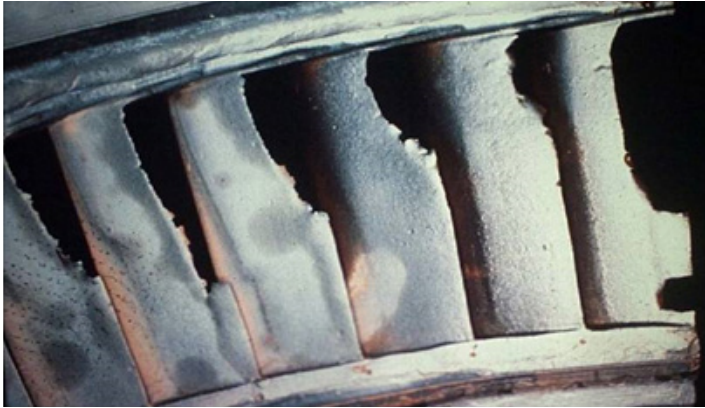
- High velocity impact to turbine blade
- Blade surface is rough and shiny

**Figure 5-6 Turbine Blade Damage – Solid Particle Erosion [8]**

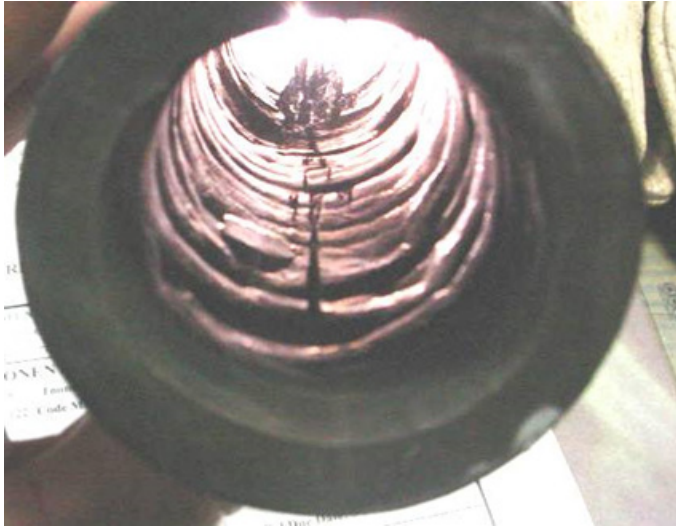
**Figure 5-7 Steam Generator Blowdown System – Solid Particle Erosion [3, 8]**

- Solid Particle Erosion downstream of stainless steel angle control valve in Steam Generator Blowdown System
- Pipe is lined with P11 material
- Damage appears as a rippled surface due to small impingement angle

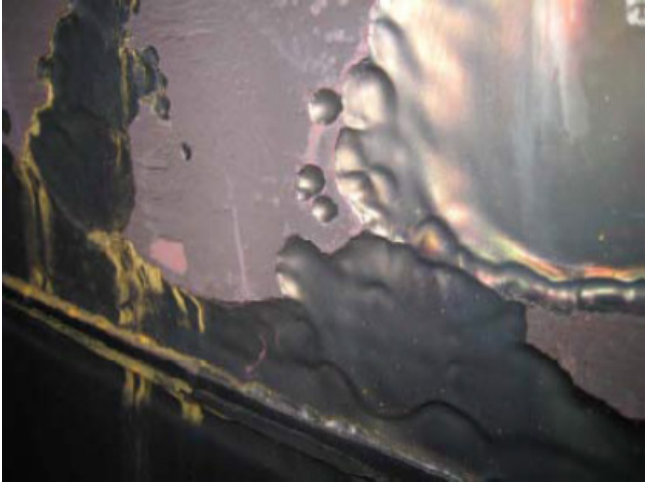
**Figure 6-2 Feedwater Heater Shell – Steam Cutting Erosion  
[16]**

- Steam Cutting/Erosion on Feedwater Heater Shell
- Smooth shiny surface
- Hemispherical pits are created by the steam eroding the metal surface
- With time the pits will connect and form a trough

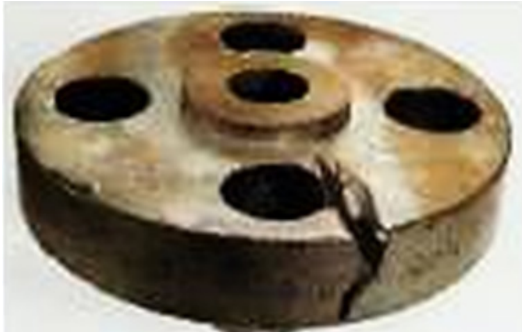
**Figure 6-3 Pipe Flange – Steam Cutting Erosion [8]**

- Sliced through the entire thickness of the flange
- High velocity steam created narrow path in the flange

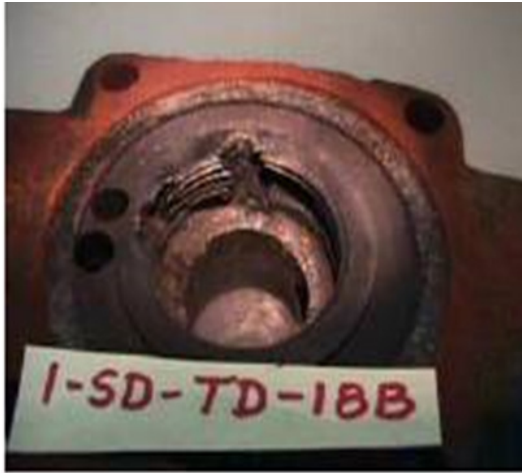
- Steam jet eroded the steam trap body in the 12 o'clock position
- Steam trap may not have been functioning normally

Figure 6-4 Steam Trap Body – Steam Cutting Erosion [8]

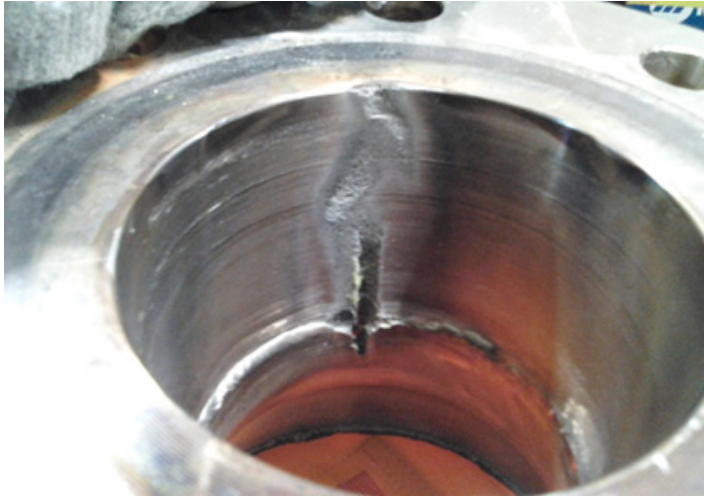
**Figure 6-5 Stainless Steel Expander – Steam Cutting Erosion**  
(Photo Courtesy of TVA)

- Steam jet eroded the stainless steel expander
- Located downstream of normally closed moisture separator emergency drain control valve
- The damage occurred within a five (5) month period

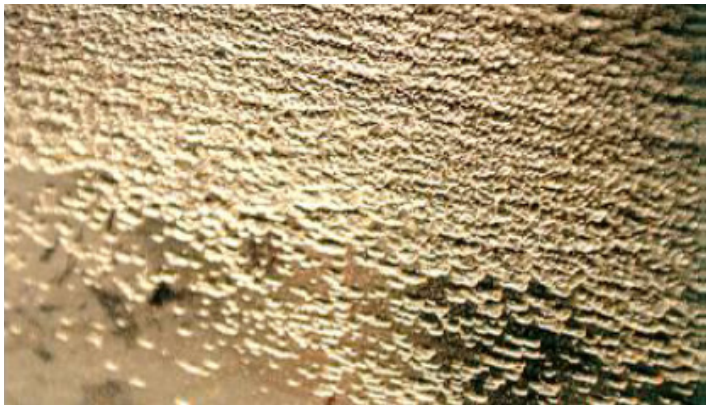
Figure 7-1 Surface Damage – Single Phase Flow Accelerated Corrosion [11]

- Single-phase FAC described as:
  - “Orange Peel”
  - “Scalloped”
  - “Fish Scale”
  - “Interlocking Horseshoe Pits”
