# Field Guide: Flow-Accelerated Corrosion and Erosion

3002008124

Final Report, December 2016

EPRI Project Manager  
R. Wolfe

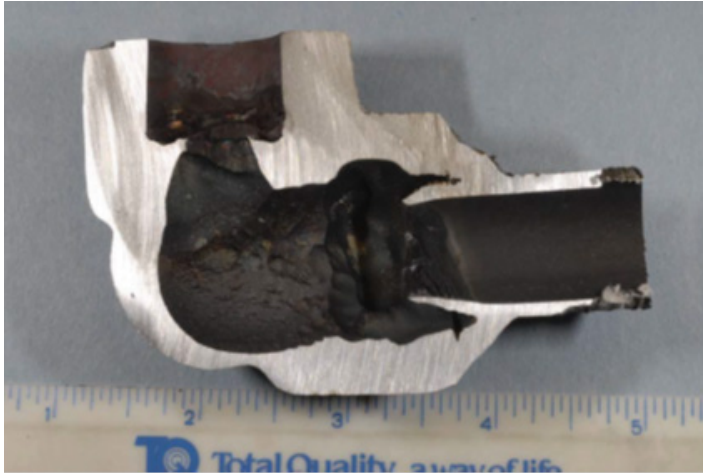
**Figure 7-3 Socket Welded Connection Downstream of Normally Closed Valve – Single Phase Flow Accelerated Corrosion [13]**

- Socket welded elbow and pipe downstream of normally closed valve
- Valve leaking by in drain line
- Surface damage appears scalloped shape
- Erosion mechanism may also be present
- Wear on back side of socket welded elbow
- Wear at socket welded elbow-to-pipe connection

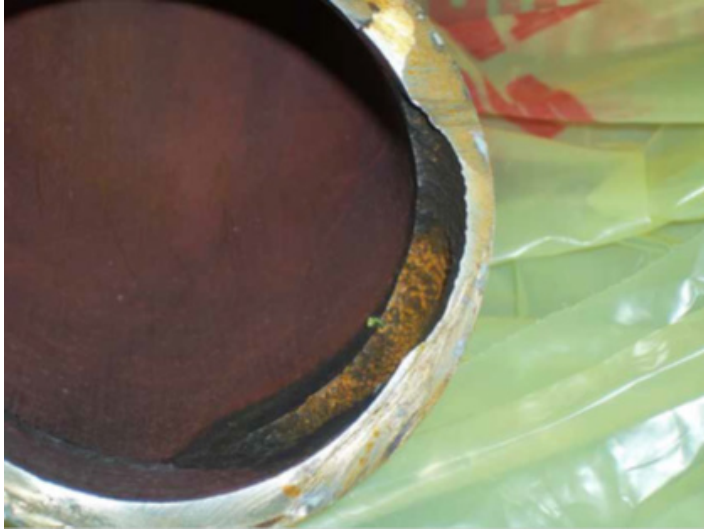
**Figure 7-5 Reactor Water Clean Up – Close Up View of Wall Loss - Single Phase Flow Accelerated Corrosion [20]**

- Significant single-phase FAC wall loss
- Operating temperature 230°F (110°C)
- Operating pressure 1253 psi (86.39 bar)
- Fluid velocity = 11.6 feet/second (3.5 m/s)

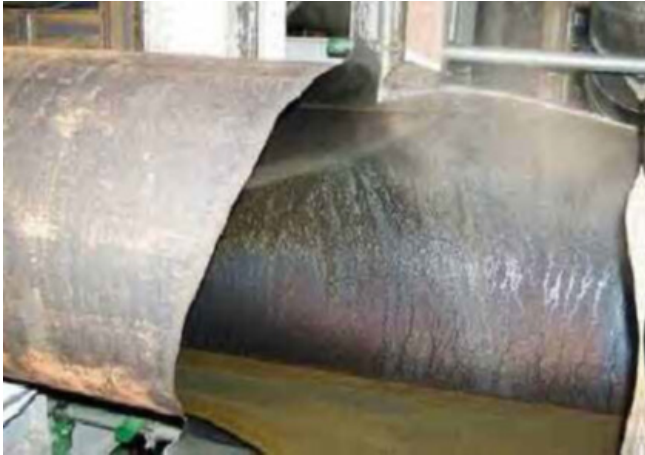
**Figure 7-6 Condensate Line Downstream of Flow Measuring Orifice – Mihama Unit 3 Single-Phase Flow Accelerated Corrosion [20]**

- Condensate line catastrophic failure immediately downstream of orifice
- 22" NPS (560 mm)
- Nominal thickness of 0.394" (10 mm)
- Operating temperature 284°F (140°C);
- Operating pressure 135 psia (0.93MPa)
- Fluid velocity = 6.4 feet/second (2 m/s)
- Five fatalities

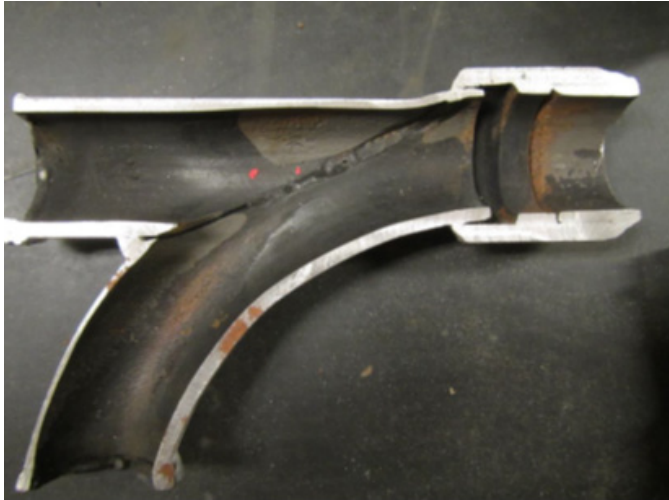
**Figure 7-9 Socket Welded Fitting in Drain Line – Single Phase Flow Accelerated Corrosion [23]**

- Single-phase wear at several locations
- Socket welded coupling connection wear
- Pipe wall thinning immediately downstream of the coupling connection
- Wall thinning on extrados of elbow

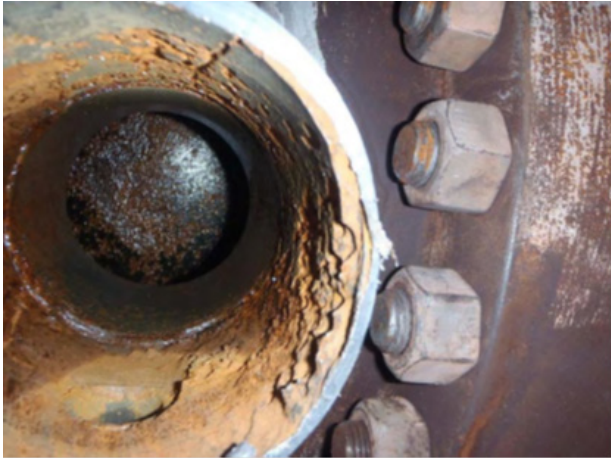
**Figure 7-10 Reactor Water Clean Up Heat Exchanger Nozzle and Pipe – Single Phase Flow Accelerated Corrosion [25]**

- RWCU interconnecting piping
- Single-phase FAC damage
- Additional influences expected based on rough and crater-like surface damage

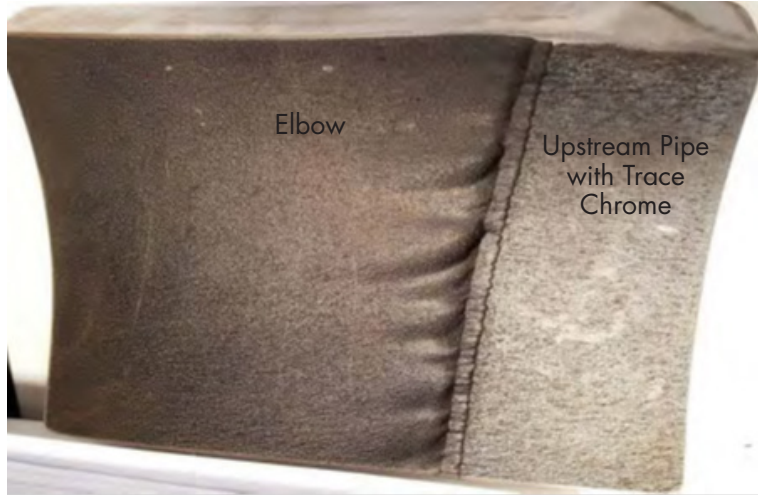
- Upstream pipe contains 0.08% trace chrome
- Weld and elbow contain no trace chrome
- Single-phase FAC in 16" (40.6 cm) NPS carbon steel elbow
- "Entrance Effect" may also be present

**Figure 7-11 Carbon Steel Feedwater Elbow Downstream of Carbon Steel Pipe with Trace Chrome – Single Phase Flow Accelerated Corrosion [25]**

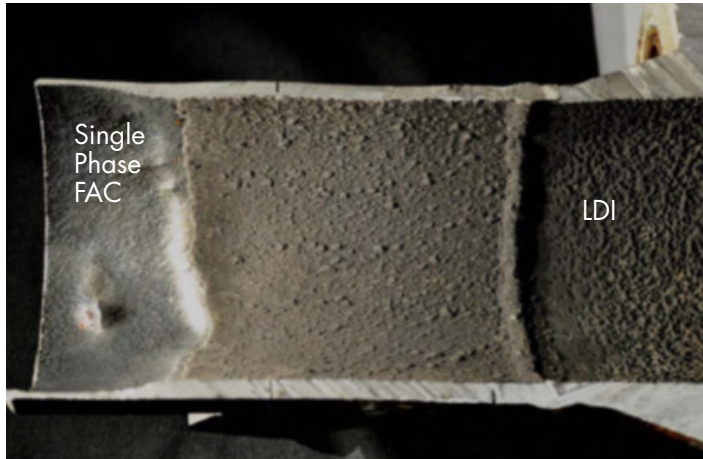
**Figure 7-12 Pipe with Two Damage Mechanisms – Liquid Droplet Impingement Erosion and Single Phase Flow Accelerated Corrosion [25]**

- Liquid Droplet Impingement erosion on pipe immediately downstream of orifice
- Surface pits were shallow and smooth
- Single-phase FAC at location of through wall leak
- Magnified surface showed scalloped features

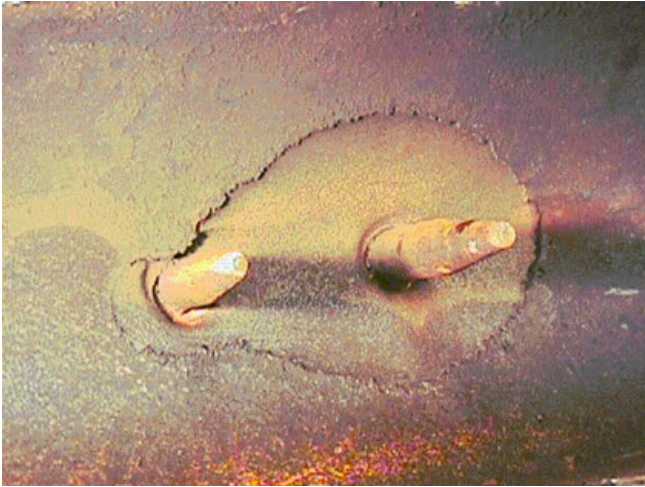
**Figure 7-14 Damaged Pipe Wall at Thermowells – Single Phase Flow Accelerated Corrosion [7]**

- Single-phase FAC
- Thermowells protrude into fluid stream
- Local velocities increase around and downstream of the obstructions
- Scalloped surface

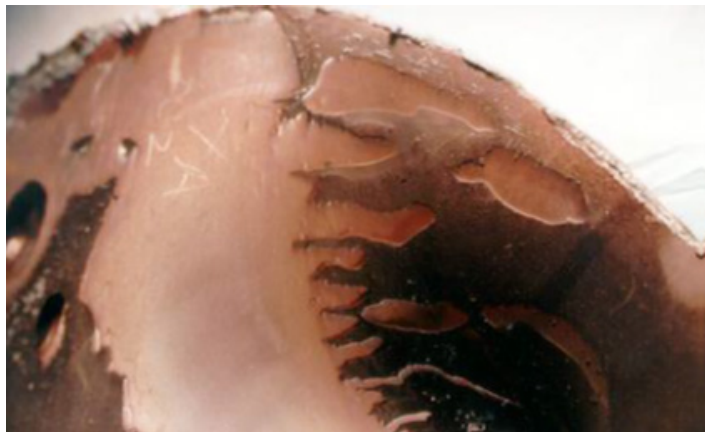
Figure 8-1 Pipe Damage – Two Phase Flow Accelerated Corrosion [11]

- Two-phase FAC “Tiger Striping” in piping component
- Plateaus and valleys

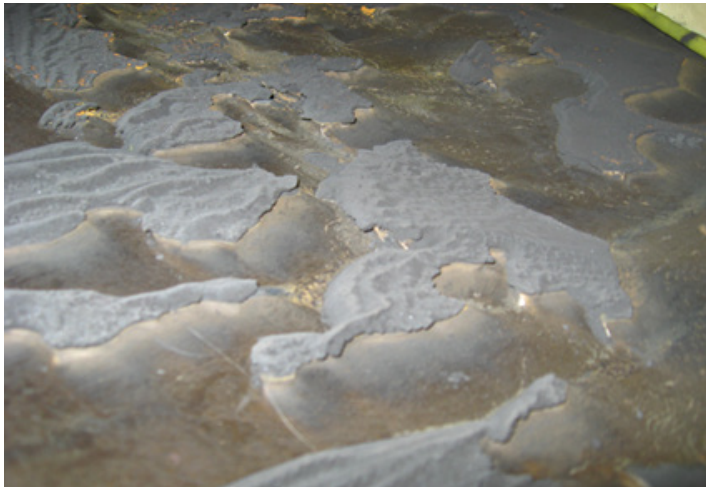
**Figure 8-4 Feedwater Heater Shell Wear – Two Phase Flow Accelerated Corrosion [14]**

- Two-phase FAC “Tiger Striping” in heater shell
- Plateaus and valleys

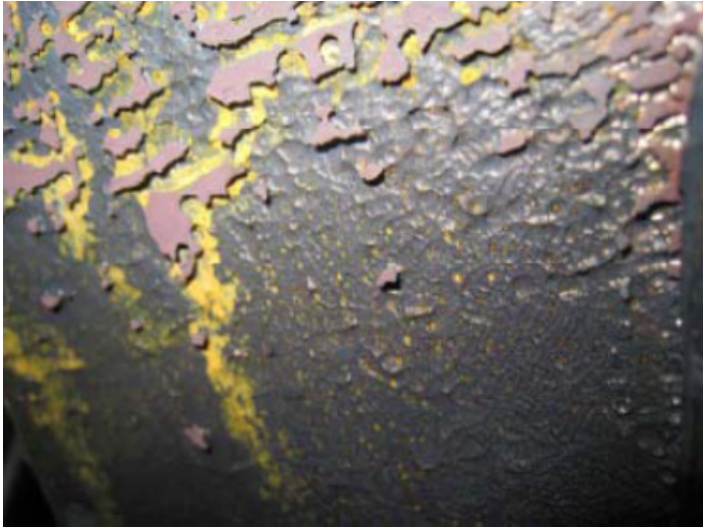
**Figure 8-5 Feedwater Heater Shell – Two Phase Flow Accelerated Corrosion [15]**

- Two-phase FAC “Tiger Striping” in heater shell
- Plateaus and valleys

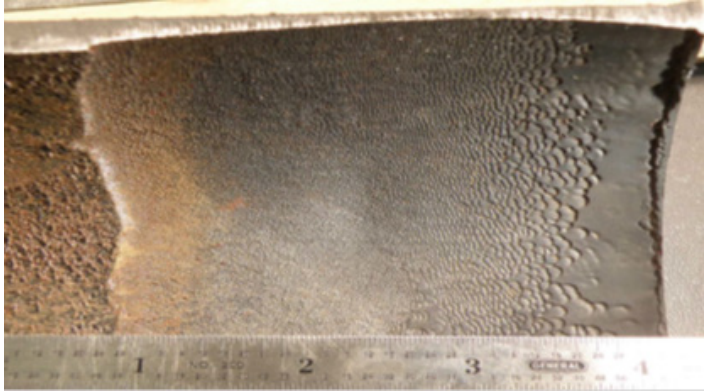
**Figure 8-7 Steam Supply to Gland Steam – Two Phase Flow Accelerated Corrosion and Liquid Droplet Impingement Erosion [17]**

- 2nd Point Extraction Steam: 210 psig (1.448 MPa), 394°F (201°C), Quality = 0.89 supply to Gland Steam
- Pipe extension located downstream from tee main
- Top section of pipe wall significantly thinned
- Multiple wear mechanisms present: two-phase FAC and Liquid Droplet Impingement

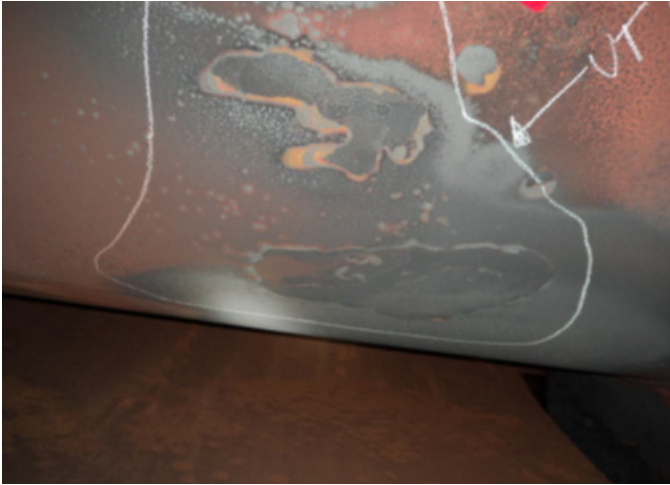
**Figure 8-8 Low Pressure Feedwater Heater – Two Phase Flow Accelerated Corrosion [18]**

- Low Pressure Feedwater Heater Shell is in the Condenser
- Two-phase FAC “Tiger Striping”

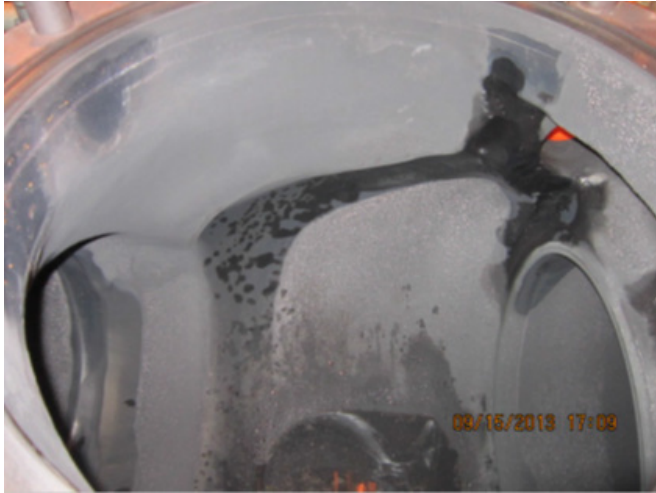
**Figure 8-9 Extraction Steam Wear in Non-Return Valve Body  
– Two Phase Flow Accelerated Corrosion [21]**

- 2nd Point Extraction Steam: 43 feet/s (13 m/s); 225 psig (1.55 Mpa); 397°F (203°C); Q = 0.905
- Non-Return Valve body is A216 WCB
- Two-phase FAC on check valve body
- Valve was previously replaced
- Upstream piping is P22 chrome-moly piping

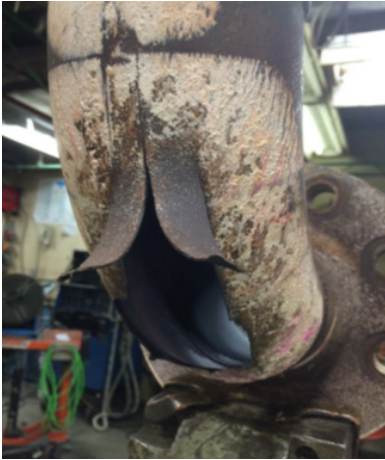
**Figure 8-12 Reheat Steam and Moisture Separator System Elbow Downstream of Orifice – Two Phase Flow Accelerated Corrosion [24]**

- Rupture in 2015
- 4" (10.2 cm) NPS
- 0.237" (6.02 mm) nominal thickness
- Carbon steel elbow A234 WPB
- Operating Conditions 874 psig (60.26 bar) and 529°F (276°C);  $Q = 0.99$
- Flow rate 20,148 lbs/hr (9,139 kg/hr)
- Detailed views shown in Figures 8-13, 8-14, and 8-15

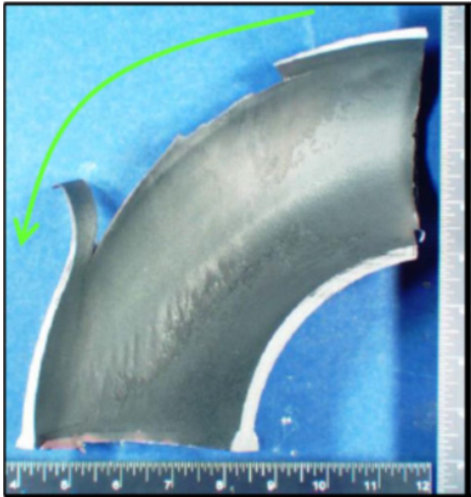
**Figure 8-13 Reheat and Moisture Separator System Side View of Failed Elbow – Two Phase Flow Accelerated Corrosion [24]**

- Rupture and adjacent wall loss on extrados of elbow
- Lab results indicated “tiger striping”

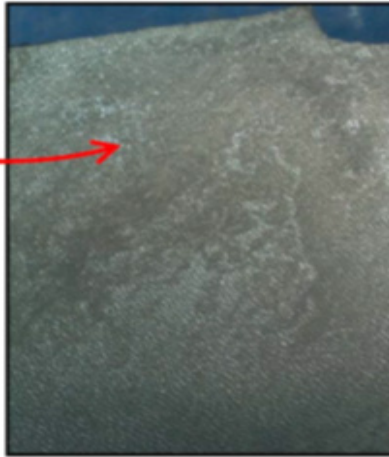
- Ruptured area and adjacent wall magnified
- Lab results indicate two-phase FAC

Figure 8-14 Reheat and Moisture Separator System  
Magnified View of Failed Section of Elbow – Two Phase Flow  
Accelerated Corrosion [24]

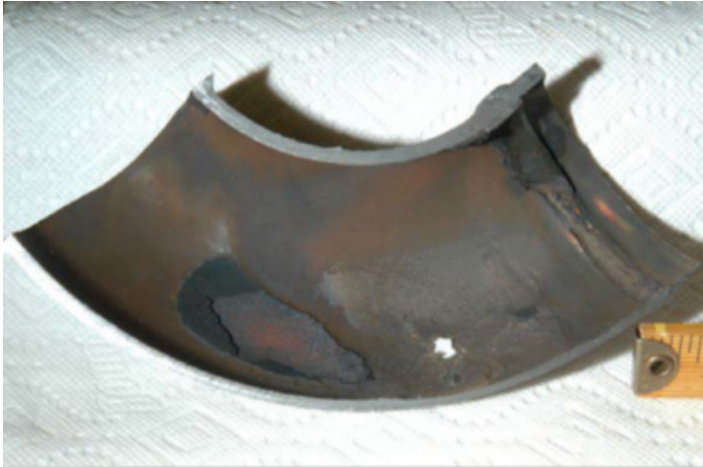
**Figure 8-16 Steam Seal Leak in Elbow – Two Phase Flow Accelerated Corrosion [24]**

- Hole in Steam Seal elbow
- Two-phase FAC patten
- Significant wall loss on extrados of elbow beyond hole
- Elbow to pipe weld shows partial loss of weld

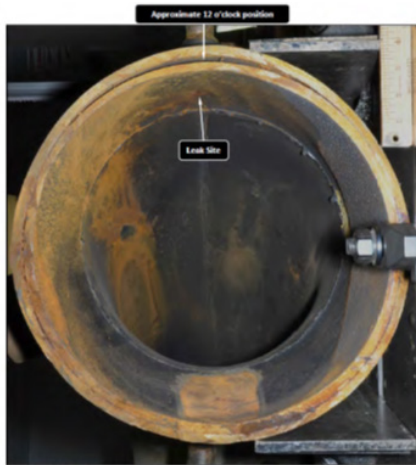
Figure 2: MMS 2HA-8 spool piece, as received (looking in direction opposite to steam flow).

- Pipe is downstream of stainless steel elbow
- Operating conditions about 444°F (229°C), 398 psia (27.44 bar), 0.84 steam quality
- Flow rate about 89 feet/second (27.1 m/s)
- Two-phase FAC pipe wear was in line with the extrados of the stainless steel elbow
- Some wear noted at the 6 o'clock position of the pipe

**Figure 8-18 High Pressure Extraction Pipe Shown with Clam Shell – Two Phase Flow Accelerated Corrosion [25]**

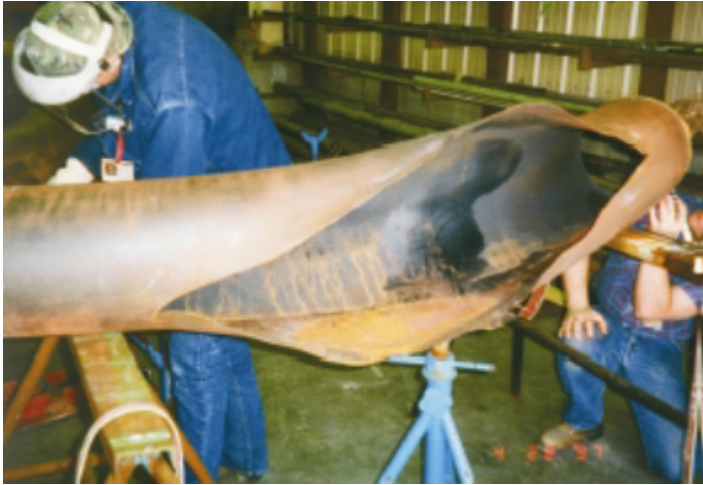
**Figure 8-20 High Pressure Extraction Steam Bend Failure – Two Phase Flow Accelerated Corrosion [9]**

- Failure of H.P. Extraction Steam Bend or Sweep
- Two-phase FAC “Tiger Striping”

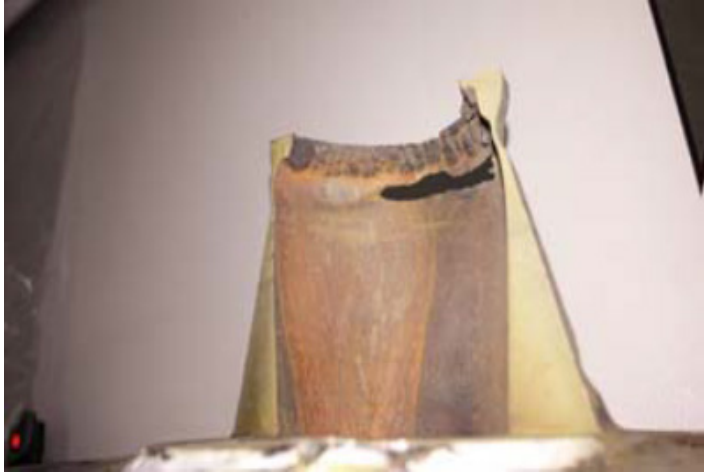
**Figure 8-21 Steam Line – Two Phase Flow Accelerated Corrosion [29]**

- Inside surface of failed carbon steel flange
- Downstream weld (towards top of photo) appears to be intact

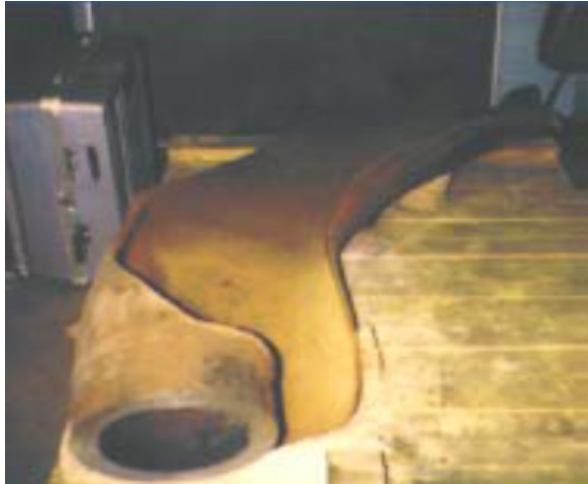
**Figure 9-6 Ruptured Feedwater line to Economizer at Fossil Power Plant [28]**

#### Items of Note

- Failed section of pipe was on branch side of tee
- 12" (30.5 cm) NPS; A106 Gr. C; Seamless
- Tee had trace chrome of 0.12%
- Branch pipe had trace chrome of 0.03%
- Difference in chromium content was enough to cause the Entrance Effect downstream of the tee branch to pipe weld

Plant System	Wear Mechanism Identified	Figure No.
Feedwater System	Entrance Effect/Leading Edge Effect	Figure 9-1
Feedwater System	Entrance Effect/Leading Edge Effect	Figure 9-2
Feedwater System	Entrance Effect/Leading Edge Effect	Figure 9-3
Feedwater System	Entrance Effect/Leading Edge Effect	Figure 9-6
Fire Protection System	Cavitation	Figure 2-4
Heater Drain System	Cavitation	Figure 2-10
Heater Drain System	Cavitation and FAC	Figure 2-15
Heater Drain System	Flashing Flow	Figure 3-4
Heater Drain System	Entrance Effect/Leading Edge Effect	Figure 9-4
Heater Drain System	Entrance Effect/Leading Edge Effect	Figure 9-5
Heater Shell	Liquid Droplet Impingement	Figure 4-3

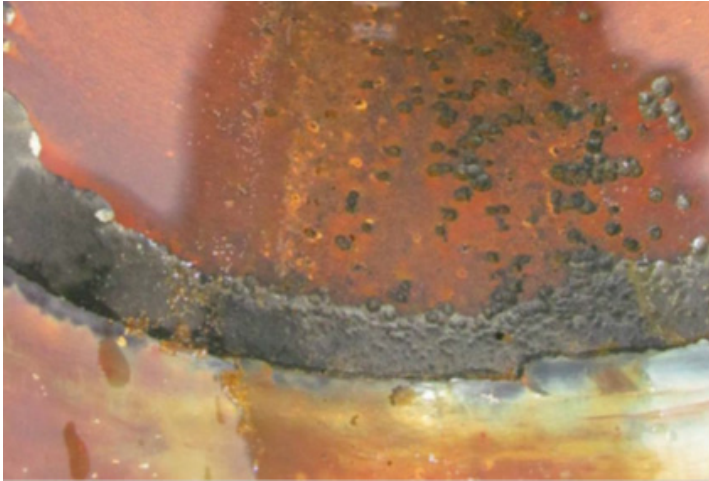
Figure 10-1 Low Temperature FAC – Polisher Piping between Isolation Valve and Resin Trap [24]

### Items of Note

- Condensate Polisher Piping System
- Low Temperature < 200°F (93°C)
- Damage similar to single-phase FAC
- Surface degradation appears to have some Cavitation wear mechanism also occurring

<b>Plant System</b>	<b>Wear Mechanism Identified</b>	<b>Figure No.</b>
Condensate Polisher and Demineralizer System	Low Temperature FAC	Figure 10-6
Condensate Polisher and Demineralizer System	Low Temperature FAC	Figure 10-7
Condensate Polishing System	Low Temperature FAC	Figure 10-1
Condensate Polishing System	Low Temperature FAC	Figure 10-8
Condensate Polishing System	Low Temperature FAC	Figure 10-9
Condensate Polishing System	Low Temperature FAC	Figure 10-10
Condensate System	Cavitation	Figure 2-25
Condensate System	Single Phase FAC	Figure 7-6
Control Rod Drive System	Low Temperature FAC	Figure 10-11
Condenser Tubing, Copper Alloy	Liquid Droplet Impingement	Figure 4-9
Condenser Tubing, Copper Alloy	Liquid Droplet Impingement	Figure 4-10
Core Spray System	Cavitation	Figure 2-27

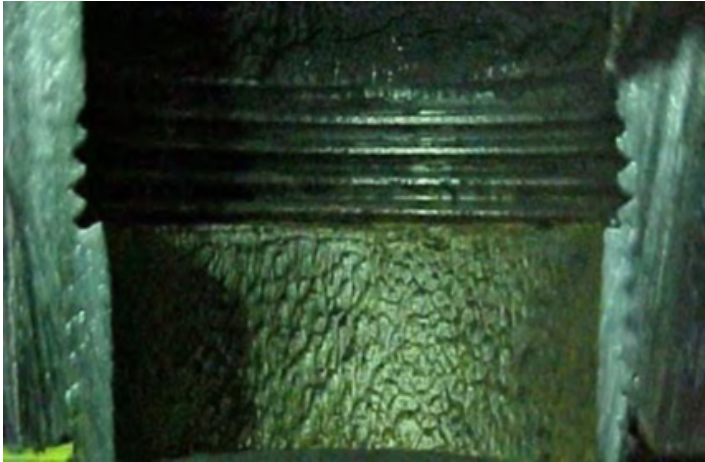
**Figure 10-2 Low Temperature FAC – Reactor Building Closed Loop Cooling Showing Scalloped Surface [6, 25, 27]**

#### Items of Note

- Leaks in Reactor Building Closed Loop Cooling
- Operating temperature 120°F (49°C)
- Small bore carbon steel threaded pipe
- Resulted in plant shutdown
- Surface degradation appears to have “orange peel” finish similar to single-phase FAC
- Surface also appears to be rippled

<b>Plant System</b>	<b>Wear Mechanism Identified</b>	<b>Figure No.</b>
Main Steam System	Liquid Droplet Impingement	Figure 4-12
Miscellaneous Equipment Drain Header	Liquid Droplet Impingement	Figure 4-20
Moisture Separator Drain System	Liquid Droplet Impingement	Figure 4-17
Moisture Separator Emergency Drain	Steam Cutting	Figure 6-5
Moisture Separator Reheater Drain System	Single Phase FAC	Figure 7-15
Moisture Separator Reheater Drain System - P22 Elbow	Cavitation	Figure 2-20
Moisture Separator Reheater System	Two Phase FAC	Figure 8-17
Moisture Separator Reheater System Vents	Liquid Droplet Impingement	Figure 4-15
Moisture Separator Reheater Vent System	Entrance Effect/Leading Edge Effect	Figure 9-7
Reactor Building Closed Loop Cooling System	Low Temperature FAC	Figure 10-2

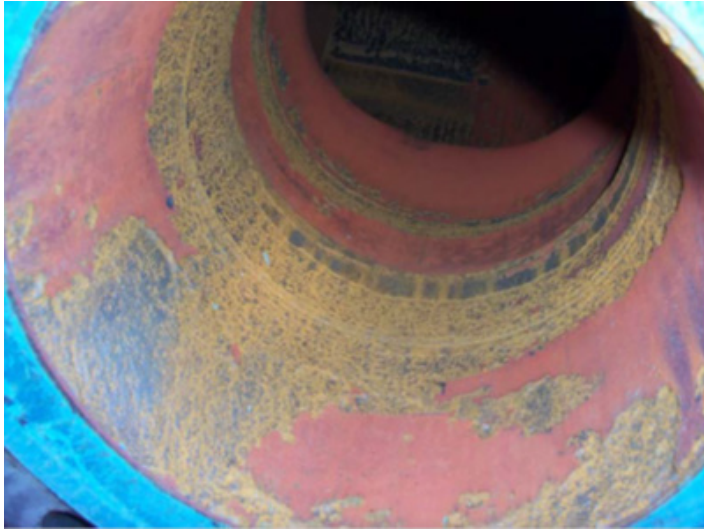
**Figure 10-3 Condensate Polishing System [6]**

#### Items of Note

- Low Temperature FAC wear mechanism
- Operating temperature between 90°F to 130°F (32°C to 54°C)
- Low oxygen ~5 ppb
- Degraded pipe surface downstream of butterfly valve
- Utility also noted damage to reducer and expander connected to the butterfly valve
- Velocity in 12" (30.5 cm) NPS < 9 ft/s (2.7 m/s)
- Similar wear was identified at the sister unit

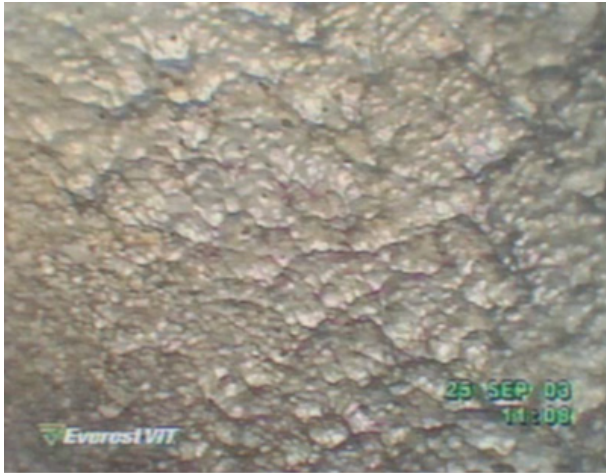
#### Items of Note

- Low Temperature FAC wear mechanism
- Operating temperature between 90°F to 130°F (32°C to 54°C)
- Similar surface characteristic to single-phase FAC
- Neutral pH water environment

**Figure 10-4 Magnification of the Condensate Polishing Pipe Surface from Previous Photograph [6, 27]**

Plant System	Wear Mechanism Identified	Figure No.
Bleed Steam System	Liquid Droplet Impingement	Figure 4-4
Bleed Steam System	Liquid Droplet Impingement	Figure 4-13
Boiler Blowdown System	Solid Particle	Figure 5-3
Boiler Blowdown System	Solid Particle	Figure 5-4
Condensate Cooling Water	Cavitation	Figure 2-28
Condensate Cooling Water	Cavitation	Figure 2-29
Condensate Cooling Water	Cavitation	Figure 2-30
Condensate Cooling Water	Cavitation	Figure 2-31
Condensate Polisher and Demineralizer System	Low Temperature FAC	Figure 10-3
Condensate Polisher and Demineralizer System	Low Temperature FAC	Figure 10-4
Condensate Polisher and Demineralizer System	Low Temperature FAC	Figure 10-5

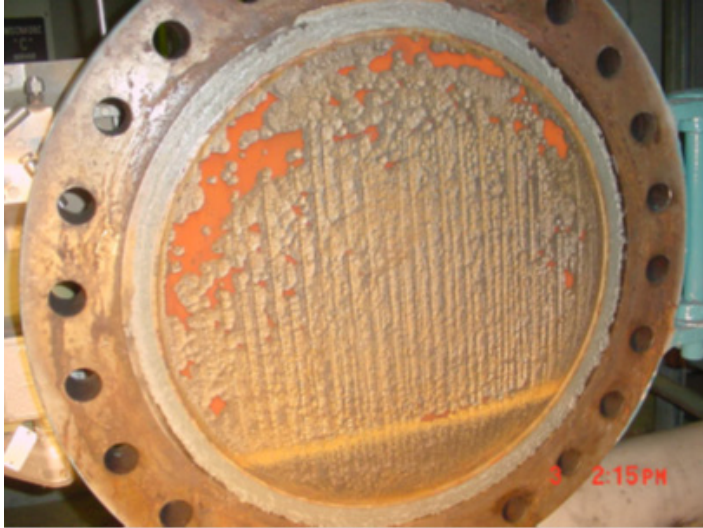
Figure 10-5 Condensate Polisher Resin Trap [6, 27]

#### Items of Note

- Low Temperature FAC wear mechanism
- Operating temperature 135°F (57°C)
- Low oxygen ~1 to 3 ppb
- Neutral water
- 20" NPS (508 mm OD)
- Carbon steel material
- Damaged surface appears to have vertical rows of grooves
- Similar damage was found in the other unit on site

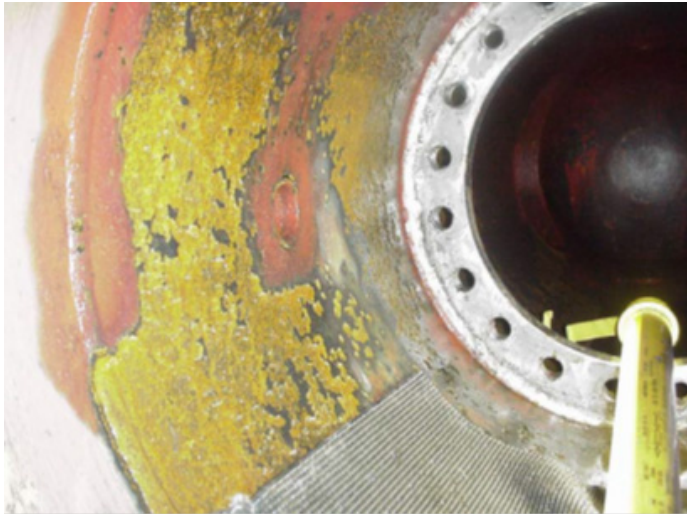
**Figure 10-8 Degradation within Resin Trap [6]**

#### Items of Note

- Low Temperature FAC wear mechanism
- Operating temperature between 90°F to 130°F (32°C to 54°C)
- Low oxygen ~5 ppb
- Degraded section within resin trap
- Similar wear was identified at a sister unit

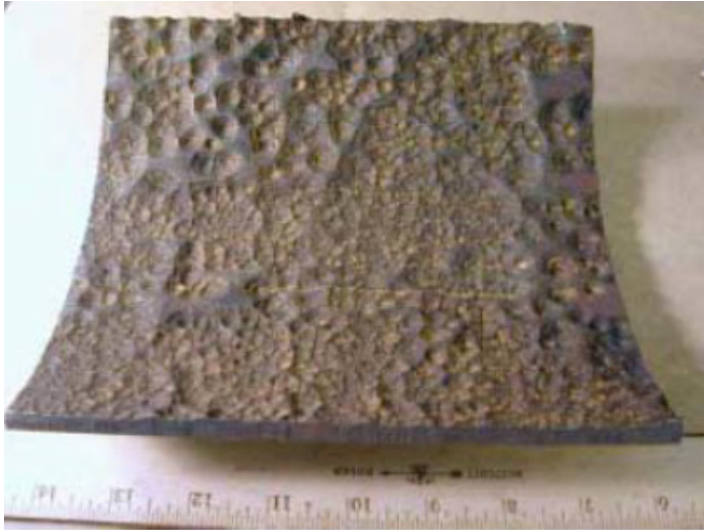
**Figure 10-9 Degradation of Pipe Surface in the Condensate System Downstream of the Polishers [6]**

#### Items of Note

- Low Temperature FAC wear mechanism
- Close-up view of surface degradation
- Operating temperature between 75°F to 125°F (24°C to 52°C)
- Carbon steel material

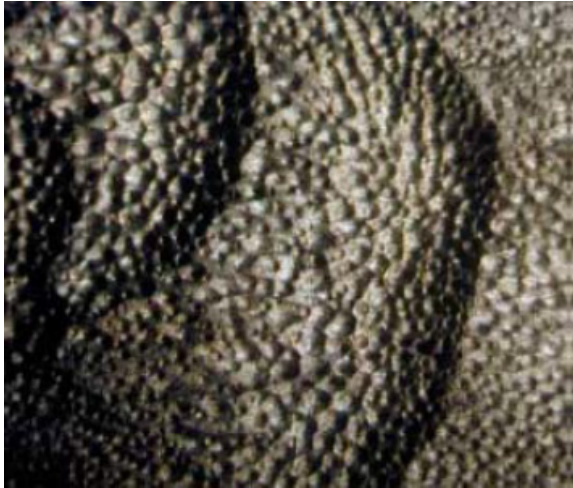
**Figure 10-10 Low Temperature FAC Surface Degradation shows Rippled Surface [9, 27]**

#### Items of Note

- Low Temperature FAC wear mechanism
- Close-up view of surface degradation of elbow
- Operating temperature between 75°F to 125°F (24°C to 52°C)
- Carbon steel material
