# Guide to Optimized Nuclear Low-Pressure Turbine Rotor Inspection

Prepared by  
EPRI NDE Center, Charlotte, North Carolina

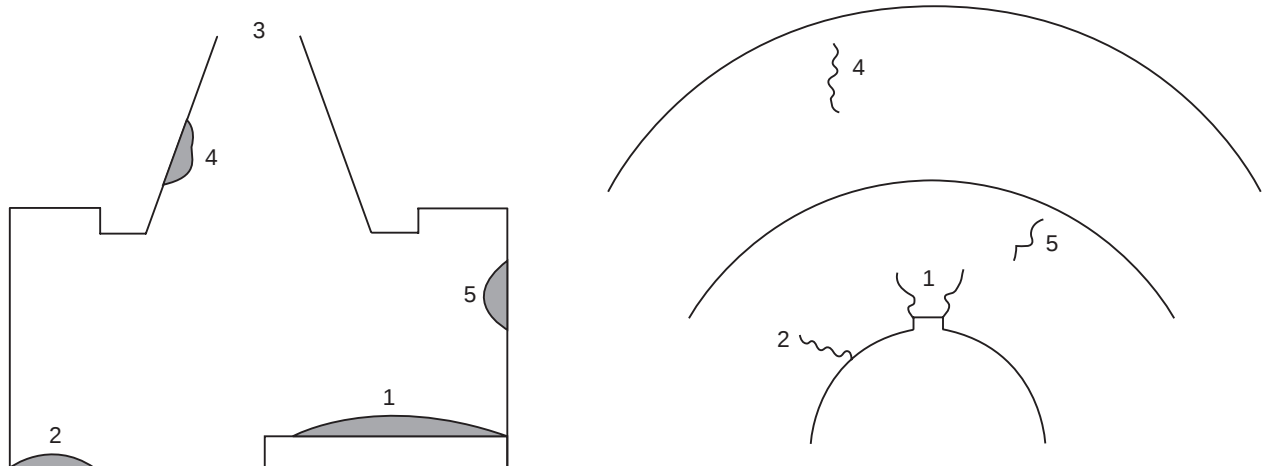
Figure 2-1  
Primary Locations for Stress Corrosion Cracking

Disk inspection is a term commonly used to describe the techniques applied to ultrasonic inspection of the keyway, bore, and hub face region of shrunk-on disks. Cracks 1, 2, and 5 (see Figure 2-1) are of the type the inspection is designed to detect. Indication 3 represents cracking in the blade attachment region and will be discussed later in this section. Indication 4 in Figure 2-1 is a crack on the surface of the web and is detected by surface-sensitive techniques, such as magnetic particle testing (MT) or penetrant testing (PT), which are not part of the disk ultrasonic inspection procedure.

To detect flaws that are aligned on the hub face, shown as crack-type 5 in Figure 2-1, a refracted ultrasonic beam from the hub outside diameter (OD) is used. The transducer is placed on the hub OD and pitched slightly toward the face of the hub to obtain the best results.

The purpose of the blade attachment inspection is to detect cracks in the dovetails of the disk rim where the blades are installed, shown as Indication 3 in Figure 2-1. EPRI has published technical report TR-104026, *Inspection of Turbine Disk Blade Attachment Guide: Volume 1, Background and Inspection Principles* that provides more detailed descriptions of these inspections [7]. Depending on the design, the dovetails can be circumferential or axial. Figure 2-4 shows a typical circumferential dovetail design with cracks in the expected locations. It is important to know certain features about the dovetail geometry to enable proper inspection. The manufacturers have machine drawings of the dovetails. Other vendors must rely on alternative methods to determine the geometry prior to the inspection.

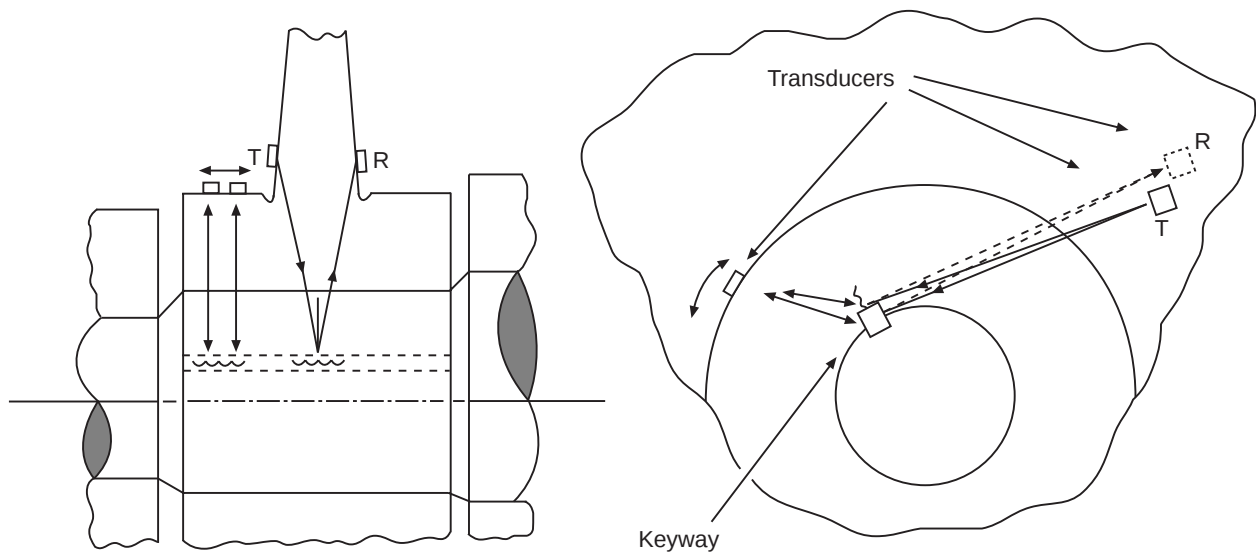
Figure 2-2  
Ultrasonic Transducer Placement for Crack Detection

Most vendor inspection routines require two separate scans: detection scans and defect sizing scans. During detection scans, the ultrasonic transducers are placed on the wheel, as shown in Figure 2-2. The ultrasonic beam is introduced in a tangential direction toward the bore and keyway region, approaching the expected flaw as shown. Best detection occurs when the beam direction is perpendicular to the flaw face or when a corner reflector is formed by the flaw and the disk surface. To maximize the coverage

area at the keyway and bore during the web inspection, the pitch-catch transducers are moved radially inward and outward on opposite sides of the disk.

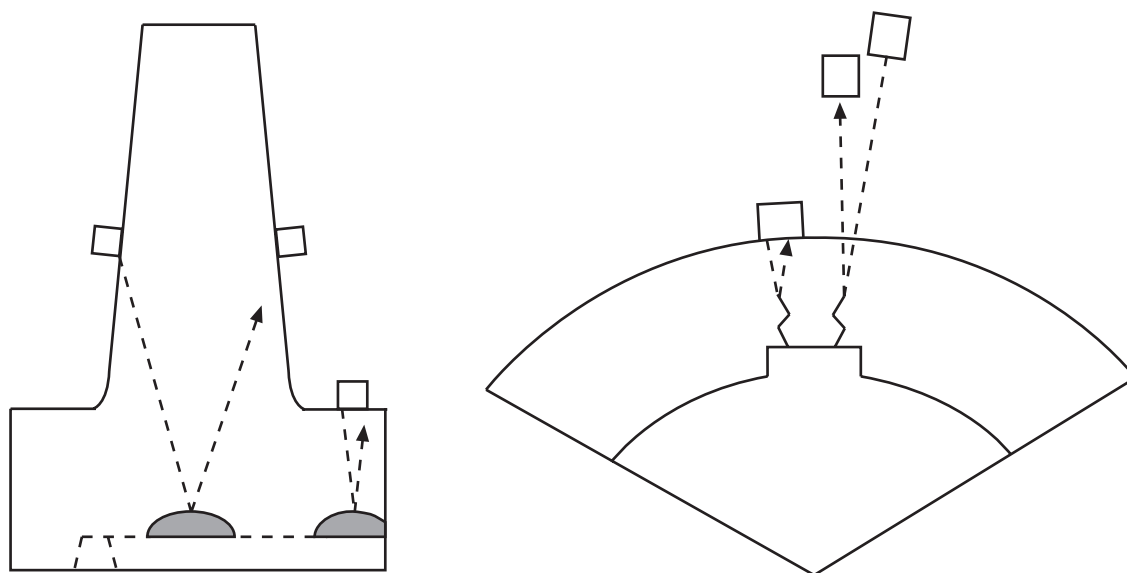
Figure 2-3  
Ultrasonic Transducer Placement for Crack Sizing

In the second step, sizing of indications found during the detection scans is typically performed using a zero-degree tip diffraction technique, directing the ultrasonic beam radially inward, as shown in Figure 2-3. Pitch-catch techniques are again used to size flaws under the web and pulse-echo techniques are used under the hub. Often during an inspection, flaws will be identified during the detection scan that cannot be verified with the sizing scan because they are too small or unfavorably oriented. When this occurs, the vendor usually assigns a default size that is based on historical data of such experiences.

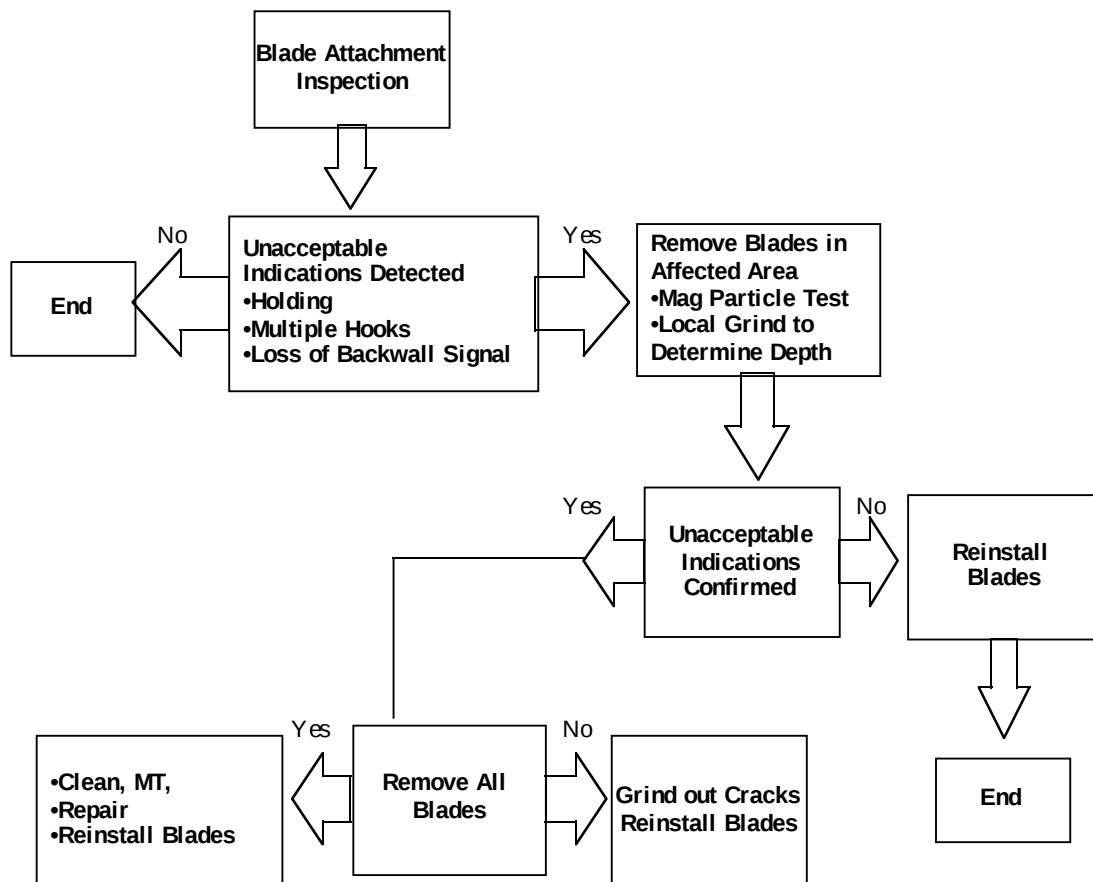
Figure 3-1  
Sample Decision Tree for Blade Attachment Inspection

Once the preliminary engineering analysis is complete, decision trees or flowcharts can be developed. The goal is to gather the key engineering and management decision makers together, review the most probable “what if” scenarios, and map out the actions to be taken based on the actual inspection results. The decision trees permit significant decisions to be made prior to the beginning of the outage based on the quantity and size of indications found during the actual inspection. Then, if problems arise with one or more of the most life limiting rotor components during the exam, the appropriate alternative inspection, analysis, or repair options will have already been considered and a course of action can be chosen quickly. A sample decision tree is shown in Figure 3-1.

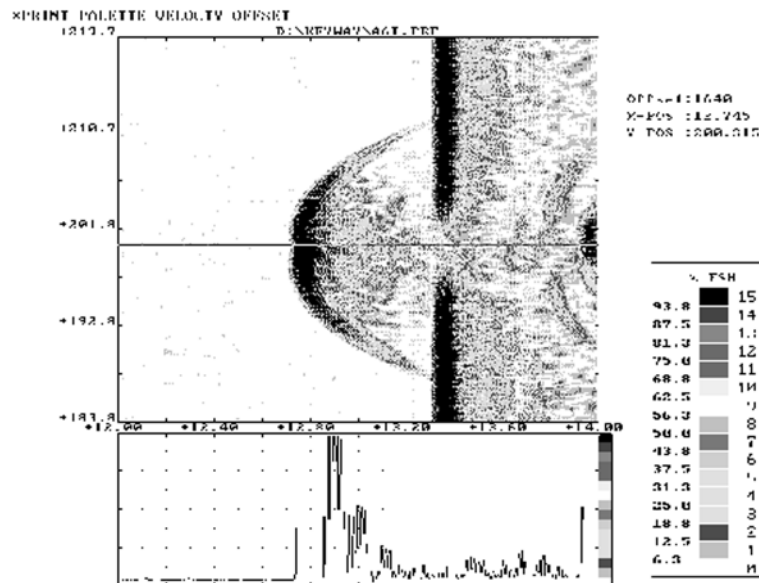
Figure A-1a  
Keyway with No Indications

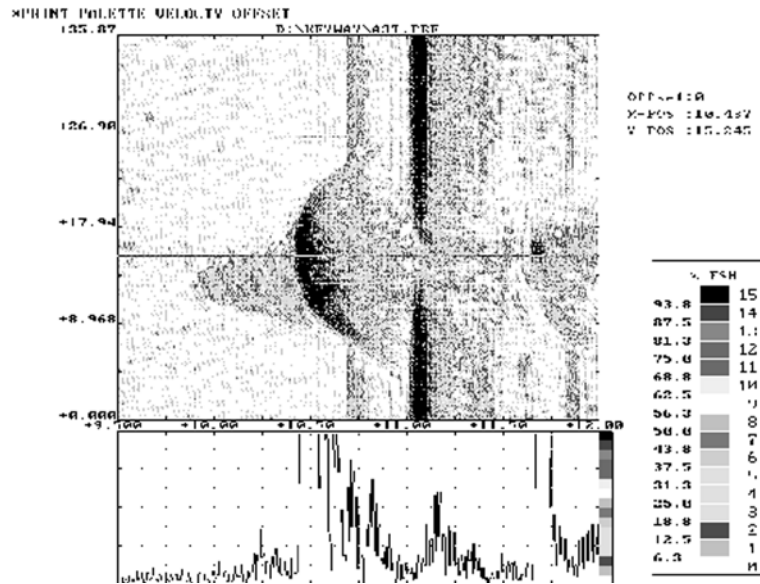
Figure A-1b  
Keyway with Crack Indications

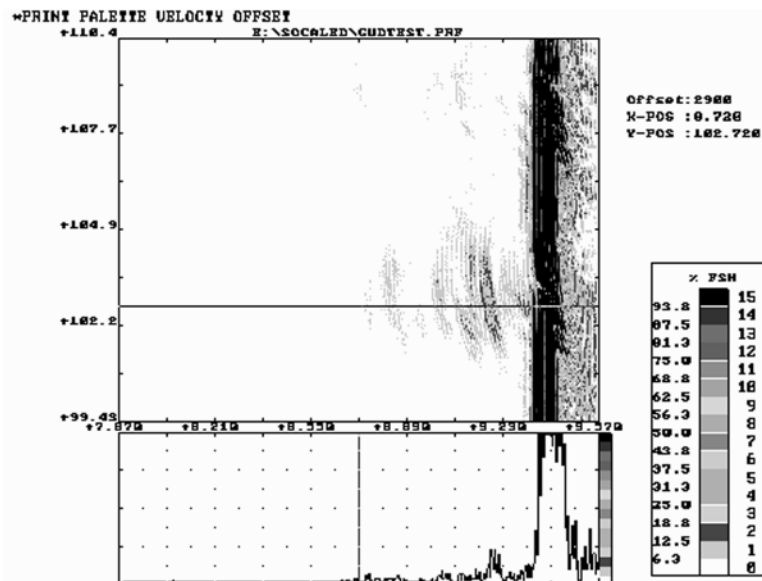
Figure A-1c  
Bore Crack Indications
