Materials Reliability Program (MRP) EdF Thermal Fatigue Monitoring Experience on Reactor Coolant System Auxiliary Lines (MRP - 69)

Technical Report

Final Report, April 2002

Electricité de France

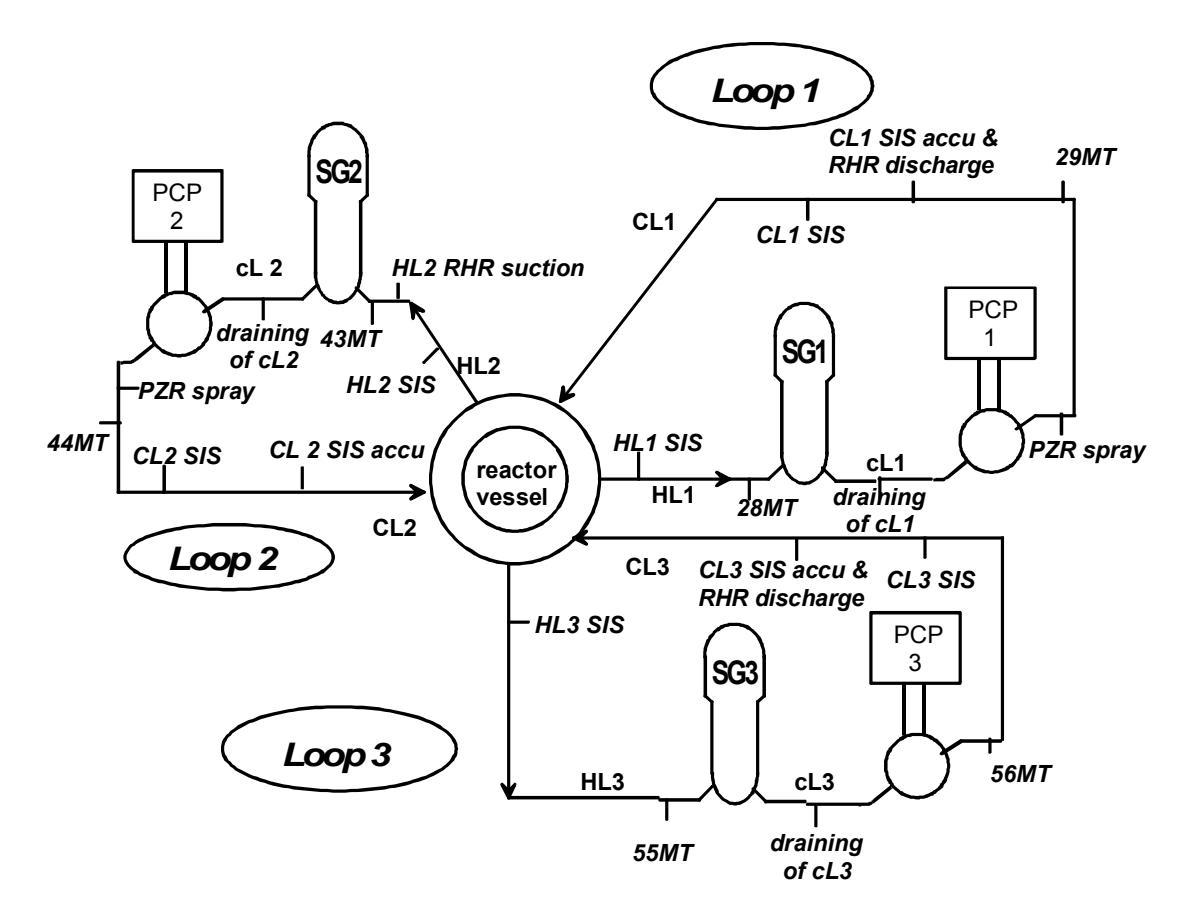
Figure 2-1 shows the positions of the main auxiliary lines of the RCS on a 900 MW power plant. It also indicates the position of the primary temperature sensors in Hot and Cold Legs (44 MT, 43 MT, ...). The surge line to the pressurizer is located approximately 2000mm upstream of the HL1 SIS branch.

Figure 2-1 900 MW Reactor Coolant System diagram

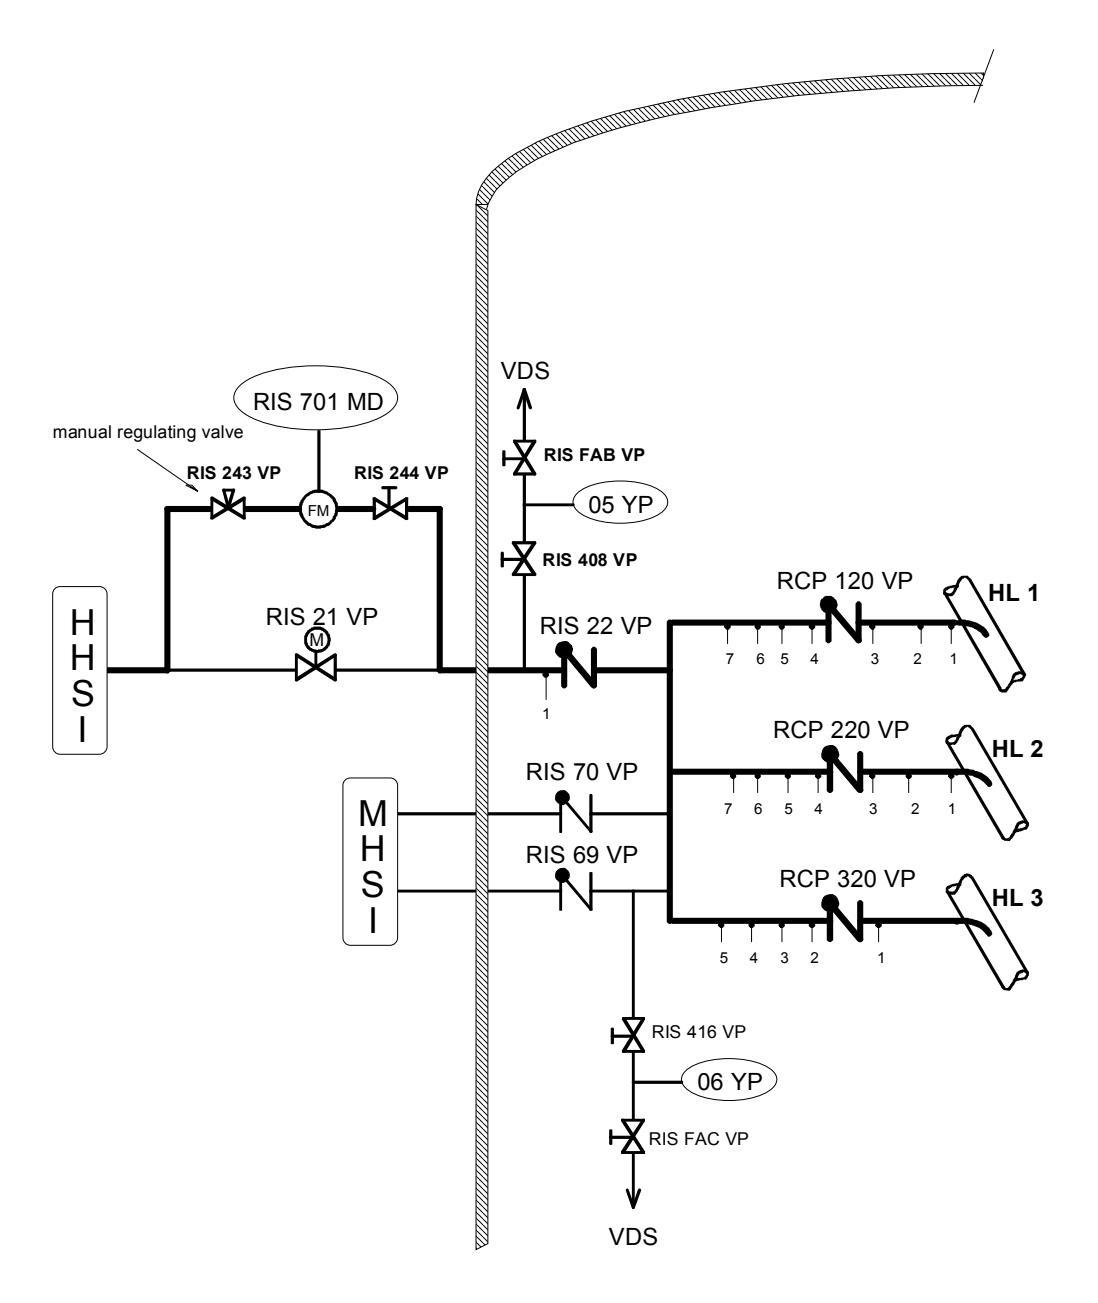
The data of Blayais 1 injection tests were forwarded to EPRI in their entirety. Figure 2-2 is a functional diagram of the specific instrumentation.

1, 2, 3 ... = instrumented section number 06 & 05 YP = pressure sensor RIS 701 MD = flow meter M = motorized valve

Figure 2-2 Blayais 1 injection tests diagram

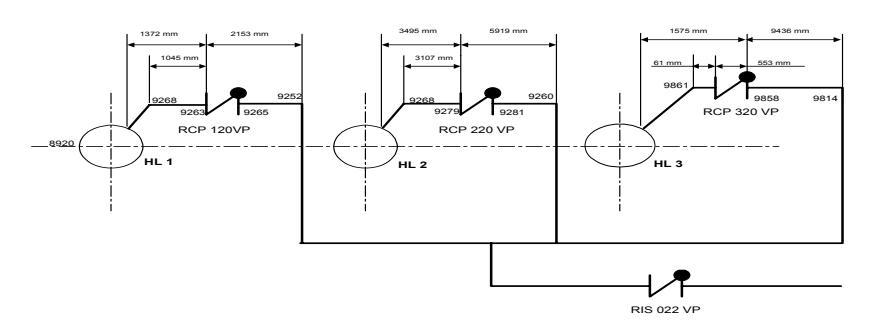
Figure 2-3 and Table 2-5 give positions and elevations of the Hot Legs, the first elbow, the first isolation valve, and the second elbow for the three SIS in Hot Leg lines. Some dimensions are not real dimensions but represent the cumulative length of the auxiliary lines. All branches shown in Figure 2-3 are oriented 30-degrees upward from the horizontal. The elevation of the branch inlet is approximately 9080mm. The dimensions indicated are horizontal lengths measured to the inside surface of the pipe.

Figure 2-3 Blayais 1 SIS in Hot Leg positions and elevations

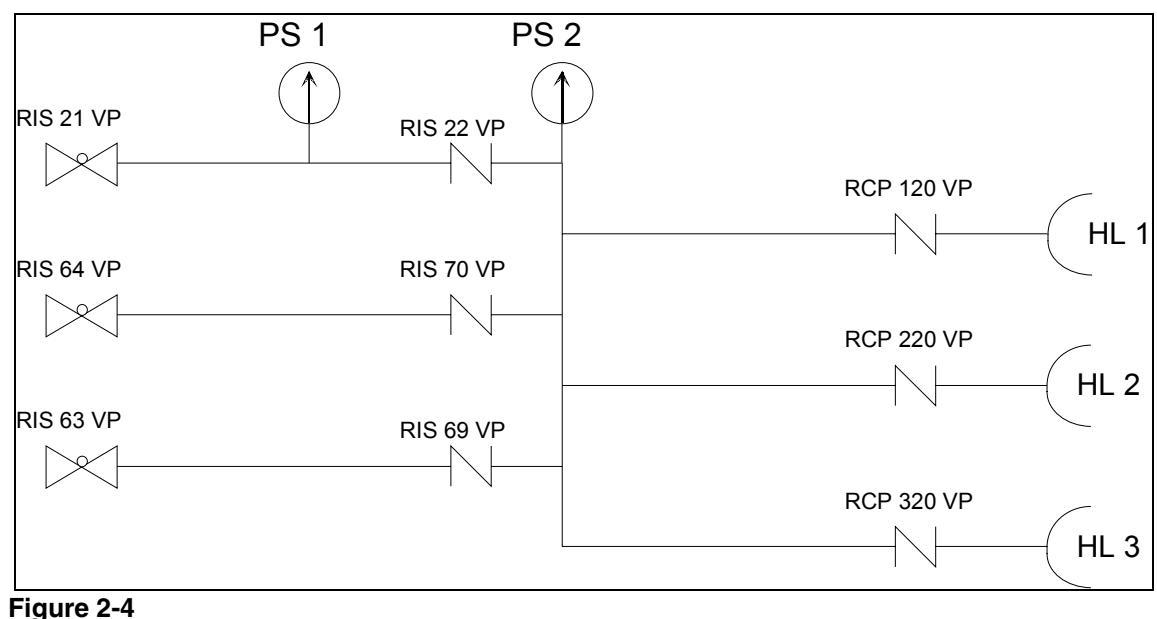
Figure 2-4 presents the position of pressure sensors :

Dampierre 1 pressure sensors positions

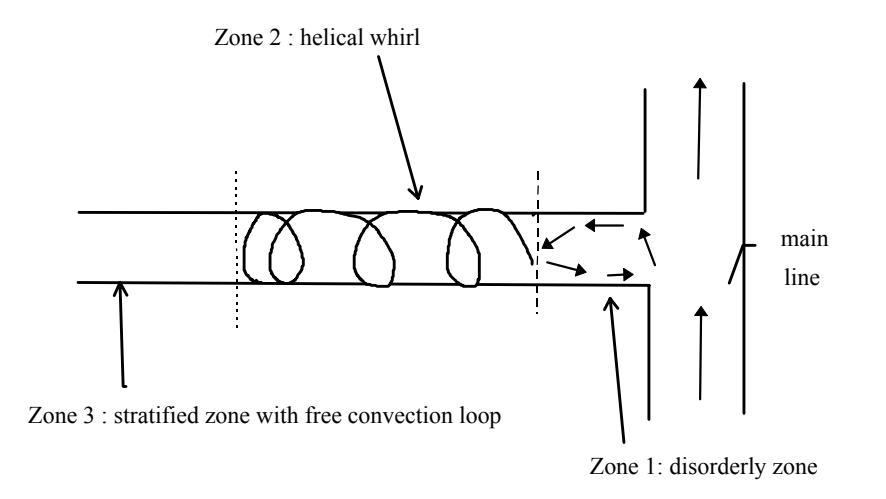
The intersection between the main piping and the auxiliary line is called the nozzle. This is the place where the turbulent flow (with a high Reynolds number) of the primary fluid undergoes shearing, thereby causing the fluid to be recycled in the dead leg. Under certain circumstances, this recycling may degenerate into a whirl. Its complex structure is made up of three zones (Figure 3-1).

Figure 3-1 Diagram showing dead leg penetration

The flow is very disorderly in the zone next to the nozzle (the first three diameters of the dead leg). We have here a penetration vortex the axis of which is perpendicular to the nozzle plane. The vortex then becomes gradually dissymmetric and turns into a helical whirl structure. At this stage, it is made up of two interweaved helical zones, the fluid originating from the nozzle being located in the most outlying zone (Figure 3-2). The fluid returns back toward the nozzle down the center of the pipe. This phenomenon does not appear to depend on the orientation of the pipe and has been confirmed by velocity measurements made in a mock-up facility.

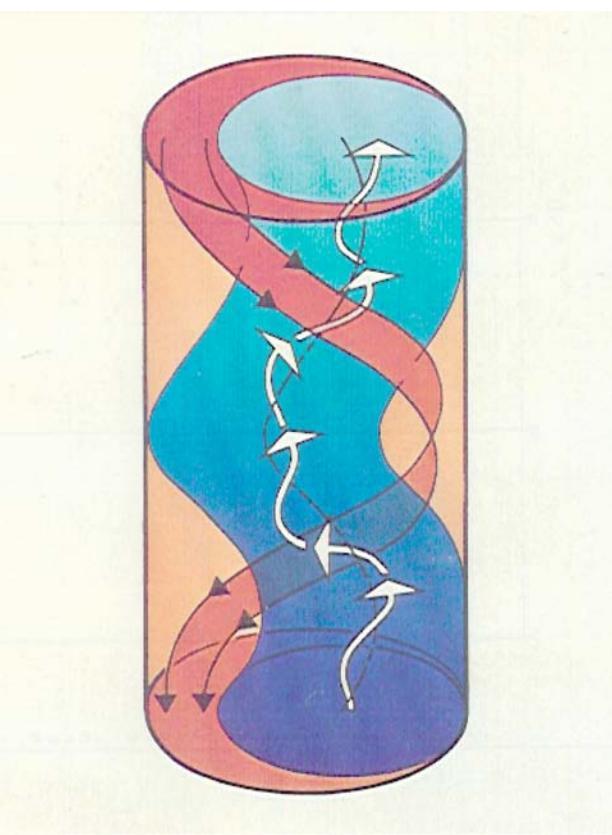
Figure 3-2 Diagram of the flow measured on mock-up

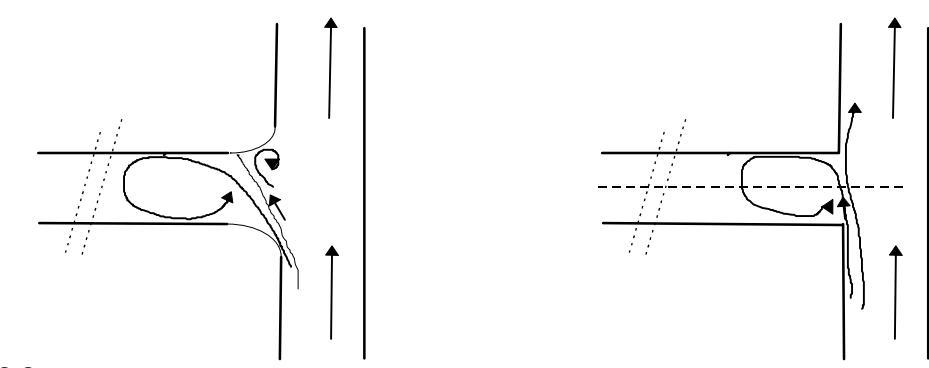
- the Reynolds number;
- the shape of the nozzle blend radius which strongly influences the penetration depth and possibly, to a lesser extent, the branch line/RCS diameter ratio (Figure 3-3);
- the upstream conditions (i.e., mean velocity field), on which the penetration depth is dependent.

Figure 3-3 Influence of the welding chamfer on the penetration depth

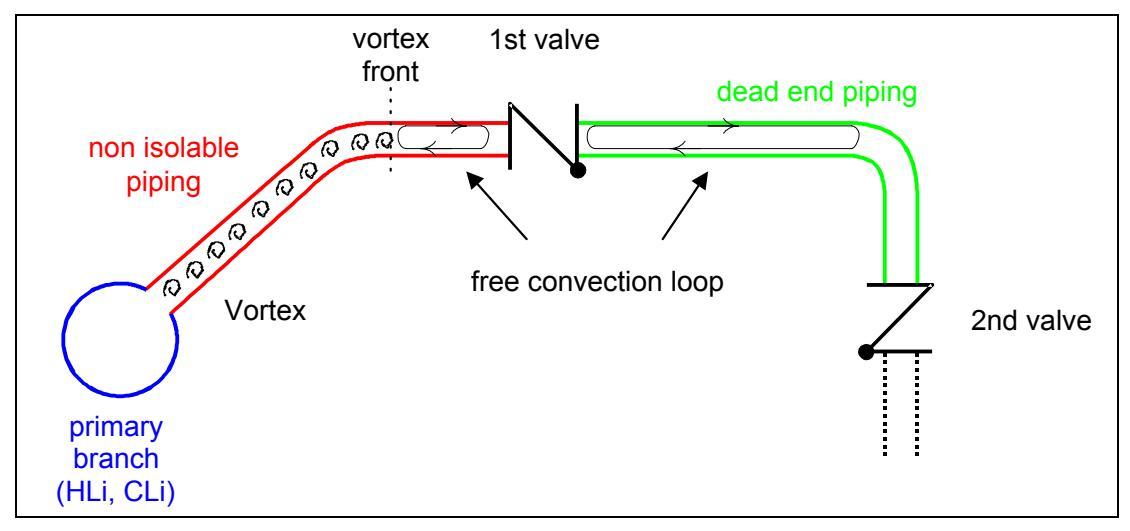
In this case or when the vortex reaches the first valve, provided that the line configuration permits this, the valve becomes the hot source of a natural convection loop developing within the dead end line portion of the isolable piping, with a mechanism identical to that of the non isolable line section.

This mechanism is shown in Figure 3-4:

Figure 3-4 Diagram of convection loops in a dead leg

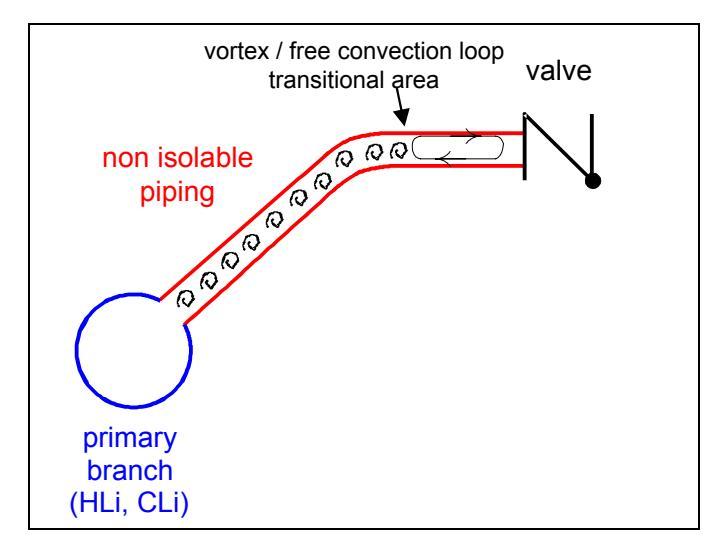
The type of cycling generally appears in the transitional area between the zone still affected by the whirl penetration and the associated convection loop (Figure 3-5). The less the vortex energy, the more important the cycling. Sometimes, lesser fluctuations can be observed in the vortex area.

Figure 3-5 Location of cycling in the non-isolable section

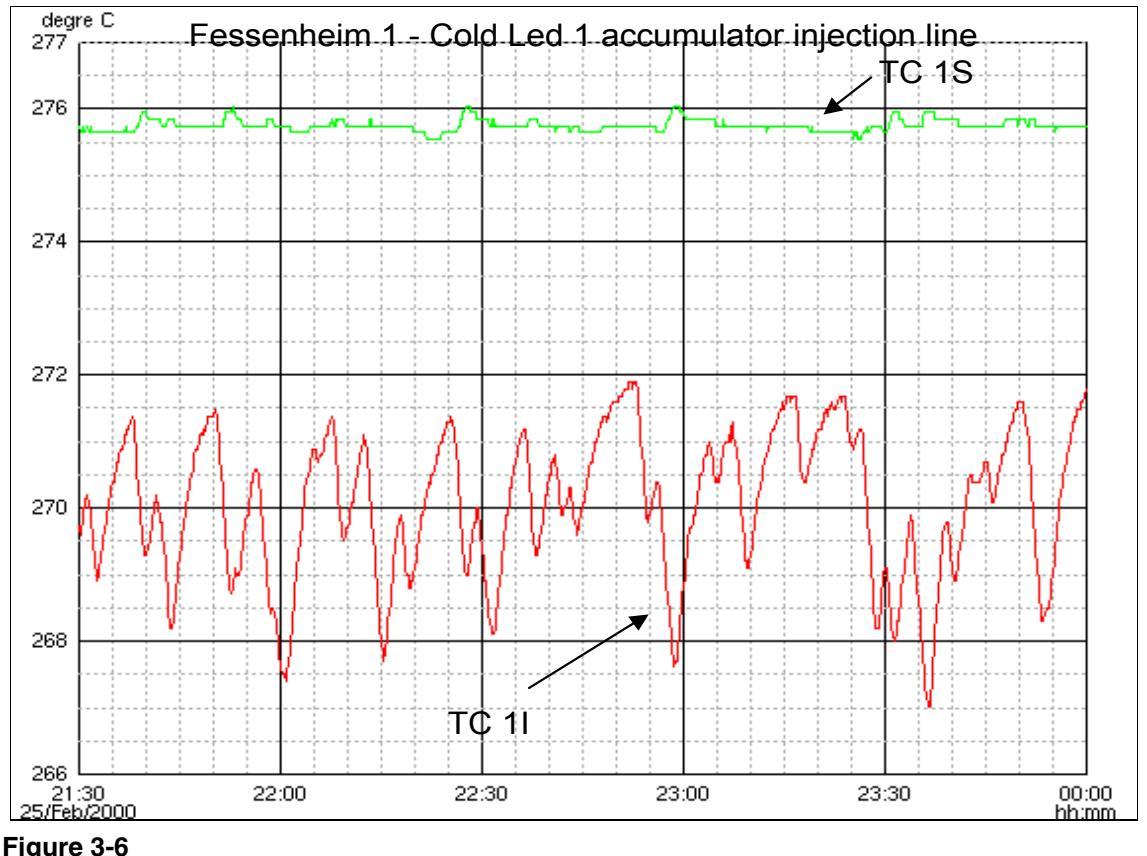
In case the whirl reaches the first valve, the line temperature is very close to that of the primary line. When dealing with a horizontal section between two isolation valves, a slight difference in temperature between the top and bottom of the pipe (Figure 3-6) is often to be seen in the vicinity of the valve located on the primary side, even though one would rather expect the temperature to become homogenized by the vortex. This is due to the fact that the heat transferred through the valve leads to the formation of a natural convection loop on the opposite side of the valve. This loop tends to cool down the lower part of the valve. From this results a

stratification gradient of a few degrees centigrade between the top and the bottom of the pipe in the non-isolable section.

Difference in temperature on the non-isolable section

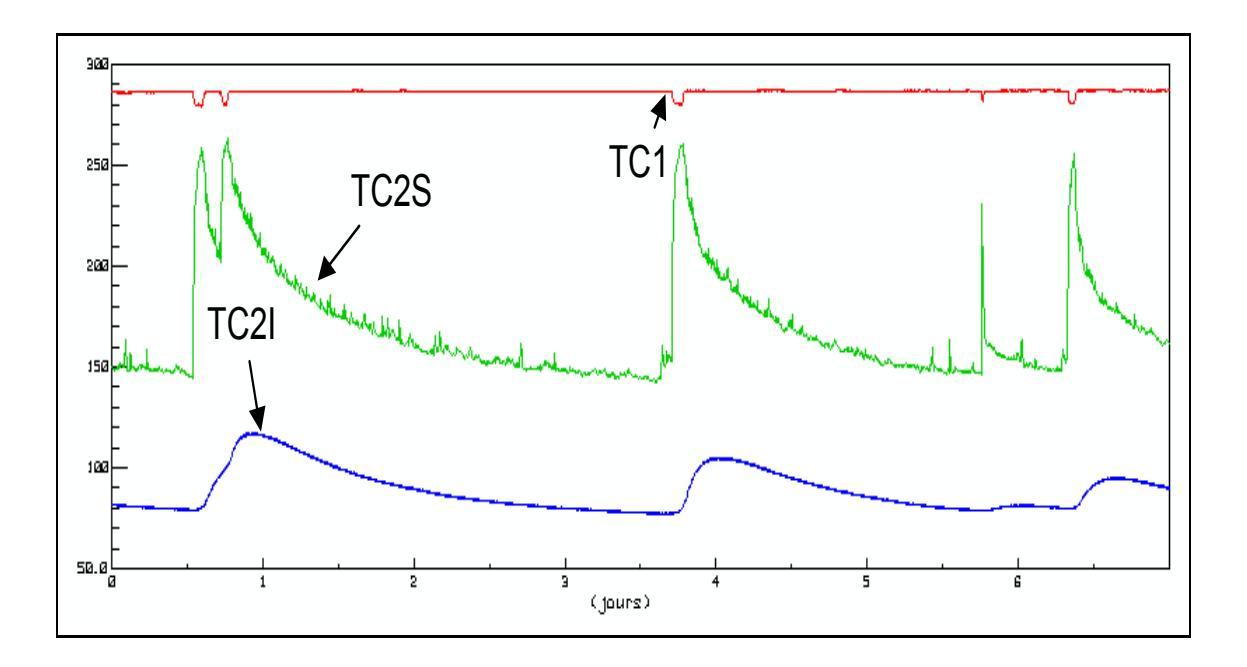
On some longer downward vertical lines (such as the Blayais 1 Cold Leg 3 accumulator injection line), the cycling is noticed along the upper pipe surface (Figure 3-7). It is combined with substantial thermal stratification ($\Delta T_{_{25-21}} = 85^{\circ}$ C in this case). This can be explained by the fact that the vortex front is located in the zone of the vertical elbow (located at a distance of about 18 D from the nozzle) and that a hot stream, the temperature of which varies depending on the instability of the whirl, heats up the upper surface of the pipe, thus creating a strongly stratified zone. These variations remain within a limited range (<28°C), compared with the thermal shocks which are the subject of 4.2.

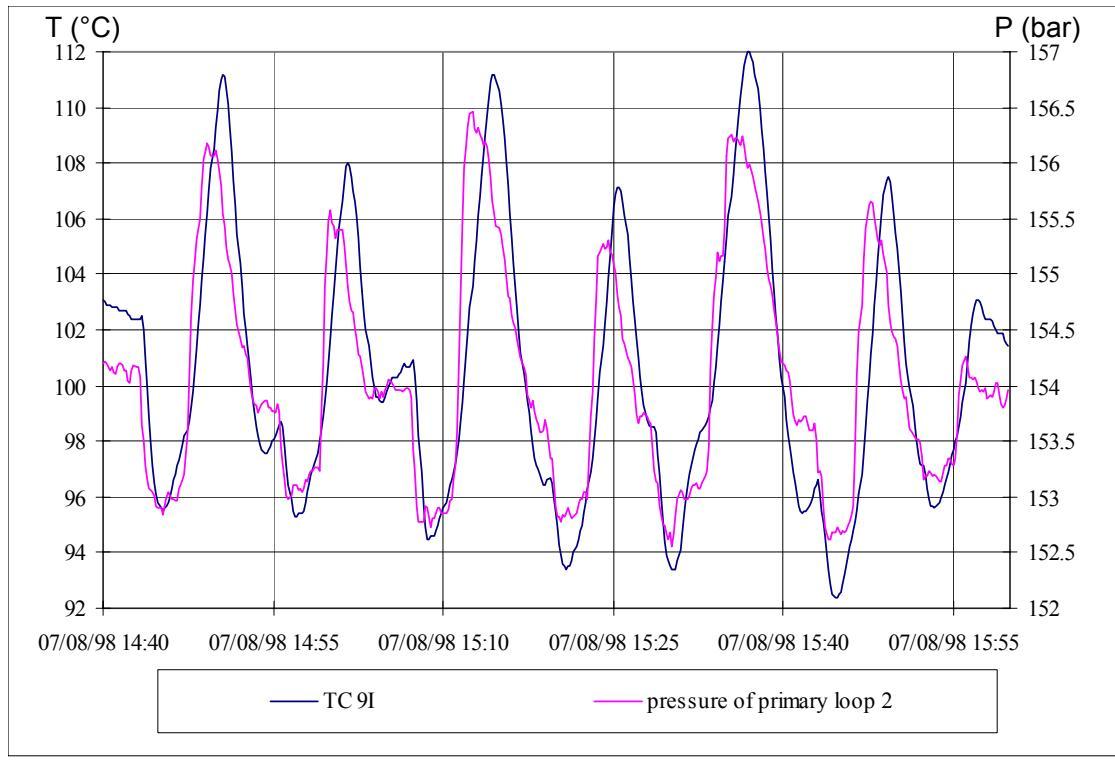
The cycling taking place in this section is either due to variations in the primary pressure in the equipressurized situation (Figure 3-8) or to fluctuations in the position of the interface water / saturated mixture of water and steam. In the first case, it concerns small displacements of fluid caused by variations in the primary pressure which show themselves by cycling (i.e., a small reduction in pressure allows a small flow of cold water past the check valve which cools the fluid near the thermocouple).

Figure 3-8 Thermal cycling due to variations in the primary pressure (Dampierre 1 Hot Leg 1 SIS)

Additionally, some cycling has been observed during peculiar periods. Indeed, a cycling correlated with exceptional variations in the primary pressure was proven at the level of the lower surface of the dead-end section of the Hot Leg 1 injection line at Blayais 1 (TC 5I and TC 6I). This situation is possible because of the balance of pressure. The fluctuations in temperature remain within a limited range, lower than 10°C. It must be noted that the Hot Leg 2 and 3 injection lines are not affected by this phenomenon which was also proven at Dampierre 1. At the level of TC 9I of this unit, slow thermal variations with a significant maximum range (20°C) were observed, closely correlated with the pressure within the primary coolant loop 2 (Figure 3-8). Due to the lack of information on the pressure values of the other primary legs, this instrumentation has not enabled us to refine our knowledge of the phenomenon involved. However, one may state that wide ranges which are connected to substantial variations in the pressure of loop 2 are rare. Moreover, in the Hot Leg 1 injection line at Blayais 1, more precisely in non-pressurized situations (dead-end section pressure of 3 bar), we observed a thermal cycling during the power decrease to hot shutdown (amplitude 10°C and pseudo-period 10 min) in the lower surface of the dead-end section, which was attributed to a fluctuation of the water – saturated water/steam mixture interface. The occurrence of this phenomenon solely during the pressure decrease to hot shutdown phase was unable to be explained.

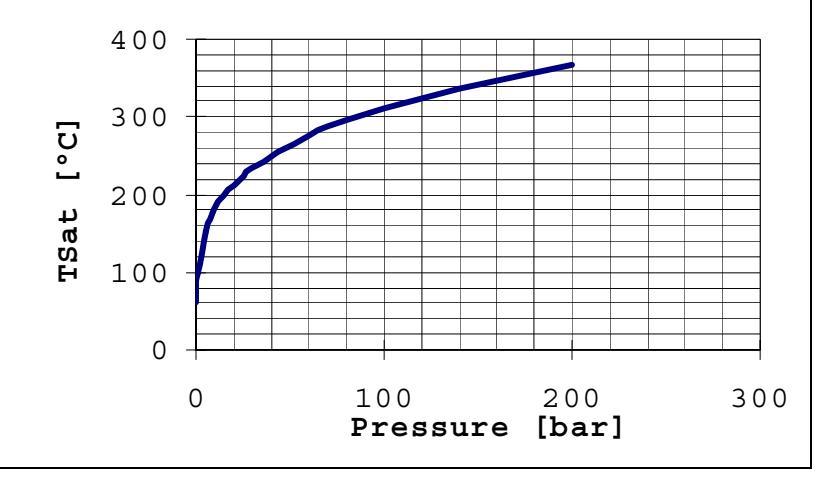
⁽⁴⁾ A cross indicates that, depending on the pressure in the dead-end section, the zone may show a two-phase state. The water saturation curve is shown in Figure 3-9.

Figure 3-9 Water saturation curve

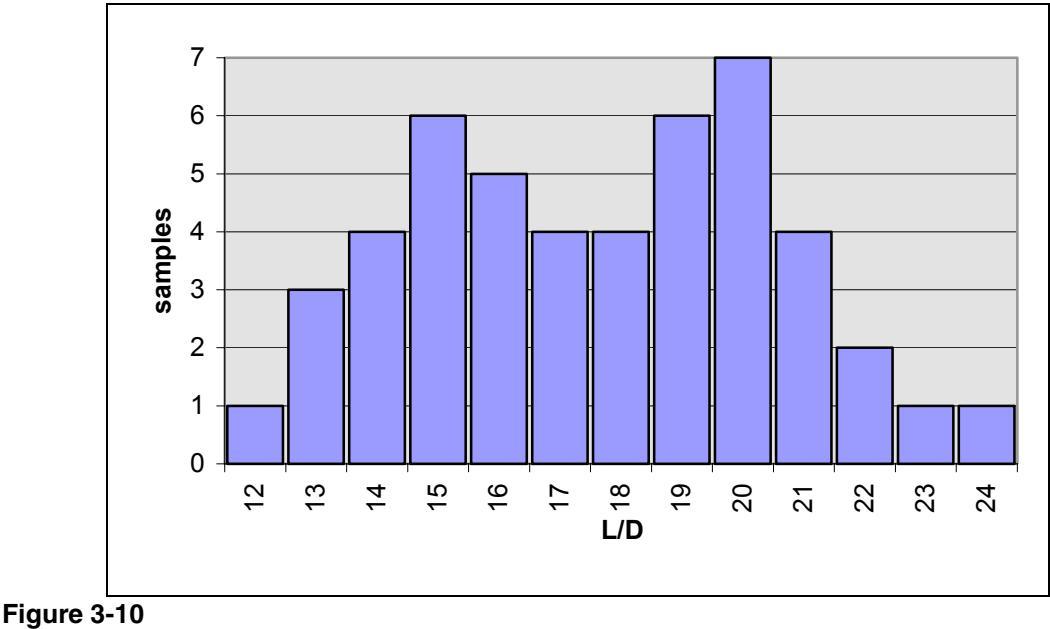
The superposition of these brackets produces the histogram shown in Figure 3-10.

It should be noted that the histogram above does not show the exact position of the vortex phenomenon, but the range in which the phenomenon is observable. Therefore, the extreme values are probably not indicative of vortex fronts and depend on the definition of the instrumentation. Thus, the actual distribution of vortex front lengths is narrower.

In conclusion, the vortex phenomenon can be observed in all instrumented lines. The penetration varies for every line investigated, independently of its geometry. Instrumentation of dead legs allows us to conclude with near certainty that the vortex length always ranges from 14D to 21D.

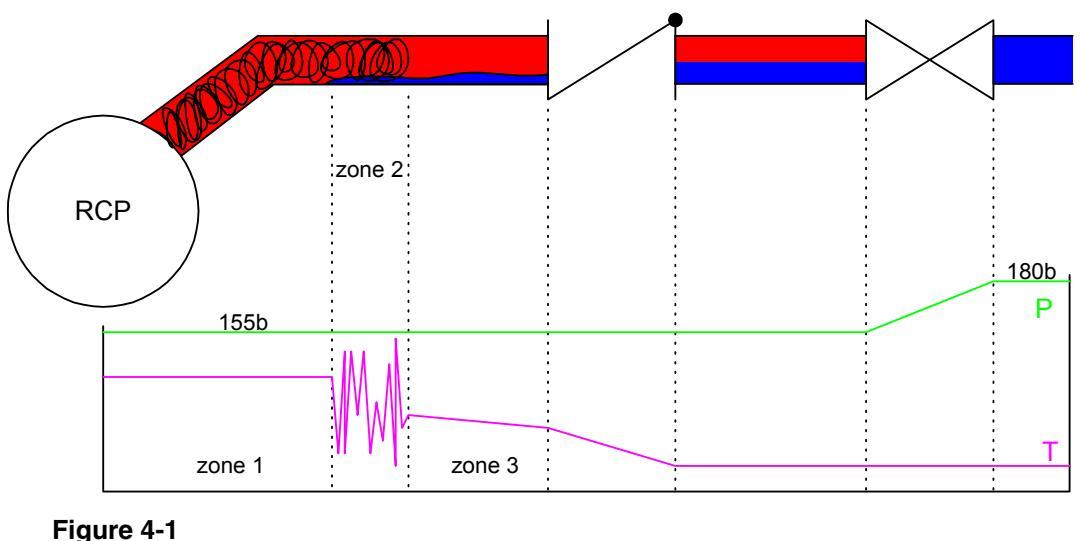
The high-pressure safety injection is performed by the charging pumps (CVC). The motorized or manually operated wedge gate valves isolating the SIS lines from the CVC system must withstand a pump discharge pressure of 180 bar. The RCS pressure being 155 bar, the non-tightness of either of these valves leads to the appearance of a thin cold water stream along the lower surface of the non-isolable section, so that a thermal stratification zone is created (zone 3 of Figure 4-1). The thin cold water stream meets with the hot water vortex; this is the clash zone (zone 2), the location of which depends on the cold water flow rate. In this zone 2, when the cold water comes in contact with the pipe, the temperature of the metal decreases. Then the water conveyed by the vortex chases the cold water and heats the wall. Therefore, the vortex loses part of its energy and is no longer capable of bringing along the thin cold water stream, so that the latter will flow again. When the energy brought in by the primary fluid becomes preponderant anew, the cycle will take place again.

Diagram of the Farley-Tihange phenomenon

Thus, the wall metal undergoes a thermal cycle that leads to substantial periodic mechanical stresses along the lower pipe surface. Consequently, there is a risk of primary fluid leakage that cannot be isolated when a through-wall crack appears.

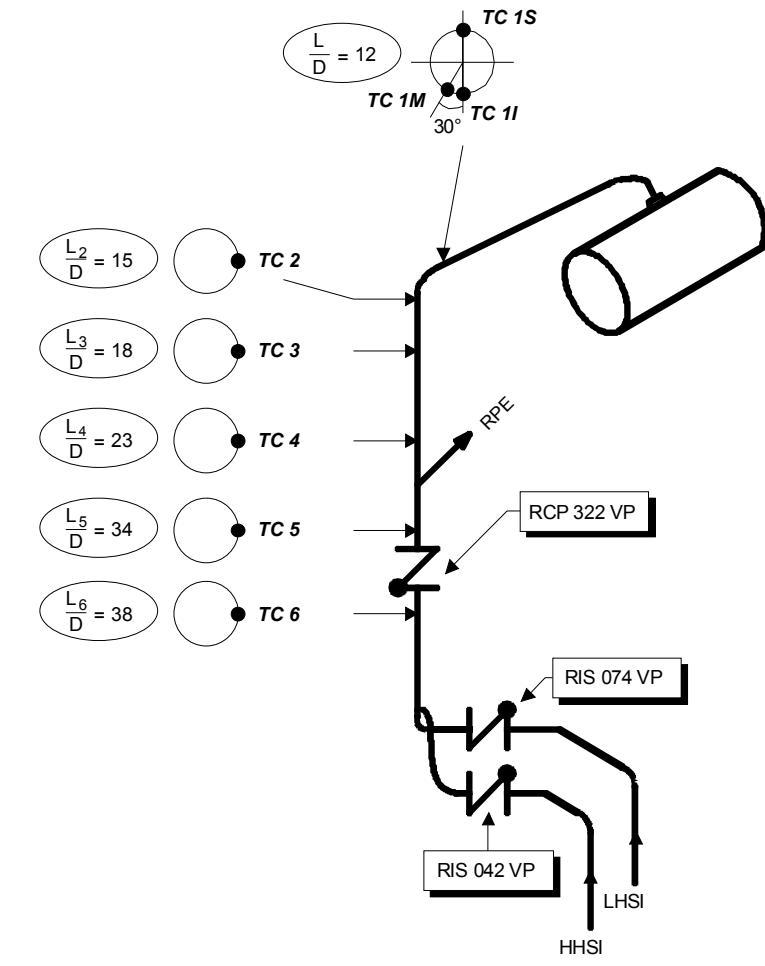
This has been proven by means of the instrumentation set up in Blayais 1 on the Cold Leg 3 injection line (Figure 4-3). Cooling down of section 3 located in the straight line portion downstream of the check valve RCP 322 VP is followed by rapid heating. The maximum thermal characteristics are the following:

- $-\Delta T_{max} = 60 \ ^{\circ}C \ (local \ cooling \ range)$
- $\Delta T / \Delta t_{max} = 0.5 \ ^{\circ}C / min \ (cooling)$
- $\Delta T / \Delta t_{max} = 7 \ ^{\circ}C / min (heating)$
- pseudo-period: variable over the cycle
- maximum frequency of appearance: 3 / day

Figure 4-3 Blayais 1 Cold Leg 3 injection line

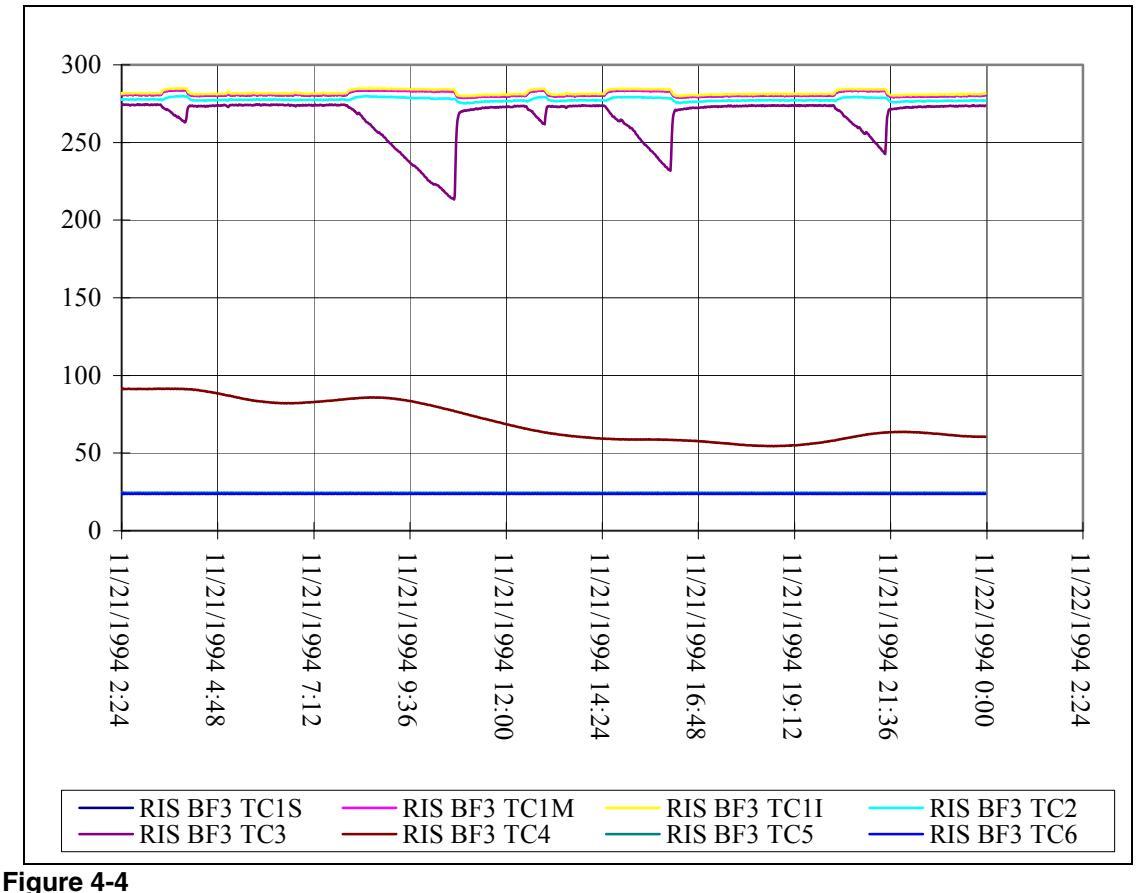
The phenomenon showed itself in a random (or pseudo-random) manner during normal operating modes at 100-percent power in the way described as follows: in parallel to the cooling-down of a part of the vertical section downstream of the check valve RCP 322 VP, followed by rapid heating, one observes slight warming by about 5 °C of the branch pipe (TC1I, TC1M and TC2). The time of occurrence of the phenomenon is totally random. Cooling is ascribed to slow retreat of the vortex in the vertical section towards the branch, thus causing slight warming in the branch area. It should be noted that cooling and warming kinetics are different. The line cools down slowly (this process lasts approximately two hours) by natural conduction to the ambient external milieu, whilst the heating initiated by vortex withdrawal is faster due to forced convection. This phenomenon is shown in Figure 4-4.

Thermal transients on Blayais 1 Cold Leg 1 injection line (°C)

The mechanical calculations performed on this type of transient state (mono-dimensional) show that the axial stress remains far below the fatigue limit of the material (180 MPa).

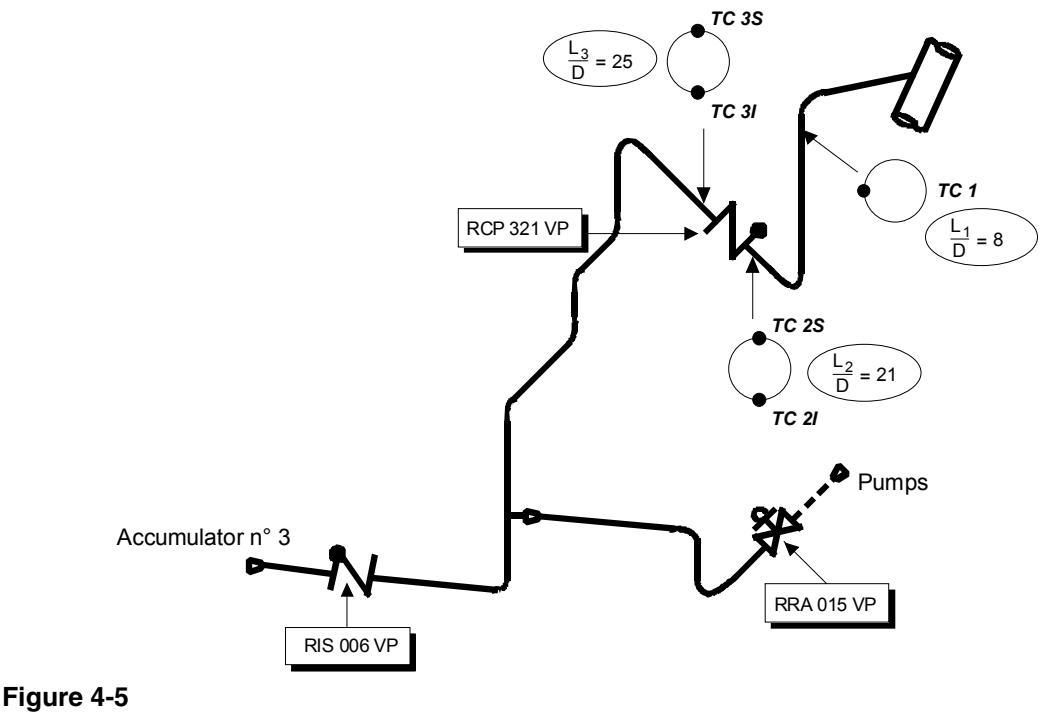
However, this instability may have a greater impact when the vertical section is followed by a horizontal section and when the vortex is located within the elbow zone. Such a case was found in the Cold Leg 3 accumulator injection line of the same unit (Figure 4-5). Heating occurred in the horizontal section downstream of check valve RCP 321 VP and to a greater extent along the upper pipe surface (TC 2S). The phenomenon is shown in Figure 3-7. The maximum thermal characteristics of this case are as follows:

- $-\Delta T_{max} = 120 \ ^{\circ}C$ (heating range)
- $\Delta T / \Delta t_{max} = 25 \ ^{\circ}C / min$
- pseudo-period: variable over the cycle
- maximum frequency of appearance: 3 / day
- heating time: approximately two hours

Cold Leg 3 accumulator injection line

This localized heating phenomenon appeared about ten days after criticality while an overall cooling-down of sections 2 and 3 was observed. From this day on, it showed itself in a random way, whatever the boiler operating mode (power on or shutdown), in a nearly instantaneous temperature increase along the upper pipe surface of section 2 (by 100 to 130 °C) and, as for section 3, in a temperature increase which took place at a slower pace and remained within a less wide range (by 70°C). The lower pipe surfaces of these sections are also affected by the increase in temperature, but with a delay of 2 hours and a range three times smaller. As of mid-October 1994, overall heating of the line occurred and the frequency of occurrence of the phenomenon increased without any obvious cause, thereby preventing the line from cooling down. The range of the transient states in fact diminished; from late January 1995 until the shutdown of the unit in June 1995, the line's thermal load remained globally high and stable without any fluctuation.

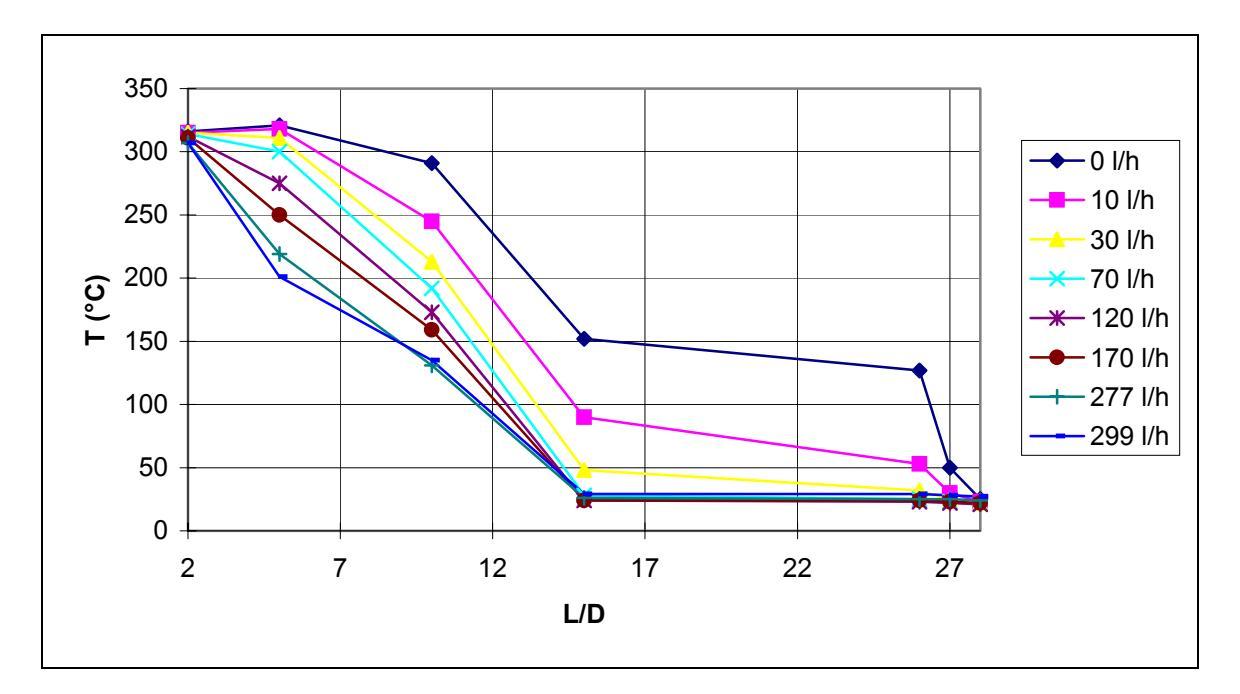
Figure C-1 Hot Leg 1 injection test (0-300 l/h)

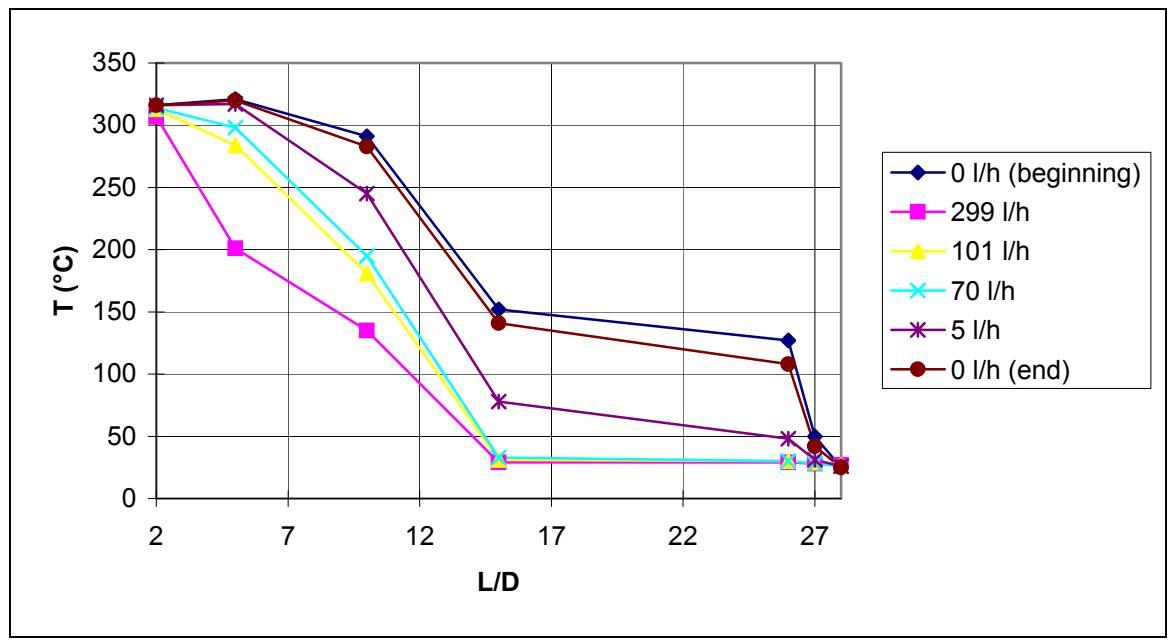
Figure C-2 Hot Leg 1 injection tests (300-0 I/h)

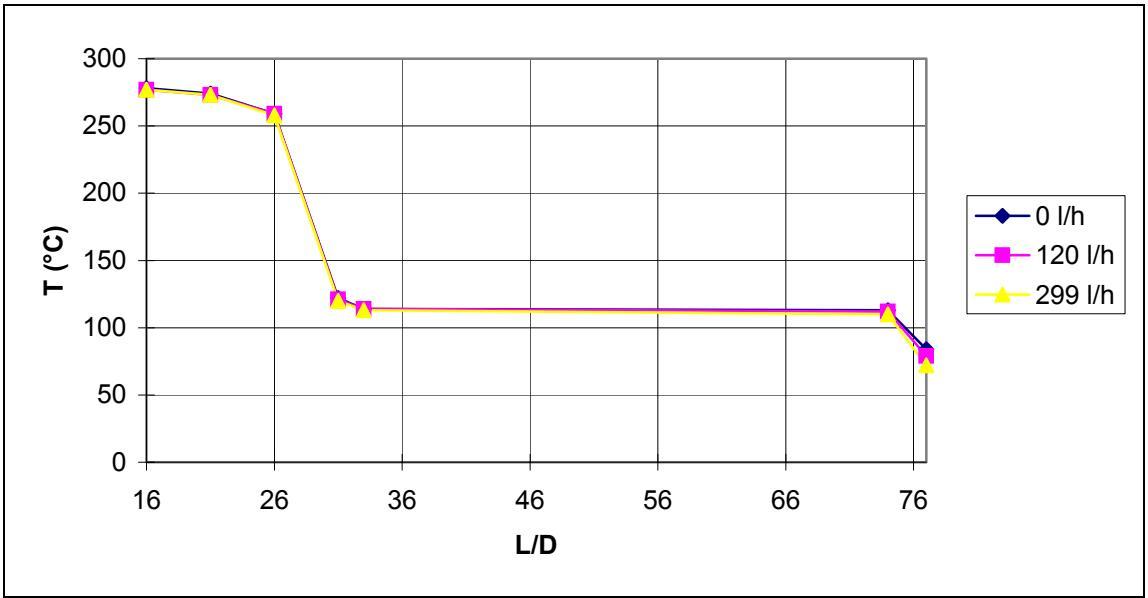
Figure C-3 Hot Leg 2 injection tests (0-300 I :h)

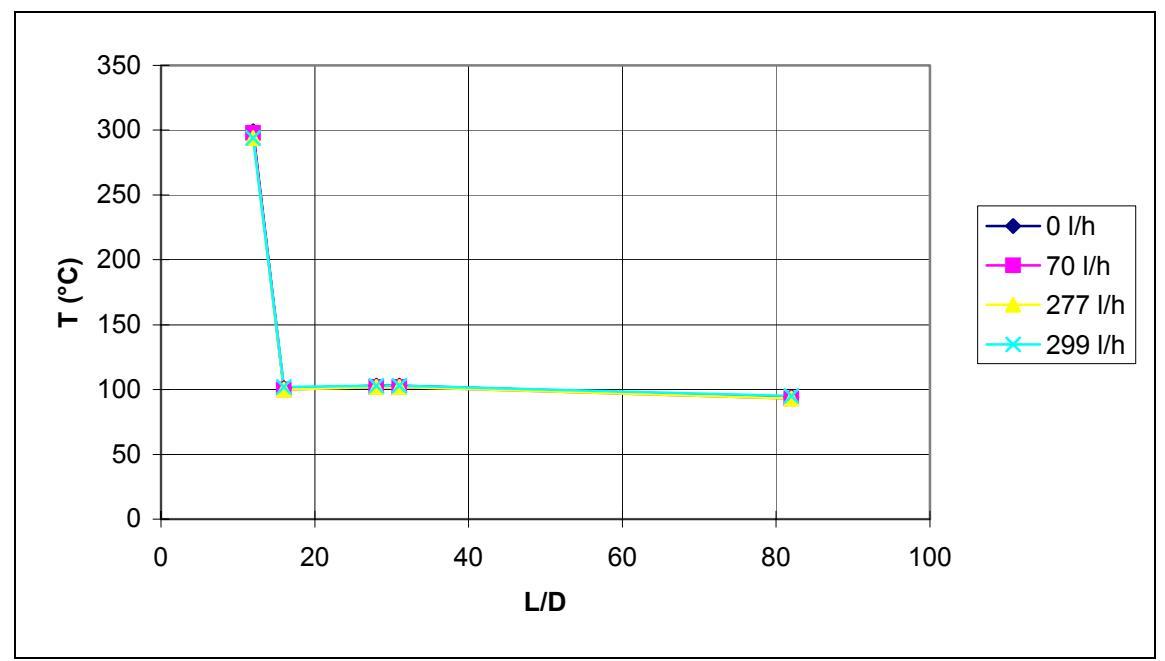
Figure C-4 Hot Leg 3 injection tests (0-300 l/h)

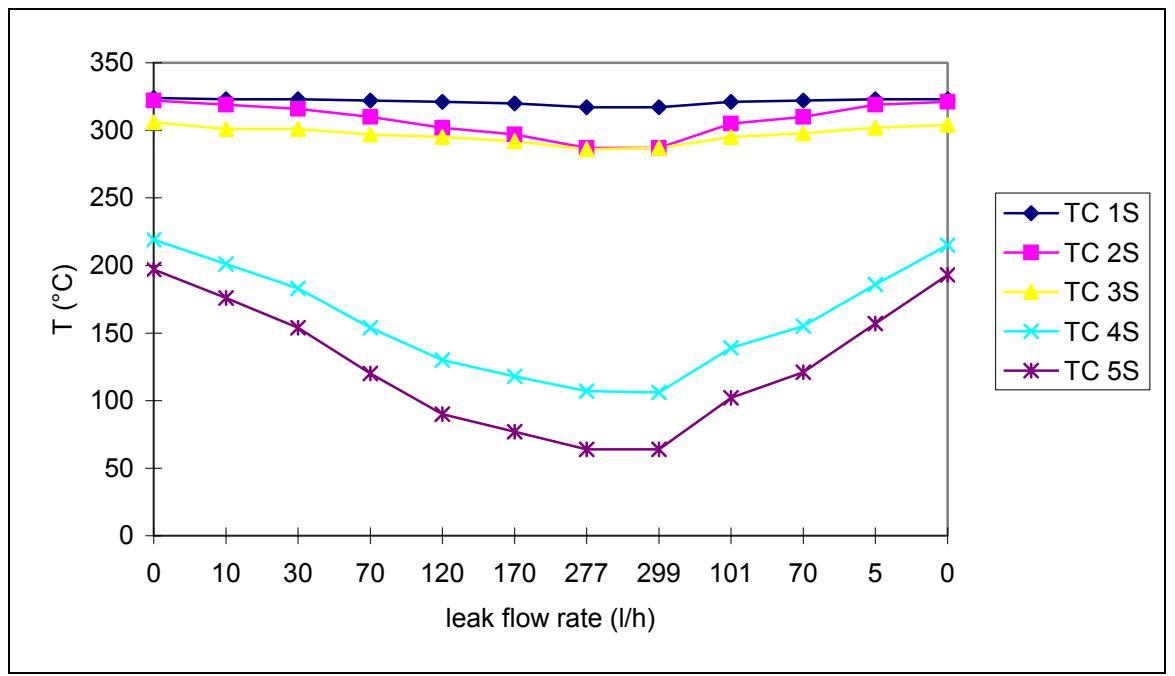
Figure C-5 Hot Leg 1 upper zone temperature evolution

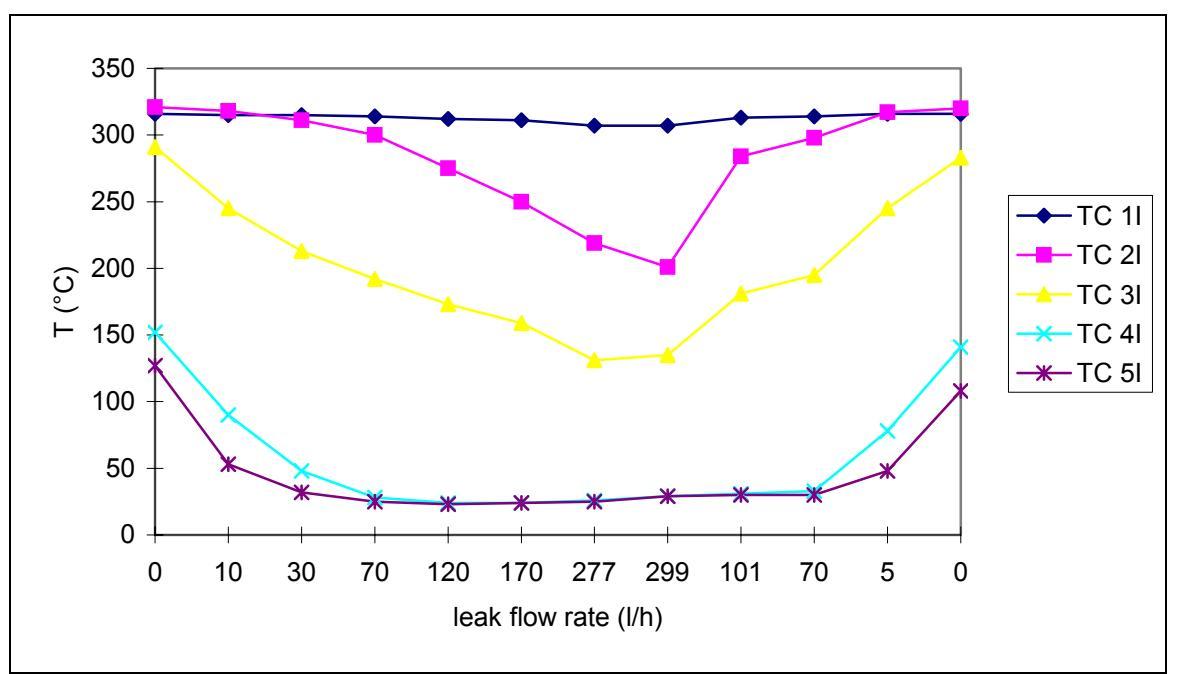
Figure C-6 Hot Leg 1 lower zone temperature evolution

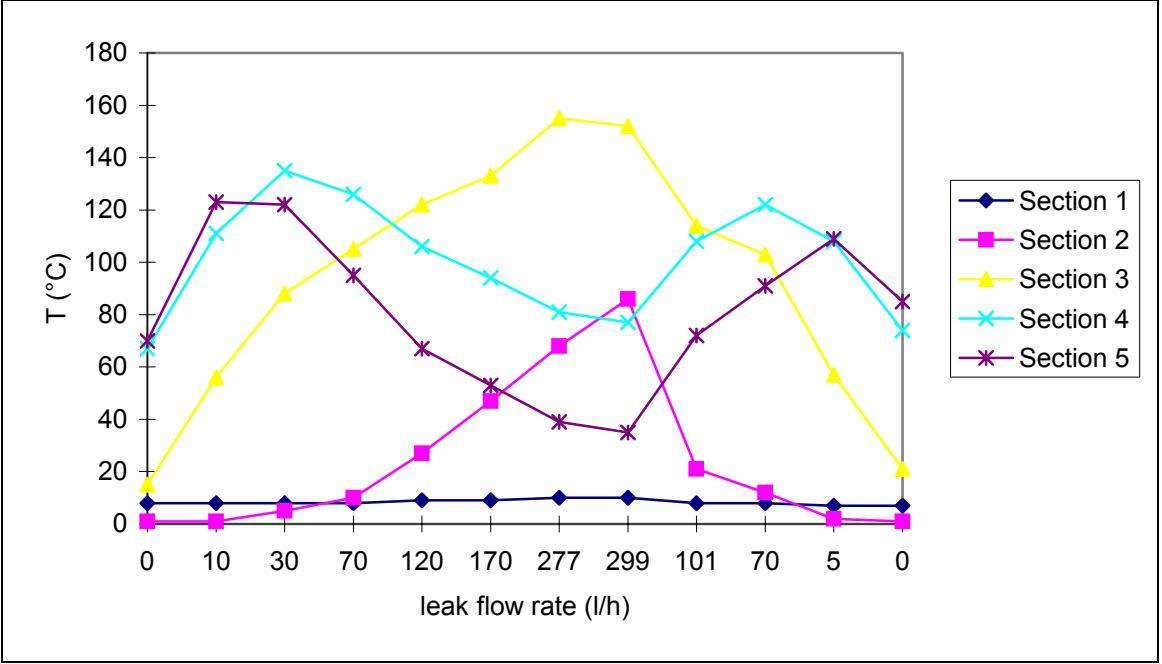
Figure C-7 Hot Leg 1 stratification evolution
