EPRI Case History Study: High Pressure Feedwater Heater Replacement

A Success Story in Outage Management and Project Execution

Technical Update, December 2005

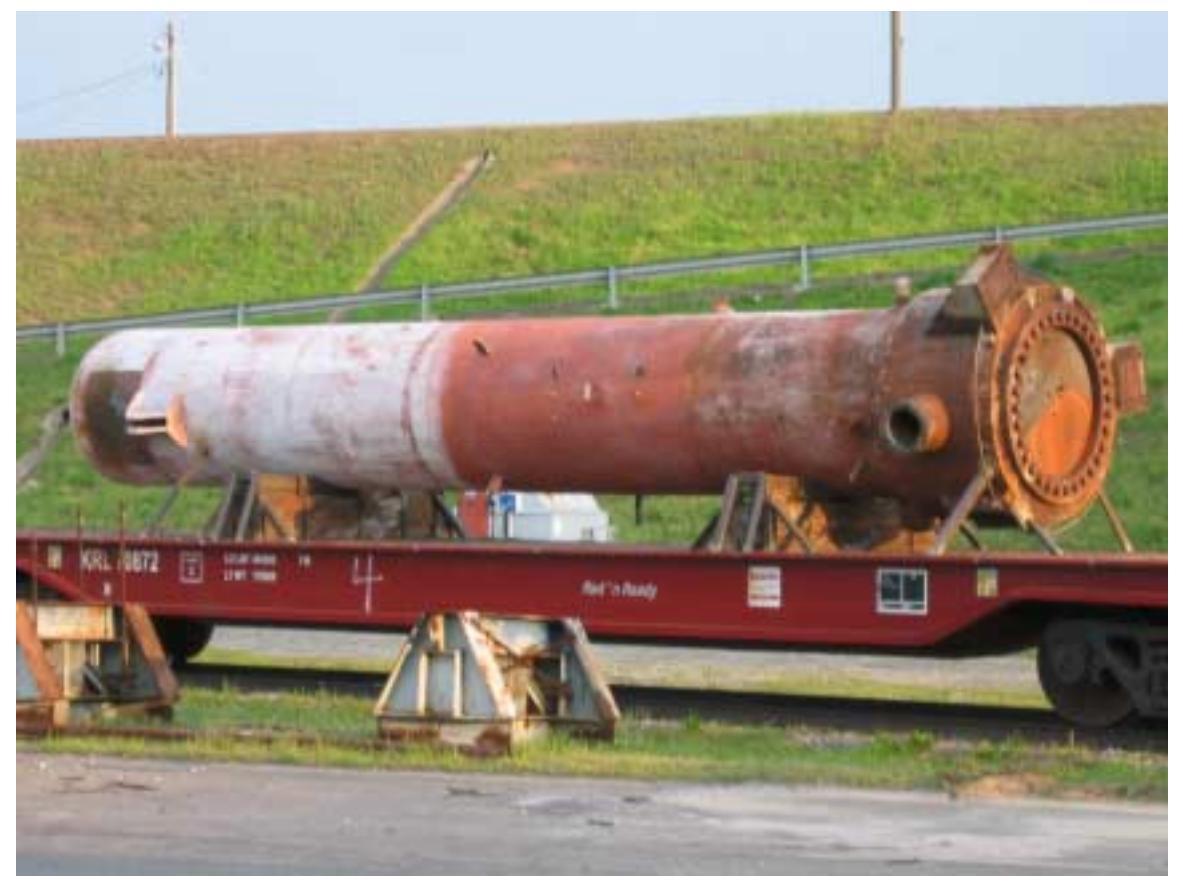
Figure 1 Old Feedwater Heater Ready for Disposal

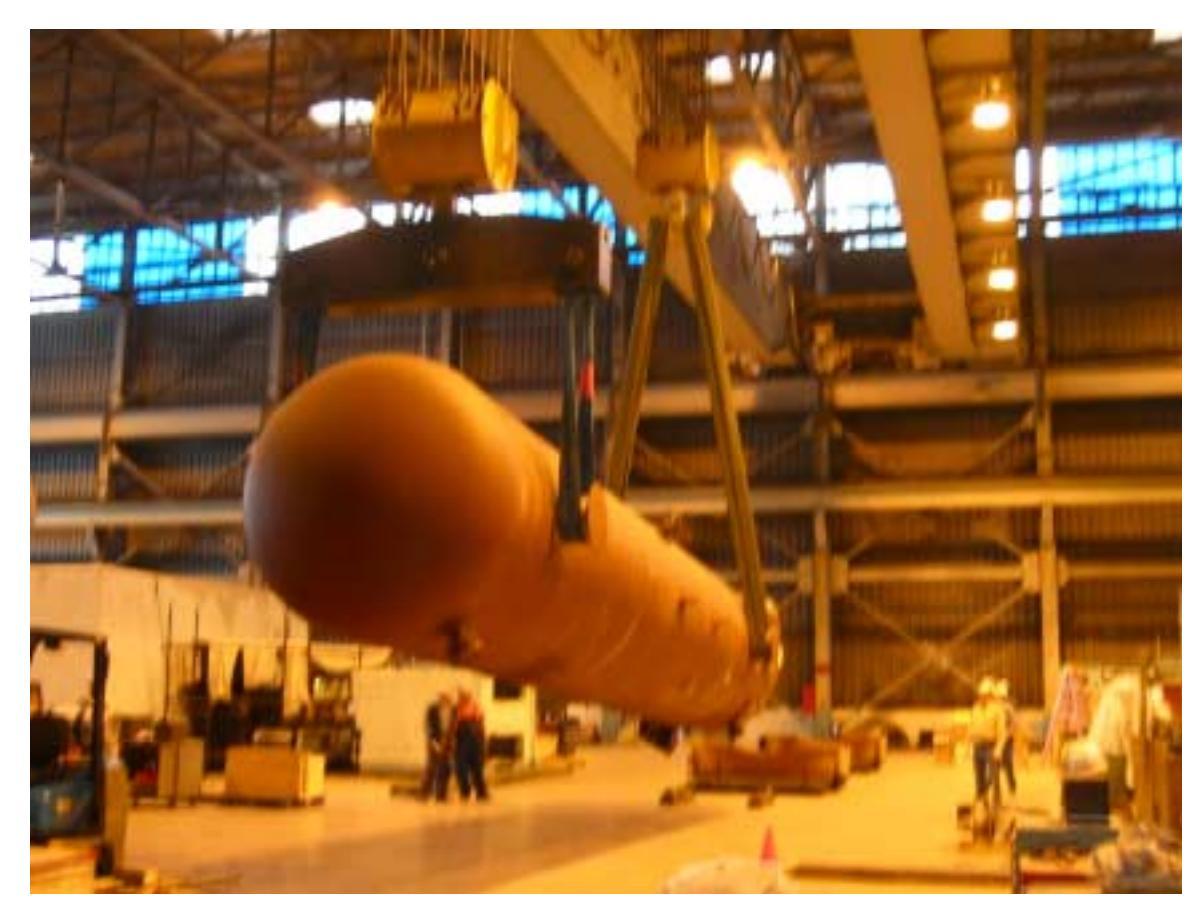
Figure 2 New Feedwater Heater Prior to Uprighting Over Heater Bay

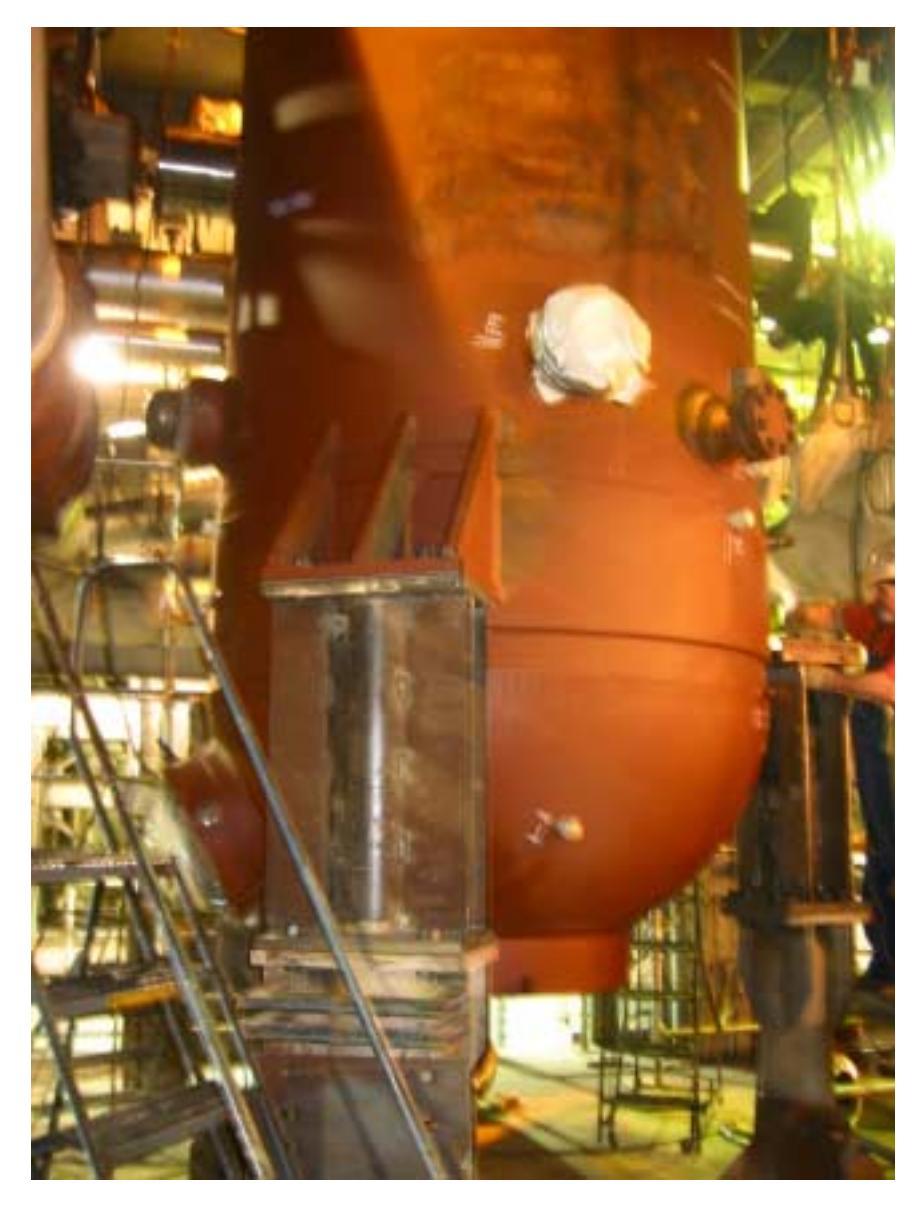
Figure 3 shows support leg extensions needed for the new feedwater heaters.

Figure 3 New Feedwater Heater Showing Support Leg Extensions

Structurally, high loads from new heavier heaters had to be considered all the way from the rail spur entering the turbine building to the support steel around and under the heaters. The initial idea of reinforcing existing steel underneath the heaters was scrapped in favor of adding new

columns transferring the additional load down to the basement floor. This represented a savings in both schedule and construction scope.

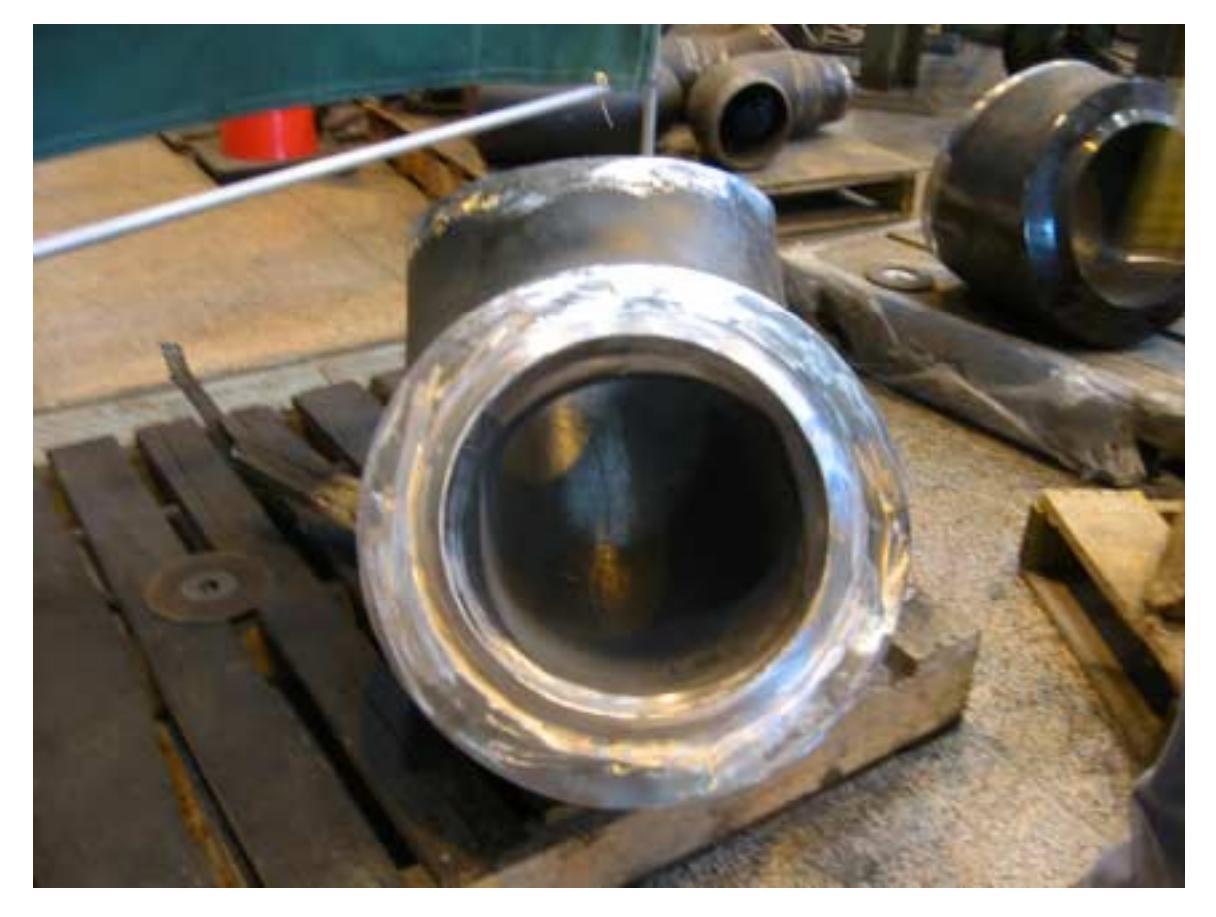
Figure 4 16-Inch Elbow for New Feedwater Line

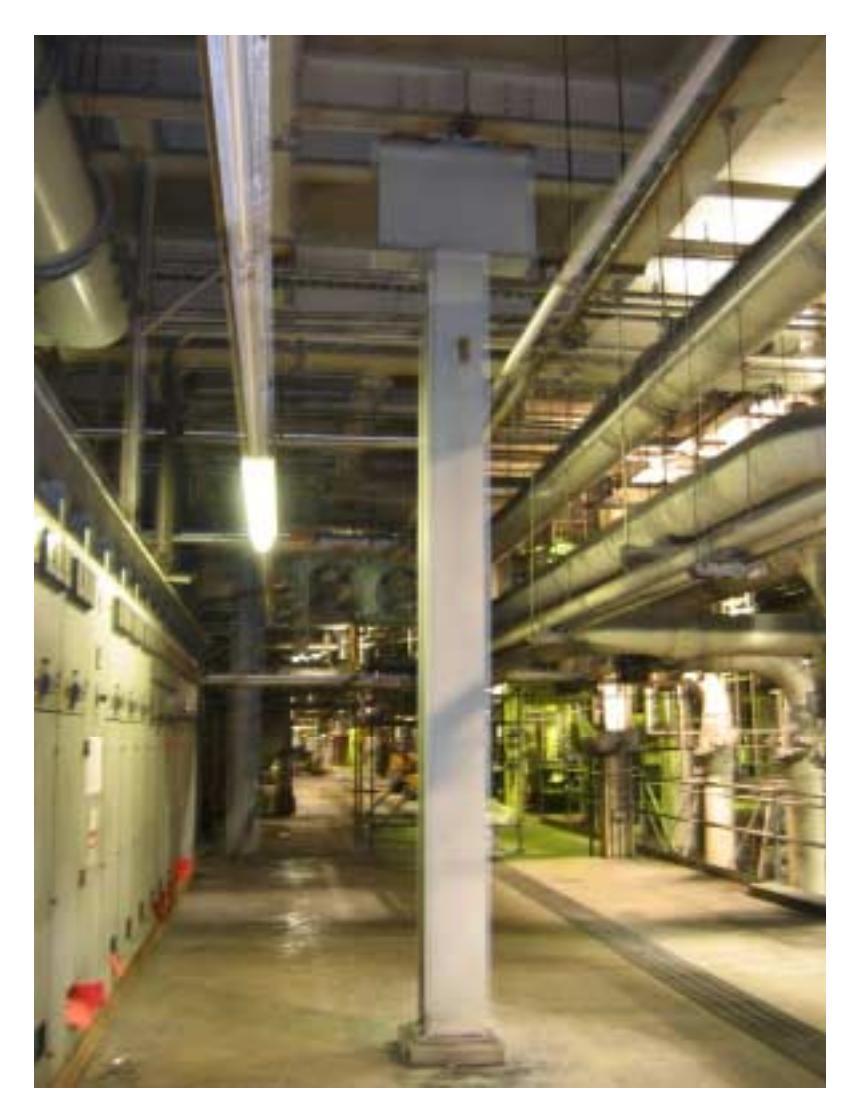
The first was adding new columns to the floor support steel below the heaters, between the mezzanine and basement floors. Figure 5 depicts these new supports. This work was handled pre-outage but still required careful planning because of the nearby 4160 volt bus duct shown to the upper left of the columns to the left of the light fixtures. Steel modification work was done in the fall of 2002.

Figure 5 New Support Columns

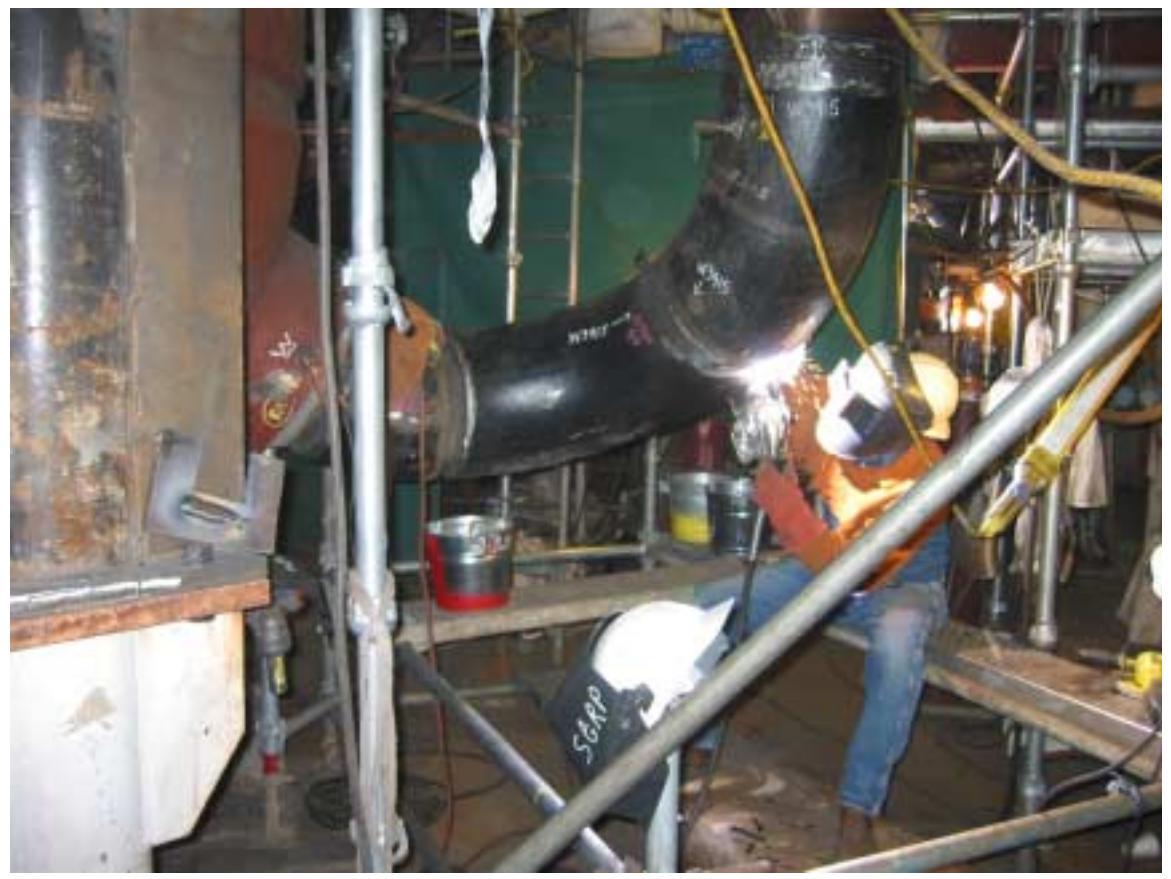
Figure 6 shows the installation work under way on the new feedwater line.

Figure 6 Feedwater Line Welding

There are 40 connections on each heater, most of which are between the mezzanine floor and turbine room floor. Although several of these are maintenance drains that aren't connected to piping, the nozzles that are connected to permanent piping systems provide a view looking up from the mezzanine floor that can best be described as "spaghetti." Obviously this presents some installation issues for the pipe fitters. Pipe work including cutting, welding, NDE, hanger installation, and thermal insulation all had to be carefully coordinated. For these heaters, the largest line was 16" (feedwater) with a minimum wall thickness of 2.19 inches. All piping was carbon steel.

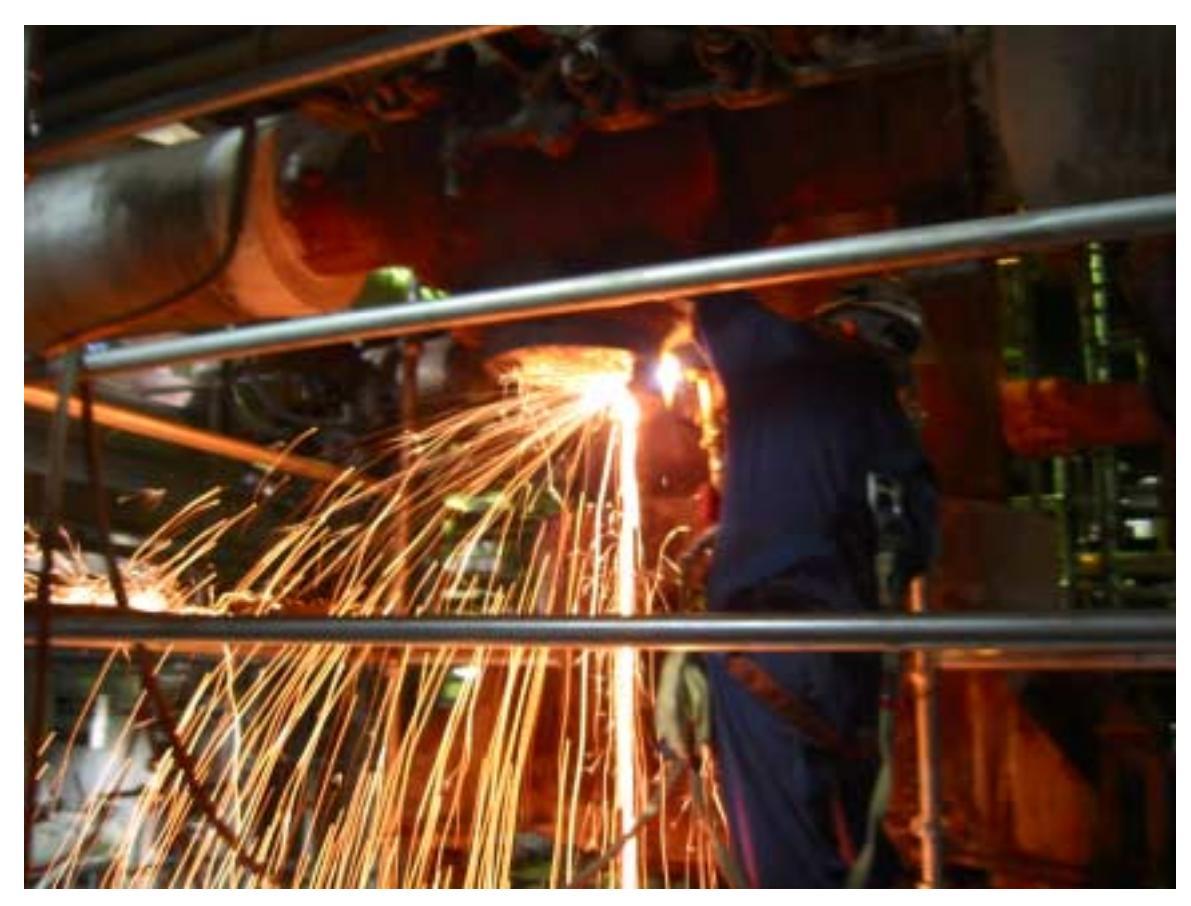
Weld preparation or repair work is shown in Figure 7.

Figure 7 Sparks Fly During Weld Prep/Repair

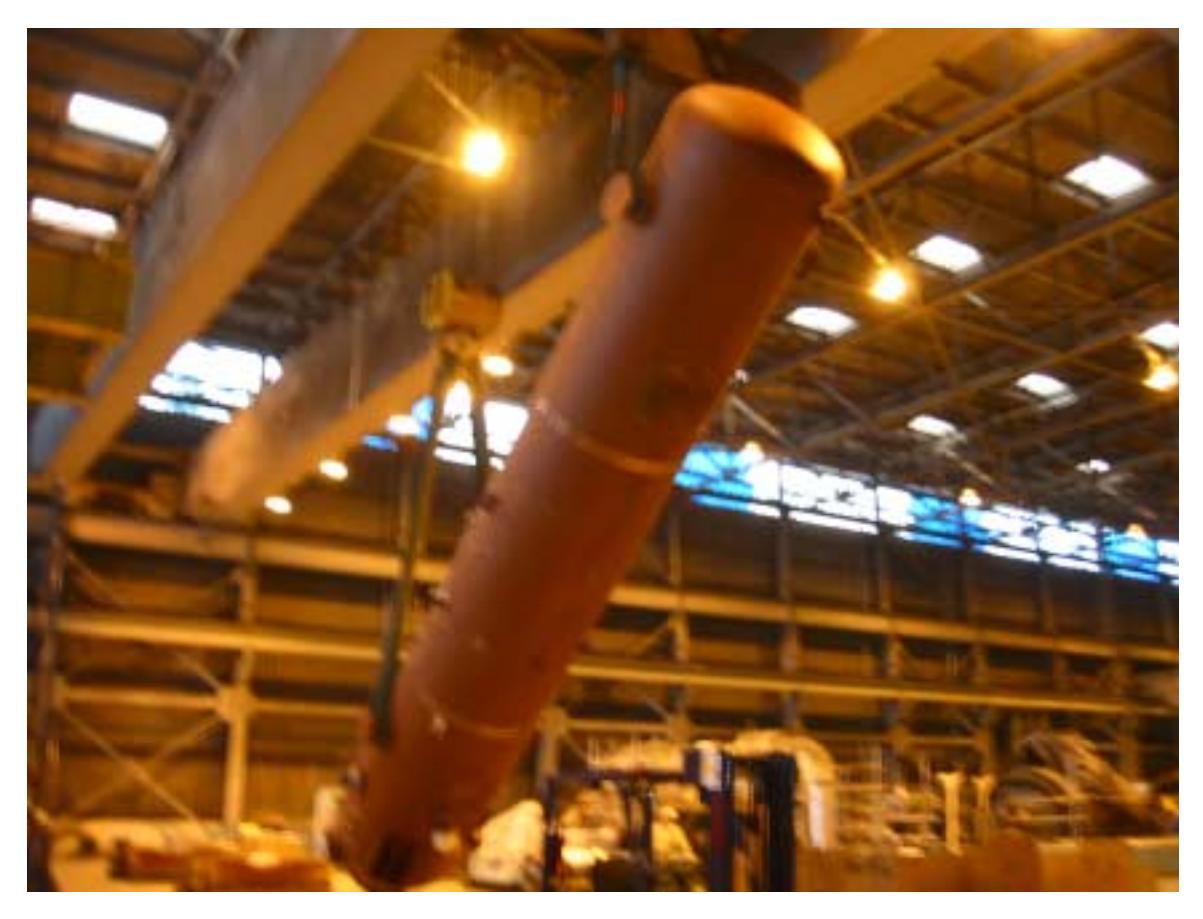
Kevlar slings were used around the trunnions to rig the heater to the crane. While the heater was vertical, supported only by the upper trunnions, a tear developed in the protective sleeve surrounding the sling. Although the structural integrity of the sling was intact, the visibility of the tear provided some anxiety for the rigging crew and crane operator. Figure 8 shows the feedwater heater being uprighted in the turbine building.

Figure 8 Uprighting Process

Lifting the new longer, wider, and heavier heaters was the dominant installation concern, requiring a detailed lifting and rigging plan. Although the heaters were set on "feet" having the same footprint as the old heater, the larger shell diameter required that one of the three legs be shipped loose, and welded on in the field. The new heater had to stay on the crane hook until the third leg was welded on.
