Deaerator Tank Assessment Guideline

Current Industry Technology and Approaches

1021199

Technical Update, December 2010

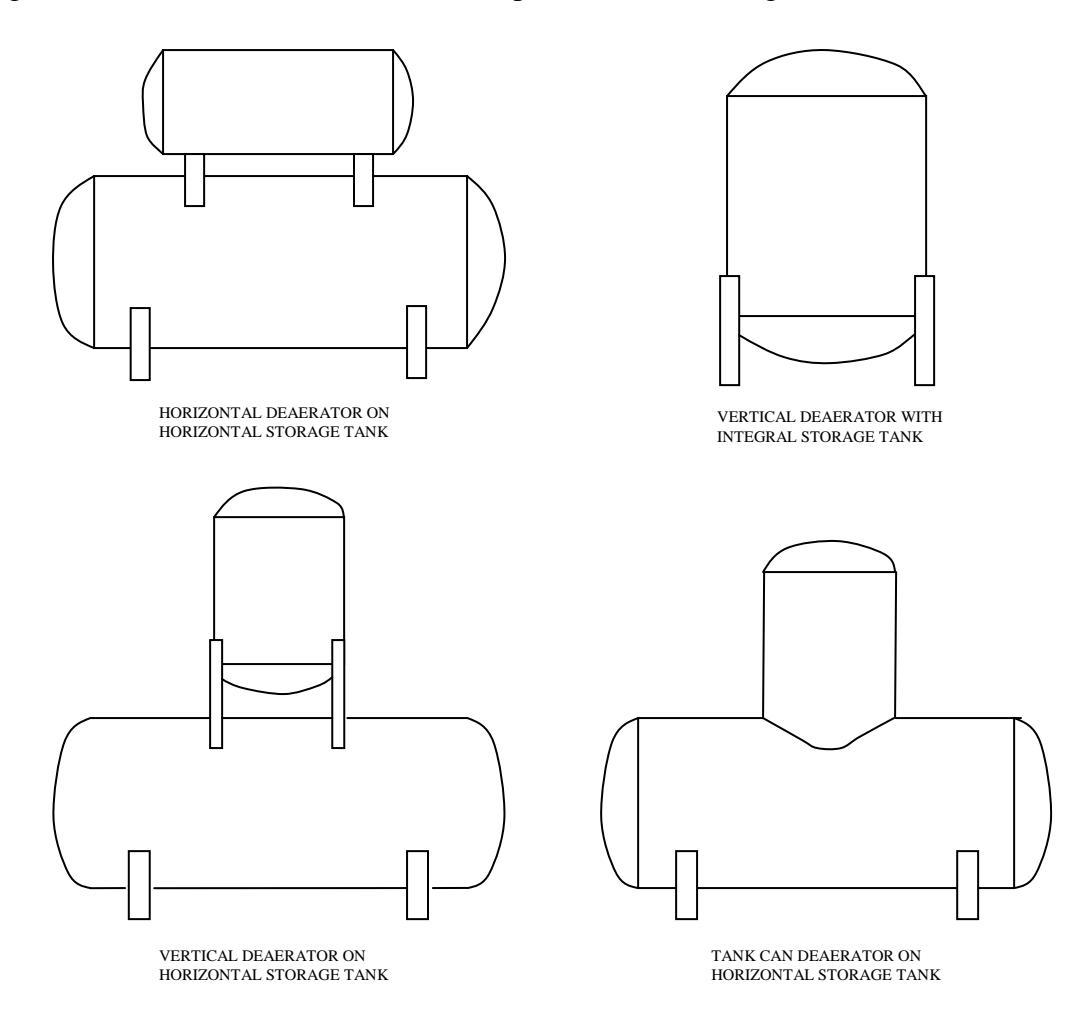
Figure 2-1

Orientation and combinations of deaerators and storage tanks. Source: Heat Exchange Institute standards and typical specifications for tray-type deaerators.

Deaerator systems for power generation utilities are designed and built as either spray-tray (sometimes referred to as simply "tray") or spray-scrubber units. Although both systems can achieve the above performance requirements, utility systems require the high capacity provided by spray-tray deaerators. Spray-tray deaerators may be designed with varying orientations with respect to the storage tank (Figure 2-1). In high capacity utility systems it is most common to have a horizontal or vertical water deaerator vessel positioned over the storage tank, connected by a short length of water downcomer and equalizing piping. A typical vertical deaerator and storage tank with connections and names of parts is shown in Figure 2-2.

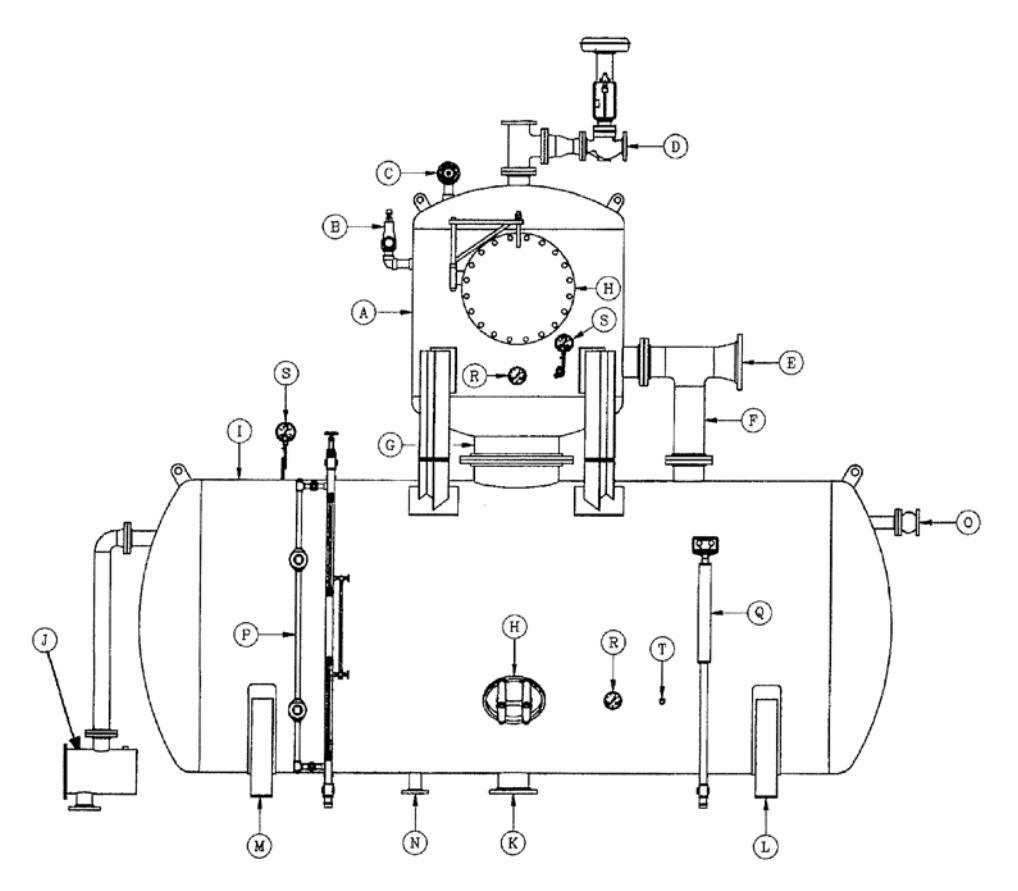
Typical Deaerator Connections and Accessories

- K. Deaerator Section
- L. Relief Valve
- M. Vent
- N. Water Inlet
- O. Steam Inlet
- P. Equalizer
- Q. Downcomer
- R. Access Manway
- S. Storage Section
- T. Overflow Control

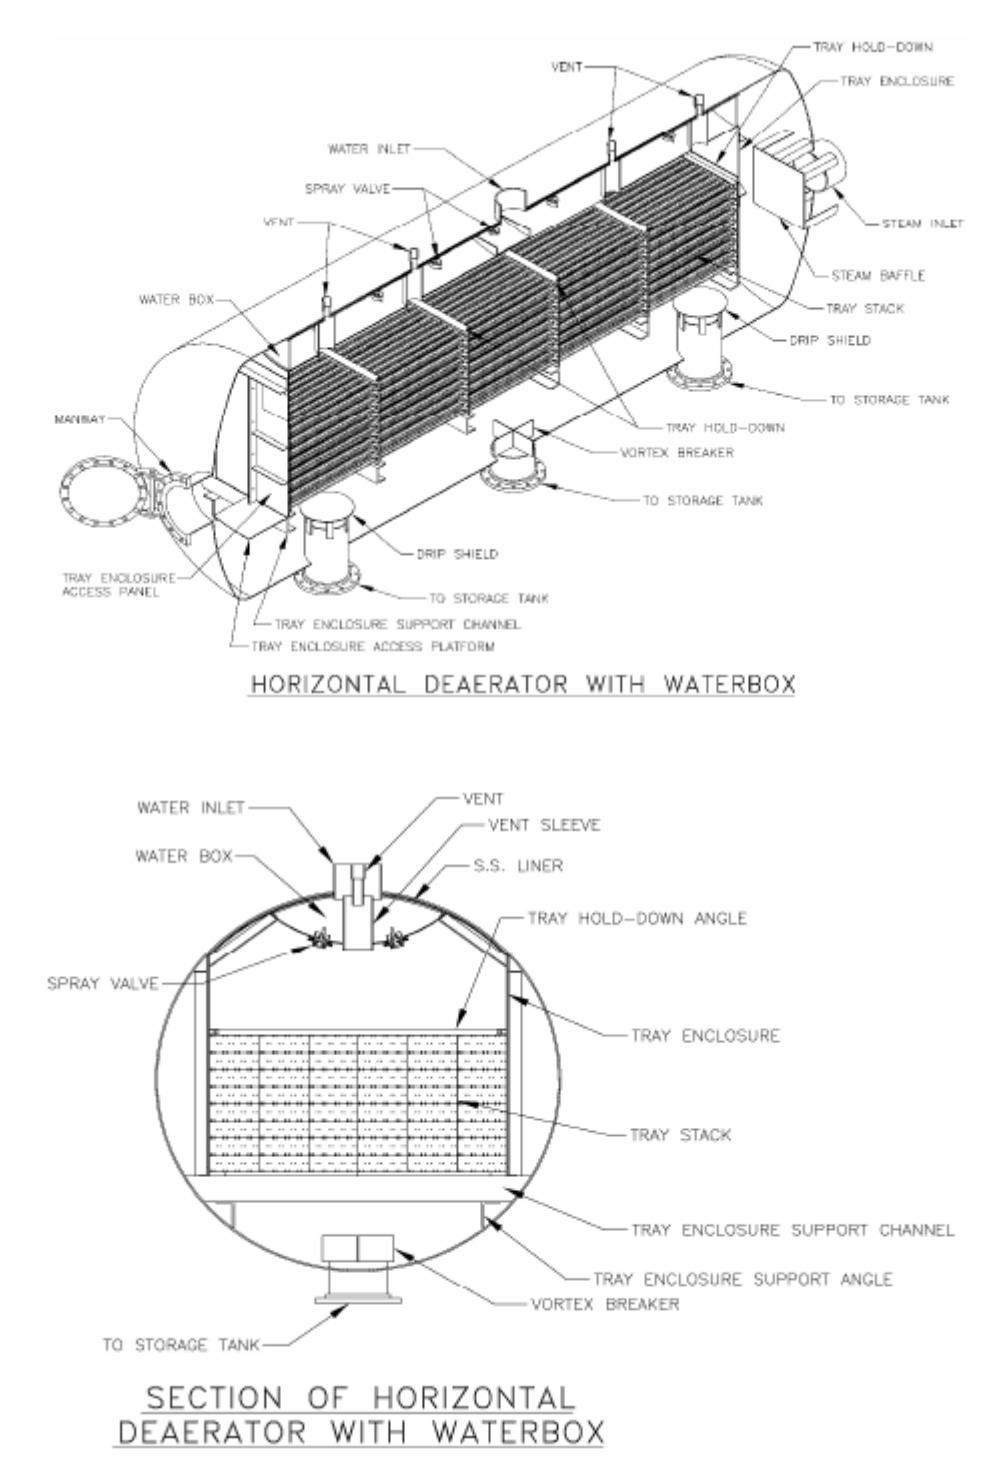
Typical arrangement of horizontal deaerator with a waterbox (Courtesy of Kansas City Deaerator Company, Inc.)

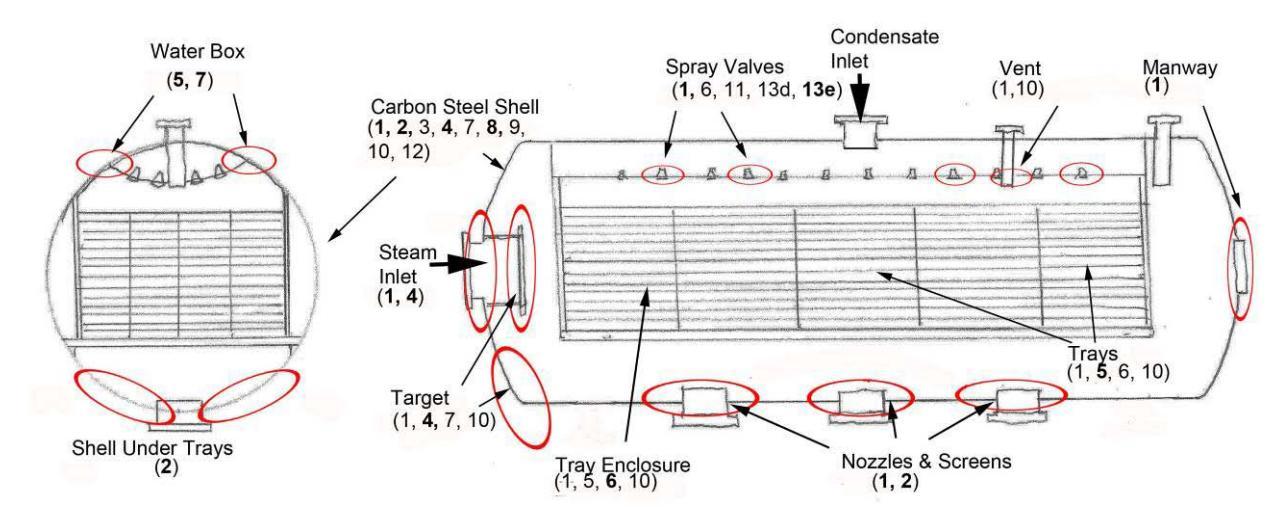
Figure 4-1 Damage mechanism locations within the deaerator heater

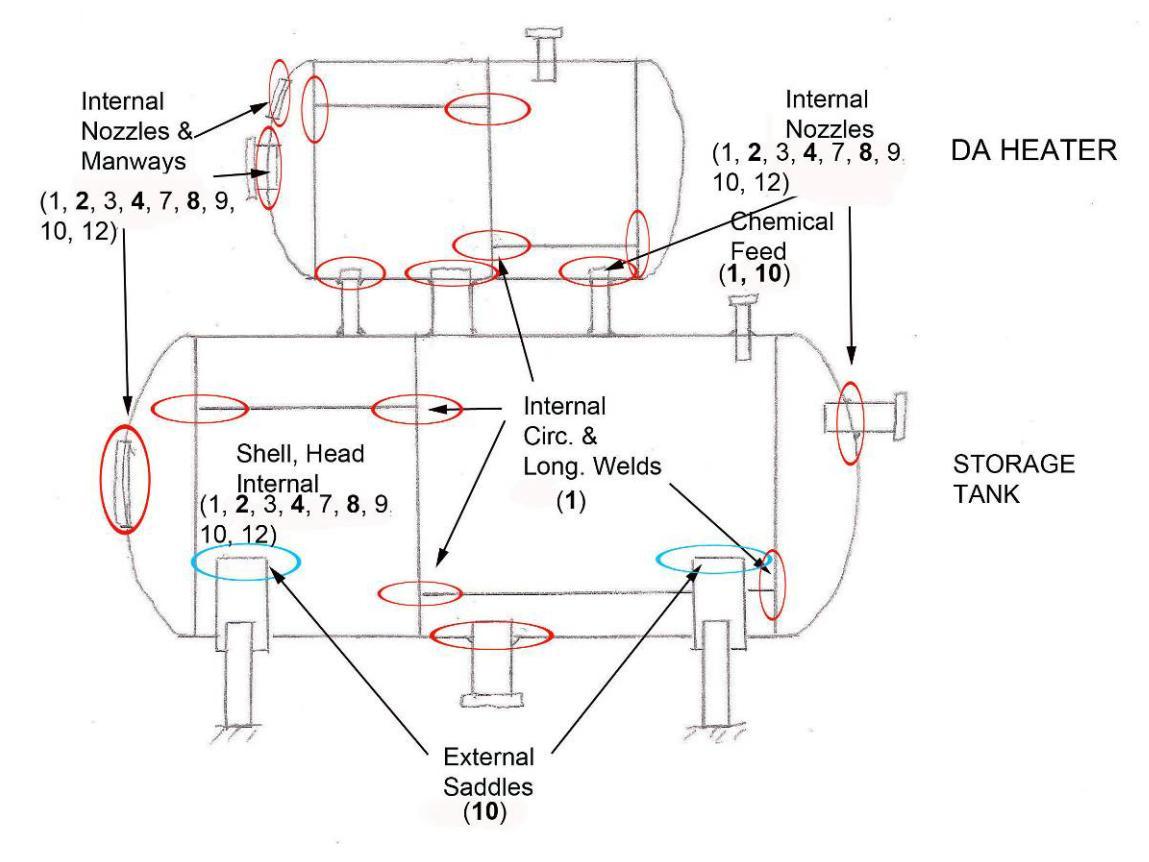
Damage mechanism locations on the inside and outside, including the deaerator storage tank

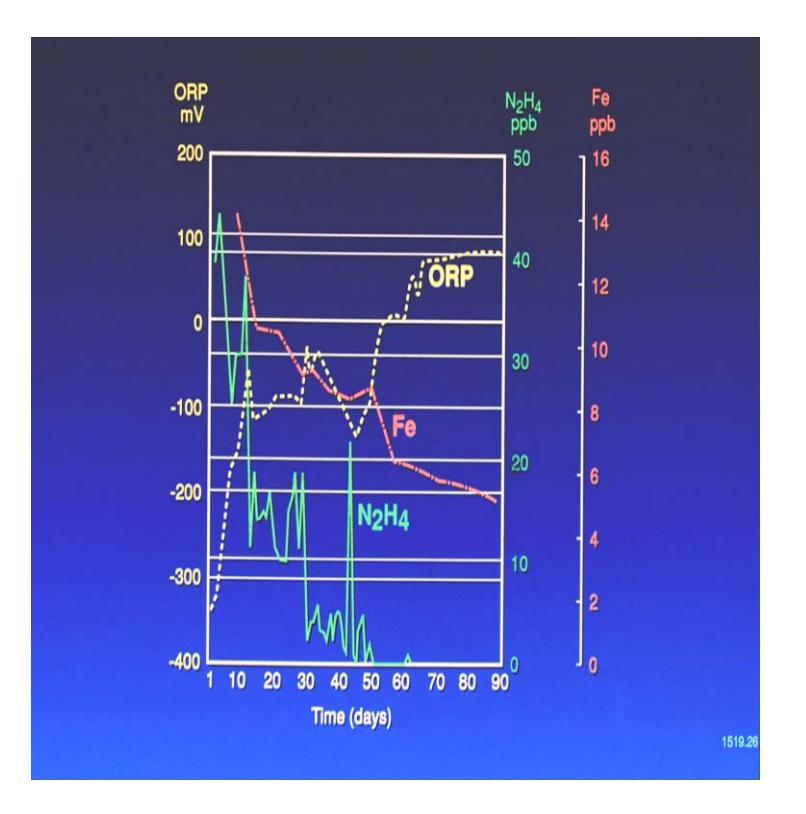
Figure 5-1

Change in oxidizing-reducing potential (ORP) and feedwater iron levels (Fe) at the economizer inlet when Hydrazine (N2H4) is gradually reduced on a 600MW drum rnit with an all-ferrous feedwater system (Source: R.B. Dooley, J. Mathews, R. Pate and J. Taylor, "Optimum Chemistry for 'All-Ferrous' Feedwater Systems: Why Use an Oxygen Scavenger," Proc. 55th International Water Conference, Pittsburgh, PA, Oct. 1–Nov. 2, 1994.)

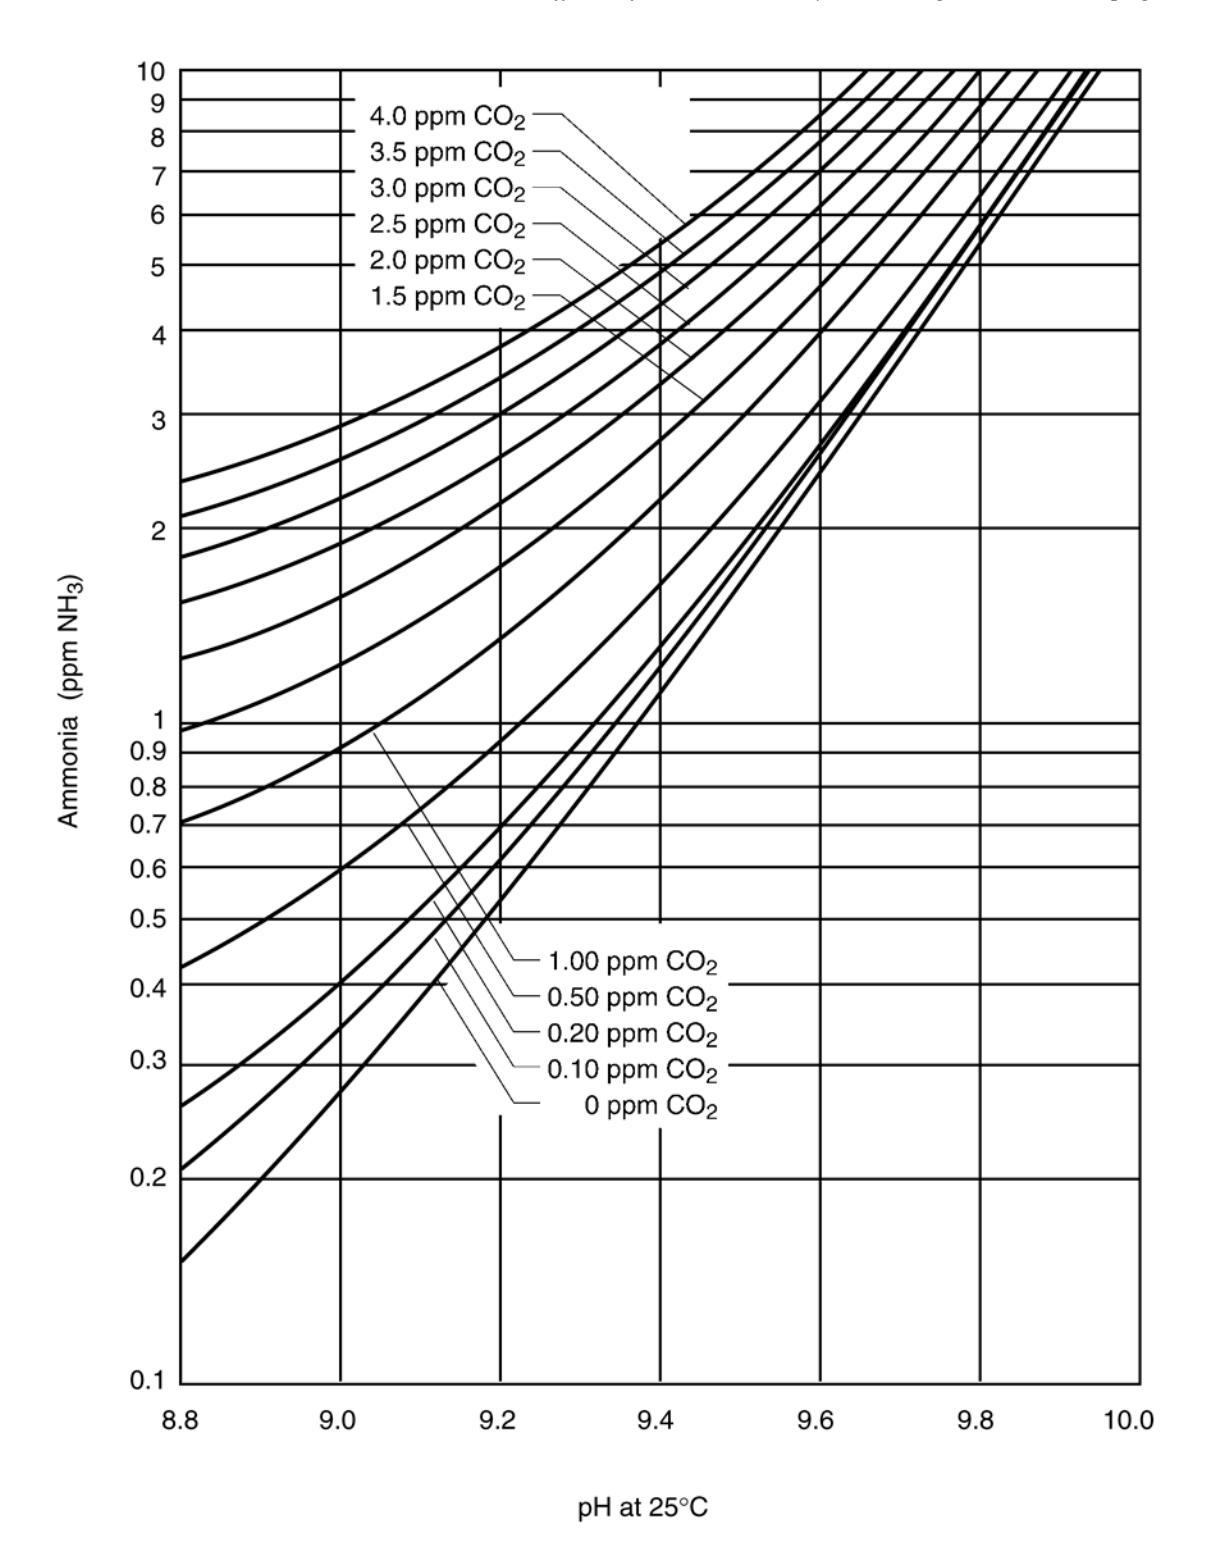
Figure 5-2

The pH relationship between carbon dioxide and ammonia in feedwater (Source: Cycle Chemistry Guidelines for Fossil Plants: Phosphate Continuum and Caustic Treatment, EPRI, Palo Alto, CA: 2004. 1004188)

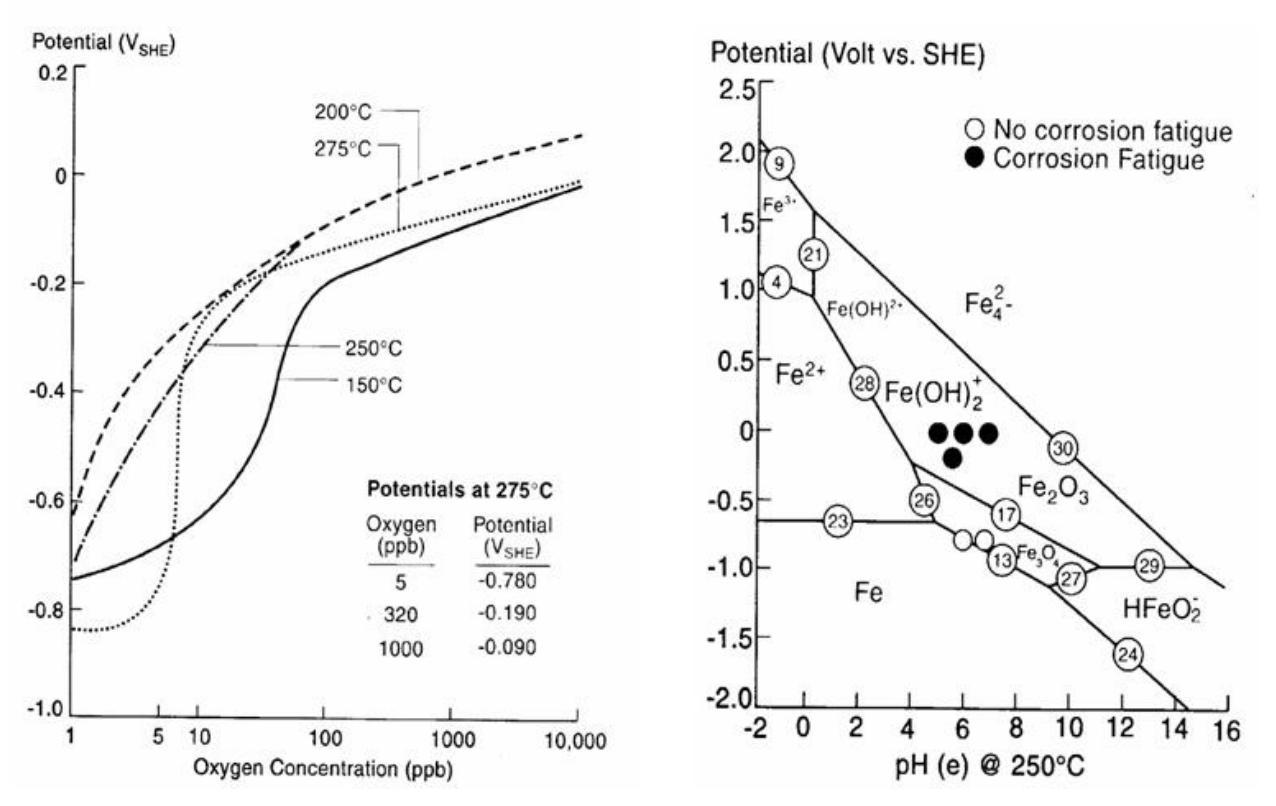
Figure 5-3

Corrosion fatigue and dissolved oxygen concentrations (Source "Corrosion Fatigue Boiler Tube Failures in Waterwalls and Economizers Volume 2: Laboratory Corrosion Studies EPRI, Palo Alto, CA 1992, TR-100455)

Removing dissolved oxygen from the feedwater prior to startup reduces the risk of corrosion fatigue. In Figure 5.3 the Pourbaix diagram on the right shows that the risk of corrosion fatigue is greater when the oxidation reduction potential is greater than - 0.5 mV with a pH (at 250°C (482°F)) between 6 and 8. (Neutral pH at 250°C (482°F) is 5.6) These graphs are at temperatures higher than typical DA operation, but similar principles apply. In the industry, maintaining feedwater dissolved oxygen levels below 100 ppb during the entire startup process is considered good practice.

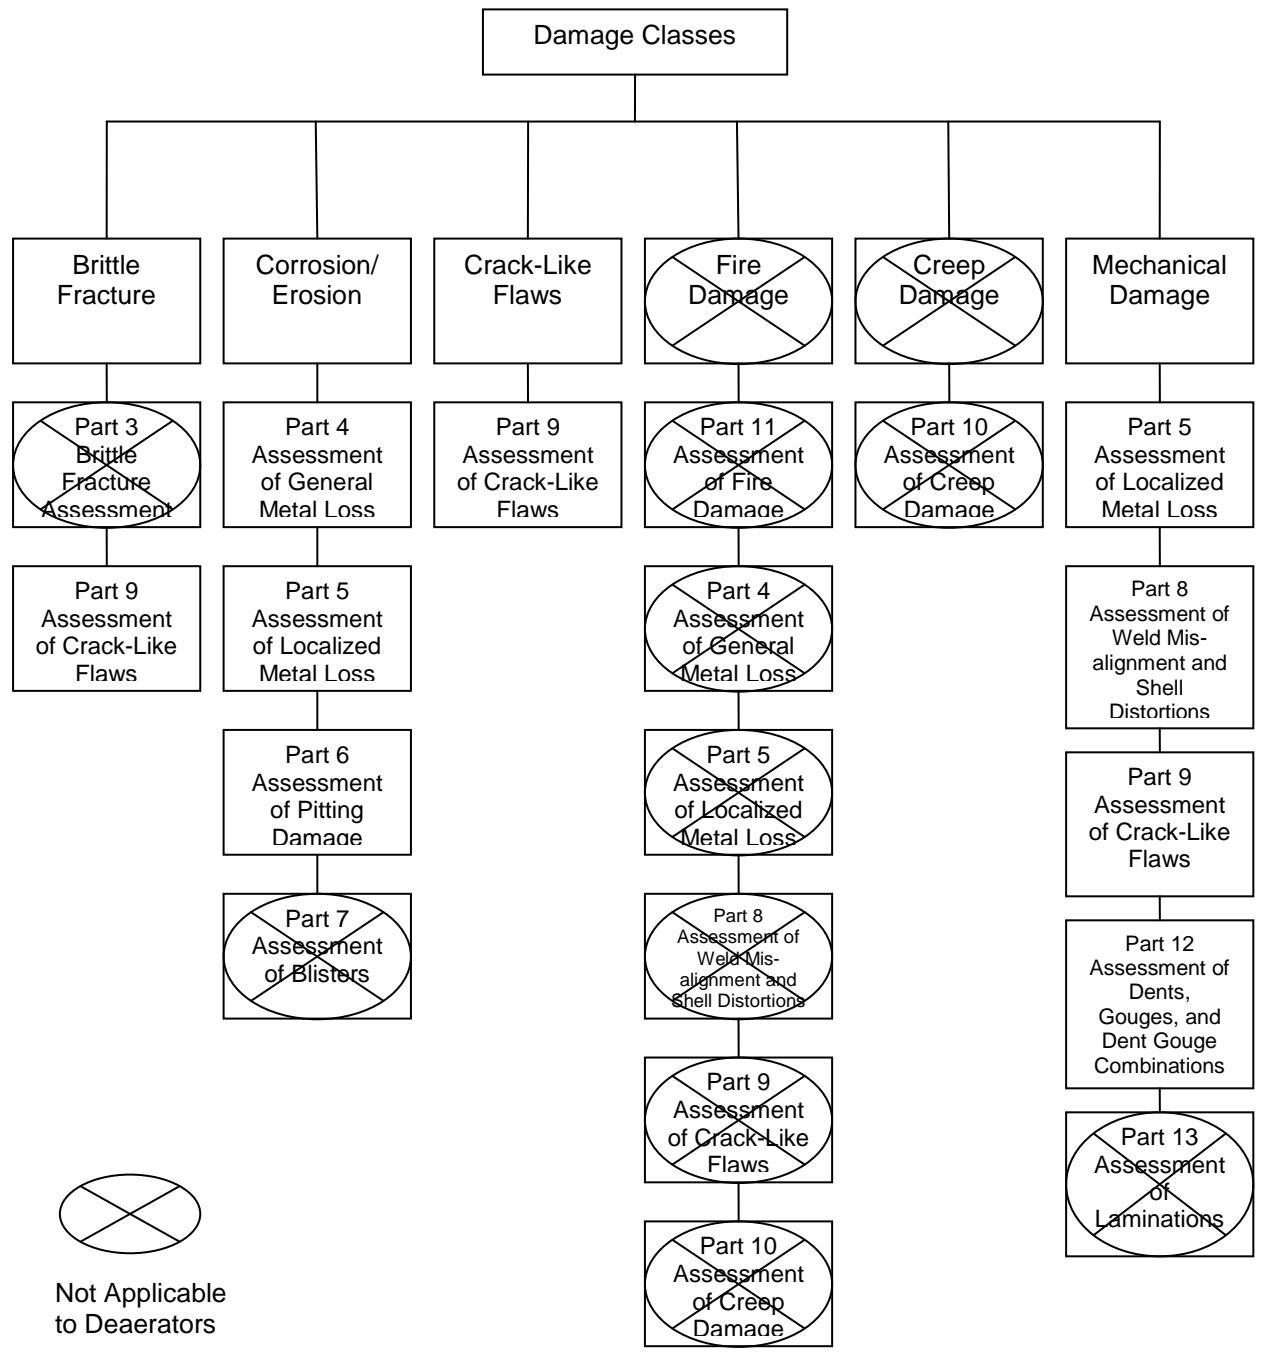
Figure 8-1

FFS assessment procedures for various damage classes, taken from Figure 2.1 in API 579-1/ASME FFS-1 and modified for deaerators.

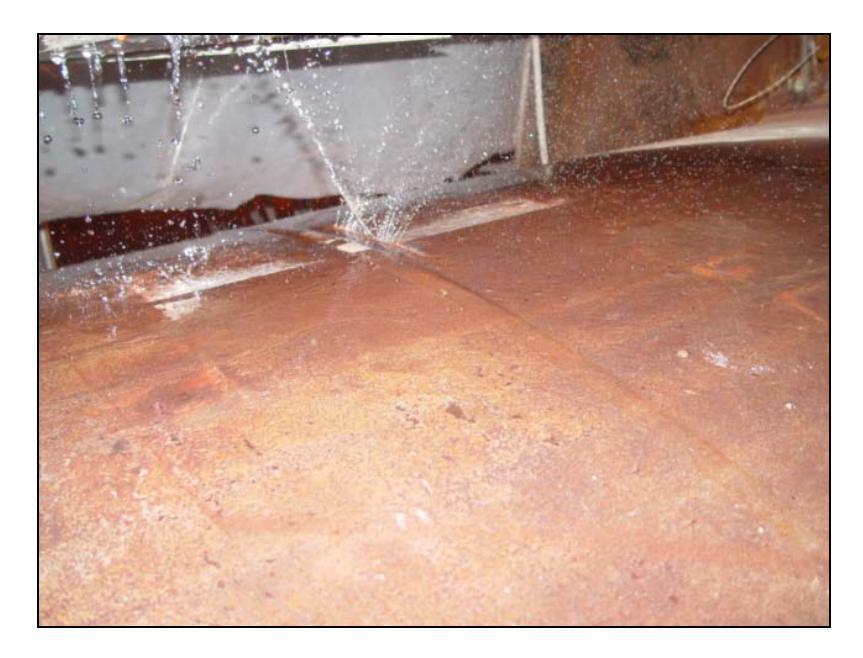
A crack was discovered in the center of the vessel on top near a circumferential weld. The crack was ~twelve inches long on the external surface and over twenty-five inches on internal surface. The crack initiated on the internal surface at the weld for a vacuum (stiffening ring). The top 70 degrees of the vacuum ring was removed to allow for repair. The weld was removed by grinding, followed by re-welding.

Figure 10-1 Photograph shows the crack in the circumferential weld of the deaerator storage tank

Industry:	Utility
Deaerator Type:	Spray-Tray
Damage Location:	Storage Tank Circumferential Weld
Damage Mechanism:	Corrosion fatigue
Cracking Orientation:	Circumferential
Component Material:	SA-212, Grade B
Years in Service:	Forty-Five Years
Tank Pressure:	150 psi Design/132 psi Operation

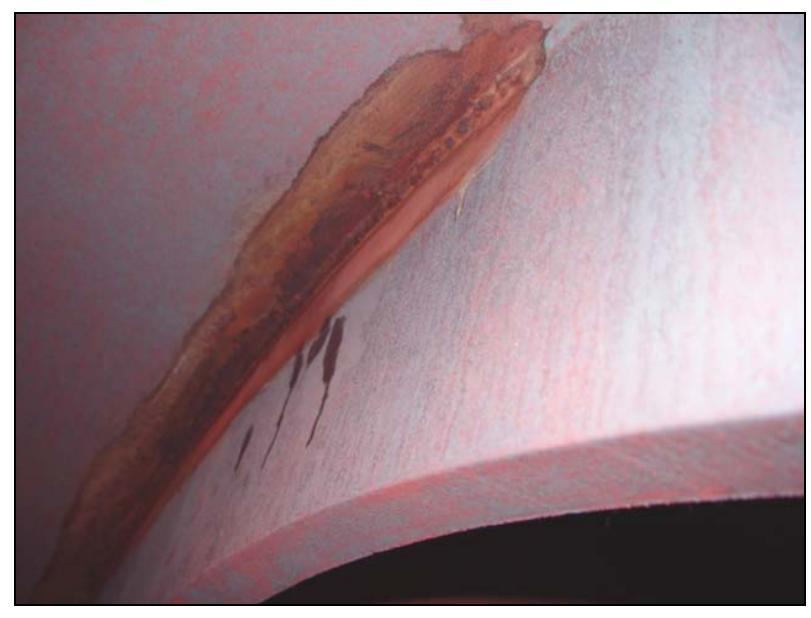
Figure 10-2 Photograph showing the same crack from inside the storage tank

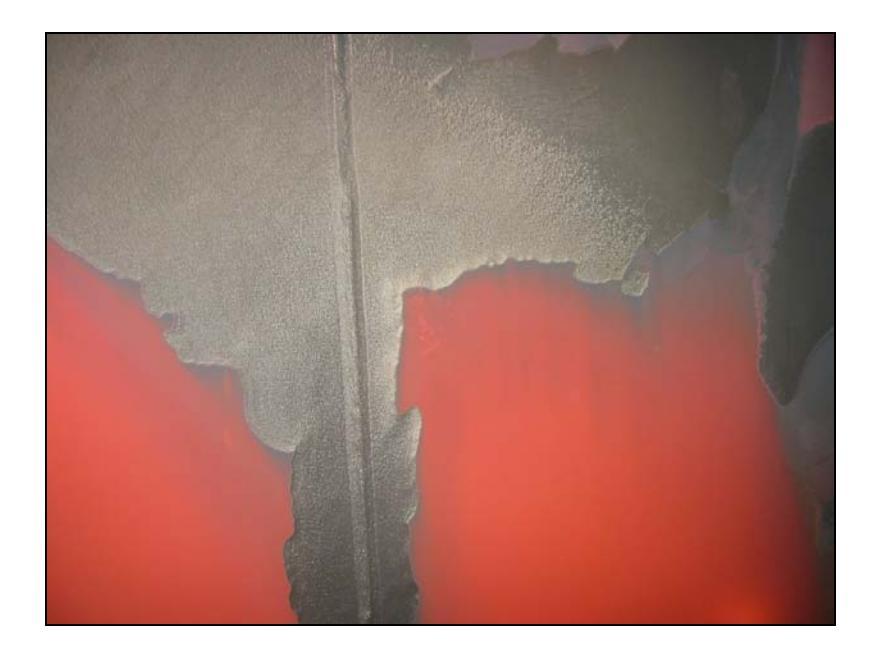
Figure 10-3

Flow accelerated corrosion on the ID of the spray-scrubber deaerator. The circumferential weld was previously ground.

An original tray-spray deaerator heater was installed in 1980 but was replaced due to performance problem with a vertical spray-scrubber heater in 1983. The replacement DA was not post weld heat treated. During the twenty-six years of service, the vessel exhibited corrosion fatigue cracking at welds and significant thinning from flow accelerated corrosion of the shell adjacent to baffle plates (Figure 10.3). An inspection in 2009 revealed thinning at a weld joint, and a region of incomplete penetration of the weld (Figure 10.4). The unit was replaced with a new vertical spray-scrubber during 2009.

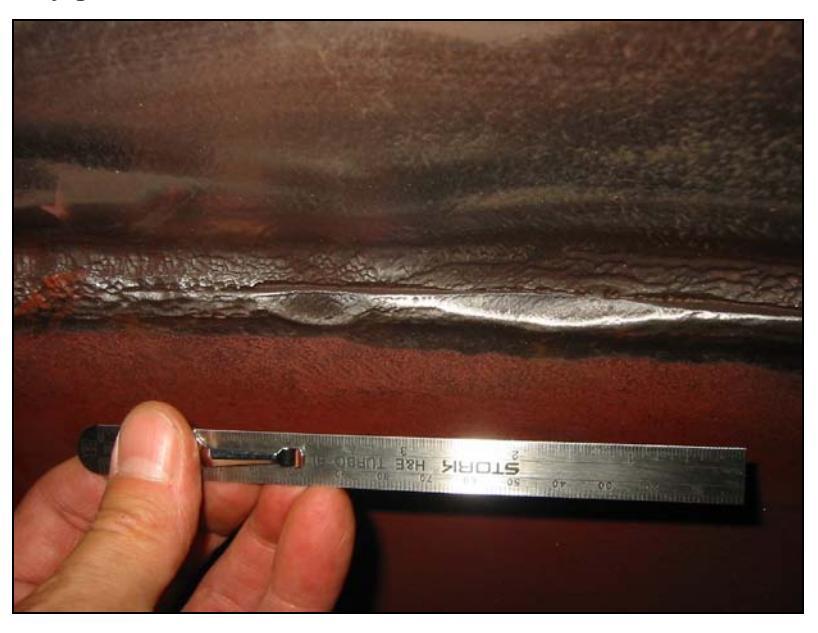
Figure 10-4

Flow accelerated corrosion of the DA heater circumferential weld seam revealed a partial penetration weld. The DA heater was replaced.

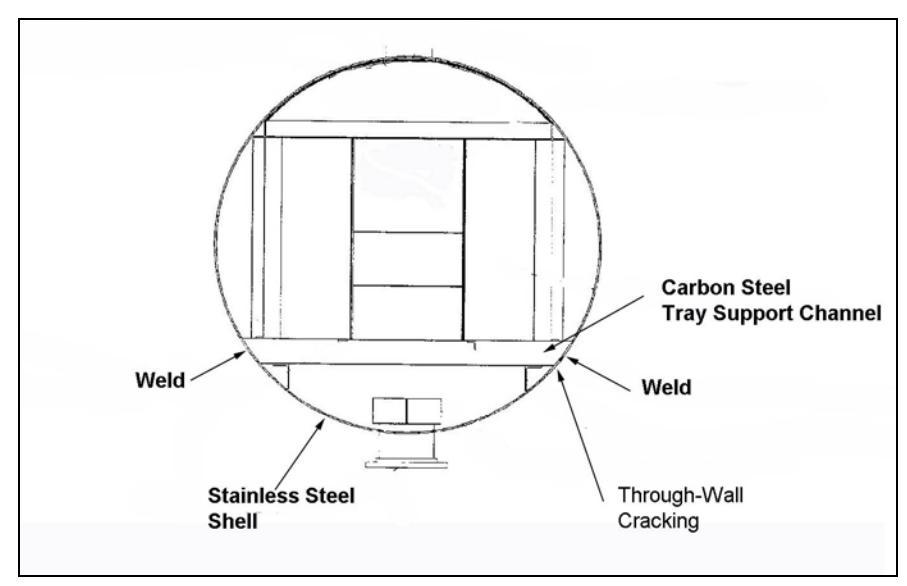
Two original carbon steel deaerator heaters were replaced during 2005 due to problems with severe flow accelerated corrosion. The new DA shells were fabricated from Type 304L stainless steel—carbon steel tray support channels were welded to the shell. The new units operated satisfactorily for approximately three years when a through-wall crack was discovered in the proximity of a support saddle attachment on one unit. Internal examination revealed cracking adjacent to an internal tray enclosure support channel. Further examination revealed that the carbon steel support channel had been rigidly welded to both sides of the stainless vessel walls (Figure 10.5). The analysis concluded that the difference in coefficient of thermal expansion for the stainless steel shell and carbon steel supports produced high stresses and yielding of the vessel wall, ultimately resulting in cracking. A check of the original vessel design revealed that the support channel was to be welded to one side only, and the channel was to "float" on the opposing wall. Additionally, the proximity of the support to the external saddle attachment increased rigidity and local stresses. A check of the mating stainless steel heater showed cracking in the same location, but the crack had not progressed completely through the vessel wall.

Industry:	Utility
Deaerator Type:	Horizontal Spray-Tray on a Horizontal Storage Tank
Damage Location:	DA Heater
Damage Mechanism:	Through-Wall Cracking Due to Differential Thermal Expansion
Cracking Orientation:	Horizontal at Vessel Sidewall
Component Material:	SA 240, Type 304L Stainless Steel
Years in Service:	Five Years
Tank Pressure:	Unknown
