Interim Report Field Evaluation of Airepel® HC to Reduce Woodpecker Damage to Utility Poles – Year 2

Technical Update, April 2023

EDM International, Inc.

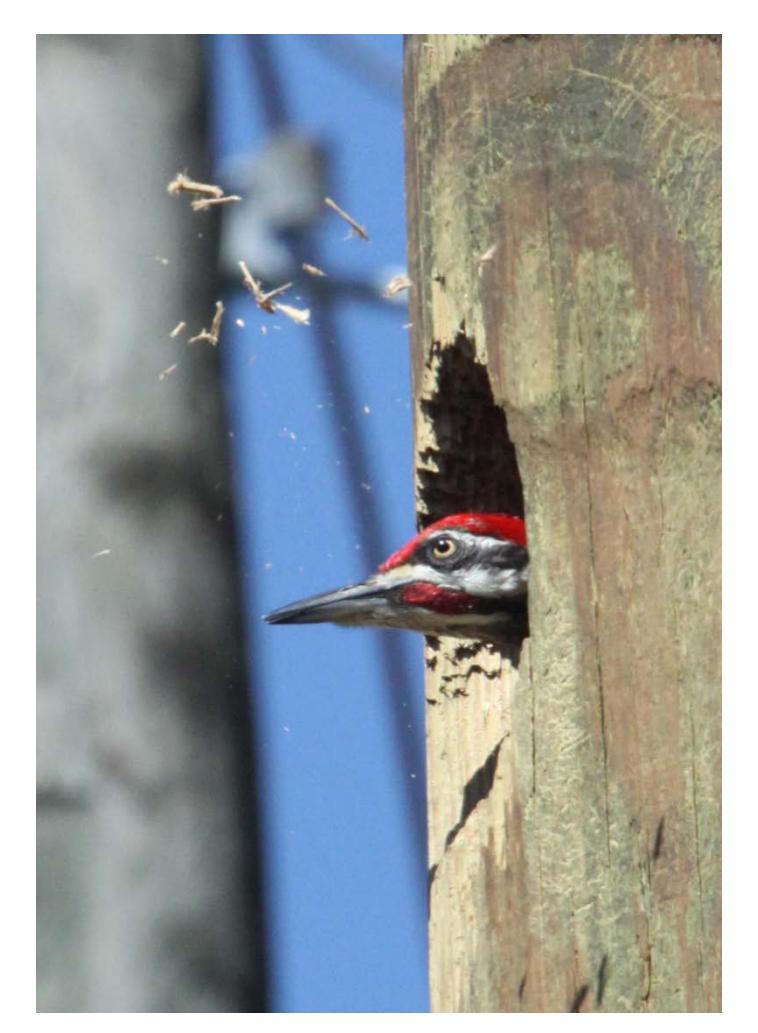
Figure 1-1 Pileated Woodpecker nesting cavity in a utility pole.

Although several species of woodpecker damage utility poles, Pileated Woodpeckers (*Dryocopus pileatus*) cause some of the most severe damage (Figure 1–1). The most extensive damage occurs when birds are excavating nesting or roosting cavities and when birds are searching for insects or drumming to announce their territory. In southern regions, nesting typically occurs from March to May [3]. Their territory size may be inversely related to tree, log and stump volume, and canopy cover within territories. Territories range in size from 106 to 173 acres (43 to 70 hectares; 0.43 to 0.70 km²) in the southeastern regions of the United States [4, 5].

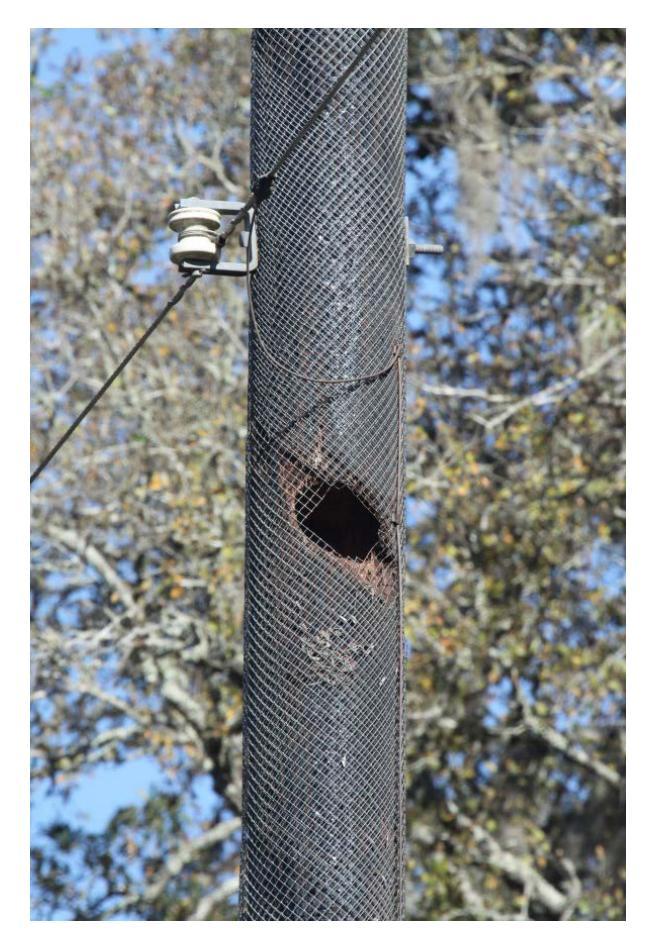
Figure 1-2 Wire wrap defeated by a Pileated Woodpecker

Several techniques are available to alleviate woodpecker damage, including exclusion, mechanical and pyrotechnic devices, chemical repellents, and lethal removal [1, 6, 7, 8, 9]. Each of these techniques has limitations because of cost, logistics, effectiveness, public relations, or a combination of these factors. For example, means for excluding woodpeckers (wire or wraps) are difficult to install or interfere with lineman access. In some cases, Pileated Woodpeckers have defeated exclusion materials (Figure 1-2). A 19-gauge galvanized welded wire mesh (0.5 x 0.5 inches [1.25 x 1.25 centimeters]) is the pole wrap most used by the utility industry to reduce woodpecker damage to poles. However, under controlled testing of various wire wraps, Pileated Woodpecker damage was greatest to poles wrapped with 19-gauge wire. Woodpeckers were capable of bending or breaking welds and/or wires in a brief time. The least damage occurred on poles wrapped with 16-gauge welded wire (Cummings et al., unpublished data, 2001).

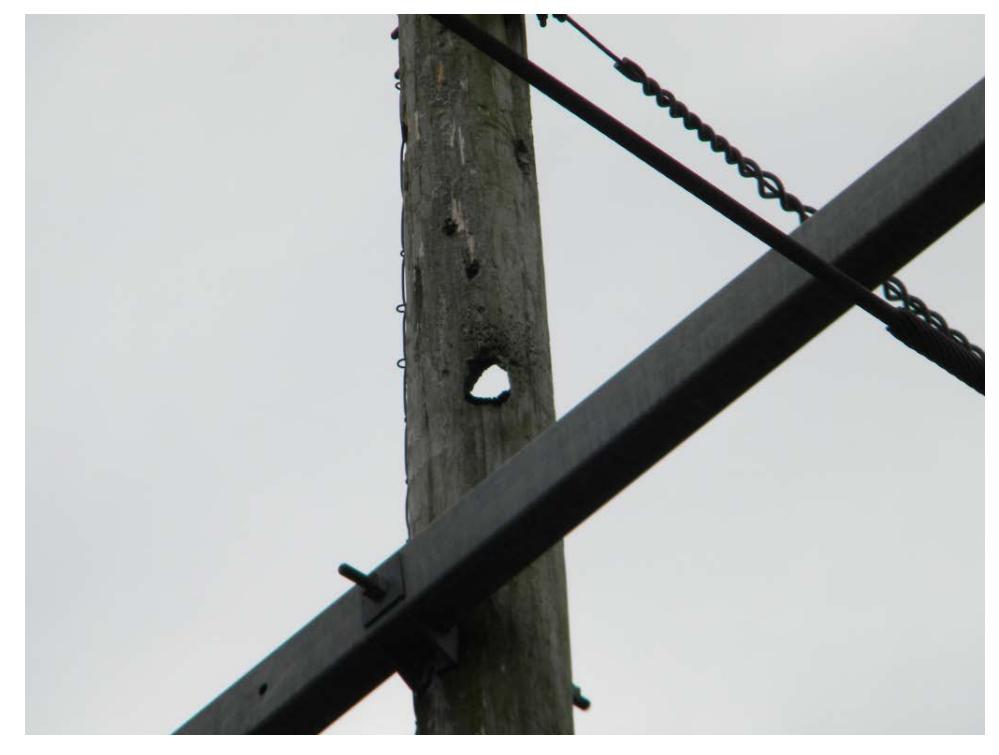
Figure 3-1 Severely damaged transmission pole identified for replacement

PowerSouth identified areas with historic woodpecker damage. Problem areas included Graceville/Chipley Junction, Florida (seven poles), Victoria/Ariton, Alabama (26 poles), Oak Grove/Chumuckla, Florida (four poles), and Belleville/Eliska Junction, Alabama (four poles). In some cases, newly inserted poles in these areas were replaced within one to two years, due to woodpecker damage. The general rule for PowerSouth is when a pole has a hole completely through it or has a nesting cavity, it must be replaced (Figure 3–1).

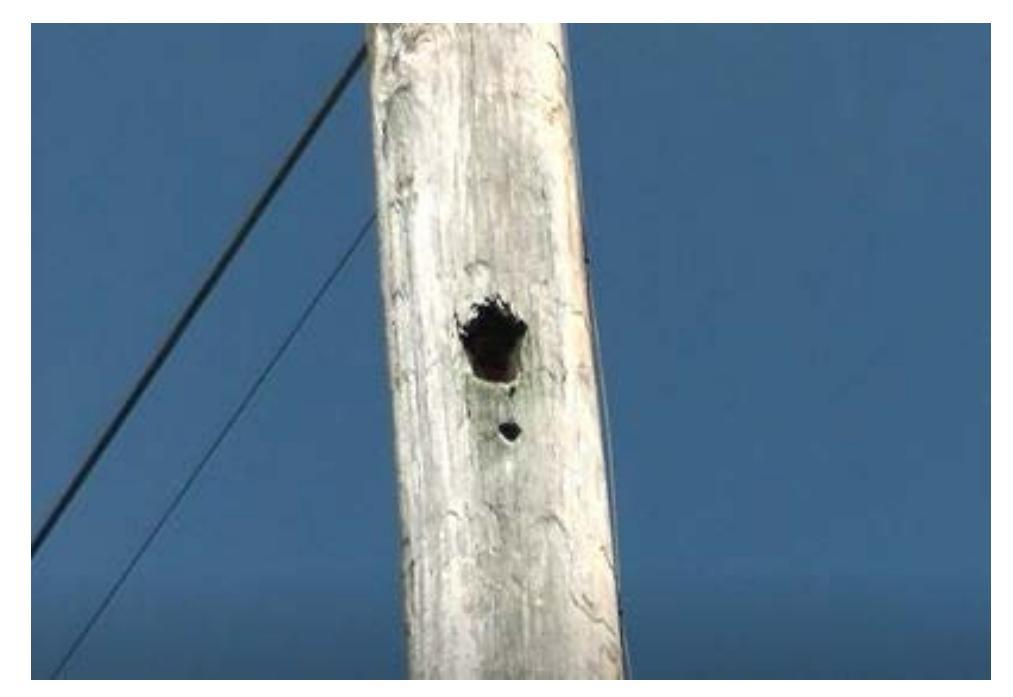
Figure 3-2 Two woodpecker holes classified as 3-large (top) and 1-small (bottom)

During the December 12-13, 2019, Victoria/Ariton H-structure inspection, the number of woodpecker-caused holes on each H-structure pole was documented and photographed to establish a baseline (Figure 3–2). Photos of the poles were taken from each cardinal direction. Woodpecker damage was recorded as small (less than 1-inch [2.54-centimeter] opening hole) or a scrape, medium (1- to 3-inch [2.54- to 7.62-centimeter] opening hole), or large (greater than 3-inch [7.62-centimeter] opening hole). A numerical value was assigned for each hole; small, medium, and large holes were given a value of 1, 2, and 3, respectively. These values were summed for each pole. For example, if a pole had 3 small holes and 1 scrape, 5 medium holes, and 2 large holes, the value for that pole was $(4 \times 1) + (5 \times 2) + (2 \times 3)$ for a value of 20. This process was repeated for the post-treatment inspections. A One-Way Analysis of Variance was used to compare woodpecker damage among control, AQ treated, and wire wrapped poles.

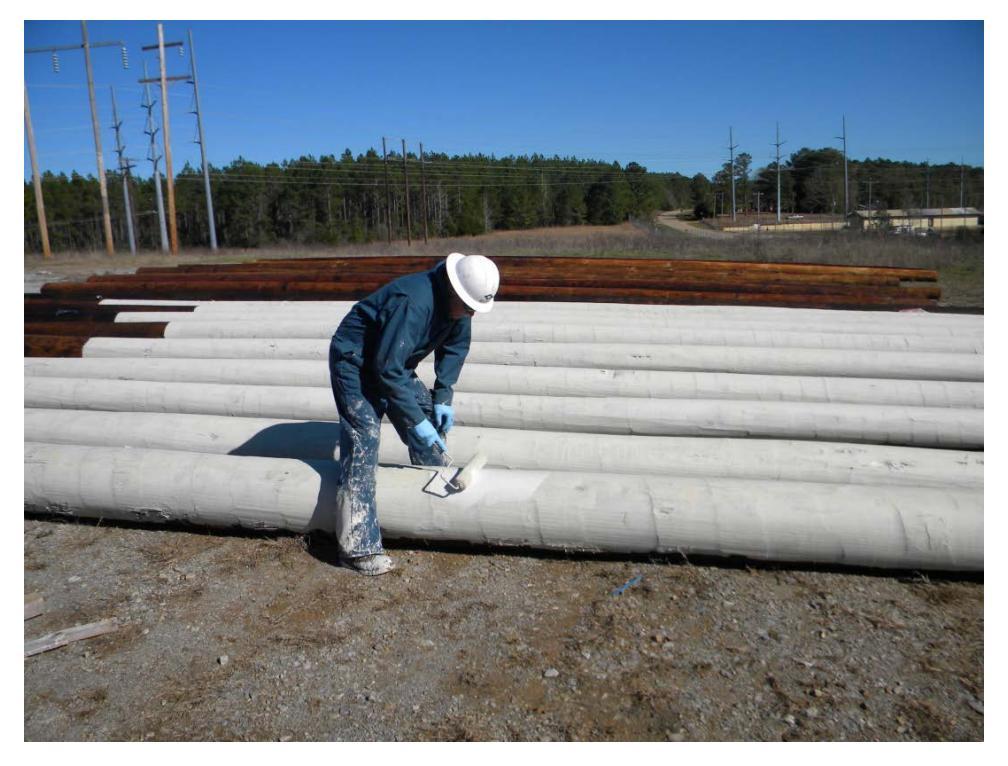
Figure 3-3

New transmission poles coated with Airepel[®] HC combined with Kilz Premium Primer at a 50/50 mixture

February 2-3, 2020, EDM treated 20 new poles (17 for the trial plus three spares) at a PowerSouth pole vard. Poles were treated with Airepel[®] HC 50% AQ combined with Kilz Premium Primer at a 50/50 mixture applied manually with a paint roller (Figure 3–3). By diluting Airepel[®] HC 50% AQ with the same amount of Kilz Premium Primer, the final mixture contained 25% AQ. A primer was needed to make the formulated product adhere to the pole. Kilz Premium Primer is a superior primer and out preformed the other primers in a previous wood pole test conducted at the National Wildlife Research Center (Cummings et al., unpublished data, 2001). It also provides excellent adhesion and a mildew resistant coating. Tom Jerrell, VP Research and Development, Arkion Life Sciences, LLC recommended the use of Kilz Premium Primer. The final application was based on previous repellency testing with pileated woodpeckers. No treatment was applied to the pole within six feet (1.8 meters) of the ground surface as part of the EPA approved testing (Mark Suarez, EPA, personal communication, 2015). When exposed to or handling Airepel® HC, applicators and linemen are required to wear a longsleeved shirt, long pants, socks, appropriate footwear, and chemical-resistant gloves. Although the product dries within two hours at 70° Fahrenheit (21° Celsius), the treated poles were air dried for at least 24 hours before installation.

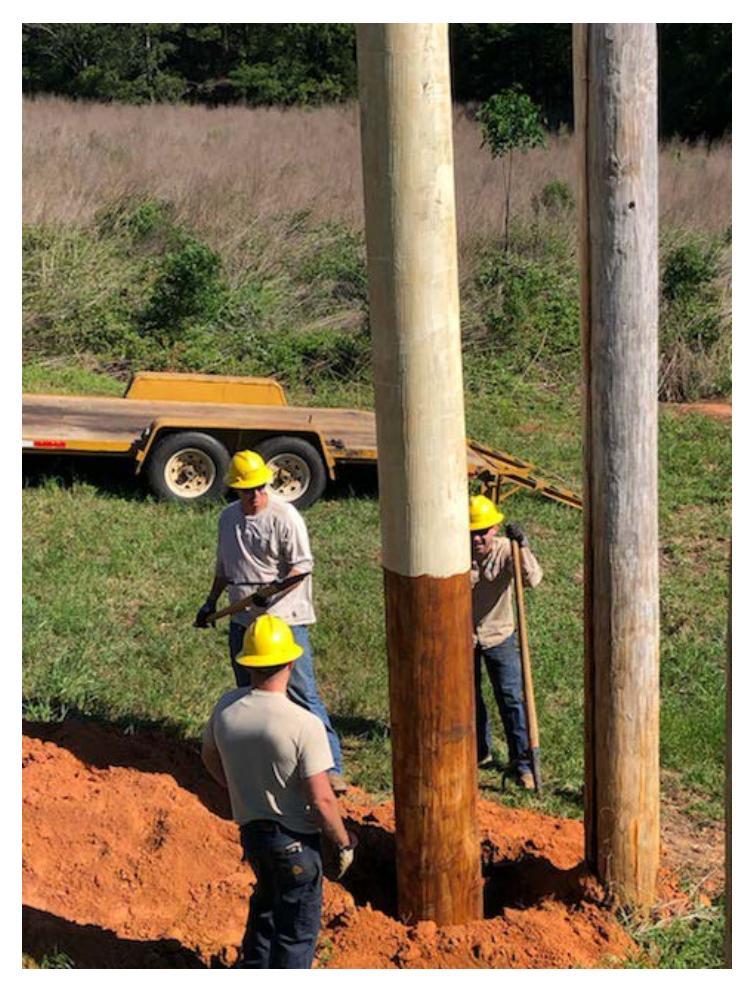
Figure 3-4 PowerSouth crew installing AQ treated pole. Note the base is untreated.

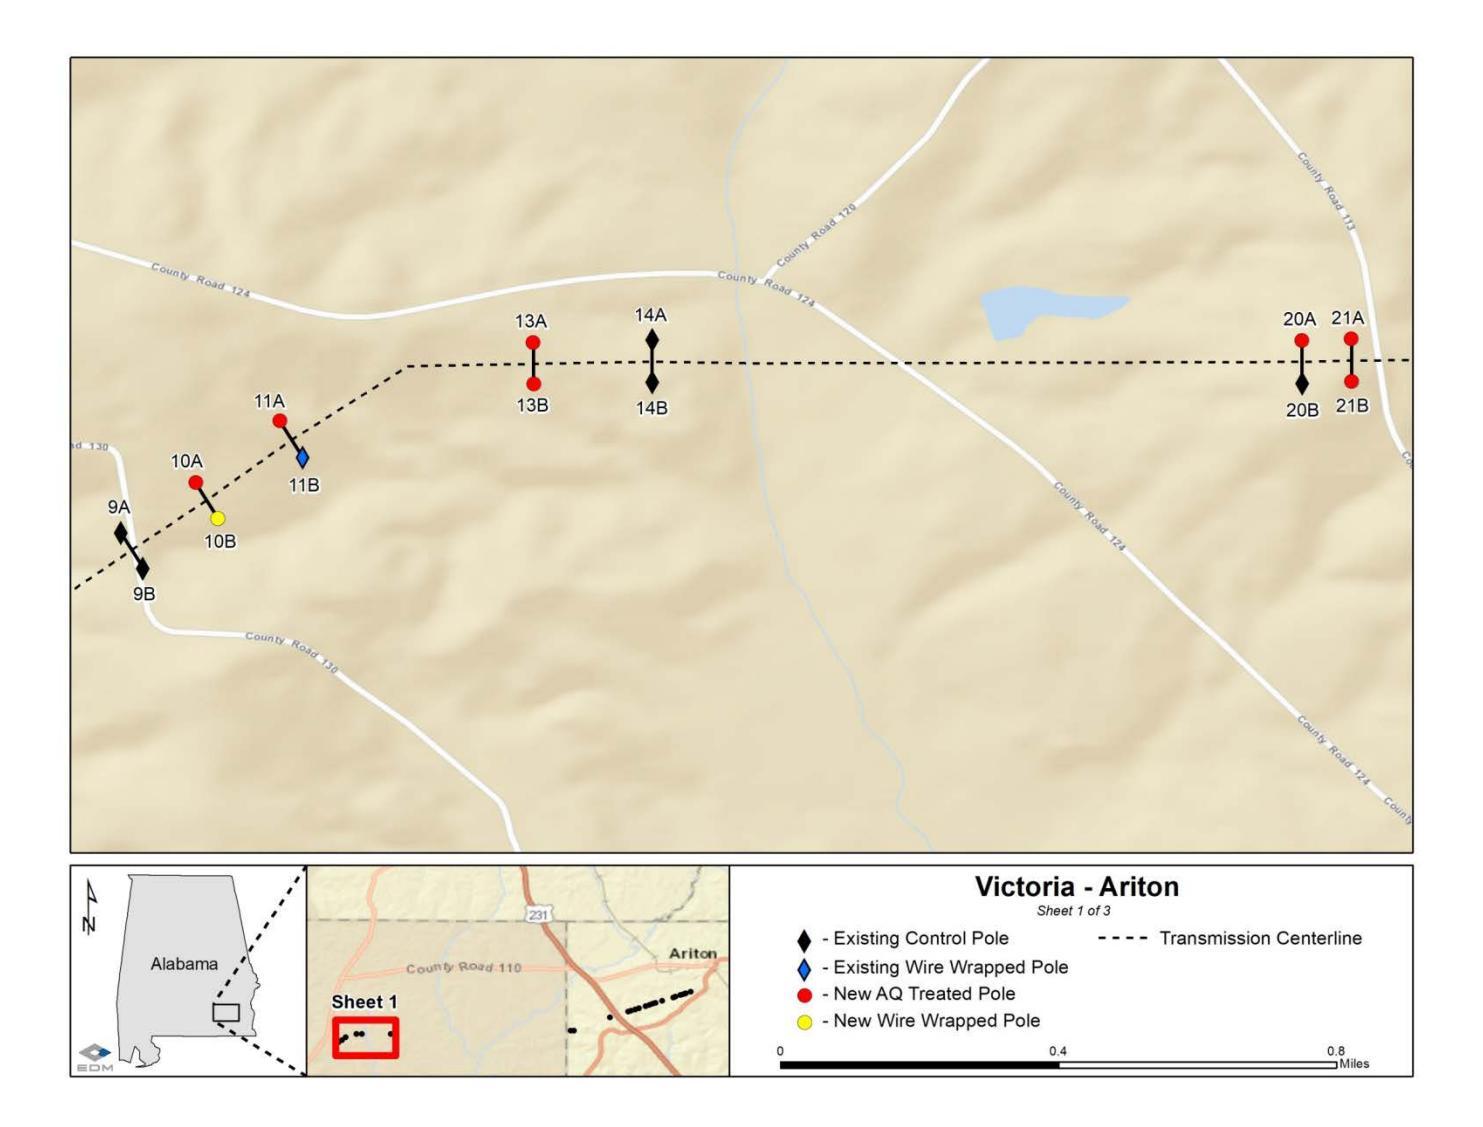
Figure 3-5

Victoria/Ariton transmission line power pole replacements. Note in 2022 it was discovered 10B was not wrapped and became a control pole. In addition, 14B, a control pole, was replaced due to damage with a wire wrapped pole.

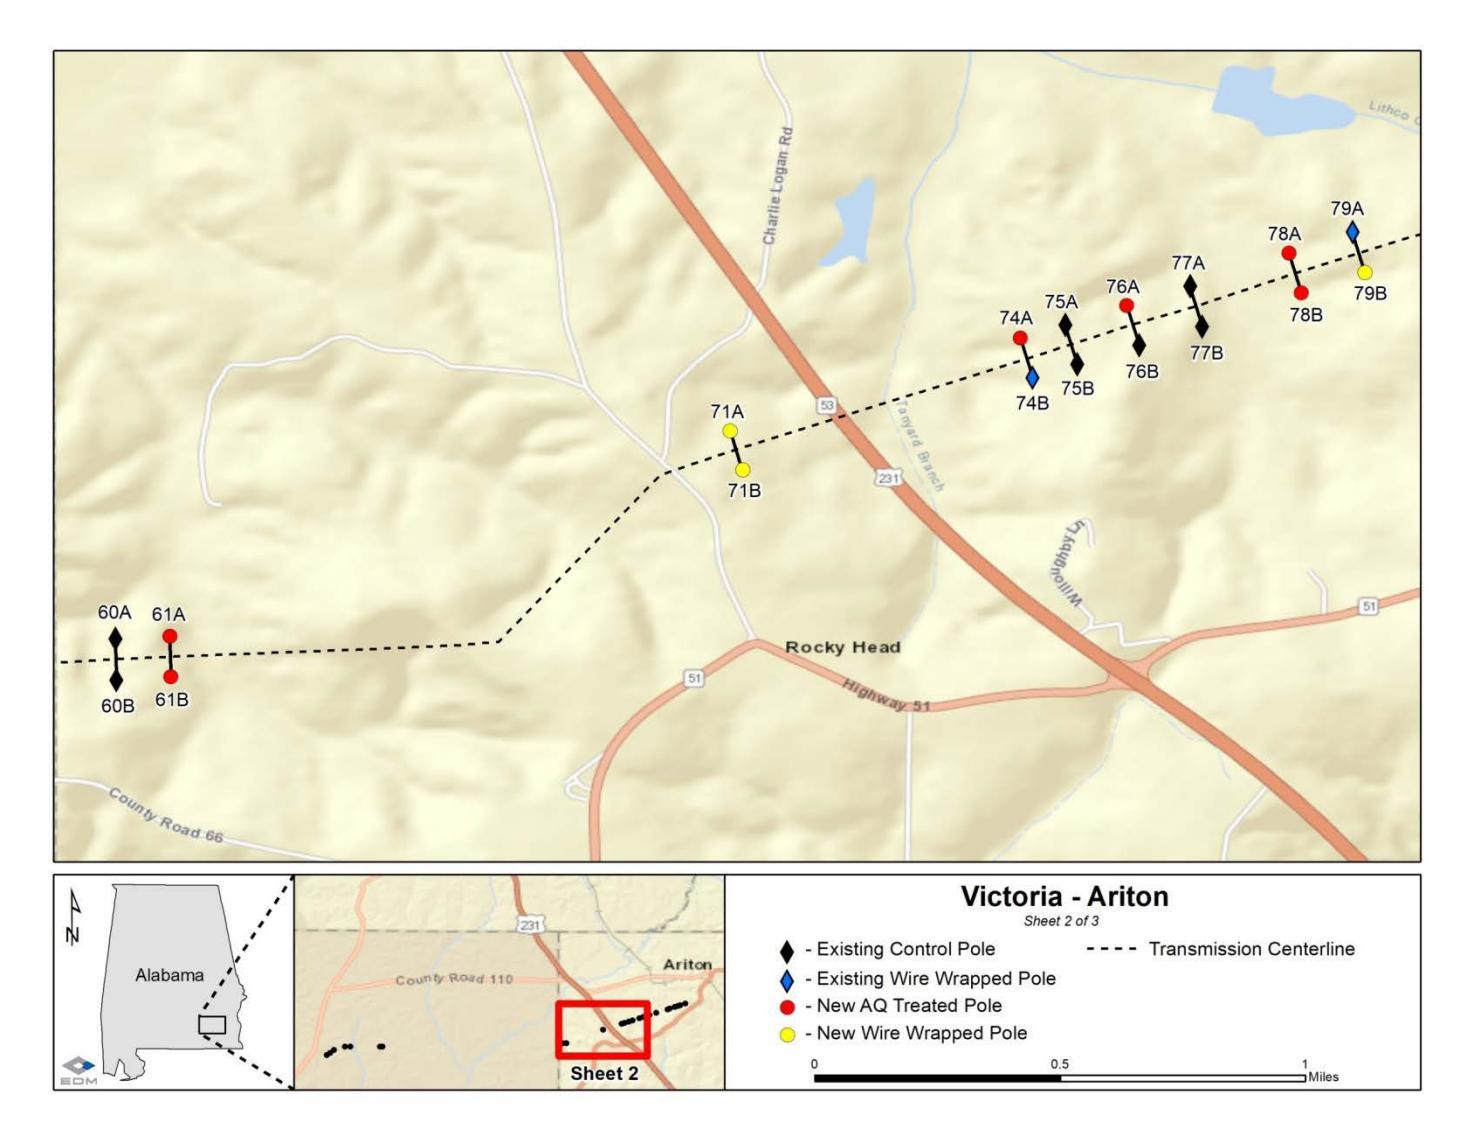
Figure 3-6 Victoria/Ariton transmission line power pole replacements

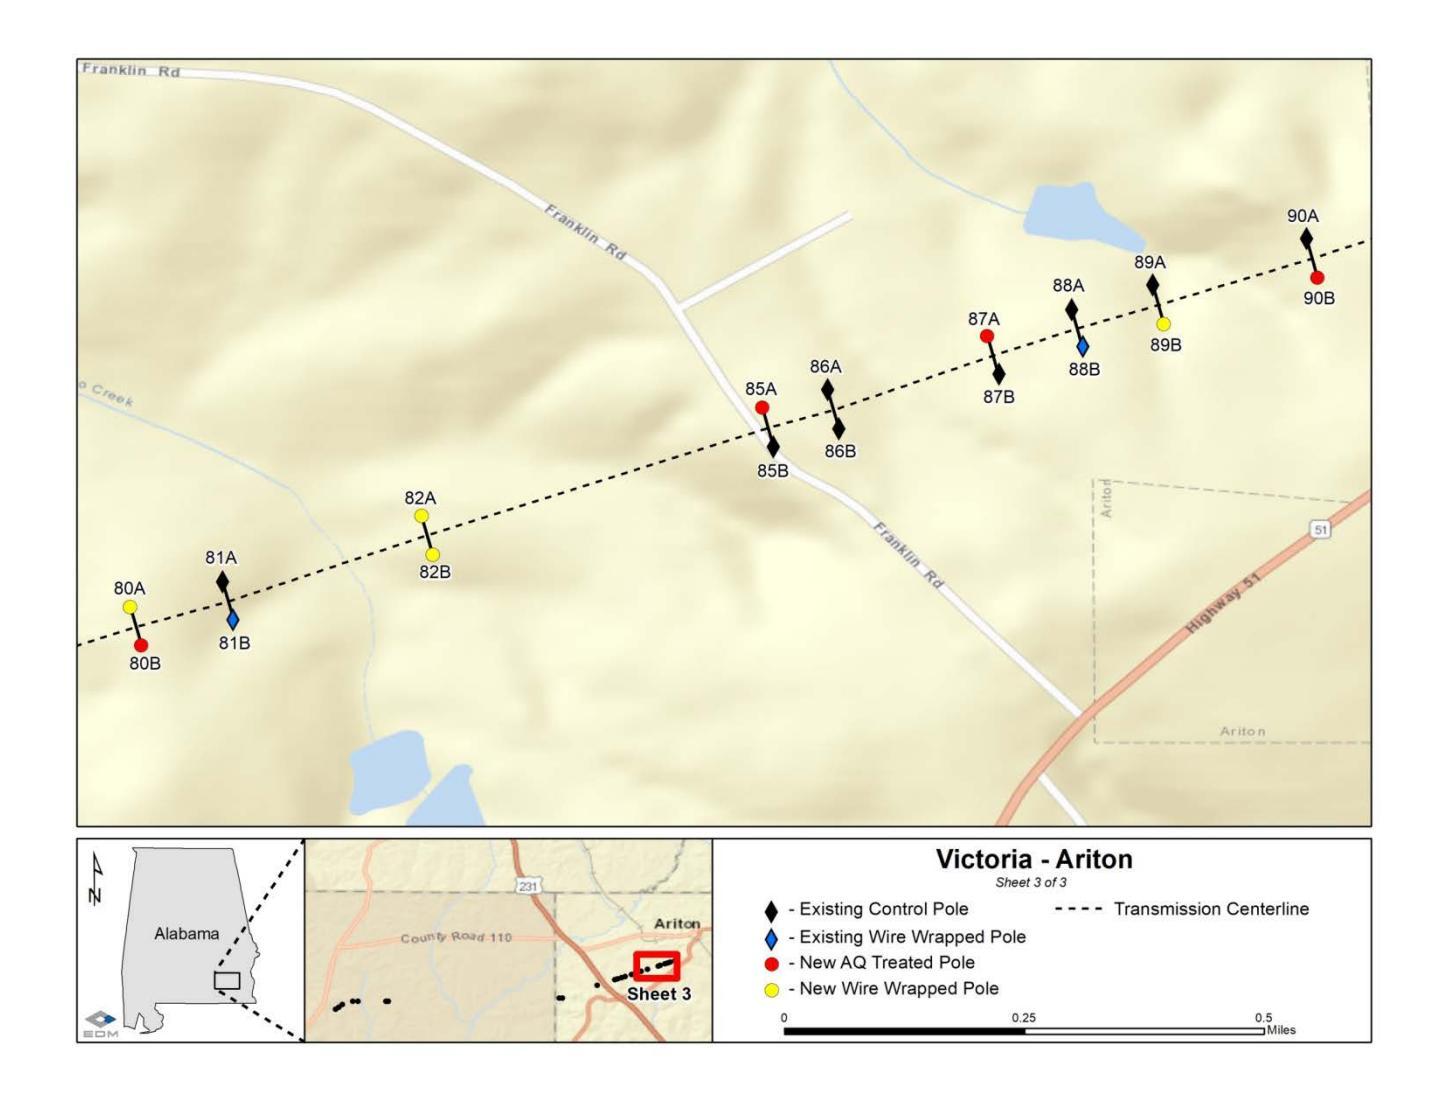
Figure 3-7

Victoria/Ariton transmission line power pole replacements. Note in 2022 it was discovered 82B was not wrapped and became a control pole. In addition, 87B, a control pole, was replaced due to damage with a wire wrapped pole.

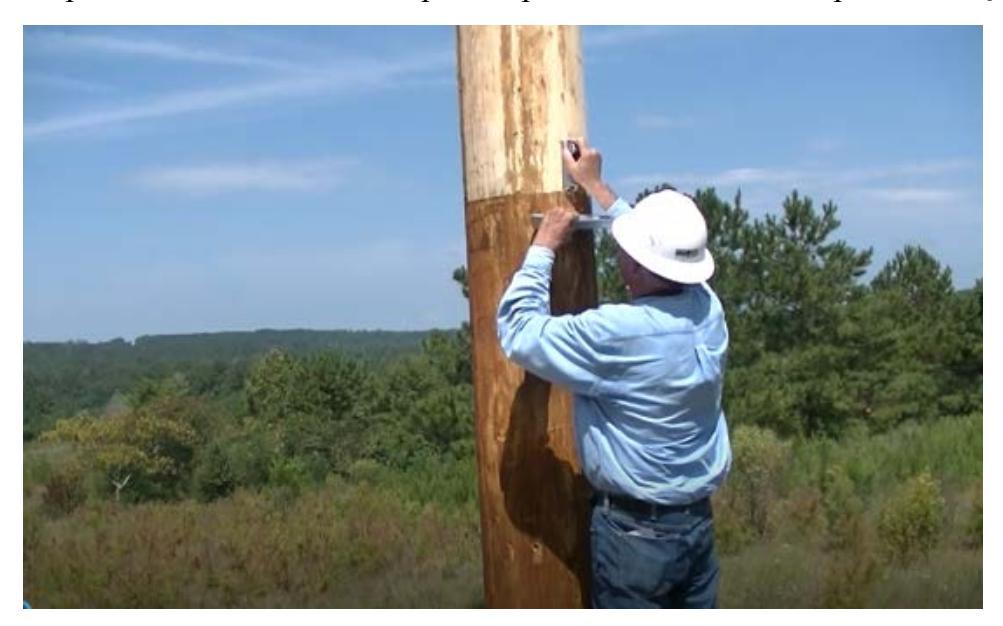
Figure 3-8 Pole shavings collected for residue analysis

Analysis of the Airepel[®] HC product and AQ formulation was required to verify concentrations used on the treated poles. Initially a raw sample collected directly from the product container of Airepel[®] HC product 50% and two samples of AQ/Kilz formulation 25% (AQ mixed with the primer to achieve a 25% rate of AQ) were collected to verify the base concentrations. Next, surface pole shavings were collected to determine target concentrations on treated poles coated with a mixture of Airepel[®] HC product and Kilz (AQ/Kilz 25% formulation, Figure 3-8). Seven treated poles were randomly selected (Poles 10A, 11A, 20A, 21A, 21B, 78A, and 90B) and scraped to remove AQ from a small pole section (approximately 6 inches by 6 inches, 15 centimeters by 15 centimeters). Each scrape was taken near the transition between treatment and the untreated pole butt. Last, three samples of untreated wood were also randomly collected. Subsequent samples were taken in proximity to the first sample. Samples were collected August 13, 2020 and March 23, 2022.

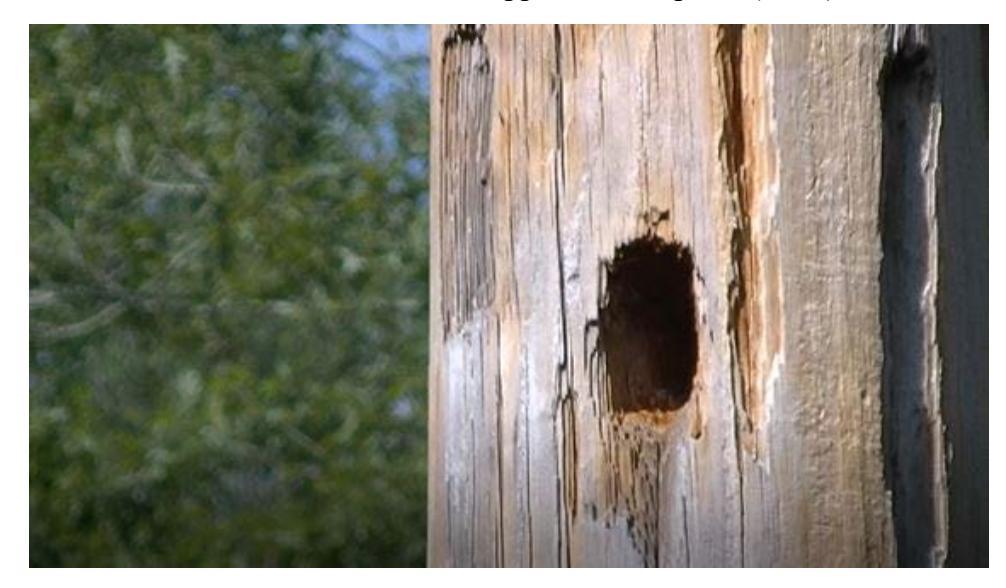
Figure 4-1 Control Pole 81A with fresh woodpecker damage noted during inspection

Woodpecker damage to control poles (Figure 4–1) increased significantly from pre-treatment to post-treatment (F = 4.51, d.f. = 1, P = 0.04). The total numerical woodpecker damage value increased from 160 to 338, or 52% on the unwrapped control poles (n=20).

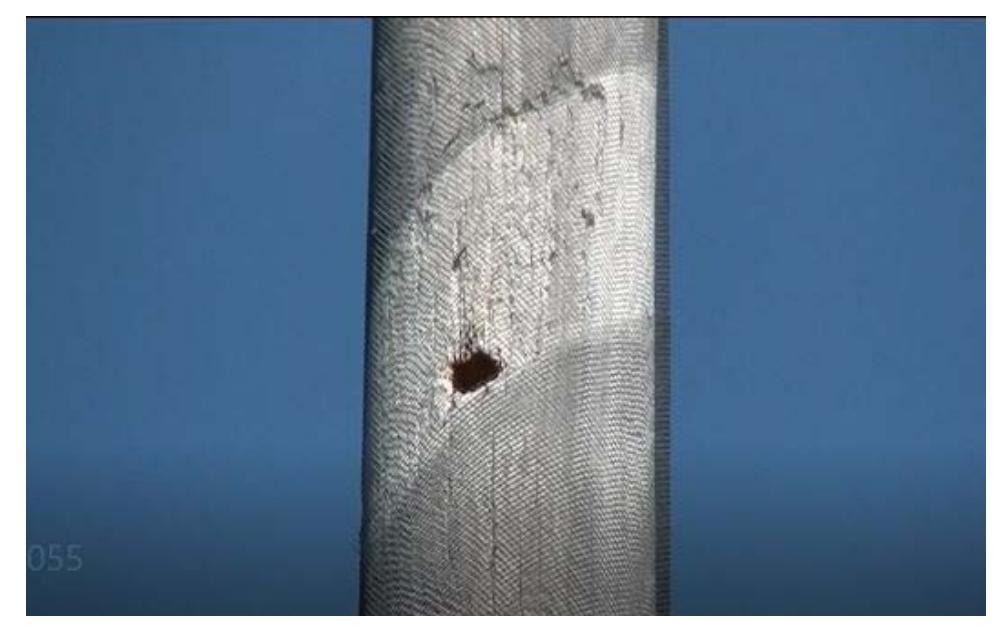
Figure 4-2 Woodpecker damage through a PowerSouth wire wrapped pole

There was no significant difference in woodpecker damage between AQ treated and wire wrapped poles (F= 3.98, df = 1, P = 0.055). As previously noted, the numerical woodpecker damage value increased to 1 for the AQ treated poles (n=17). For wire wrapped poles collectively, damage increased by 8 (n=11, 0.7 per pole). From 2020 to 2022, damage that occurred to wire wrapped poles was mostly on the existing wrapped poles (n=5). Only one newly wrapped pole had new damage, a small woodpecker hole (value 1). The baseline survey of this right-of-way line section noted three poles where woodpeckers defeated wire, going completely

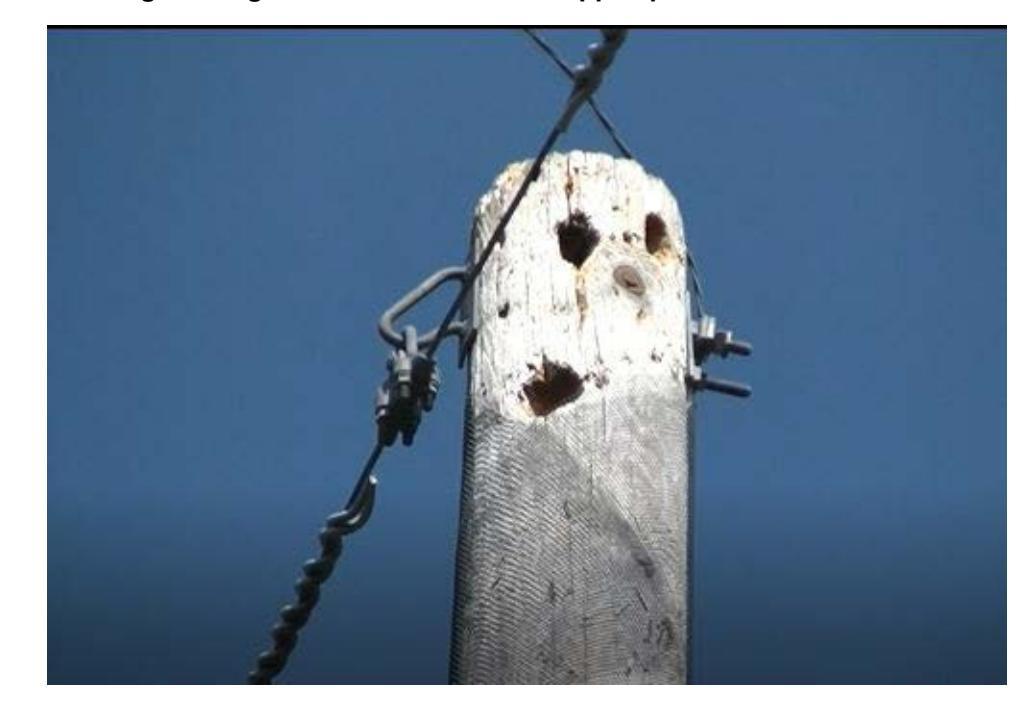
Figure 4-3 Woodpecker damage above the wire wrap on a PowerSouth pole

through the wrap (Figure 4–2). In other locations, woodpeckers exploited gaps in the wire coverage at a total of three poles (Figure 4–3).

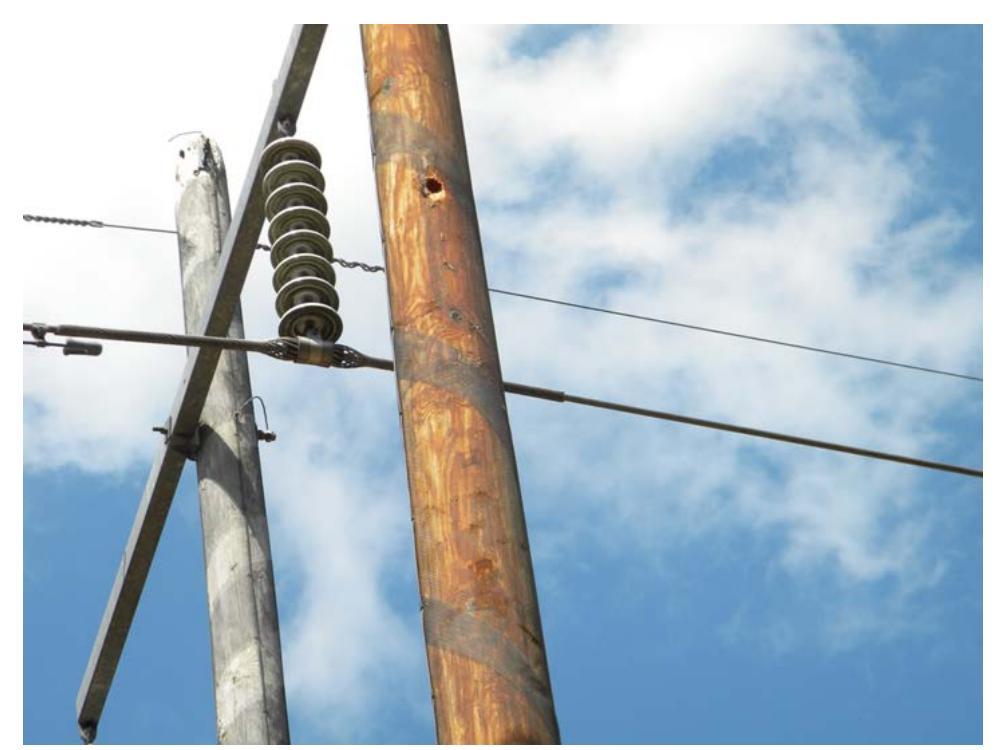
Figure 4-4 Pileated Woodpecker damage to a new wired replacement pole 79B

added since they only had one year of exposure. Most damage occurred on the existing wrapped poles. However, one newly wrapped pole which had sustained a small woodpecker hole (value 1) in the first assessment, was excavated further to a value of 2 and one additional medium hole (value 2) was documented (Figure 4-4).
