# technical update

## Shield-Grounding Practices and Surge Implications

### Power Quality Tools

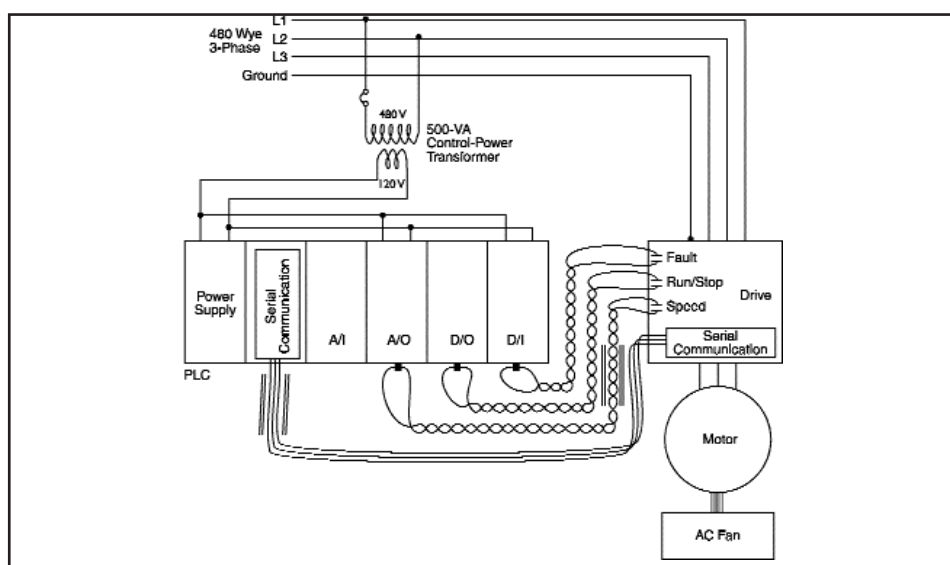
Figure 1. System Under Test

The equipment under consideration is a simple industrial control system comprised of a PLC, adjustable-speed drive (ASD), and motor. The PLC and ASD were interconnected by multiple communication schemes, both analog and digital. Figure 1 is a wiring diagram of the subject equipment.

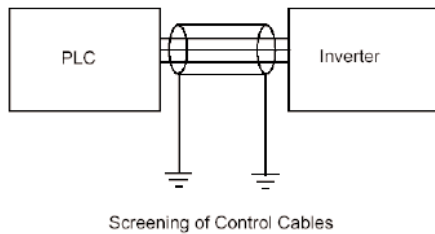
The diagram illustrated below was found on page 40:

2. Use screened leads for connections to the control circuitry. Ground the screen at both ends.

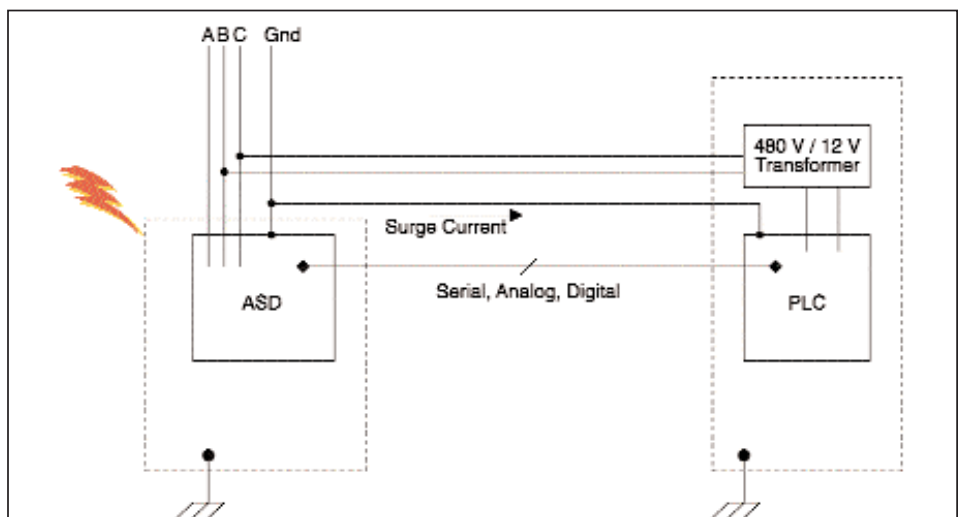
Figure 2. Typical Surge Scenario at an Industrial Facility

For example, consider the following scenario: A PLC and ASD are part of the same industrial process but are located in different control cabinets and are separated by a distance of 25 feet (7.6 m). Their power wires and communication wires are run through conduits and cable trays. Lightning strikes the building or the ground nearby. This elevates the ground potential in the area of the strike, but at increasing distance from that point, the ground potential is lower. The difference will cause current to flow in all building ground paths, as shown in Figure 2. This scenario is described in ANSI/IEEE C62.45-1992, Annex C and IEC 61000-4-5 p.15. If current flows in a ground wire that is connected between two pieces of equipment and if that ground wire is bundled with or near the communication cables, the surge can be induced into the communication cables by magnetic coupling.

For reference, this coupling scenario is described in IEEE 1100-1999 pp. 118-119. Additionally, if a shield is grounded at both ends, it will carry surge current itself.

The amount of the surge coupled onto the communication wires is related to the magnitude of the surge current, the proximity of the communication wires to the surge-carrying conductor, the length of wire, and any terminating resistance in the communication scheme. Input impedance of the ASD and PLC also play a role in the induced voltage.

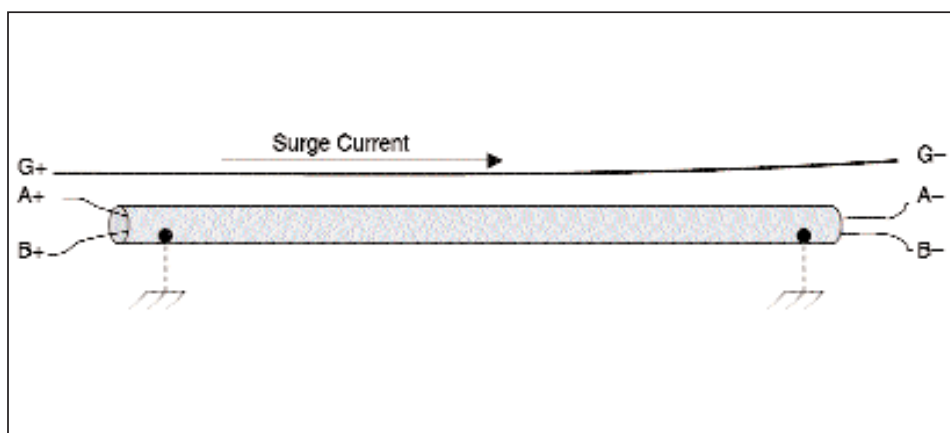
Figure 3. Surge Coupling Scenario

The long wires were then bundled together. The objective of the tests was to induce a surge into the communication wires by bundling them with a ground wire and applying a surge to the ground wire. Surge current traveling through the ground wire will induce a surge onto the communication wires, as shown in Figure 3. The coupling would then be measured in four grounding modes: positive end grounded, negative end grounded, both ends grounded, neither end grounded.

The coupling mechanism was verified by initial experiment using 25-foot (7.6-m) lengths of cable and no EUT connected. Each surge was applied across the ground wire (generator connected G+ to G-), forcing a current (approximately 50 A peak) through the wire. A corresponding surge voltage was measured across a single conductor in the shielded cable as shown in Figure 3. The voltage measured from A+ to A- was approximately 80% of the voltage produced by the surge generator. If A+ and A- are shorted together with a short piece of wire, then the current in A is approximately 80% of the current in G.

- Starting with the serial port, connect transducers at the following monitoring points (referring again to Figure 3):
  - Surge voltage across the surged (ground) conductor (G+ to G-)
  - Surge current through ground conductor
  - Voltage across one conductor in the shielded pair (A+ to A-)
  - Current through that conductor
  - Voltage across the other conductor in the shielded pair (B+ to B-)
  - Current through that conductor
  - Voltage across the shielded pair at the ASD (A+ to B+)
  - Voltage across the shielded pair at the PLC (A- to B-)
- With equipment connected to the power source and running normally, apply one surge in each of the following grounding configurations:

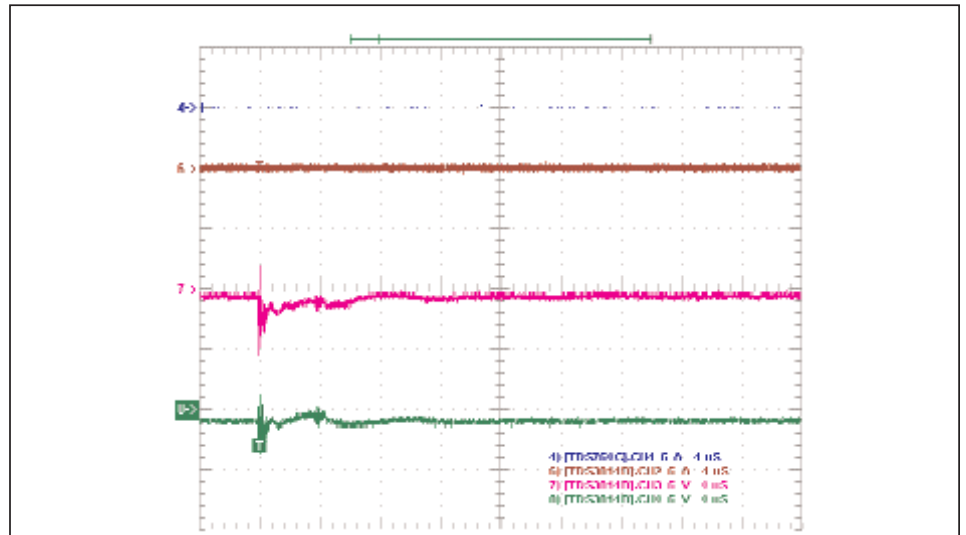
Figure 4. Results for No Grounds: Fast Ringing Transient of Very Low Magnitude ( $\leq 5V$ )

The four graphs shown in Figures 4 through 7 use the channel scheme shown in Table 2. For clarity, only the four channels that reveal the most information are shown. Note that Figures 6 and 7 show significantly more voltage across the differential pair of signal-carrying conductors. Additionally, Figure 6 is the only test result with a measurable current into the port (Channels 4 and 6). The system was upset (tripped) in

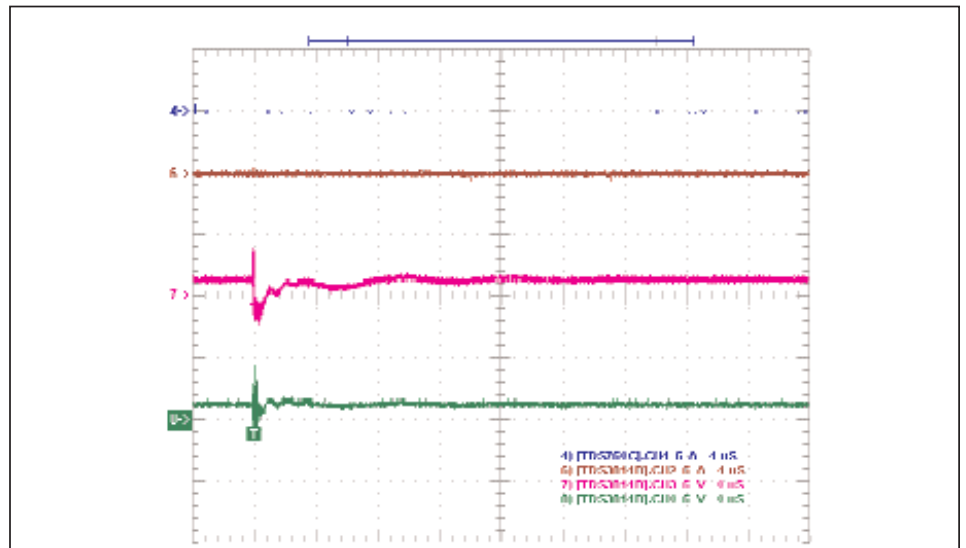
Figure 5. Results for Shields Grounded at ASD: Fast Ringing Transient of Very Low Magnitude ( $\leq 5V$ )

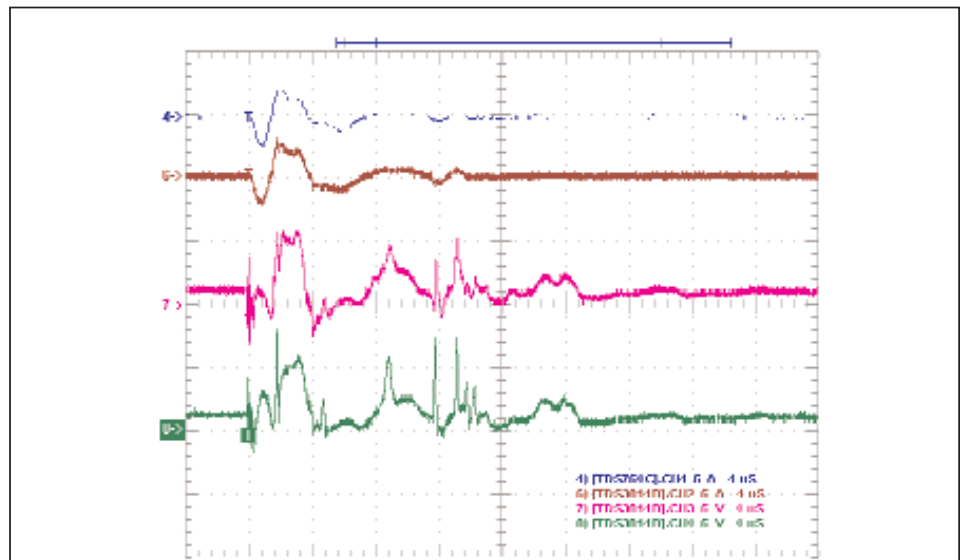
Figure 6. Results for Shields Grounded at PLC: Voltage Peaks  $\sim 7V$ , Current Peaks  $\sim 3A$

response to the surge applied when the shield was grounded at the PLC end. All graphs are results from testing the serial port.

Preliminary tests showed that grounding of shields did play a role in the operation of the control system under test. With moderate surges, the equipment would consistently trip when the serial cable shield was grounded at the PLC only. We might speculate that if the relatively small surge can cause upset, then a larger surge could cause permanent damage. According to IEEE 1100, actual lightning currents can range from a few hundred amperes to more than 500 kA. In much of North America, 20-40 kA is the value that is often used to estimate typical lightning current conditions. Compare this to the roughly 50 amps that were produced in the ground wire during the surge tests.

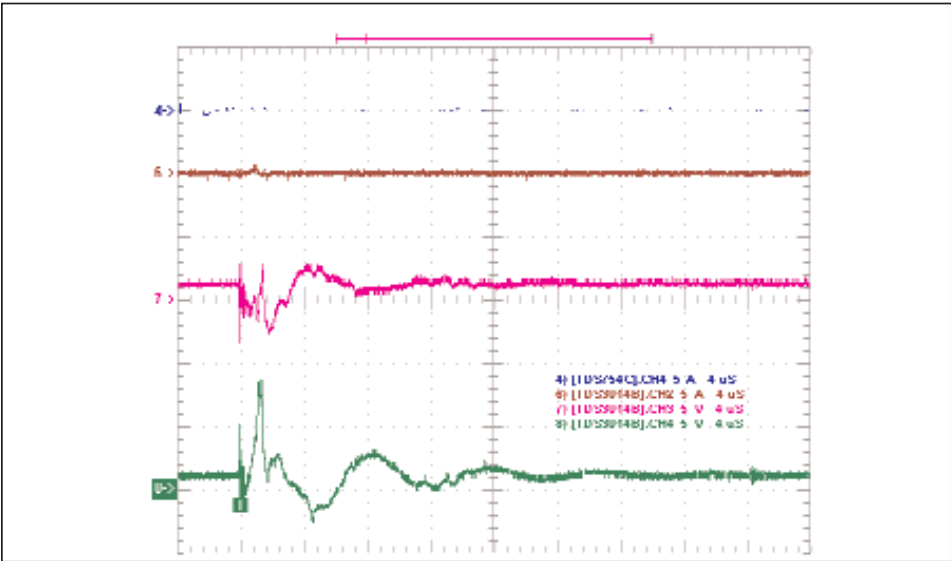
Figure 7. Results for Shields Grounded at Both Ends: Voltage Peaks ~7V, No Current
