# Assessment of the Need to Chemical Clean

## Effects of Waterside Deposits on Heat Recovery Steam Generator (HRSG) Performance

**1008089**

Final Report, November 2005

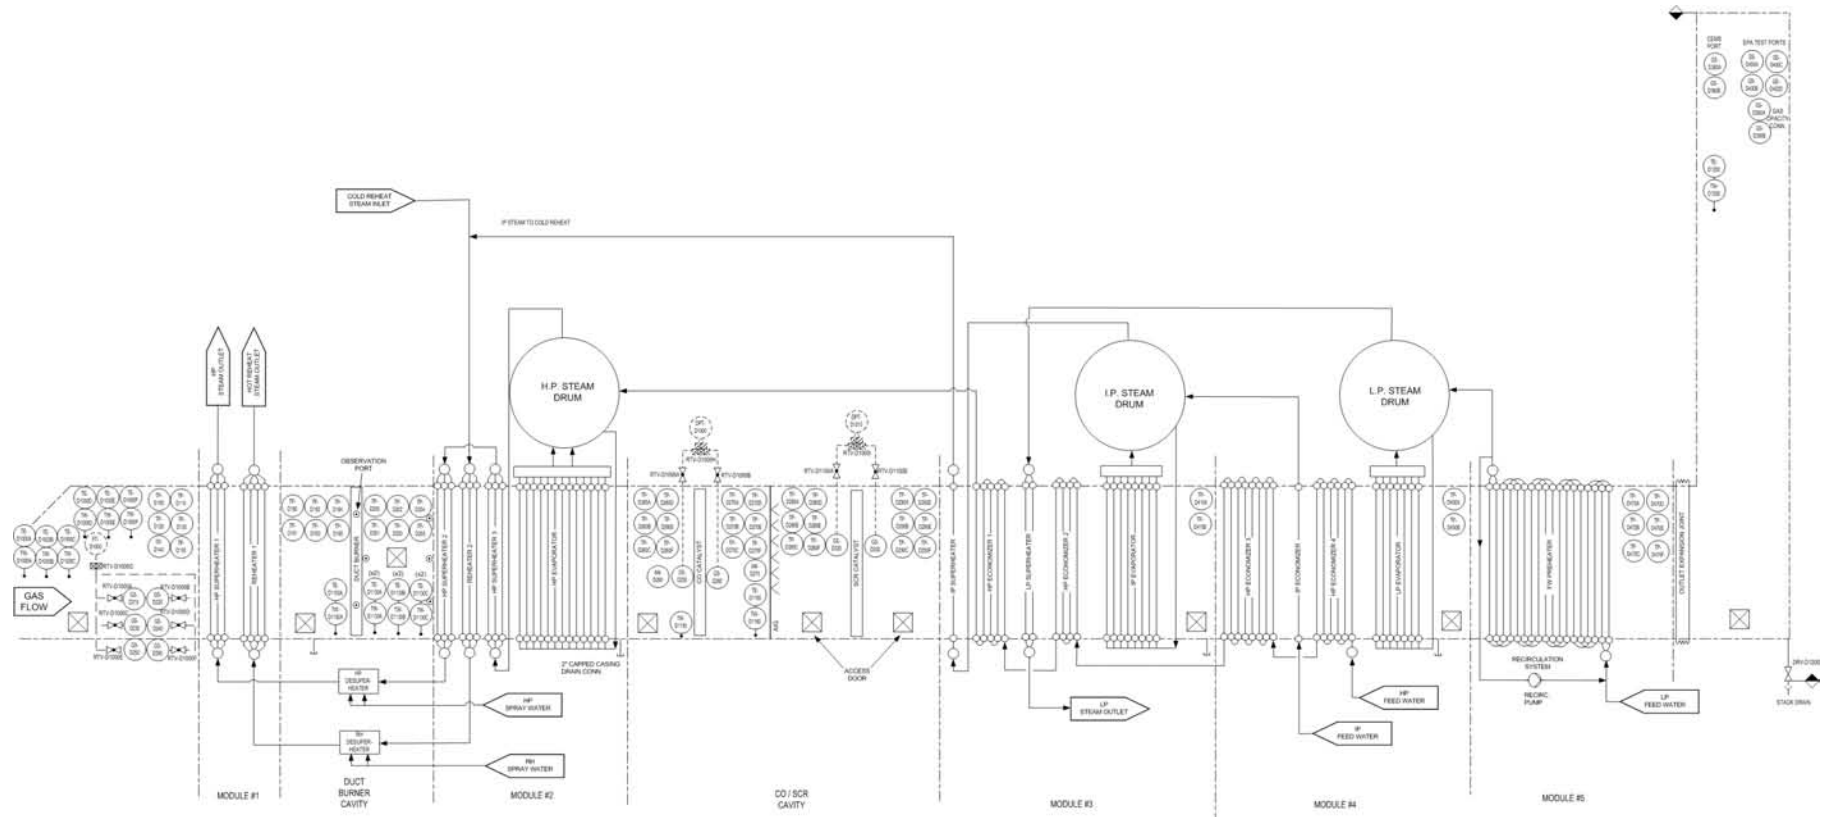
**Figure 2-1**  
Typical Layout of a Triple Pressure HRSG

A triple pressure drum-type HRSG of horizontal gas pass configuration with supplemental duct firing as shown in Figure 2-1 was initially selected for evaluation since this type of HRSG is the most common in newer combined cycle plants. As shown in the figure, duct burners are located between various HP superheater/reheater harp assemblies followed by the HP evaporator. If a selective catalytic reactor is required, this is installed downstream of the HP evaporator since it operates at relatively high gas temperatures. All other heat transfer surfaces are basically located to maximize efficiency as dictated by the difference in temperatures between the water/steam and gas streams. This is exemplified by the placement of multiple HP economizer sections in the gas pass.

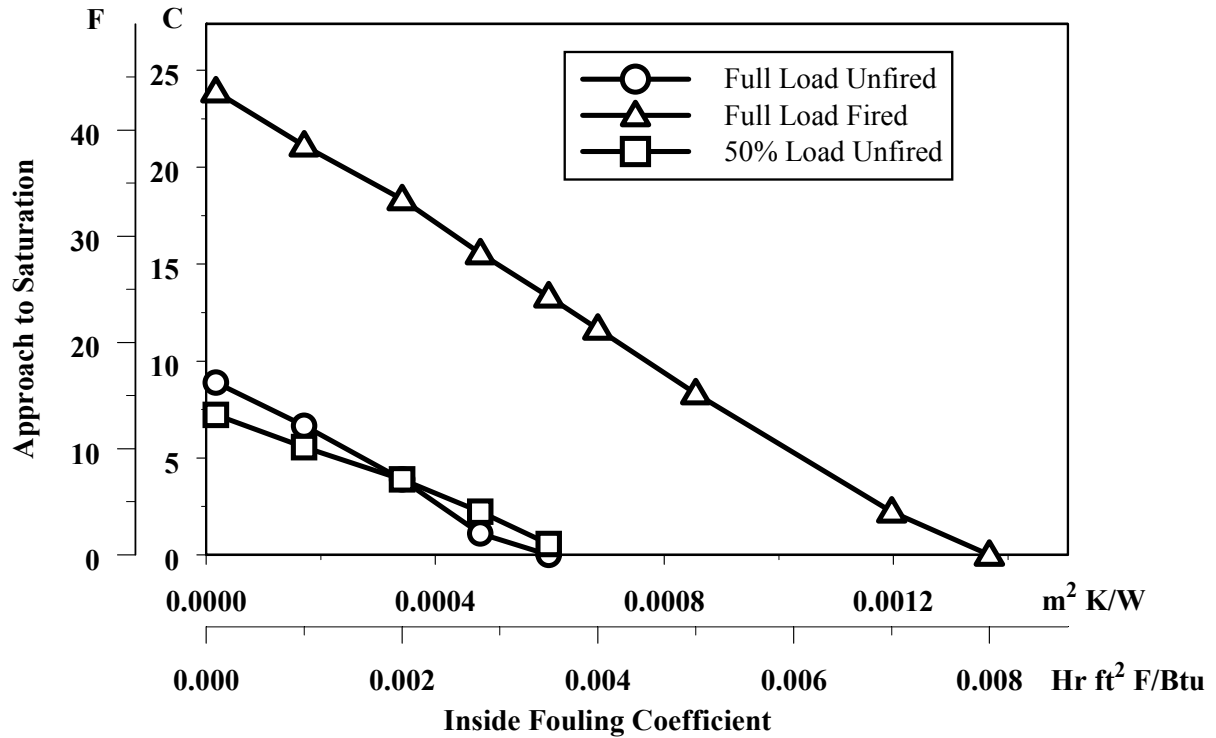
**Figure 2-2**  
**Effect of Waterside Fouling Coefficient on the Economizer Approach to Saturation Temperature**

Data resulting from the initial assessment effort are reported in Tables 2-1 through 2-3. (It should be mentioned that calculations were made in US units and conversions were made to SI units during preparation of this report. This process involved some rounding of temperature values reported in Tables 2-1 to 2-4.) The parameter most significantly affected under various heat transfer internal resistance values was the economizer approach to saturation temperature for the full load/unfired case (Table 2-1). These data are plotted in Figure 2-2. The approach to saturation temperature decreases as the internal coefficient or degree of fouling increases. This pinch point temperature decreases below the design range as the internal coefficient approaches  $0.000171 \text{ m}^2\text{K/W}$  ( $0.001 \text{ ft}^2 \text{ }^\circ\text{F hr/Btu}$ ), which is ten times the base design value for new tubing. The calculated temperature corresponding to this internal coefficient value is between  $6^\circ\text{C}$  and  $7^\circ\text{C}$  ( $11$  and  $13^\circ\text{F}$ ). The temperature value of  $6^\circ\text{C}$  ( $11^\circ\text{F}$ ) was used for the rest of the evaluation activity as the assumed limit for the allowable degree of fouling in the HP evaporator.

For an HRSG, the assessment indicates that HP economizer approach to saturation temperature appears to be the parameter best suited as the key indicator for the need to chemically clean based on performance (and in the absence of tube failures caused by underdeposit corrosion). For the purpose of this assessment, it was decided that when an amount of deposit drove the approach to saturation temperature below 6°C (11°F), it would signal the need for chemical cleaning. This value may not be optimum for all situations though it is considered a useful starting point for the purpose of this evaluation and discussion of the results.

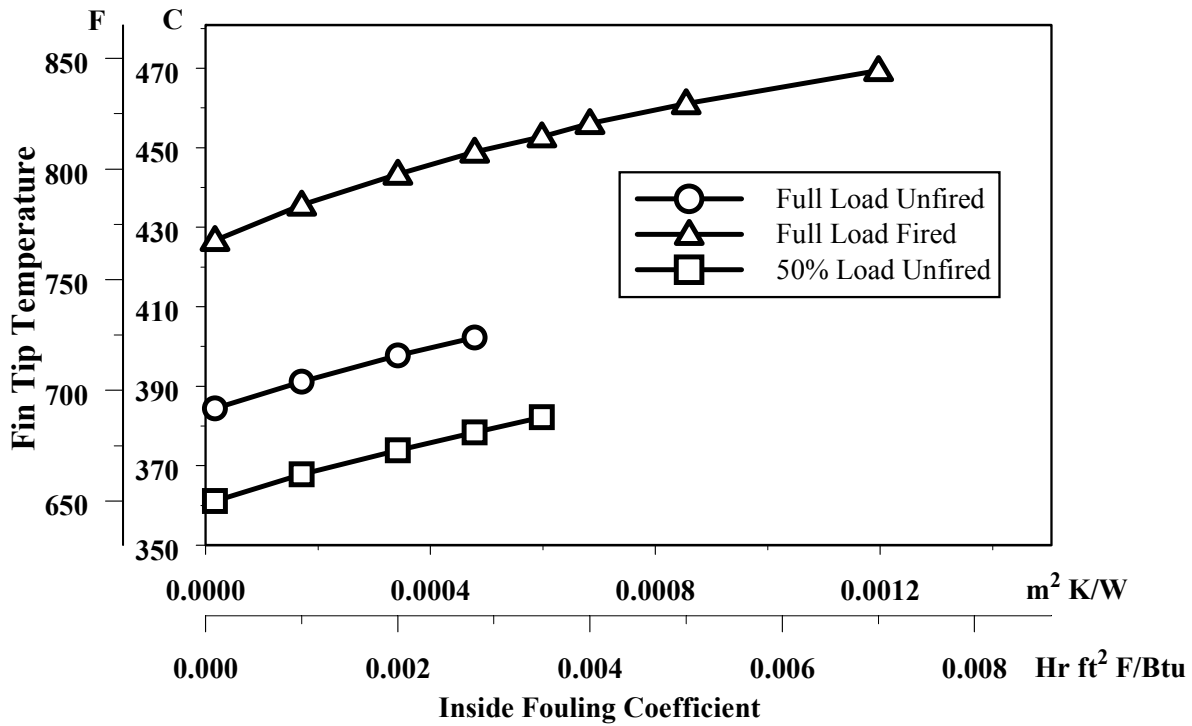
**Figure 2-3**  
**Effect of Waterside Fouling Coefficient on Tube Fin Temperature**

Figures 2-3 and 2-4 are plots of two other parameters, fin temperature and steam flow, that were also affected by tube deposits but to a lesser extent. The HP evaporator tube temperatures remained well below the design limit for carbon steel materials. The stack gas temperatures did not change, which was somewhat surprising based on the degree of HP evaporator fouling. As indicated earlier, it was originally anticipated that this parameter would be affected by HP waterside fouling. It clearly demonstrates the capability of components downstream of the HP evaporator in recuperating heat from the exhaust gas and thus maintaining relatively stable stack gas temperatures.

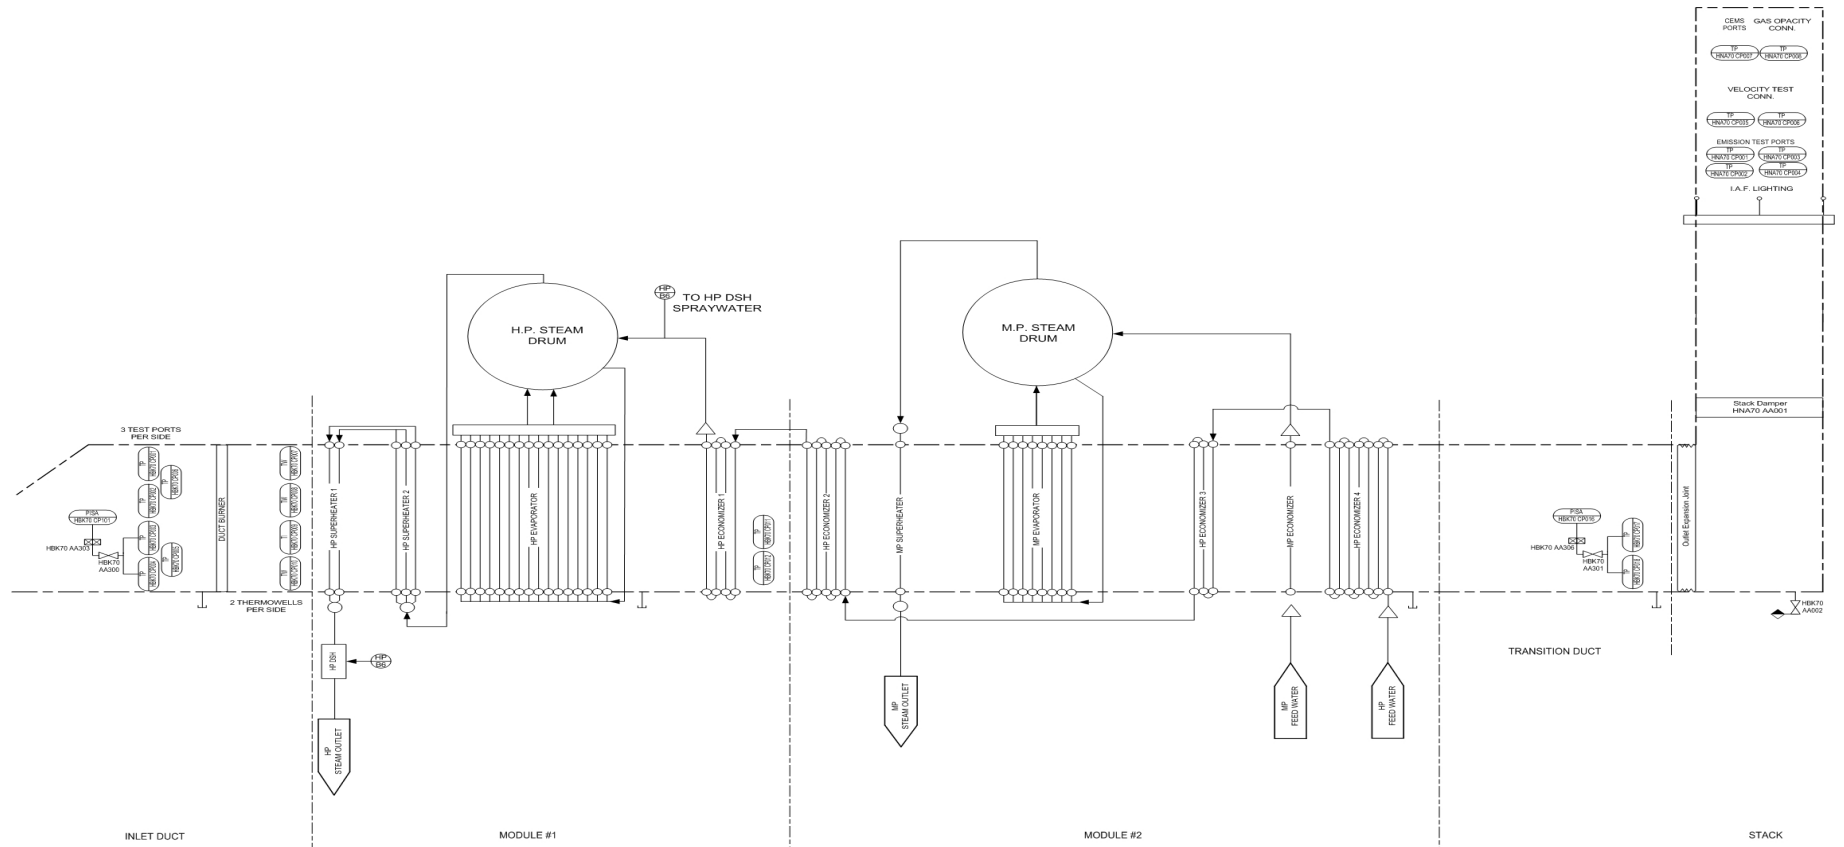
**Figure 2-5**  
**Typical Layout of a Double Pressure HRSG**

A similar evaluation was conducted on a double pressure HRSG (Figure 2-5) at full load – unfired conditions. Unfired conditions are typical for double pressure HRSG. The main difference from triple pressure HRSG system designs is that the double pressure HRSG is a non-reheat cycle and therefore lacks the intermediate pressure (IP) components. In general, a double pressure HRSG/combined cycle is not as efficient as a triple pressure cycle. A test run was also performed with deposits in the HP economizer at half the thermal resistance of that in the HP evaporator. The entire set of calculation results is listed in Table 2-4.

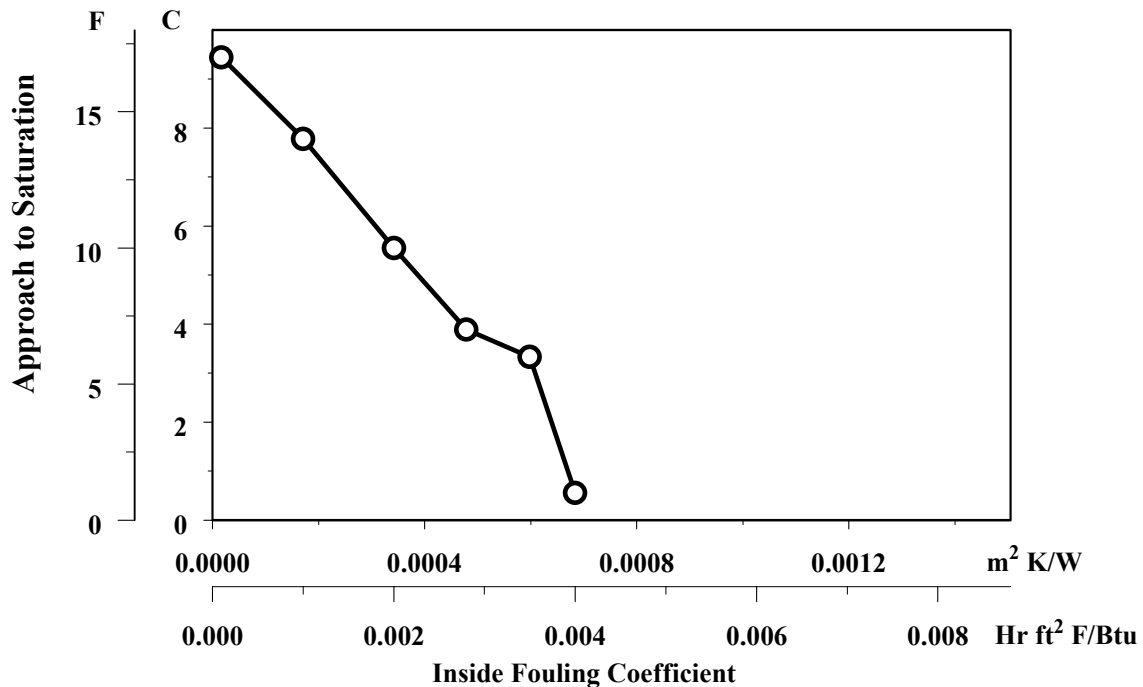
**Figure 2-6**  
**Effect of Waterside Fouling on the Economizer Approach to Saturation Temperature in a Double Pressure HRSG**

The deposits in the HP evaporator tubes affect the various parameters in a similar fashion as determined for the triple pressure system. As an example, Figure 2-6 is a plot of the economizer approach to saturation temperature. This temperature or pinch point decreases below the recommended range although not as low as in the triple pressure case. However, from a practical point of view, these results can be considered similar. The fouling of the economizer in a double pressure HRSG has a much more significant impact on several of the parameters than noted during assessment of the triple pressure system. This is understandable since there is less heat transfer surface past the HP economizer in the direction of the gas flow. As with the triple pressure case, the calculations were carried out for the HP evaporator tubing resistance of  $0.000171 \text{ m}^2\text{K/W}$  ( $0.001 \text{ ft}^2 \text{ }^\circ\text{F hr/Btu}$ ). The economizer tube deposit resistance was assigned half the resistance -  $0.000085 \text{ m}^2\text{K/W}$  ( $0.0005 \text{ ft}^2 \text{ }^\circ\text{F hr/Btu}$ ). The internal fouling of the economizer had a reverse effect on the saturation approach temperature as it increased from  $8^\circ\text{C}$  to  $22^\circ\text{C}$  ( $15^\circ\text{F}$  to  $40^\circ\text{F}$ ). The significant impact was on the stack gas temperature as it increased by about  $14^\circ\text{C}$  ( $25^\circ\text{F}$ ) (Figure 2-7). The HP steaming rate was also significantly reduced (about 3%) as plotted in Figure 2-8. These last two changes have measurable effect on both the system efficiency and steam turbine output. The other parameters were not significantly affected.

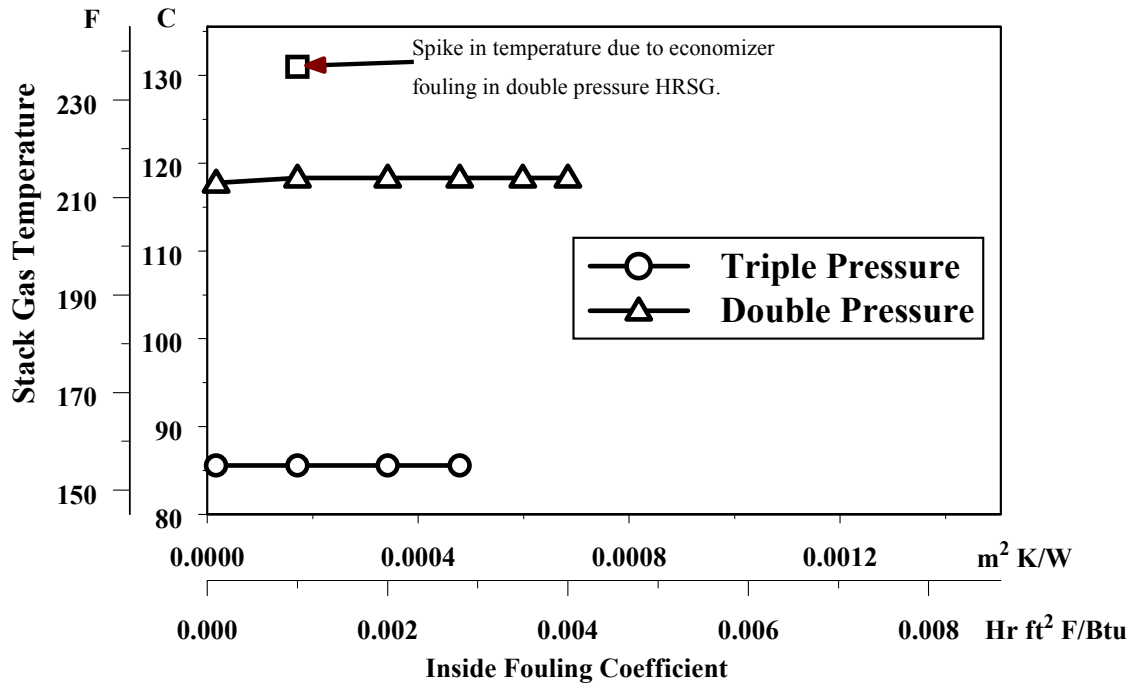
**Figure 2-7**  
Effect of Economizer Waterside Fouling on the Stack Gas Temperature for a Double Pressure HRSG

In a double pressure HRSG, fouling of the HP economizer impairs heat transfer into the feedwater whereby the saturation approach temperature will increase significantly. Since the amount of heat transfer surfaces downstream of the economizer is less than in a triple pressure system, there is less opportunity to compensate for the heat loss. This results in a reduction in HP steam flow and an increase in stack gas temperatures. In this case, the key HRSG performance parameters for determining the need to clean become the stack gas temperatures and HP steam flow.

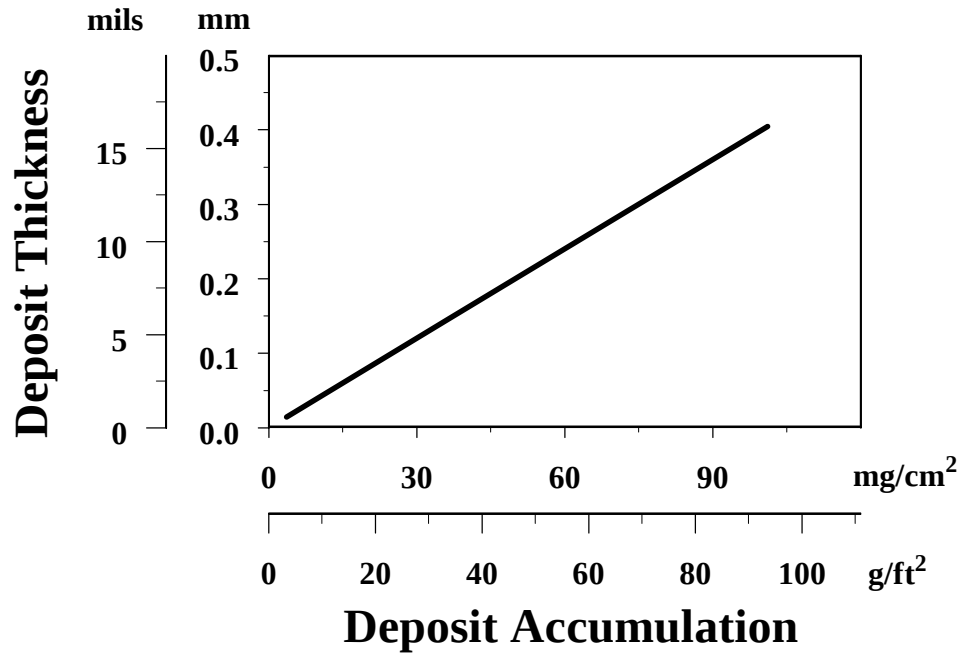
**Figure 2-9**  
**Correlation Comparing Waterside Deposit Loading and Corresponding Thickness at a Deposit Density of 2.5  $\text{g}/\text{cm}^3$  (156 pounds/ $\text{ft}^3$ )**

The review of this body of information led to the conclusion that the average deposit density and thermal conductivity values under boiling heat transfer conditions could be assumed to be 2.5 g/cm<sup>3</sup> (156 pounds/ft<sup>3</sup>) and 0.845 W/mK (0.5 Btu/hr ft °F), respectively. The thermal conductivity is valid for temperatures up to 380°C (716°F) and deposit porosity up to 50%. Higher deposit porosities exhibit lower thermal conductivities unless steam chimneys are formed and then the thermal conductivities can increase. The deposit density was further used to correlate deposit accumulation and deposit thickness.

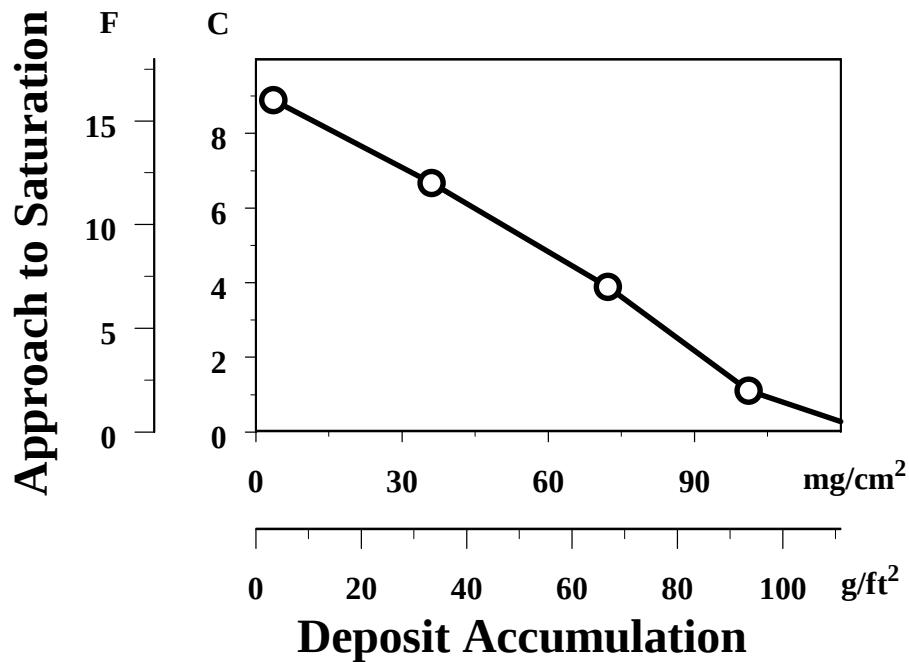
**Figure 2-10**  
**Effect of Deposit Accumulation on Economizer Approach to Saturation Temperature**

The subject assessment suggest that the amount of deposit in the HP evaporator tubes that warrants a chemical cleaning based on an economizer saturation approach temperature of 6°C (11 °F) (even with a clean economizer) is approximately 40 mg/cm<sup>2</sup> (37 g/ft<sup>2</sup>). Interestingly, this amount of deposit corresponds to the amount estimated to provide a thermal resistance in a conventional boiler tube to drive the tube temperature to 454°C (849°F). Further, this amount corresponds to the upper limit of the cleaning guidelines for subcritical boilers when a boiler must be cleaned to avoid overheating problems. If the HP steam flow and/or stack gas temperature in a double pressure HRSG indicate significant changes from normal, then obtaining tube samples from the HP economizer may aid in the determination of the need for cleaning as well as field cleaning requirements.

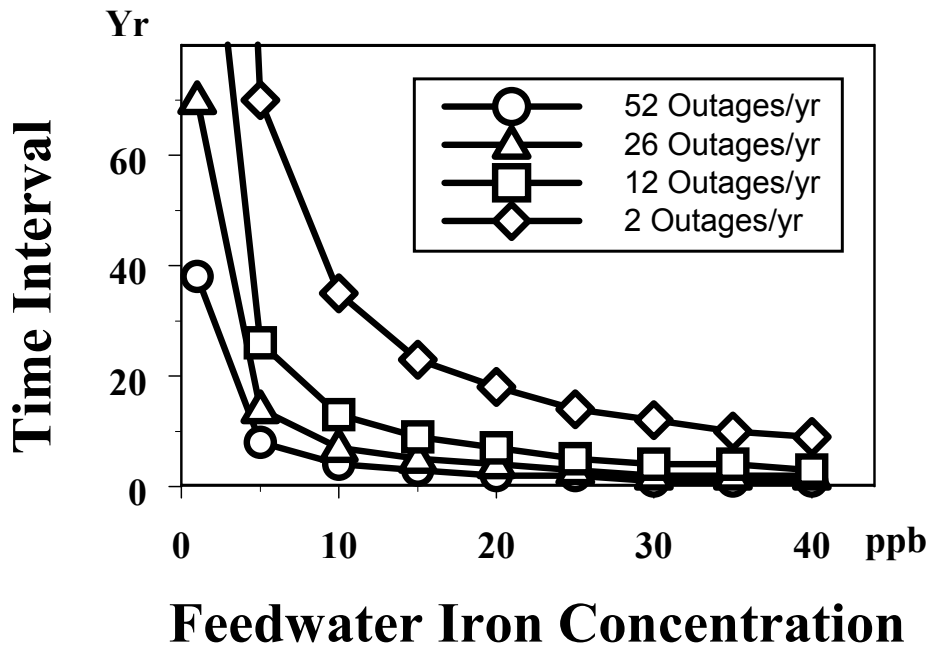
**Figure 2-11**  
**Estimate of Time Required for Deposition to Decrease the Economizer Approach to Saturation Temperature to 6°C (11°F)**
