*Technical Report*

# **Initial Acceptance Criteria Concepts and Data for Assessing Longevity of Low-Voltage Cable Insulations and Jackets**

**1008211**

Final Report, March 2005

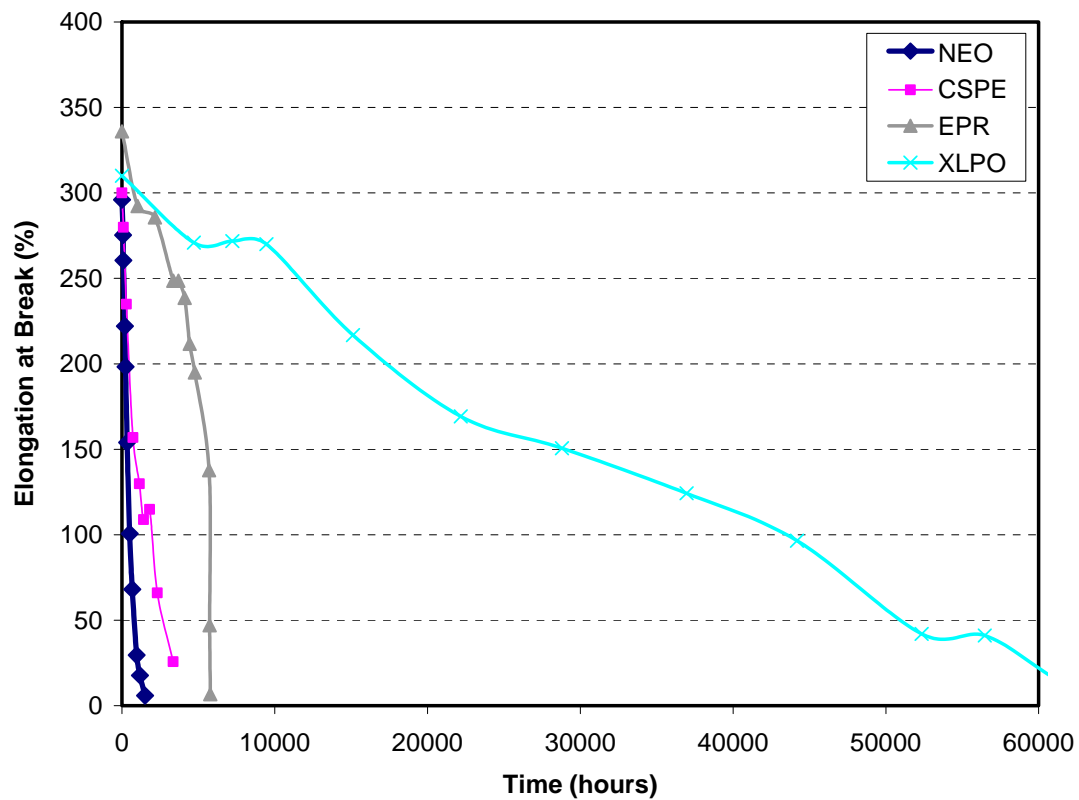
**Figure 5-1**  
**Nature of Aging of Cable Materials, 110°C Aging**

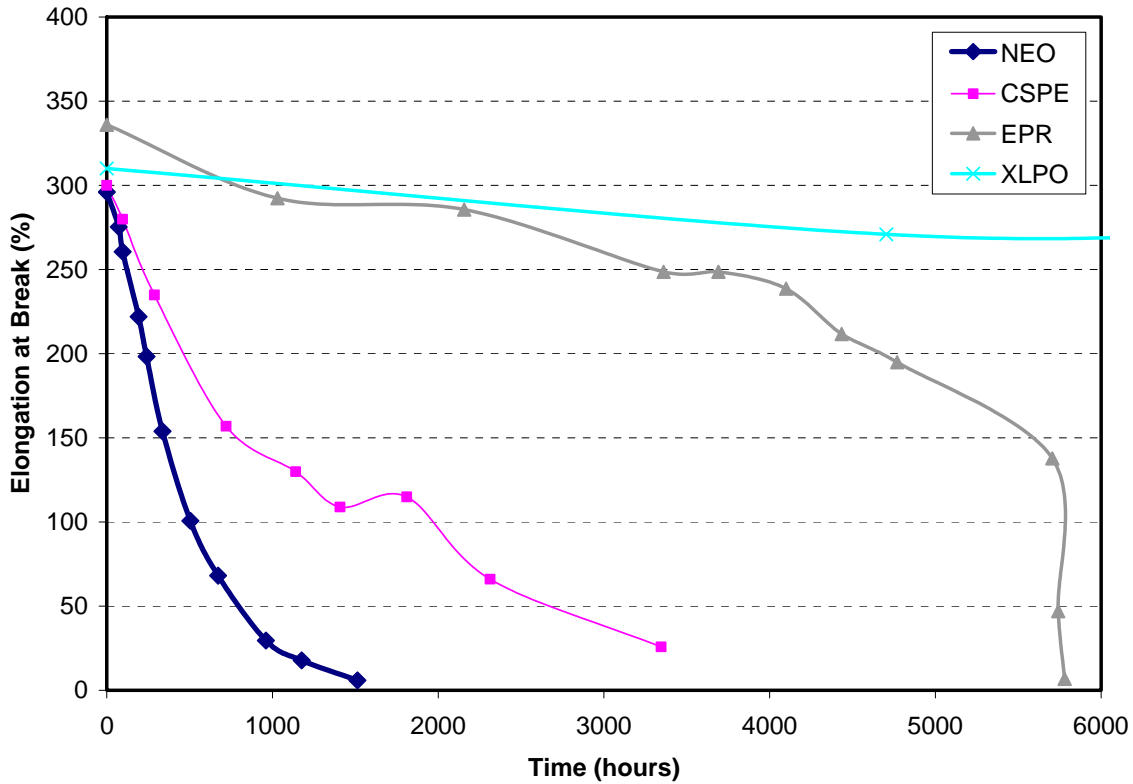
**Figure 5-2**  
**Nature of Aging of Cable Materials, 110°C Aging: Neoprene, CSPE, and EPR Subset**

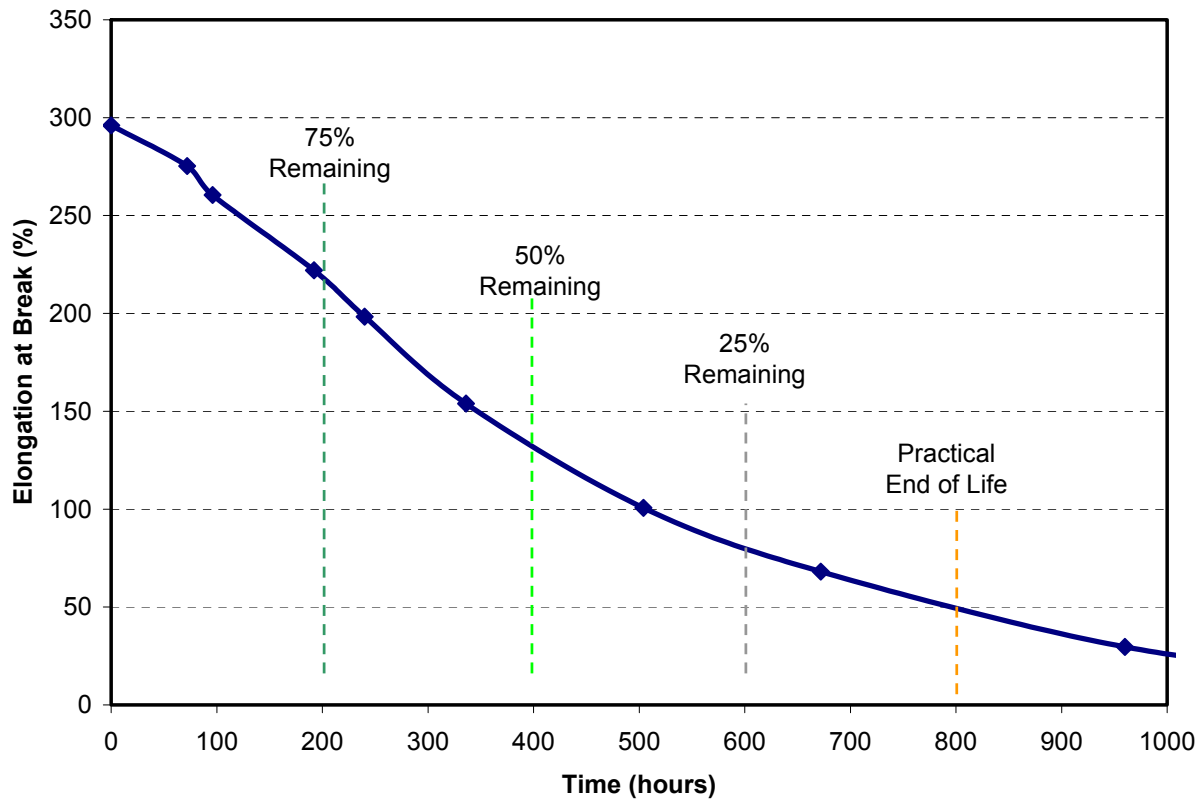
Figure 5-3 shows the life curve for neoprene. For the “practical” end of life, 50% E-at-B was chosen. The material can still be used after that point but with caution because it is approaching the point where the cable cannot be bent without cracking. Based on the practical end of life at 800 hours, 75%, 50%, and 25% remaining life points are shown. Neoprene is used as a jacket rather than as an insulation. Accordingly, if the neoprene is used as the end-of-life control for the overall cable, the end of life for the cable will be very conservative because at 800 hours at 110°C, 75% of an EPR material’s capability and nearly 100% of an XLPE material’s capability remains.

**Figure 5-3**  
**Remaining Life Curve for Neoprene, 110°C Aging**

Figures 5-3 through 5-6 have been presented to show a concept for using aging curves to estimate remaining life. Relatively low-temperature (110°C) aging data was chosen for these examples to provide results that are most closely related to normal plant temperatures. Some materials have different aging rates at higher temperatures than at lower temperatures. Where data are available, this report has evaluated such effects. If only high-rate aging data (140–60°C) are available, caution should be used when estimating remaining life.

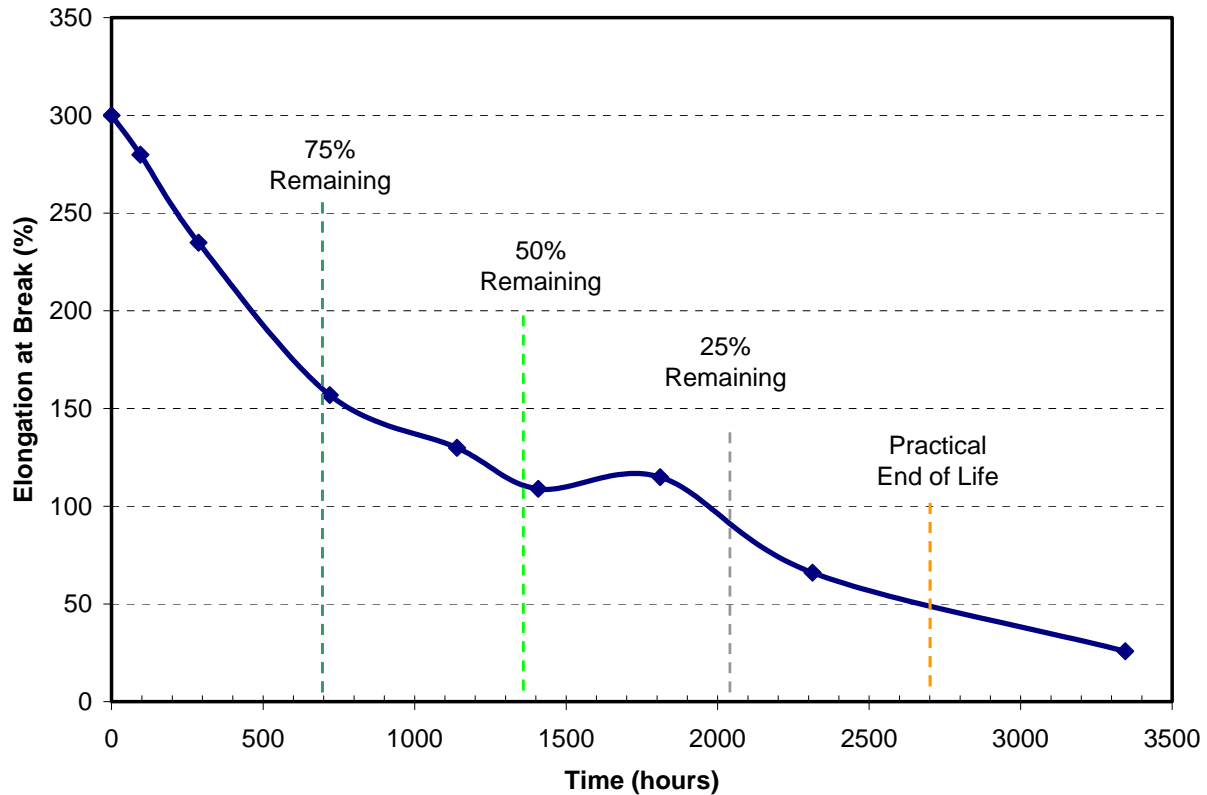
Figure 5-4 shows the remaining life curve for a CSPE. The practical end of life occurs at 2700 hours. The rate of change is gradual (as it was in the neoprene case). Between 50% and 25% remaining life, the fluctuation in the curve causes an uncertainty with respect to whether 110% E-at-B indicates 50% remaining life or 30% remaining life. For conservatism, the lower remaining life should be chosen.

**Figure 5-4**  
**Remaining Life Curve for CSPE, 110°C Aging**

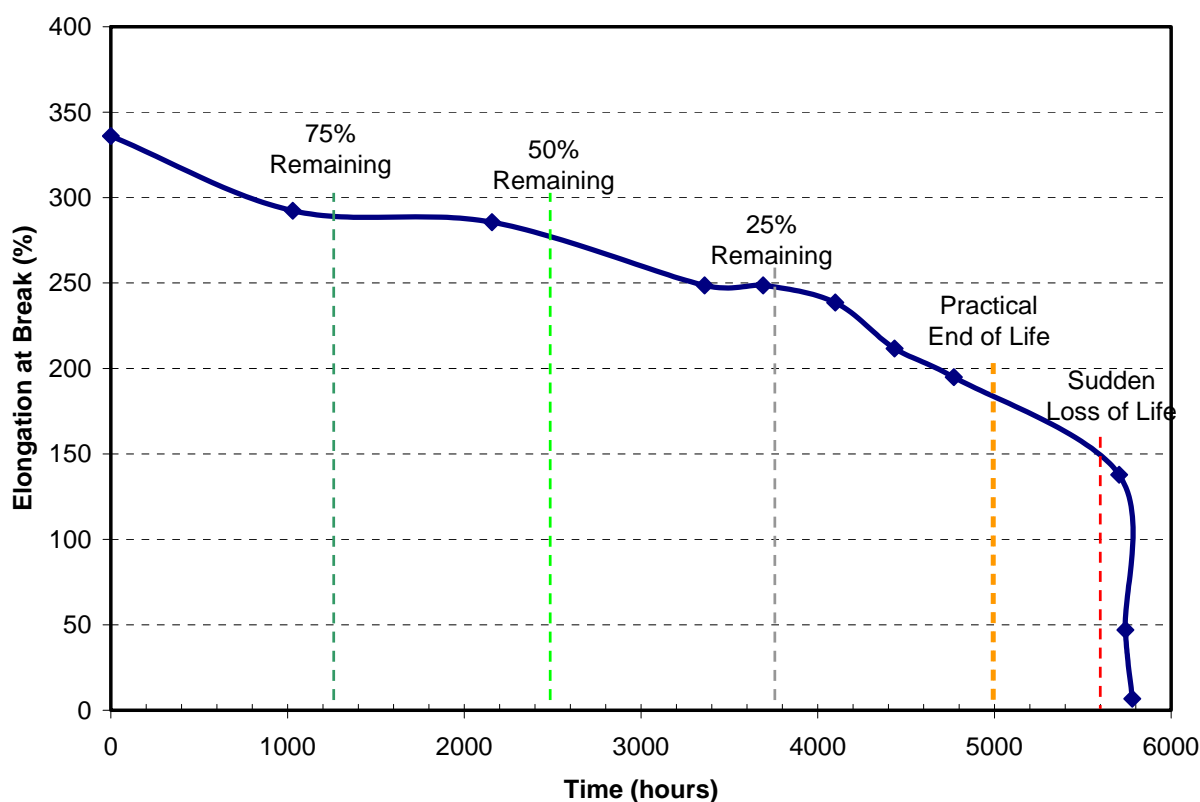
Figure 5-5 shows the remaining life curve for an EPR. This material has a precipitous change near the end of its life. Accordingly, the practical end of life has been chosen at a point where the E-at-B is quite high (170%). A sudden loss of life occurs below 150% E-at-B. At 250% E-at-B, 25% remaining life occurs and at 275% E-at-B, 50% remaining life occurs. Resolution is not good for determining a useful 75% remaining life. For this EPR, the proposed remaining life system is somewhat less than satisfactory. However, EPR is used only for insulation and will always have a neoprene or CSPE jacket that may be used as an early indicator of degradation. For control and instrumentation cables, if the neoprene or CSPE jacket has a significant remaining life, there is no concern for the EPR insulation. For lightly loaded power cables, the same holds true. However, if an EPR power cable is heavily loaded, ohmic heating may increase the rate of aging of the EPR and the condition of the neoprene or CSPE jacket may not be fully indicative of the degree of aging.

**Figure 5-5**  
Remaining Life Curve for an EPR, 110°C Aging

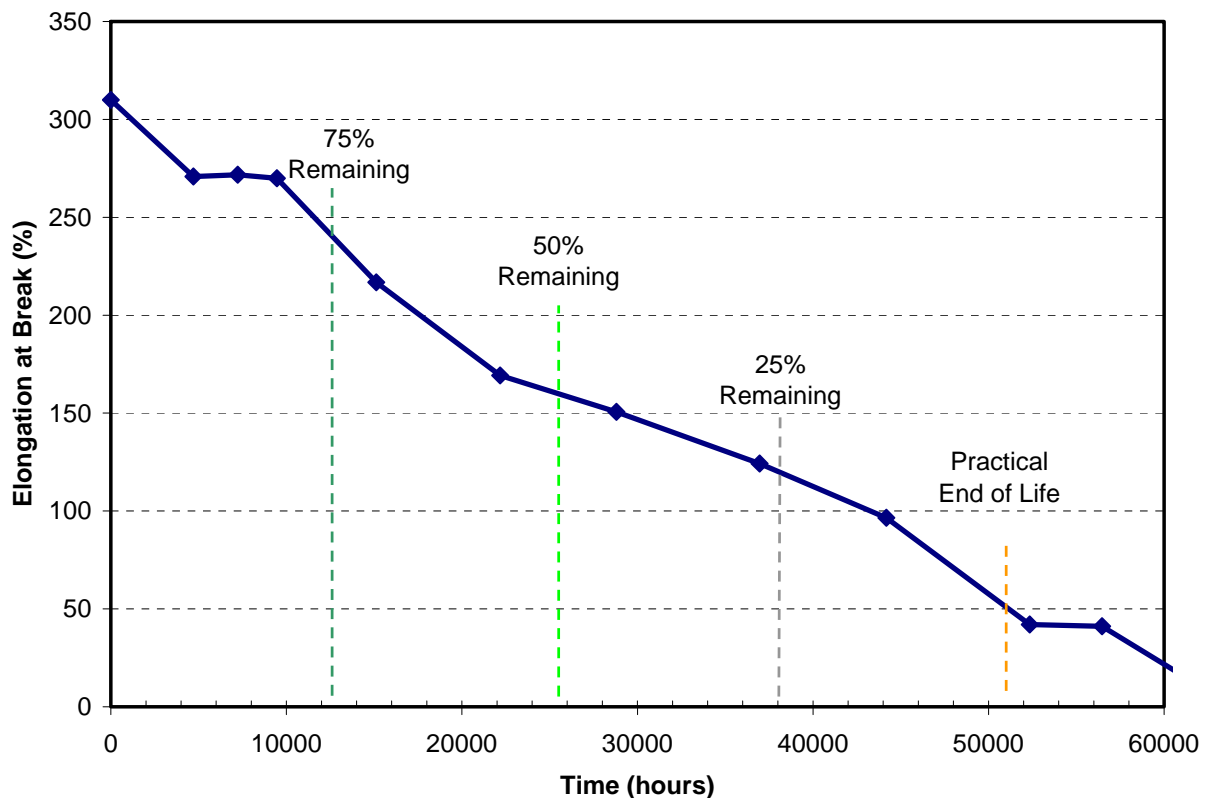
**Figure 5-6**  
Remaining Life Curve for an XLPE, 110°C Aging

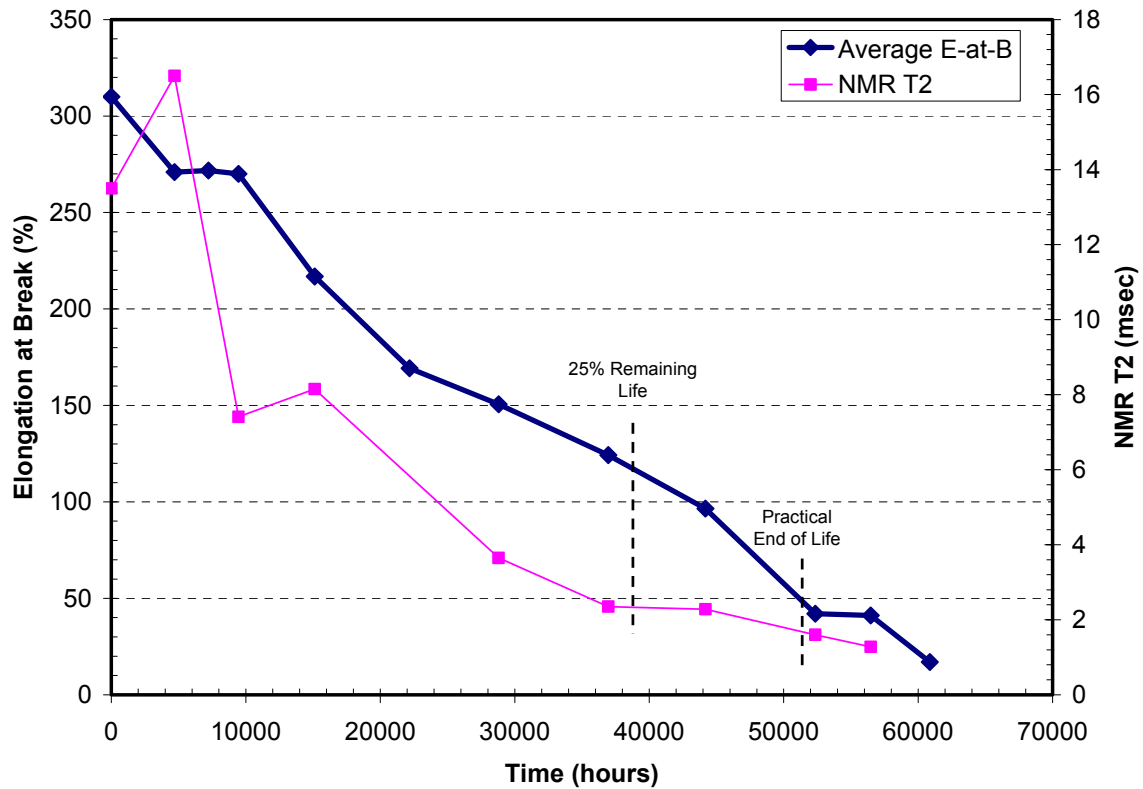
Figure 7-1 shows E-at-B for Brand Rex XLPE for thermal aging at 110°C. An initial review of the data appears to indicate a steadily declining E-at-B with time at temperature. However, the E-at-B stays above 270% for the first 10,000 hours of aging. Under pure thermal aging, this XLPE has a life of approximately 50,000 hours (5.7 years) at 110°C. Figure 7-1 also shows the NMR T2 time for the material, which drops from 13.5 to 1.7 msec at 50% E-at-B. NMR T2 appears to have an excellent correlation with the degree of thermal aging.

**Figure 7-1**  
Brand Rex XLPE E-at-B Versus NMR T2, 110°C, 0 rd/hr Aging

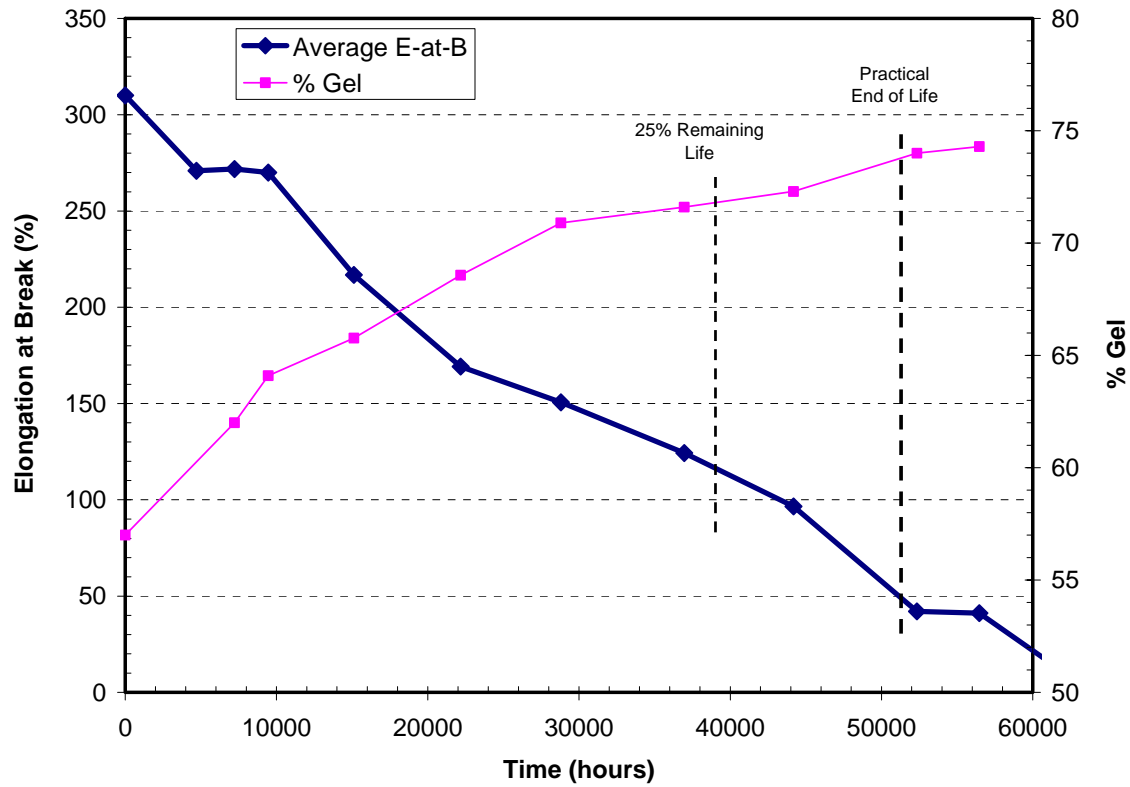
Figure 7-2 shows the comparison of percent gel to E-at-B for the material. The percent gel increases from 57% at the start of aging to 73% when the material has 50% retained E-at-B. The correlation between E-at-B and percent gel is good.

**Figure 7-2**  
**Brand Rex XLPE E-at-B Versus % Gel, 110°C, 0 rd/hr Aging**

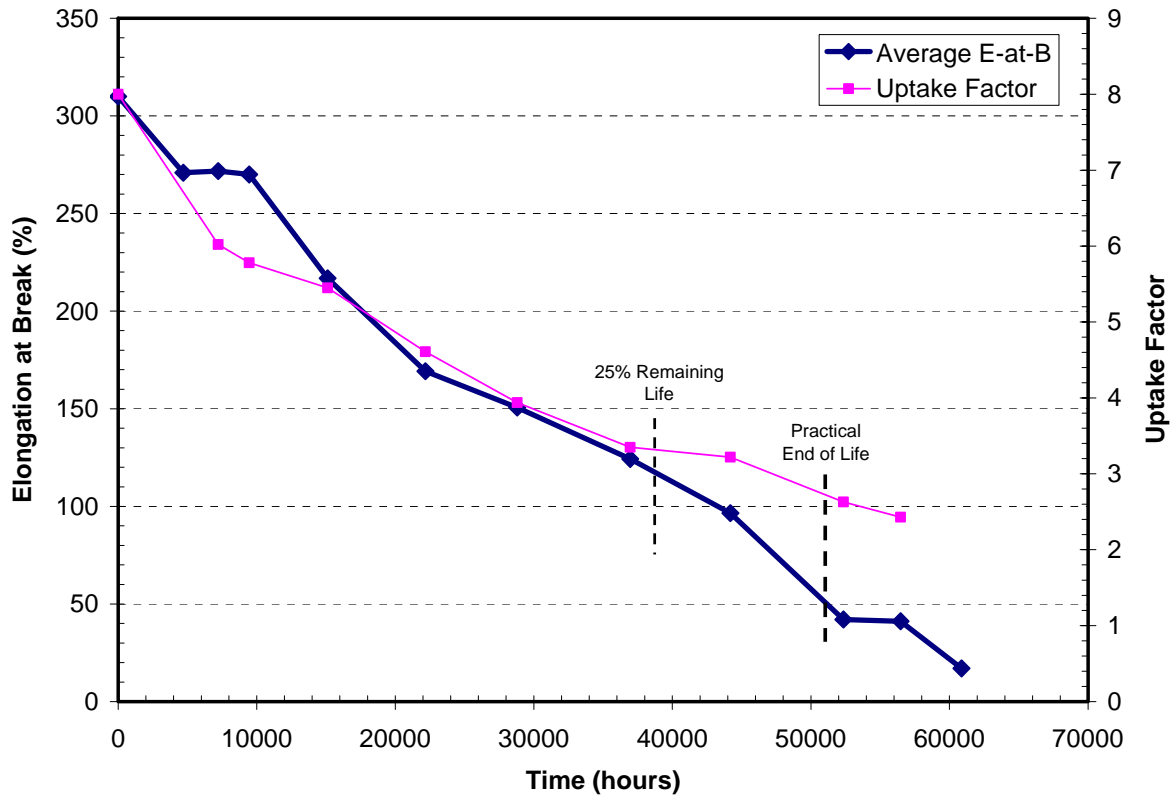
Figure 7-3 shows the comparison of uptake factor to E-at-B for the Brand Rex. The uptake factor decreases from 8.0 when new to 2.7 at the point of 50% remaining E-at-B. The correlation is strong and resolution seems good, therefore allowing ease of interpretation.

**Figure 7-3**  
**Brand Rex XLPE E-at-B Versus Uptake Factor, 110°C, 0 rd/hr Aging**

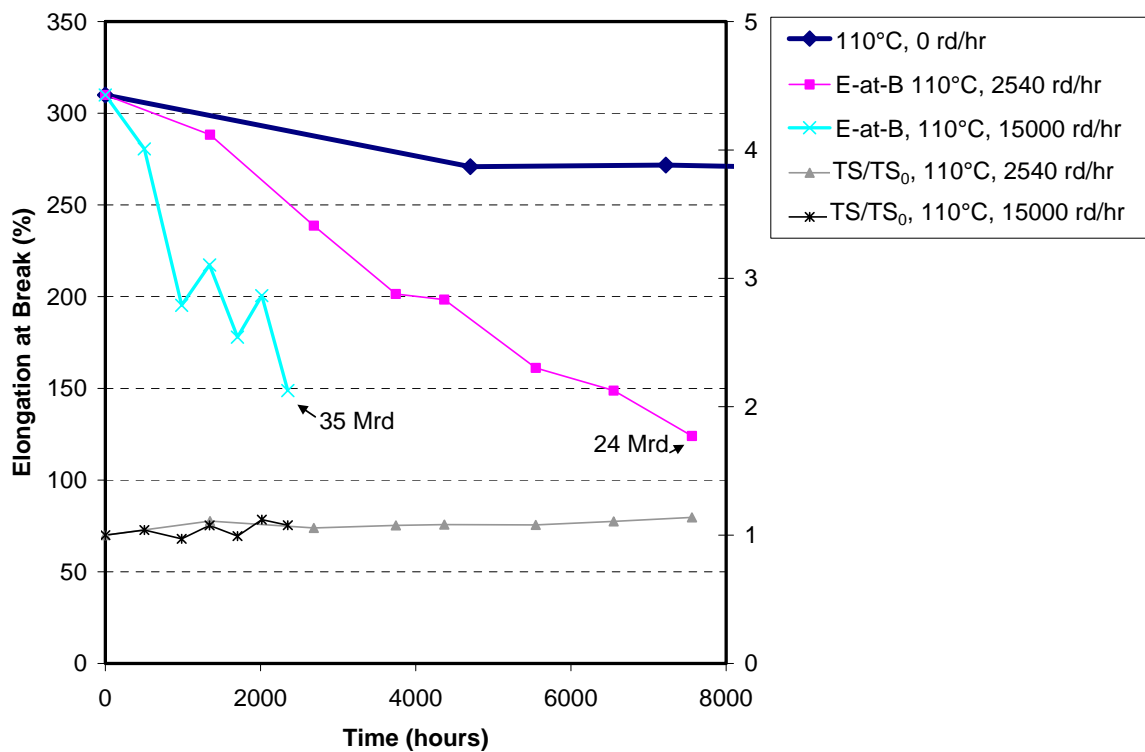
**Figure 7-5**  
Brand Rex XLPE E-at-B, Various Dose Levels, 110°C

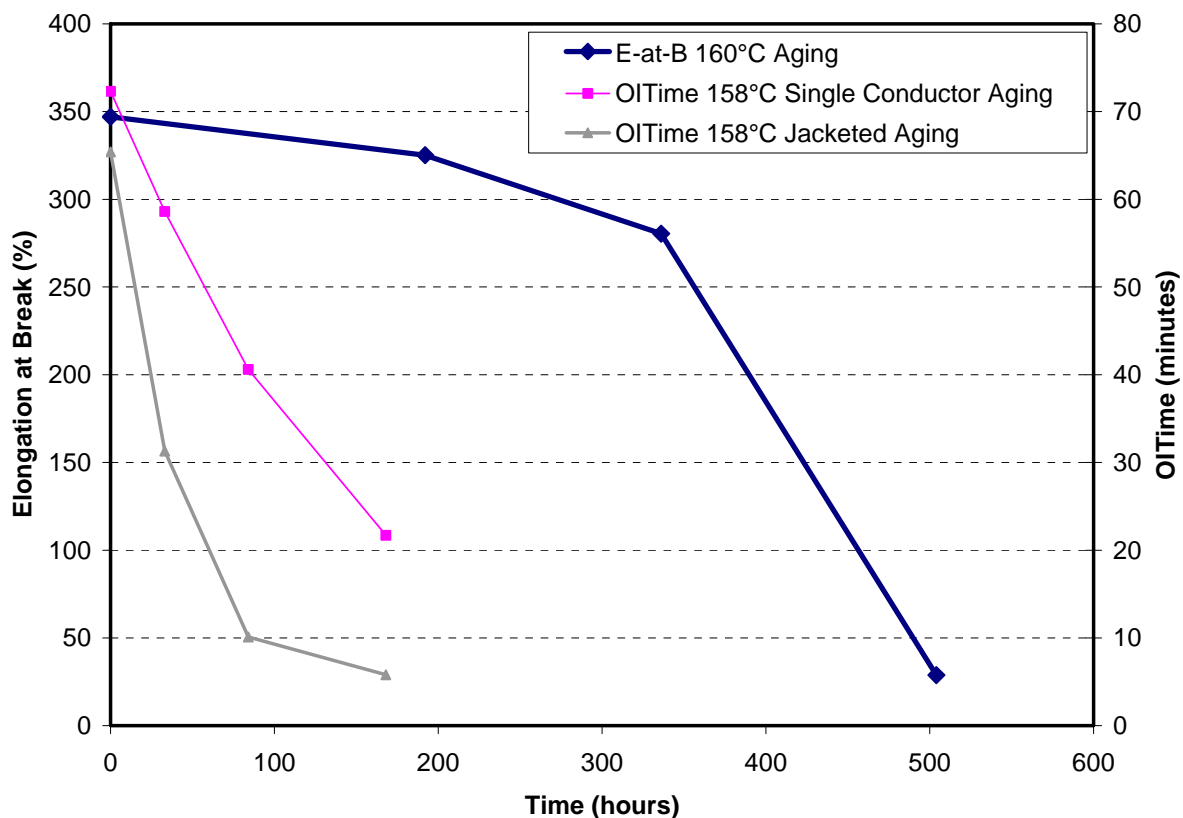
Figure 7-6 shows E-at-B versus oxidation induction time (OITime) for Brand Rex XLPE. The data are from two separate tests (E-at-B performed by Sandia at 160°C and OITime performed by Pacific Sierra Research Corporation at 158°C). While the differences in aging temperatures will produce somewhat different aging, the tests are close enough to show a comparison between the two techniques. Figure 7-6 shows that the OITime drops from 75 minutes under thermal aging alone to 5 minutes for a single conductor specimen. This point equates to the point where the XLPE has ended its period of little aging and more rapid aging has begun. Unfortunately, only one-third of the life of the polymer has been expended at this point and there is little ability to assess the aging of the remaining two-thirds of life. Figure 7-6 also shows results for single conductors that were aged under an overall jacket. The plot shows that much less aging has occurred. Because these tests were performed at very high temperature, it is unclear whether a similar effect would result (for example, the jacket provides a large amount of protection for the conductor insulation) if the aging occurred at moderately high to very low temperature (100–40°C).

**Figure 7-6**  
**Brand Rex XLPE OITime, 225°C Test Temperature**

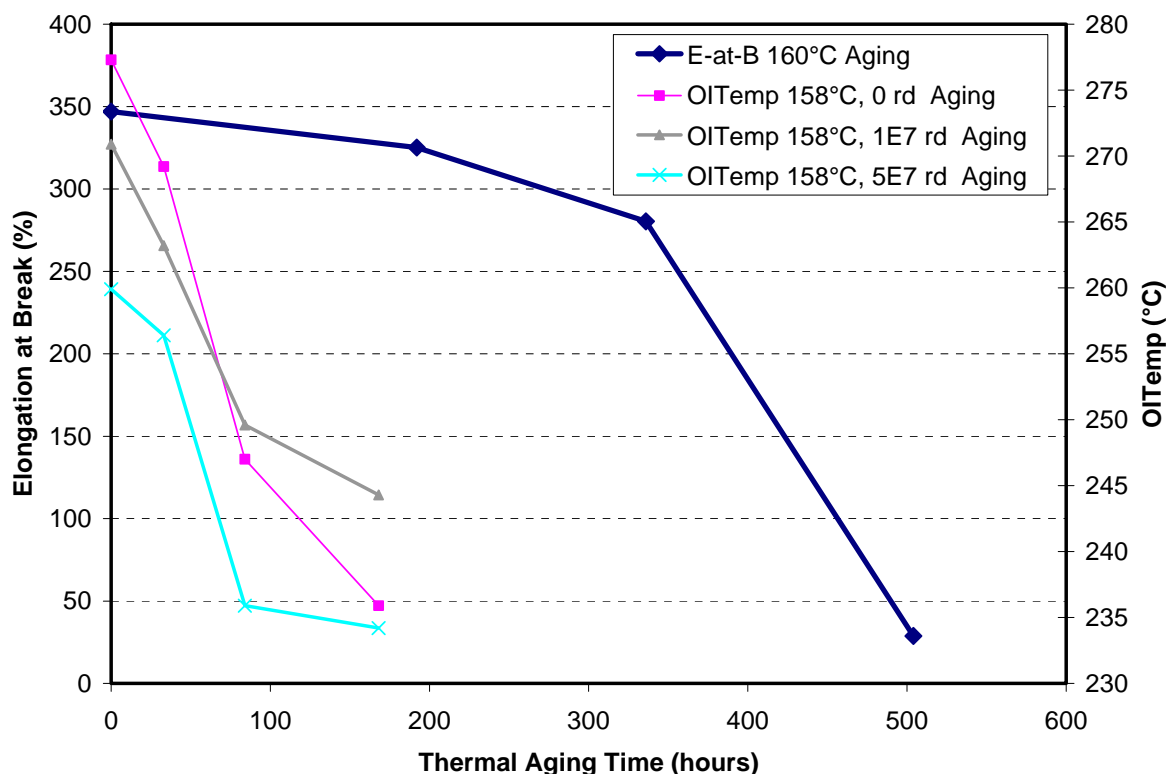
Figure 7-7 shows oxidation induction temperature (OITemp) versus E-at-B for the Brand Rex XLPE including the effects of radiation. When the material is new, the exothermic reaction occurs when the temperature ramps to 277°C at 10°C/min. When aged for 168 hours at 158°C, the OITemp drops to 236°C. Figure 7-7 is also based on Sandia and Pacific Sierra testing. Irradiation adds some confusion to the data in that at 10 Mrd, the material seems less aged (OITemp of 244°C) than the test of thermal alone and at 50 Mrd seems somewhat more aged (OITemp of 234°C). It is not clear if further aging would have resulted in significantly lower OITemp results or if the OITemp results will stabilize at 230°C with further aging. The 168-hour endpoint of aging has essentially consumed only one-third of the total available capability of the material.

**Figure 7-7**  
Brand Rex XLPE OITemp, 10°C/Min Test Ramp Rate

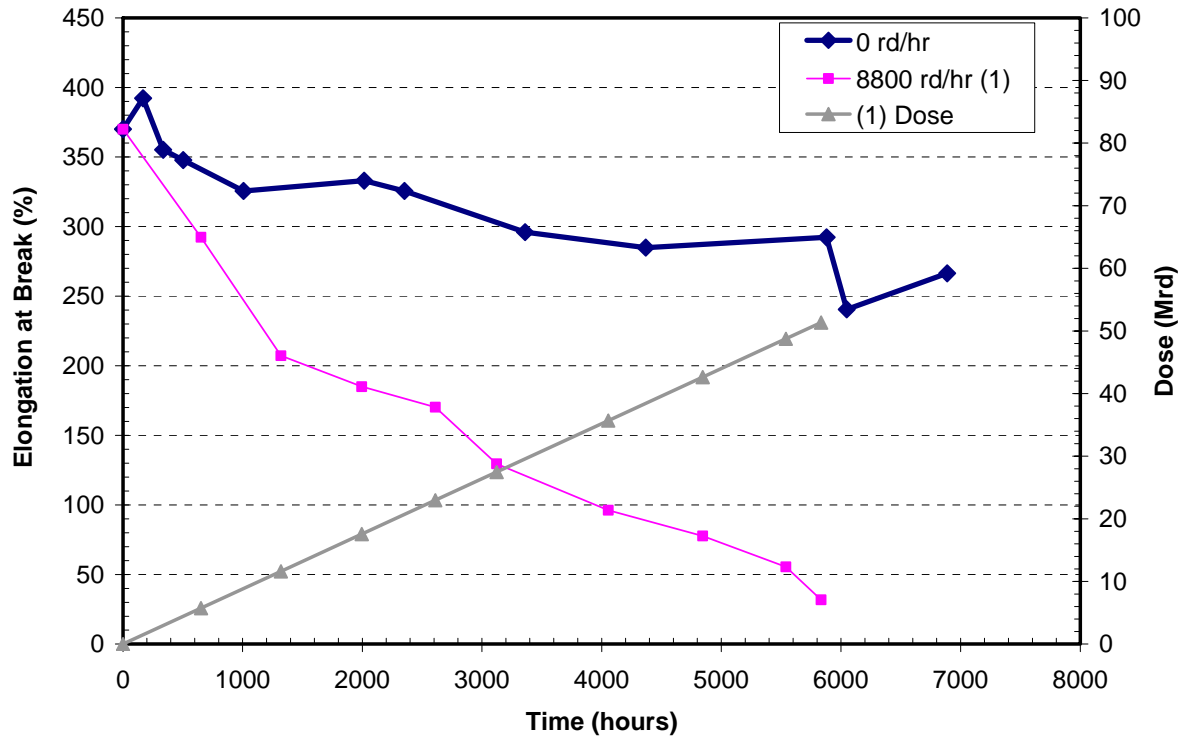
original (25.2 krd/hr versus 8.8 krd/hr). At the higher dose rate (50 Mrd), 50% E-at-B occurs at 2000 hours. The effect of tripling the dose rate essentially has an inverse linear effect of causing the life to be reduced to one-third.

**Figure 7-8**  
**Eaton Dekoron Polyset E-at-B – 120°C, 0 rd/hr and 120°C, 8800 rd/hr Aging**

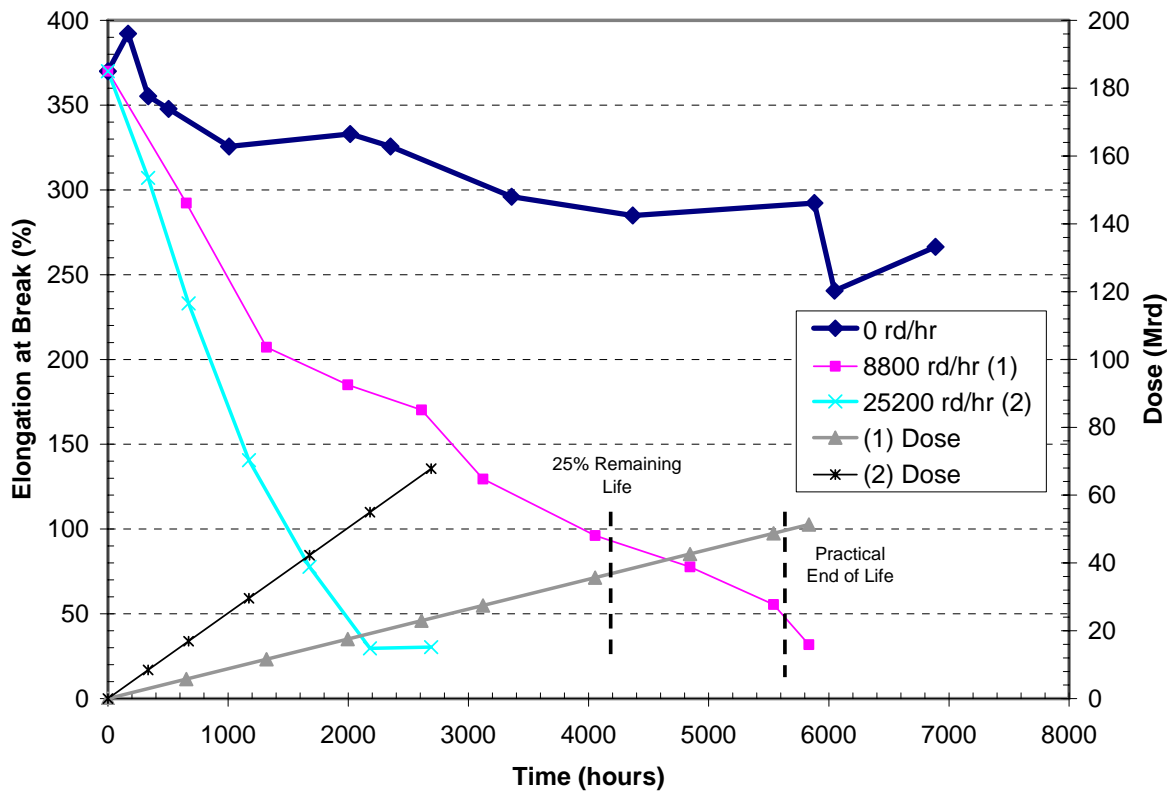
**Figure 7-9**  
**Eaton Dekoron Polyset E-at-B – 120°C, 0 rd/hr; 120°C, 8800 rd/hr; and 120°C, 25200 rd/hr**  
**Aging**

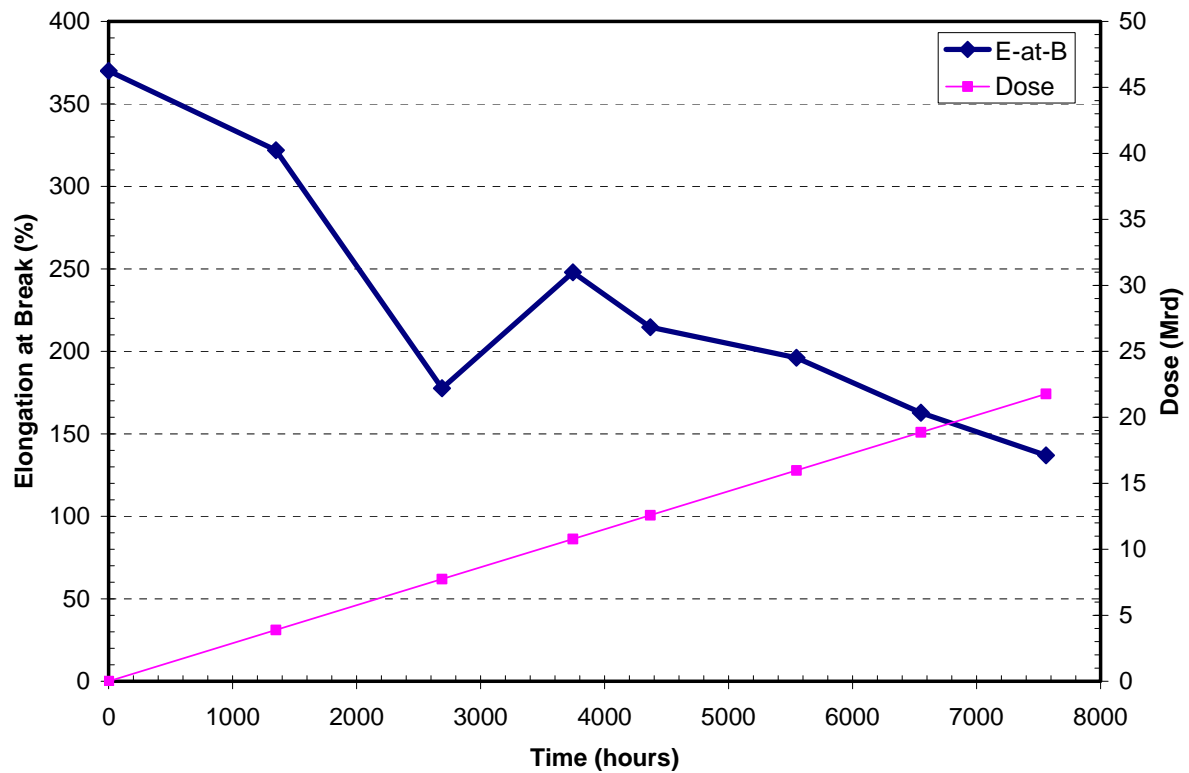
Figure 7-10 shows E-at-B for 110°C thermal aging with simultaneous irradiation at 2.88 krd/hr. At the end of the aging, 140% E-at-B remains at 7500 hours with a total dose of 22 Mrd.

**Figure 7-10**  
**Eaton Dekoron Polyset E-at-B, 110°C, 2880 rd/hr Aging**

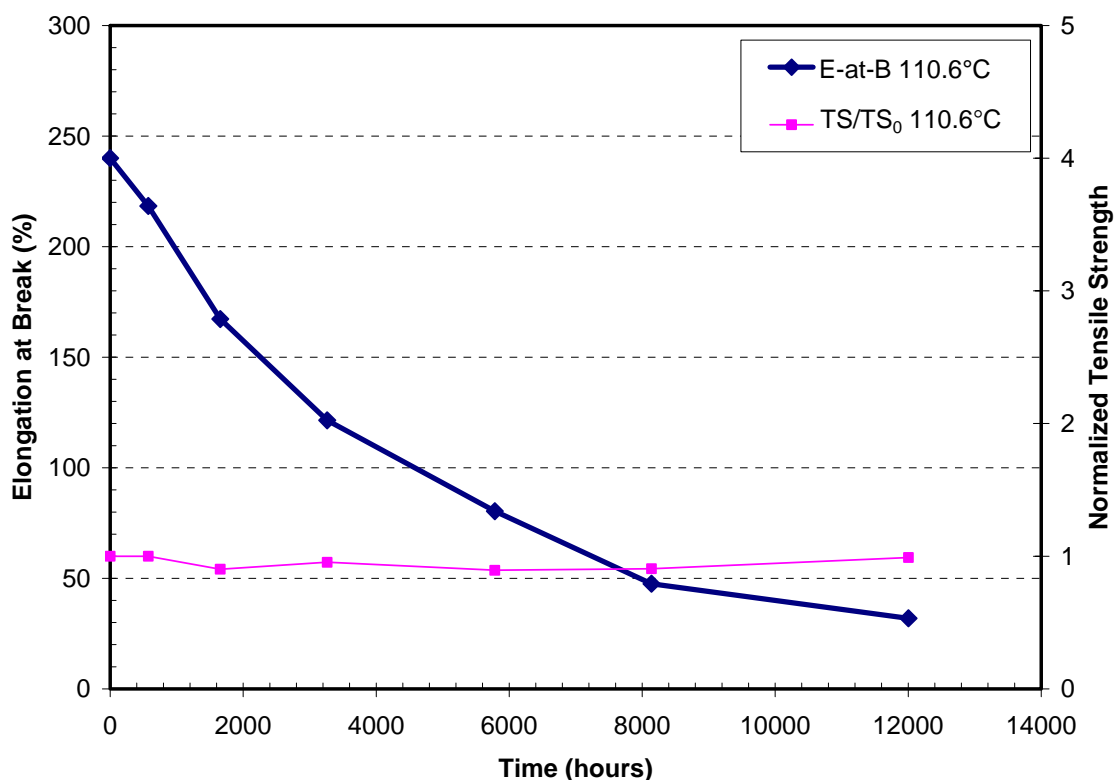
**Figure 7-11**  
ITT Suprenant Exane II E-at-B Versus Relative Tensile Strength, 110.6°C, 0 rd/hr Aging

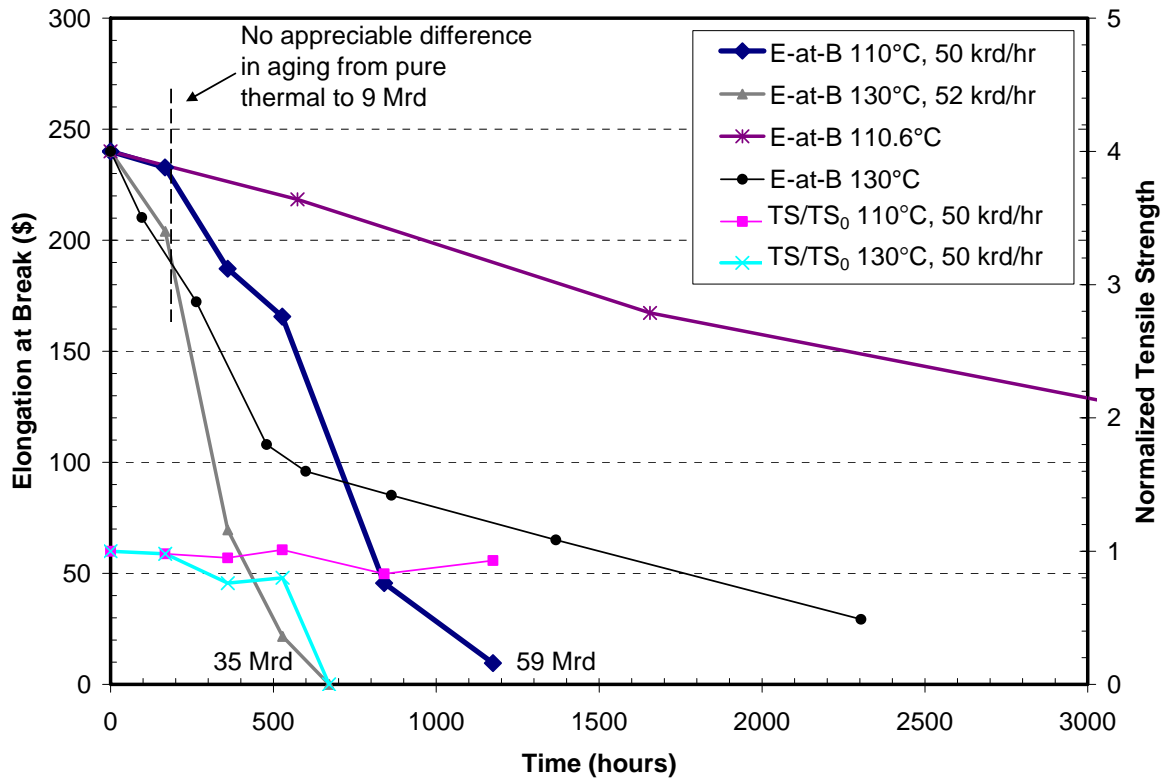
Figure 7-14 compares thermal aging to combined thermal and radiation aging at 110°C and 130°C and approximately 50 krd/hr irradiation. The radiation significantly reduces life by a factor of approximately 10 at 110°C. The effect is not linear. Below 9 Mrd, there is effectively no difference between thermal aging alone and combined thermal and radiation aging. Beyond 9 Mrd, the effects of radiation are significant.

**Figure 7-14**  
**Exane II E-at-B with and Without Radiation**

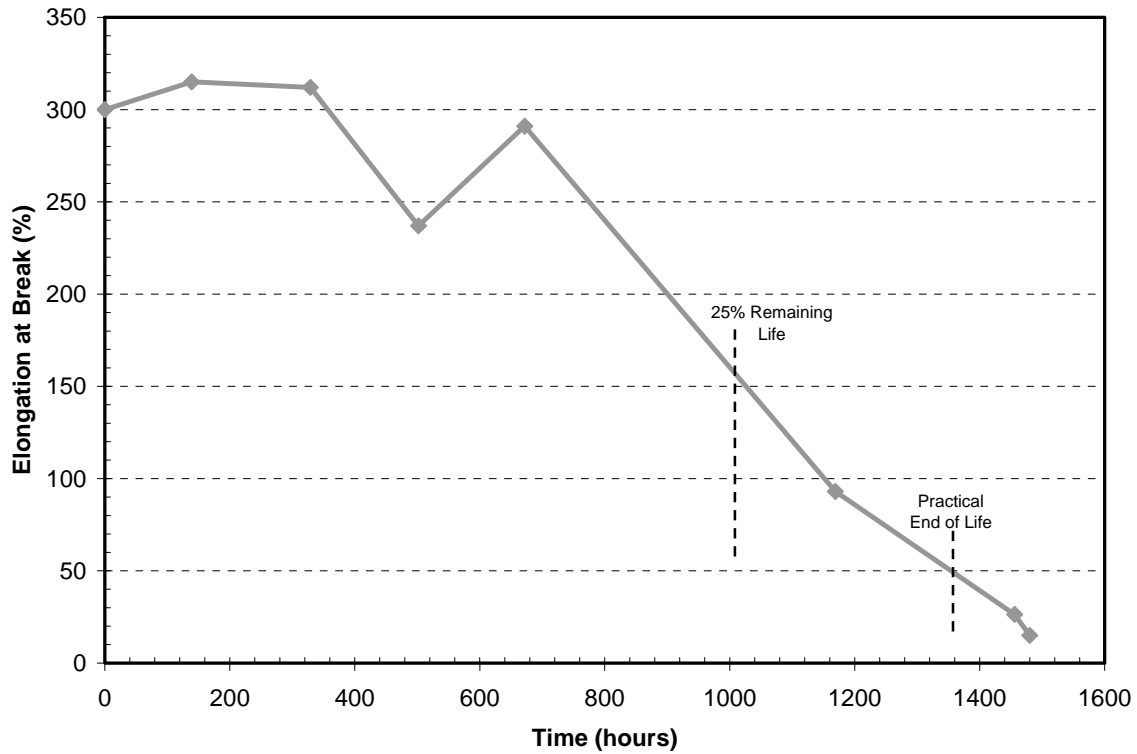
Aging data at lower temperatures without irradiation are not yet available for Rockbestos Firewall III cable. Figure 7-15 shows the effects of aging at 151°C. At approximately 1350 hours, 50% E-at-B occurs, which indicates a very long life at normal operating temperatures. Figure 7-16 shows the effects of irradiation at low temperatures and two different dose rates. Thermal aging at 23°C and 40°C at the same dose rate (21 krd/hr) shows that the age temperature at low temperatures has no significant effect, but the irradiation does. Aging at two different dose rates at approximately 40°C shows that the lower rate has the same effect when the same dose is achieved in both aged specimens.

**Figure 7-15**  
Rockbestos Firewall III E-at-B, 151°C, 0 rd/hr Aging

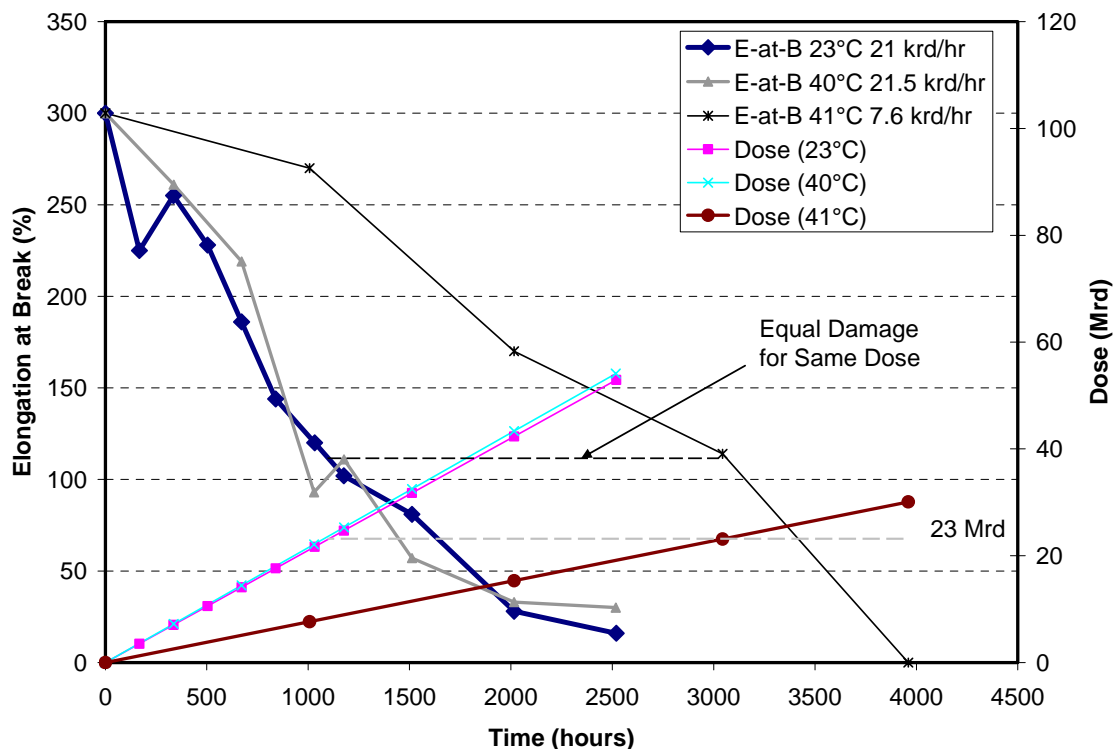
**Figure 7-16**  
Rockbestos Firewall III E-at-B, Radiation Effects

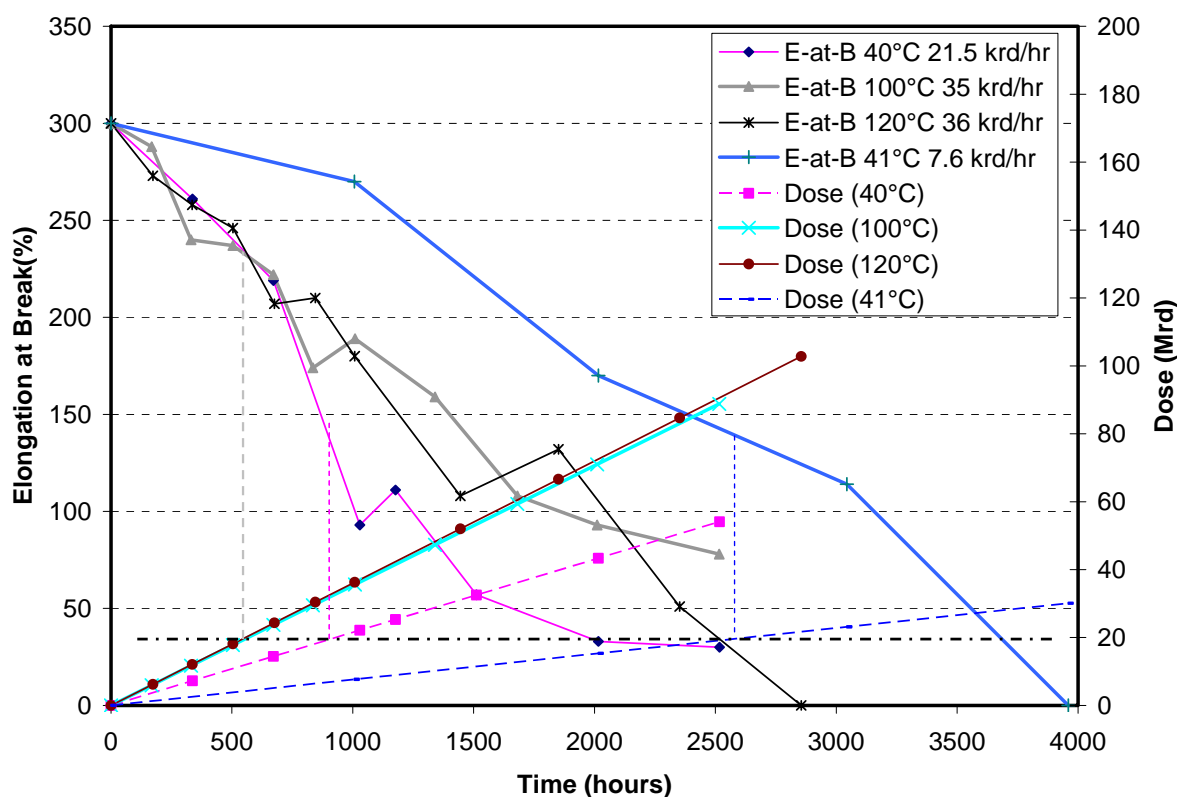
Figure 7-17 shows the effects of higher temperature irradiation in comparison with lower temperature irradiation. Two 40°C plots at 7.6 and 21.5 krd/hr are shown along with a 100°C, 35 krd/hr and a 120°C, 36 krd/hr plot. The two 40°C plots bracket the higher temperature plots. Logically, the lower dose rate 40°C plot shows the same damage when equal doses are examined. However, the higher temperature/higher dose plots show less degradation than the 40°C plots when equal doses are examined. For a 20-Mrd dose, Figure 7-17 indicates that the 40°C plots result in 140% E-at-B, but that the higher temperature plots show 230% E-at-B. This means that less damage occurred even though the samples were aged at significantly higher temperatures. As the aging time increases, the divergence in the plots becomes more obvious with the higher dose/higher temperature plots continuing to exhibit less aging until near end of life where convergence seems to be occurring. The damage caused by high-level normal irradiation seems to be partially negated by the slightly elevated temperature in the exposure.

**Figure 7-17**  
**Rockbestos Firewall III E-at-B, Radiation Effects, Higher Temperatures**

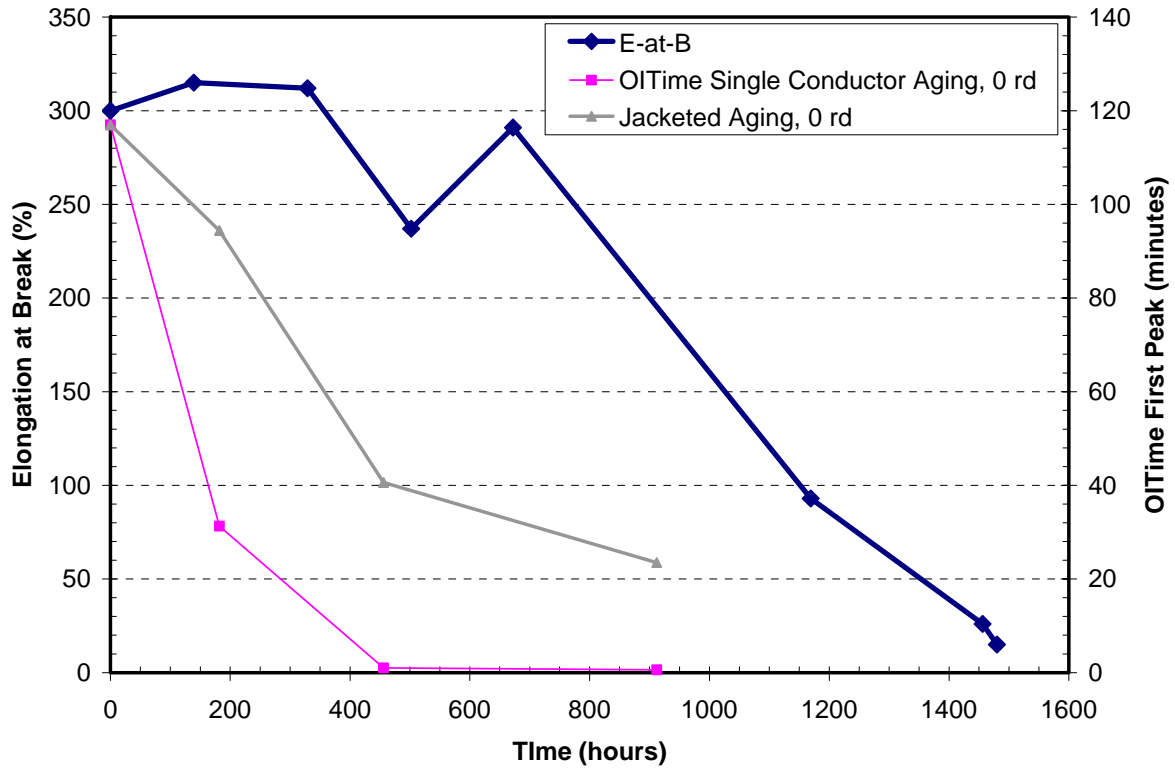
**Figure 7-18**  
Rockbestos XLPE OITime, 150°C, 0 rd Aging

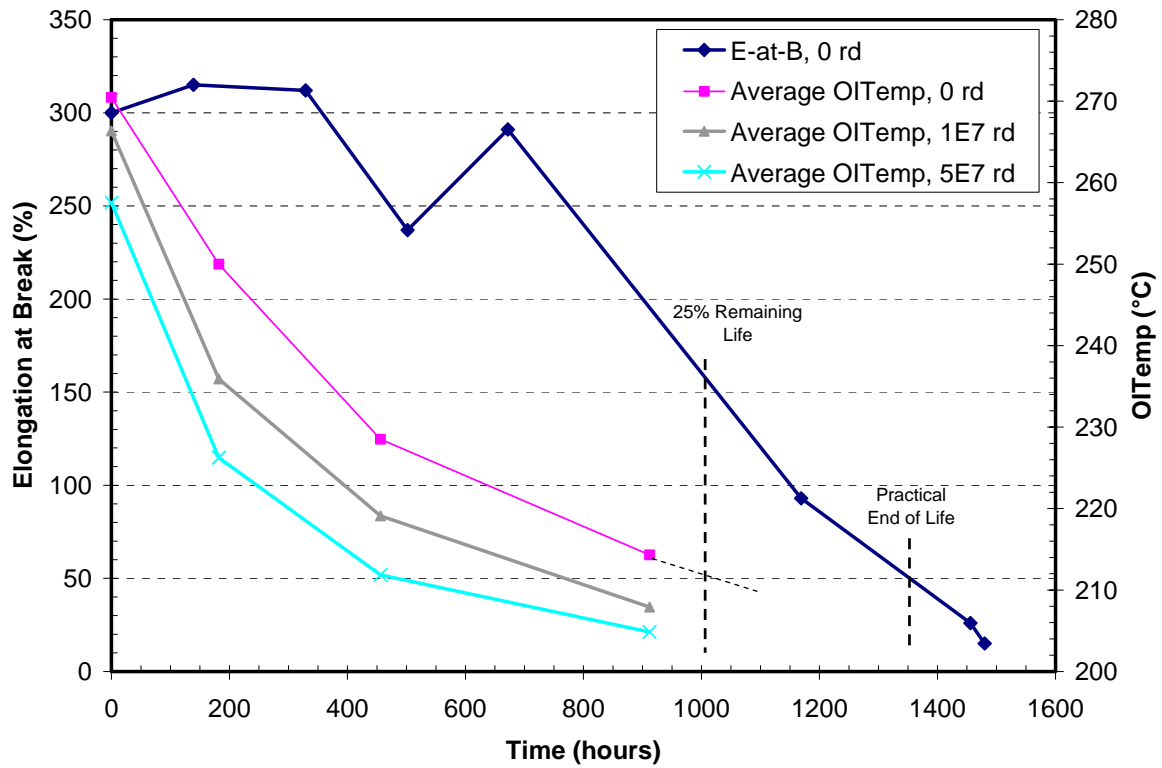
214°C. With 10 Mrd included, the OITemp drops to 208°C. With 50 Mrd included, the OITemp is 205°C. The OITemp data cover about two-thirds of the useful life of the insulation. If further aging had been performed, the plots indicate that resolution would be available through most if not the entire life of the material.

**Figure 7-19**  
Rockbestos XLPE OITemp, 150°C, 0 rd, Single Conductor Aging, 10°C Ramp Rate
