*Technical Report*

# **Initial Acceptance Criteria Concepts and Data for Assessing Longevity of Low-Voltage Cable Insulations and Jackets**

**1008211**

Final Report, March 2005

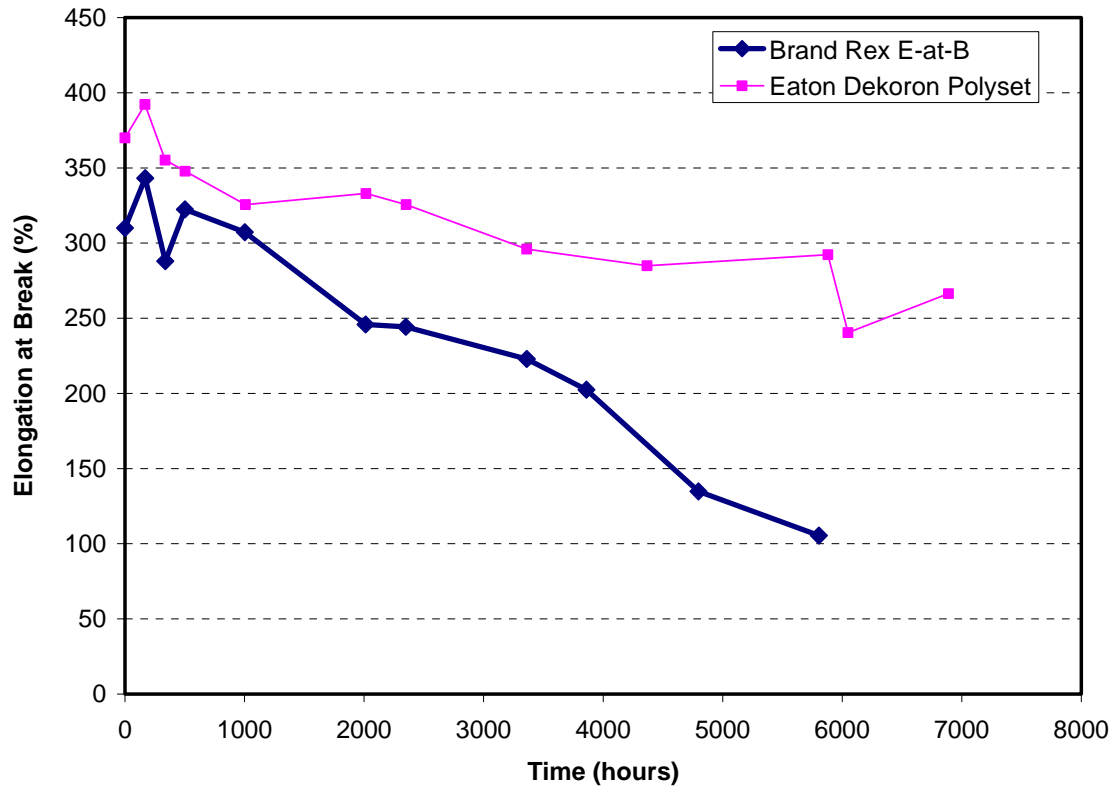
Figure 7-20 shows a comparison between Brand Rex and Eaton Dekoron Polyset insulation when aged at 110°C. Figure 7-21 compares Brand Rex to Rockbestos insulation when aged at 150°C. Unfortunately, data are not available at a consistent temperature for all three materials.

**Figure 7-20**  
**Comparison of Brand Rex and Eaton Dekoron Polyset, 110°C Aging, XLPE**

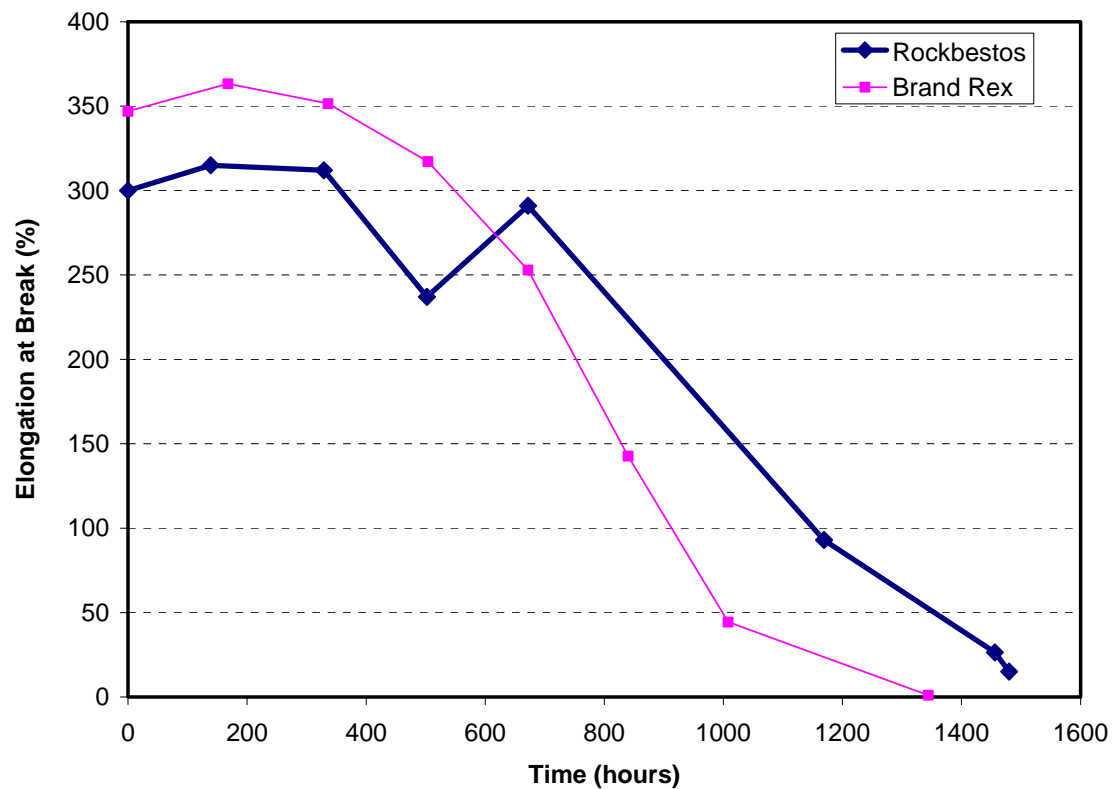
**Figure 7-21**  
**Comparison of Brand Rex and Rockbestos XLPE, 150°C Aging, XLPE**

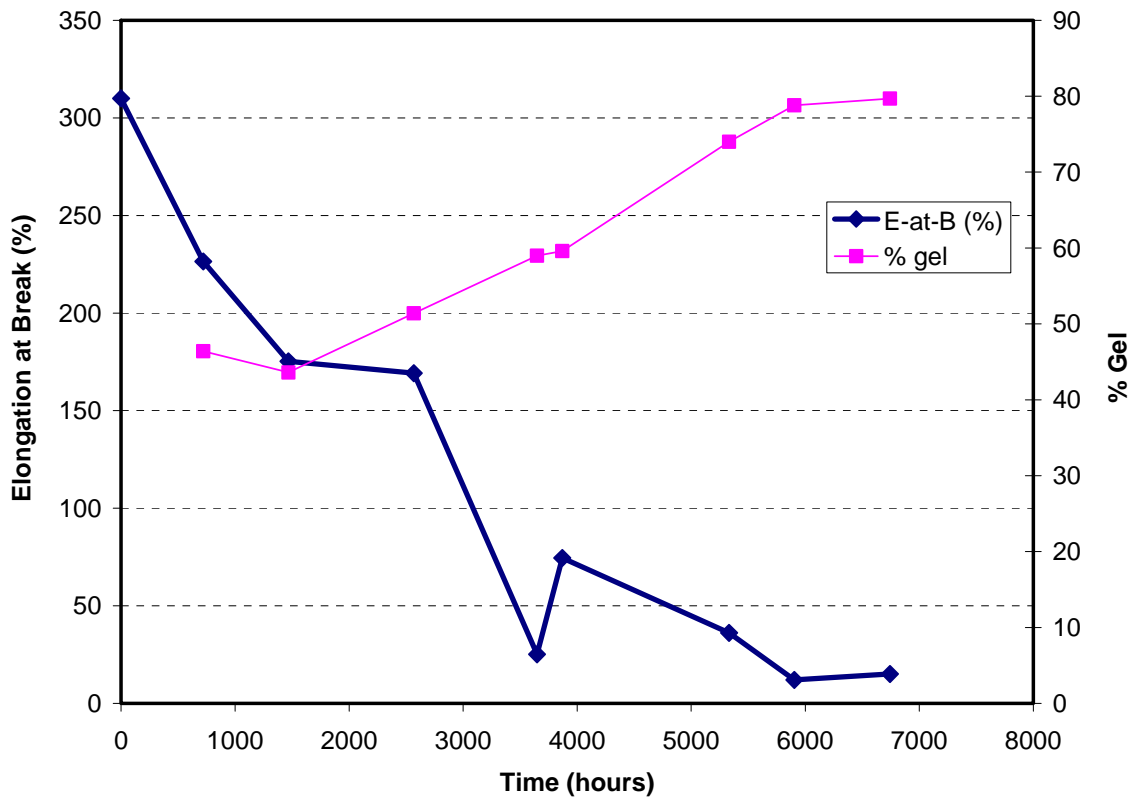
Figure 7-22 shows E-at-B and percent gel for Anaconda CPE Flameguard-EP Y jacket material. The reversal in the 3500 to 4000 hour period may be a recording error in the original data. (Figure 7-23 is based on the same data. Figure 7-24 is based on a separate test and shows the expected progression of aging.) Figure 7-22 indicates that percent gel provides a good indication of the degree of aging through and somewhat beyond 50% E-at-B. Figure 7-23 shows E-at-B, uptake factor, and density. While the uptake factor shows a useful correlation with E-at-B, density is essentially unchanged and does not provide a useful trend. Figure 7-24 shows the correlation of percent gel with E-at-B with 140°C aging.

**Figure 7-22**  
Anaconda CPE E-at-B Versus % Gel, 125°C, 0 rd/hr Aging

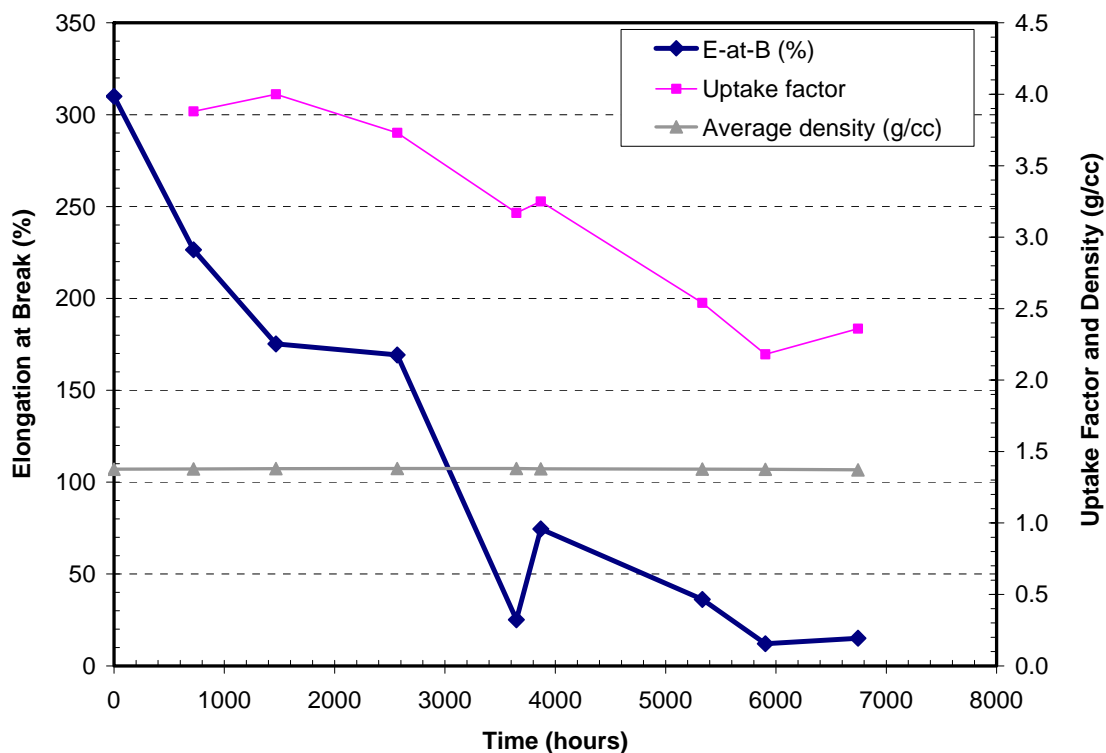
**Figure 7-23**  
Anaconda CPE E-at-B Versus Update Factor and Density, 125°C, 0 rd/hr Aging

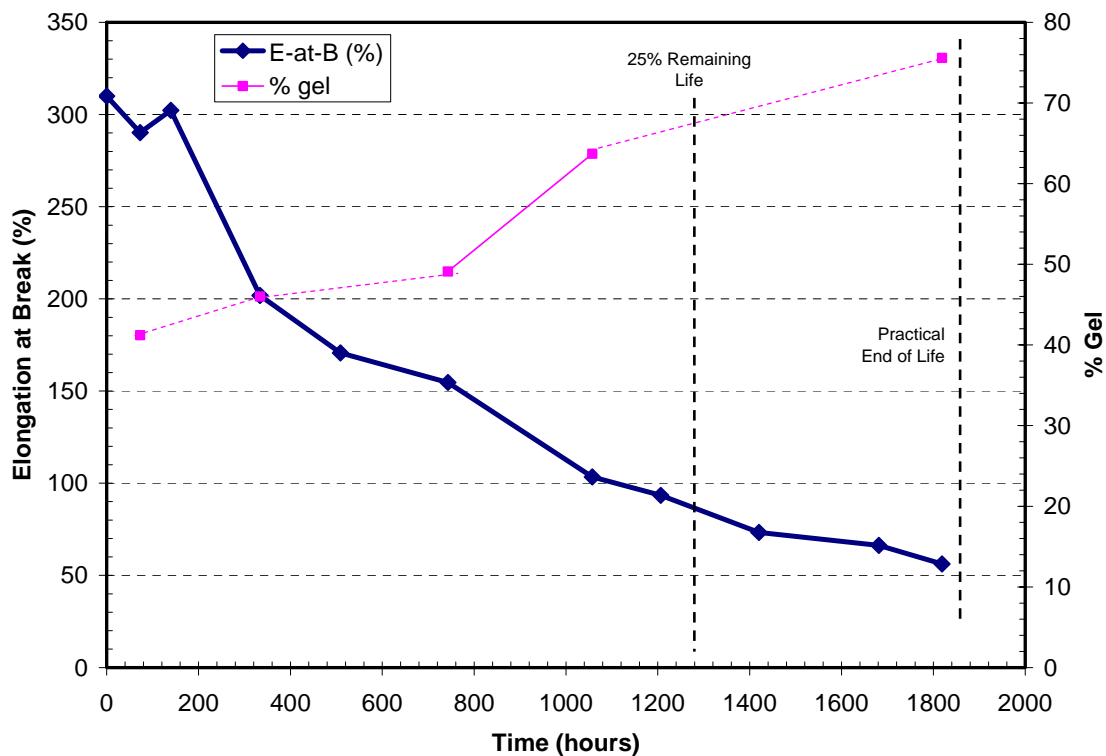
**Figure 7-24**  
Anaconda CPE E-at-B Versus % Gel, 140°C, 0 rd/hr Aging

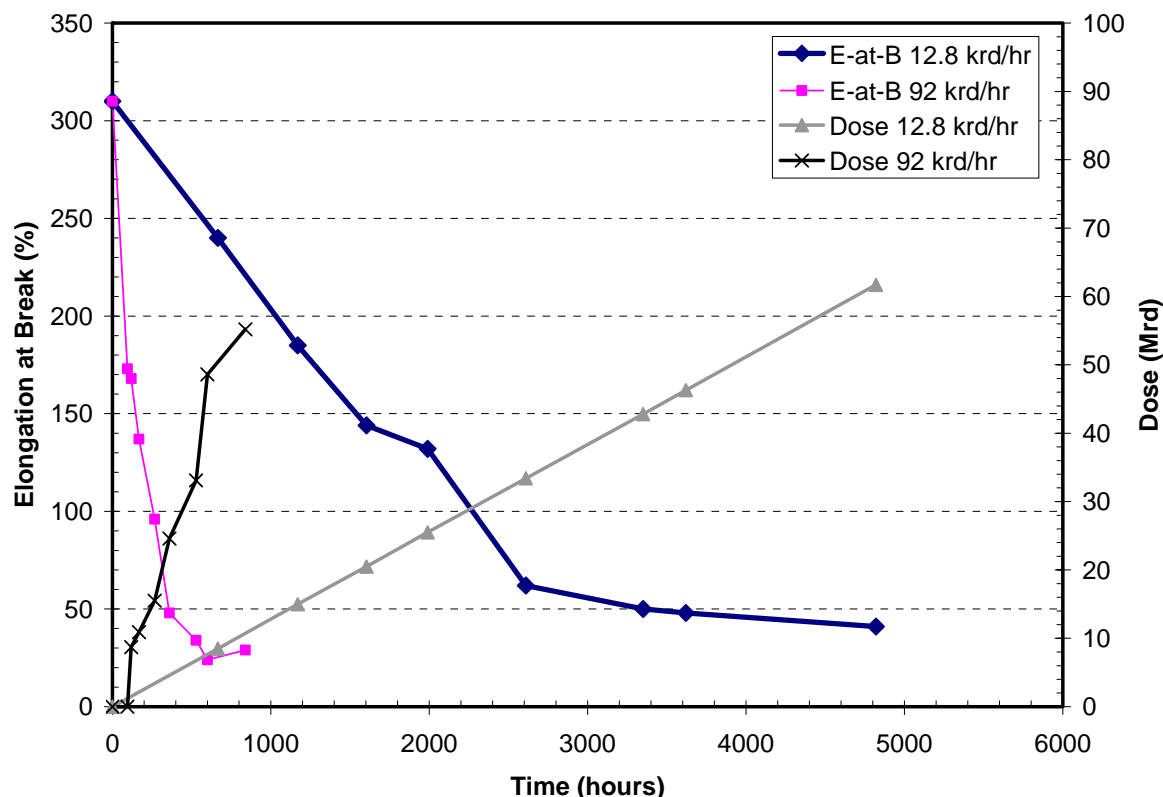
Figure 7-25 shows the effect of simultaneous irradiation at 70°C at 12.8 and 92 krd/hr; 50% E-at-B is reached at 3500 hours and 45 Mrd at 12.8 krd/hr. At 92 krd/hr, 50% E-at-B is reached at 400 hours and 25 Mrd. In this case, the higher dose rate had a larger effect than the lower dose rate (which is unusual).

**Figure 7-25**  
Anaconda CPE E-at-B, 70°C Aging with Radiation

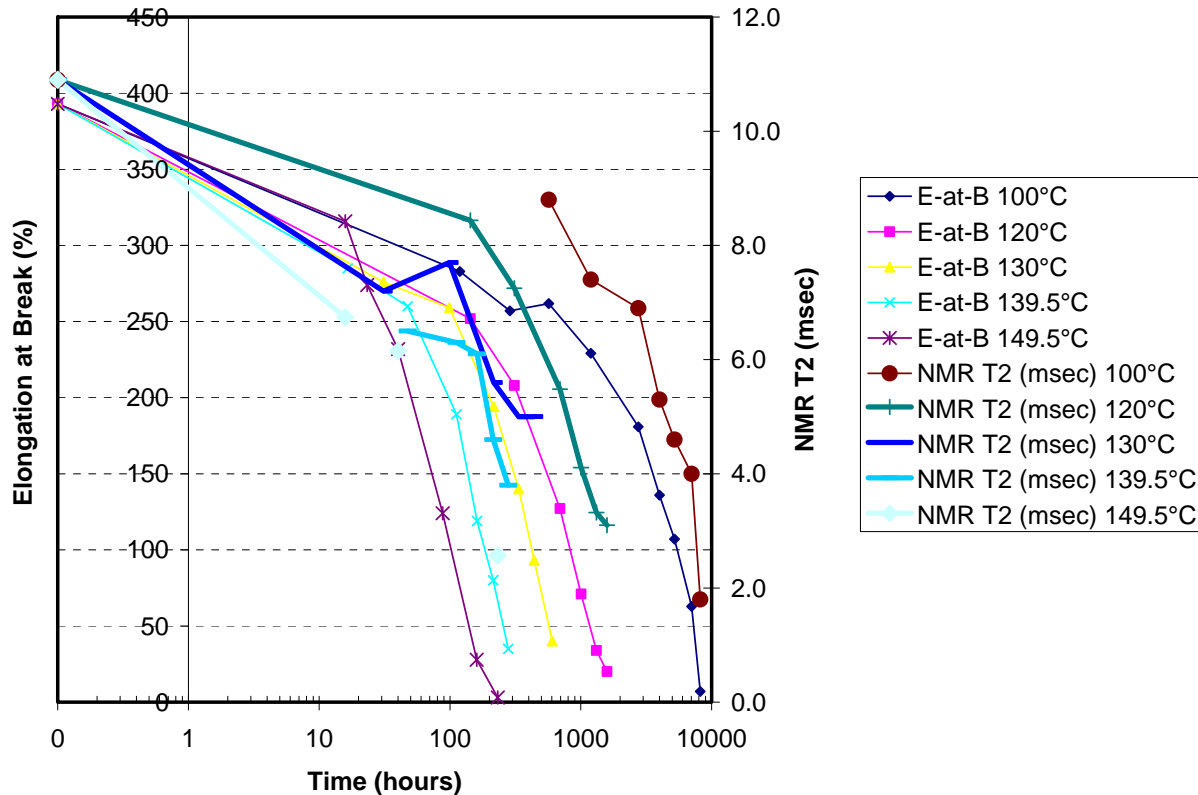
**Figure 7-26**  
Anaconda CSPE E-at-B Versus NMR T2, Various Aging Temperatures

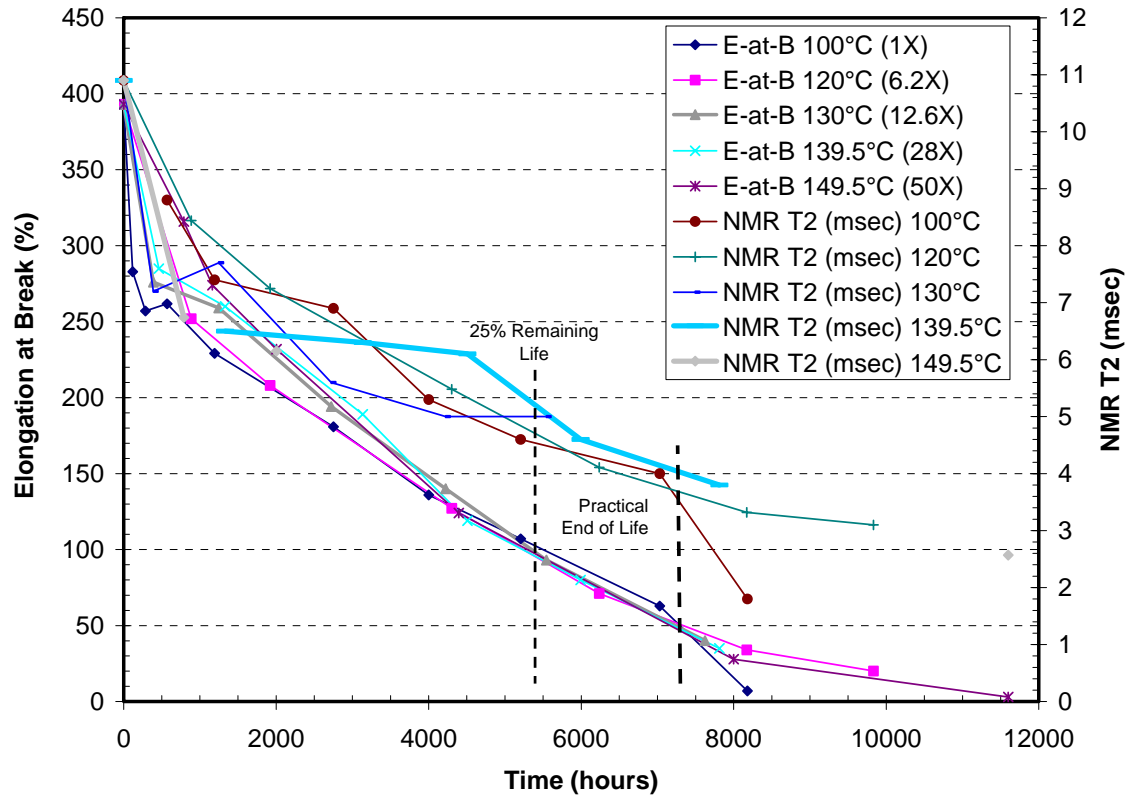
data referred to 100°C by multiplying the aging times by the factors shown in the legend to achieve best fit at 50% remaining E-at-B. Figure 7-27 shows that the different aging temperatures did not result in significantly different aging patterns especially as the material is beginning to age significantly (below 150% retained E-at-B). At 50% remaining E-at-B, the NMR T2 has dropped to 3.5–4 msec from the original 10.9 msec. Figure 7-28 shows E-at-B versus edge modulus. Again, the correlation is good. Figure 7-29 shows the same data referred to 100°C. The correlation is strong, but the data are less well-behaved as the material becomes significantly aged (at and below 75–100% remaining E-at-B).

**Note:** Time multipliers (for example, 1X, 6.2X) are shown for each temperature to superpose to 100°C.

**Figure 7-27**  
**Anaconda CSPE E-at-B Versus NMR T2 with Aging Temperatures Superposed to 100°C**

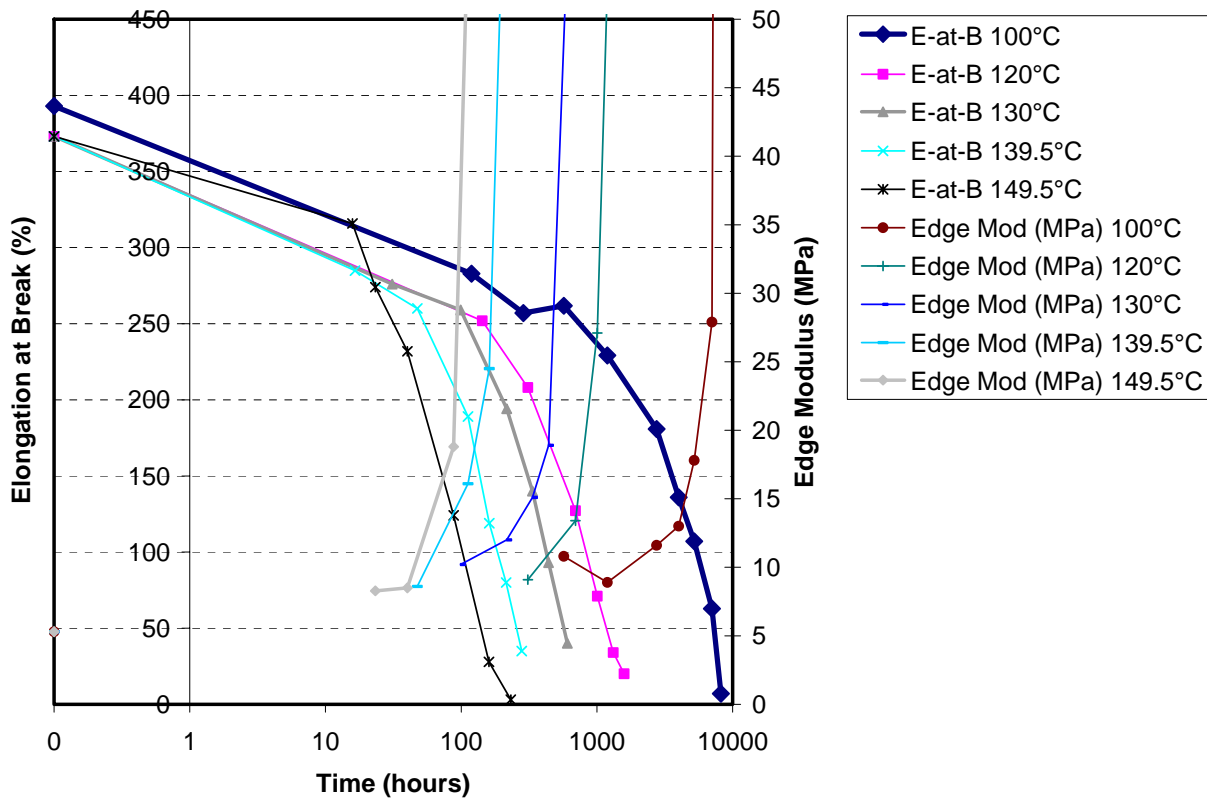
**Figure 7-28**  
**Anaconda CSPE E-at-B Versus Edge Modulus, Various Aging Temperatures**

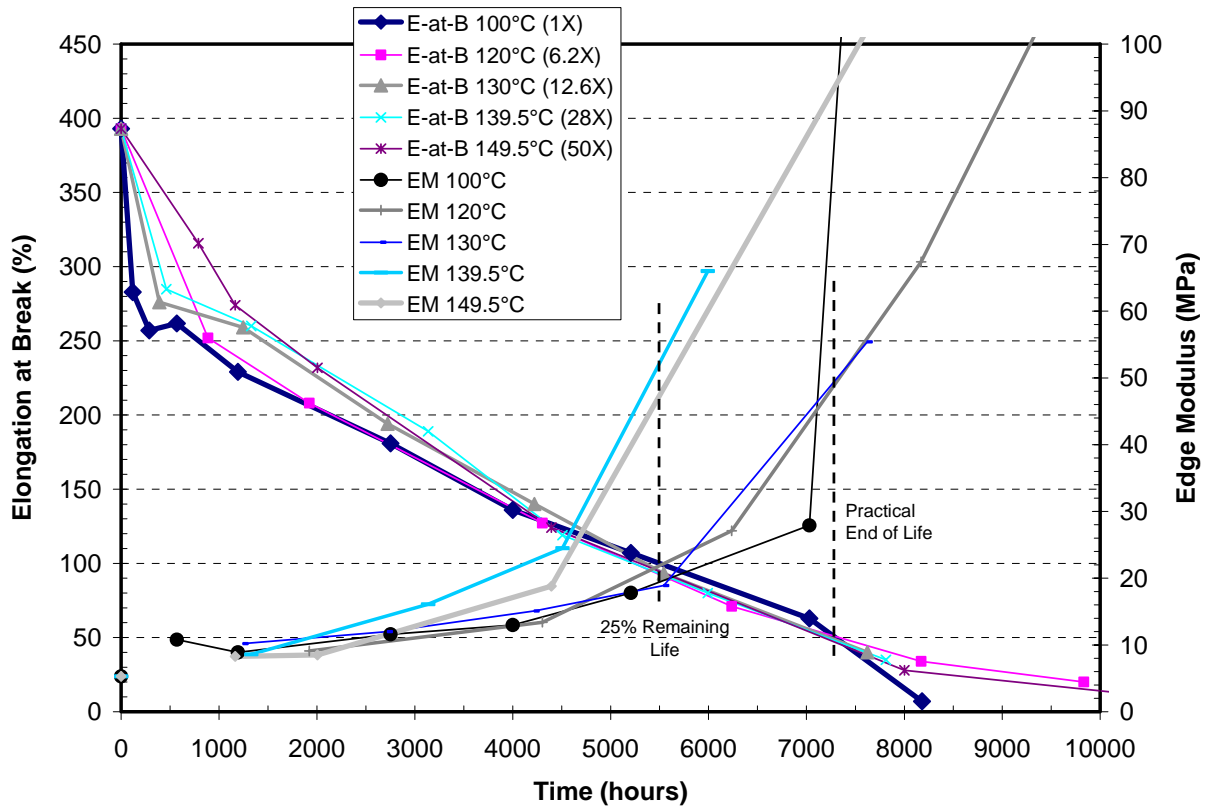
**Figure 7-29**  
**Anaconda CSPE E-at-B Versus Edge Modulus, Superposed to 100°C**

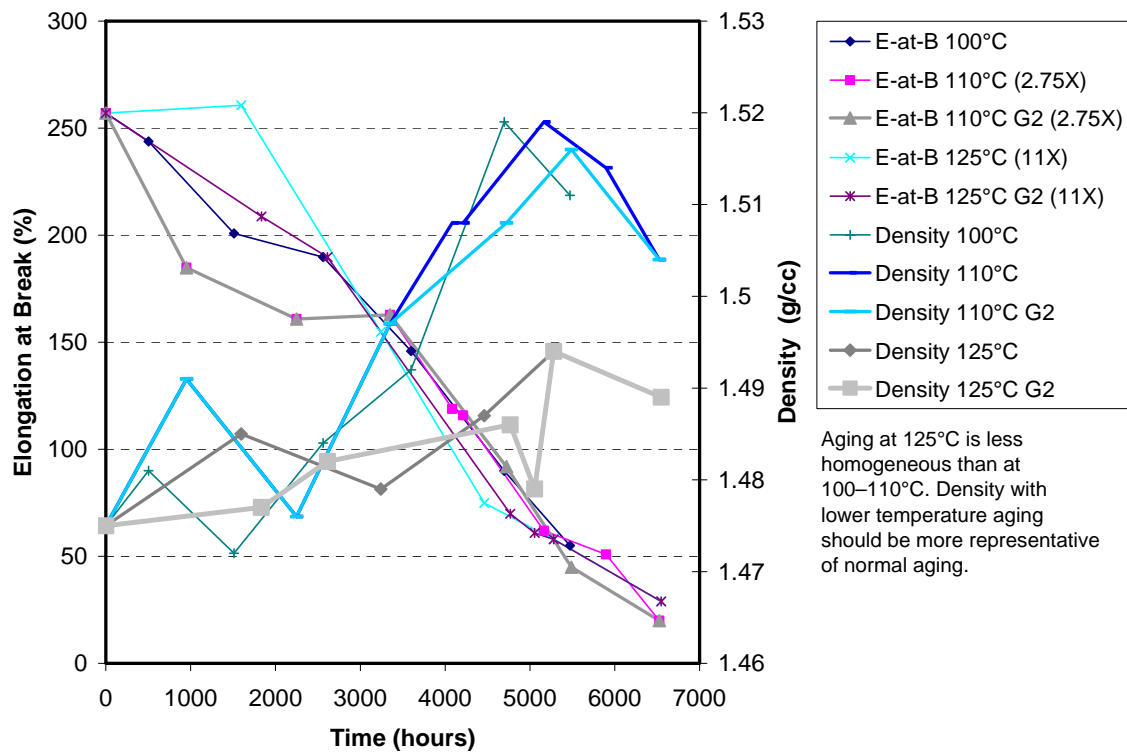
**Figure 7-31**  
BIW Jacket E-at-B Versus Density, Superposed to 100°C

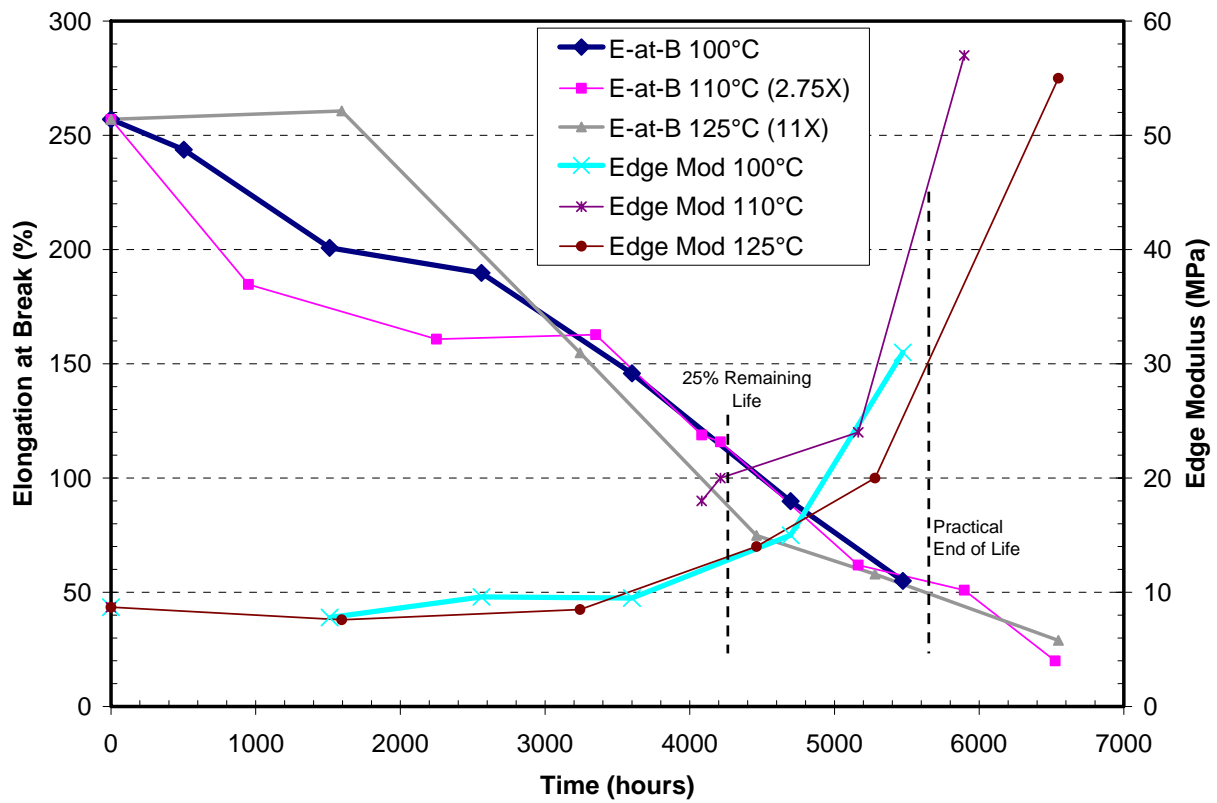
**Figure 7-32**  
BIW Jacket E-at-B Versus Edge Modulus, Superposed to 100°C

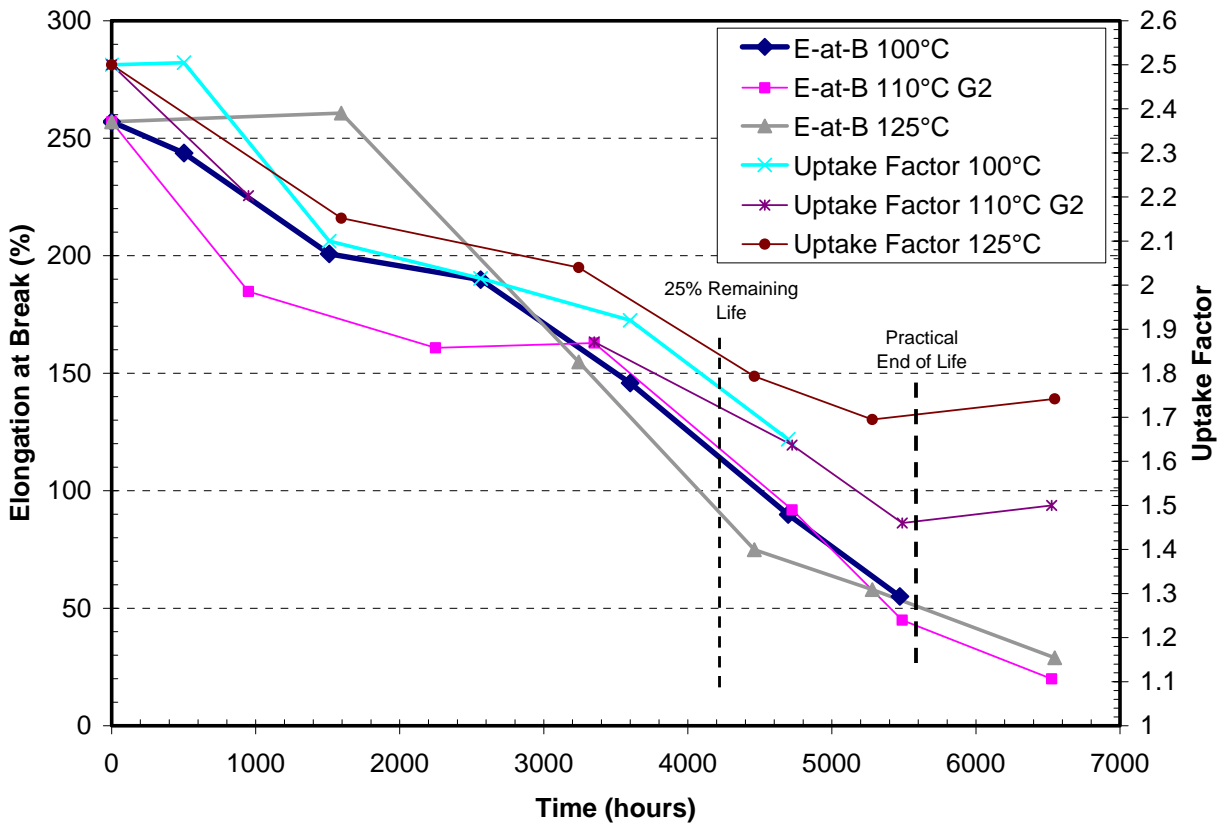
Figure 7-33 shows the correlation between E-at-B and the uptake factor. The correlation is good, but resolution is limited. Below 50% remaining elongation, resolution is lost totally. Figure 7-33 provides the correlation between E-at-B and the uptake factor with the data superposed to 100°C. The uptake factor correlates well with E-at-B, but may suffer from a lack of resolution. Figure 7-34 shows the correlation between E-at-B and percent gel. While there is an obvious correlation, resolution is not ensured and, at higher levels of aging, there is no discrimination between degrees of degradation.

**Figure 7-33**  
BIW Jacket E-at-B Versus Uptake Factor, Superposed to 100°C

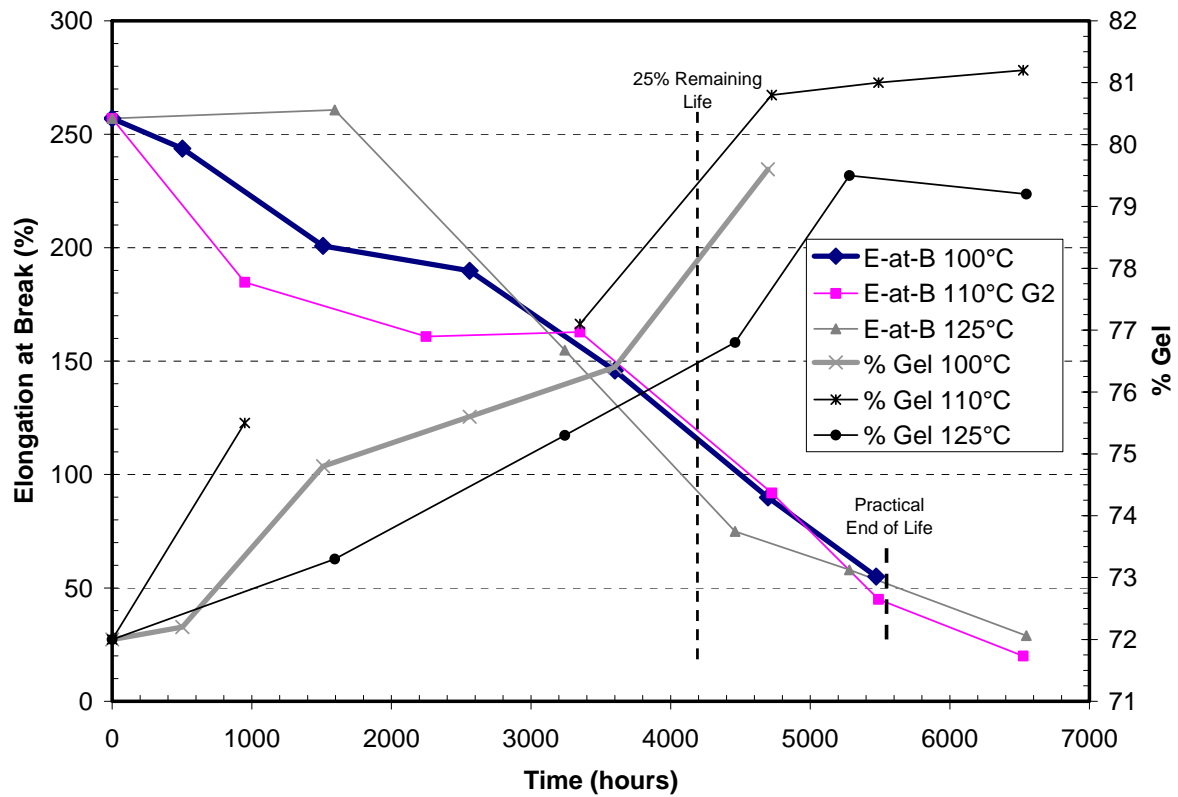
**Figure 7-34**  
BIW Jacket E-at-B Versus % Gel, Superposed to 100°C

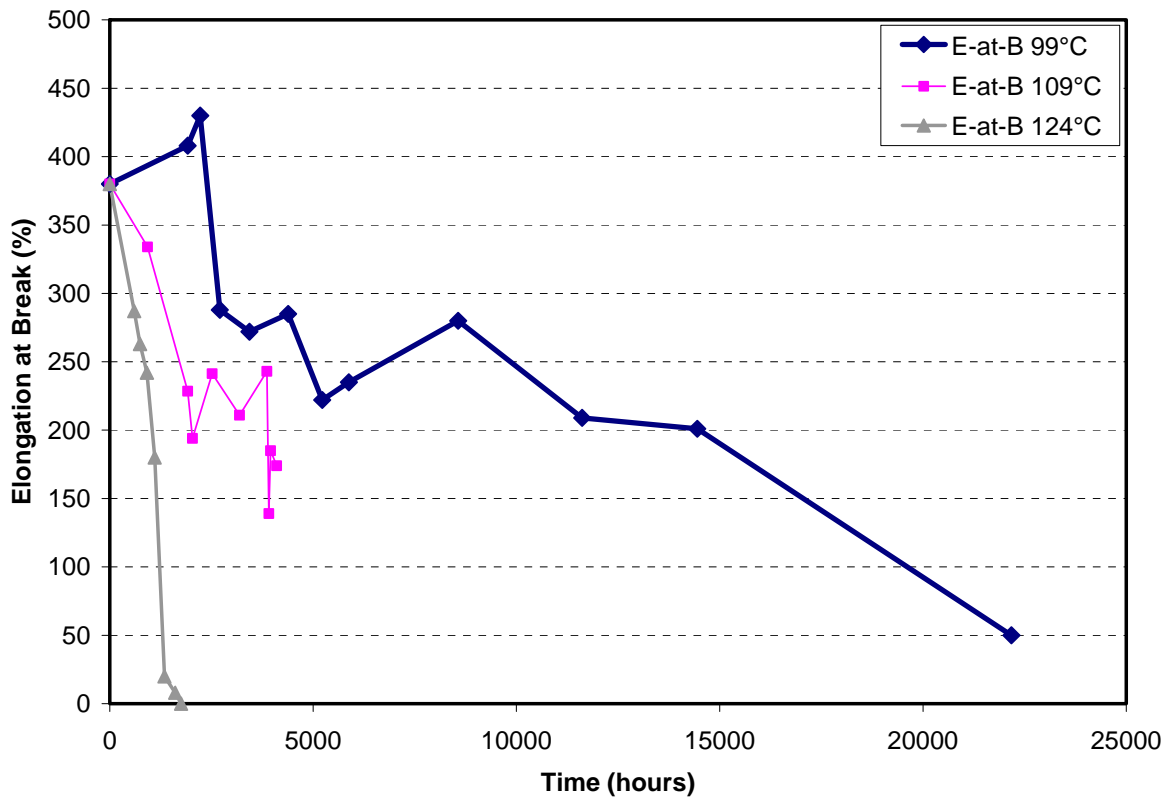
**Figure 7-35**  
**Brand Rex Jacket E-at-B, Various Aging Temperatures**

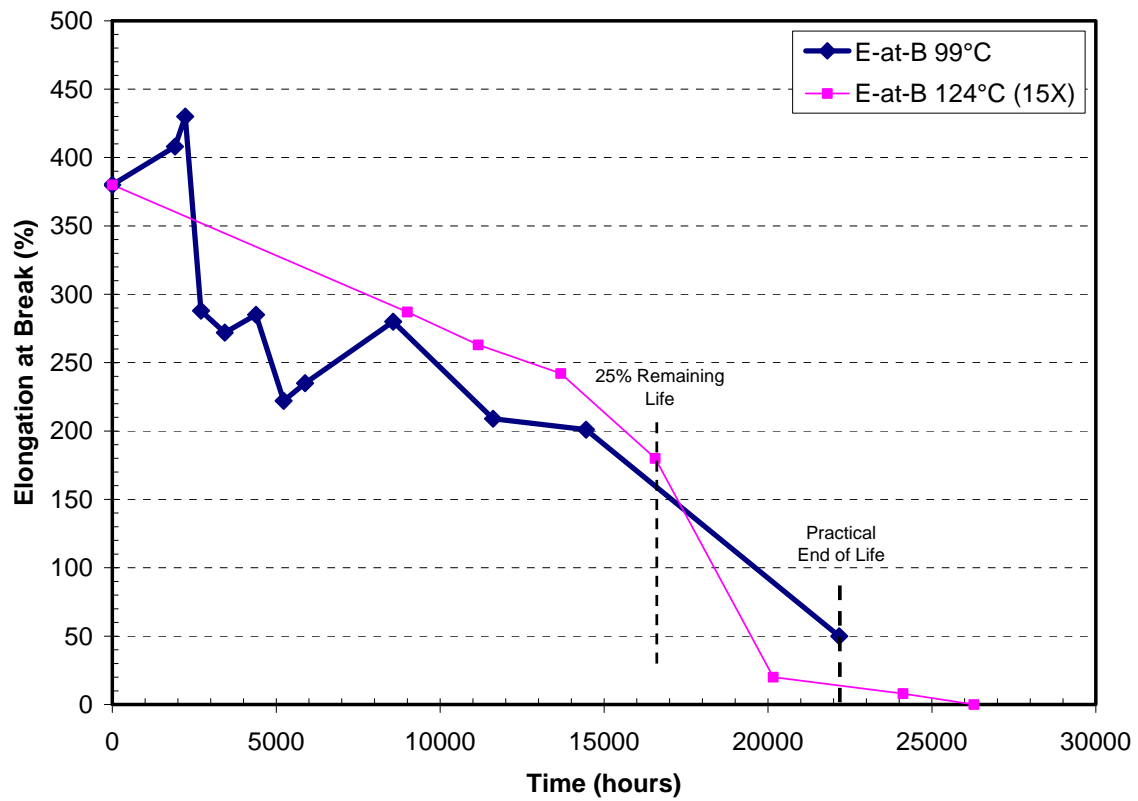
**Figure 7-36**  
**Brand Rex Jacket E-at-B, Various Temperatures Superposed**

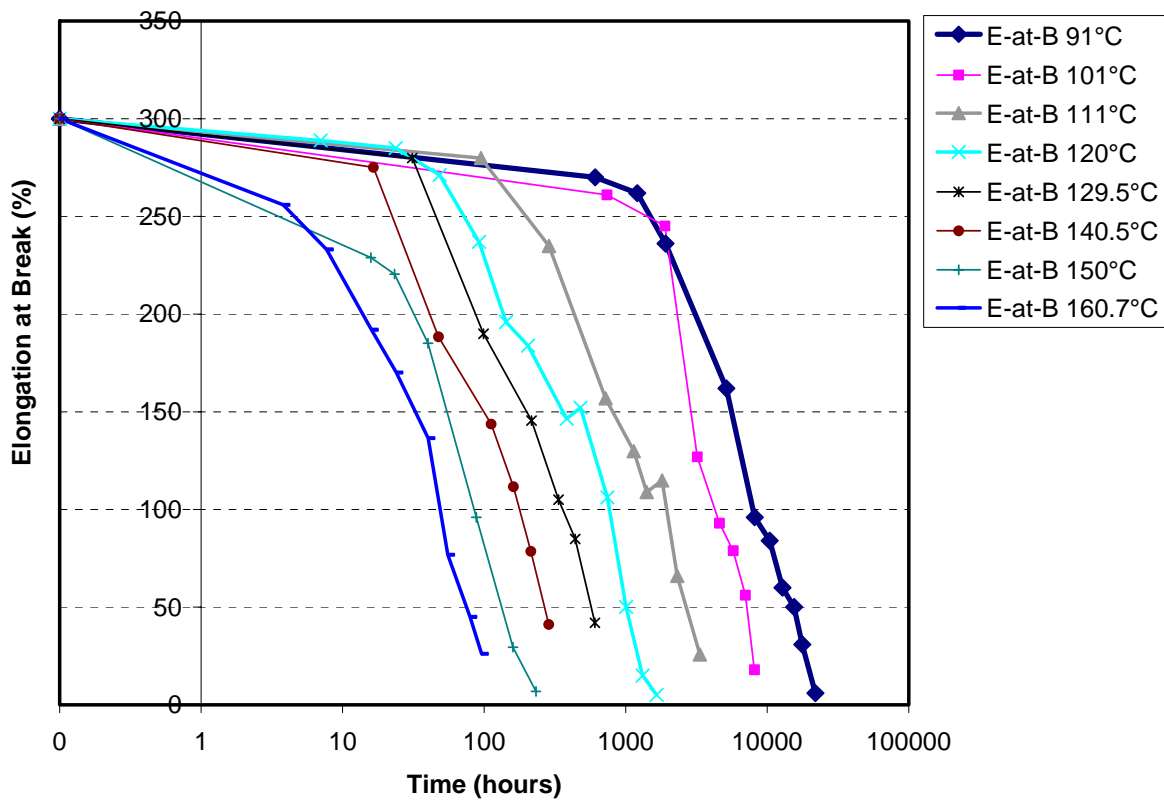
**Figure 7-37**  
Kerite CSPE Outer Jacket E-at-B, Various Aging Temperatures

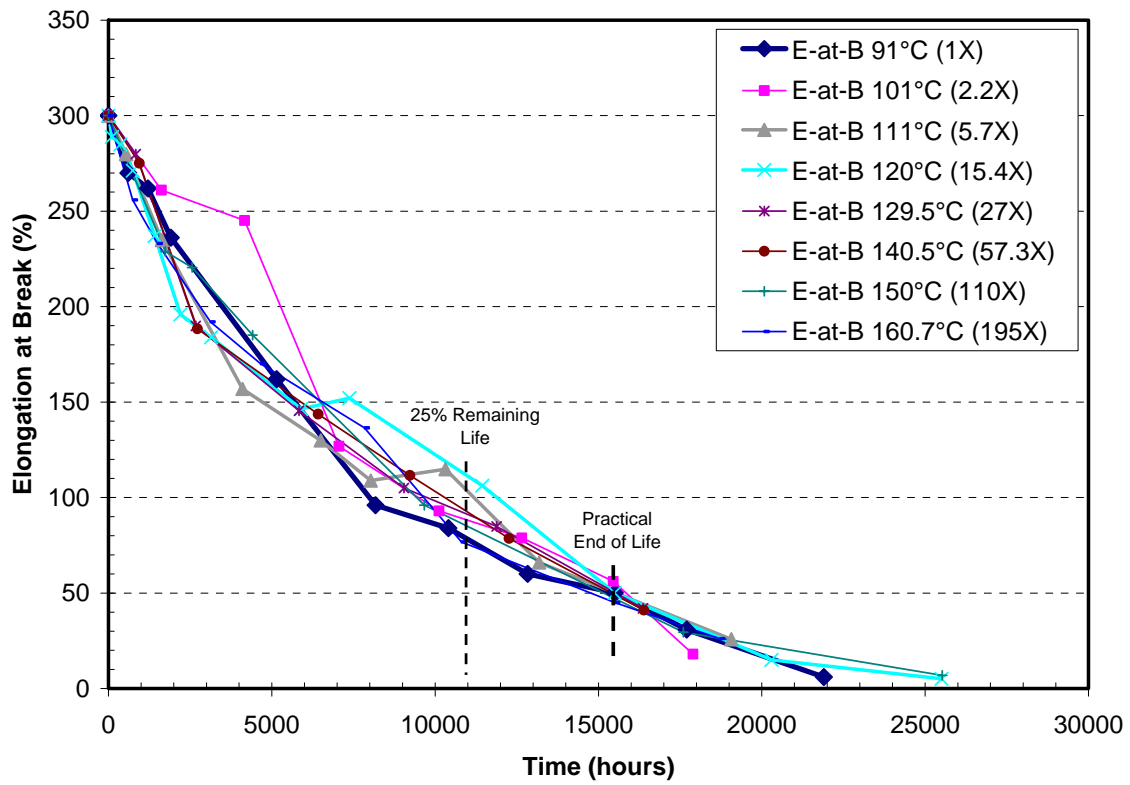
**Figure 7-38**  
Kerite CSPE Outer Jacket E-at-B, Time Superposed to 91°C

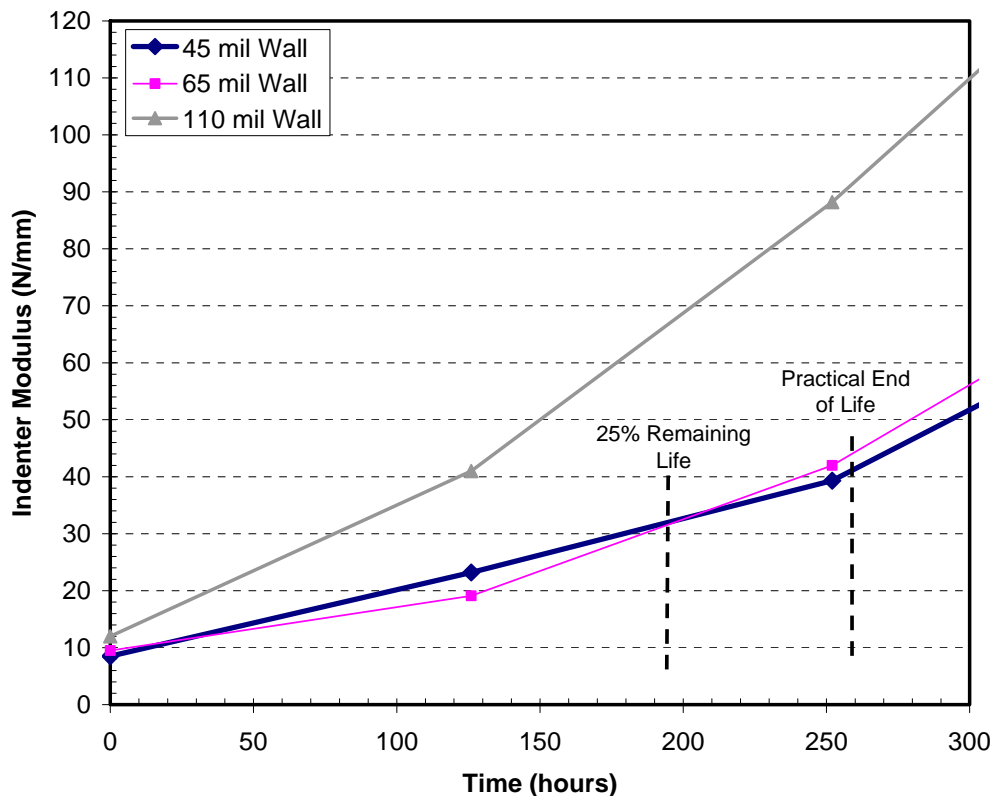
**Figure 7-39**  
Okonite CSPE Outer Jacket, Indenter Modulus, 150°C Aging

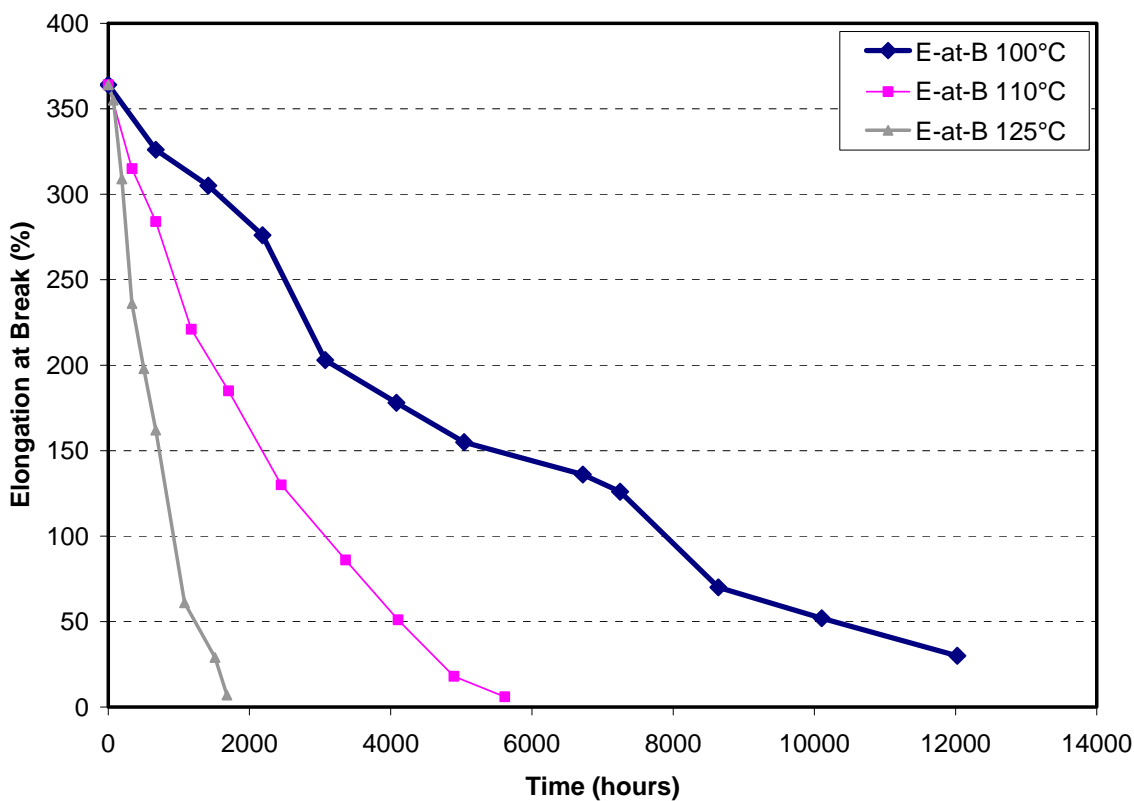
**Figure 7-40**  
**Rockbestos CSPE Jacket E-at-B, Various Aging Temperatures**

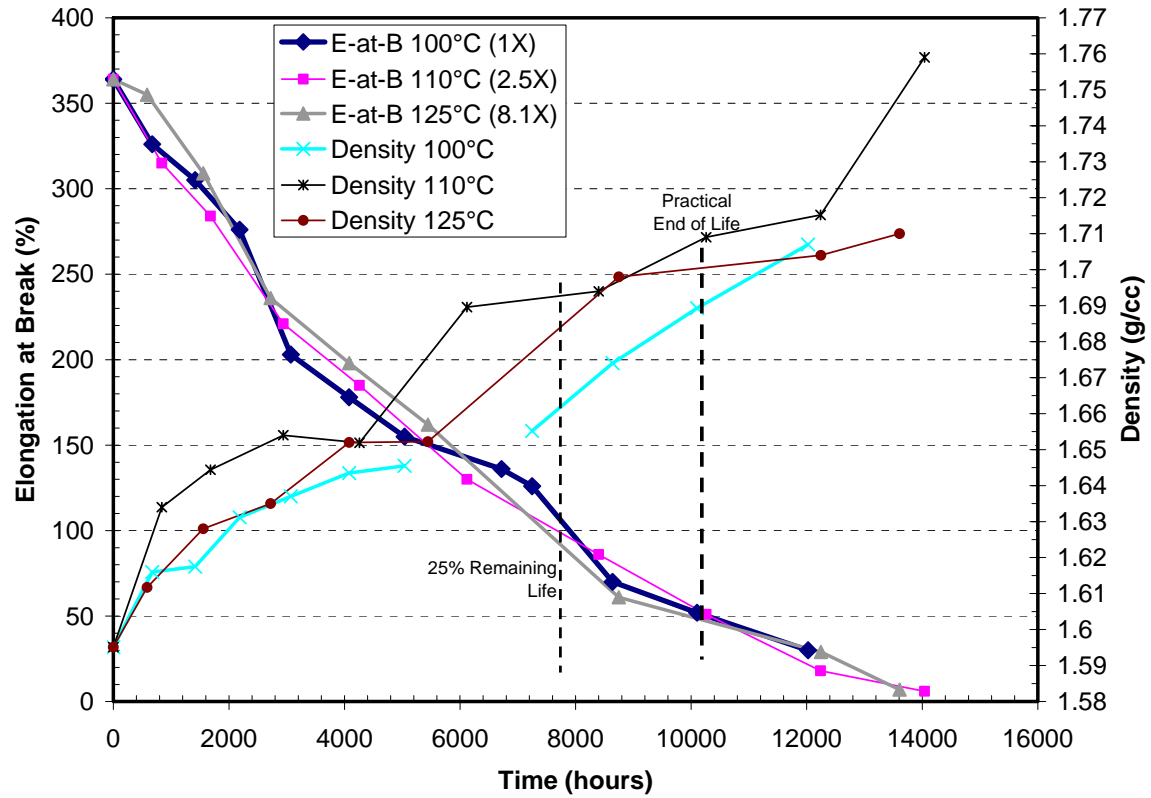
**Figure 7-41**  
**Rockbestos CSPE Jacket E-at-B Versus Density, Superposed to 100°C**

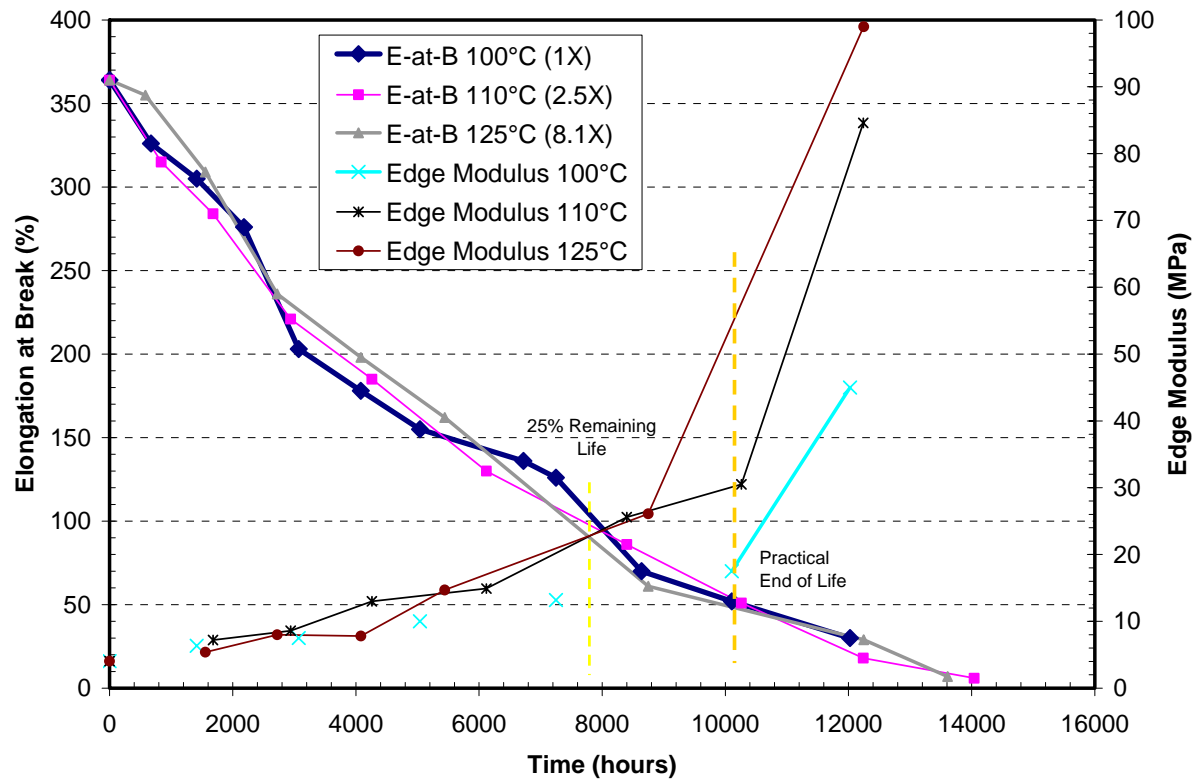
**Figure 7-42**  
Rockbestos CSPE Jacket E-at-B Versus Edge Modulus, Superposed to 100°C

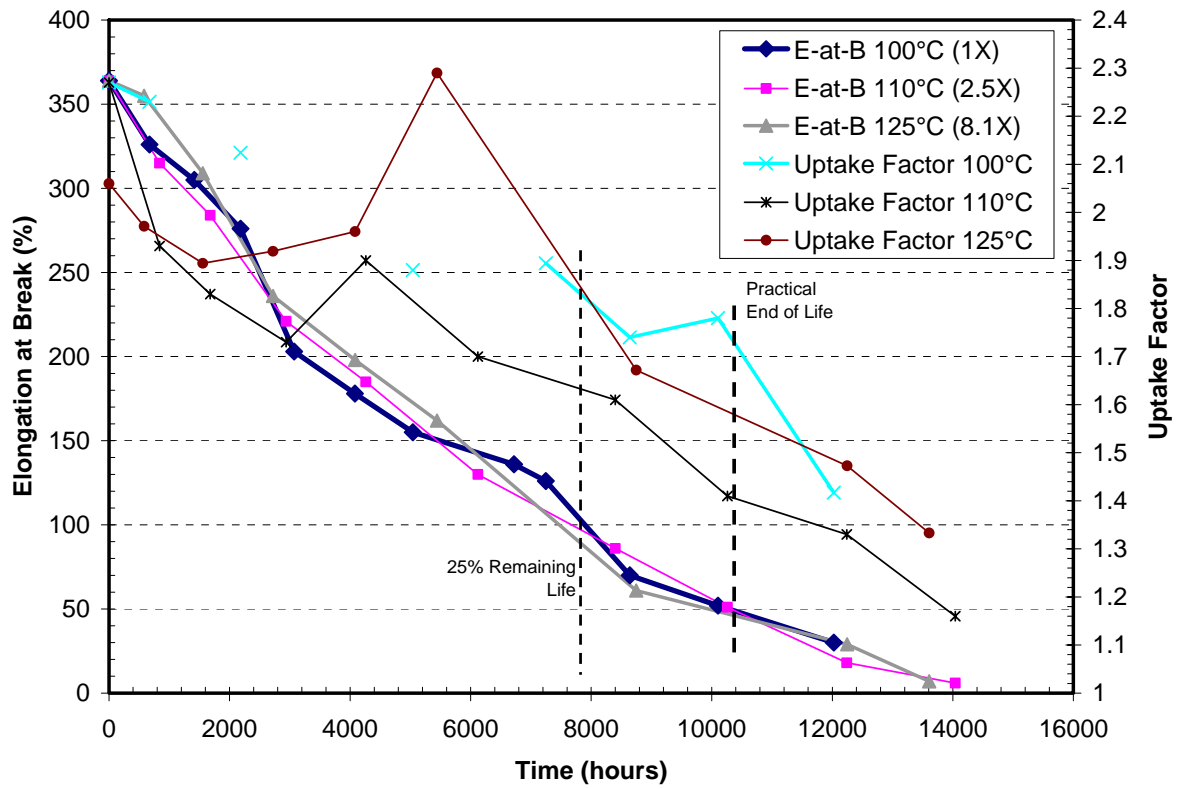
**Figure 7-43**  
**Rockbestos CSPE Jacket E-at-B Versus Uptake Factor, Superposed to 100°C**

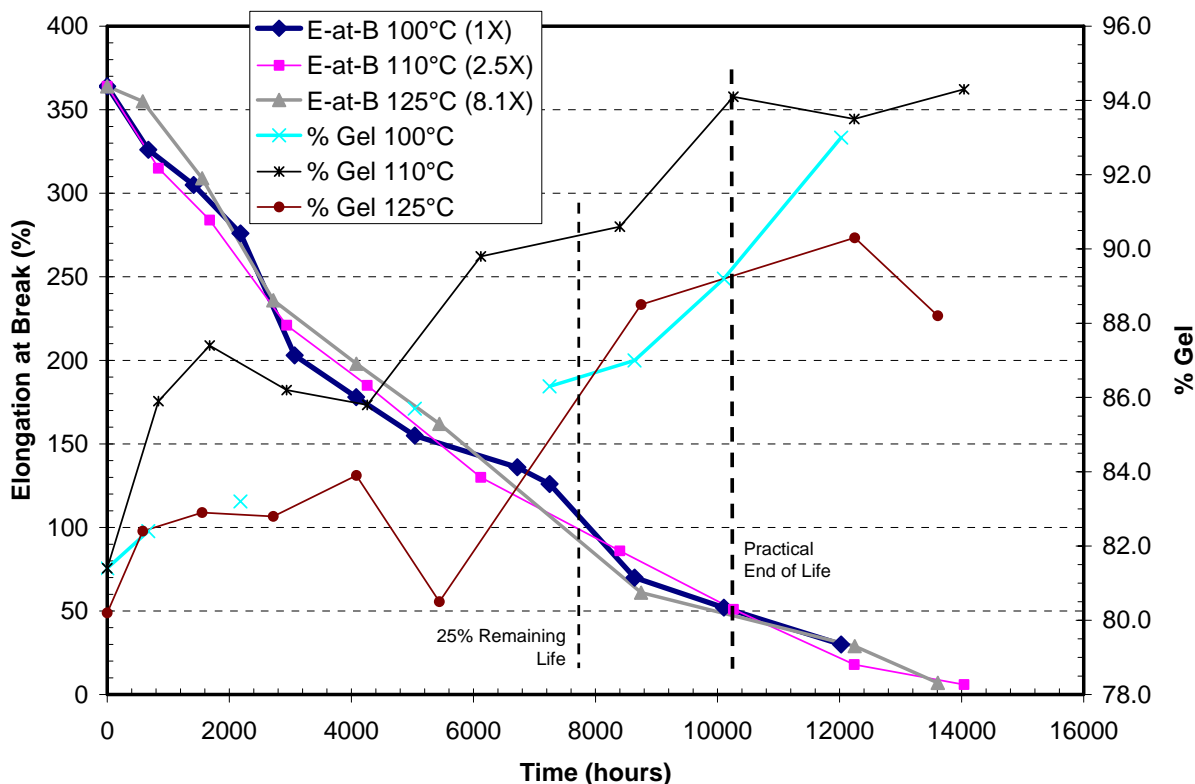
**Figure 7-44**  
**Rockbestos CSPE Jacket E-at-B Versus % Gel, Superposed to 100°C**
