*Technical Report*

# **Initial Acceptance Criteria Concepts and Data for Assessing Longevity of Low-Voltage Cable Insulations and Jackets**

**1008211**

Final Report, March 2005

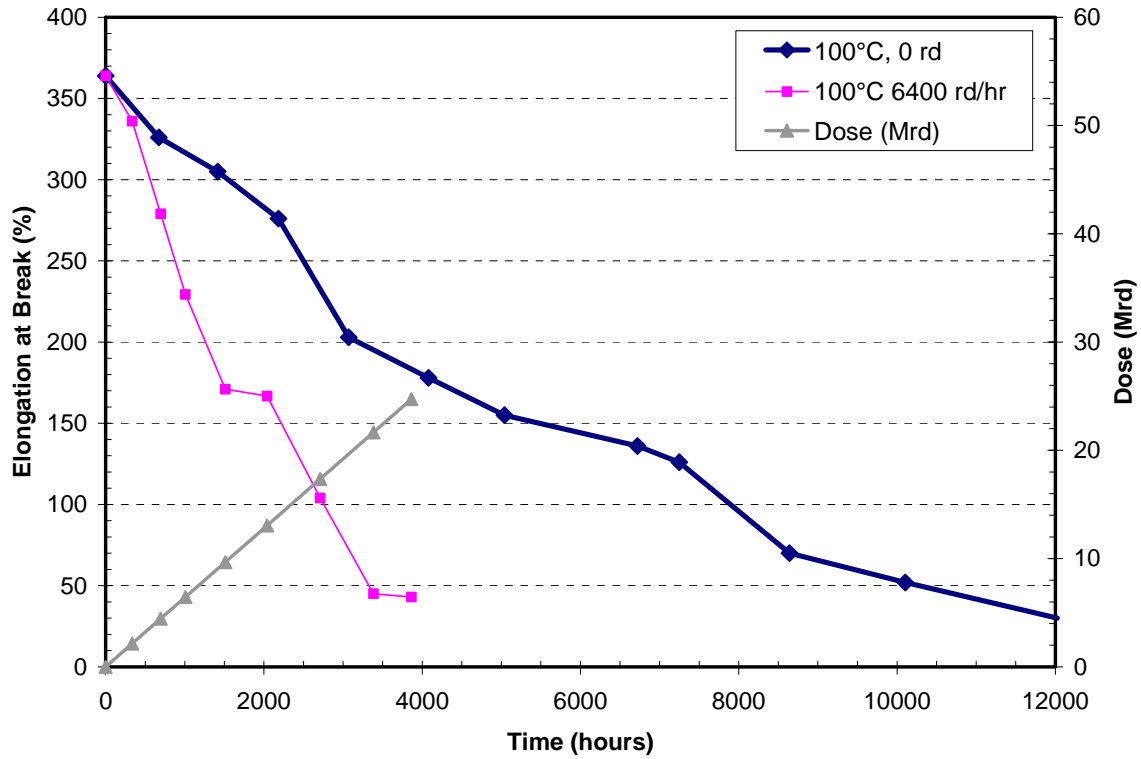
**Figure 7-45**  
Rockbestos CSPE Jacket Effect of Radiation, 100°C, 6.4 krd/hr Aging

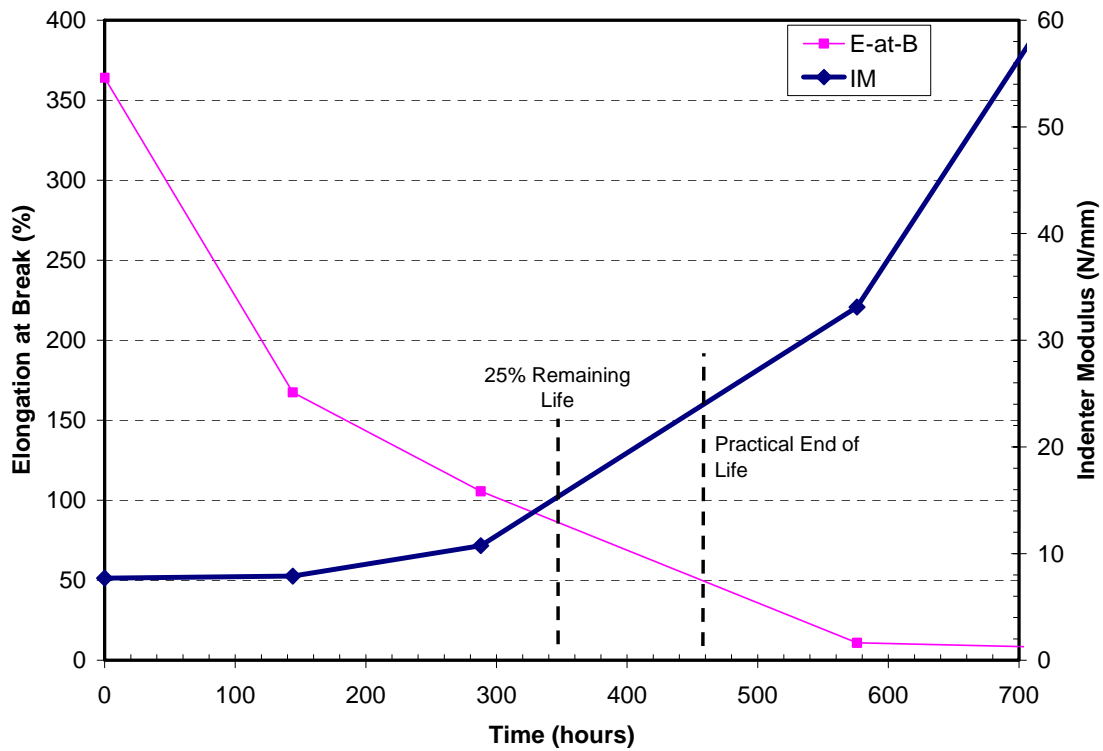
**Figure 7-46**  
Rockbestos CSPE Jacket E-at-B Versus Indenter Modulus, 142°C Thermal Aging

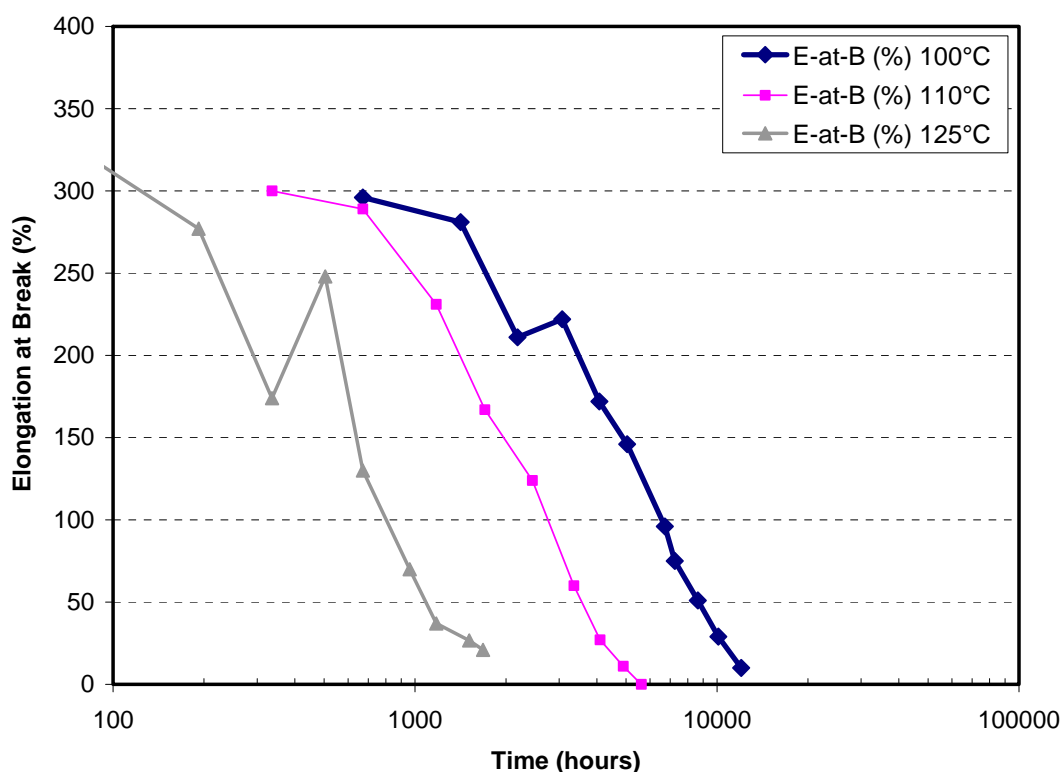
**Figure 7-47**  
Samuel Moore Dekoron CSPE E-at-B, Various Aging Temperatures

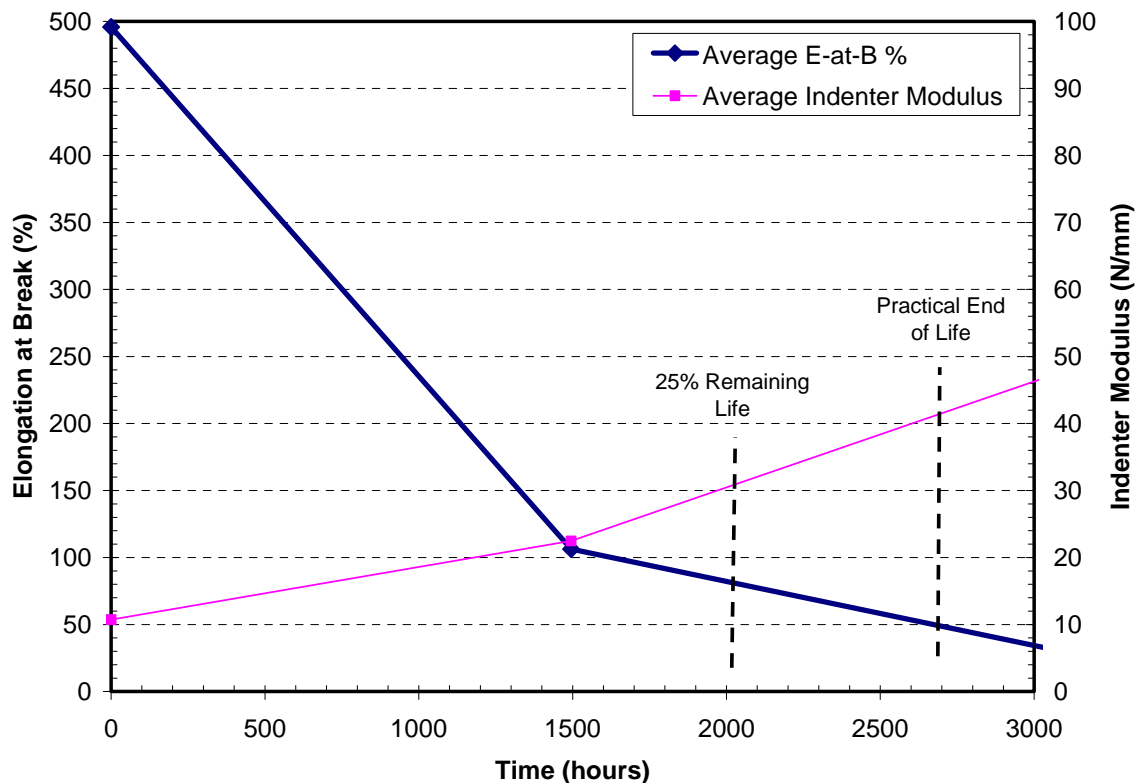
**Figure 7-52**  
BIW Bostrad 7E CSPE/EPR E-at-B Versus Indenter Modulus, 110°C Aging

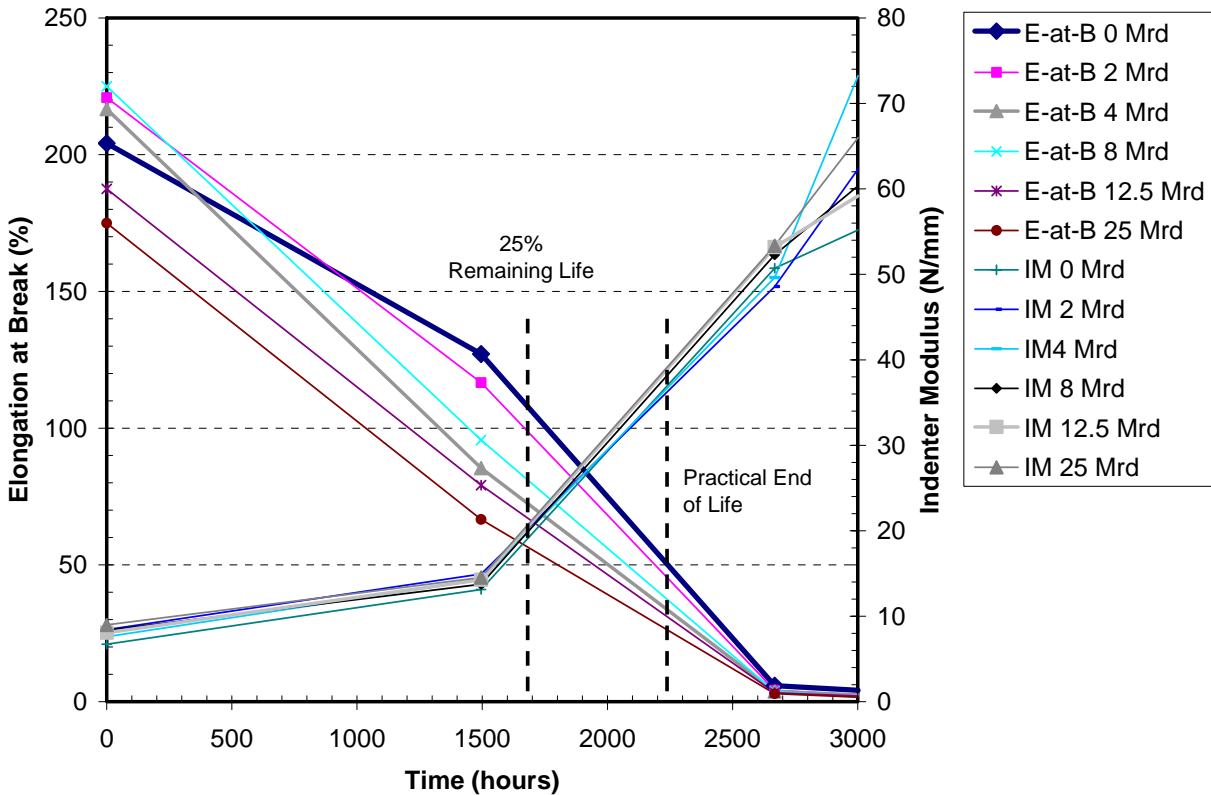
**Figure 7-53**  
Okonite Okolon Single E-at-B Versus Indenter Modulus, 110°C Various Doses

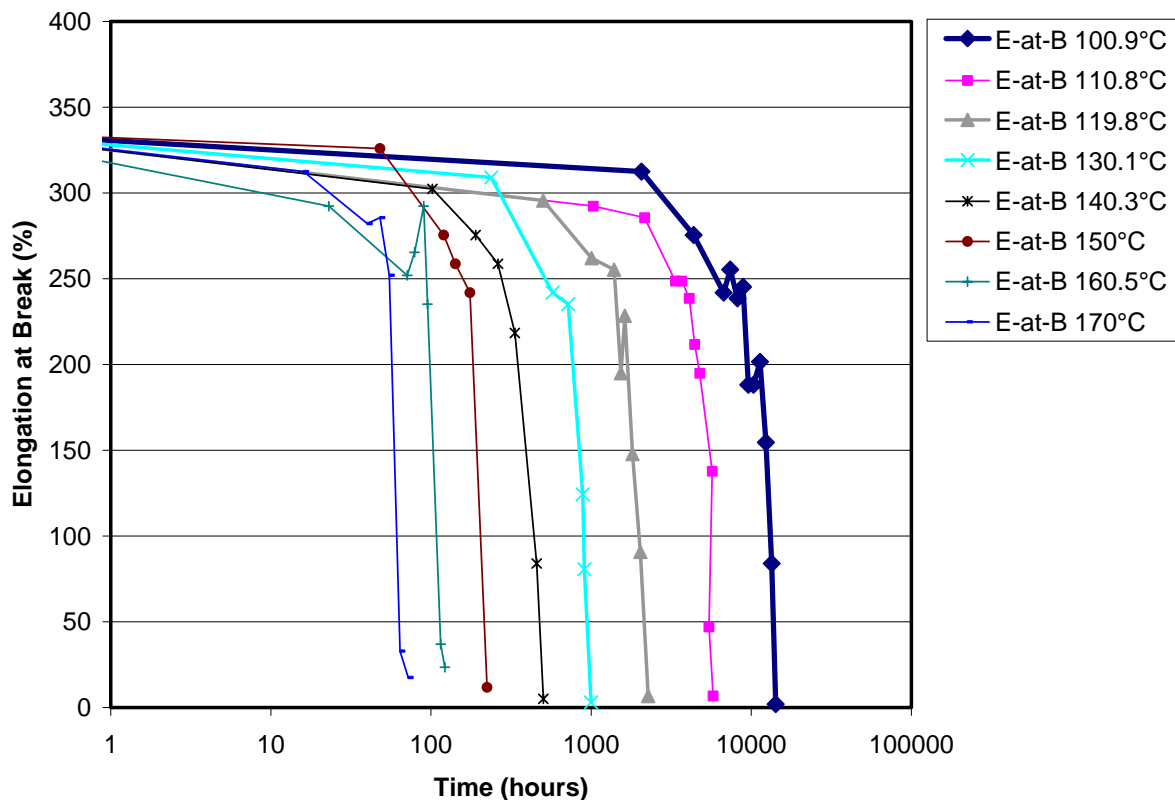
**Figure 7-54**  
Anaconda Flameguard EPR E-at-B, Various Temperatures

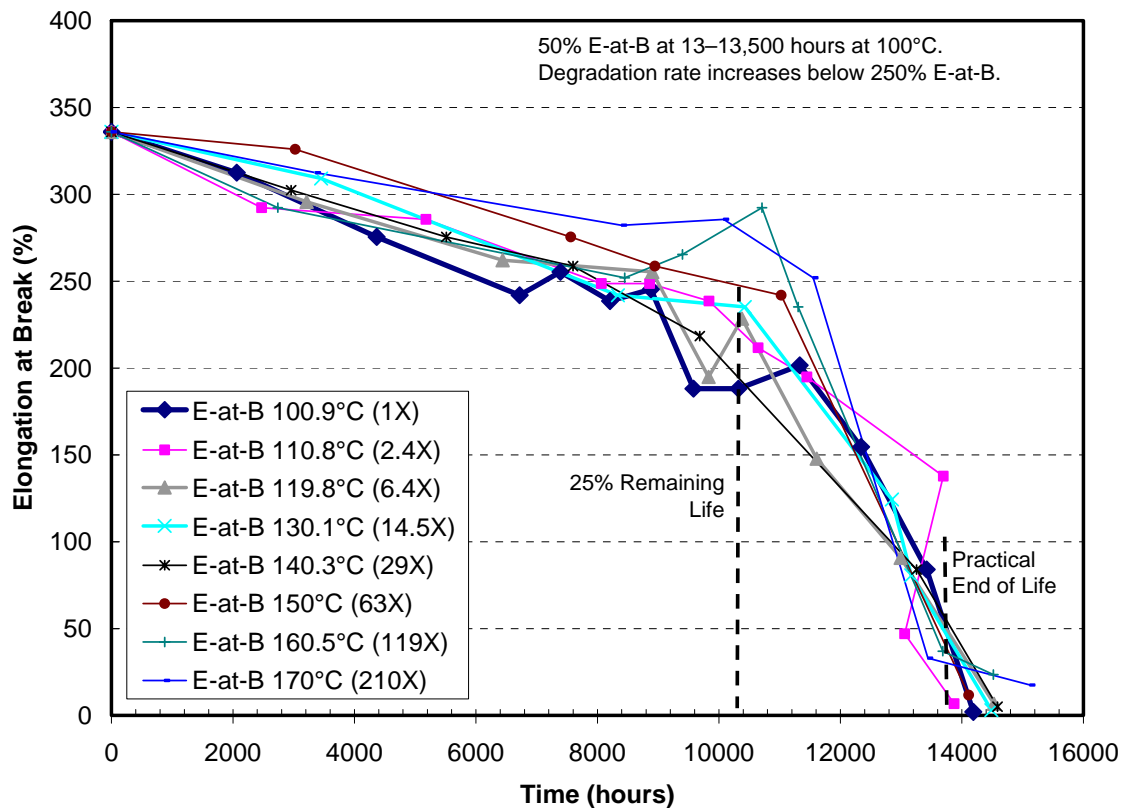
**Figure 7-55**  
**Anaconda Flameguard E-at-B, Superposed to 100.9°C**

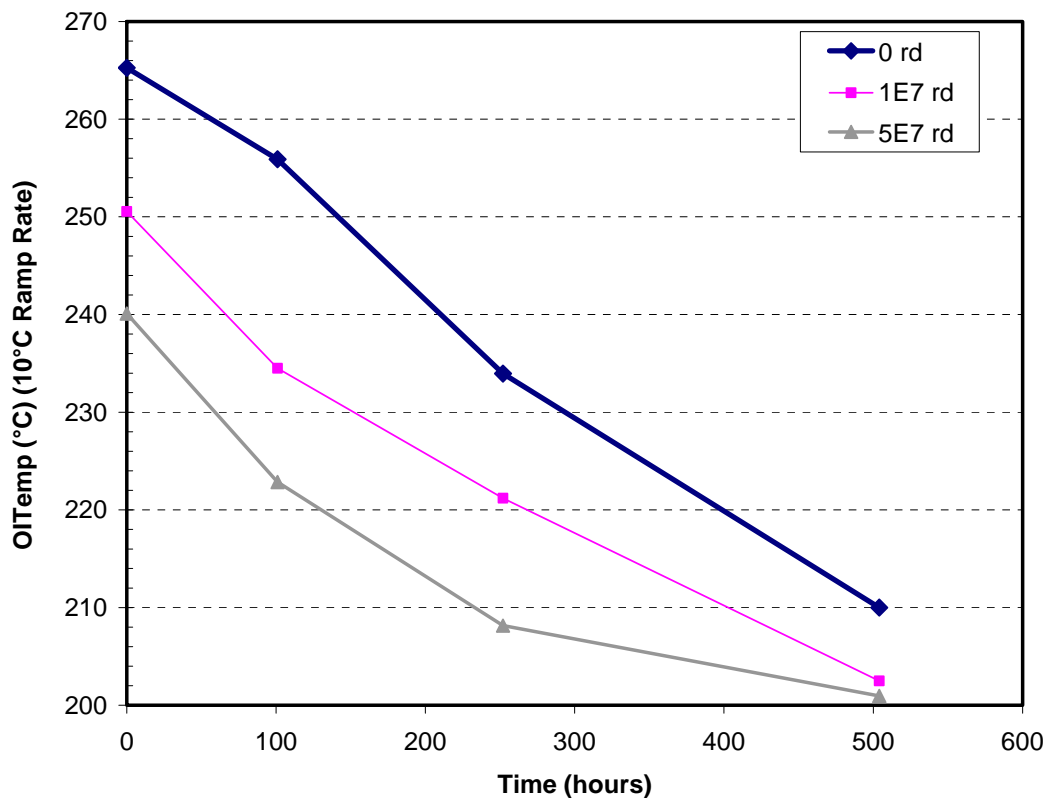
**Figure 7-56**  
**Okonite EPR Oxidation Induction Temperature, 150°C Aging**

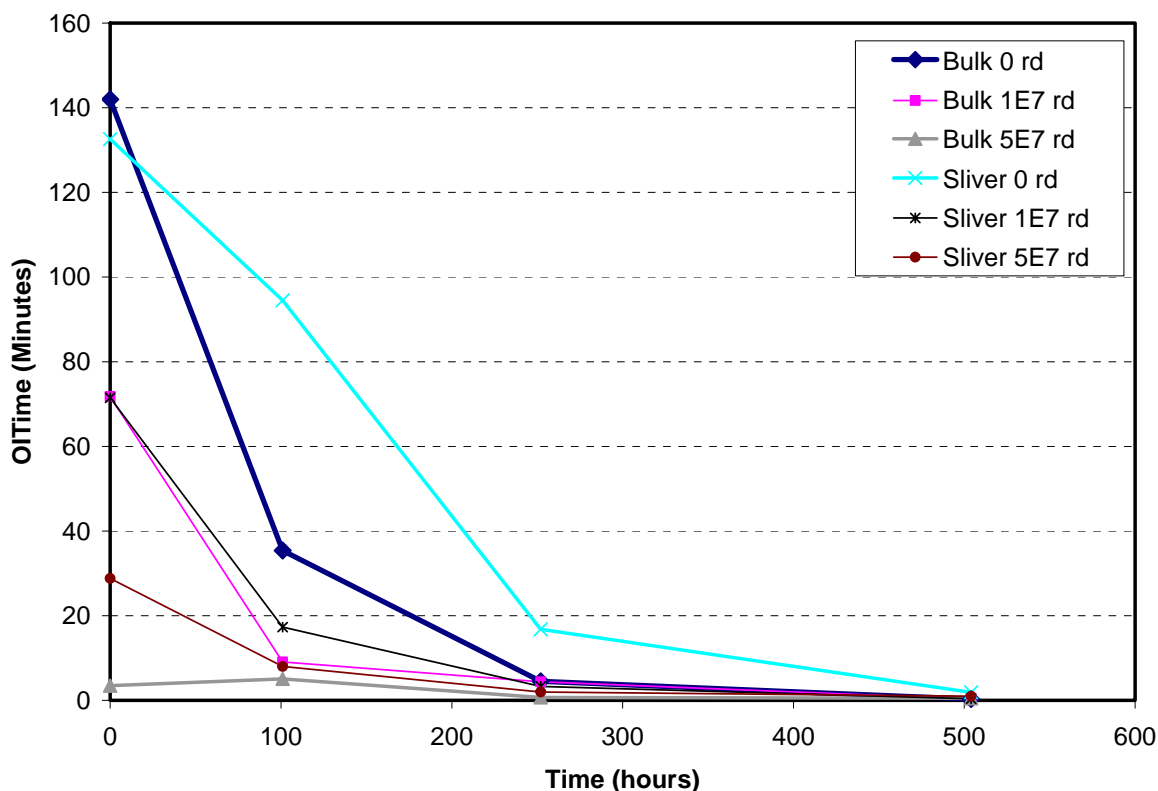
**Figure 7-57**  
Okonite Oxidation Induction Time, 150°C Aging

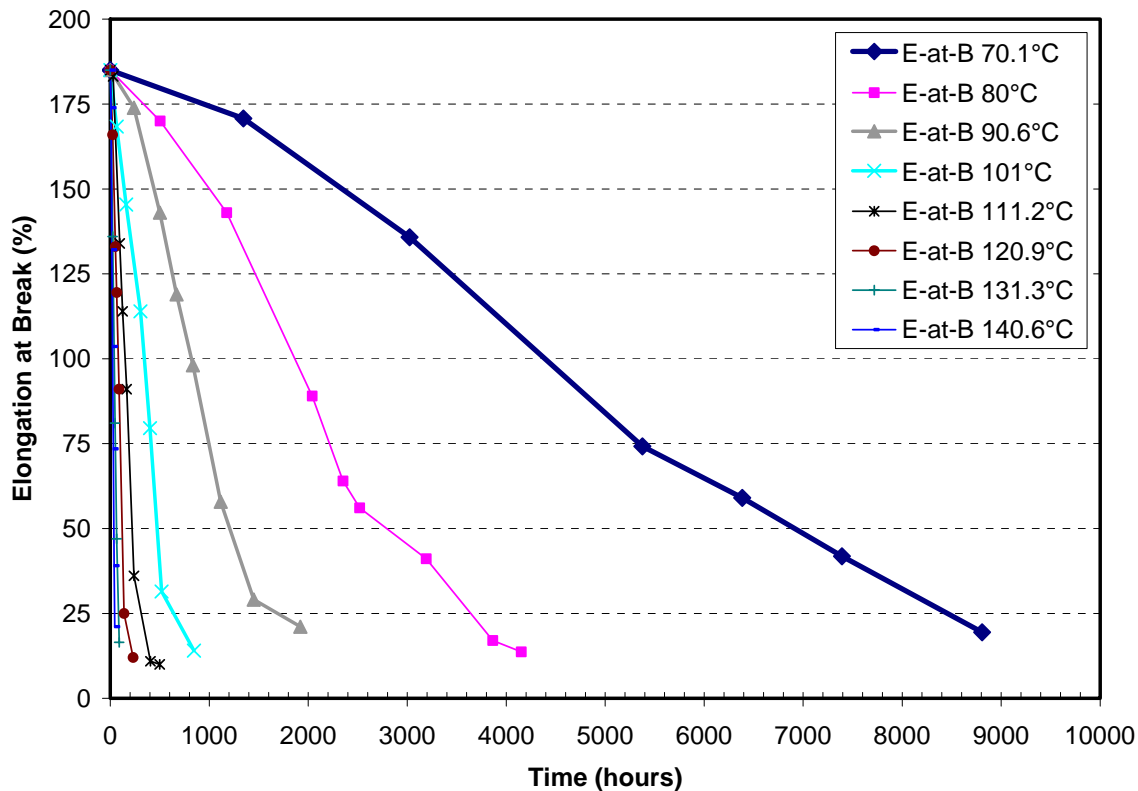
**Figure 7-58**  
Okonite Jacket E-at-B, Various Temperatures

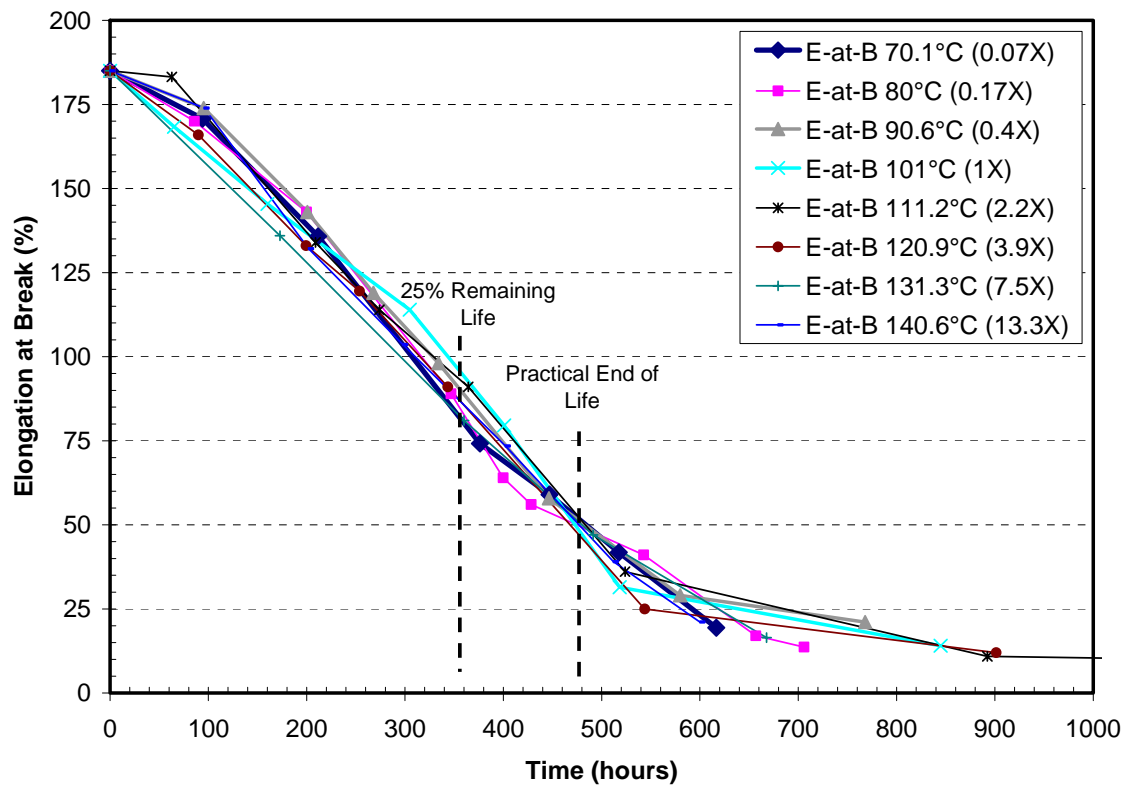
**Figure 7-59**  
Okonite Neoprene Jacket E-at-B, Superposed to 101°C

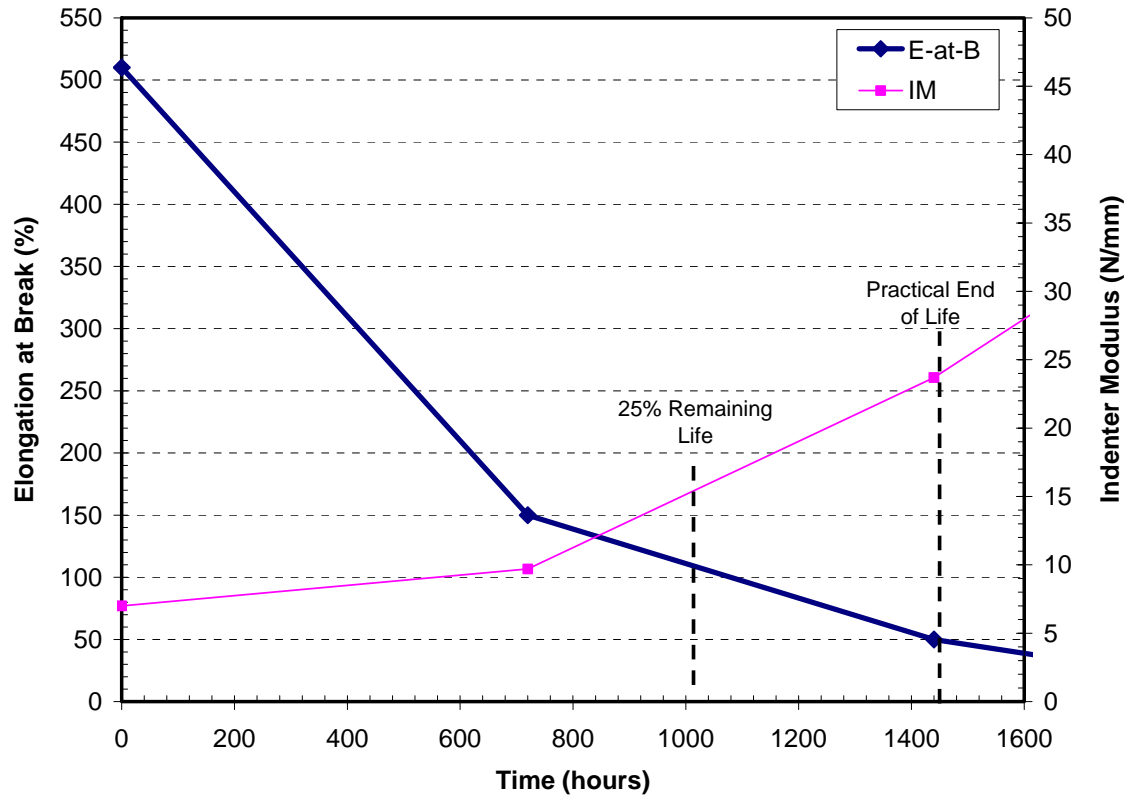
**Figure 7-60**  
**Neoprene Jacket E-at-B Versus Indenter Modulus, 110°C Thermal Aging**

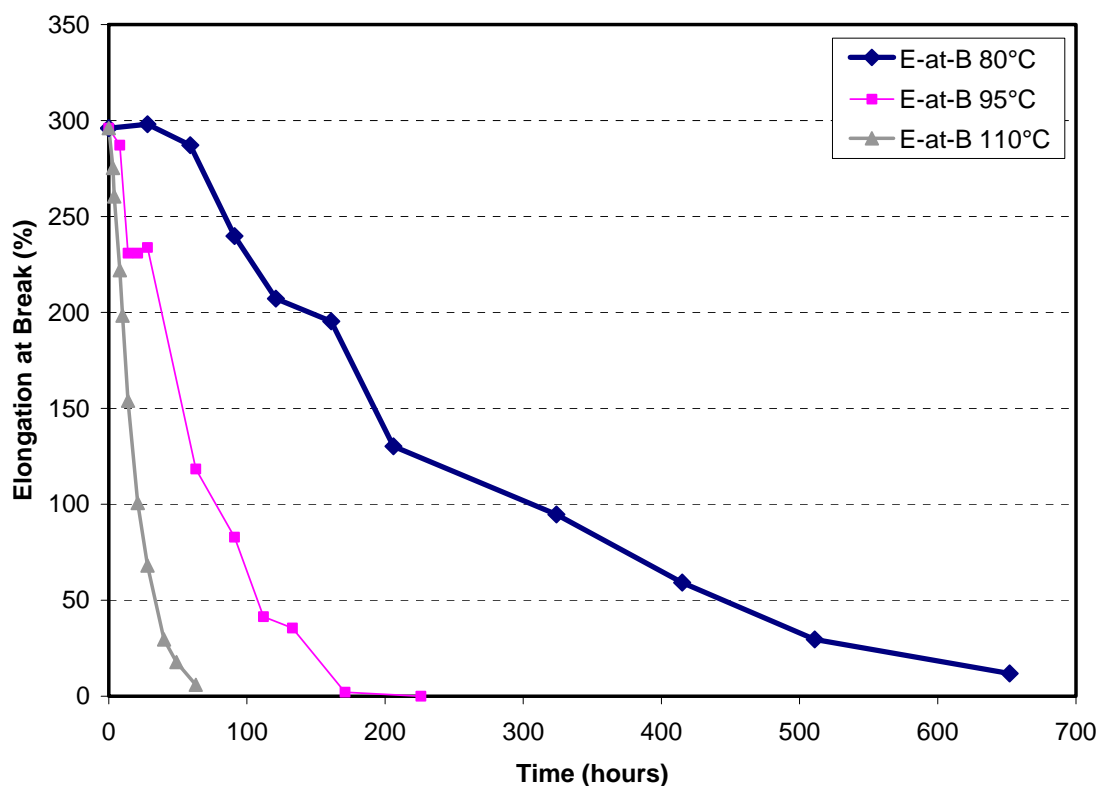
**Figure 7-61**  
Rockbestos Neoprene Jacket E-at-B, Various Aging Temperatures

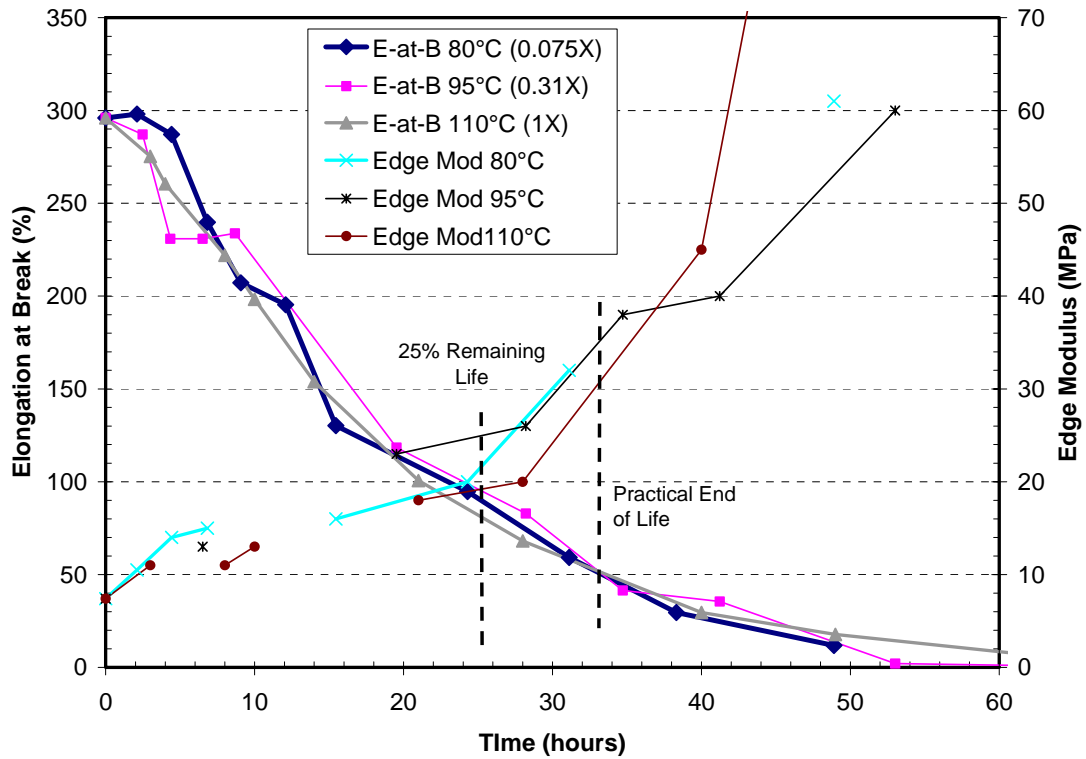
**Figure 7-64**  
Rockbestos Neoprene Jacket E-at-B Versus Edge Modulus, Superposed to 110°C

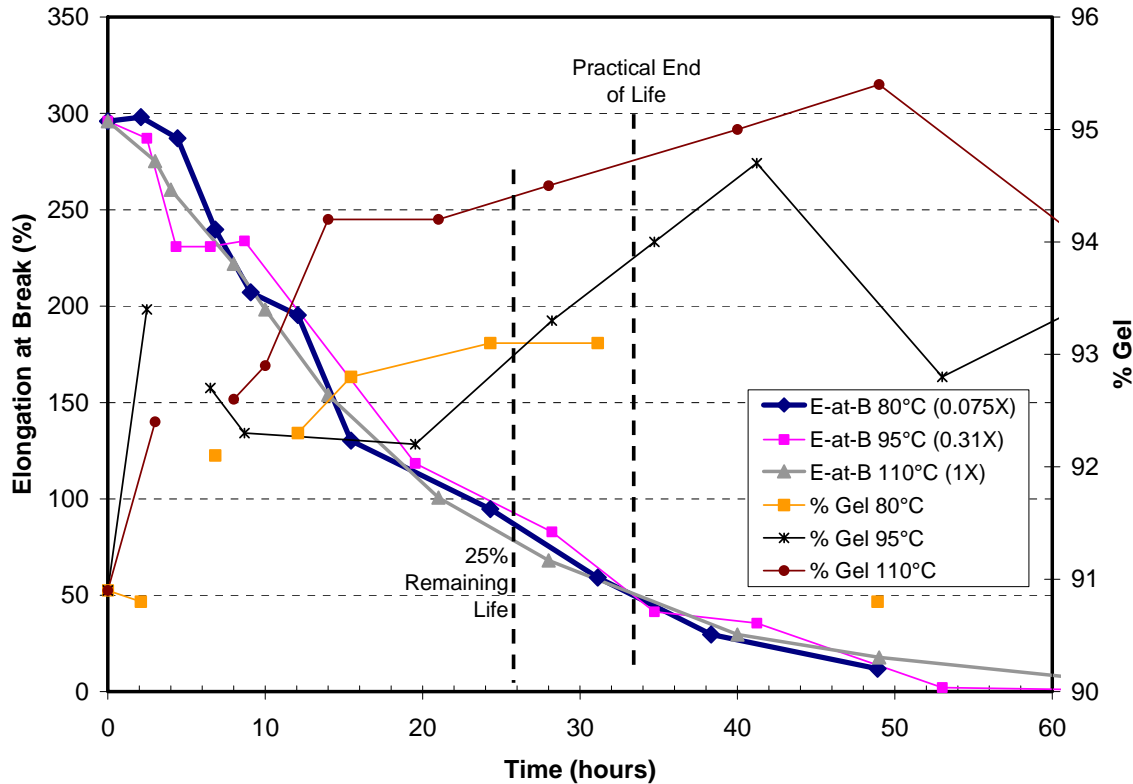
**Figure 7-66**  
Rockbestos Neoprene Jacket E-at-B Versus % Gel, Superposed to 110°C

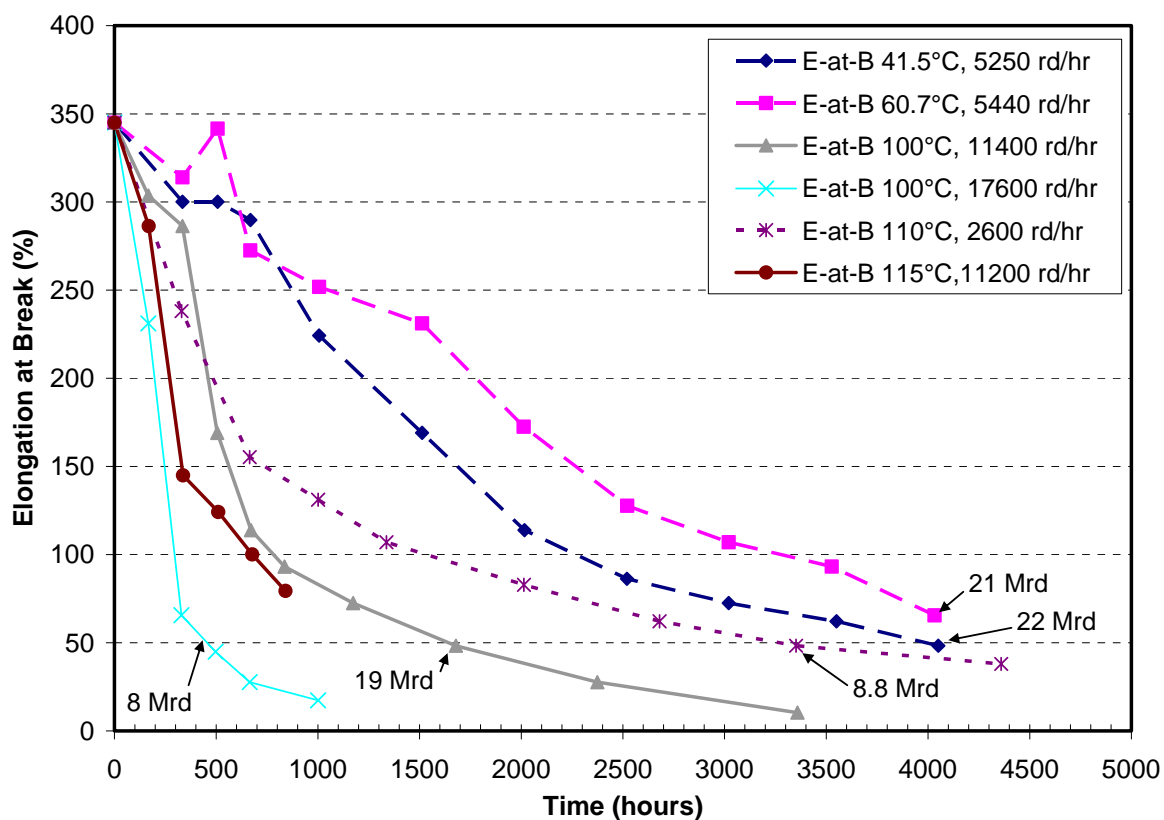
**Figure 7-68**  
**Rockbestos Silicone Rubber (FW-II) E-at-B, Various Aging Temperatures and Dose Rates**

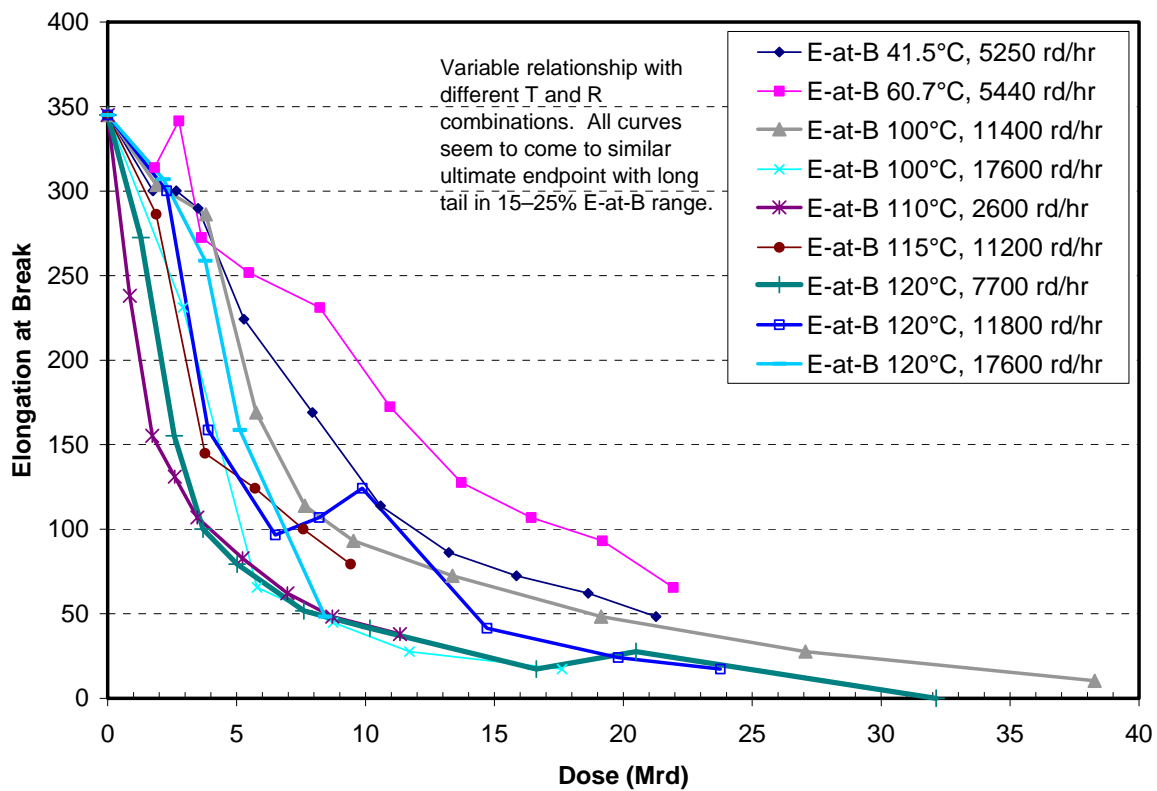
**Figure 7-69**  
**Rockbestos Silicone Rubber (FW-II) E-at-B, Various Aging Temperatures and Dose Rates by Dose**

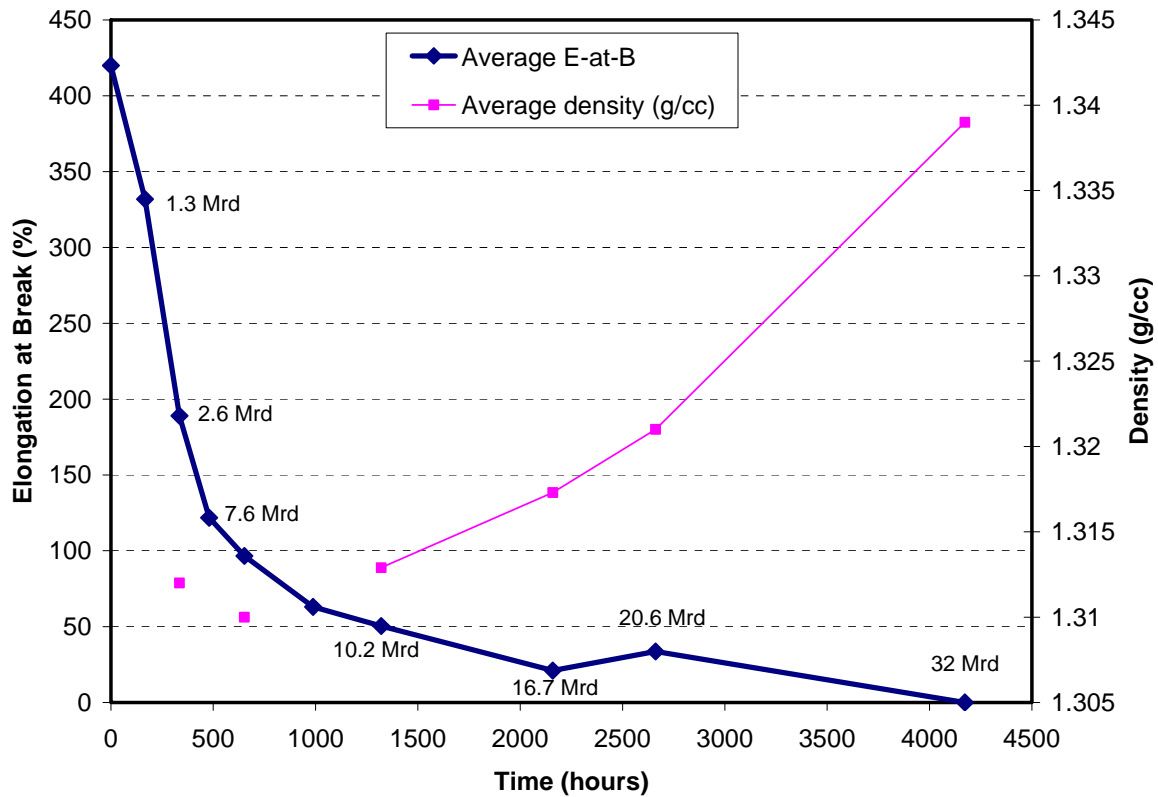
**Figure 7-70**  
Rockbestos Silicone Rubber (FW II) E-at-B Versus Density, 120°C, 7700 rd/hr Aging

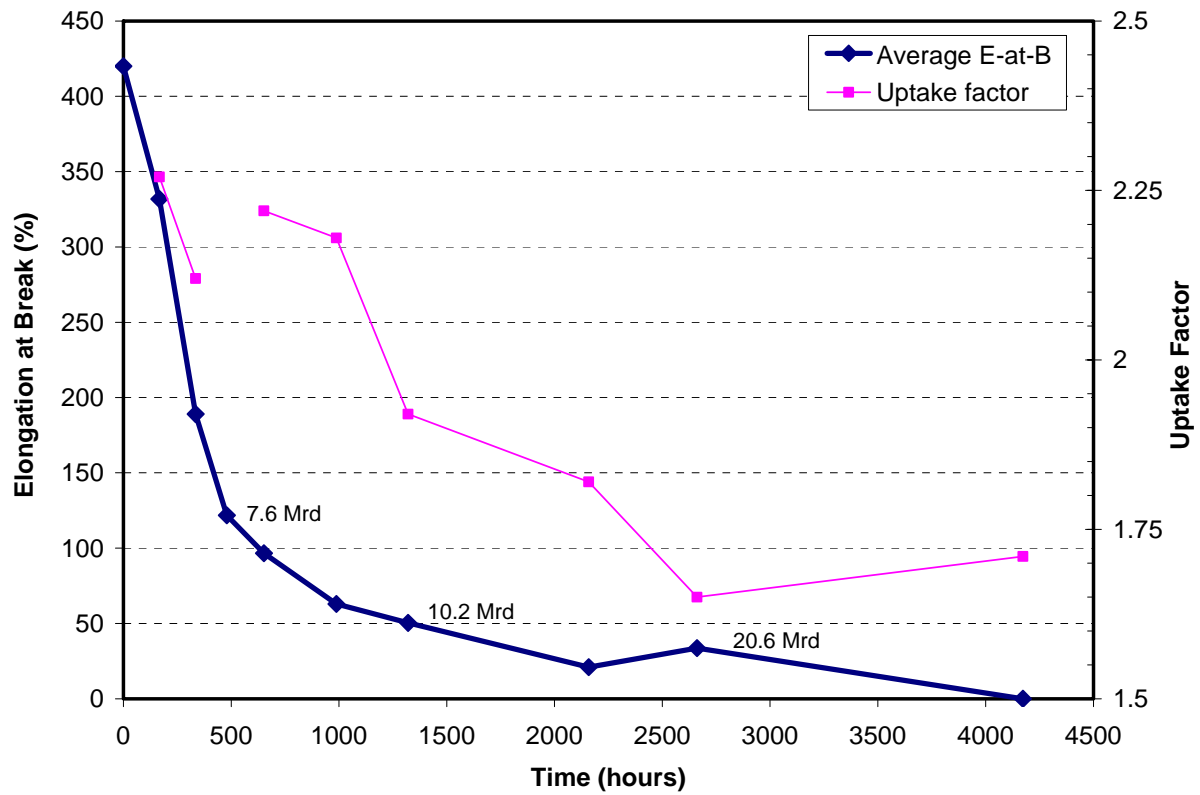
**Figure 7-71**  
**Rockbestos Silicone Rubber (FW II) E-at-B Versus Uptake Factor, 120°C, 7700 rd/hr Aging**

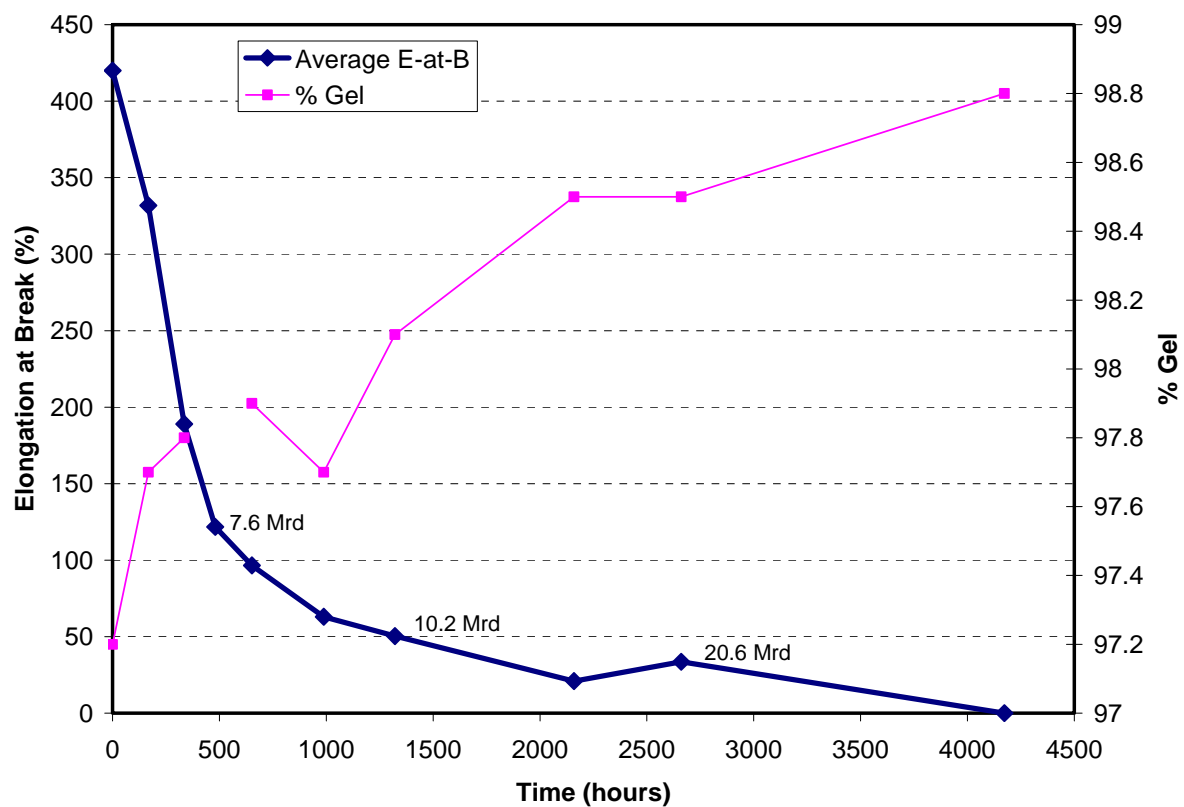
**Figure 7-72**  
**Rockbestos Silicone Rubber (FW II) E-at-B Versus % Gel, 120°C, 7700 rd/hr Aging**

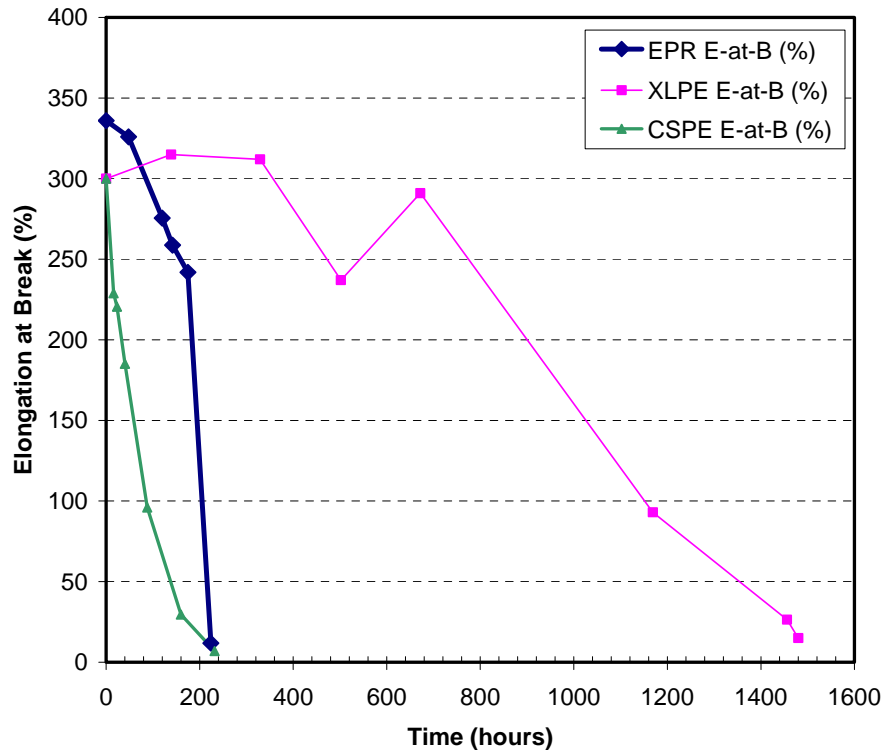
**Figure 8-1**  
**E-at-B Comparison of CSPE, EPR, and XLPE, 150°C Aging**

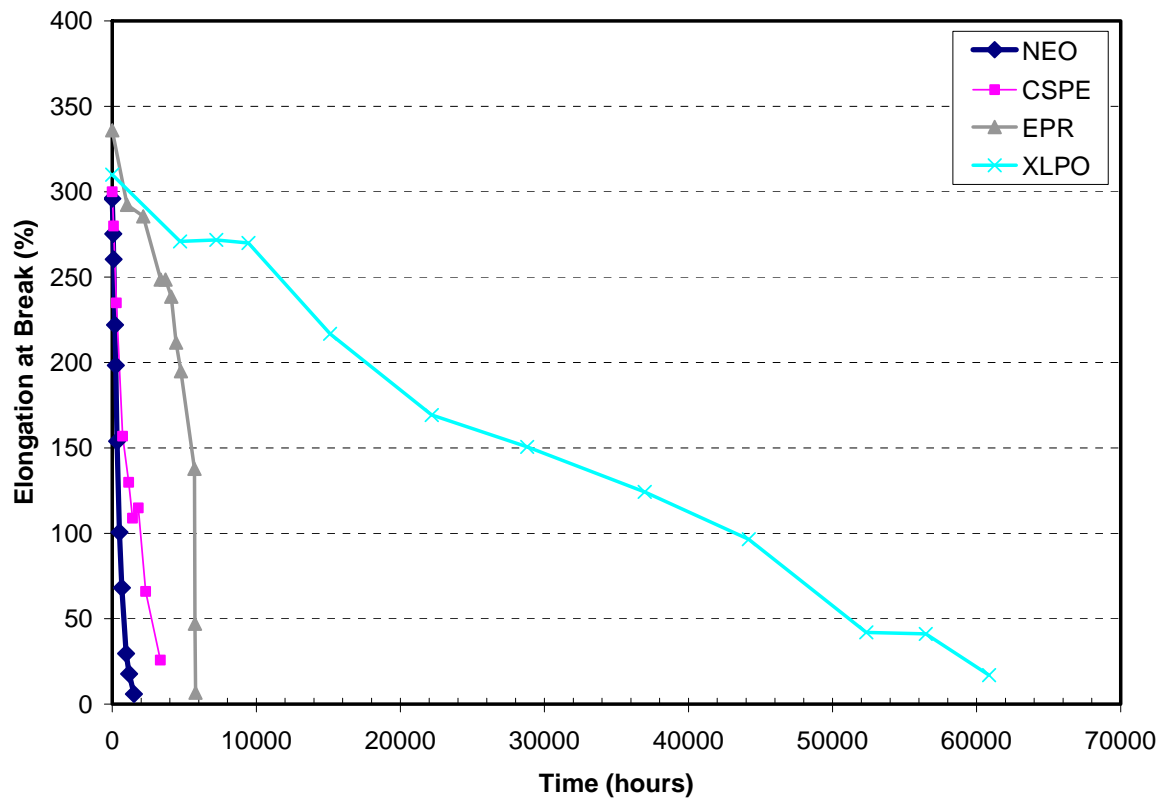
**Figure 8-2**  
Comparison of Neoprene, CSPE, EPR, and XLPE, 110°C Aging

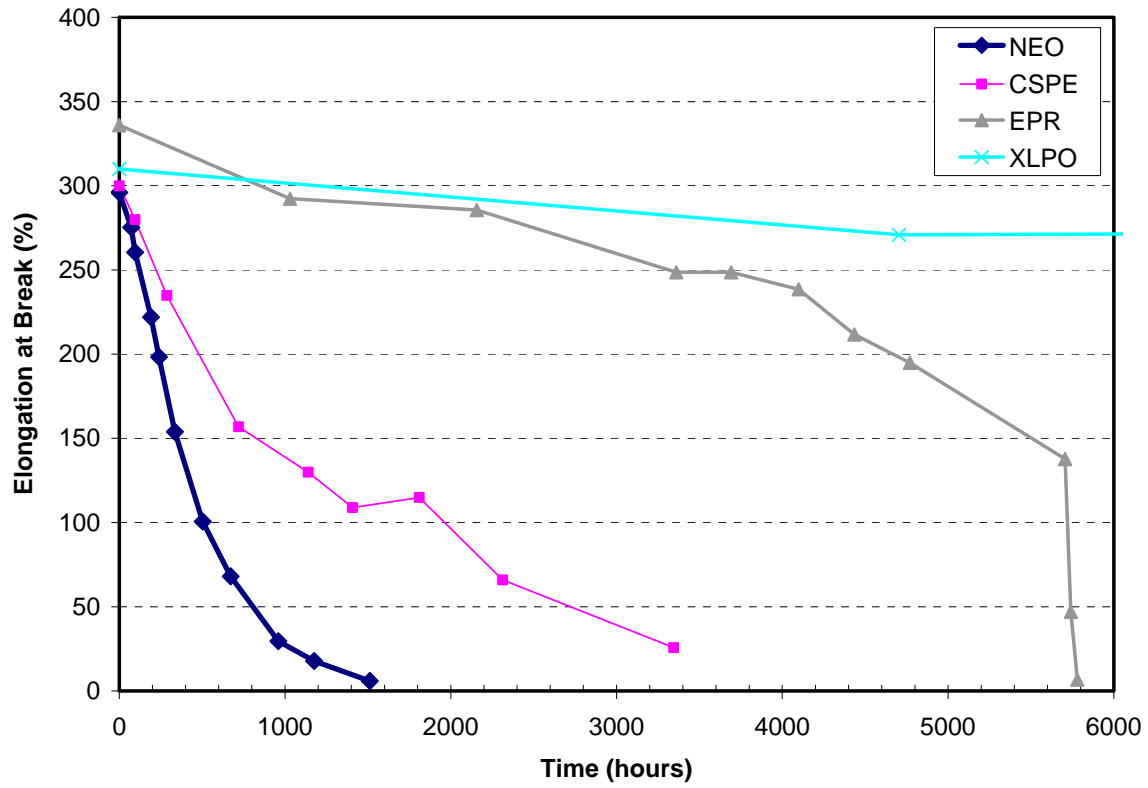
**Figure 8-3**  
**Comparison of Neoprene, CSPE, EPR, and XLPE to 6000 Hours at 110°C**

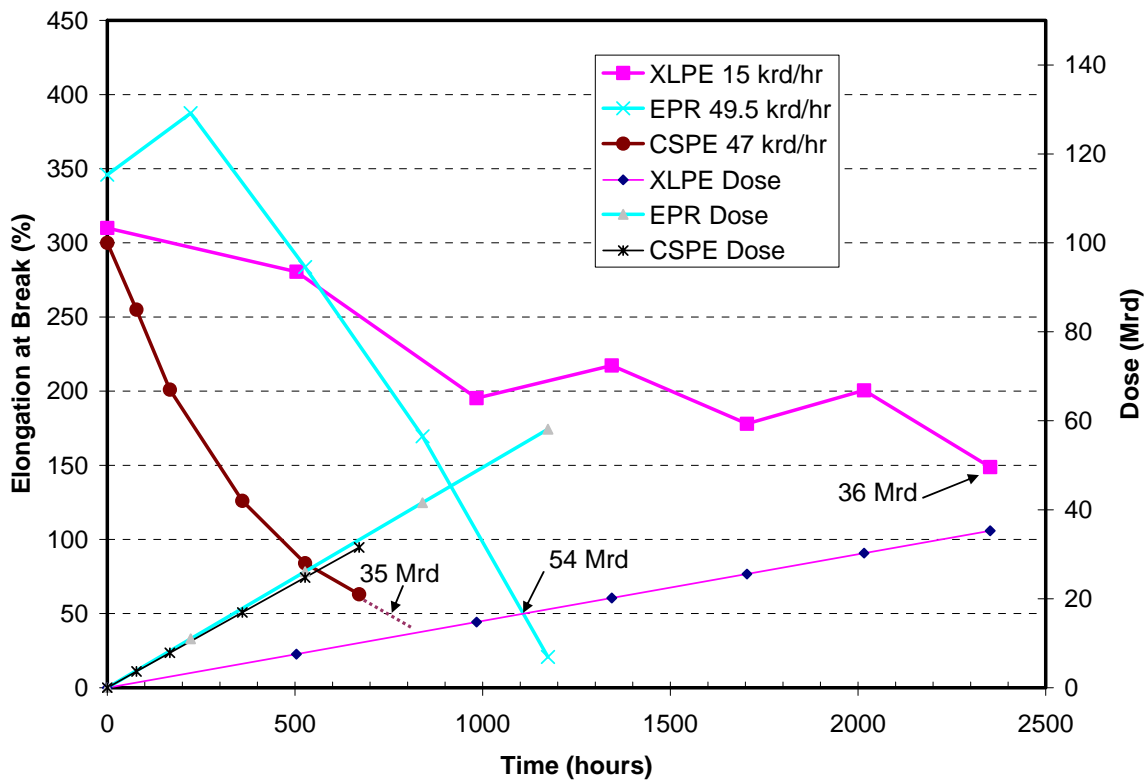
**Figure 8-4**  
Comparison of CSPE, EPR, and XLPE with Irradiation at 110°C
