# **Evaluation of Plant Data to Determine Effects of Zinc on Primary Water Stress Corrosion Cracking in Pressurized Water Reactors**

**1011775**

Final Report, December 2005

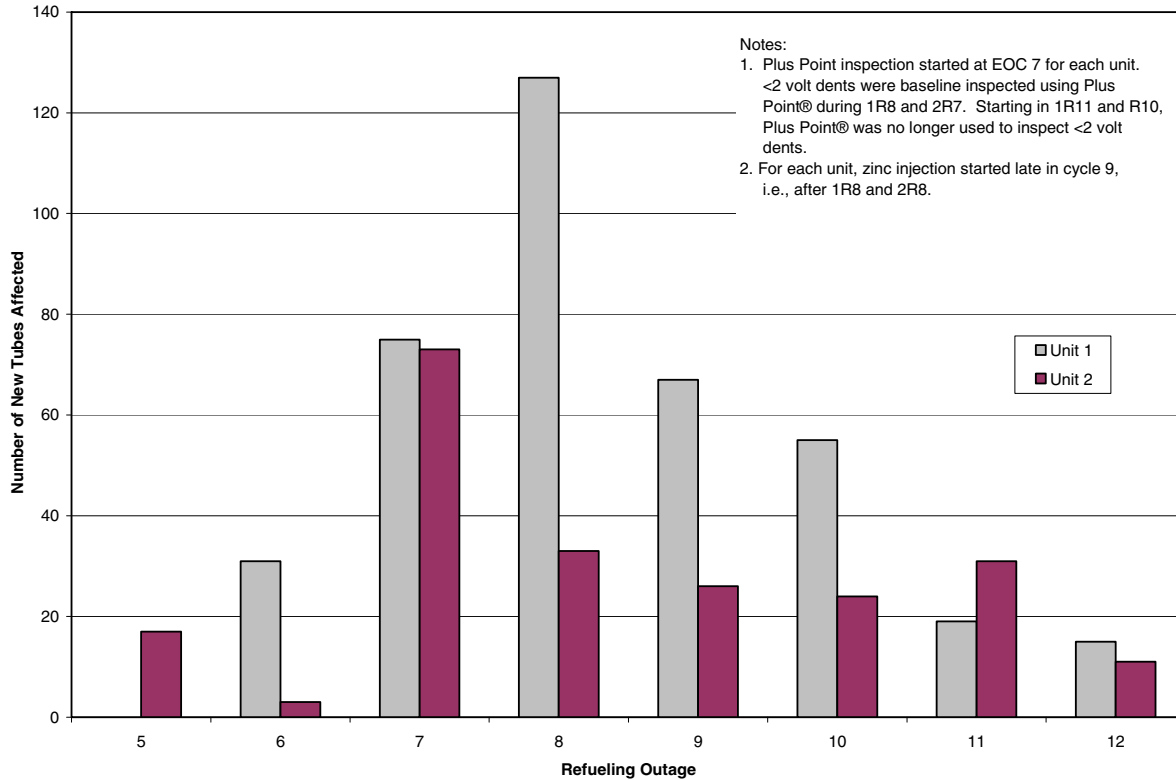
**Figure 2-1**  
Number of New Tubes Affected with TSP PWSCC per Outage at Diablo Canyon

As mentioned above, an ARC for TSP PWSCC is used at Diablo Canyon 2 as well as DCP2 1. The number of tubes affected for DCP2 2 is shown in Table 2–2. Figure 2–1 is a graphical representation of the data tabulated for TSP PWSCC. As can be seen in the graph, TSP PWSCC defects were first detected at Diablo Canyon 2 during EOC 5. The number of tubes affected at Unit 2 is less than at Unit 1, with less than 2% of the total tube population having a defect of this type as of EOC 12. As with Unit 1, the defects have been primarily axial in orientation. Note that the graph shows a decline in the incremental number of tubes affected starting in EOC

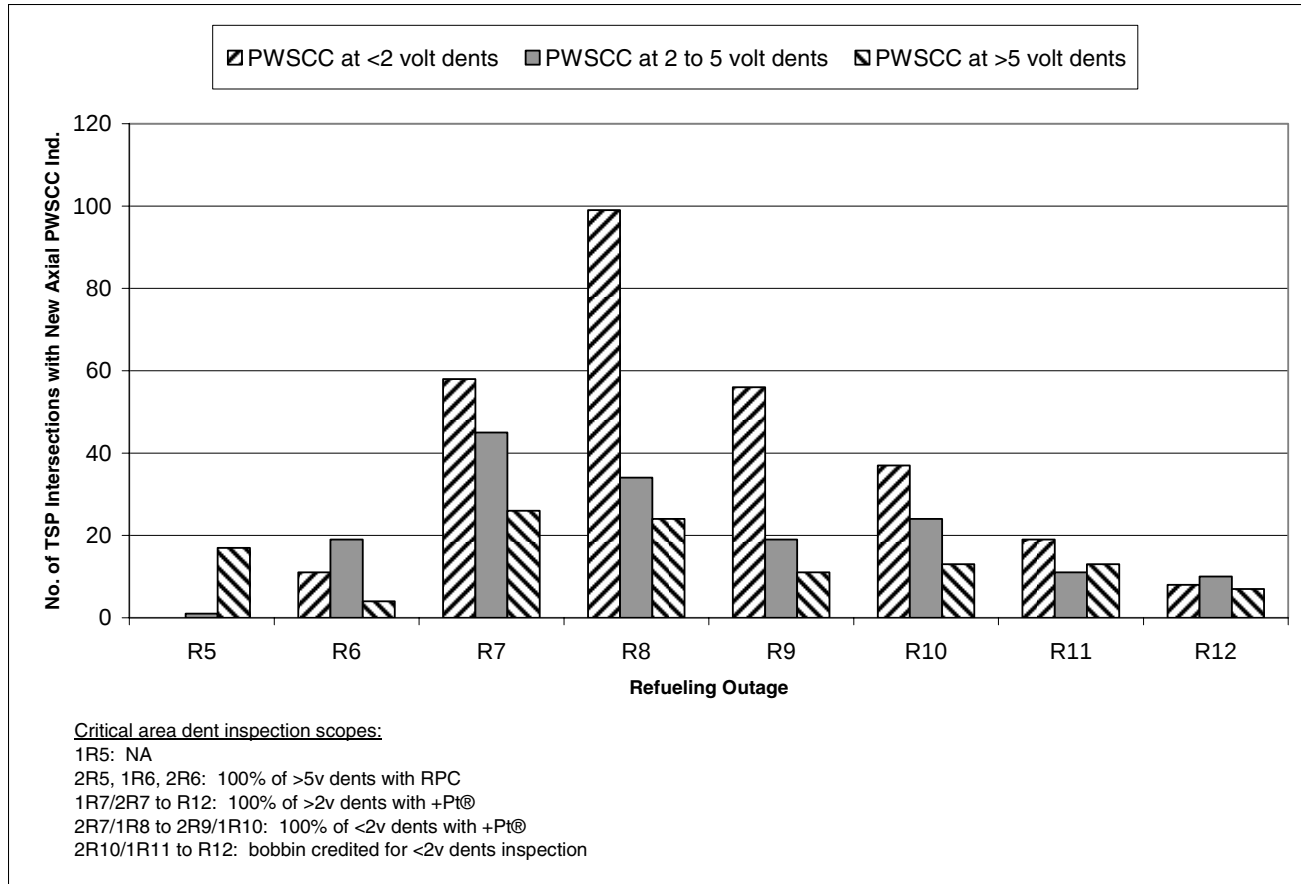
**Figure 2-2**

**Number of TSP Intersections Affected with New Axial PWSCC Indications per Outage at Diablo Canyon 1 and 2 (Combined Data)**

Because Diablo Canyon 1 began injecting zinc in 1998, two different failure rates (pre-zinc and post-zinc Weibull slopes) were determined. Three data points were available for the pre-zinc Weibull fit, i.e., EOC 6 through EOC 8. While the error in the Weibull fit to these three points is relatively small (6.6%), it must be noted that each of the three data points is the result of a different inspection methodology. DCP1 began performing partial inspections of the TSPs with Plus Point® probes at EOC 7. In addition, the dent inspection scope was increased at EOC 8, as described in Table 2-3; starting at EOC 8, <2 volt dents were baseline inspected using Plus Point® for the first time when it was discovered that the bobbin coil was detecting many PWSCC indications in <2 volt dents that were not originally planned for Plus Point® inspection. This led to a large number of new indications being detected in <2 volt dents (see Figure 2-2<sup>4</sup>).

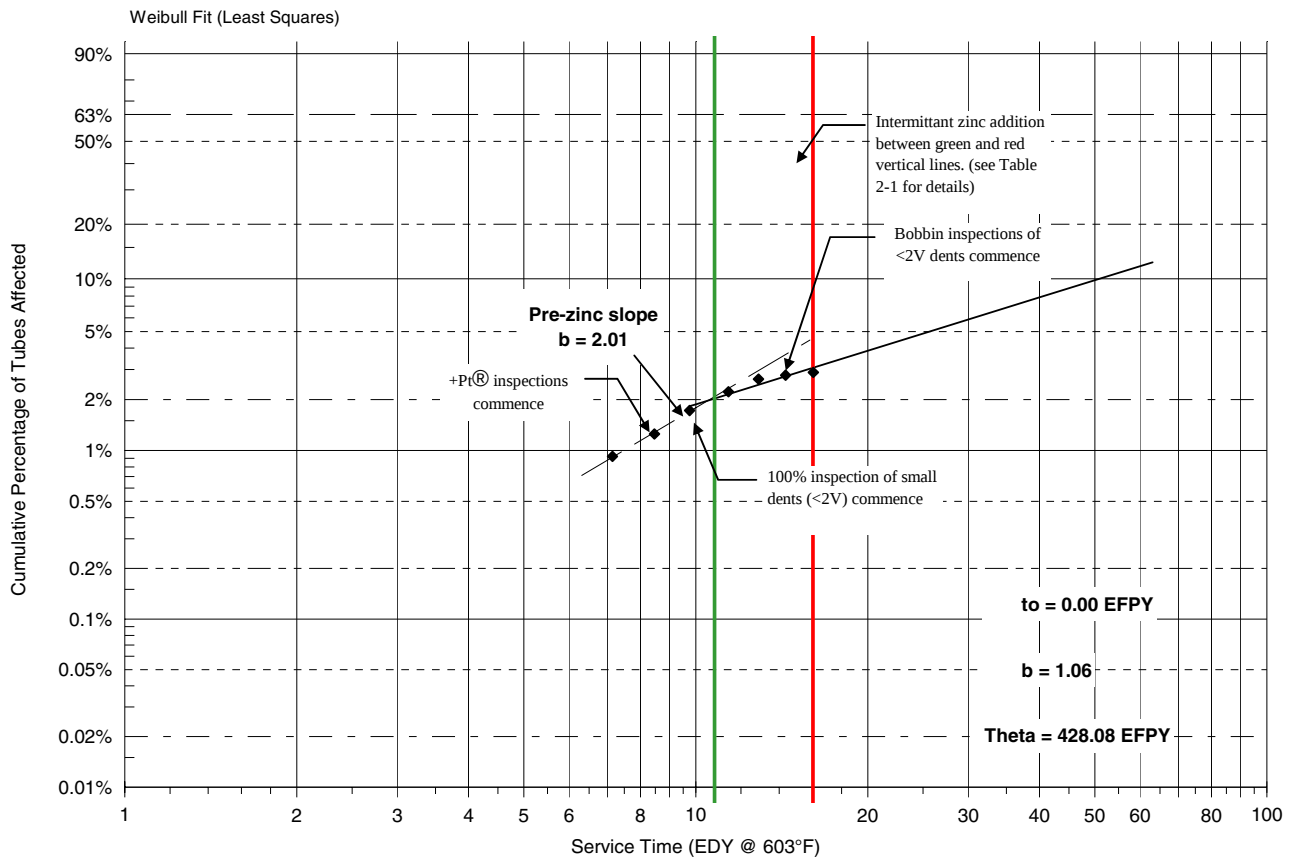
**Figure 2-3**  
**Diablo Canyon 1 – All SGs – TSP PWSCC (Axial and Circ.) – Tubes Affected**

points were from 100% combined bobbin/ Plus Point® inspections (Plus Point® was no longer used to inspect <2 volt dents, and bobbin coil was relied upon for detection of PWSCC based on the completion of the bobbin qualification program as part of the PWSCC ARC development). This change in inspection methodology has resulted in less Plus Point® inspections, but is judged not to have had a significant affect on the number of new PWSCC indications detected. The error in the Weibull fit using all five data points is relatively small (5.5%), so using all five data points for the post-zinc fit was judged to be acceptable. The Weibull slope parameter for the post-zinc fit is  $b = 1.06$ . Both the pre- and post-zinc fits are shown in Figure 2-3.

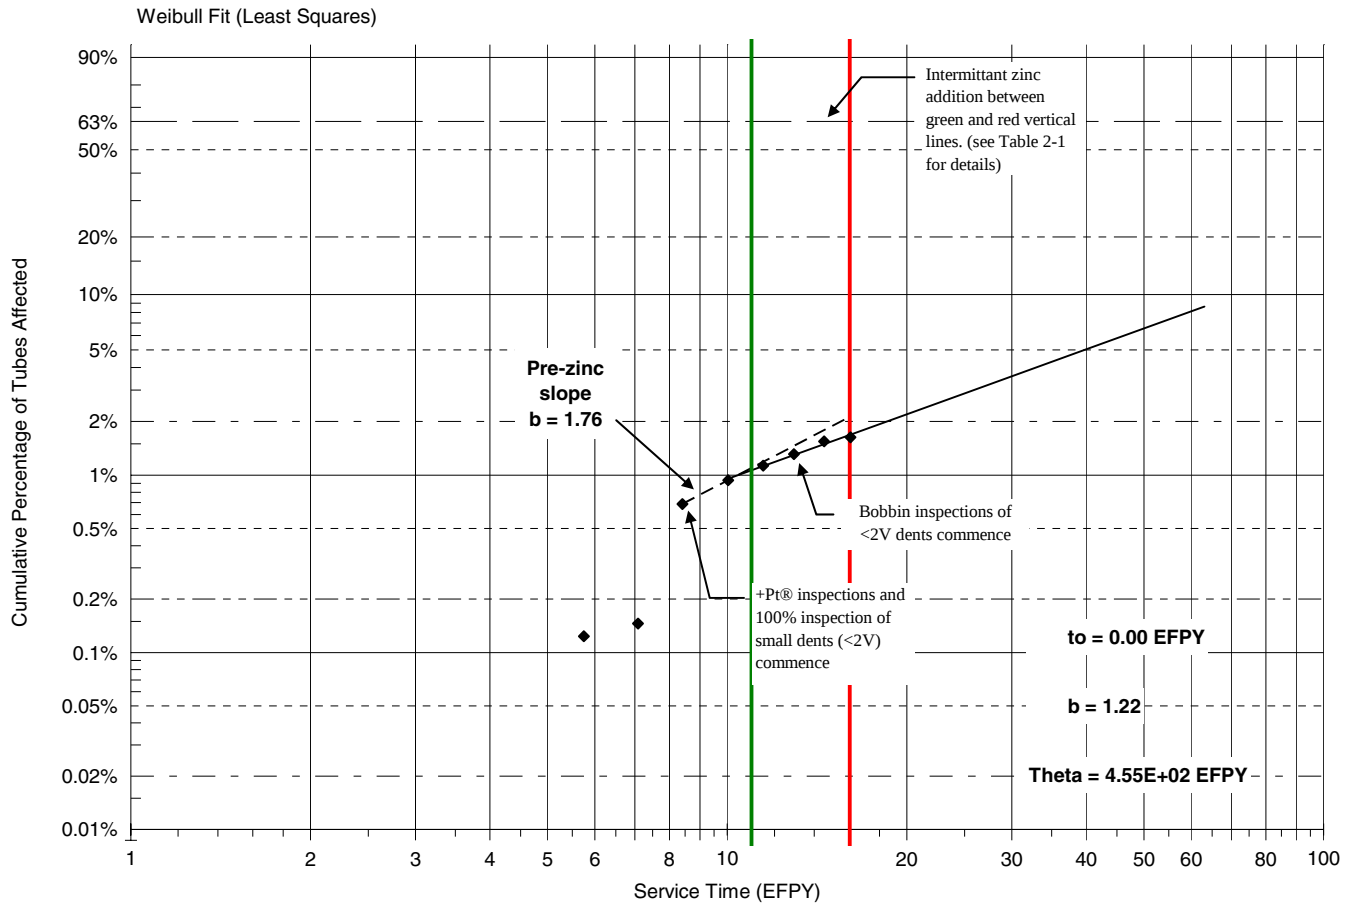
**Figure 2-4**  
**Diablo Canyon 2 – All SGs – TSP PWSCC (Axial and Circ.) – Tubes Affected**

Because Diablo Canyon 2 began injecting zinc in 1999, two different failure rates were determined. The pre-zinc failure slope was developed using data for the two inspections immediately prior to the addition of zinc, i.e., EOC 7 and EOC 8. Inspections for both outages were performed using similar techniques, i.e., 100% Plus Point® inspections (including <2V dents). Inclusion of the EOC 5 and EOC 6 data, which were collected prior to the use of the Plus Point® probe for inspecting dents at Diablo, would have increased the error in the Weibull fit to 31%. The Weibull slope parameter for the pre-zinc fit is  $b = 1.76$ . The post-zinc slope was developed using data for EOC 8 through EOC 12. The same inspection techniques were used during the EOC 8 and EOC 9 outages. The data from EOC 10 through EOC 12 are products of 100% combined bobbin/ Plus Point® inspections (bobbin probes were used to inspect <2V dents). As with DCP1, this change is judged not to have any transient affect on the number of new PWSCC indications detected. The error in the post-zinc Weibull fit is relatively small (2.4%), so using all five data points for the post-zinc fit was judged to be acceptable. The Weibull slope parameter for the post-zinc fit is  $b = 1.22$ . Both the pre- and post-zinc fits are shown in Figure 2-4.

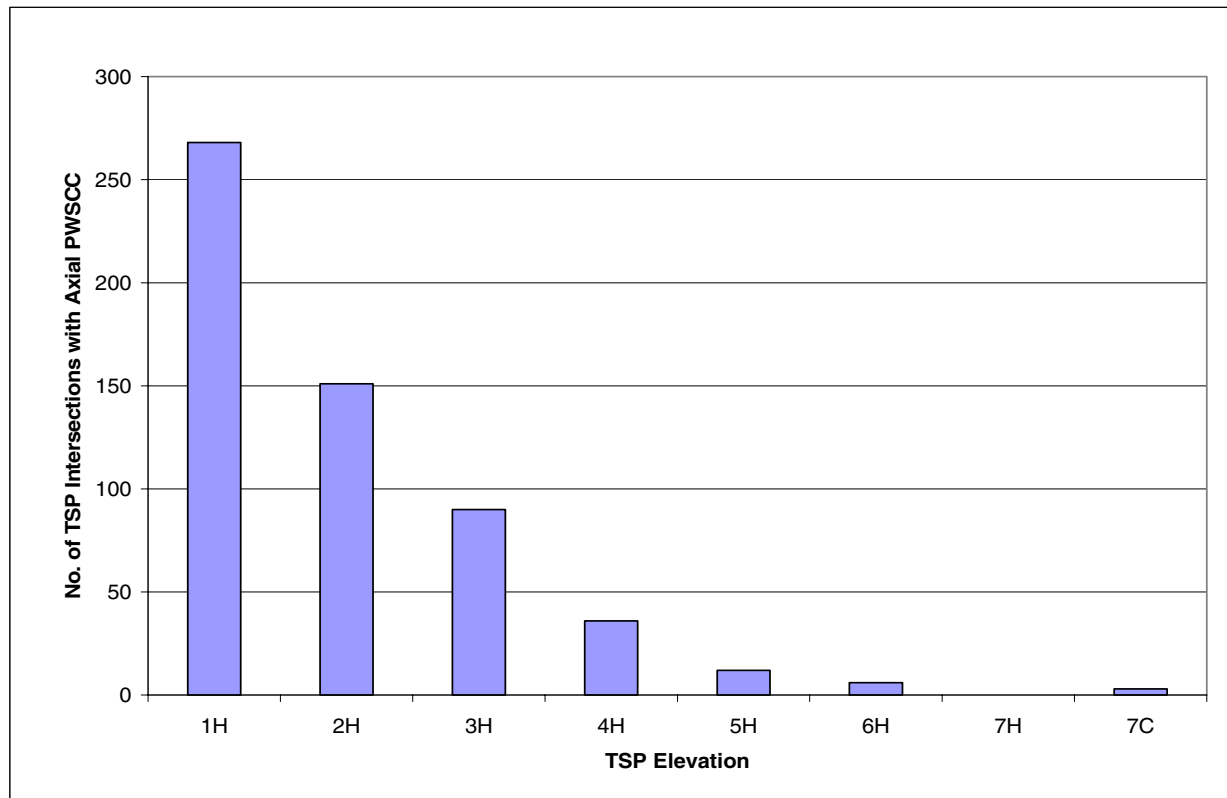
**Figure 2-5**  
**Number of TSP Intersections with Axial PWSCC Indications per Elevation at Diablo Canyon 1 and 2 (Combined Data)**

Note that Figure 2–5 was prepared as part of the review of the DCPD data. It shows the declining trend of axial PWSCC at DCPD 1 and DCPD 2 as the TSP elevation increases, reflecting the strong dependence of PWSCC on temperature. About 75% of PWSCC indications occur at the hot leg sides of the 1<sup>st</sup> TSP (1H) and 2<sup>nd</sup> TSP (2H), with 90% occurring up to the 3<sup>rd</sup> TSP (3H). These data support the EPRI Examination Guidelines [12] recommendation to perform Plus Point® inspections of dents up to the highest TSP elevation where PWSCC has been observed in the affected SG.

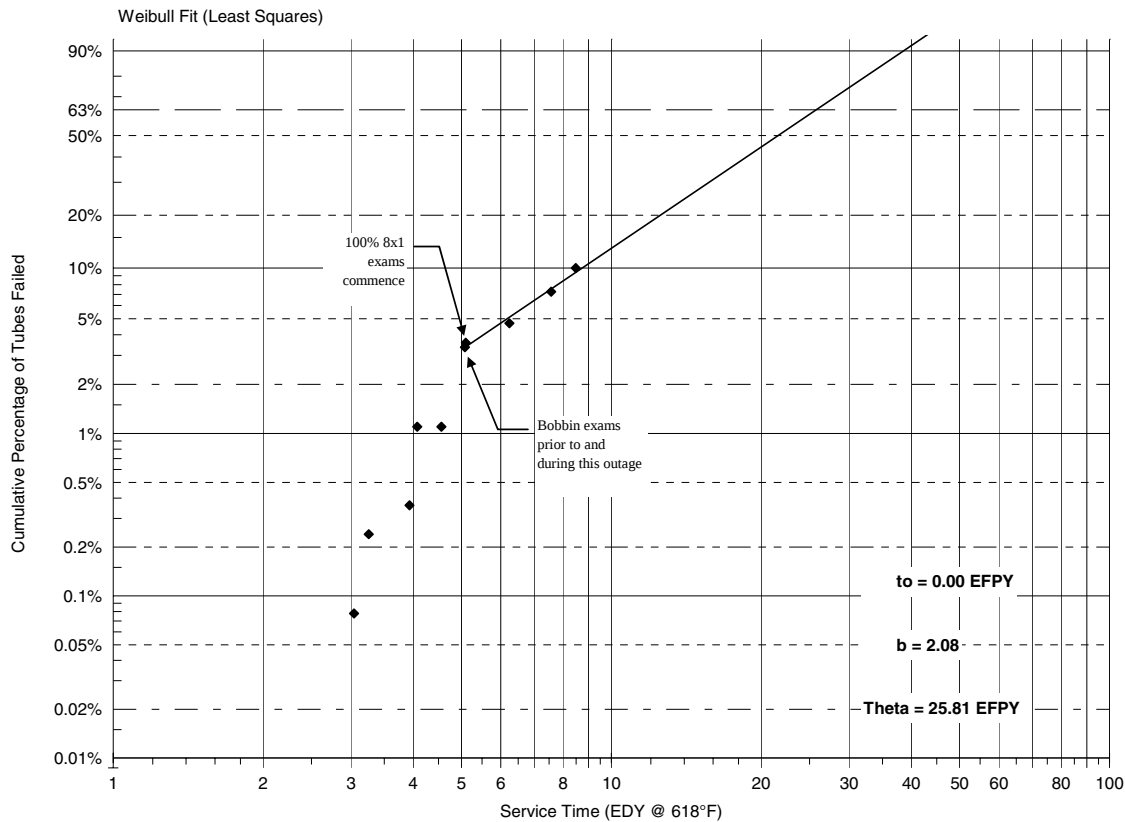
**Figure 2-6**  
North Anna 1 – All Orig. SGs – TSP PWSCC (Axial and Circ.) – Tubes Repaired

The failure rate for North Anna 1 was determined using the inspection data for EOC 6 through EOC 8, including the leaker outage during Cycle 7 and the midcycle outage following EOC 8. Despite a change in inspection technology after EOC 6 (from bobbin to 8x1<sup>7</sup> probes), the data from these five inspections were judged to be the most representative of the failure rate late in the life of the SGs, with a Weibull fit error of only 5.5%; inclusion of data prior to EOC 6 would have increased the error of the Weibull fit substantially. The Weibull slope parameter based on the five inspections is  $b = 2.08$ , as shown in Figure 2-6.

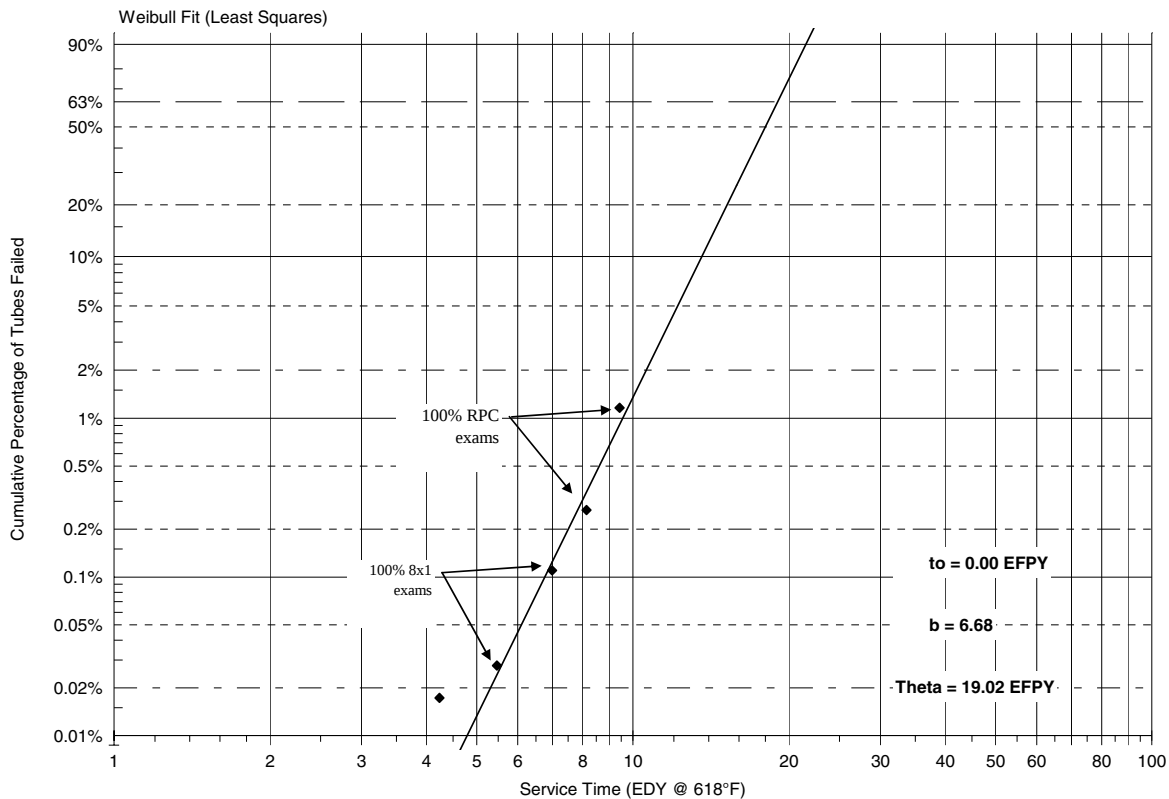
**Figure 2-7**  
**North Anna 2 – All Orig. SGs – TSP PWSCC (Axial and Circ.) – Tubes Repaired**

The failure rate for North Anna 2 was developed using the inspection data for the last four inspections prior to replacement (EOC 6 through EOC 9). The first two data points were the result of 100% 8x1 exams. The other two were the result of 100% rotating pancake coil (RPC) exams. All four data points were used in an attempt to generate a reasonable slope; the Weibull slope calculated using just the two RPC points is fairly high ( $b = 10.13$ ). Inclusion of the EOC 5 data point would have doubled the error of the Weibull fit, so that data point was excluded. The Weibull slope parameter based on these four inspections is  $b = 6.68$  (see Figure 2-7).

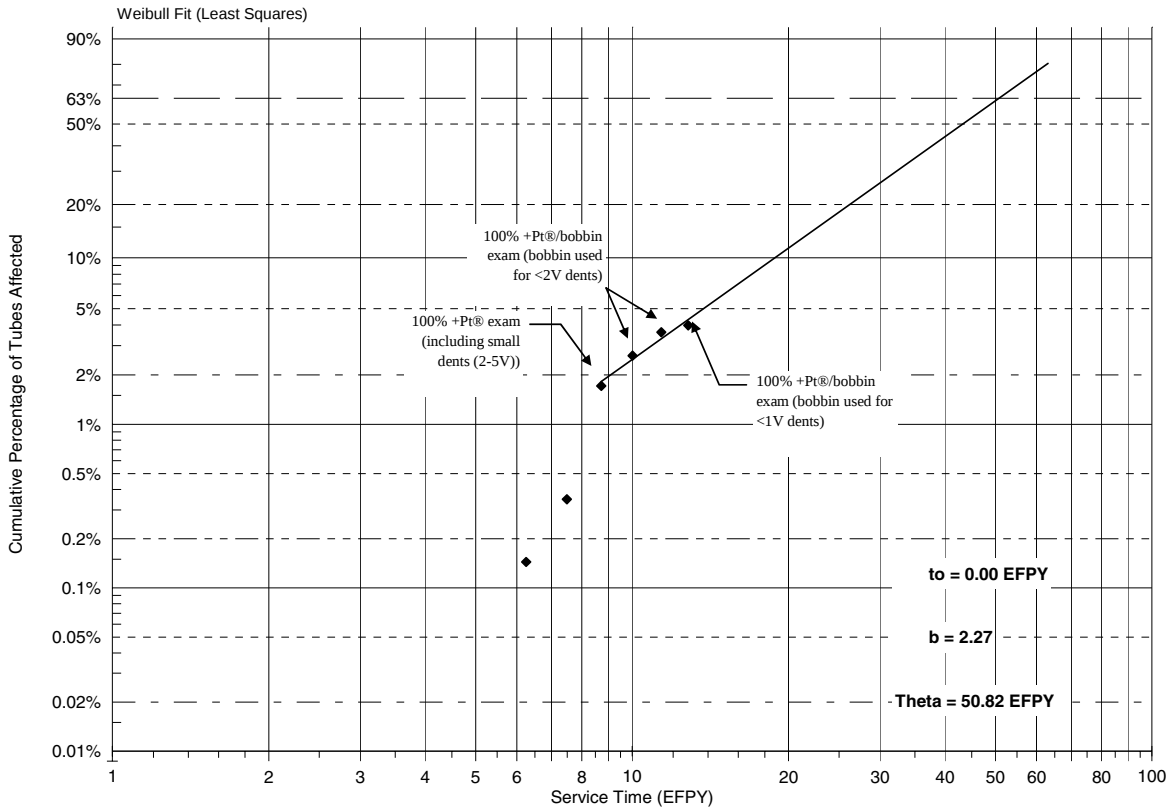
**Figure 2-8**  
**Sequoyah 1 – All Orig. SGs – TSP PWSCC (Axial and Circ.) – Tubes Affected**

The failure rate for Sequoyah 1 was developed using the inspection data for the last four inspections prior to the replacement outage (EOC 8 through EOC 11). Of the four inspections, only the middle two were performed using the same methodology, but the data from all four inspections were judged to be the most representative of the failure rate late in the life of the SGs, with a Weibull fit error of 7.2%. Data prior to EOC 8 were excluded from the Weibull fit because their inclusion would have resulted in a large increase in the Weibull fit error. The Weibull slope parameter based on these inspections is  $b = 2.27$ , as shown in Figure 2–8.

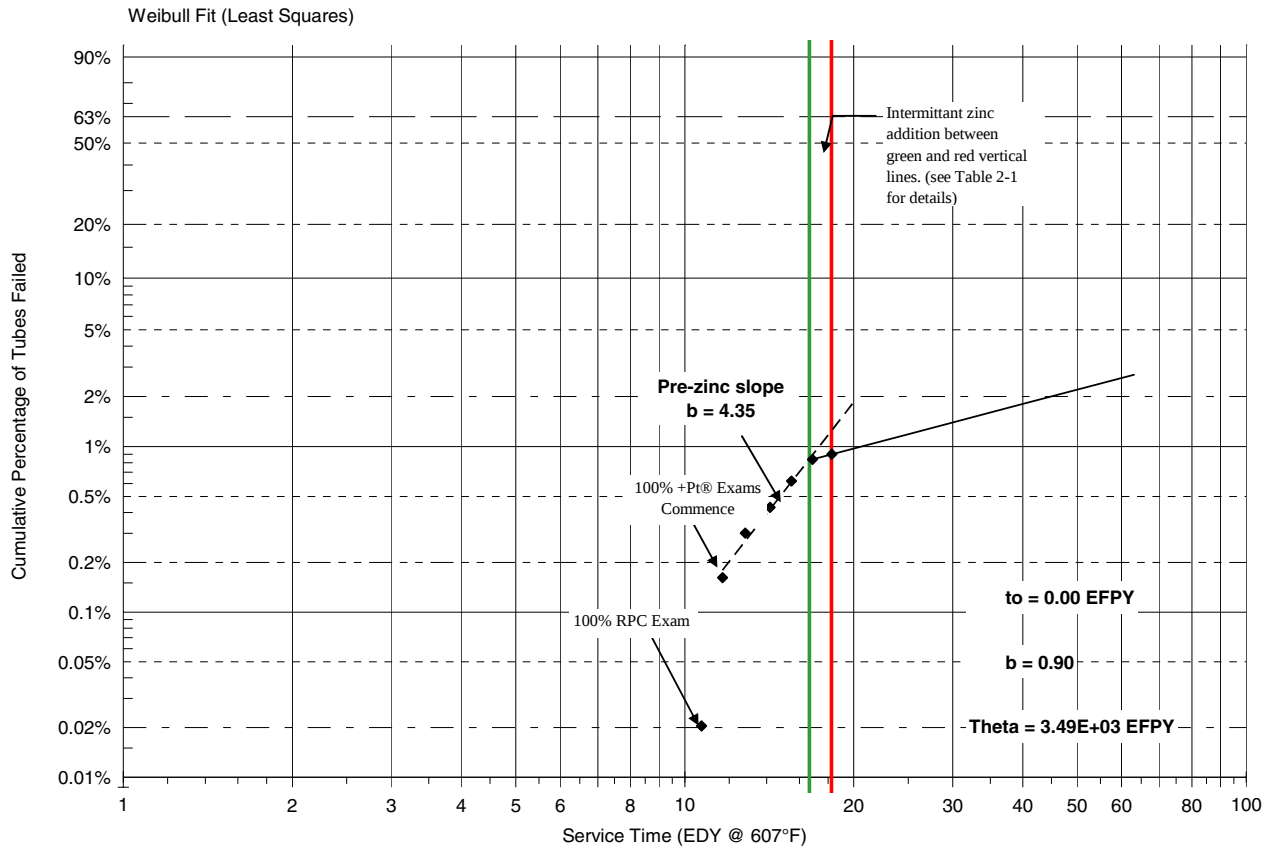
**Figure 2-9**  
**Beaver Valley 1 – All SGs – WEXTEx PWSCC (Axial and Circ.) – Tubes Repaired**

inspections were both 100% Plus Point® inspections. The Weibull slope parameter for the post-zinc fit is  $b = 0.90$ . Both the pre- and post-zinc fits are shown in Figure 2–9. Note that the number of post-zinc data points is limited to one full cycle of zinc injection, so the Beaver Valley 1 reduction factor based on this analysis is not entirely beyond question and would significantly benefit from additional data as they are available.

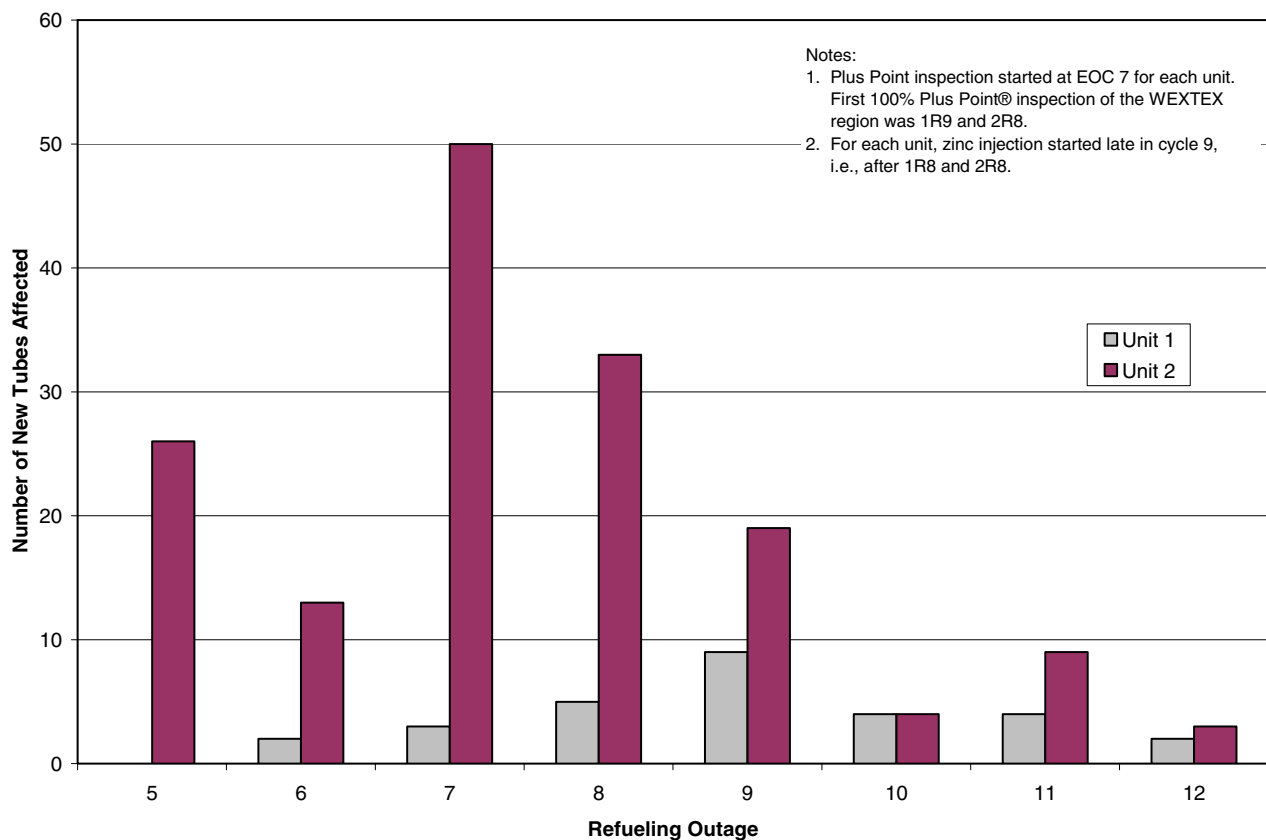
**Figure 2-10**  
Number of New Tubes Affected with TS PWSCC per Outage at Diablo Canyon

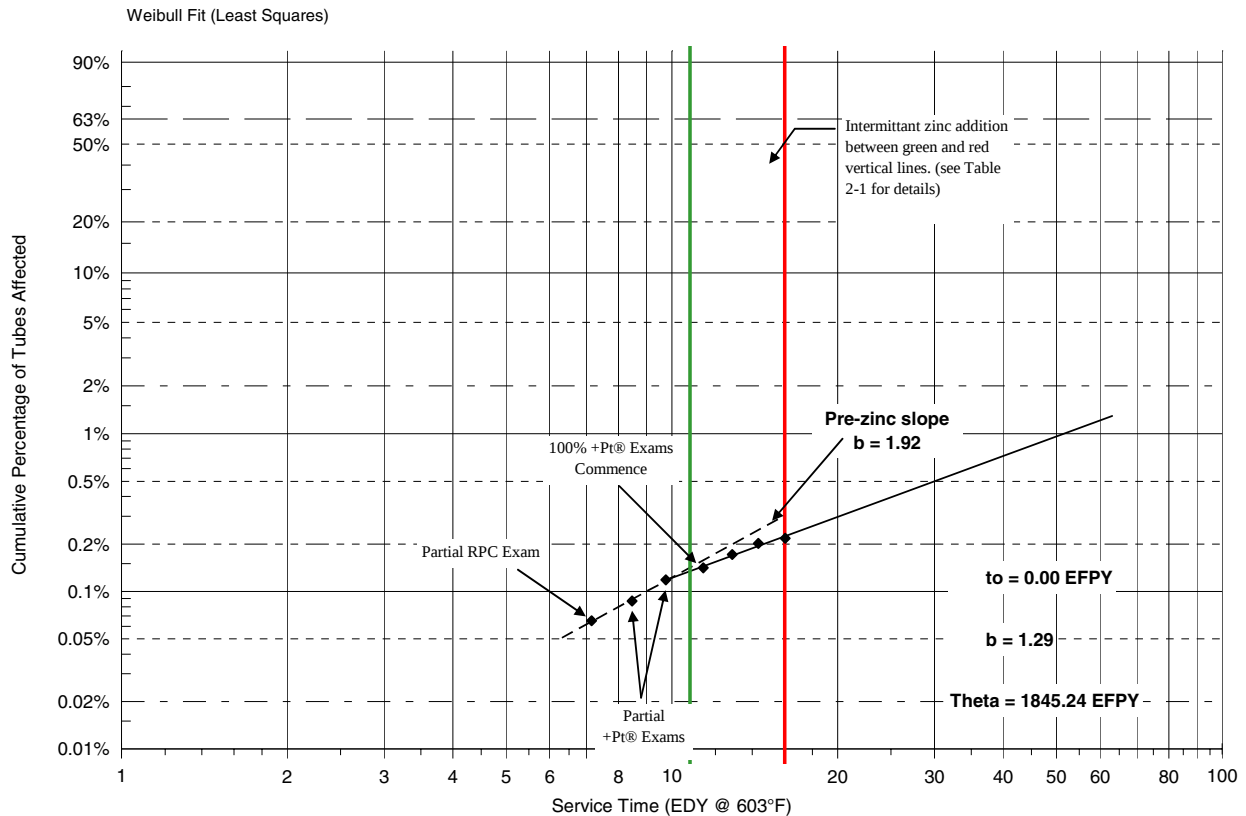
**Figure 2-11**  
**Diablo Canyon 1 – All SGs – WEXTX PWSCC (Axial and Circ.) – Tubes Affected**

fit is  $b = 1.92$ . The post-zinc slope was developed using data for EOC 8 through EOC 12. With the exception of the EOC 8 exam, all inspections were 100% Plus Point® exams. The Weibull slope parameter for the post-zinc fit is  $b = 1.29$ . Both the pre- and post-zinc fits are shown in Figure 2–11.

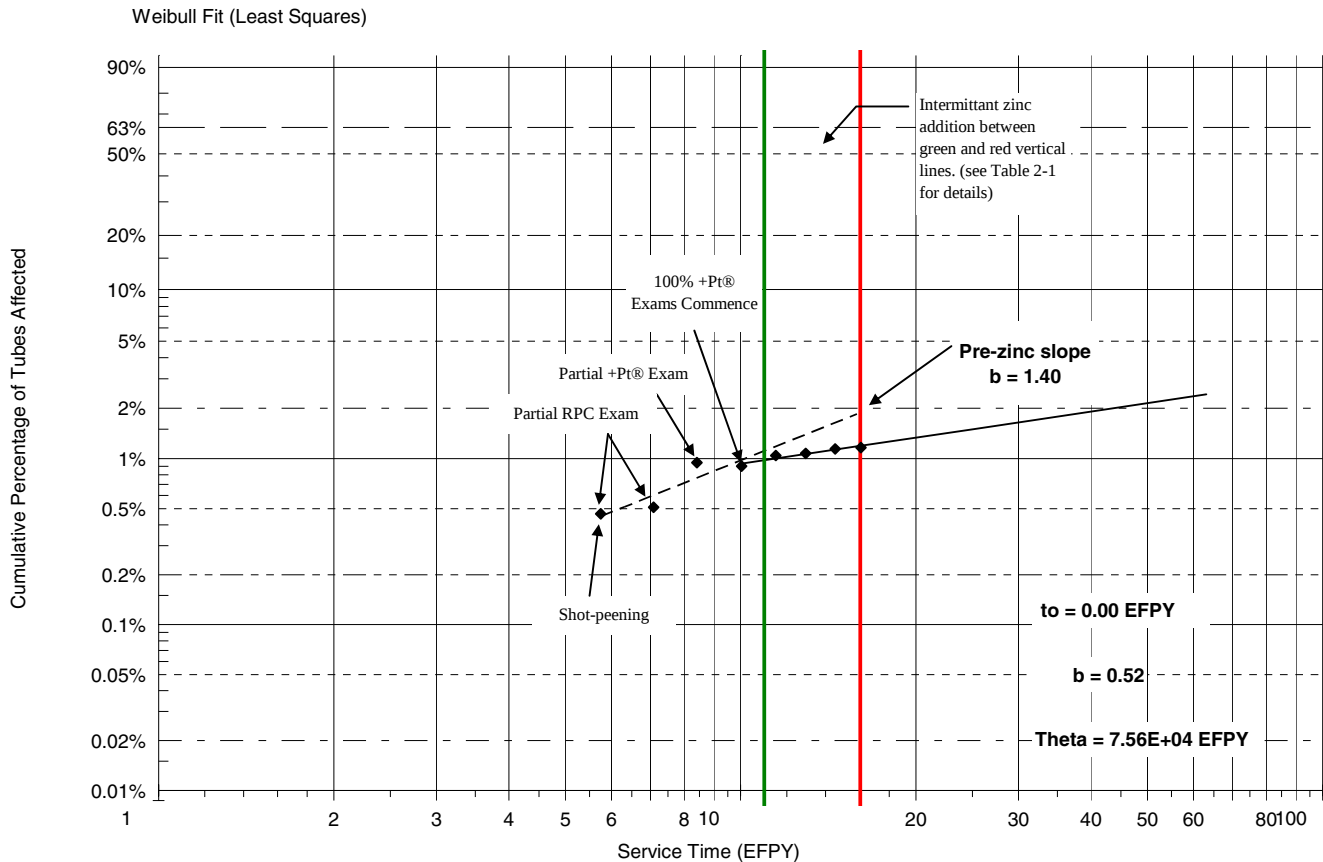
**Figure 2-12****Diablo Canyon 2 – All SGs – WEXTEx PWSCC (Axial and Circ.) – Tubes Affected**

Because Diablo Canyon 2 began injecting zinc in 1999, two different failure rates were determined. The pre-zinc failure slope was developed using data for the four inspections prior to the addition of zinc, i.e., EOC 5 through EOC 8. The three earliest data points represent partial exams, the first two by RPC and the last one by Plus Point®; the fraction of tubes inspected was considered as part of the analysis, and the estimated cumulative number of tube failures was adjusted accordingly. The Weibull slope parameter for the pre-zinc fit is  $b = 1.40$ . The post-zinc slope was developed using data for EOC 8 through EOC 12. All five inspections were 100% Plus Point® exams. The Weibull slope parameter for the post-zinc fit is  $b = 0.52$ . Both the pre- and post-zinc fits are shown in Figure 2–12. Note that the pre-zinc slope includes data from the cycle prior to peening as a way of capturing the rate change immediately after peening. All other data used for fits were post-peening.

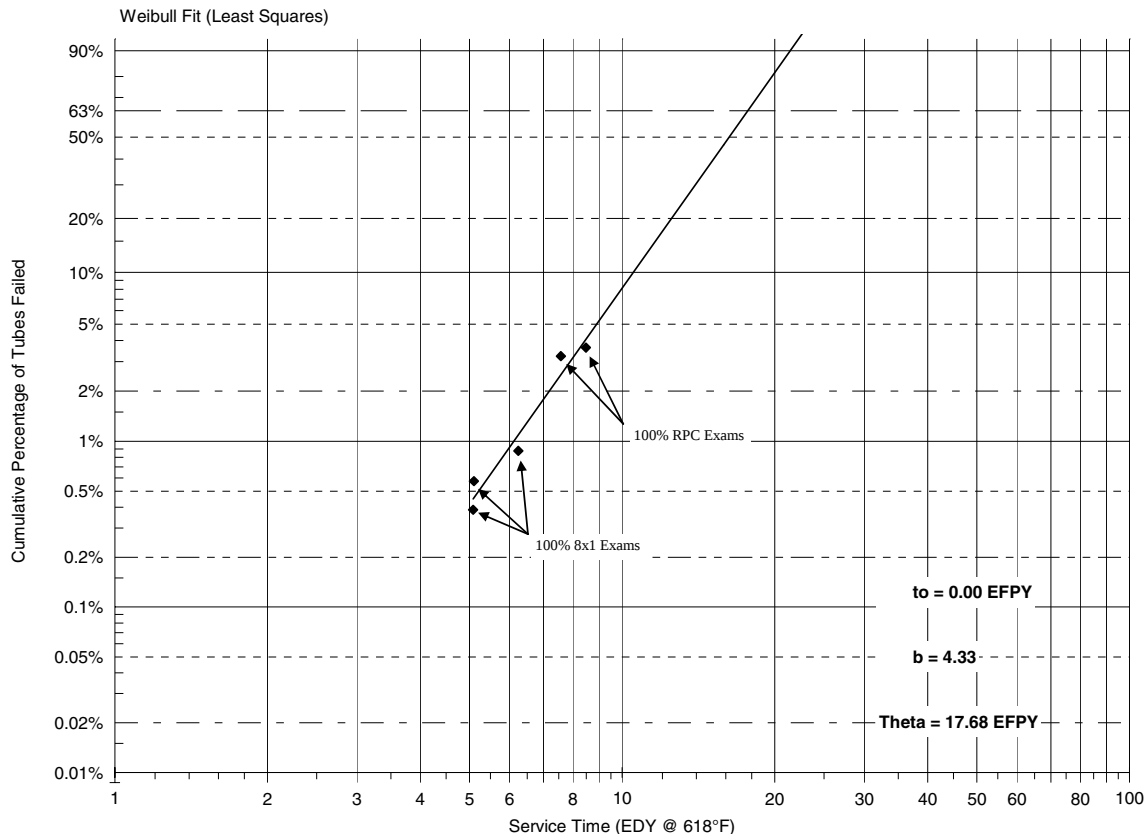
**Figure 2-14**  
North Anna 1 – All Orig. SGs – WEXTEx PWSCC (Axial and Circ.) – Tubes Repaired

The failure rate for North Anna 1 was determined using the inspection data for EOC 6 through EOC 8, including the leaker outage during Cycle 7 and the midcycle outage following EOC 8. The first three inspections were 100% 8x1 exams, and the later two were 100% RPC exams. The extra scatter introduced by using the data from both inspection technologies is considered to be acceptable. The Weibull slope parameter based on the five inspections is  $b = 4.33$ , as shown in Figure 2-14.

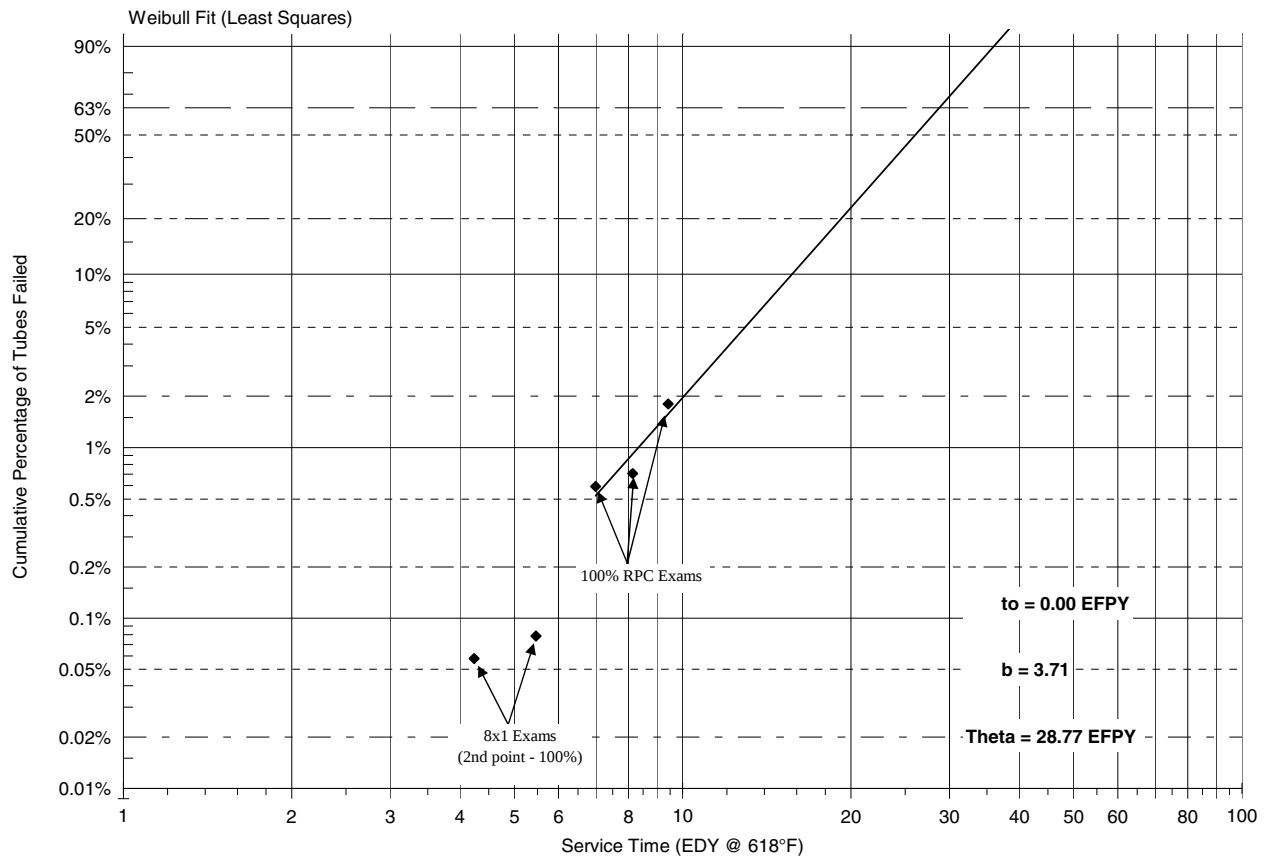
**Figure 2-15**  
North Anna 2 – All Orig. SGs – WEXTEx PWSCC (Axial and Circ.) – Tubes Repaired

The failure rate for North Anna 2 was developed using the inspection data for the last three inspections prior to replacement (EOC 7 through EOC 9). Inclusion of data prior to EOC 7 would have doubled the Weibull fit error. Therefore, only the three 100% RPC inspections were included, and the two inspections using the 8x1 probe were excluded. The Weibull slope parameter based on these three inspections is  $b = 3.71$  (see Figure 2-15).

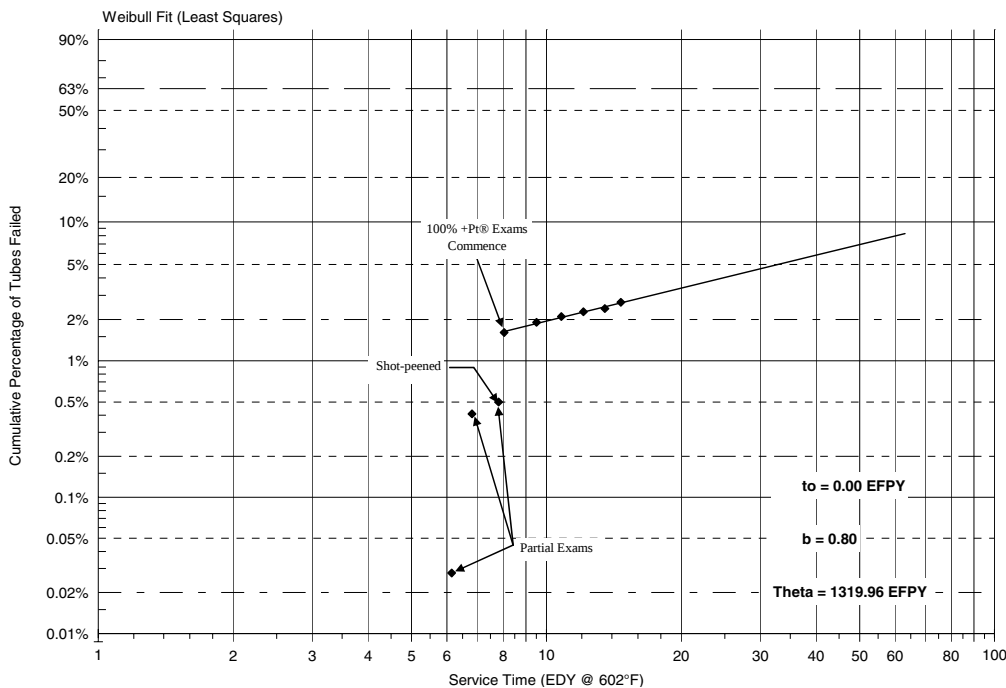
**Figure 2-16**  
**Salem 2 – All SGs – WEXTEx PWSCC (Axial and Circ.) – Tubes Repaired**

The failure rate for Salem 2 was determined using the inspection data for the last six outages, i.e., EOC 9 through EOC 14, all 100% Plus Point® inspections. Inclusion of the three RPC inspections would have increased the error in the Weibull fit substantially (>30%). The Weibull fit to the last six data points is considered to be excellent, with an error of 1.8%. The Weibull slope parameter based on these inspections is  $b = 0.80$ , as shown in Figure 2–16. All the data used for the fit were post-peening.

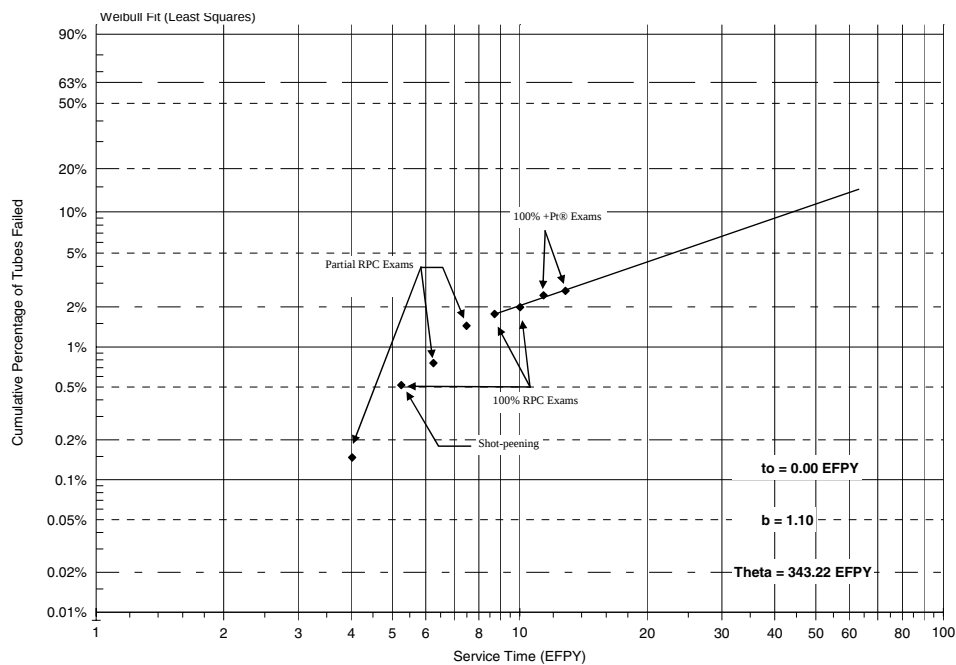
**Figure 2-17**  
**Sequoyah 1 – All Orig. SGs – WEXTEx PWSCC (Axial and Circ.) – Tubes Repaired**

The failure rate for Sequoyah 1 was developed using the inspection data for the last four inspections prior to the replacement outage (EOC 8 through EOC 11). The EOC 8 and EOC 9 exams were 100% RPC exams, and the EOC 10 and EOC 11 exams were 100% Plus Point® exams. No obvious inspection transient is apparent, and the Weibull fit to the four data points has an error of only 2.6%. Three of the four earliest inspections were excluded since they were partial inspections and would have increased the uncertainty in the fit. The EOC 5 data point represents a 100% RPC inspection, but it was also the outage during which shot peening was performed; it was excluded in order to maintain a small Weibull fit error. The Weibull slope parameter based on the last four inspections is  $b = 1.10$ , as shown in Figure 2–17. All the data used for the fit were post-peening.

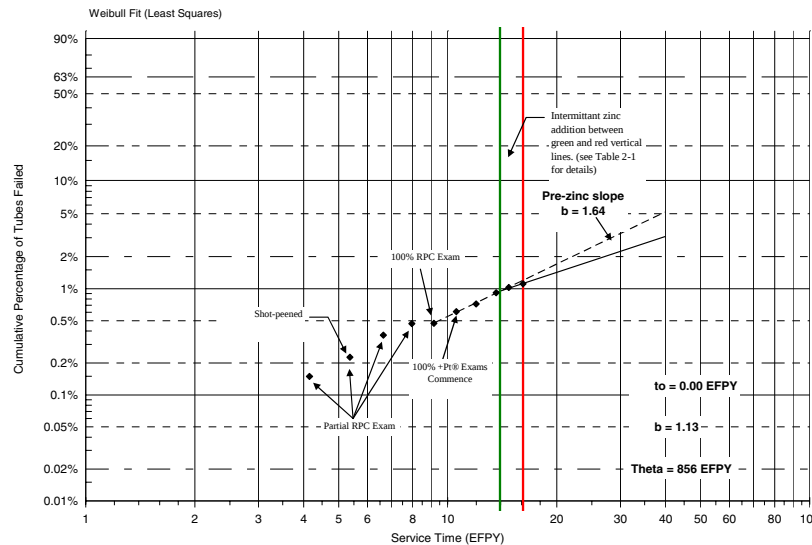
**Figure 2-18**  
**Sequoyah 2 – All SGs – WEXTEx PWSCC (Axial and Circ.) – Tubes Repaired**

Because Sequoyah 2 began injecting zinc in the fall of 2002, two different failure rates were determined. The pre-zinc failure slope was developed using data for the four inspections prior to the addition of zinc, i.e., EOC 8 through EOC 11. EOC 8 was a 100% RPC exam, whereas the other three were 100% Plus Point® exams. Despite the change in inspection probes, the pre-zinc Weibull fit is considered to be excellent, with an error of 2.4%. The four earliest inspections were excluded because they were partial inspections and, even though the fraction of tubes inspected is accounted for as part of the analysis, would have increased the uncertainty in the fit. The Weibull slope parameter for the pre-zinc fit is  $b = 1.64$ . The post-zinc slope was developed using data for EOC 11 through EOC 13. All three inspections were 100% Plus Point® exams. The Weibull slope parameter for the post-zinc fit is  $b = 1.13$ . Both fits are shown in Figure 2–18. All the data used for the fits were post-peening.

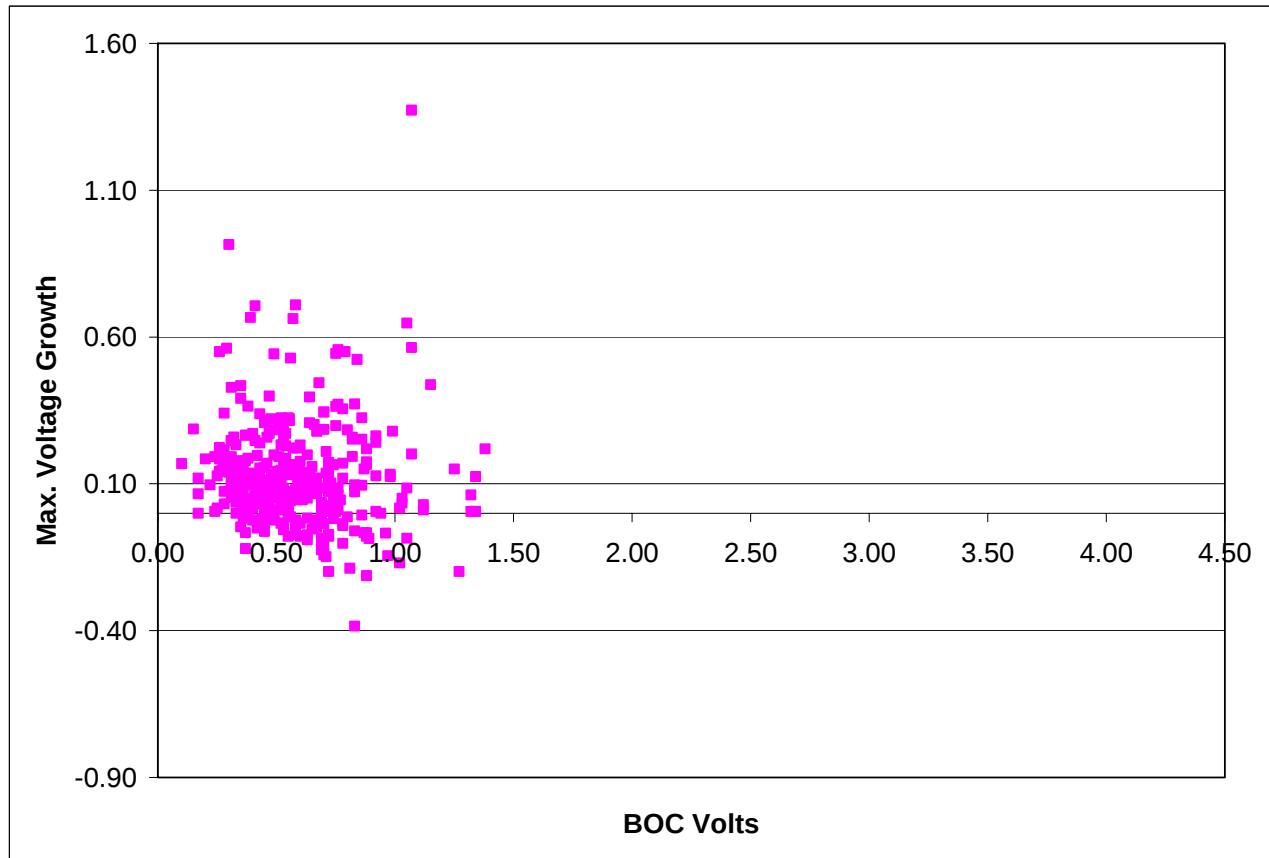
**Figure 3-1**  
**BOC Volts vs. Max Voltage Growth at 603°F – No Zinc (DCPD + SQN 1)**

For the no zinc and post zinc datasets, scatter plots of the voltage growth as a function of the beginning-of-cycle (BOC) volts were prepared to determine the relationship between the two variables. The results, as shown in Figure 3–1 and Figure 3–2, indicate that the voltage growth is not dependent on the BOC volts. Because TSP PWSCC voltage dependent growth is not apparent, it was considered reasonable to examine and compare the cumulative probability distributions (CPDs) of the voltage growth rates for the no zinc and post-zinc period. These are shown in Figure 3–3.

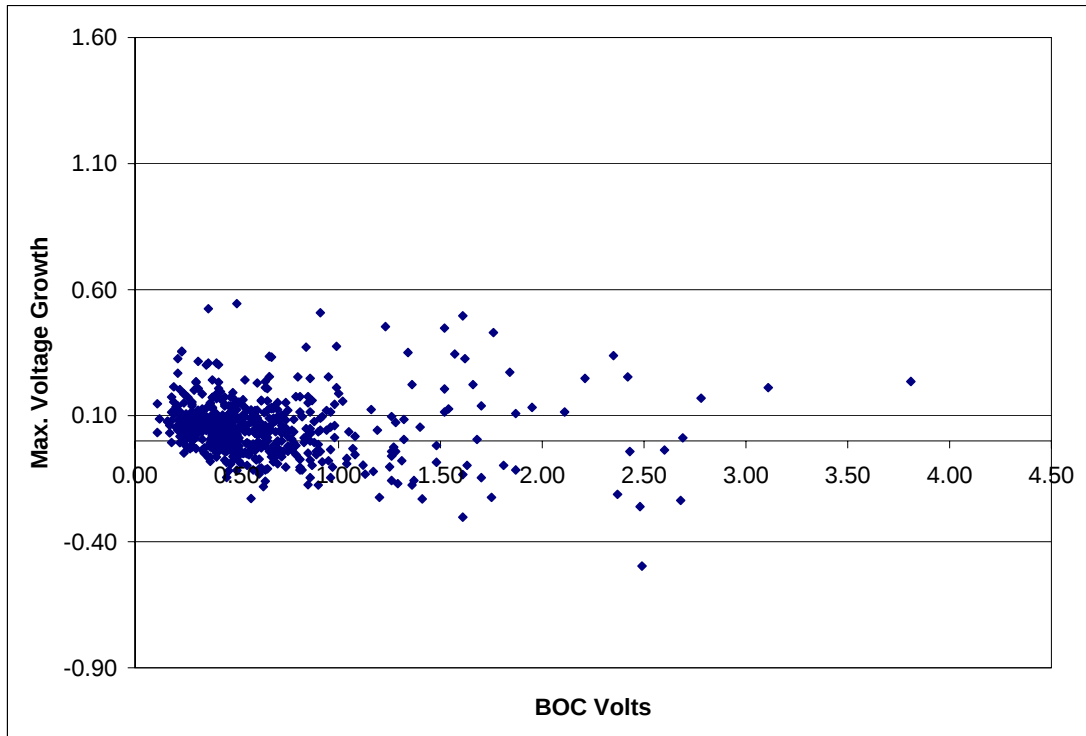
**Figure 3-2**  
**BOC Volts vs. Max Voltage Growth at 603°F – Post-Zinc (DCPP)**
