# **Evaluation of Plant Data to Determine Effects of Zinc on Primary Water Stress Corrosion Cracking in Pressurized Water Reactors**

**1011775**

Final Report, December 2005

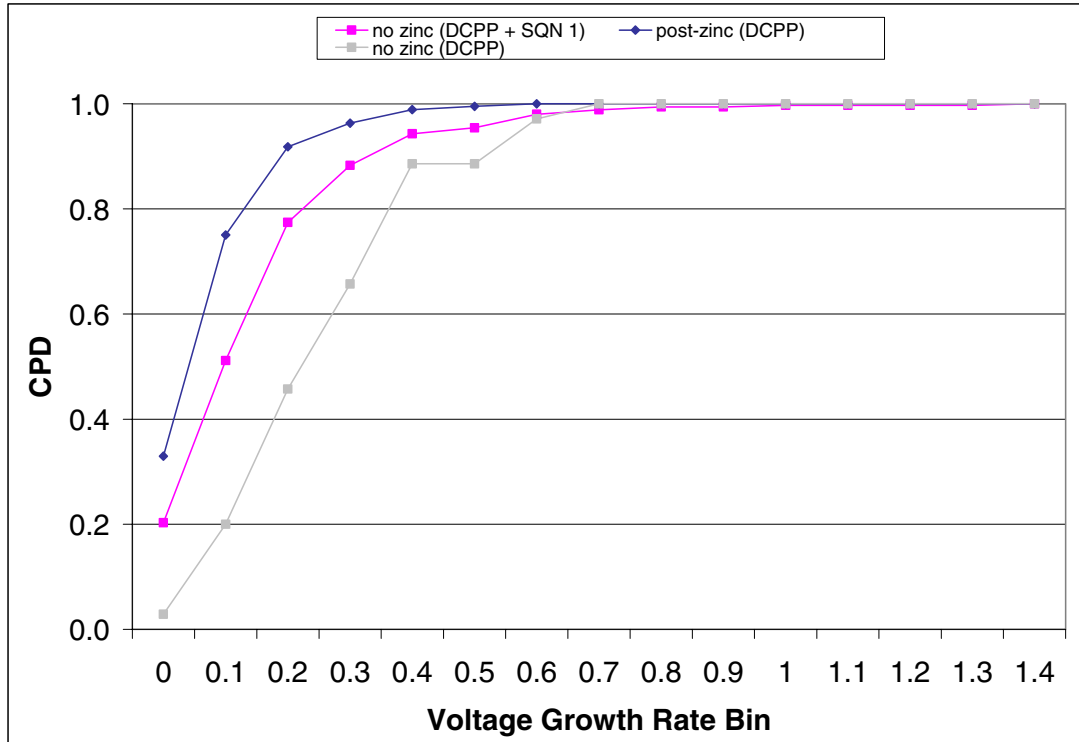
**Figure 3-3**  
TSP PWSCC Maximum Voltage Growth at 603°F

For the no zinc and post zinc datasets, scatter plots of the voltage growth as a function of the beginning-of-cycle (BOC) volts were prepared to determine the relationship between the two variables. The results, as shown in Figure 3–1 and Figure 3–2, indicate that the voltage growth is not dependent on the BOC volts. Because TSP PWSCC voltage dependent growth is not apparent, it was considered reasonable to examine and compare the cumulative probability distributions (CPDs) of the voltage growth rates for the no zinc and post-zinc period. These are shown in Figure 3–3.

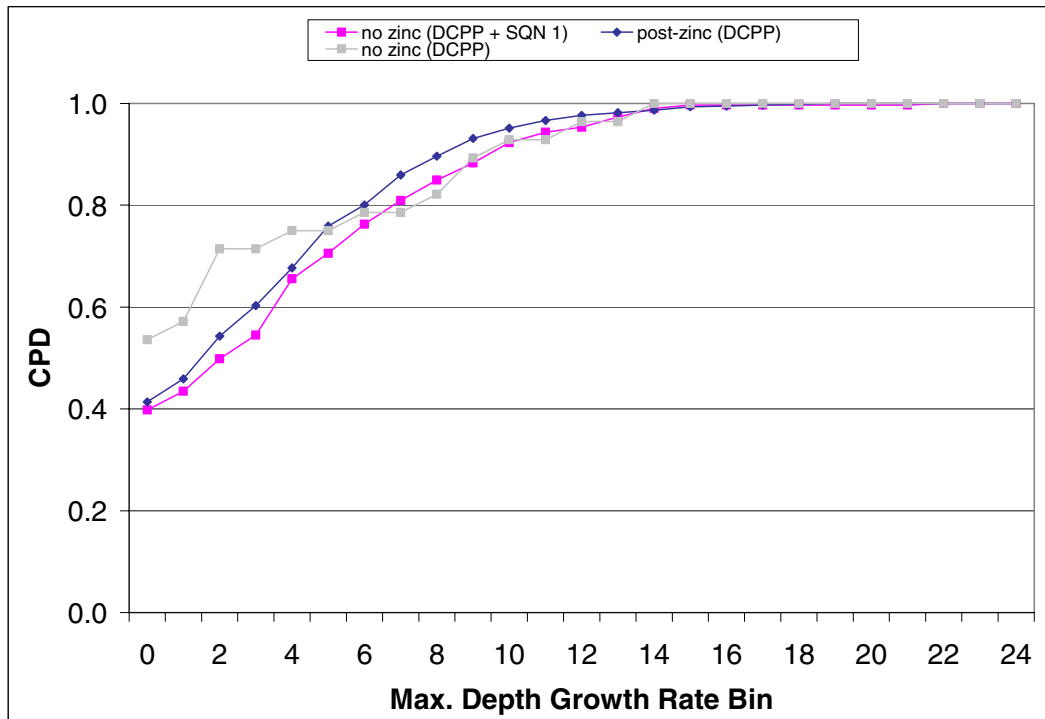
**Figure 3-4**  
TSP PWSCC Maximum Depth Growth at 603°F

in the growth rate assessment. Table 3–1 compares the number of data points available for the voltage growth rate analysis against the number available for the maximum depth growth rate analysis. The CPDs for the maximum depth growth rates for the no zinc and post-zinc period are shown in Figure 3–4.

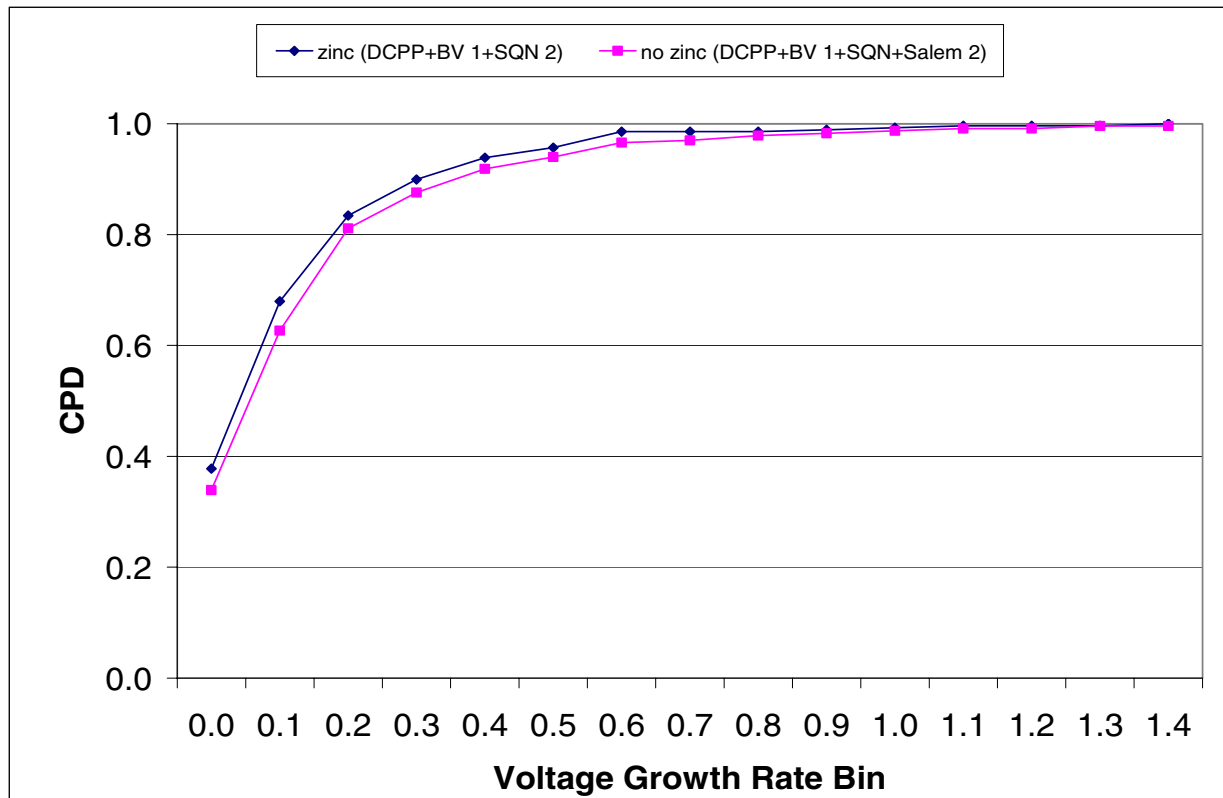
**Figure 3-5**  
**TS PWSCC Maximum Voltage Growth at 603°F**

- For each unit, the growth rates were adjusted to an operating temperature of 603°F using the Arrhenius equation and a Q value of 32.5 kcal/mole [6].
- For the two units at which zinc addition is being performed (Beaver Valley 1 and Sequoyah 2), separate pre- and post-zinc reviews were performed. The zinc addition history for each of these units is shown in Table 2–1.
