# **Development and Testing of an On-Line AE (Acoustic Emission)/Vibration Instrument**

1012344

Technical Update, December 2006

**Physical Acoustics Corporation**

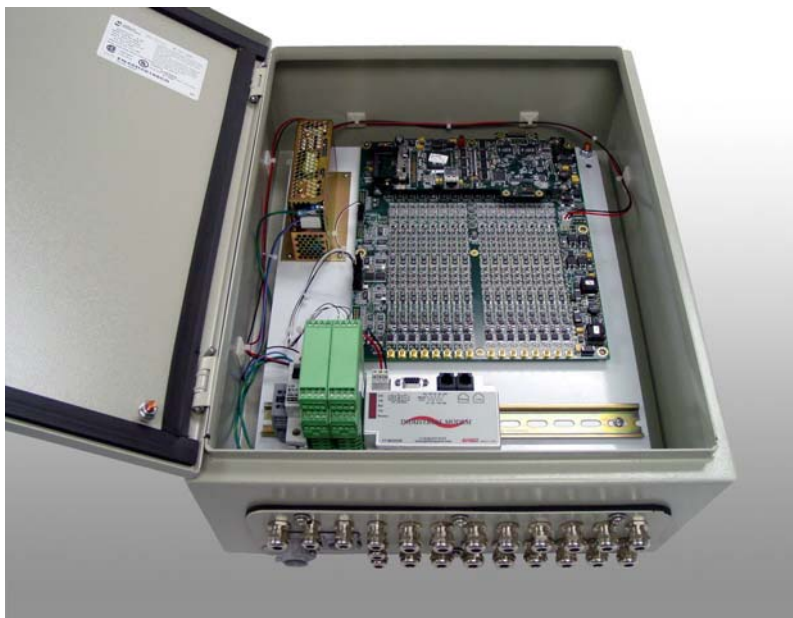
**Figure 1-1**  
**Internal view of Sensor Highway II**

The sensor highway system is a combined Acoustic Emission (AE) and Vibration monitoring system with up to 16 high speed (for AE, Vibration) monitoring channels and 4 additional parametric input channels. The Sensor Highway II has been developed for un-attended use in “Asset Integrity Monitoring” management and condition monitoring applications. The system consists of a 16-channel unit (node) in a rugged outdoor case (figure 1-1), capable of operating in extreme weather and factory conditions.

The key feature of the sensor highway system is its highly flexible sensor fusion interface for input and processing of any and most different sensors. The system is able to accept AE sensors (using the standard “phantom power” coaxial connection for powering external preamplifiers), ICP (Amplified) Accelerometers, and various sensors with current and voltage outputs. This interface is accomplished through the use of standard industrial, DIN Rail mounted signal conditioning modules, with options for proximity probes, tachometers, pressure transducers, load cells, thermocouples, environmental sensors, strain gages, etc.

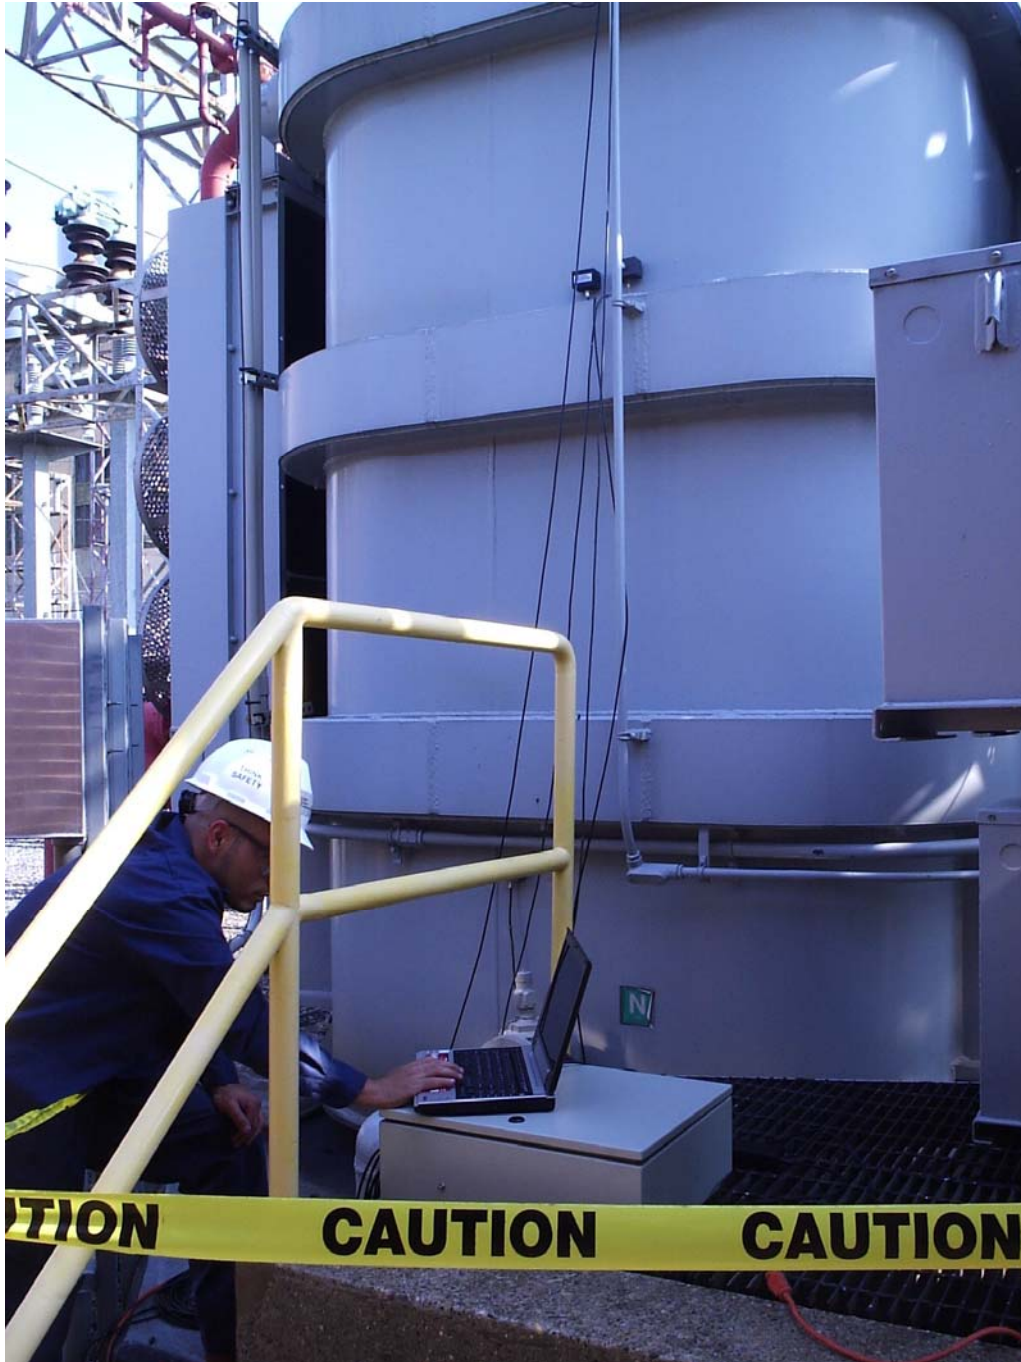
**Figure 1-3**  
**Plug in laptop computer**

The case size is approximately 20" x 16" x 6" deep. The AE Sensor Highway is scalable for large factory use, allowing for multiple units to be placed near the machinery or structures that are being monitored. There is no theoretical limit to the number of overall channels (based on 16 channel separate units) that can be connected in one location (plant).

The system is designed for outdoor environments, with a minimum power dissipation and a temperature range of (-35° - 70° C) without the need for heaters or air conditioners.

The “Data Collection” (SH-II DC) system, figure 1-2, (the most basic and low cost system), is capable of remote acquisition and storage of (short term) sensor data, with some basic signal processing and alarm screening capabilities. Data download can be accomplished by a walk-up attachment (plug in a notebook computer via its standard Ethernet port, see figure 1-3) or through an automated remote interface, either via Ethernet, or optional wireless Ethernet, Internet, or Telephone Modem, to a remote control and data processing station. The remote system with the aid of a trained user, performs the data analysis and asset integrity assessment. This SH-II DC system is the lowest cost solution and is for situations where remote analysis is desired, and is usually associated with a monitoring contract. Optionally, an Internet web access site can be made available for customer status, activity, trend monitoring and customer data visualization.

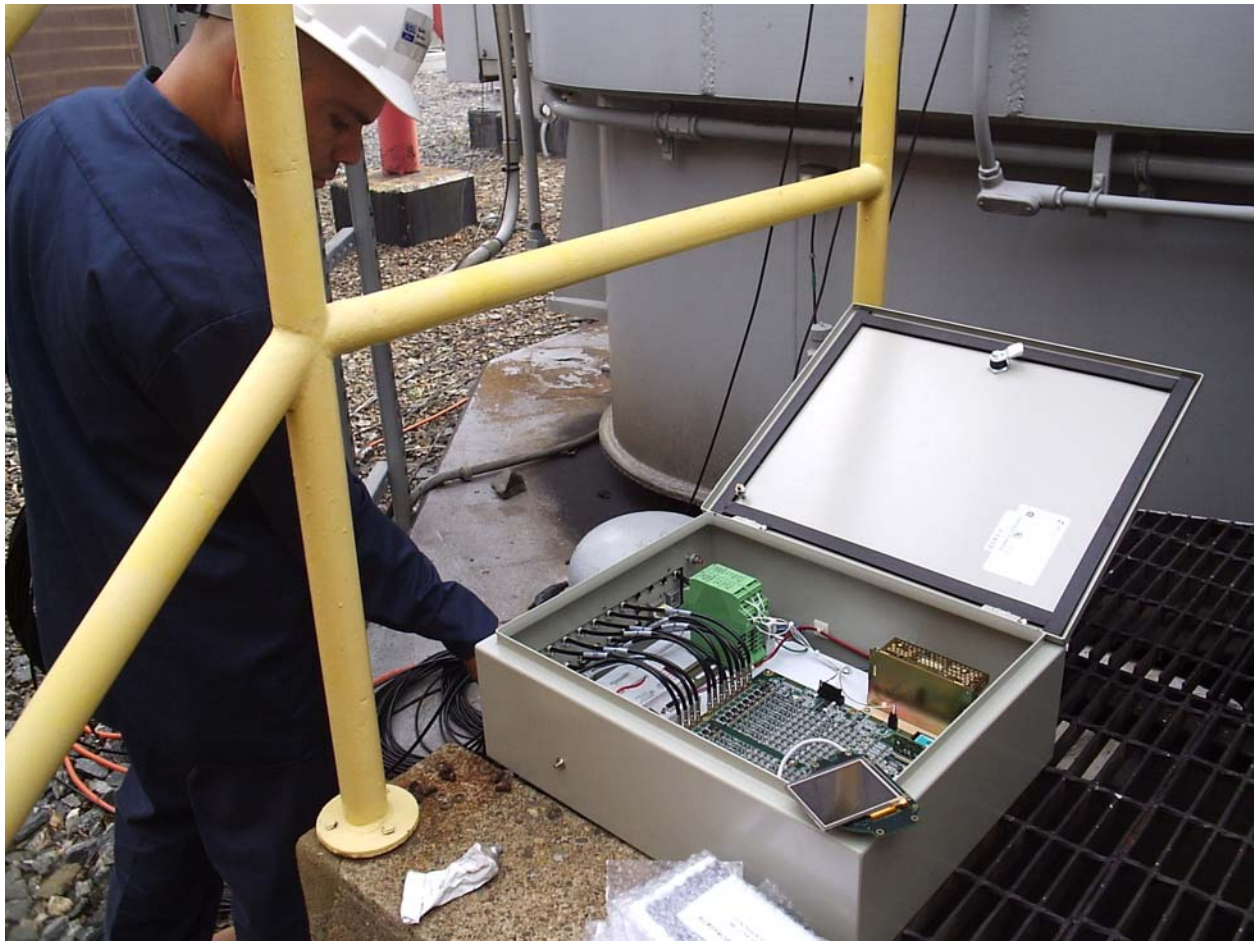
Also, one parametric channel was used to monitor the oil temperature on the transformer.

**Figure 2-6**  
**Installation on-site of the acoustic sensors and parametric channel**

As can be seen on the photographs, this transformer has 4 oil pumps on the upper part of the transformer (two on the High Voltage side and 2 on the LV side). This unit being a FOA-T class indicates that at least 2 pumps need to be running at all the time.

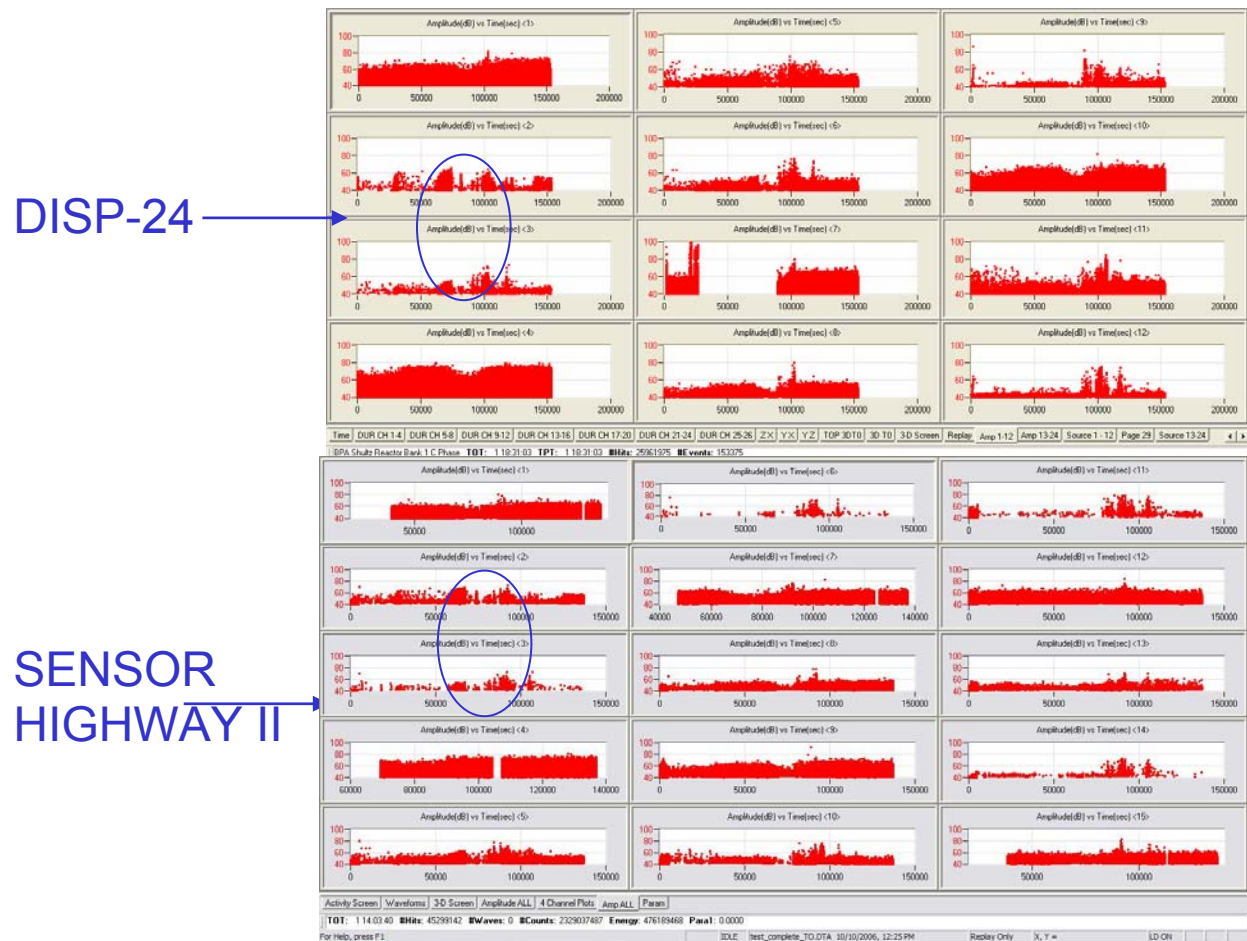
Very similar responses were obtained for both systems as can be observed on figure 2-7.

Most of the data detected by both systems corresponds to pump operating noise, however, an increase in acoustic activity can be observed on sensors 2 & 3 as well as continuous activity on sensors 4, 5, 6, 7 & 8 (same numbers on both systems).

**Figure 2-7**  
**Comparison of data collected by Sensor Highway II and Standard instrumentation**

After data analysis, two areas were identified as having activity different that pump operation noise. One is on the lower part of the phase C coil and the other on the middle section of the Phase A coil.

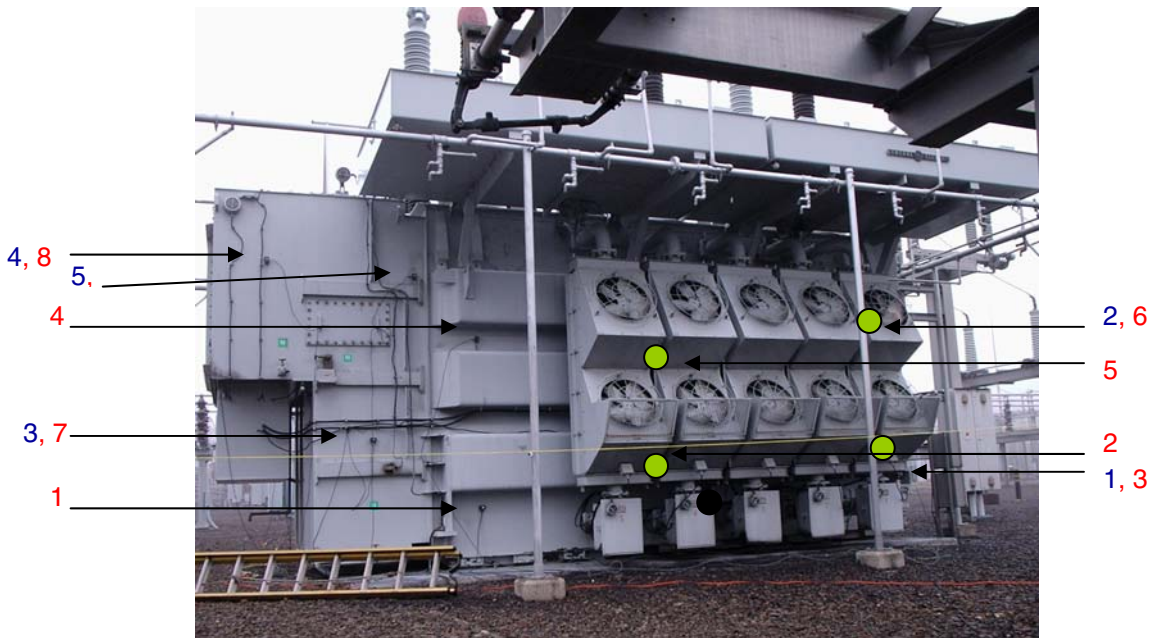
**Figure 3-2**  
Location of acoustic sensors on HV side

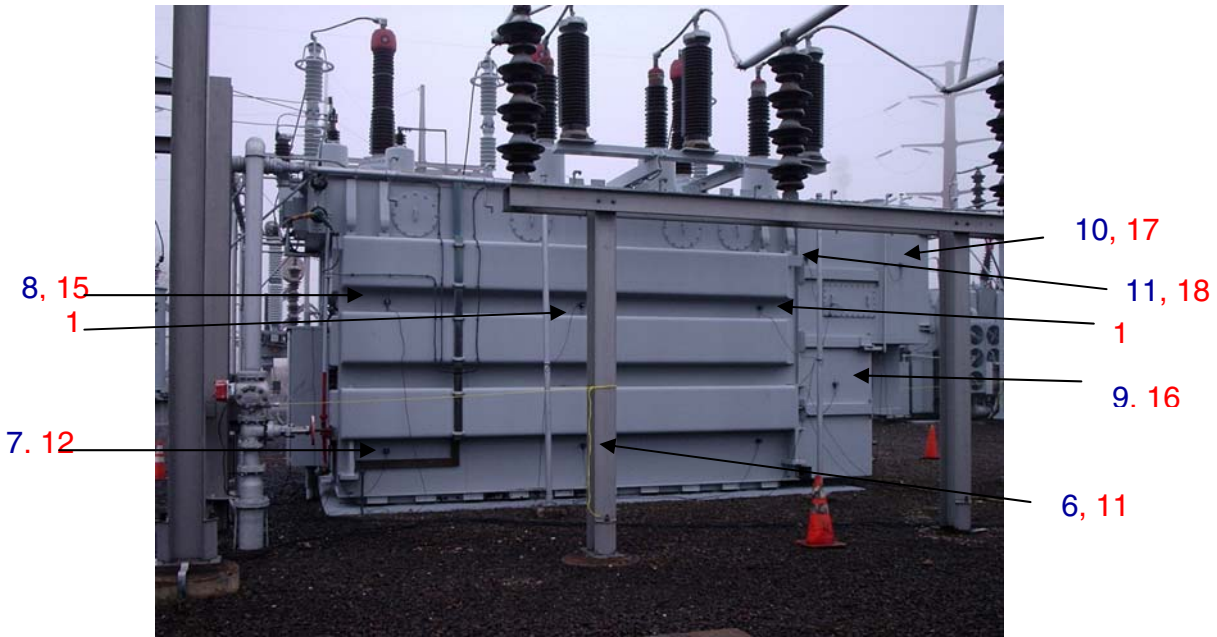
**Figure 3-4**  
Location of acoustic sensors on LV side

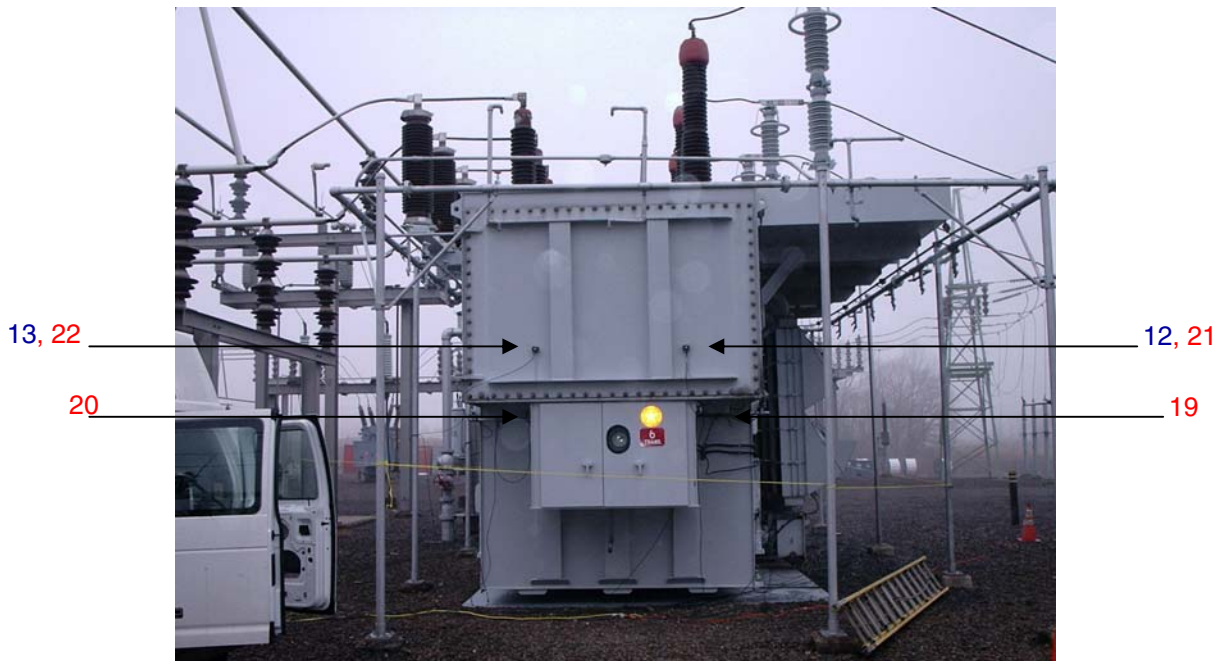
**Figure 3-5**  
Location of acoustic sensors on Load Tap Changer compartment side

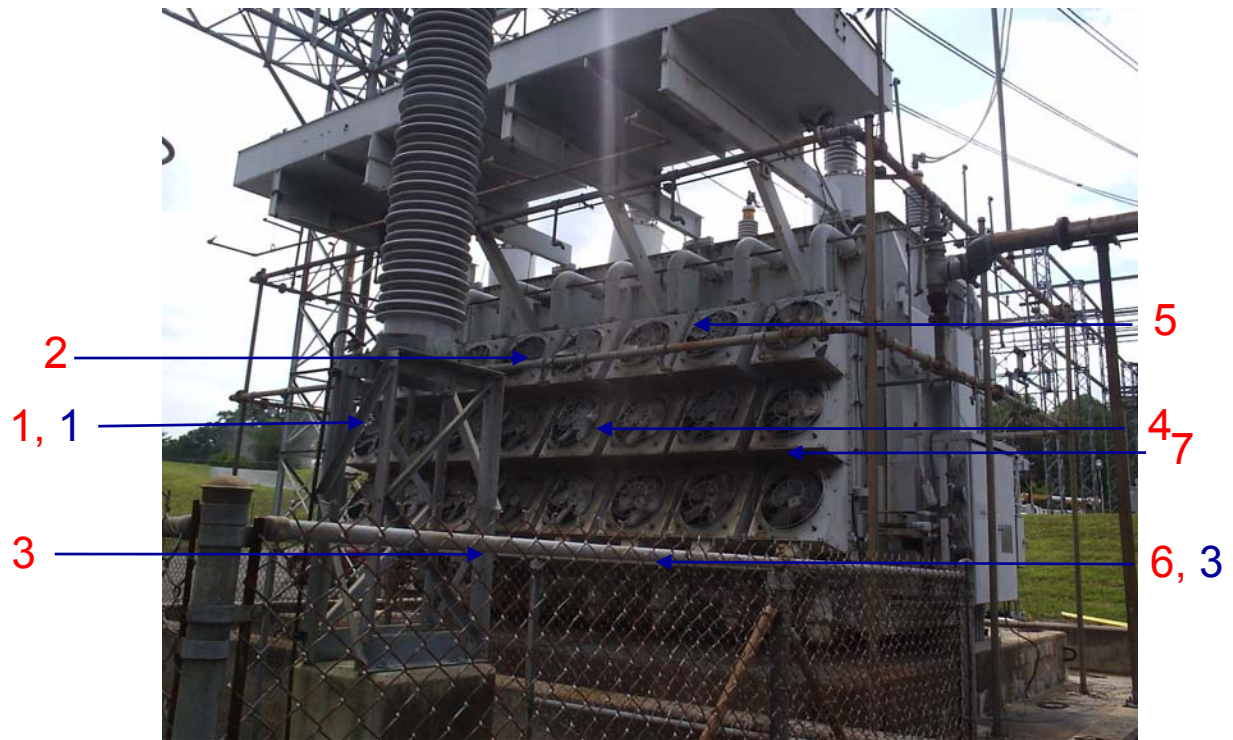
During the June test, 23 acoustic sensors were used to monitor this unit, see figures 3-11 to 3-14 for sensor location. At the end of the test, two areas of acoustic activity were detected, one on the lower part of the Phase A coil and the other on the upper part of the Phase C coil, see figure 3-15

**Figure 3-11**  
**Sensor location HV side**

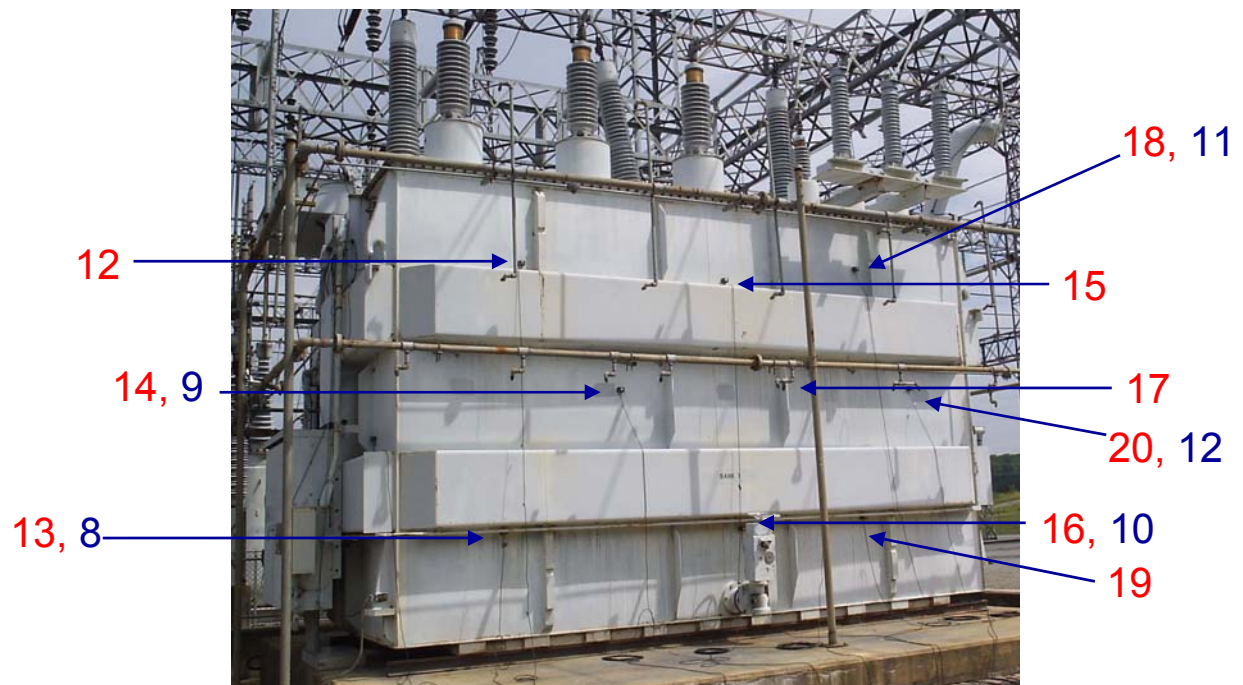
**Figure 3-13**  
Sensor location Low Voltage Side

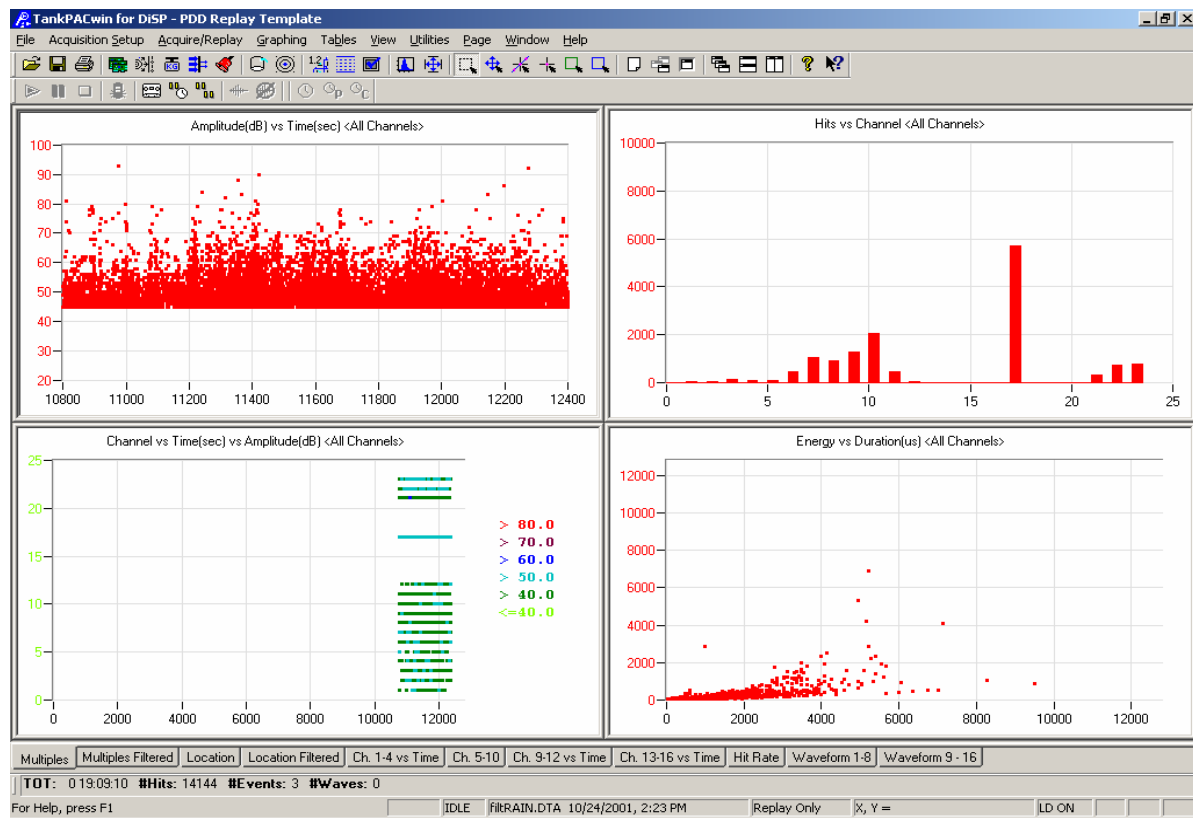
It is known that rain affects the quality of an AE test as it usually generates a significant AE data. An example of AE features obtained during rain periods can be seen in figure 4-4. Not only many AE hits were detected in each channel, but also high amplitude hits were detected. If analyzed by inexperienced persons or if the person who does the analysis does not know the data is contaminated with rain they could easily misinterpret this data as AE hits generated by a fault. However, calculating the TAFI and TAFID values, the data produced by rain can be easily identified as shown in figures 4-5 and 4-6 in comparison with the PD case presented above.

**Figure 4-4**  
**AE data obtained during rain**
