# **Evaluating and Avoiding Heat Recovery Steam Generator Tube Damage Caused by Duct Burners**

**1012758**

Final Report, March 2007

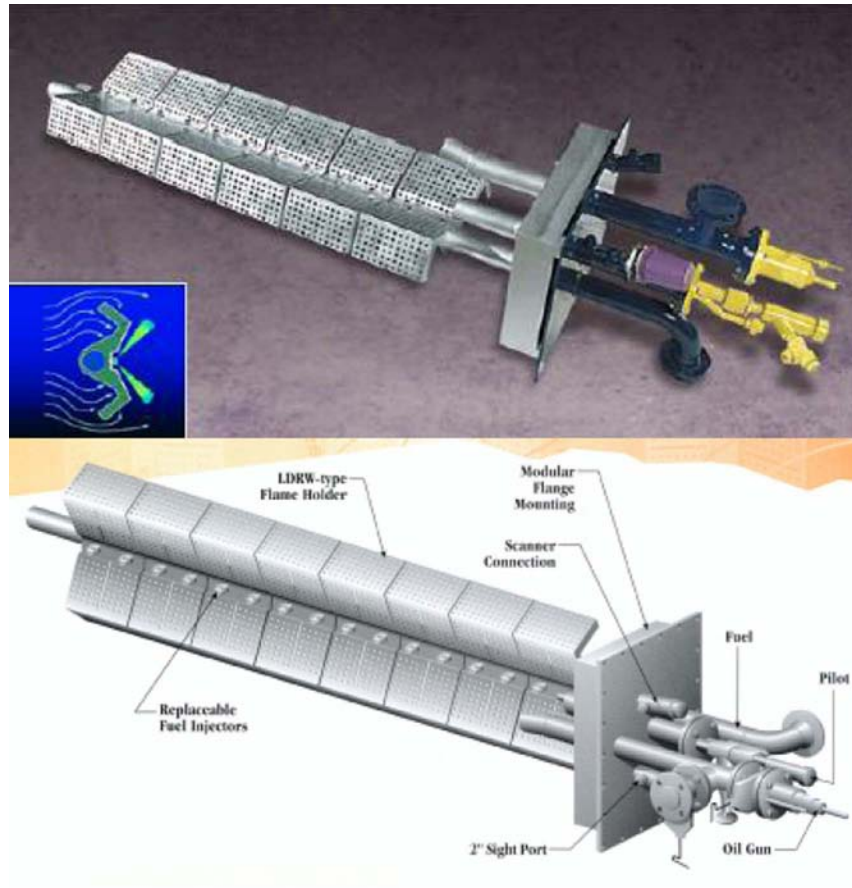
**Figure 1-1**  
**Typical Duct Burner Runner Components (Courtesy John Zink, LLC)**

Duct burners may be configured much like a conventional register-style burner. These generally require a source of augmentation air in addition to the CT exhaust gas. However, this report deals with the type of DB system used in the large majority of HRSGs that utilize only CT exhaust gas for combustion and has no secondary source of augmentation air. This type of DB system consists of an assembly of fuel piping (runners or rails), fuel nozzles, flame holders, exhaust-gas diffusers, and a support structure arranged in a grid pattern directly in the hot gas stream inside the HRSG duct (Figures 1-1 through 1-5).

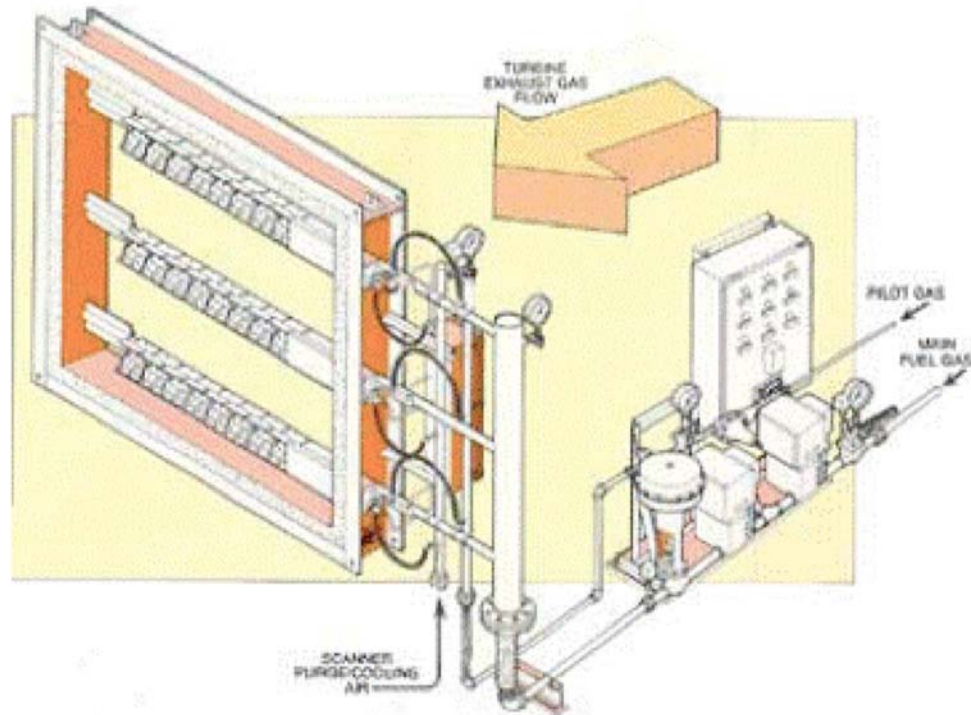
**Figure 1-2**  
HRSB Duct Burner Array (Courtesy Coen Company, Inc.)

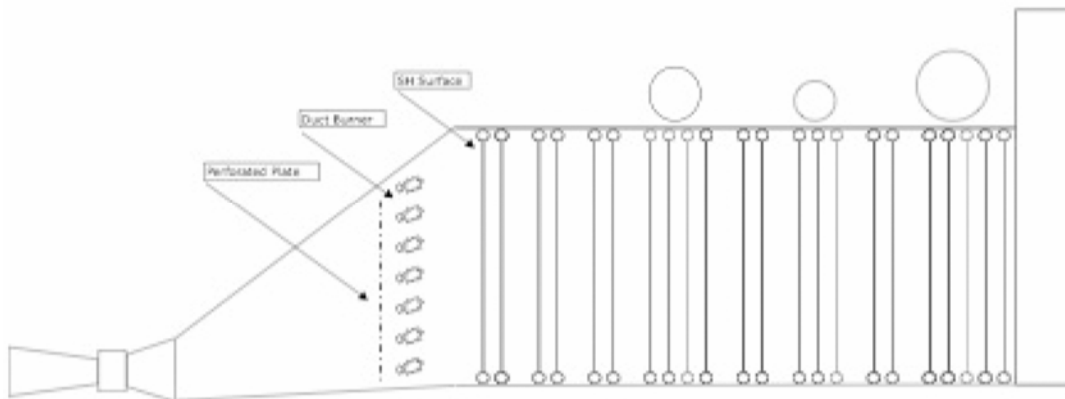
**Figure 1-3**  
Duct Burner Installed Between a Perforated Plate Flow Diffuser and the Final Superheater/Reheater

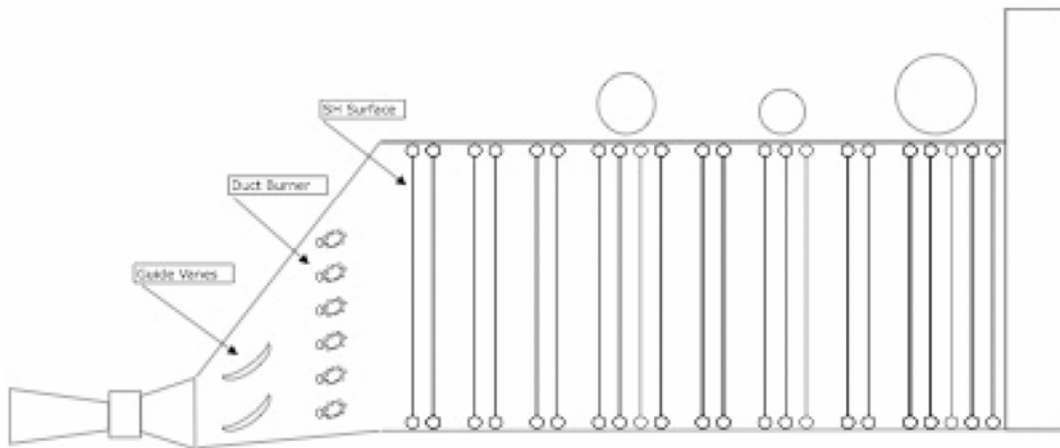
**Figure 1-4**  
**Duct Burner Installed Between Fixed Guide Vanes and the Final Superheater/Reheater**

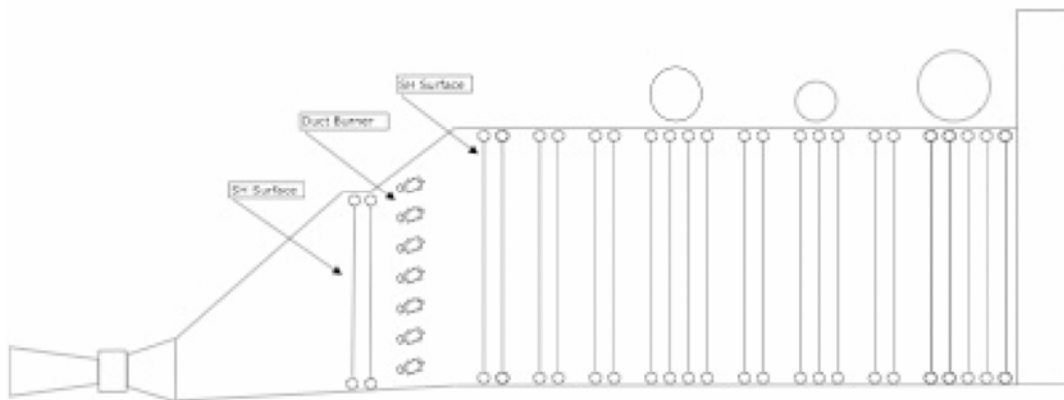
**Figure 1-5**  
**Typical F-Class Arrangement with Duct Burner between Final Superheater/Reheater and Primary Superheater/Reheater**

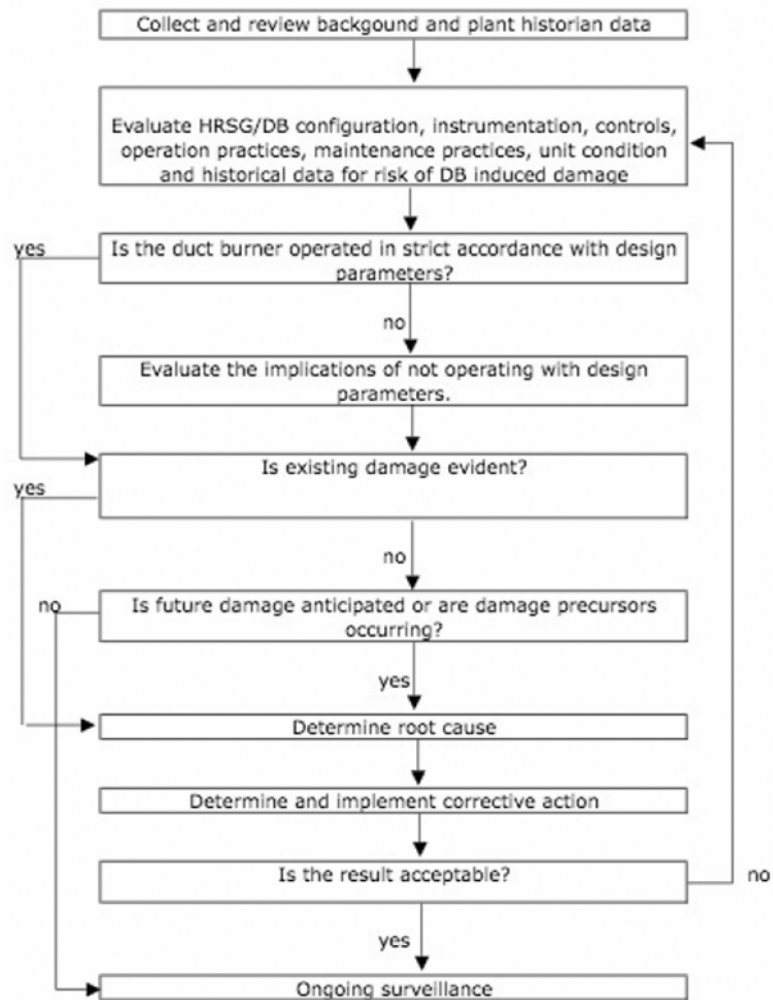
**Figure 2-1**  
**Roadmap for Optimizing Duct Burner Operation and Maintenance to Avoid Pressure Part Damage**

The frequency of reported pressure part failures associated with DB operation indicates that many existing combined cycle units experience unanticipated off-design operation during steady-state and transient operating conditions. Many of these units may not yet have experienced pressure part failures if the off-design conditions are not too severe. However, they may expect premature pressure part failures well before nominal design life is reached. Some of the key actions required to assess the likelihood of this damage are documented in the following roadmap (Figure 2-1).

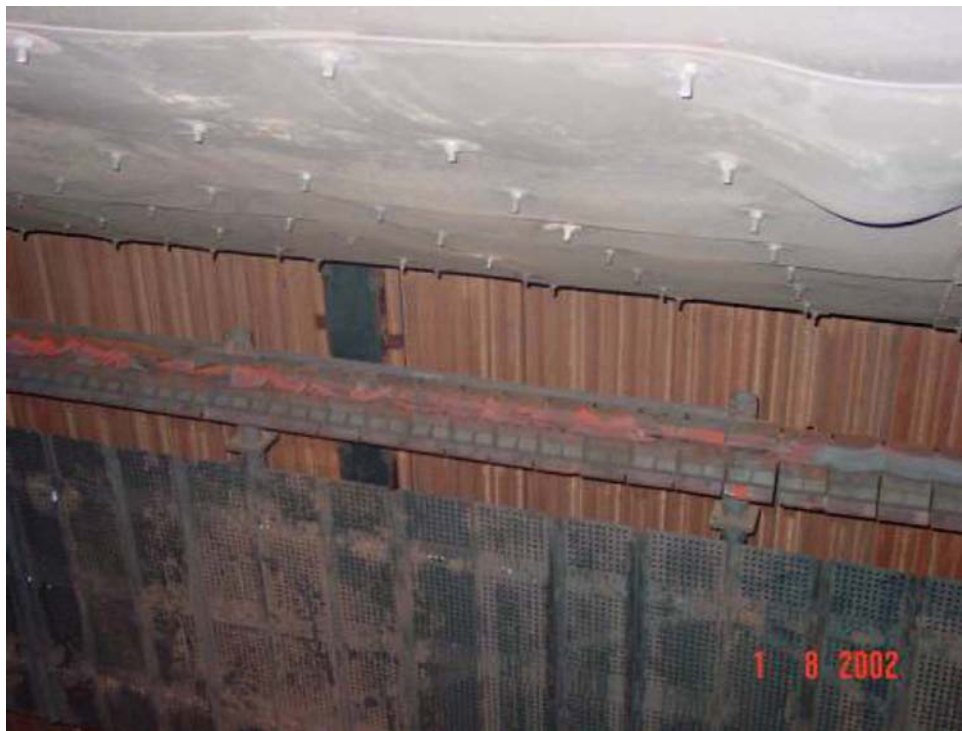
**Figure B-1**  
**Damage to Duct Burner Assembly and Firing Duct Stainless Steel Liner above Duct Burner. Overheating damage (not shown in photo) also occurred in the HRSG outer casing adjacent to locations where liner damage was most severe.**

This HRSG behind a GE-7FA combustion turbine suffered extensive damage to the DB, firing duct lining, HRSG casing and HP superheater tubes downstream of the DB. The DB was heavily fired with the CT at 60% load. The GE-7FA produces its hottest exhaust gas ( $\approx 1200$  °F; 649 °C) near this load (Figures B-1 to B-4).

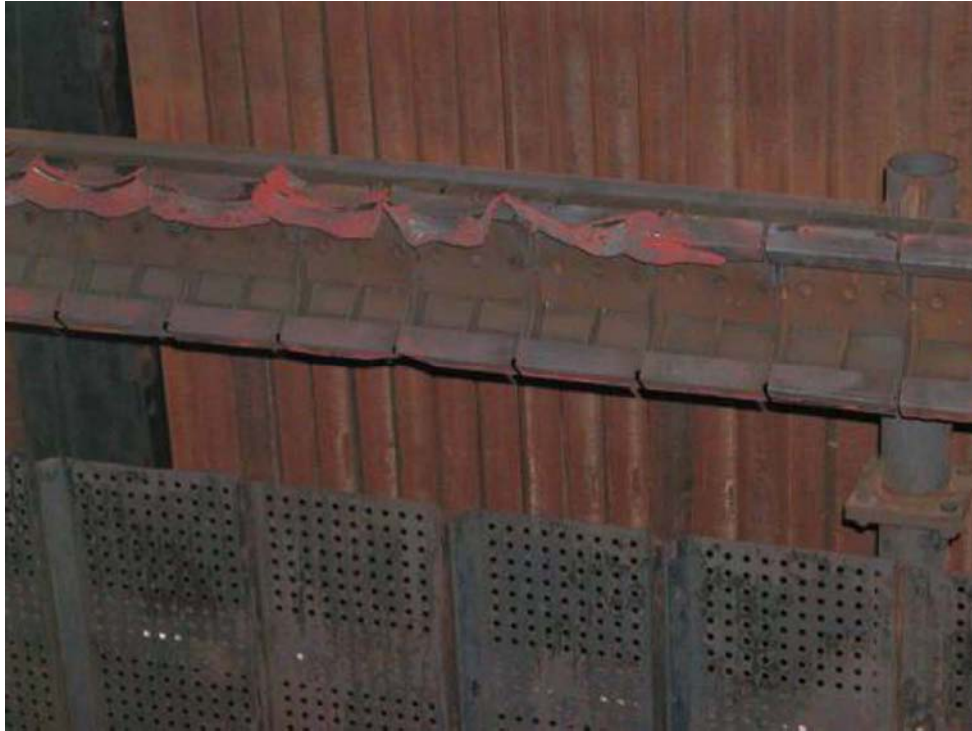
**Figure B-2**  
**Close Up of Duct Burner Damage**

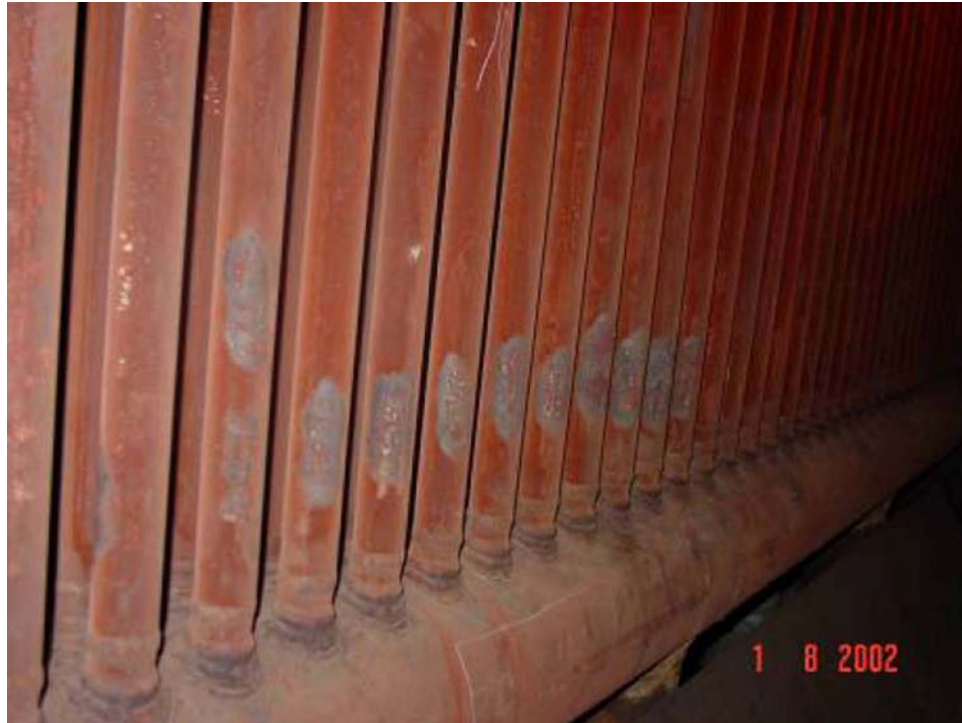
**Figure B-3**  
**Visible Evidence (Oxide Spalling) on First Row of Superheater Tubes (Unfinned)**  
**Downstream of Duct Burner**

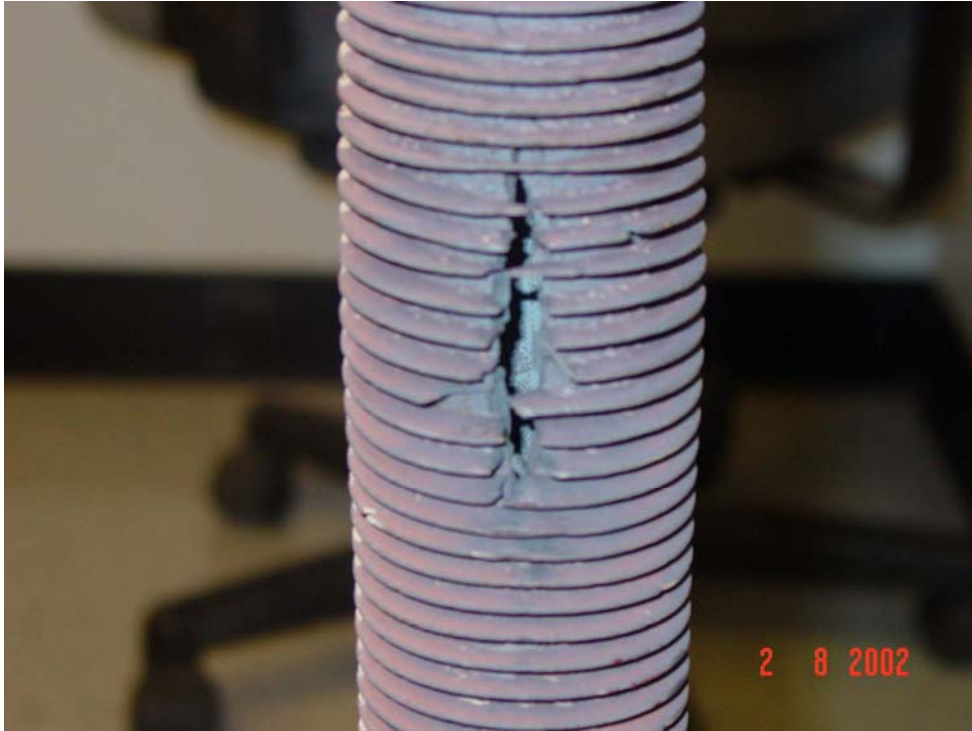
**Figure B-4**  
**Creep Rupture Failure in the Second Row of Superheater Tubes (Finned) Downstream of Duct Burner. It is one of many that occurred within three years of the over-fire event.**

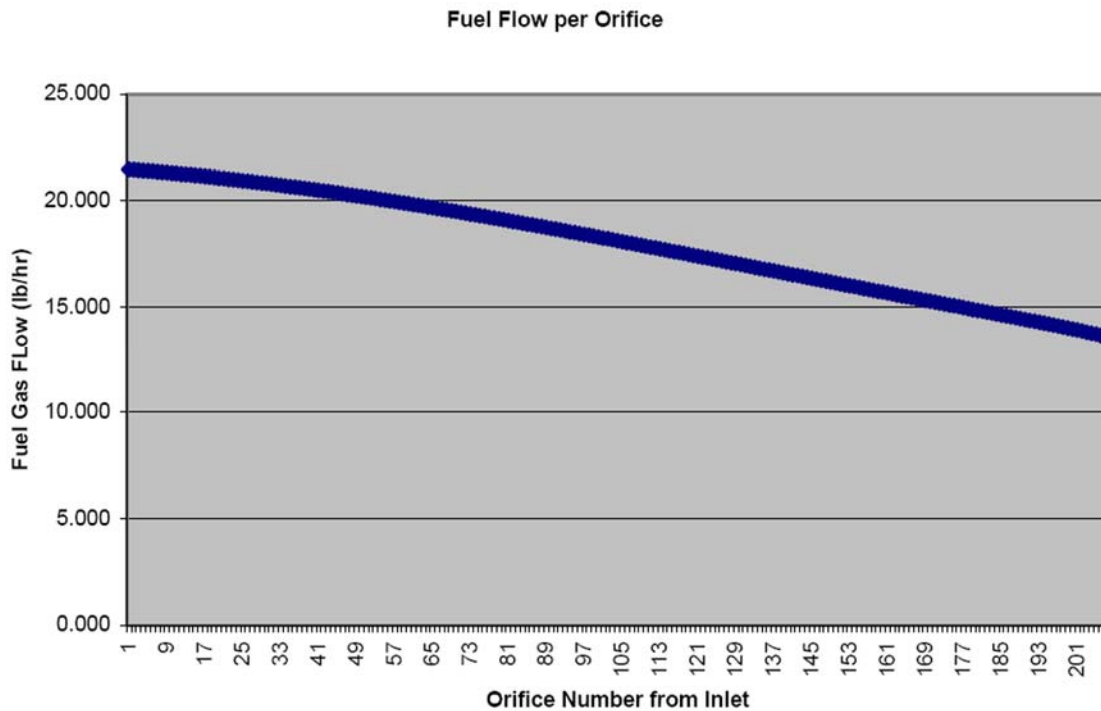
**Figure B-5**

**Estimated Gas Flow across the Length of Duct Burner Runners. Due to the pressure drop in the runner fuel pipe the fuel flow rate is higher in the burner openings nearest the fuel inlet side of the runner.**

The 625-MMBtu/hr maximum output DB array consisted of seven burner runners with 207 orifices per runner. Engineering calculations revealed that under normal DB firing conditions, the burner openings (orifices) across the length of each burner runner should produce an average estimated flow of 17.9 lb/hr per orifice with a significant systematic variation of +20/-24% lb/hr (Figure B-5). This suggested that some significant gas temperatures and heat flux variations in the downstream tube coils could be present.

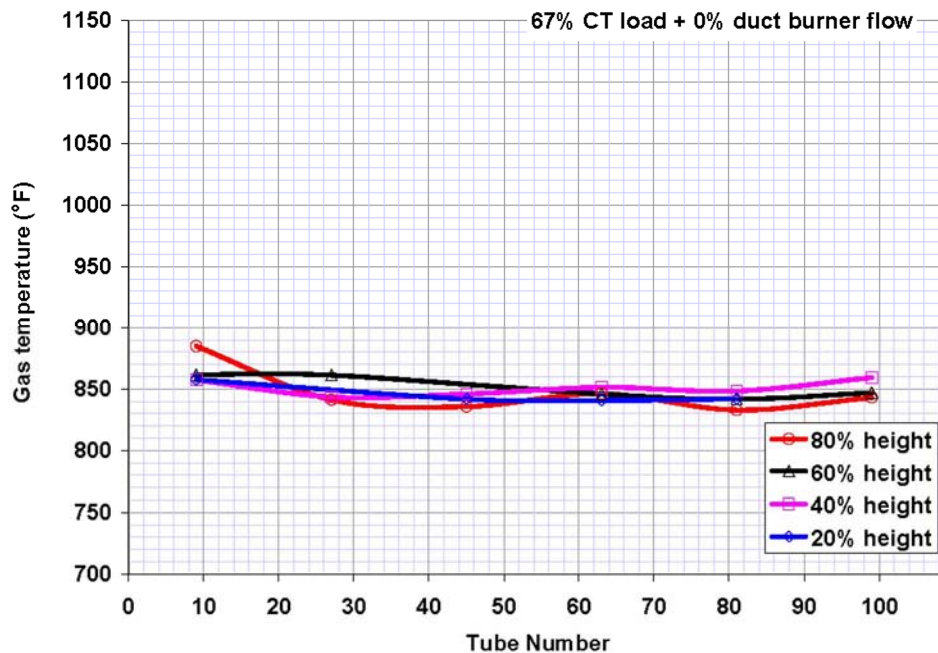
**Figure B-6**  
**Gas Temperatures at the Leading Row of the HP Evaporator with the Combustion Turbine at Approximately 67% of its Normal Operating Load and the Duct Burners Off**

Findings from the gas-side thermocouples revealed that with the DB out of service and the combustion turbine operating at 67% or 100% of its normal full load value, there was a very uniform side-to-side and top-to-bottom gas temperature distribution (Figures B-6 and B-7). However with the DB operating at their preferred fuel flow rates for the part- and full-load CT operating conditions, there was still a significant ( $\sim 50$  °F to  $70$  °F) side-to-side and even more severe ( $\sim 80$  °F to  $90$  °F) top-to-bottom gas-temperature profile at the leading edge of the HP evaporator (Figures B-8 and B-9). This indicated that the initial modification of the burner orifices was not sufficient. This was further verified with HP Superheater 1 coil outlet steam nozzle pipe temperature measurements.

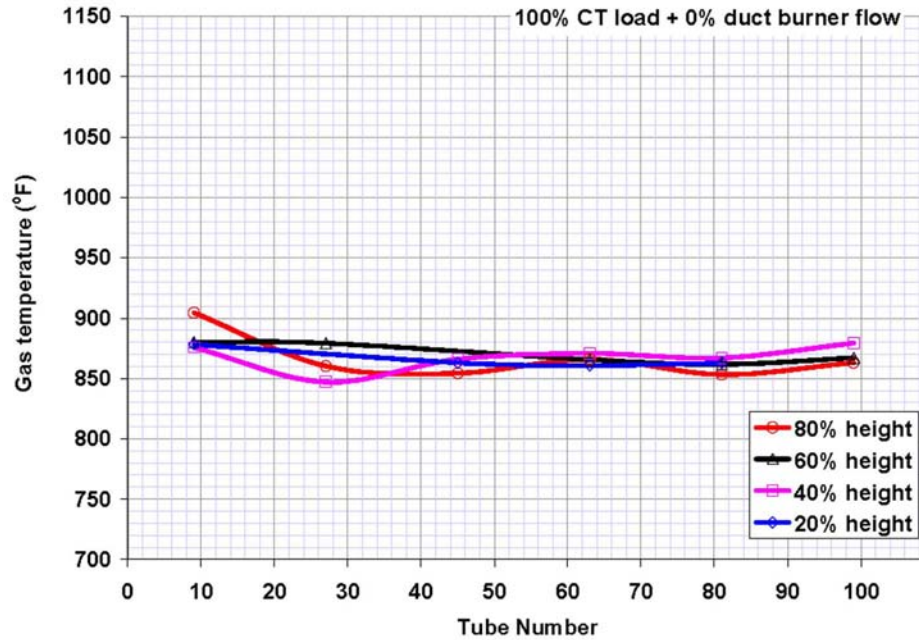
**Figure B-7**  
Gas Temperatures at the Leading Row of the HP Evaporator with the Combustion Turbine at Approximately 100% of its Normal Operating Load with the Duct Burners Off

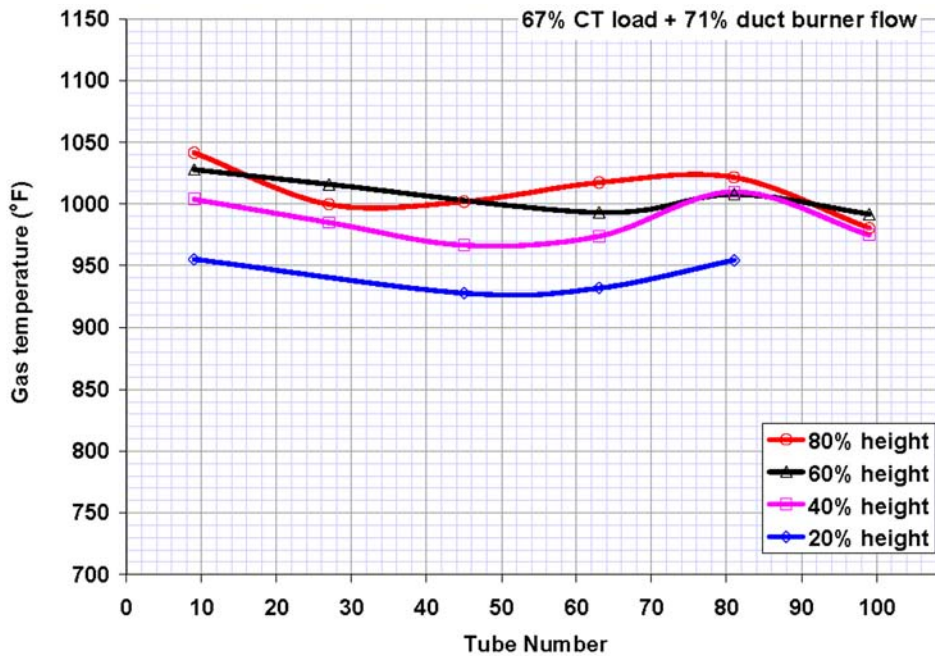
**Figure B-8**  
Gas Temperatures at the Leading Row of the HP Evaporator with the Combustion Turbine at Approximately 67% of its Normal Operating Load and the Duct Burners Firing at Approximately 70% of their Normal Full Load Fuel Flow Rate

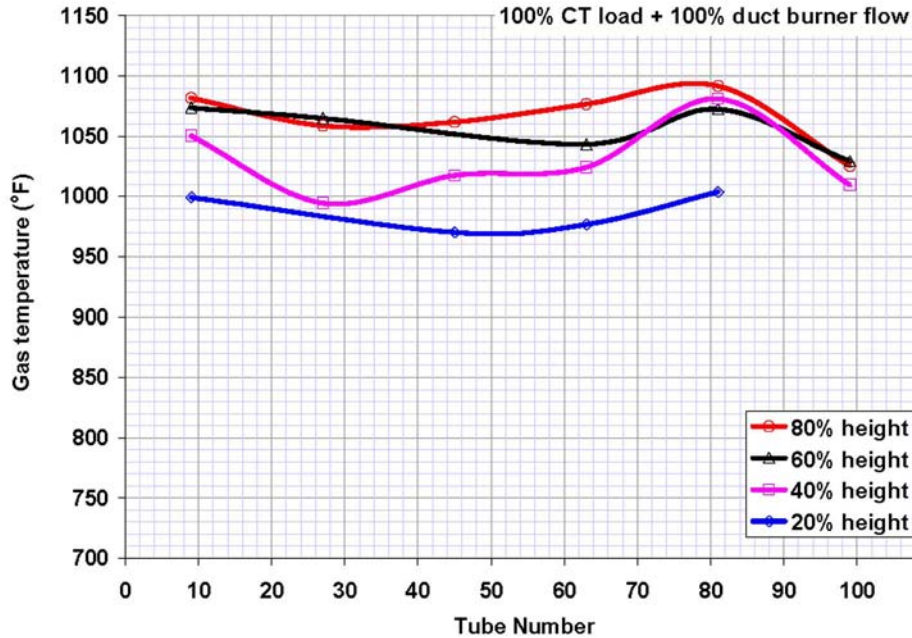
**Figure B-9**

**Gas Temperatures at the Leading Row of the HP Evaporator with the Combustion Turbine at Approximately 100% of its Normal Operating Load and the Duct Burners Firing at Approximately 100% of their Normal Fuel Full Load Flow Rate**

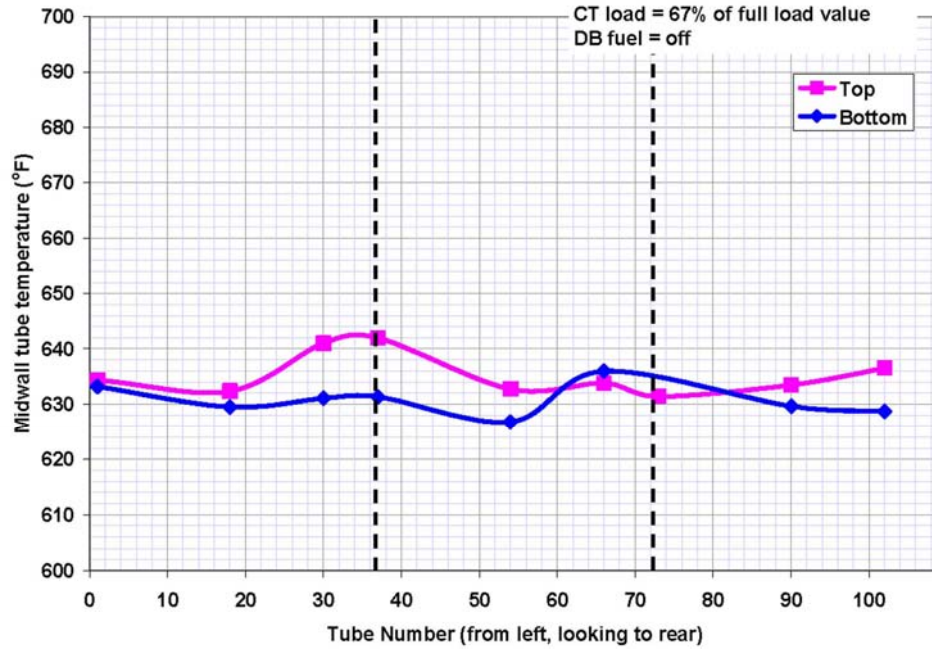
**Figure B-10**  
Mid-wall Tube-metal Temperatures at the Leading Row of the HP Evaporator with the Combustion Turbine at Approximately 67% of its Normal Operating Load with the Duct Burners Off

Prior to further tuning the DB, the measured HP evaporator mid-wall tube metal temperatures were evaluated and found to be moderate (Figures B-10 through B-13). With no duct firing, the maximum temperature pickup between the lower and upper measurement locations was 10 °F to 13 °F for 67% and 100% of the normal CT load, respectively. The maximum side-to-side tube-temperature variation was in the range of 8 °F to 11 °F with no duct firing. With the CT at 67% of its normal full load value and the DBs operating with 71% of their normal full load value, the maximum tube temperature pickup between the lower and upper measurement locations was 20 °F and the maximum side-to-side temperature variation was approximately 14 °F. With the CT at its normal full load value and the DBs operating at their normal full load value, the maximum tube temperature pickup between the lower and upper measurement locations was 28 °F and the maximum side-to-side temperature variation was approximately 20 °F.

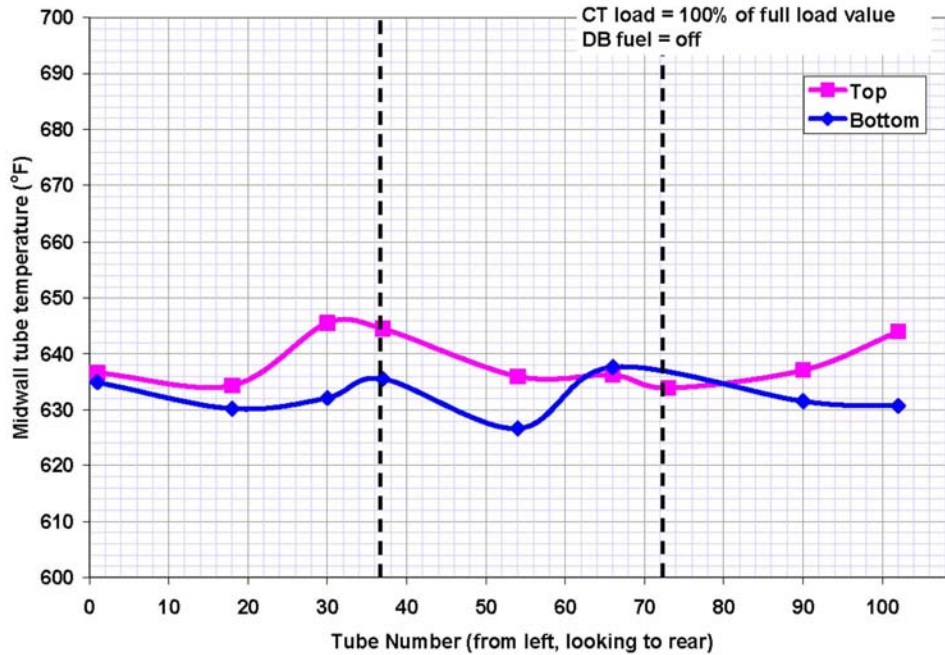
**Figure B-11**  
Mid-wall Tube-metal Temperatures at the Leading Row of the HP Evaporator with the Combustion Turbine at Approximately 100% of its Normal Operating Load with the Duct Burners Off

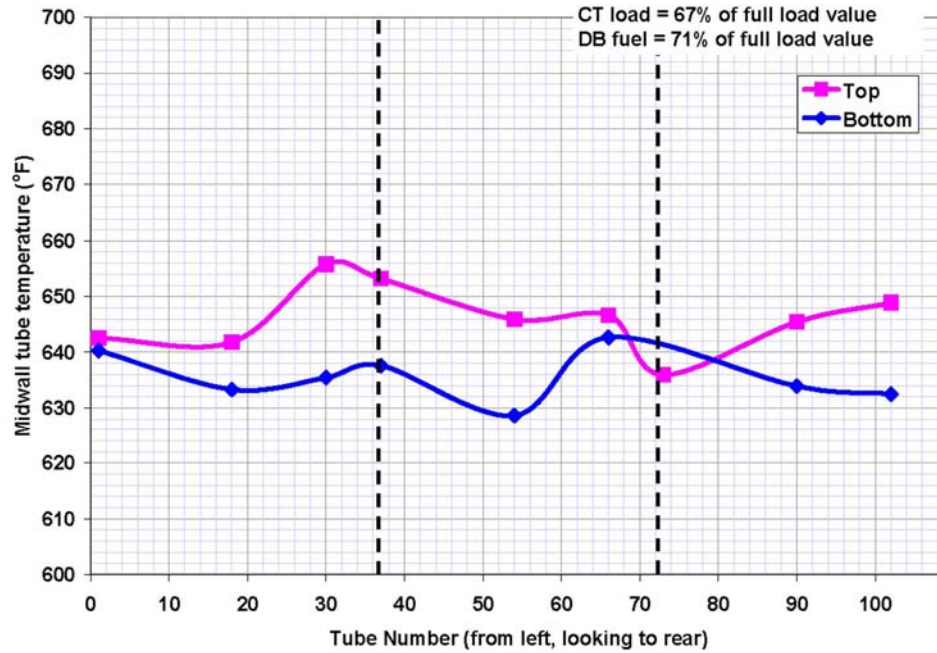
Figure B-12

Mid-wall Tube-metal Temperatures at the Leading Row of the HP Evaporator with the Combustion Turbine at Approximately 67% of its Normal Operating Load and the Duct Burners Firing at Approximately 71% of their Normal Fuel Full Load Flow Rate

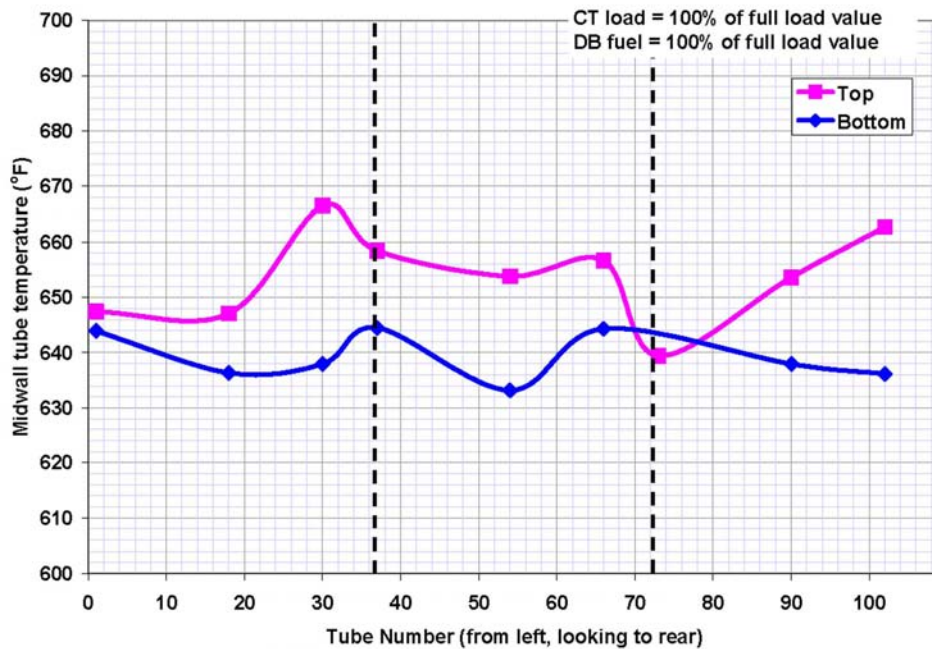
Figure B-13

Mid-wall Tube-metal Temperatures at the Leading Row of the HP Evaporator with the Combustion Turbine at Approximately 100% of its Normal Operating Load and the Duct Burners Firing at Approximately 100% of their Normal Fuel Full Load Flow Rate
