Supplemental Thread Sealant Performance Testing: Loctite 5772

*Performance of Loctite 5772 Thread Sealant on Stainless-to-Stainless
and Stainless-to-Carbon Steel Pipe Fitting Connections
Addendum to EPRI Report 1000972, Assembling
Threaded Connections (December 2000)*

1013266

Technical Update, March 2006

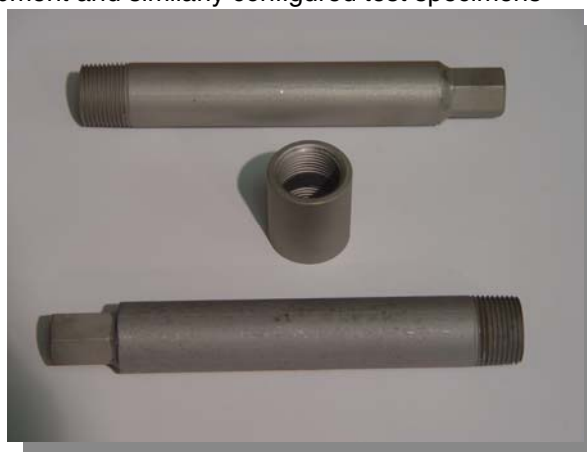
Figure 1
Test Specimen Piping Components

The previous EPRI equipment was refurbished as necessary and tested, and a new temperature-controlled environmental chamber was designed and fabricated to support this research. New piping components (nipples, couplings) were purchased from a commercial supplier, McMaster-Carr, and thread areas were grit-blasted at EPRI to a consistent finish. (See Figure 1) New test samples were configured

A combination of stainless steel pipe nipples, stainless steel couplings, and carbon steel nipples were used to prepare the test specimens. Each specimen consisted of a stainless steel nipple and a carbon steel nipple (See Figure 1) threaded into opposing sides of a stainless steel coupling. (For continuity, the stainless steel nipple was always oriented as the top nipple in the vertical specimen.) This arrangement provided a stainless-to-stainless and stainless-to-carbon steel threaded joint in each test specimen. The bottom (carbon steel) end of each specimen was seal welded, with a double O-ring seal configured at the top end of each specimen.

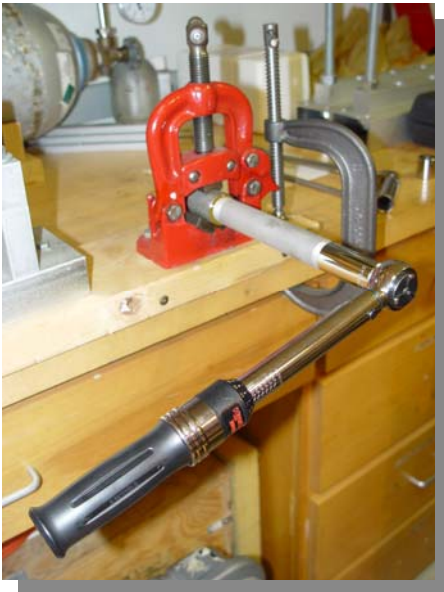
Figure 3
Test Specimen Assembly

To assemble a test specimen, the pipe coupling was inserted into a pipe vise using sufficient pressure to hold the coupling firmly in place without deforming the fitting. The nipple thread area was inspected for thread damage that might significantly increase thread friction on assembly, and if none was found, the clean threads were either wiped with the oily cloth or not, depending upon the requirements for each individual test specimen. Subsequently, the 5772 sealant was applied in the above-mentioned fashion, and the nipple inserted into the coupling and started by hand. A torque wrench set to approximately 6 ft-lbs, simulating a hand-tight condition, was then used to tighten hex stock welded to the nipple, thus driving the nipple into the coupling until the torque wrench indicated that the desired degree of tightness had been achieved. (See Figure 3)

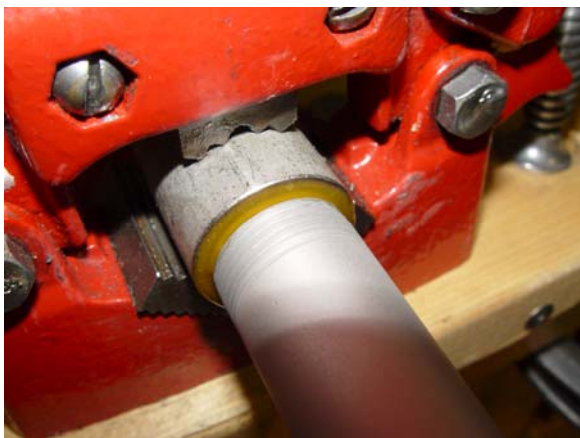
Figure 4
Correct Seal Bead Formation Post-

On assembly, this practice resulted in a nice even bead formation of sealant 360° around the nipple and coupling opening, without apparent excess sealant used. (See Figure 4) On disassembly, this method also showed that sealant had completely filled the gap in the thread form from the beginning point on the nipple to the exterior opening of the coupling.

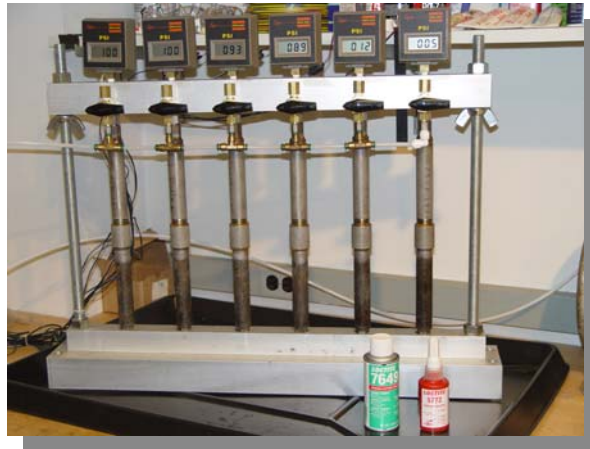
Figure 5
Short Term Screening Test Fixture

Figure 5 shows the test fixture used to perform the short term screening test.

After a total of six hours cure time, all the specimens were pressurized in common using a pressurization line from a hand-loaded pressure regulator to a pressure of 100psi nitrogen, as indicated by individual gauges incorporated in the fixture for each specimen. After a two minute duration, allowed to provide time for any minor drop in pressure to occur caused by initial pressurization of the specimens, the specimen pressure was readjusted to 100psi and the block valves for each specimen were closed, thereby isolating each specimen.

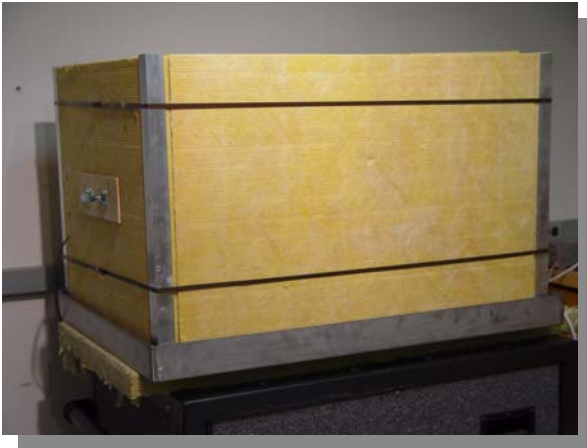
Figure 6
Long Term Test Environment Chamber

inserted into the chamber to provide circulation within the chamber during the entire 30-day test duration. Chamber temperature was monitored using two independent temperature probes linked to a Hewlett-Packard temperature display unit. As with the heaters, two probes were used to provide redundancy, and positioned in opposing corners of the chamber at specimen coupling height.

Each of the specimens was placed in a test fixture housed inside a simple insulated and heated environmental chamber constructed for this research. Two (2) thermostatically-controlled 500w strip heaters were mounted in opposing corners of the chamber, at same height as the finished elevation of the couplings used in each test specimen. This was done to assure that the temperature at the threaded coupling in each specimen would be in the same thermal layer as the thermostat/heater, even though the small size of the chamber probably limited the degree to which any significant temperature

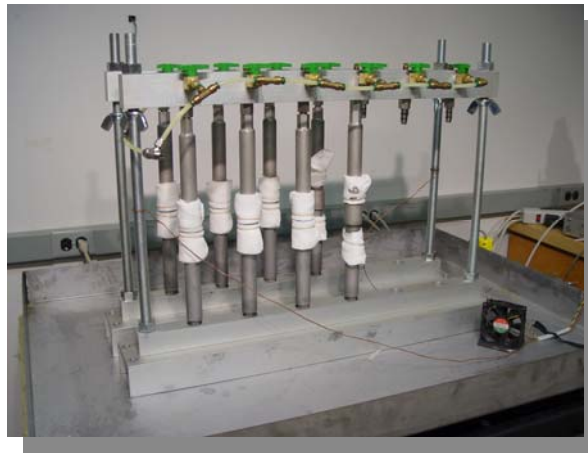
Figure 8
Results of Long Term Multi-Fluid Test at 150°F

At the end of the thirty day test, the cover of the environmental chamber was once again removed, and the test specimens once again inspected for leakage. As shown in Figure 8, no leakage was evident on any of the sixteen (16) tested joints; either stainless-to-stainless or stainless-to-carbon steel. (Circulation fan [black] shown in lower righthand corner of Figure 8)

The gauze pads on two specimens (far right) shown in Figure 8 were slid back to reveal the top and bottom threaded connections on each specimen for inspection of the seal bead itself. As shown in Figure 9, the 5772 seal bead appeared in very good condition, with no evidence of leakage whatsoever, confirming the absence of red dye on the gauze pads. All of the gauze pads were subsequently removed for inspection. No reweighing of the pads was necessary, as none showed any indication of leakage. Accordingly, no follow-on data analysis was necessary for the long term test.

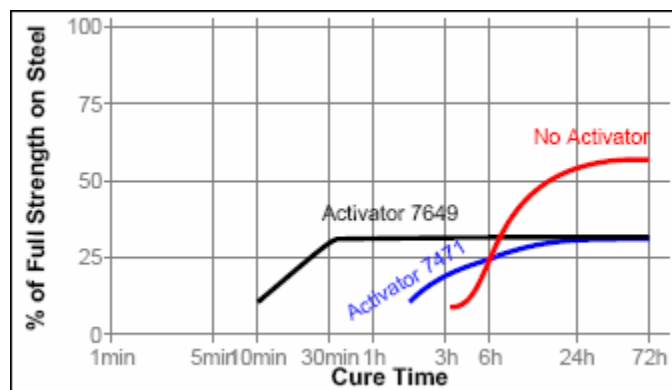
Figure 11
Cure Curves for Non-Reactive Metals Using Primers

Figure 11 illustrates a cure curve for zinc dichromate, which has a similar cure curve to stainless steel, relative to onset of curing and final strength. As the graph shows, use Primer 7649 causes curing of 5772 to begin in as little as ten (10) minutes after initial assembly, with the cure process complete after only thirty (30) minutes.

Thus, when using Primer 7649, it is reasonable to assume that curing can be complete on stainless steel in as little as thirty (30) minutes as well. The obvious downside is that the potential strength of the bond is reduced by half, to around 30% instead of 60% when allowed to cure naturally over time. (NOTE: No attempt has been made by EPRI to quantify the strength requirements for 5772 used in different applications, such with primer vs. without primer. Upon review of the vendor information, 'potential strength' appears to be measured as a function of breakaway torque required to loosen a pipe from its fitting. It is unclear whether – or to what extent – this measure has any bearing whatsoever on the leaktightness of the joint.)

It is further worth noting that – according to the vendor data – use of a different primer, such as Loctite 7471, can delay initial curing for up to two (2) hours after assembly, creating a longer period with which to adjust the piping should any adjustment be necessary, without any loss of strength (as compared to use of Loctite Primer 7649). However, the vendor data suggests that it will require approximately eighteen (18) hours to achieve that relative strength, as opposed to only thirty (30) minutes when using 7649.
