# Rancho Seco Nuclear Generating Station Decommissioning Experience Report

## Detailed Experiences 1989-2007

**1015121**

Final Report, December 2007

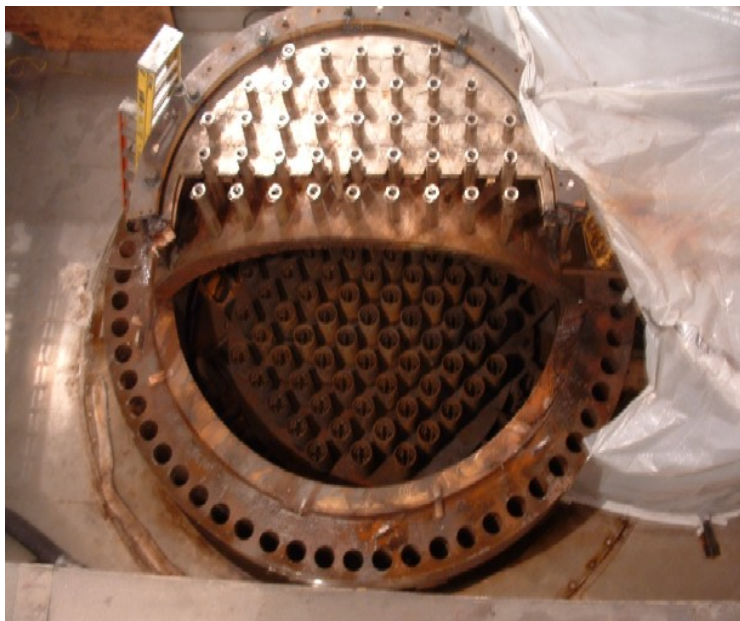
The Reactor Head was segmented with a diamond wire rope supplied by segmentation vendor Bluegrass. The five segmented sections included three sections of the flange and two sections of the top portion of the Head, cut just off-center through a clear path around the remainder of the CRDM nozzles.

Contact dose rates underneath the Head were 200 mrem/hr (2 mSv/hr) and dropped off to 80 mrem/hr (0.8 mSv/hr) at the open plane of the bottom flange. Dose rates on the exterior of the Head ranged from 15 to 30 mrem/hr (0.15 to 0.3 mSv/hr.) The four flange keyways had contact dose rates up to 800 mrem/hr (8 mSv/hr) and required shielding as the segmented pieces were prepared for shipment. High levels of contamination were found on the underside of the Head and were affixed with use of a polymer-based latex paint.

**Figure 7-1**  
**Reactor Head With First Piece Removed**

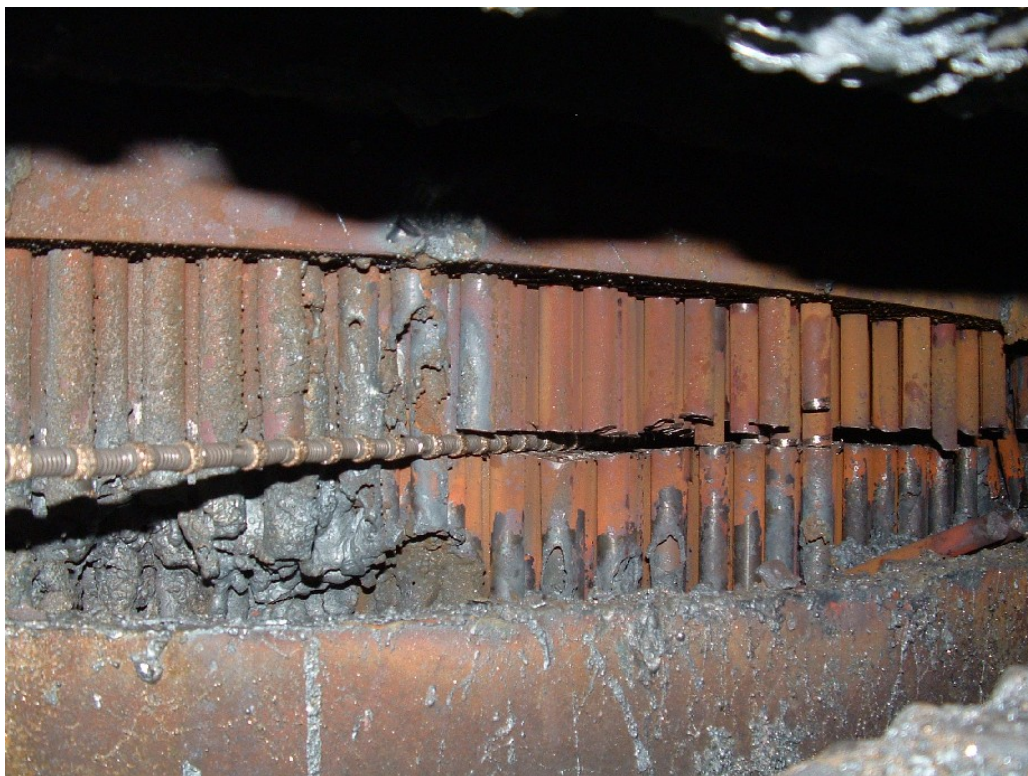
The diamond wire sawing system passed through the windows cut in the SG walls. The diamond wire was then coupled together with steel sleeves and passed around a drive wheel and over guide pulleys. Wire tension was maintained by a rack and pinion system that moved the drive wheel along the wire saw carriage. The main drive wheel had a “V” groove and rubber lining to grip the wire. A hydraulic motor rotated the drive wheel at a controlled rate and direction selected by the operator.

**Figure 7-2**  
**Diamond Wire Saw Cutting Tubes Through Window in OTSG Shell**

Work began in August of 2004 by trimming the cold leg nozzles from each SG to meet the envelope diameter dimension cleared for rail transport. By the end of August successful latitudinal cuts were completed across the SG tubes. No water was present in the tubes. With two men working on each SG the segmentation was performed in approximately 60 hours. The average cut rate was approximately 270 in<sup>2</sup>/hr (0.17 m<sup>2</sup>/hr.) Each SG was segmented using approximately 0.2 man-rem (0.002 person-Sv.)

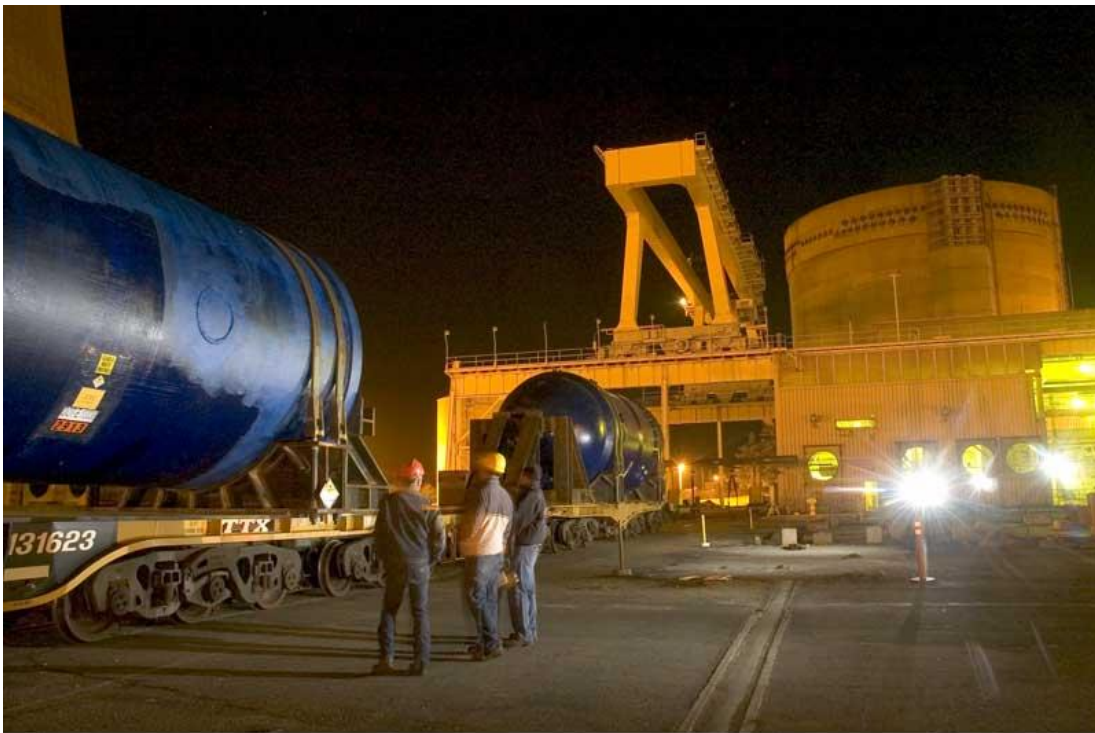
The SG sections were offloaded and placed into the appropriate disposal cell locations during the week of December 13, 2004. The QTTX railcars were then surveyed, released and sent back to Rancho Seco in preparation for the second set of SG sections.

**Figure 7-4**  
**Steam Generator Sections Leaving Rancho Seco**

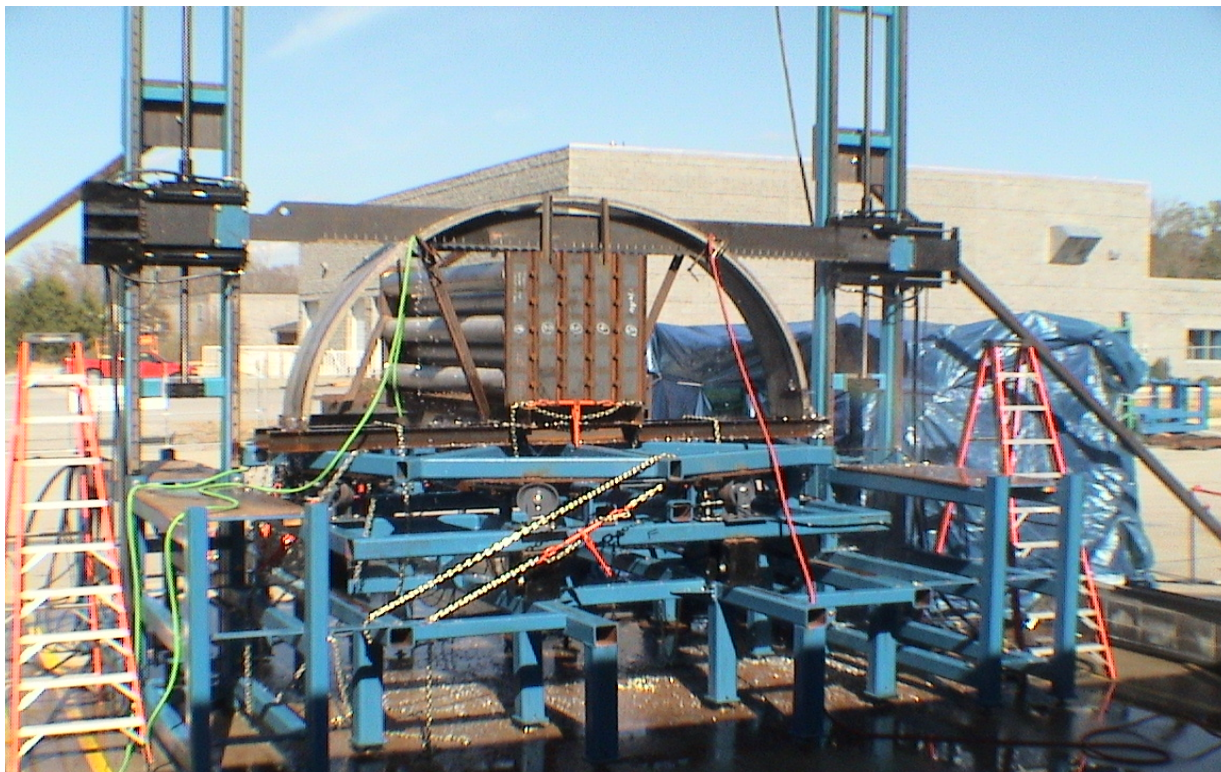
Testing of the Segmentation Tooling was performed by the vendors. Although some mockups of portions of the internals were built and cut with the tooling, the testing was primarily a tool testing program and was not a “high fidelity” mockup testing program. Since so many specialized tools are required for mechanical cutting, an aggressive testing program could tend to be more involved than with AWJ or Plasma testing methods. For example since rigidity is very critical to mechanical sawing or milling, the test piece and tool need to accurately reflect the in plant rigidity. Also sawing operations, particularly with the 18 foot (5.5 m) long blade with the RMT, failed to represent the field arrangement and accurately reflect needed rigidity. The mockups did not reflect the same combined thicknesses as the actual components being cut nor the same cutting tool and clamping mechanism (See Figure 7-8).

**Figure 7-8**  
**Reciprocating Machine Tool Mock-Up Testing**

For example, as discussed in the next section, the test program was not aggressive enough to support the successful implementation of the RMT or the cleanup systems in the actual field application.

- Testing of Reciprocating Machine Tool proved to be unreliable in terms assessing field cutting performance. This experience underscores the importance to duplicating actual field condition in the tool testing phase of the project.

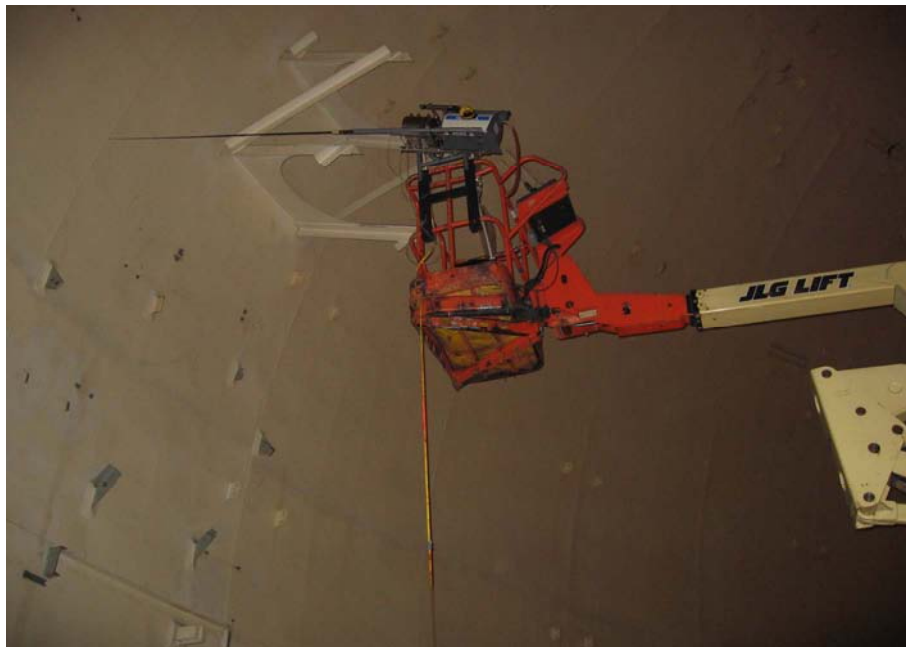
As discussed above, Rancho Seco's higher DCGLs (due to realistic scenarios associated with retained site ownership) helped to make ISOCS an acceptable alternative to scanning of the dome. Rancho Seco had decided against putting up such scaffolding in order to reduce personnel risk and to save project schedule time. The Rancho Seco approach allowed the survey of the liner to be performed with no loss of sensitivity and without having to place personnel at risk to build scaffolding upon the crane, climb the scaffolding to perform surveys, conduct remediation if necessary and then disassemble the scaffolding once the survey was complete. By employing *in-situ* gamma spectroscopy with a wireless-configured Multi Channel Analyzer (MCA), a small platform was placed on top of the polar crane which supported a remote-controlled man lift which could position the ISOCS detector at the necessary locations for performing the surveys of the dome interior surface without a technician riding the manlift (See Figure 8-1).

**Figure 8-1**  
**Final Status Survey of the Rancho Seco Containment Dome With ISOCS**

One of more successful uses of ISOCS is the FSS of the inside of the Containment Dome at Rancho Seco. Previous experience in performing the FSS of the inside of the dome at the Trojan plant involved using conventional scanning performed from a large scaffolding structure that had been constructed on top of the polar crane. This challenge along with low DCGLs made a number of decommissioning plants decide to dispose of all the above grade portions of the containment dome as radioactive waste.

The interior surface of the Rancho Seco Containment Building dome consists of the painted steel liner which extends from the spring line at elevation 115 feet (35 m) (approximately 20 feet [6 m] above the polar crane rail) to the top of the dome at elevation 158.5 feet (48.3 m.) The dome has a total surface area of approximately 1941 m<sup>2</sup>. The liner had become contaminated during plant operation and had been subsequently decontaminated.
