Strategy for Managing the Long Term Use of BORAL® in Spent Fuel Storage Pools

2012 TECHNICAL REPORT

askepri@epri.com www.epri.com **1025204** Final Report, July 2012

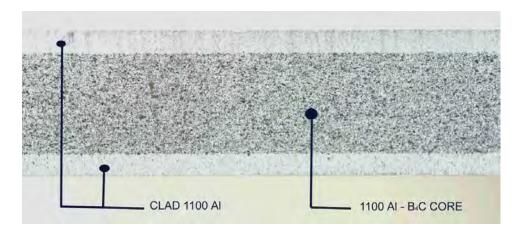
BORAL® is a hot-rolled composite sheet consisting of (1) a core of uniformly mixed and distributed boron carbide and alloy 1100 aluminum particles; and (2) a surface cladding, on both sides of the core, serving as a protective barrier. Figure 2-1 is a micro photograph of the edge of a BORAL® sample showing the core and cladding region. BORAL® has been produced with the core containing anywhere between 35 w/o and 65 w/o boron carbide. The latter represents a practical upper manufacturing limit as with 70 w/o boron carbide there are insufficient aluminum particles between the boron carbide particles to sinter and form a bonded core matrix and a sufficiently strong bond between the core and the cladding. The level of boron carbide normally in the core is greater than 50 w/o.

Figure 2-1
Microphotograph of the Trimmed Edge of BORAL® [1]

The core of BORAL® is somewhat less than maximum theoretical density and can contain varying amounts of porosity (1 to 8%). This porosity can have varying degrees of interconnectivity potentially allowing water ingress into the core. Subsequent corrosion of the inside surfaces of pores and the production of hydrogen can cause the clad to separate from the core as discussed subsequently.

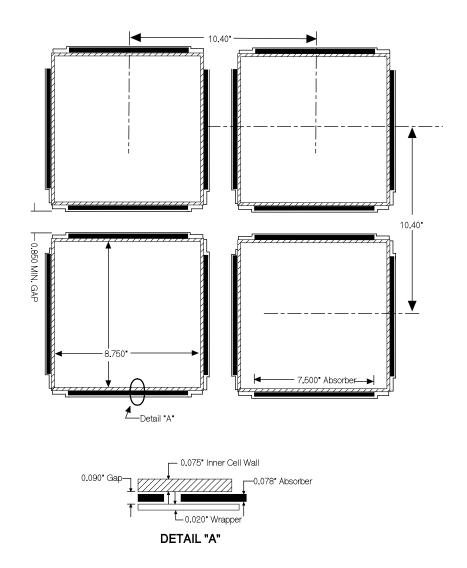
BORAL® is used in spent fuel racks in rectangular plate or sheet form typically 5.50 inches to 8.0 inches in width, 0.040 inches to 0.100 inches thick and with a length corresponding to the active fuel length (typically 144.0 inches). Either one or two plates are used between each storage cell depending on the reactivity of fuel in storage and the storage rack design. Figure 2-2 is a cross section of a typical PWR Region 1 fuel rack for high reactivity, unburned reload fuel. This design provides for two plates of absorber between each cell separated by a flux trap water gap. The latter provides for thermalization of neutrons, thus increasing the effectiveness of the neutron absorber. The absorber plates are positioned on all four faces of the stainless steel cell walls that form a storage cell and retained there by a thin gage cover plate. The cover plate is generally tack-welded to the cell wall. The individual cells are generally connected at the corners (not shown) and to a base plate containing leveling feet to form a rack.

Figure 2-2 Cross Section of a Typical PWR Region 1 Storage Cell [1]

The majority of in-service spent fuel storage racks that utilize BORAL® as the neutron absorber have a design similar to that illustrated in Figures 2-2 or 2-3. The BORAL® is captured against the rack cell by a thin wall stainless steel wrapper plate. This wrapper plate is vented to the spent fuel pool. Venting the BORAL® wrapper plate was either done as part of the spent fuel storage rack original design and fabrication or subsequently done while the racks were inservice after observation of wrapper plate deformation.

BORAL® cladding blisters may have an effect on Region 1 PWR fuel racks (Figure 2-2). The formation of intact and water tight BORAL® blisters can create voids which causes water to be displaced from the flux trap region between storage cells. Since the water in the flux trap region is used to thermalize neutrons, making the neutron absorber more effective, BORAL® blisters may result in an increase in the reactivity of the fuel/rack configuration.

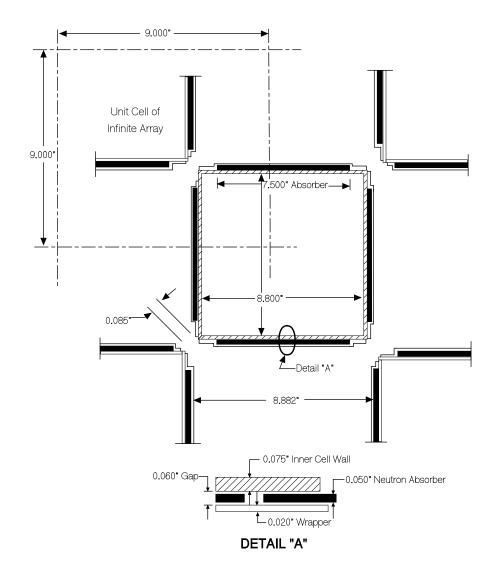
Figure 2-3 shows the cross section of a typical Region 2 PWR rack. This rack is used to store fuel of lower reactivity that has achieved a specified level of exposure. In this design, there are half as many stainless steel structural cells and resultant cells are formed by one wall of each four adjacent cells. There is only one plate of absorber between each fuel assembly in this design. The absorber plates are part of the structural cell walls in a manner similar to the Region 1 rack. As in the Region 1 design, the individual cells are connected by welding at the corners, and welded to a base plate to form a rack.

Figure 2-3
Cross Section of a Typical PWR Region 2 Storage Cell [1]

The Region 2 type rack design is also used to store BWR fuel assemblies; however, the cells have different dimensions. In the BWR design, the storage cell is approximately 6.0 inches square and the cells are positioned at a center-to-center spacing of slightly greater than 6.0 inches.

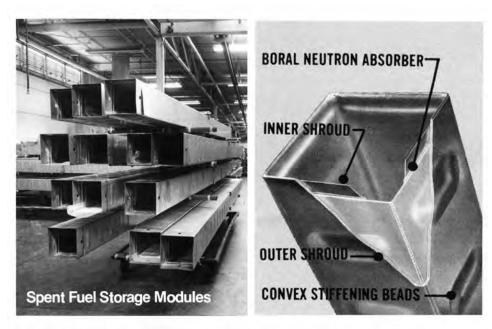
The inner and outer shrouds were constructed of either aluminum or stainless steel U elements that were seam welded along the entire length to form square tubes. The inner shroud and outer shroud were assembled with four panels of BORAL® between the shrouds on each face. The assembled shrouds containing the BORAL® were then placed in a special hydro sizing fixture. The fixture was 25 feet long and weighed 30 tons. In the fixture a hydrostatic bladder was placed inside the concentric shroud and the shrouds were expanded against a die for final sizing by hydrostatic pressure. During sizing, the shroud walls were plastically deformed and convex stiffening indents were formed in the walls to provide additional strength as shown in Figure 2-4. After sizing, the shrouds were seal-welded top and bottom providing a sealed structure that was intended to isolate the BORAL® from the pool water.

Figure 2-4
Brooks & Perkins Individual Spent Fuel Storage Modules [1]

Rack assemblies fabricated from individual spent fuel storage modules were installed in several pools, some of which are still in service today. Failure of some of the seal welds caused water to contact the BORAL® in some cells after installation. This produced the corrosion product hydrogen, and caused the module walls to deform and interfere with the fuel in storage. Brooks and Perkins subsequently ceased producing SFSMs and all rack designs are now vented to prevent deformation. The installed BORAL®, thus, is routinely in contact with the pool water.

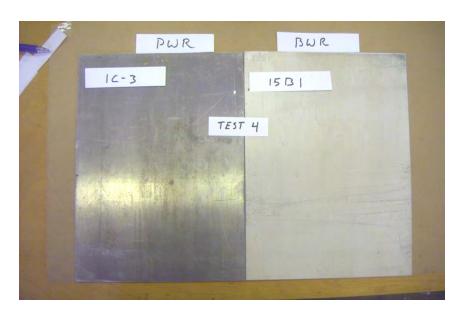
The matrix of BORAL® and alloy AA 1100 is highly corrosion resistant compared to other matrices that use other alloys of aluminum. BORAL® that is exposed to de-mineralized water, as in a BWR spent fuel pool, develops a more or less uniform oxide film. Once formed, the films serve to passivate the surface against further corrosion. In a 2,500-ppm boric acid solution, as in a PWR spent fuel pool, generalized corrosion does not occur. Figure 3-1 shows BORAL® coupons that have been exposed to de-mineralized water and a boric acid solution at a concentration of 2,400 ppm boron. The coupon exposed to de-mineralized water has a uniform light grey color characteristic of the oxide; whereas the coupon exposed to boric acid solution has an appearance characteristic of mill finish BORAL®.

Figure 3-1
Appearance of BORAL® Exposed to Boric Acid Solution and De-mineralized Water [3]

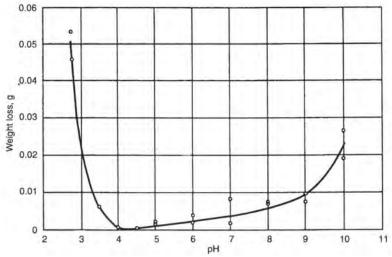
The difference in corrosion behavior in de-mineralized water and boric acid is attributable to the pH of the solution. De-mineralized water typically has a pH in the range of 6.0 to 7.0 whereas the boric acid solution is at a pH of 4.0 - 4.5. Figure 3-2 contains weight loss measurements for aluminum alloy 3004 exposed to distilled water at various pHs for one week. The pH of the water was adjusted with HCl and NaOH. These test results show that oxide formation is a minimum in the pH range of 4.0 to 4.5 and is more significant at a pH of 6.0-7.0.

Figure 3-2 Corrosion Test Results for Aluminum Alloy 3004: Weight Loss vs. pH [4]

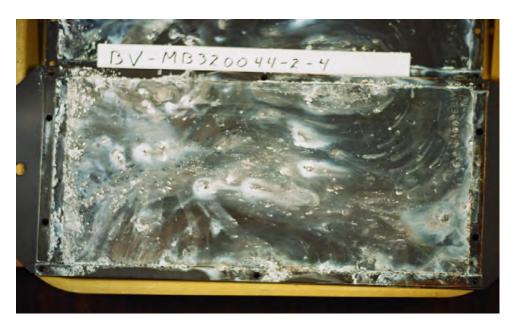
Figures 3-3 and 3-4 are macro-photographs of the front and back side of a PWR surveillance coupon with localized corrosion. This extreme example of localized corrosion is thought to be pitting corrosion initiated by residual contaminants on the surface of the BORAL® and/or impurities in the core. The local pitting corrosion was likely amplified by galvanic effects as the coupon and capsule represent two dissimilar metals separated by an electrolyte (boric acid).

Figure 3-3
Macro-photograph of BORAL® Coupon with Localized Corrosion – Front Side [1]

The pits are characterized by through-cladding penetrations surrounded by heavy white oxide deposits. A mirror image of the deposits on the coupon appear on the inside surface of the stainless steel capsules suggesting an anodic/cathodic transfer mechanism characteristic of galvanic corrosion.

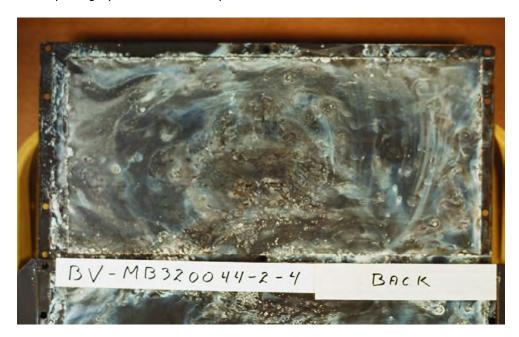
Figure 3-4 Macrophotograph of ${\it BORAL}^{\it @}$ Coupon with Localized Corrosion – ${\it Back Side}$ [1]

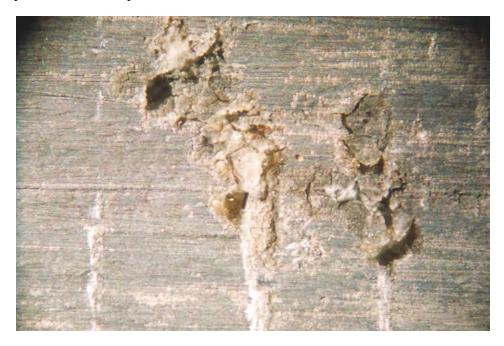
Other photomicrographs of corrosion pits and deposits are shown in Figures 3-5 and 3-6. Corrosive attack of the open edges of BORAL® have been observed in other coupons, as shown in Figure 3-7 and Figure 3-8. The edge of the coupon in Figure 3-7 appears characteristic of exfoliation corrosion that develops along the boundaries of long thin grains (caused by the rolling processing) parallel to the flat surface of BORAL®. The rust deposits in Figure 3-8 may suggest the presence of iron impurities in the core of the BORAL®.

Figure 3-5
Corrosion Pits and Corrosion Deposits [1]

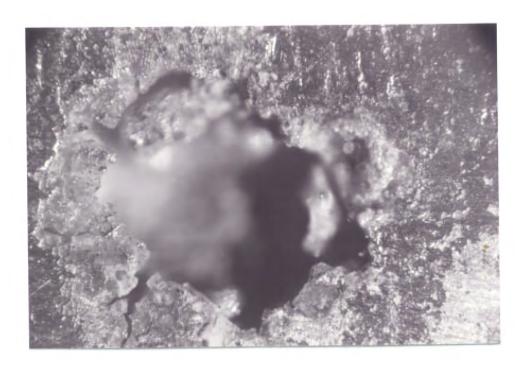
Figure 3-6 Through-Cladding Corrosion Pit [1]

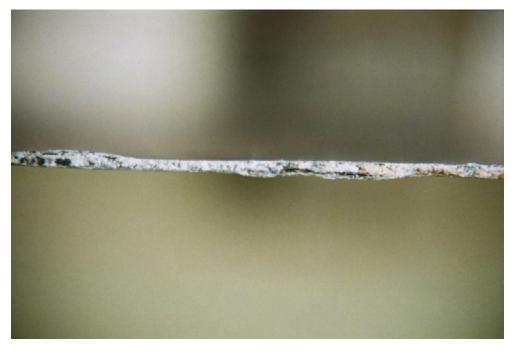
Figure 3-7 Oxidized Edge of BORAL® [1]

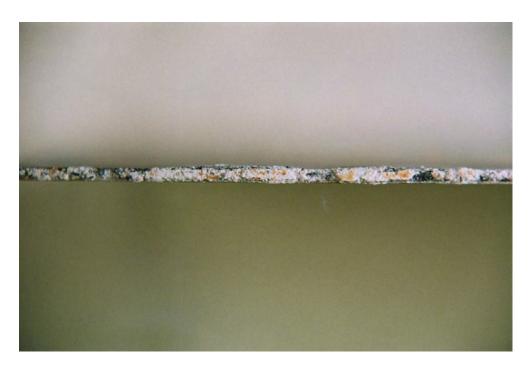
Figure 3-8
Oxidized Edge of BORAL® with Rust Deposits [1]

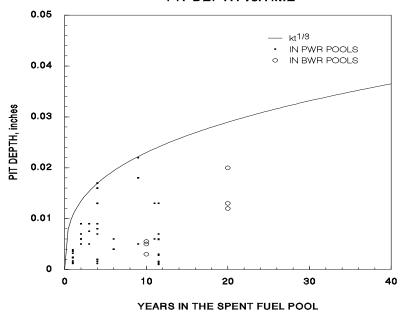
NETCO has measured pit depth of pits observed on surveillance coupons.[5] Figure 3-9 contains a plot of pit depth versus time of exposure to pool water for BORAL® pits in both PWR and BWR surveillance coupons. As the nominal cladding thickness of BORAL® is typically 10 mils (0.01 inches), a number of the measured pits have penetrated through the cladding into the core of the BORAL®. It is noted that the pit depth versus time appears to be bounded by a function of the form $kt^{1/3}$.

Figure 3-9
Pitting Corrosion on BORAL® Coupons [1]

The localized corrosion described above appears to be significant. The data points to the need for controlling impurities in both the aluminum powder and boron carbide used to manufacture BORAL®. Further, it identifies the need for complete cleaning of the surface of BORAL® after rolling to ensure that all residual oil used in the rolling process is removed. Current manufacturing processes have incorporated these improved process controls.

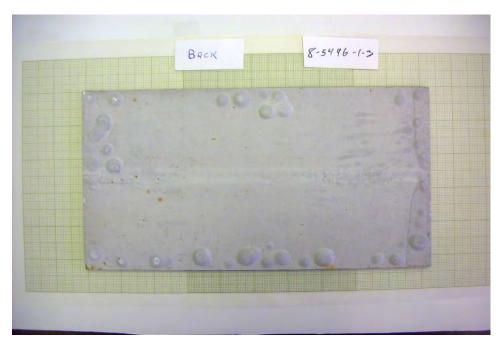
A postulated mechanism for blister formation is based on water entering the BORAL® through open porosity at the edges where the material was trimmed to size. Water in contact with the internal surfaces of interconnected pores causes internal corrosion and the production of Al_2O_3 and H_2 gas. The volume change associated with the formation of Al_2O_3 from Al causes the pores to close thus sealing H2 corrosion product and water in the core of the BORAL®. Subsequent formation of H2 and/or heating of trapped hydrogen and/or water by gamma energy from spent fuel causes an internal pressure buildup in the core. Figure 3-10 is illustrative of edge BORAL® blistering from a BWR pool.

Figure 3-10
Blister in a BWR BORAL® Coupon Manufactured in the 1970s [1]

The size and location of blisters shown in Figure 3-10 would suggest water migration in the core is restricted close to the edge of the material. This might be the case if the internal porosity was relatively low and not well interconnected.

The size of blisters and the location where they form appear to depend on when the BORAL® was manufactured and, by inference, the chemistry and process controls that were used during that period. For material manufactured in the 1970s, it has been observed that a series of relatively small blisters often formed within one inch from a cut edge of BORAL® as shown in the macro-photograph in Figure 3-10. The blisters shown in Figure 3-10 can be compared with blisters

The observation of blistering central to the BORAL® coupon would indicate that water can either migrate to the central region of the coupon core or possibly reach the core after localized corrosion has penetrated the aluminum cladding. This would indicate that the porosity of this sample is more open and well interconnected as compared to that of BORAL® made in the 1970s as illustrated in Figure 3-10.

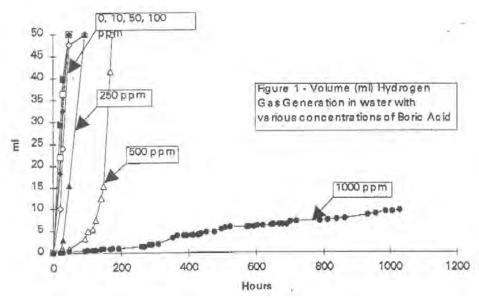
In general, blisters are more likely to occur in coupons subjected to demineralized water than those exposed to boric acid. Further, blisters that form in coupons subjected to boric acid tend to be fewer in number and smaller than those exposed to de-mineralized water. This would tend to support that corrosion product hydrogen is one factor contributing to blister formation. In the early years, AAR conducted a series of tests with powdered aluminum in demineralized water and boric acid and measured the value of hydrogen generated. Figure 3-11 contains a plot of hydrogen generation versus time in solutions of de-mineralized water and various solutions of boric acid. This result also tends to support the conclusion that generalized corrosion is reduced in PWR pools water relative to BWR pool water.

Figure 3-1 1 Hydrogen Generation from Aluminum Powder in Boric Acid [1]

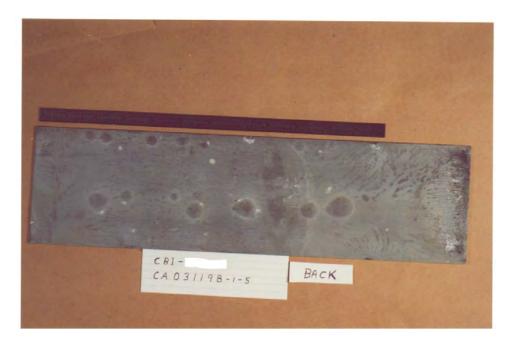
that occurred in a coupon from the same BWR pool with BORAL® manufactured in the 1990s (Figure 3-12). In this case, blisters formed along edges and in the center of the coupon as well.

Figure 3-12
Blisters in BORAL® Coupon Manufactured in the 1990s [1]

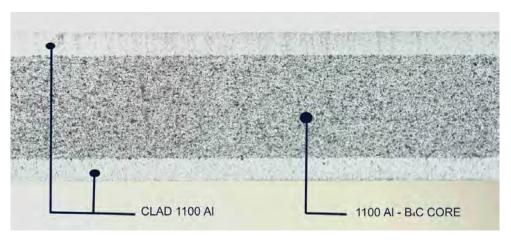
- 1. "Core" in reference to BORAL®, is the aluminum and B_4C mixture in the middle of the BORAL® composite plate. See Figure 1-1.
- 2. "Clad" in reference to BORAL®, is the outer 1100 series aluminum layer of the BORAL® composite plate. See Figure 1-1.
- 3. "Encapsulation" in reference to BORAL®, is the capture of the BORAL® composite plate within a stainless steel enclosure such as a spent fuel pool plate wrapper or coupon holder/capsule.

Figure 1-1
Definition of Core and Clad – Edge View of BORAL® Sheet [3]

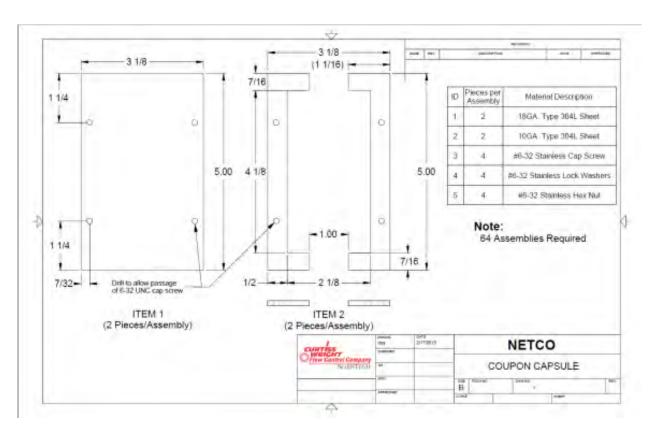
screws and nuts. The coupon resides in the volume created inside the picture frame. The inlet and outlet slots are sized to simulate the fluid exchange rate (between inner volume around the coupons and bulk pool volume) as expected in a spent fuel rack condition. For this test a minimum exchange rate of ~0.1 volumes per day was conservatively selected.

The coupon encapsulation in 304L stainless steel will also act as a bimetallic couple. Inspection of the encapsulated coupons will be via optical microscopy.

Figure 5-1 Coupon Capsules (used with permission)
