# Plant Engineering: End-of-Life Guide for Medium-Voltage Cables and Accessories

2012 TECHNICAL REPORT

**1025259**

Final Report, October 2012

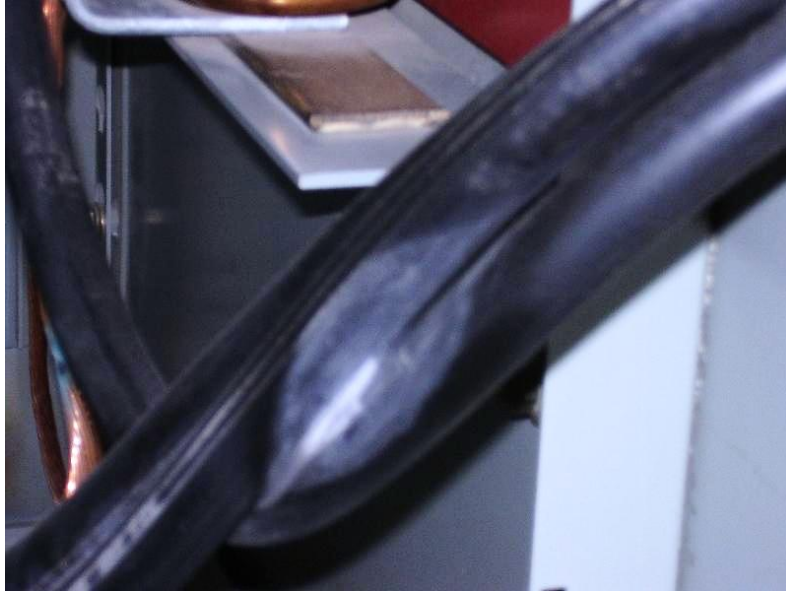
*Figure 2-1  
Partial discharge (corona) between two non-shielded medium-voltage phase conductors*

With respect to aging, non-shielded cables can be subject to partial discharge (corona) where the surfaces of two phases are close together. The partial discharge leads to erosion of the jackets and eventually the insulation and can lead to failure. Figure 2-1 shows evidence of partial discharge erosion (corona attack). The white powder in the vicinity of the area where the cables come near to contact indicates that partial discharge damage is occurring. Figure 2-2 shows partial discharge between a phase and a ground.

If such conditions are identified, the circuit should be de-energized, and the damage site inspected. Repairs should be made as appropriate, and the cables separated from each other or ground. The process of corona erosion is relatively slow, but it can cause failure in a decade or so if not corrected.

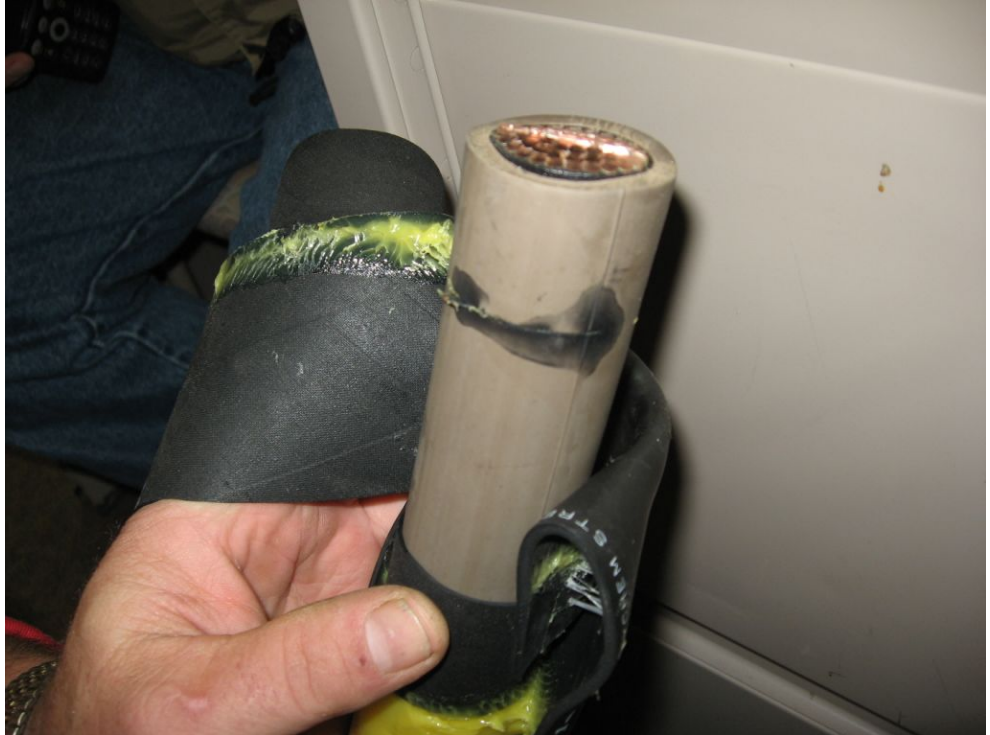
*Figure 2-4  
Damage to a newly installed cable splice that was identified by a withstand test. The black spot on the cable is where the technician accidentally cut through the insulation when removing the semiconductor shield.*

Figures 4-28 and 4-29 in EPRI report EL-5036, *Power Plant Electrical Reference Series, Volume 4, Wire and Cable* [4], show the stress levels and how a taped splice is formed to overcome the stresses. A properly made splice or termination should outlive a cable insulation system because it has thicker insulation layers than the cable itself. However, splicing errors did and do occur, from not following the manufacturer's directions for thicknesses and overlaps, as a result of cuts in the insulation or air pockets from not taping correctly, or improper heating for heat-shrinkable coverings. A small but significant percentage of splices in medium-voltage circuits have either failed or have been identified as defective during off-line electrical testing. In one case, (see Figure 2-4) a newly made splice was subjected to a  $\tan \delta$  test followed by a withstand test. The cable failed 17 minutes into the withstand test. Dissection of the splice determined that the splicer had accidentally made a through cut in the insulation while removing the shield from the cable. Feedback from the initial set of medium-voltage testing by the industry indicated that 9 of the 24 problems identified in 177 tests were splice related or about 37% of the issues identified by testing [5].

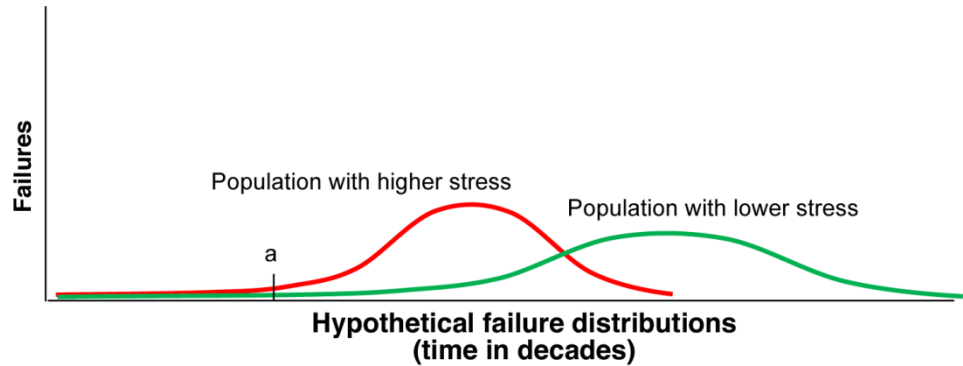
Figure 2-5 is a hypothetical case showing the effects of separating the failure distributions into subsets by stress levels such as dry versus wet circuits. The width of the age-related distribution of the highly stressed population is narrower than that for the moderately stressed population. These curves show two things: the dry population will degrade much more slowly than the wet population due to the lack of electro-chemical stresses, and both distributions are expected to be broad, although the distribution for the more highly stressed wet population will be narrower. Recent research indicates that below 65% humidity, water-induced degradation does not occur [3]. So in some environments, significant failure mechanisms related to conditions, such as wetting, cease to exist when the stress level is low. In the case of the black butyl and EPR cables, the first age-related failures that have been observed have occurred in the 30–35 year range for wetted cables [1, 6].

In Figure 2-5, these first failures would mark the beginning of the gradual increase in slope on the red curve, which is marked “a.” Figure 2-5 indicates that if all wet portions of the cable system were replaced on the basis of the first observed failure, a large amount of available service life in the original system would be lost. This would be conservative and might be justifiable in critical safety systems, but in general would be very costly.

Figure 2-5  
Failure distributions for two cable populations with different stress levels
