ELECTRIC POWER
RESEARCH INSTITUTE

Plant Engineering: End-of-Life Guide for Medium-Voltage Cables and Accessories

Final Report, October 2012

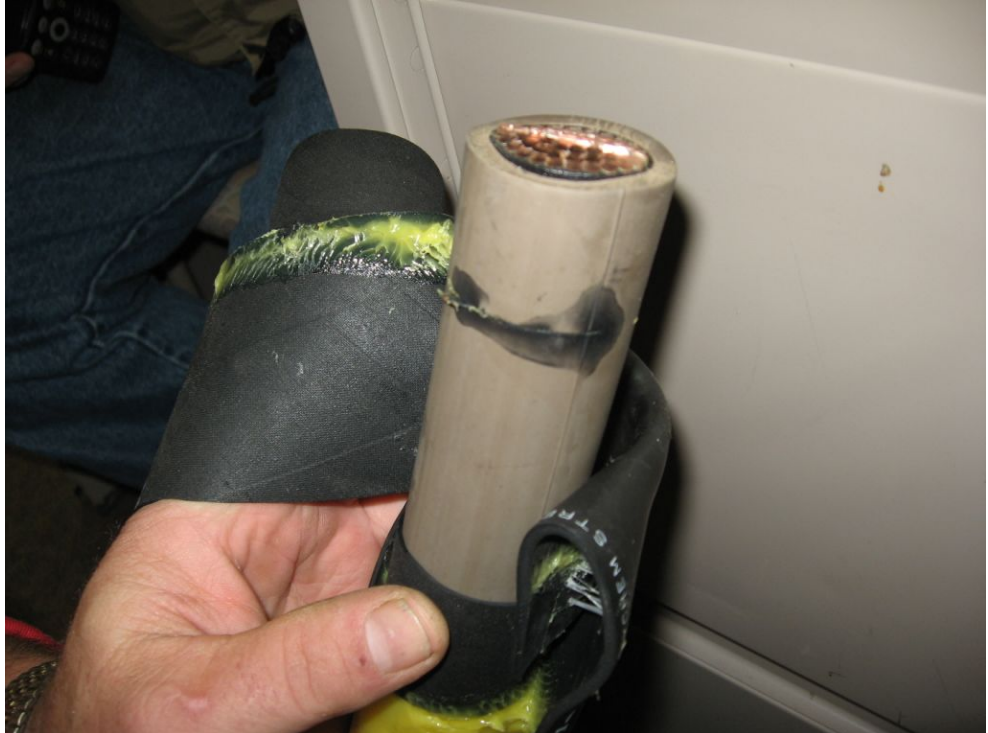
Figure 2-4

Damage to a newly installed cable splice that was identified by a withstand test. The black spot on the cable is where the technician accidentally cut through the insulation when removing the semiconductor shield.
