# **SF<sub>6</sub> Leak Location and Sealing Solutions: 2013 Update**

**3002000801**

Technical Update, December 2013

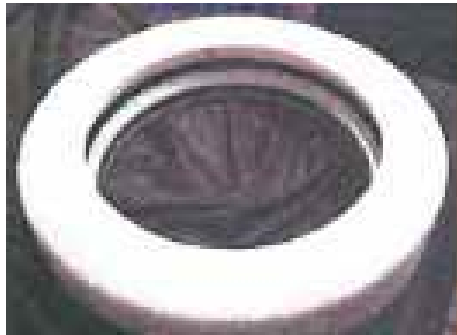
**Figure 5–1**

SF<sub>6</sub> gas 345-kV breaker bushing terminal ends are notorious for leaking where the porcelain enters the aluminum terminal end. The clamp in Figure 5-1 is made of cast nylon, and would be one style of clamp made for this repair. The clamp and cured sealant are easily removed later.

**A typical cast nylon fabricated clamp used to repair a high voltage bushing leak. The two rubber seals close on either side of the leak and sealant is injected between the rubber seals.**

The cast nylon clamp with rubber seals is designed to close on the outside diameter (OD) of the aluminum terminal end then drop down and close on the porcelain OD. This creates a barrier around the entire leaking area that can then be injected with sealant.

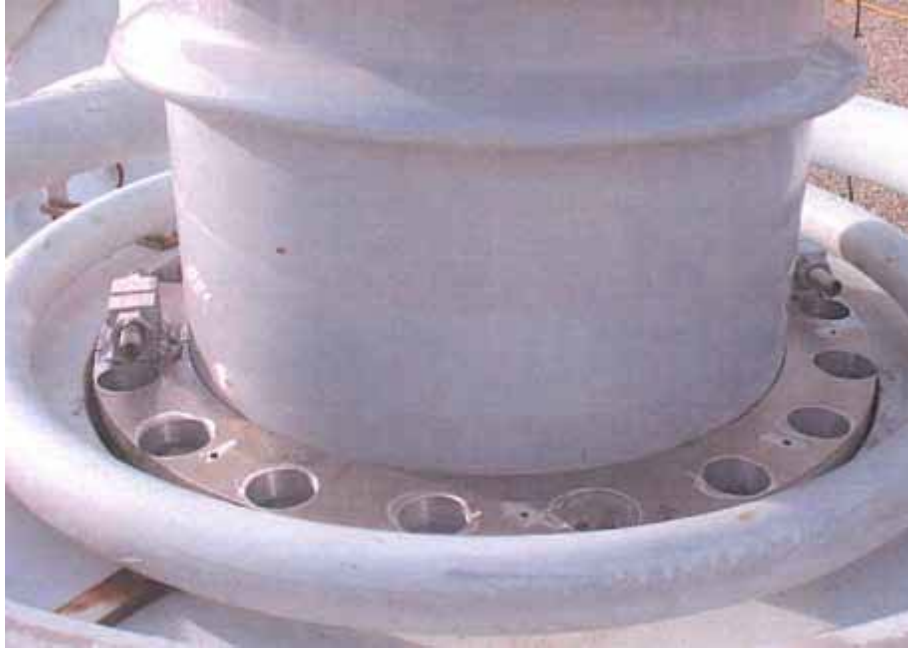
**Figure 5–2**  
**Aluminum hub clamp installed over an SF<sub>6</sub> gas leak on a 345-kVb breaker bushing.**

Figure 5-2 shows an aluminum hub clamp installed over an SF<sub>6</sub> gas leak on a 345-kV breaker bushing. The leak was located where the porcelain bushing goes through the flange. The custom-fabricated clamp has a rubber seal on the inside diameter (ID), which closes on the OD of the bushing. The clamp also has a rubber seal on the inside face. This seal is pulled up against the outside face of the existing bushing flange by using six of the existing flange bolts. This creates seals on each side of the leaking area (where the bushing goes through the flange) that encapsulate the leak. Sealant is hydraulically injected between the clamp seals for maximum penetration and compaction around the entire leaking area.

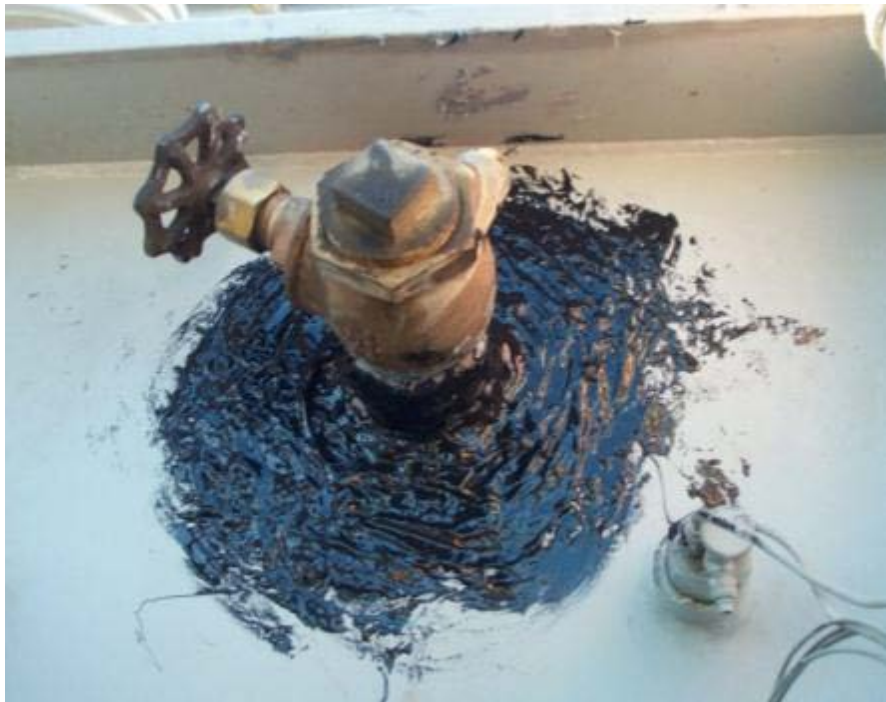
Over ten years ago, an electric transmission and distribution utility began utilizing outside specialists to seal gas leaks in their transformers and circuit breakers. Previous attempts using epoxy had yielded less than acceptable results. Use of a special epoxy mixture was attempted to seal leaks at seams, pinholes, cracks, and pipe connections. This option was easy to perform and inexpensive; however, the results were inconsistent. With proper preparation, the epoxy repairs were effective only about 50% of the time. In addition, removal of the epoxy for re-gasketing or replacement was extremely labor intensive. Figures 6-1 and 6-2 show two examples of in-house repairs.

**Figure 6-1**  
In-house repair utilizing epoxy.

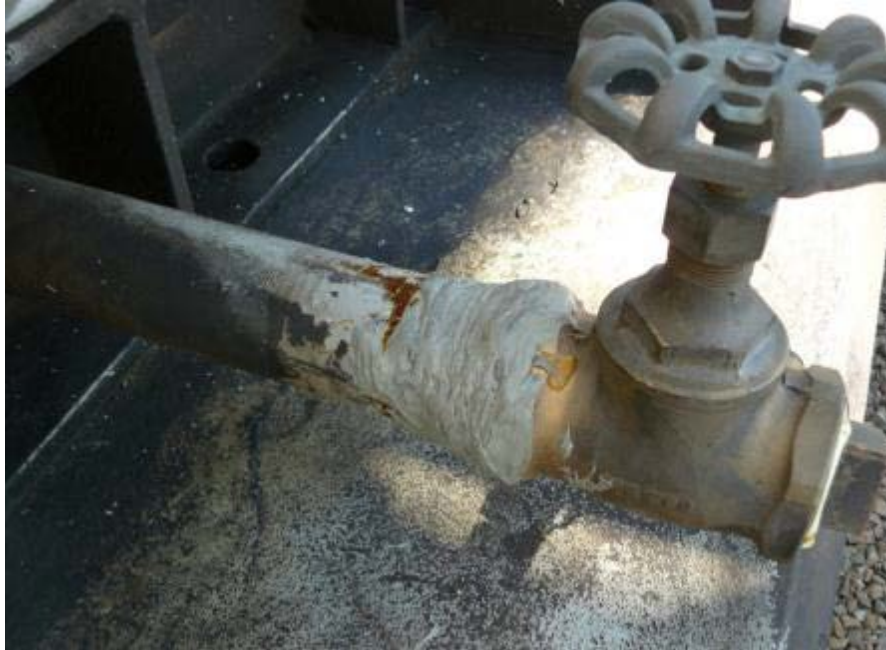
**Figure 6–2**  
**In-house repair utilizing epoxy.**

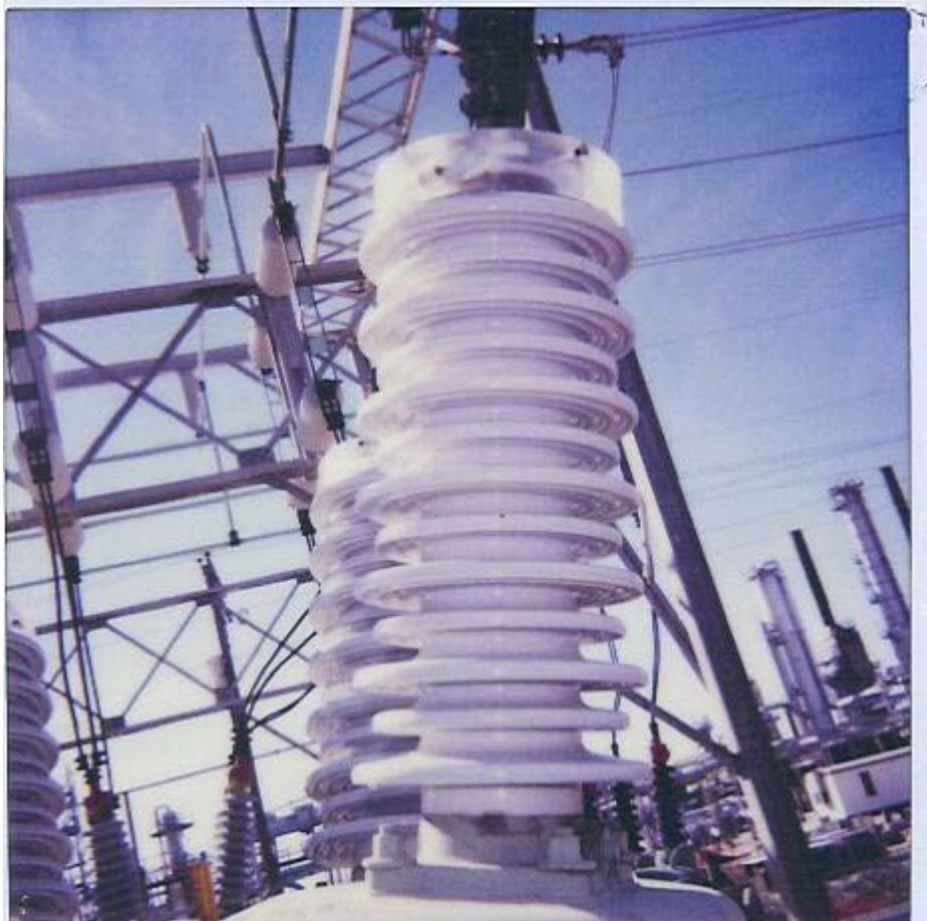
In Figure 6-3, an enclosure of nylon composite was fabricated to seal a leak at the top of a bushing. Two outages were required – on the morning of Day One, a 1-hour outage was needed for the leak seal technician to obtain precise measurements for the enclosure. The device was fabricated and overnighted to the client. A second outage of 4–6 hours was then taken to install the enclosure. Sealant is injected into a channel inside the clamp to seal the leak. The clamp remains in place and can be easily removed when needed.

**Figure 6-3**  
**An enclosure of nylon composite was fabricated to seal a leak at the top of a bushing.**

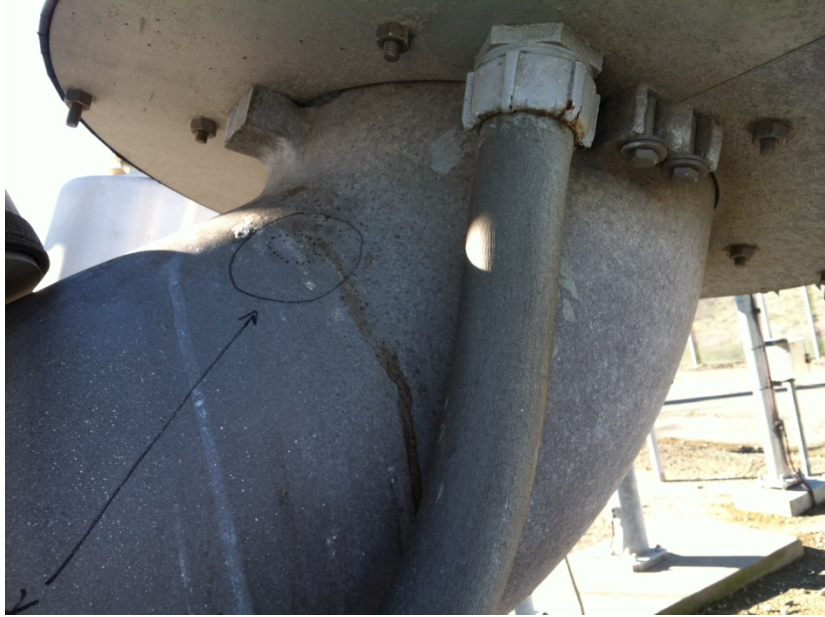
**Figure 6–4**  
**Leak is identified.**

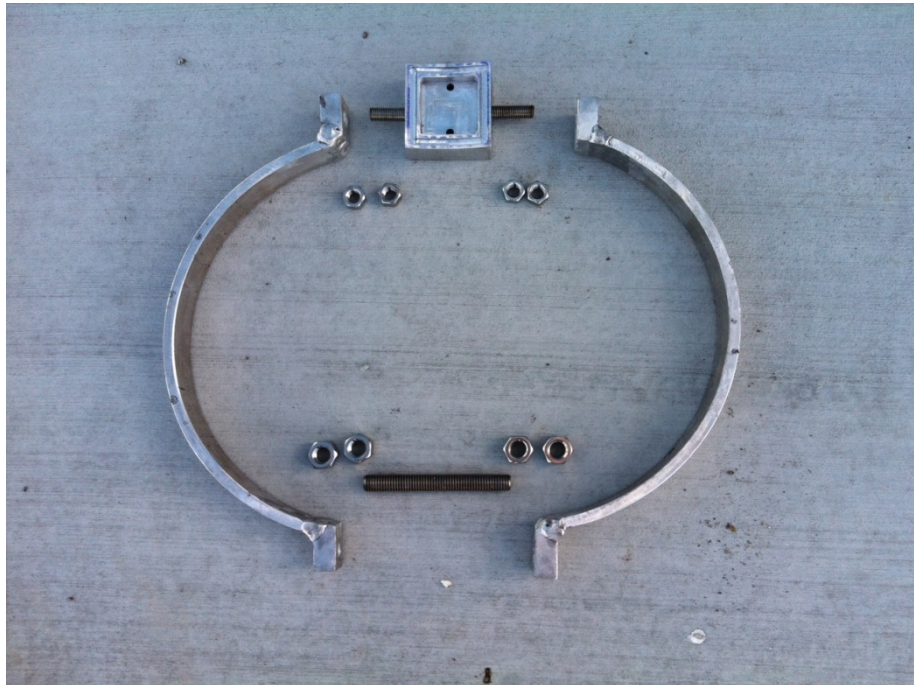
**Figure 6–5**  
**Clamp is manufactured.**

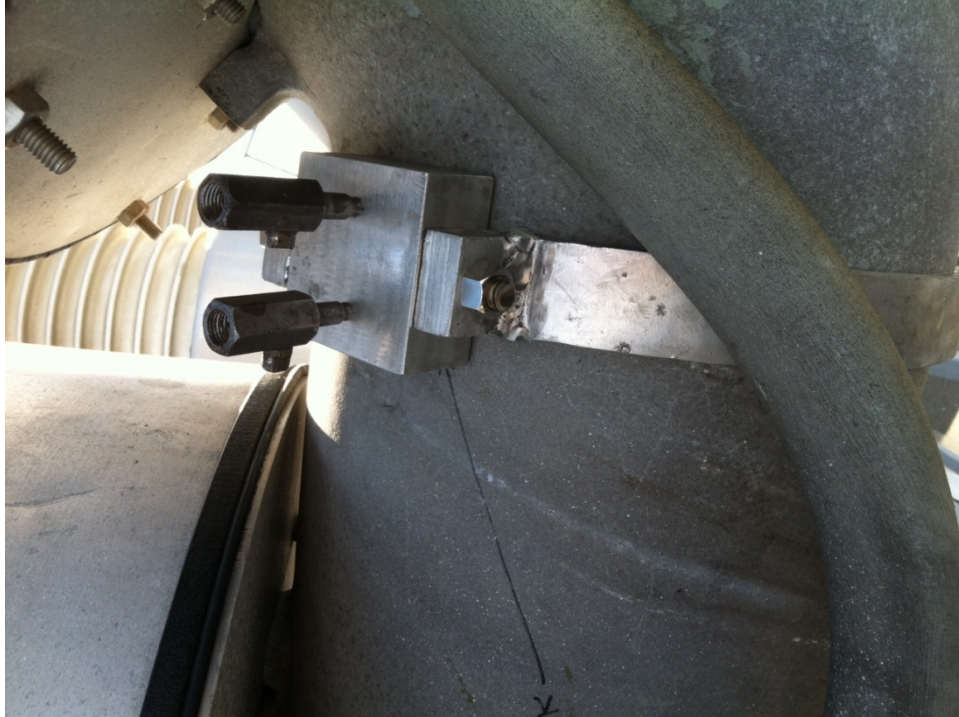
**Figure 6–6**  
**Clamp is installed over the leak with injectors to facilitate sealant injection.**

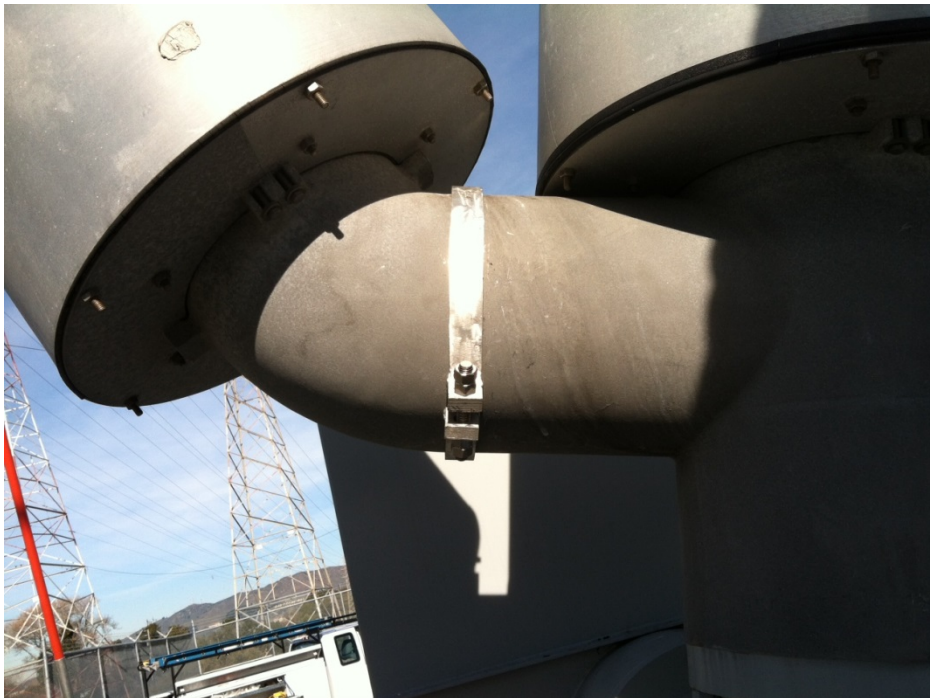
**Figure 6–7**  
**Injectors are removed and pipe plugs are installed.**

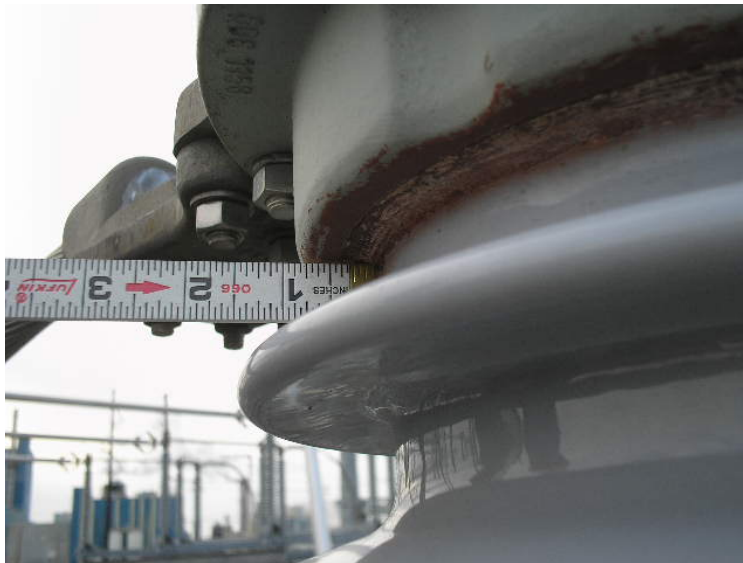
**Figure 6–8**  
Precise measurements are taken prior to designing the clamp.

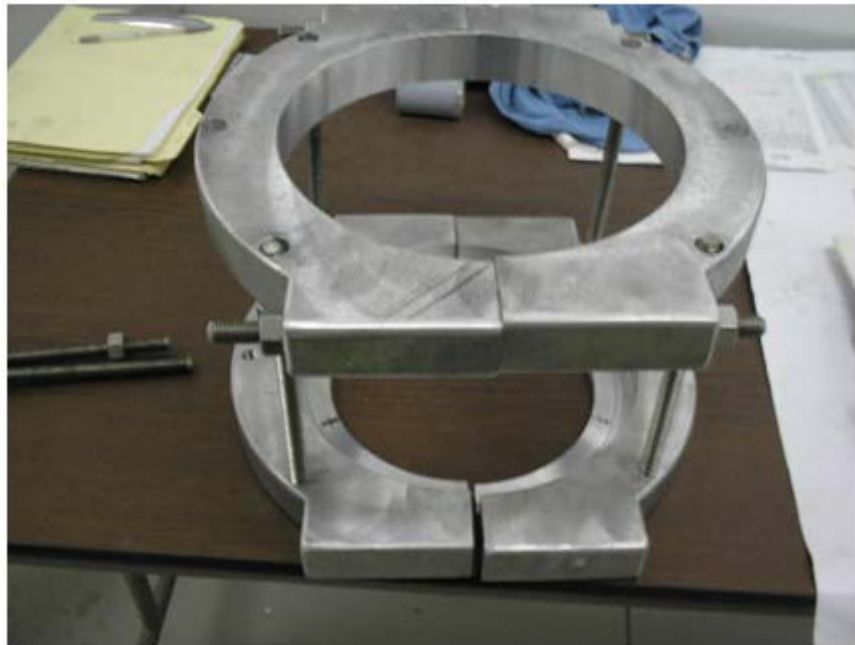
**Figure 6–9**  
The clamp is designed and manufactured.

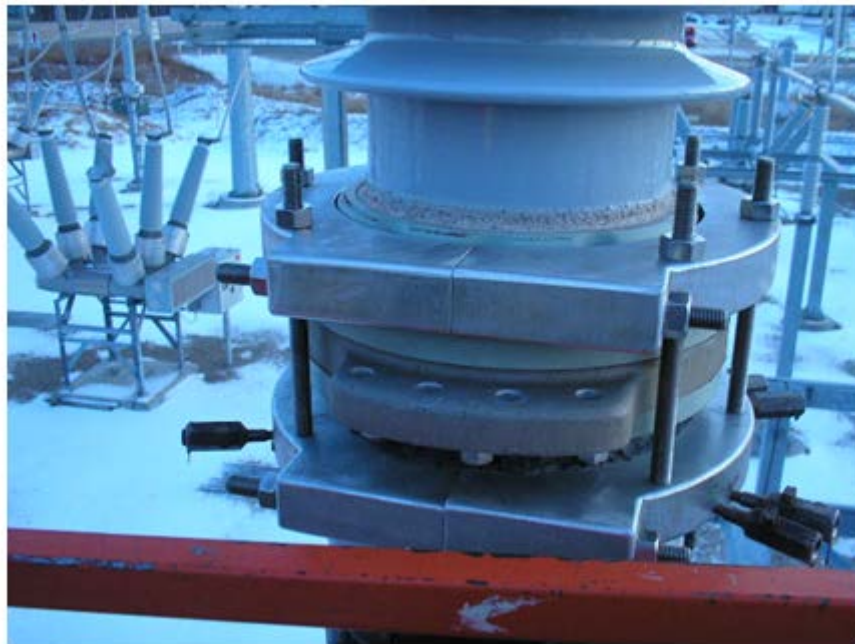
**Figure 6–10**  
The clamp is installed over the leak.
