Five Years after Initial Repair, Socket Weld Overlay at Cook Nuclear Plant Still Holding Strong

EPRI-supported socket weld repair method is proven to save money, reduce downtime, and maintain structural integrity over time.

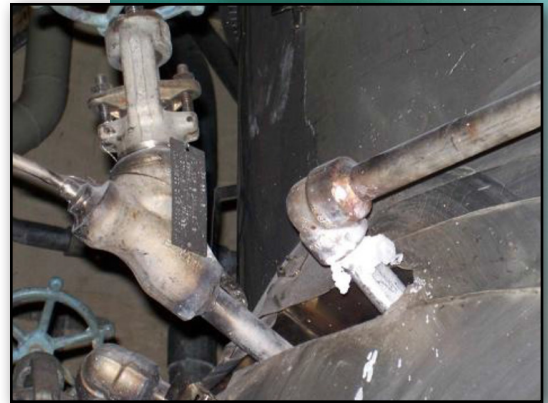
Weld overlay was applied to a socket weld in the reactor coolant system at AEP's DC Cook nuclear plant.

- First, the active leak is controlled by peening weld metal over the fatigue crack.
- Second, a weld bead is installed over the peened area to seal the leak.
- Third, the structural overlay weld metal (generally a weld metal that matches the base metal composition) is installed once the leak is successfully sealed.

By applying the weld overlay method, AEP repaired the leaking and cracked socket weld successfully without draining the reactor vessel or performing other activities needed in a traditional repair.

The weld overlay remained installed until spring of 2013 when the cantilever configuration was replaced as a part of other maintenance. Laboratory evaluation of the overlaid socket weld showed that the overlay repair performed in accordance with ASME Section XI Code Case N-666 was sufficient to prevent propagation of the 2008 crack into the repair weld through approximately three fuel cycles.
