Ground-Based Wind Turbine Blade Inspection System Successfully Demonstrated at Duke Energy Wind Farm

Wind Turbine Operators Looking for Optimized Inspection Approaches for Large Turbine Blades

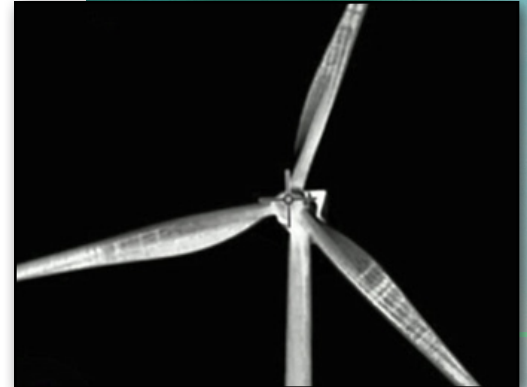
Ground-based wind turbine inspection technology can detect defects and anomalies in turbine blades while operating.

The SABRE™ system has several advantages over conventional inspection techniques for large wind turbine blades. The system inspects blades from the ground while the blades are operating. It includes a specialized, long wave infrared (IR) camera to detect slight IR emissions from structural anomalies in the rotating blades that show up as hot spots or cool spots. Acoustic spectral analysis technology uses broadband high sensitivity microphones to detect and locate lightning strike holes, cracks, and irregular surfaces. The system also includes phase imaging photography that can detect surface anomalies. The system is mounted on a sport-utility vehicle that can travel around a wind farm to inspect multiple blades and can usually inspect three blades on one turbine in less than 30 minutes.
