Method for Repair of Steam Generator and Heat Exchanger Tubing by Partial Replacement

TR-111355

Final Report
December 1998

**EPRI Repair and Replacement Applications Center
EPRI Strategic Science and Technology Program**

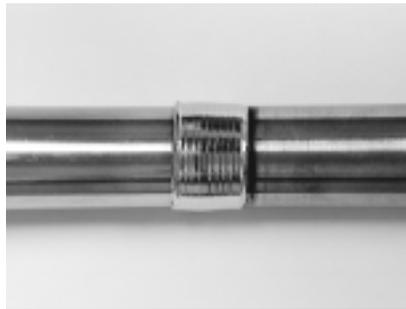
A matrix of welding parameters, including rotational rate (rpm) and laser power, was established to acquire a range of penetration through the insert into the tube material. All welds were performed at a positive 16 mm focal length, simulating the spot size of a typical ID weld end effector. A total of seven weld beads were applied to the OD inserts as seen in Figures 3-6 and 3-9. The welds were metallographically evaluated to determine the weld penetration and bead width as seen in Table 3-2. The weld penetration was significantly reduced with the circumferential welding process. Penetration ranged between .015-in. and .019-in. The penetration was affected by the rotational rate required to maintain an acceptable overlap or weld pitch at the minimum linear travel rate (0.5-in./min.) set by the equipment. Only a small increase in the penetration was observed with an increase in the laser power level (weld #7).

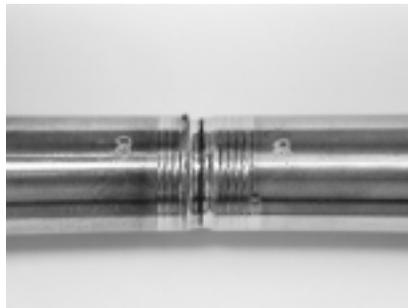
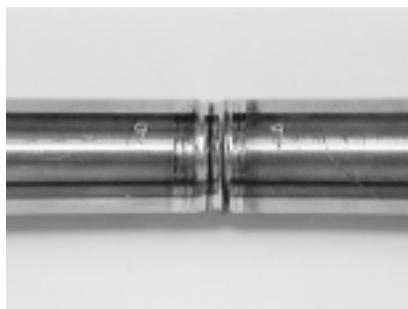
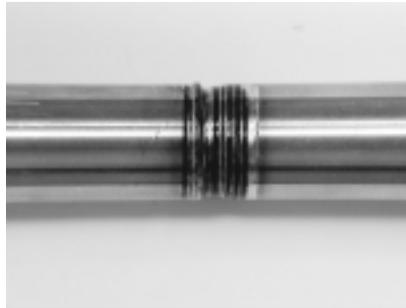
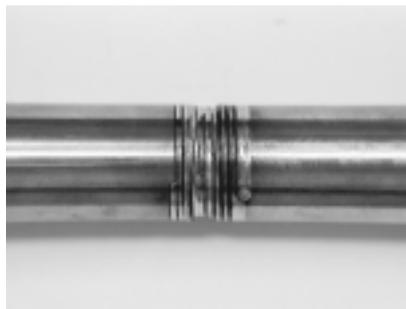
A matrix of welding parameters was established to acquire a range of penetration through the tube material and insert. A total of four weld beads were applied to the ID inserts as seen in Figures 3-10 and 3-13. All welds were performed at a constant positive 16 mm focal length, simulating the spot size of a typical ID weld end effector. Weld numbers 8 and 9 were welded with the laser beam focused on the top center of the tube (typical) and welds 10 and 11 focused the beam on the side, approximately 30° from the top. The welds were metallographically evaluated to determine the weld penetration and bead width as seen in Table 3-3. Penetration was similar to the OD weld metal inserts, ranging from 0.016-in. to 0.019-in. No improvements in the penetration were observed as a result of altering the location in which the laser beam was focused.

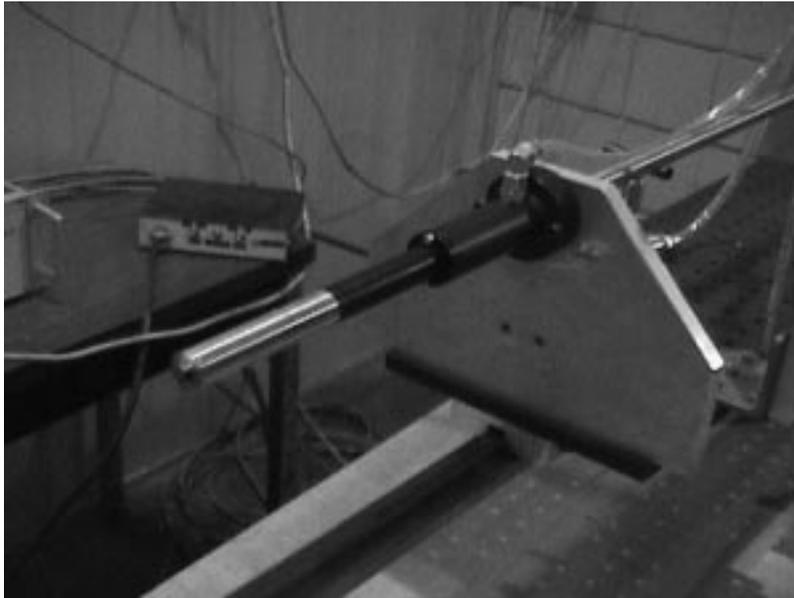
Figure 3-15
ID Laser Welding Apparatus

Welding trials were continued utilizing the standard 27° weld end effector and the modified 45° weld end effector shown in Figure 3-15. Autogenous welds were completed to establish the appropriate welding pitch (rotations per inch) for the continuous circumferential welding procedures necessary for welding inserts.

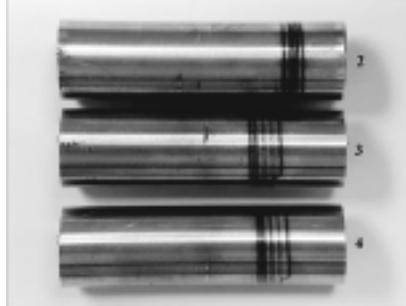
Figure 3-19
ID Weld Trials (Table 3-8)

Tables 3-6 and 3-7 compare the penetration produced with the 27° and the 45° weld end effectors at various power levels. A standard welding pitch of 15 rotations per inch was maintained for the initial welding trials. The pitch was maintained at three distinct linear travel speeds and at the corresponding rotational rate. The laser power was incrementally increased from approximately 950 watts to 1250 watts with the 27° end effector, and from 650 to 950 watts with the 45° end effector. Additional welds (3) were conducted with the 45° weld end effector at a higher pitch (40 rotations per inch) and lower laser power level (Figure 3-19).

The weld specimens were metallographically evaluated to determine the trends in penetration. An increase in penetration occurred at all laser power levels as the rotational rate decreased. This was true for both the 27° and the 45° weld end effectors. The penetration also increased with increased laser power for each rotational setting with the exception of 1250 watts at 1 ipm and 15 rpm (Table 3-6). The specimens welded at a higher pitch produced penetration between .012-.013-inches, which is significantly higher than expected for this rotational rate (Table 3-8).

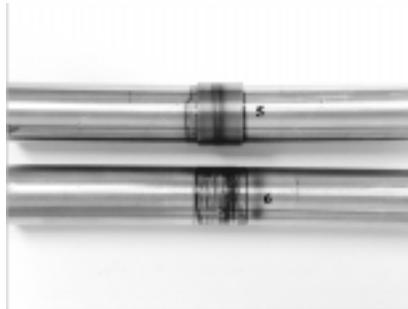
Five tube-to-tube connections were welded, as seen in Figures 3-21 through 3-24. Welds #5 and #6 (Figure 3-21) were welded with an earlier OD insert design and a modified OD insert. Welds #7, #8, and #9 (Figure 3-22 through 3-24) were welded with modified inserts seen in Figure 3-20. The length of the welds on the modified OD inserts were limited due to the distortion caused by the tack welds prior to laser welding and the overall length of the tube-to-tube connection. The weld specimens were metallographically evaluated to determine the trends in penetration (Table 3-9). The penetration of welds #8 and #9 was approximately 0.025-inches, which matches the

thickness of the insert thickness. The results indicate that the insert length and thickness need to be modified to consistently achieve penetration through the insert material into the tube material.
